**Coastal Protection and Restoration
Authority of Louisiana (CPRA)**

2012/2013 Annual Inspection Report

HWY 384 HYDROLOGIC RESTORATION PROJECT (CS-21)

March 7, 2013
Cameron Parish

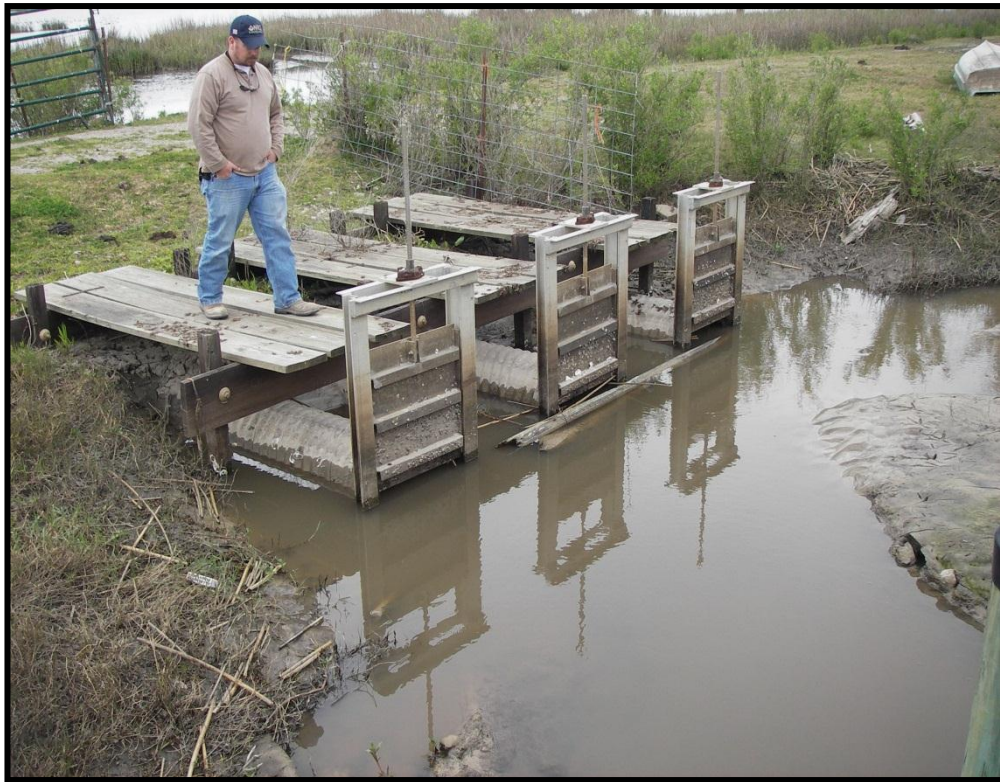
The structure is in good condition. The interior of the project area appears to have new vegetation since the last annual inspection. Mud flats were visible due to the low water level. The rock placed on the bank during the June 2002 maintenance event is stable and in no need of repair. The plastic pile caps are present and working as intended. The water elevation was at 0.21ft on the inlet side of the structure. The three sluice gates were open. Water was moving into the structure from the GIWW; however, siltation of the inlet channel is limiting the flow of water into the project area. The hyacinth fence has an accumulation of sediment and overgrowth which requires removal. It is recommended that the culverts are flushed out as well to clear any sediment which may be present. The flaps on the outlet side are choked open by rocks or debris. This will need to be cleared away for the flaps to

function as intended. The staff gauge on the outlet side of the structure is missing. The InSitu Aqua Troll 200 Sonde (Station #29r) was operational. (See Appendix B, Photos 1-4)

Photo No. 1, Structure No.1, Inlet Side- Siltation inside Hyacinth Fence

- Remove sediment in the inlet channel from the GIWW to the structure.
- Remove sediment and debris adjacent to the hyacinth fence.
- Flush the three 24" culverts to clear away any sediment present.
- Clear any obstructions preventing the flap gates from closing properly.
- Replace the staff gauge on the outlet side of the structure.
- Replace any missing wire on the hyacinth fence.
- Replace or repair any loose or deteriorating boards on the walkway to the sonde.
- Repair the levee/road north of the structure to elevation +3.5.

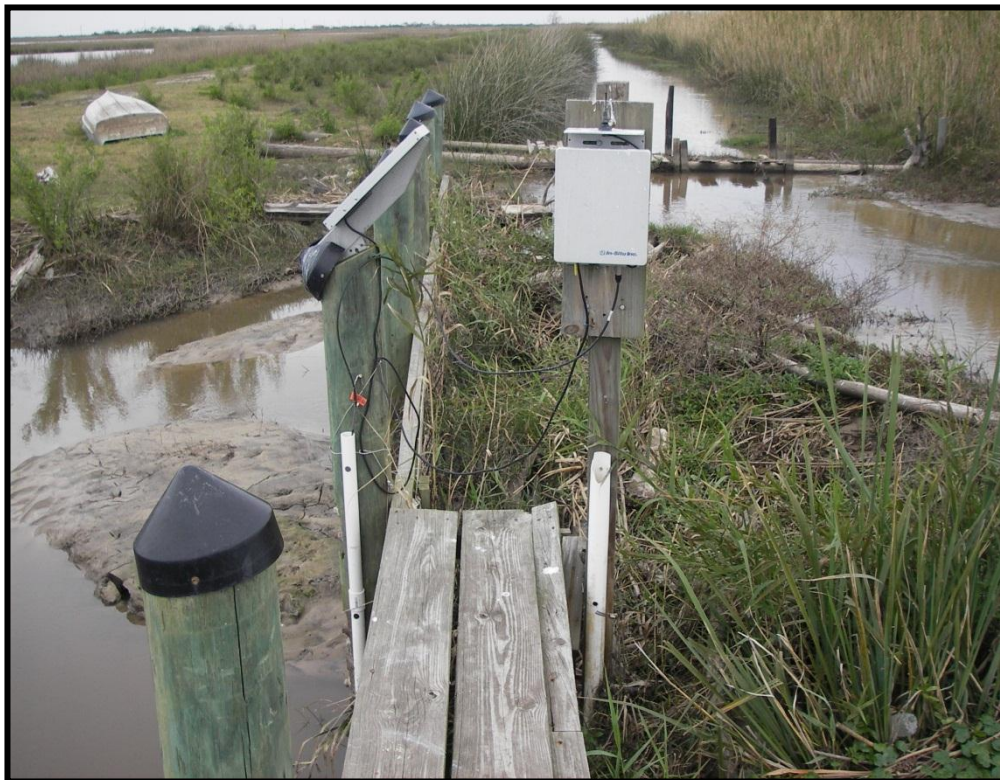
Photo No. 2, Structure No.1, Hyacinth Fence and Operations Equipment – Debris and Sedimentation around Hyacinth Fence

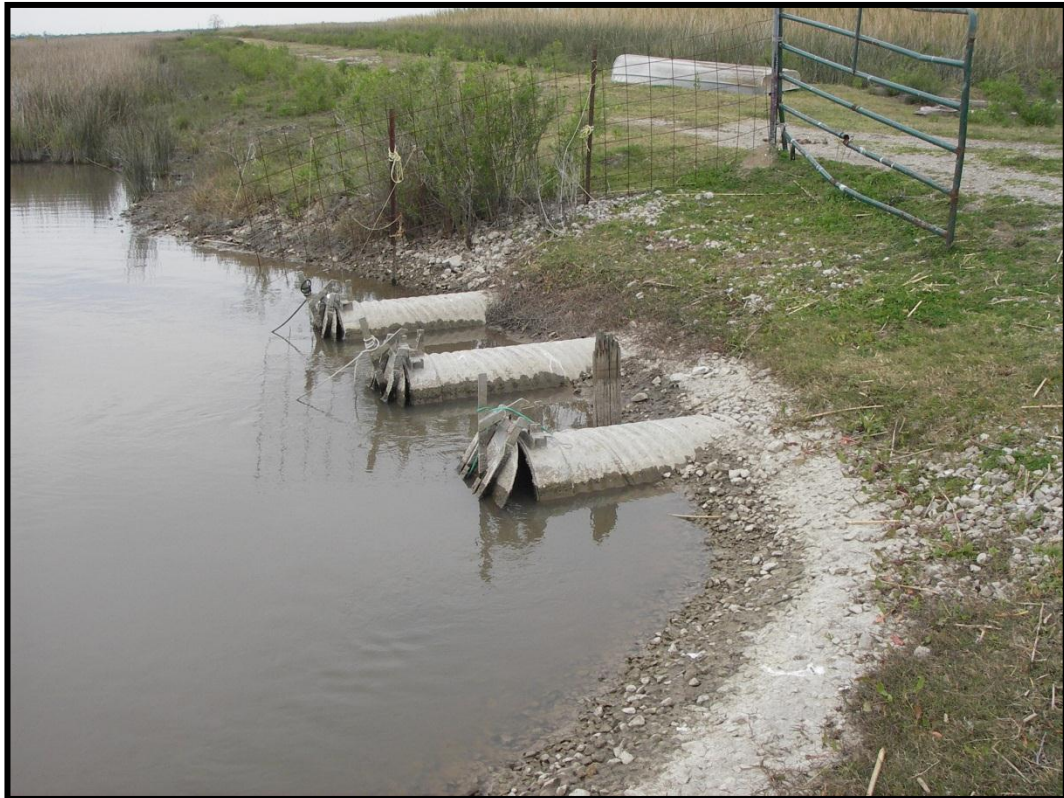
Photo No.3, Structure No.1, Outlet Side, Flapgates Open –Obstruction inside Flapgate

Item	Condition	Physical Damage	Corrosion	Photo #	Observations and Remarks
Steel Bulkhead / Caps	N/A				
Flapgates/Outlet Pipe	Good			3	Water was flowing into the structure from the GIWW. Flaps were slightly open. Will need to clear away any obstructions.
Inlet Channel	Poor			4	Then inlet channel and area near the hyacinth fence have silted in significantly and require cleaning.
Hardware/Sluiceways	Good			1	All 3 gates were open and flowing water. Flow is being restricted by sedimentation, vegetation and debris.
Hyacinth Fence	Poor			2	Debris, sediment, and vegetation have accumulated significantly since the last inspection.
Timber Piles	Good			2	
Timber Wales	N/A				
Plastic Pile Caps	Good				Plastic pile caps are present.
Cables	N/A				
Signage /Supports Staff Gauges	Poor				Need to replace the staff gauge on the outlet side of the structure.
Rip Rap embankment	Good				
InSitu AquaTroll 200 - 29r	Good				Sonde was operational.

flapgates are chocked open with something.

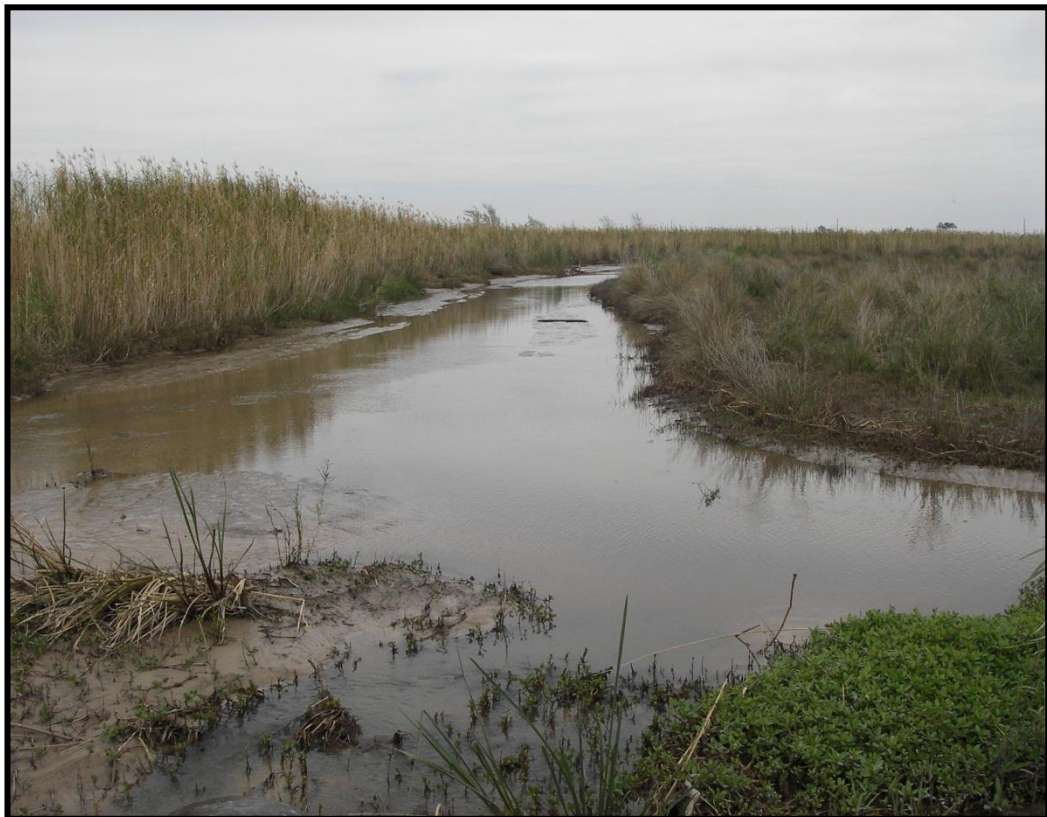
Photo No. 4, Inlet Channel to Structure No.1 from GIWW – Siltation and Vegetation

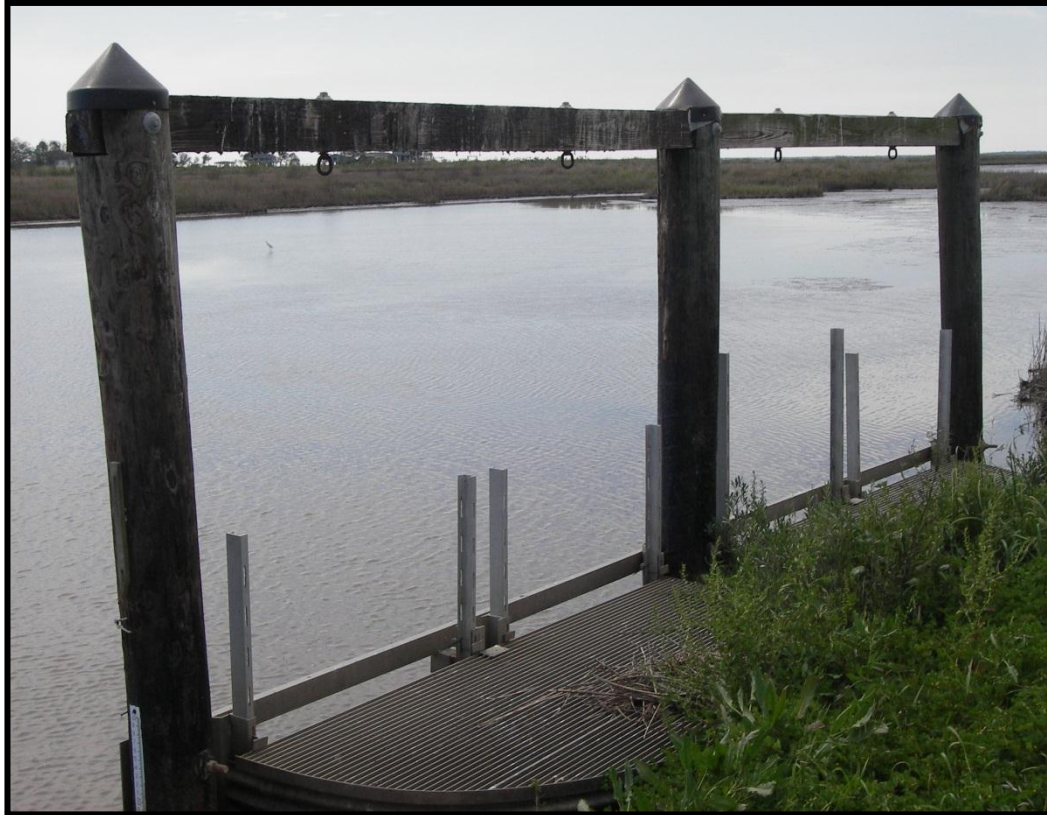
The structure is in good condition. The interior of the project area appears to have new vegetation since the last annual inspection. Mud flats were visible due to the low water level. The plastic pile caps are in place and working as intended. Rock that was placed during the maintenance of November 2000 is stable. Water elevation on the outside was at 0 ft, and the level inside was +0.1ft. Water was flowing from the project interior to the lake side. The staff gauges on the inlet and outlet side of Structure No. 12 are encrusted and difficult to read. These will be included in the proposed maintenance event. The InSitu Aqua Troll 200 Sonde (Station #15r) was operational. The road/levee (previously noted as Existing Access Road No. 1) to the structure is in good condition since it was repaired in June 2006. In addition, since the last inspection there were sections of the access road that were patched with limestone by others. (See Appendix B, Photos 5-6).

Photo No. 5, Structure No. 12, Inlet Side- Water Flowing Out to Lakeside

Item	Condition	Physical Damage	Corrosion	Photo #	Observations and Remarks
Steel Bulkhead / Caps	N/A				
Steel Grating	Good			5	
Stop Logs	Good			5	Water was flowing from within the project area to the lakeside.
Hardware/Flapgates	Good			6	Flap gate were open.
Timber Piles	Good			5	
Timber Wales	N/A				
Plastic Pile Caps	Good			5 & 6	Plastic pile caps were in place.
Cables	N/A				
Staff Gages	Fair			5 & 6	Staff gauges on the inlet and outlet side need cleaning or replacement. They are encrusted and/or covered in scum.
Rip Rap embankment	Good			6	Embankment was in good condition.
InSitu AquaTroll 200 - 15r	Good				The sonde was operational.
Access Roadway	Good				The access road was in good condition. New limestone was placed in sections on the road by others, possibly due to monitoring well work in the project area and use of the road for access.

- Clean or replace the staff gauges located on the inlet and outlet side of the structure.

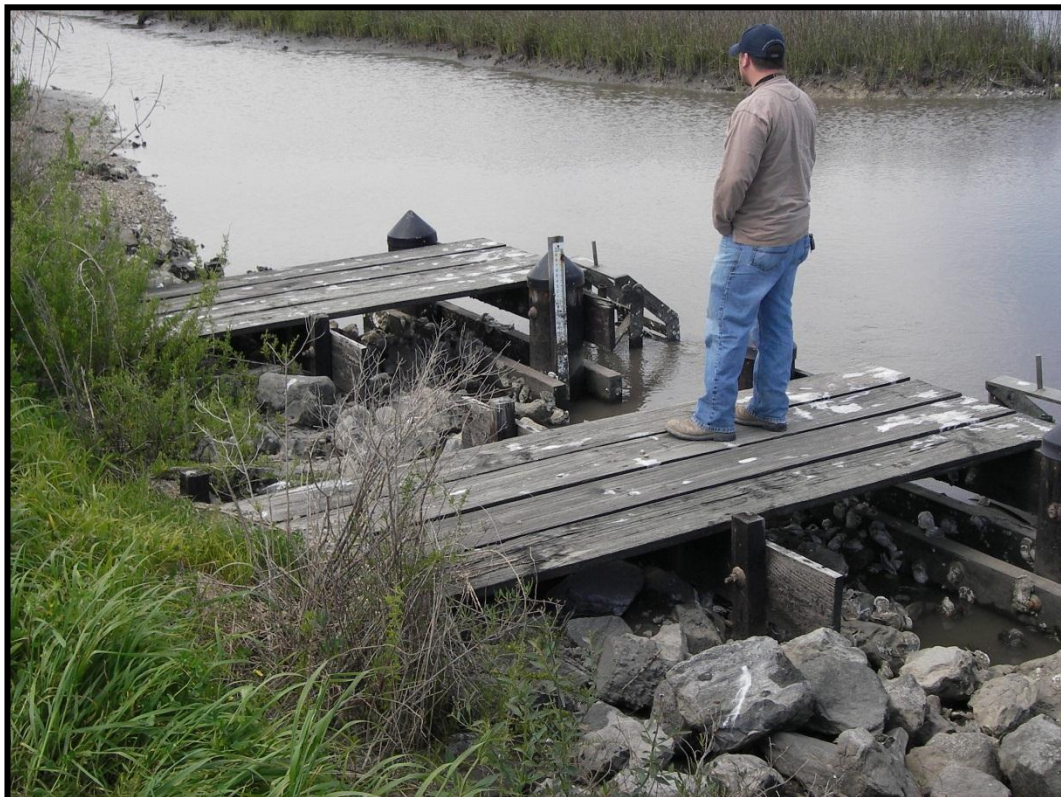
Photo No. 6, Structure No. 12, Outlet Side- Water Flowing Out to Lakeside

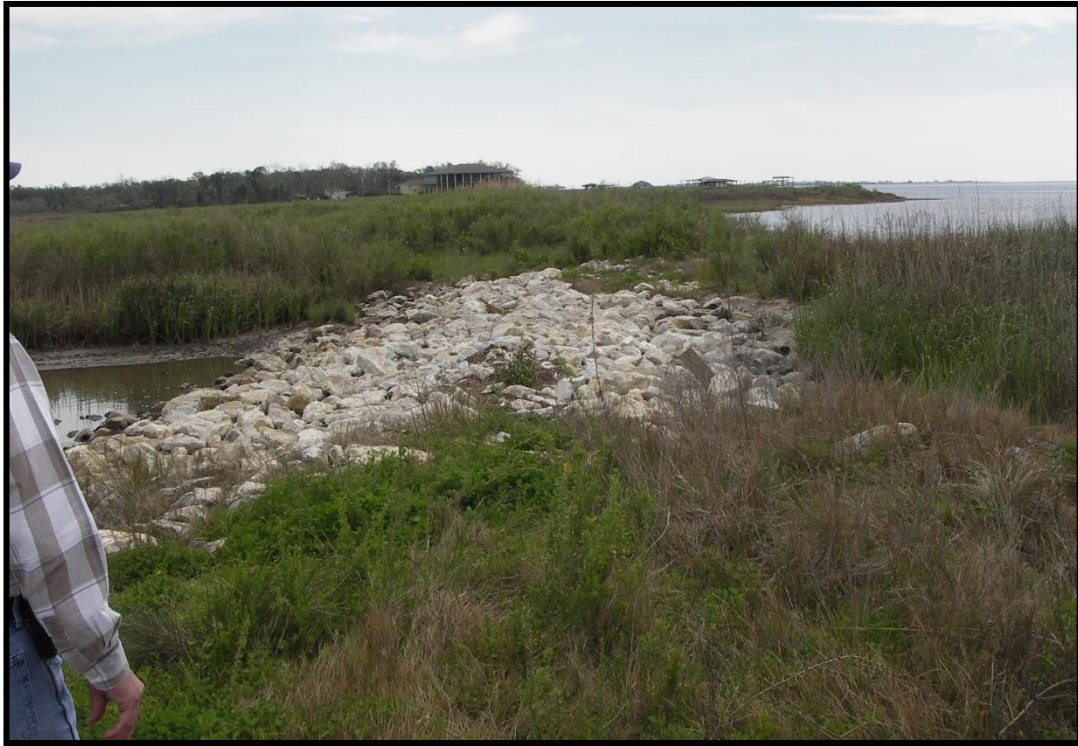
The rock plug is in very good condition. The lakeside of the rock plug has continued to silt in and new vegetation has filled in. The completed maintenance work in May 2005 to repair the plug from vandalism is stable. The interior of the project near the rock plug appears to be filling in with vegetation in locations that were previously open water. It was determined by both NRCS and CPRA that the staff gauges at this location do not need to be replaced such that there is no flow through this structure. (See Appendix B, Photos 7-9).

Photo No. 7, Structure No. 8, Rock Plug Looking South

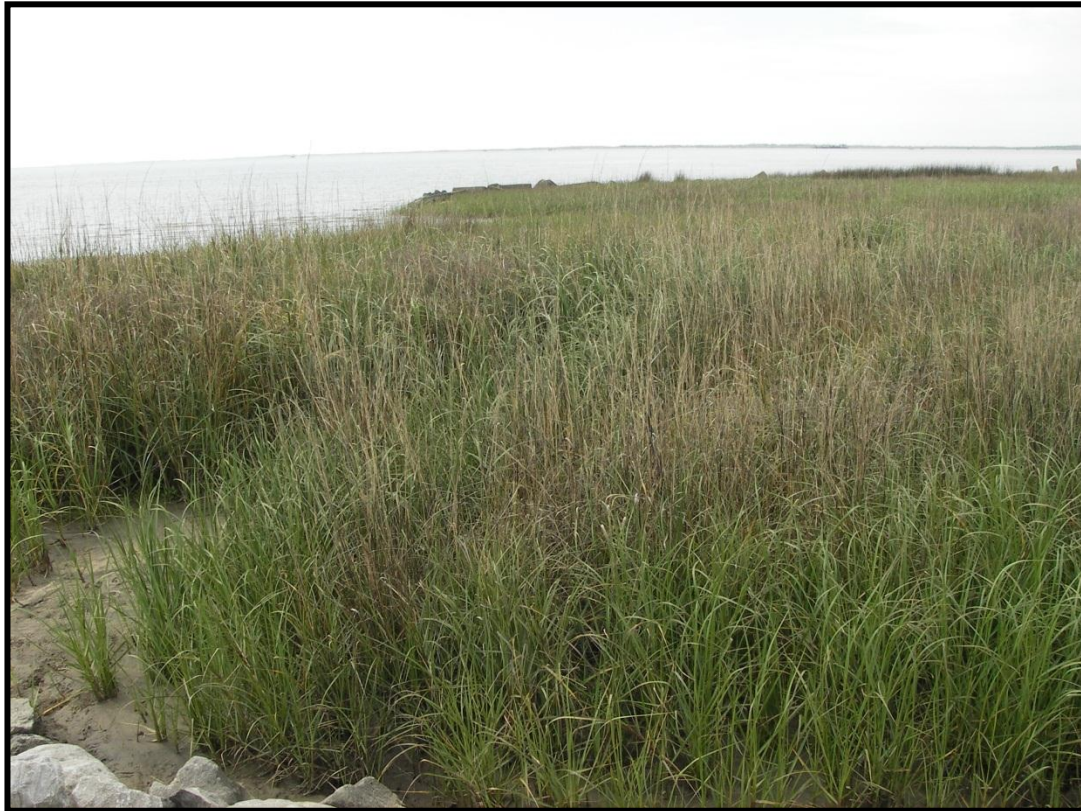
Photo No. 8, Structure No. 8, Rock Plug -Vegetation and Filling In on Lakeside

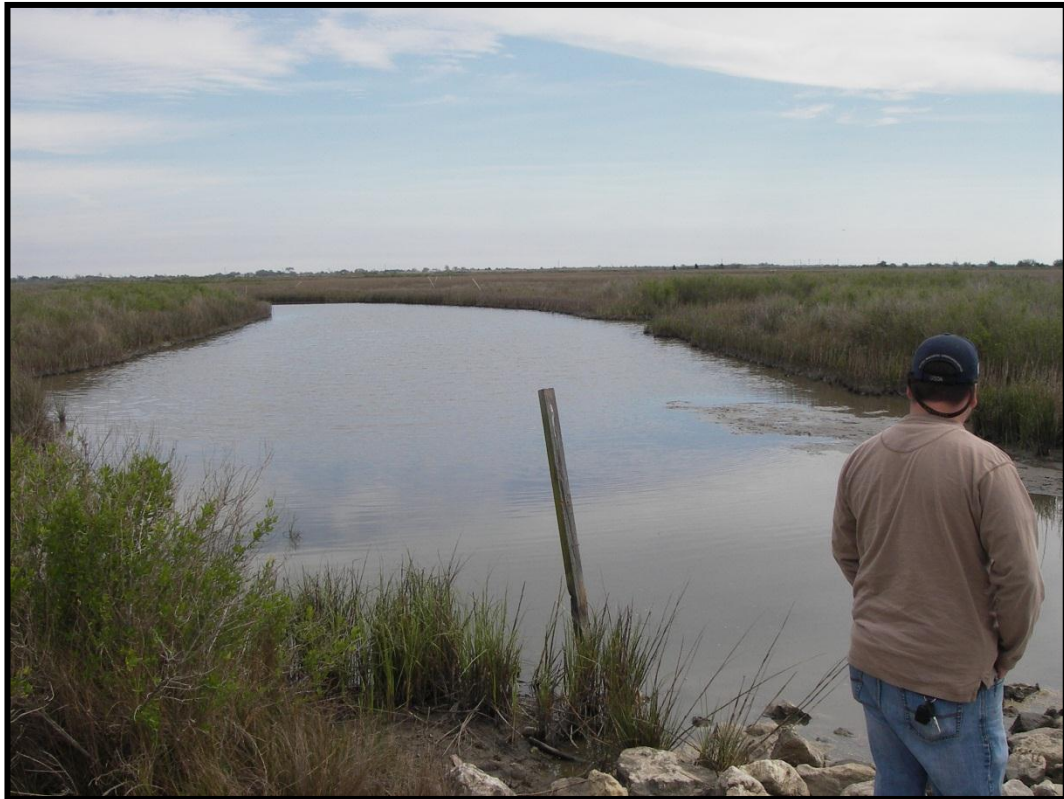
Photo No. 9, Structure No. 8, Rock Plug - Vegetation on Project Interior

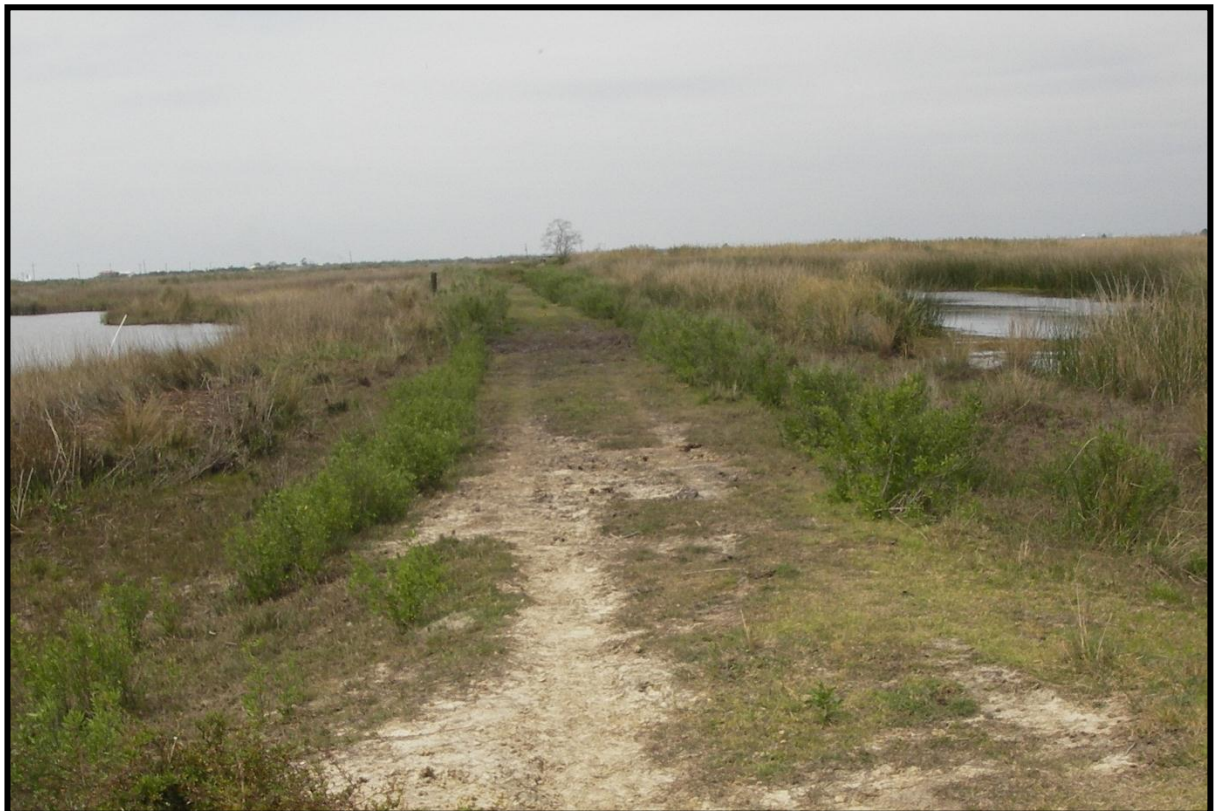
The levee/access road (previously noted as Existing Access Road No.2) leading up to the structure is in good condition since it was repaired in June 2006. Survey data and quantities have been provided by NRCS for the 1174ft repair of the access road north of Structure No. 1. The length of repair being considered includes an 86 foot section noted during last year's annual inspection report in addition to other sections of levee/road within the same vicinity which are also subject to overtopping in the future. Based on an estimated quantity of 541cyds, an incremental funding request will be made in the fall for money currently in the projected spending schedule. CPRA will move forward with tasking out E&D with funds currently available in the budget. (See Appendix B, Photo 10).

Photo No. 10, Levee/Road Section to be Repaired- North of Str. No. 1

Access Roadway	Fair			10	Levee/road north of Str. No. 1 has washed out and is overtopped at high tides. Other portions of roadway are in good condition where prior repairs had been made.

Good where previously repaired. New area north of structure has eroded and needs repair.
