**2012/2013 Annual Inspection  
Report**

**GIWW BANK STABILIZATION  
PROJECT (PERRY RIDGE TO  
TEXAS (CS-30)**

State Project Number CS-30  
Priority Project List 9

June 13, 2013  
Calcasieu Parish

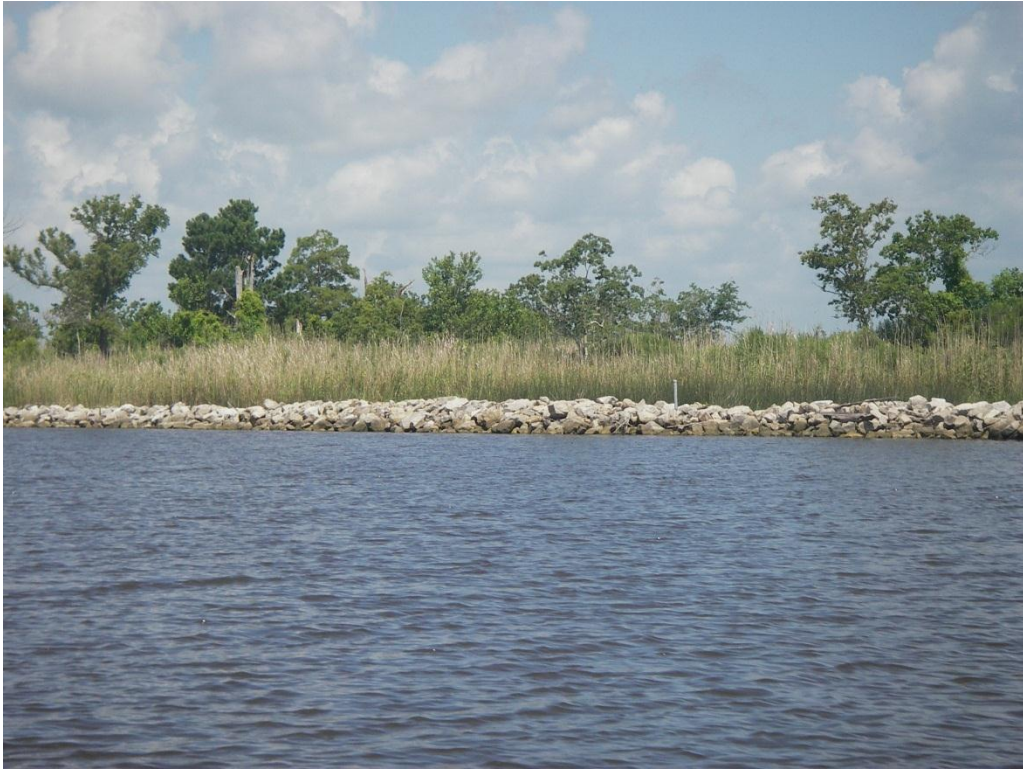
The dike is in very good condition. (Appendix B, Photo 1) As noted on prior inspections, there is one section of the dike where rock has been displaced by a barge. The condition has not changed and will continue to be monitored. (Appendix B, Photo 2) A second location was noted where it appears rock has been moved creating a 7 foot gap in the rock dike (Lat/Long N30° 03' 34", W93 ° 41' 16"). A breach has formed in the 320' earthen plug located behind the foreshore rock dike. Water is channeling through the breach in the earthen plug into the marsh creating a fairly substantial current behind the dike. (Appendix B, Photo 3-4).

**Photo No. 1, Typical Rock Dike**

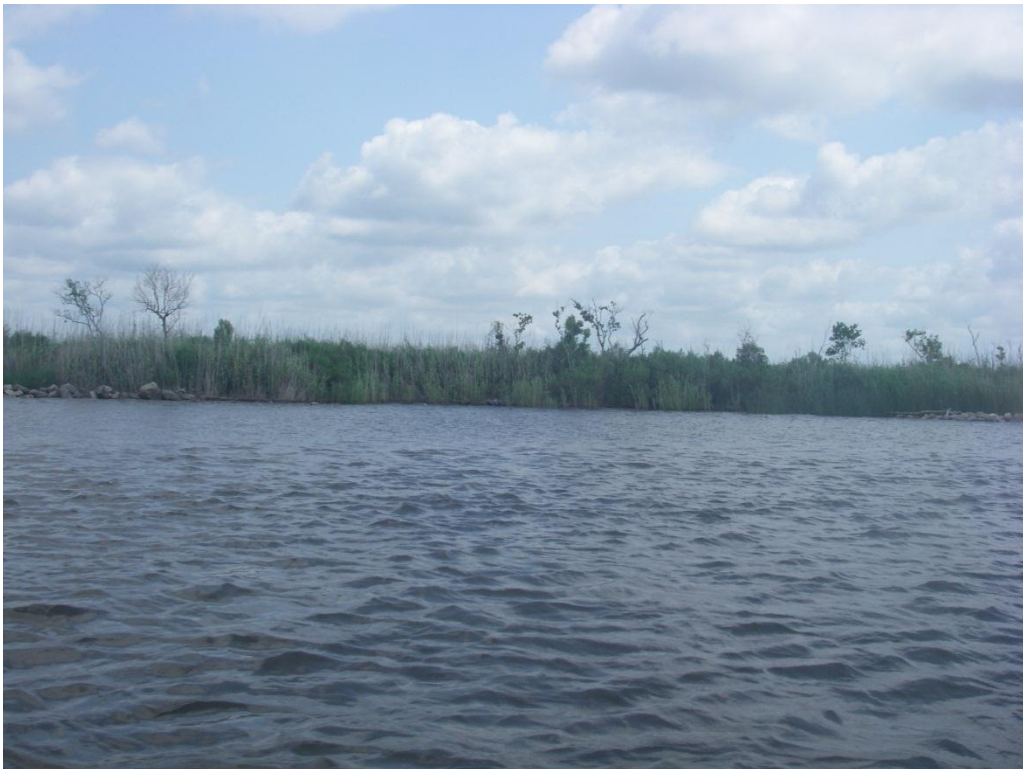
**Photo No. 2, Low Area of Displaced Rock Dike**

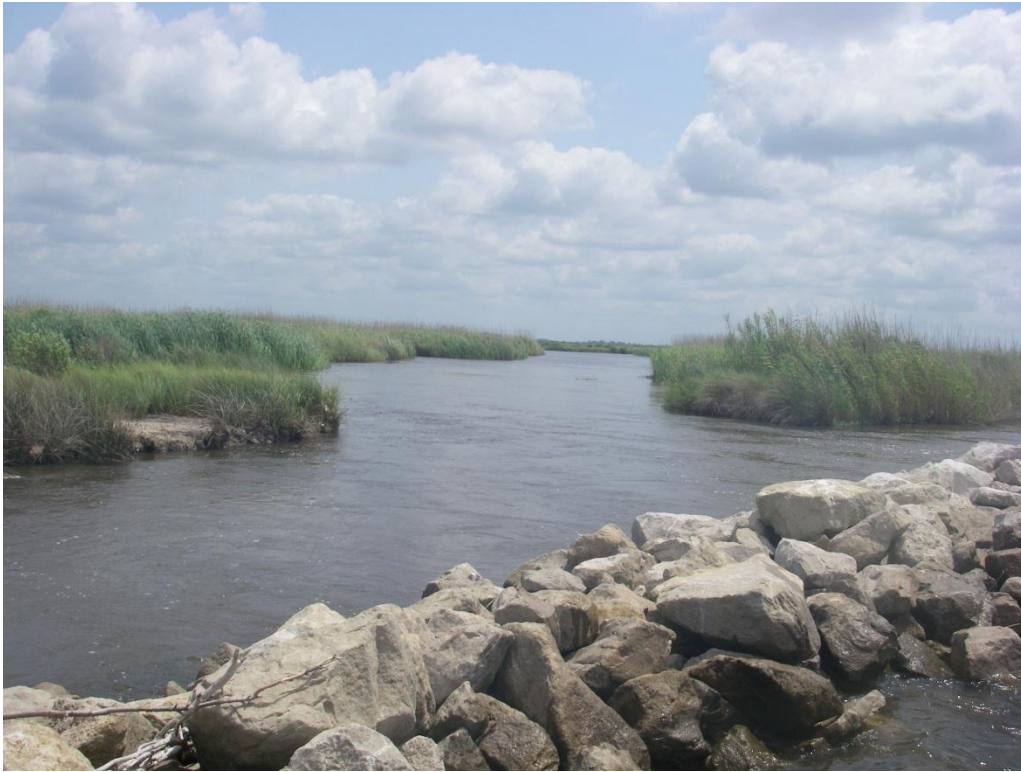
**Photo No. 3,** Gap in Earthen Plug behind Rock Dike, Water Flow Channeling into Marsh

Overall, the Perry Ridge West Bank Stabilization Project is in very good condition and functioning as designed. A maintenance event to address the breach in the earthen plug has been initiated by CPRA. Lonnie Harper & Associates Inc. has completed the surveying and engineering services necessary to prepare a final design report for the proposed repair of the breach. Incremental funding to address the breach will be requested at the October 10, 2013 CWPPRA Task Force Meeting.

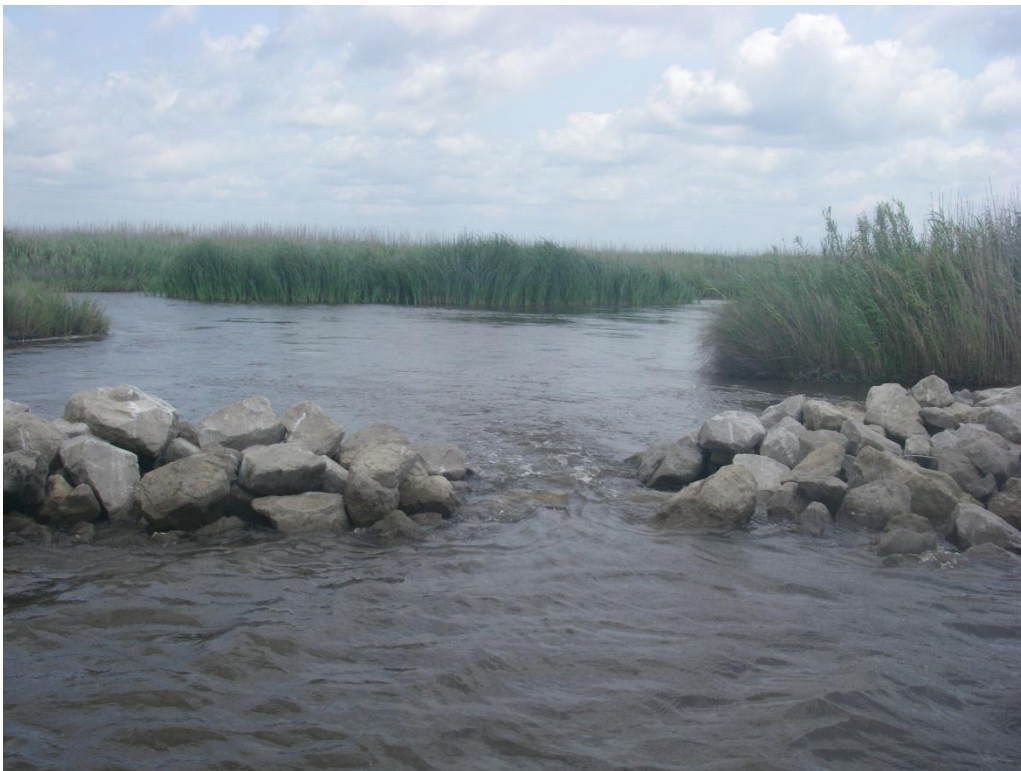
**Photo No. 4,** Water Flow through Displaced Rock Dike, Water Flow Channeling into Marsh
