**2014 Annual Inspection Report**

**DELTA MANAGEMENT AT  
FORT ST. PHILIP  
(BS-11)**

State Project Number BS-11  
Priority Project List PPL-10

June 17, 2014  
Plaquemines Parish

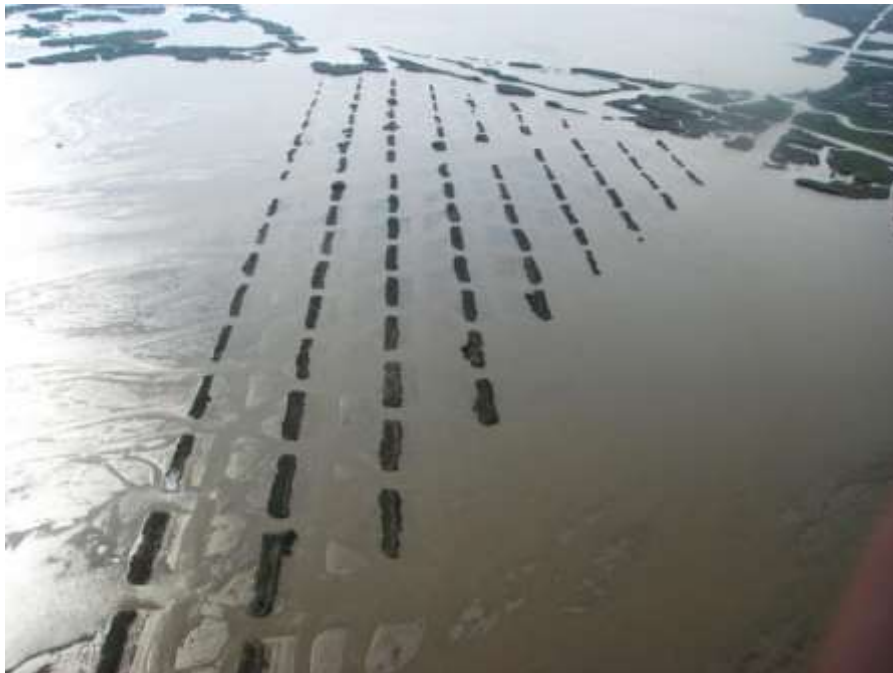
**Terrace Field (12/08/2011 Stock Photo)**

- A. Terraces: Due to shallow water adjacent to the terrace field and draft limitations of the vessel, detailed inspection of the terraces was not possible. As viewed from the receiving area at the outfall of Crevasse 1A, vegetation appeared to densely cover each terrace.

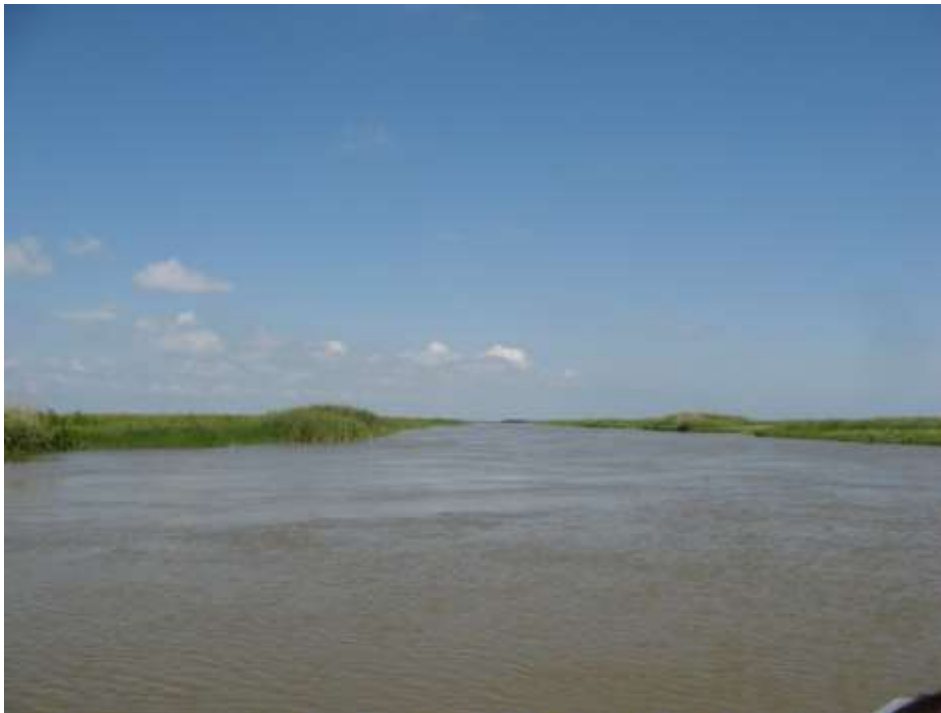
- B. Crevasse No. 1A: This crevasse is the longest of all, and funnels river water directly into the Bay Denesse terrace field. Currents through this crevasse were moving swiftly and appeared to be carrying a significant sediment load. The November 2011 survey indicates that this crevasse has deepened since construction.

**Crevasse 1A with Terrace Field in distant background**

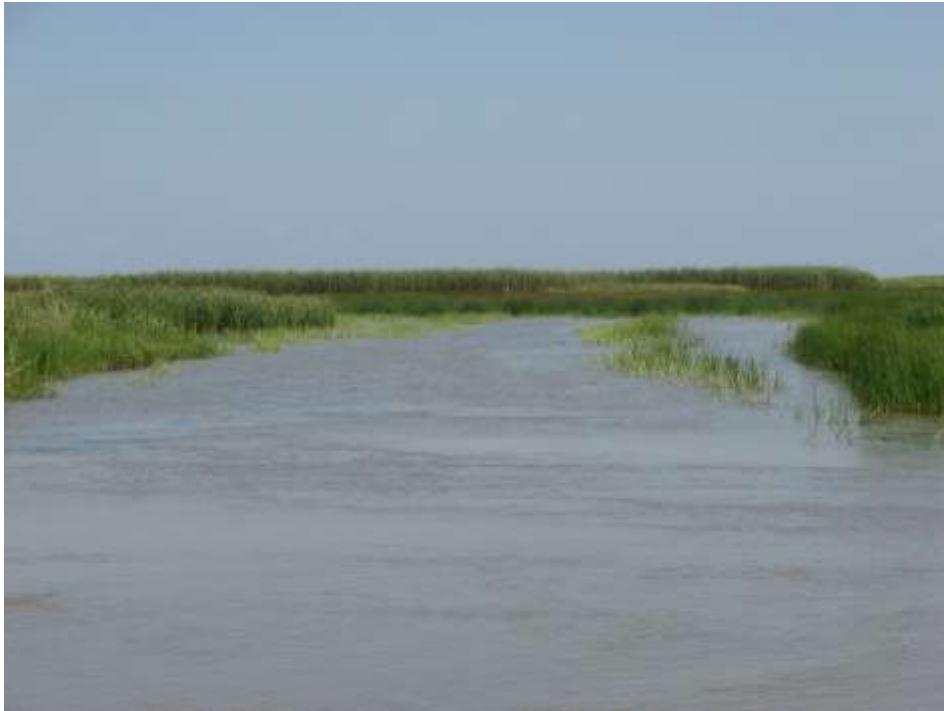
**Crevasse 1B**

- C. Crevasse No. 1B: This crevasse, which is the shortest of all, feeds a small area of marsh. Channel depth was shallow, but flow was maintained. Thick growths of marsh grass were observed on the channel banks and within the receiving area beyond the channel outfall.

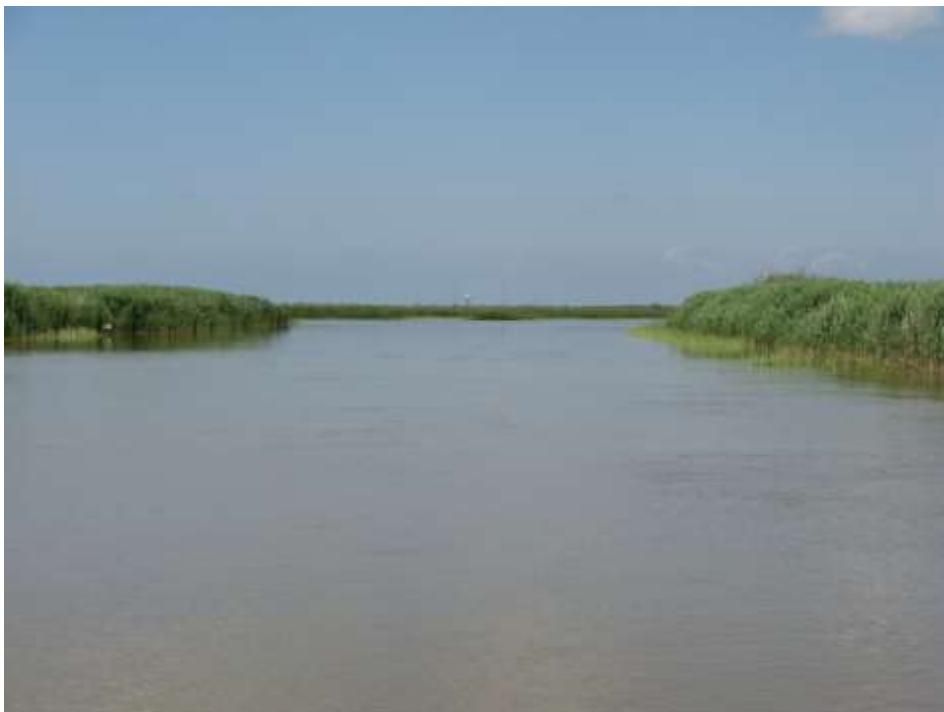
**Crevasse 1C**

- D. Crevasse No. 1C: Flow was visible in the channel. Tall stands of emergent vegetation were present on both channel banks and in the receiving area, and small vegetated islands have developed near the channel outfall. Due to previously documented siltation, this crevasse is planned for inclusion in the 2014 Maintenance Project.

Crevasse 1C	Good	None	Flow was visible in the channel. Tall stands of emergent vegetation were present on both channel banks and in the receiving area, and small vegetated islands have developed near the channel outfall. Due to previously documented siltation, this crevasse is planned for inclusion in the 2014 Maintenance Project.
Crevasse 2A Alt.	Good	None	Channel banks are well-vegetated, and flow is maintained within the channel. Previous annual inspections and a 2011 survey indicate that the channel has begun infilling. Dredging is planned for this channel as part of the 2014 Maintenance Project.
Crevasse 2B	Good	None	Flow is maintained within the channel. Tall stands of vegetation lined both spoil banks, and emergent marsh growth was observed in the receiving area.
Crevasse 2C	Good	None	Channel banks and receiving area are well vegetated, and flow was maintained in the channel. Previous inspections have indicated that the channel has begun infilling; therefore this crevasse is planned for inclusion in the 2014 Maintenance Project.

As a result of prior annual inspections, maintenance dredging of some crevasses was recommended to keep the project functioning as designed. Surveys performed in November of 2011 indicate that shoaling is occurring within several of the channels. The CPRA Engineering Division is developing plans and specifications for maintenance dredging of Crevasses 1C, Alt. 2A, and 2c; this work is planned to begin by the end of 2014.

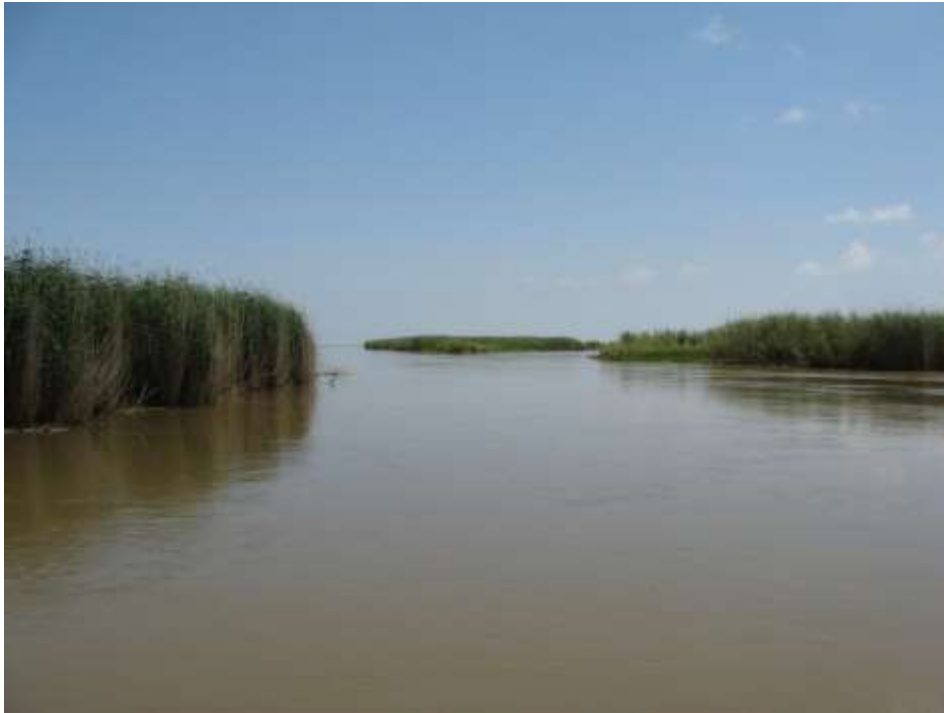
**Crevasse Alt 2A**

- E. Crevasse No. Alt. 2A: Channel banks are well-vegetated, and flow is maintained within the channel. Previous annual inspections and a 2011 survey indicate that the channel has begun infilling. Dredging is planned for this channel as part of the 2014 Maintenance Project.

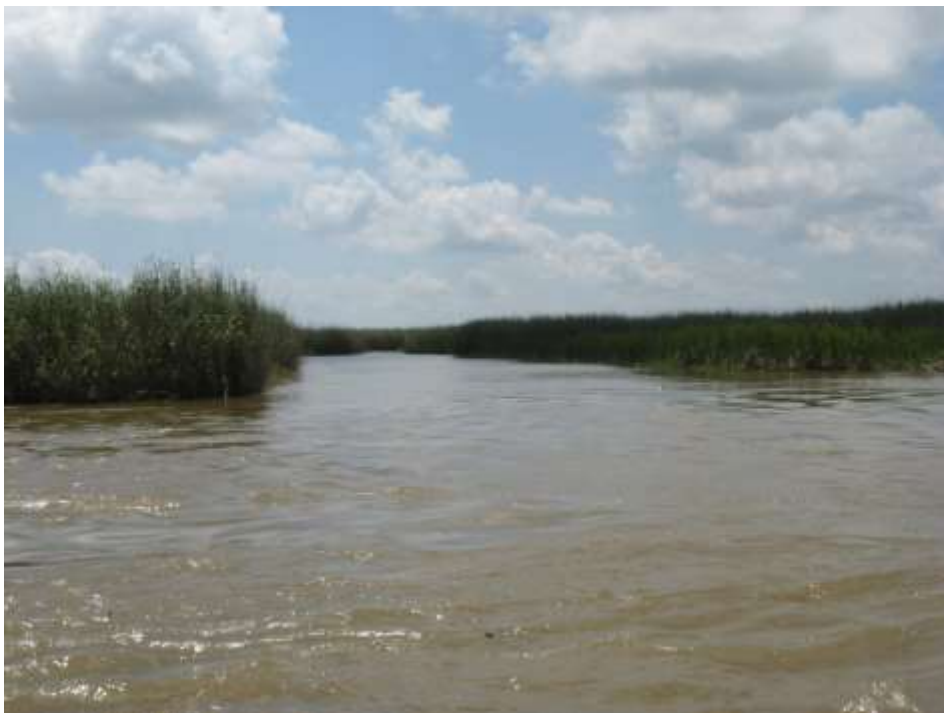
**Crevasse 2B**

- F. Crevasse No. 2B: Flow is maintained within the channel. Tall stands of vegetation lined both spoil banks, and emergent marsh growth was observed in the receiving area.

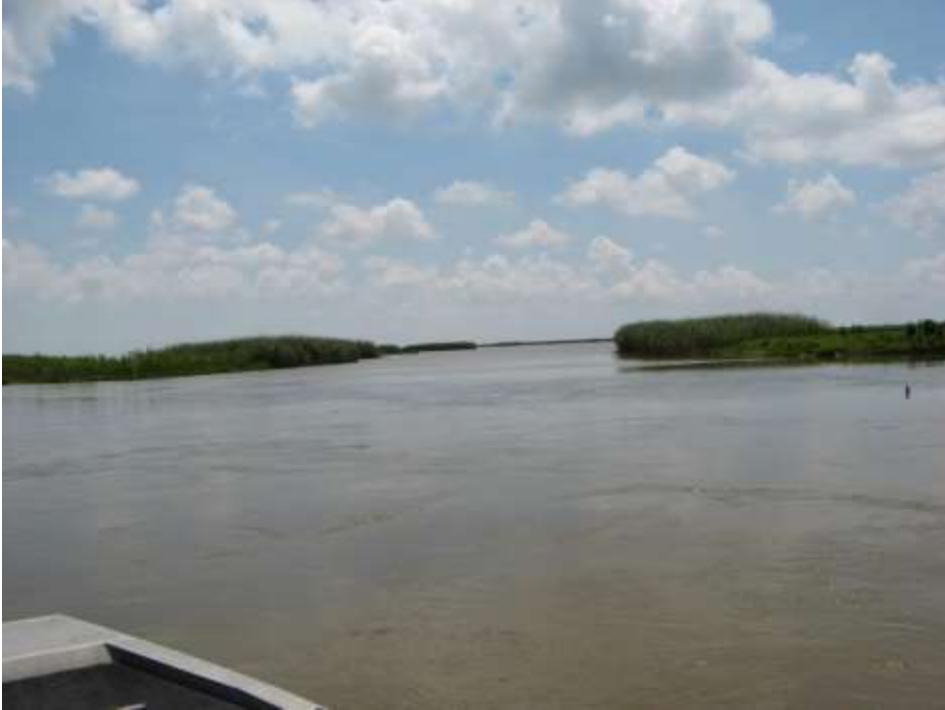
**Crevasse 2C**

- G. Crevasse No. 2C: Channel banks and receiving area are well vegetated, and flow was maintained in the channel. Previous inspections have indicated that the channel has begun infilling; therefore this crevasse is planned for inclusion in the 2014 Maintenance Project.
