2014 Annual Inspection Report

**GOOSE POINT / POINT PLATTE
MARSH CREATION PROJECT**

State Project Number PO-33

July 16, 2014

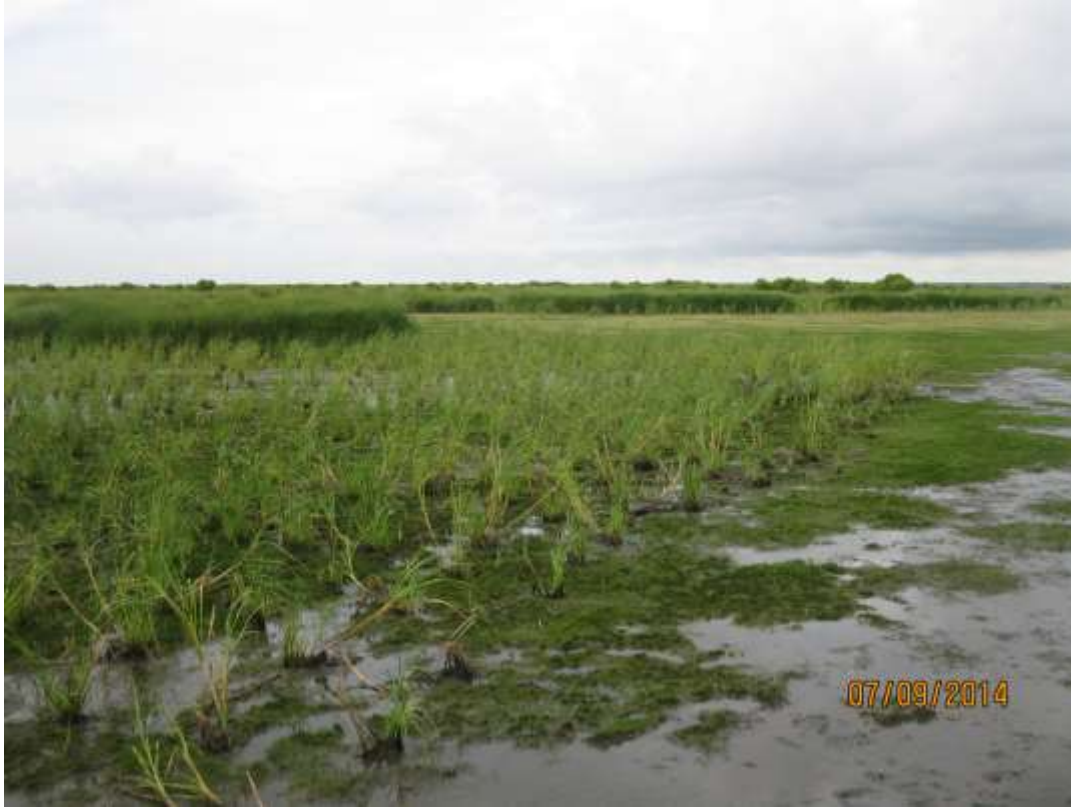
Area A – Marsh grass plantings with vegetated fill area beyond

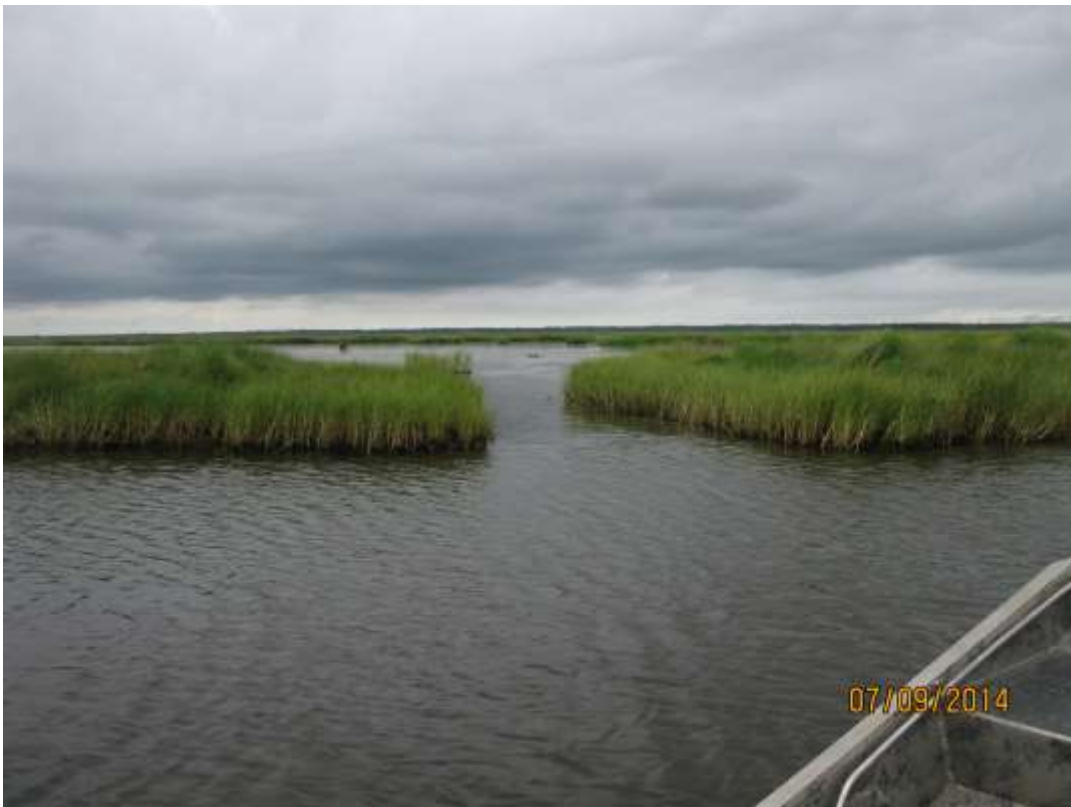
Area A – Containment degraded for tidal exchange at north end of fill area

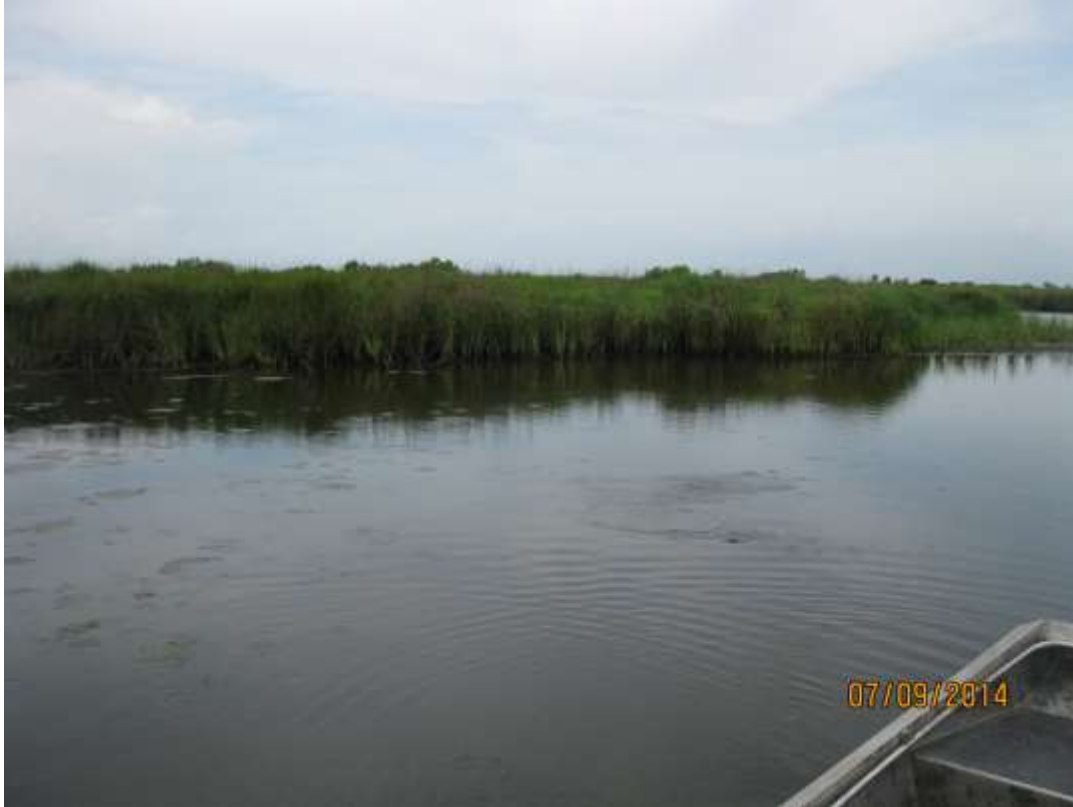
Area B – Shallow water in containment borrow area with fill area beyond

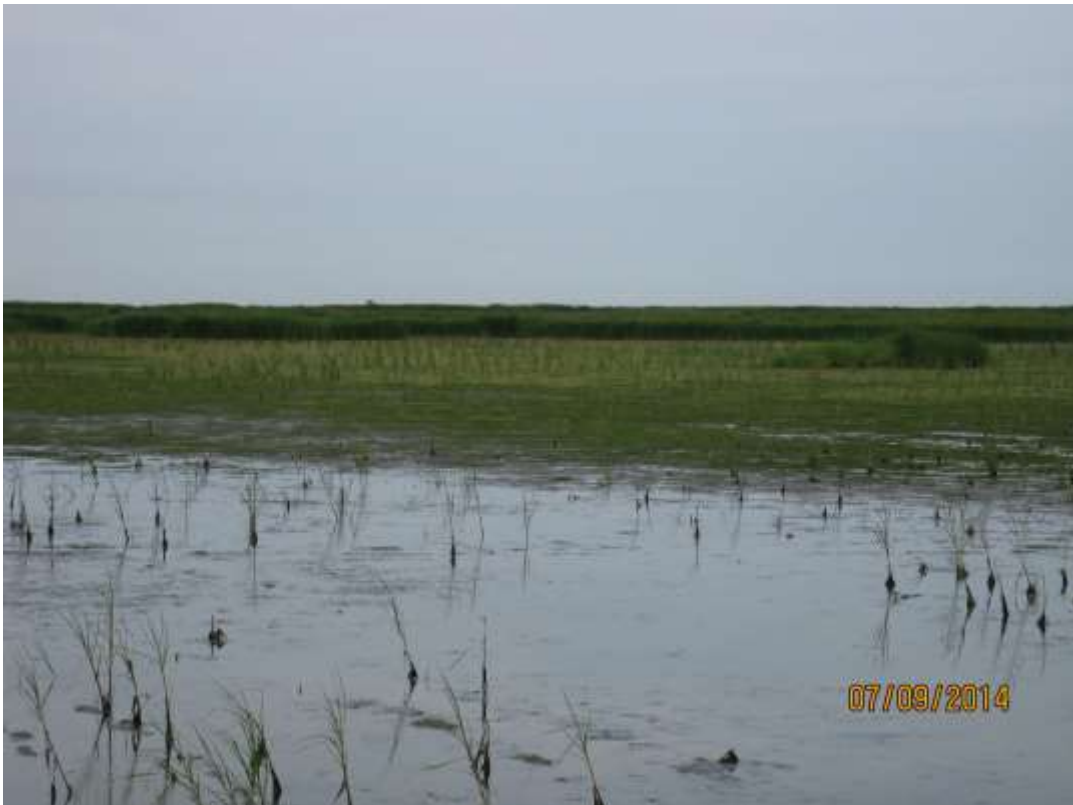
Area B – Recent grass plantings with marsh nourishment area in background

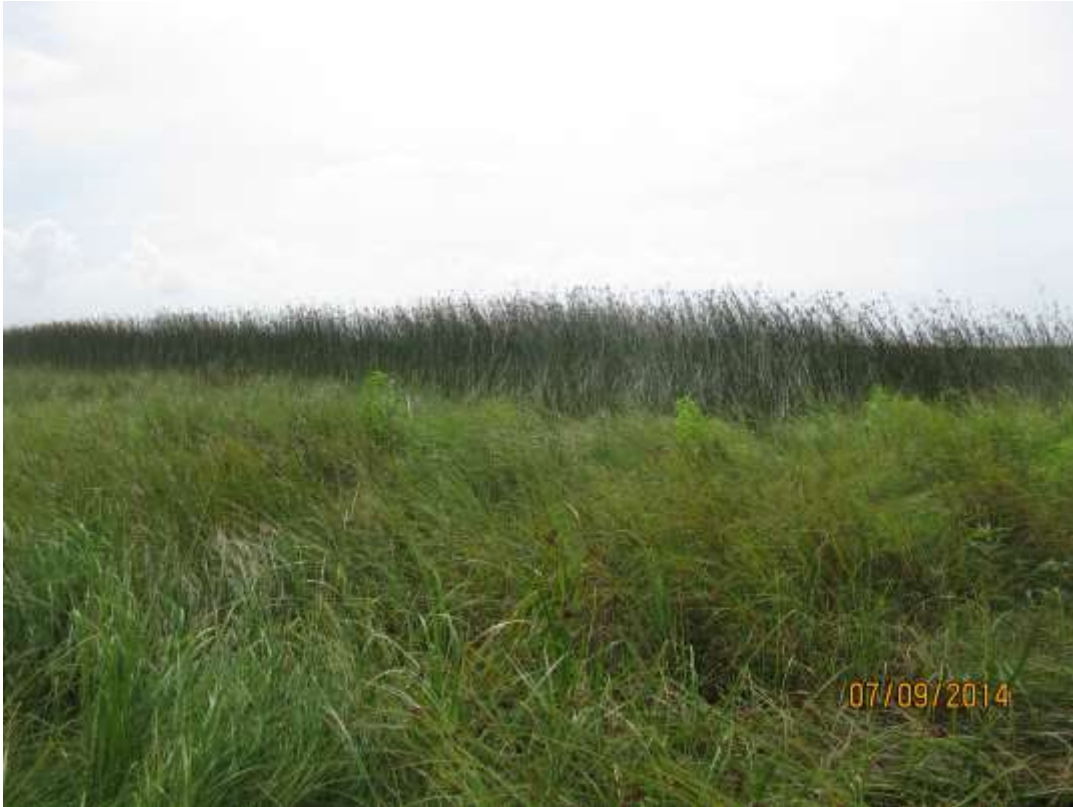
Area C – North containment berm with marsh creation in background

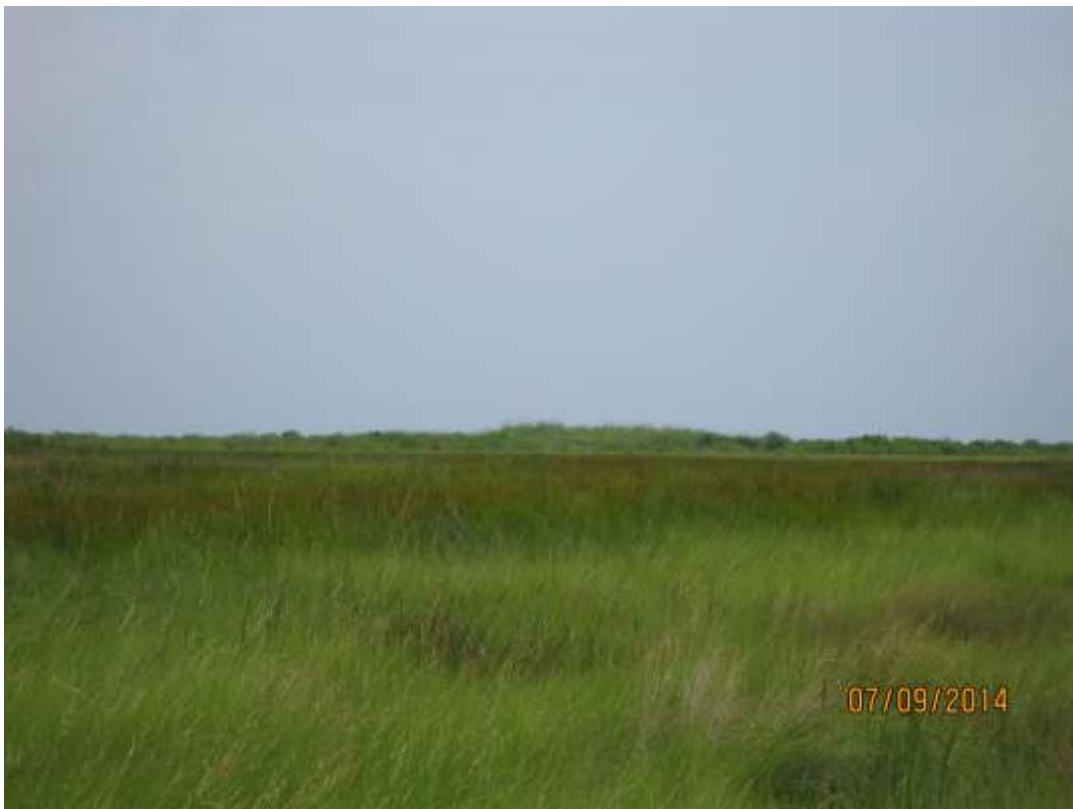
Area C – Interior marsh viewed from north containment rim

<u>Fill Area "C"</u>	Very Good	None	Very Good Gaps remain open	Very Good	This area has vegetated very well. The perimeter containment borrow area has subsided, but no open water areas are visible. This marsh creation area and the containment berms are nearly 100% vegetated.		
<u>Fill Area "D"</u>	Good	See Remarks	Very Good	Very Good	Some of the vinyl sheet piles along the lake shore show signs of damage, probably vandalism from hunters attempting to access the marsh creation areas. Marsh conditions behind the sheet pile wall appeared to be very good, but some scour was visible behind the damaged wall sections.		
Vinyl Sheet Pile 504 ft.							
<u>Fill Area "E"</u>	Very Good	None	Very Good	Very Good	Low water conditions prevented a thorough inspection of this fill cell, however the marsh creation area as seen from the northwest containment berm looked very good. Containment area was almost 100% vegetated.

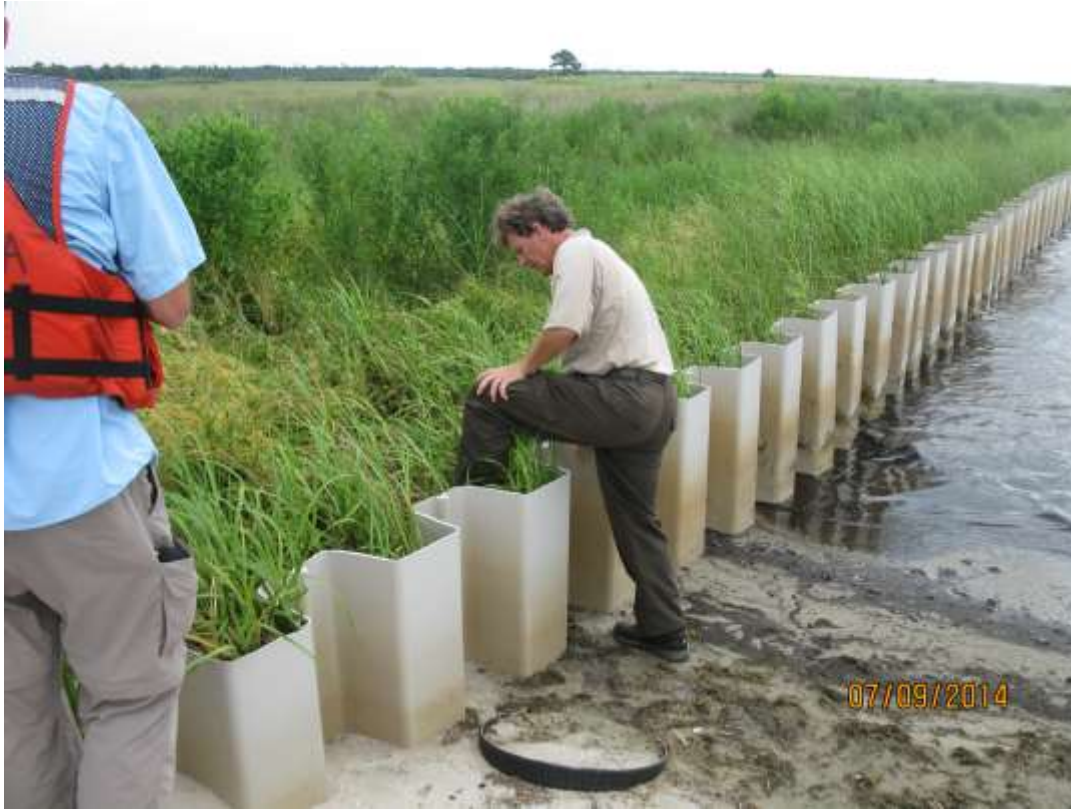
Area D – Marsh infill behind vinyl sheet pile wall

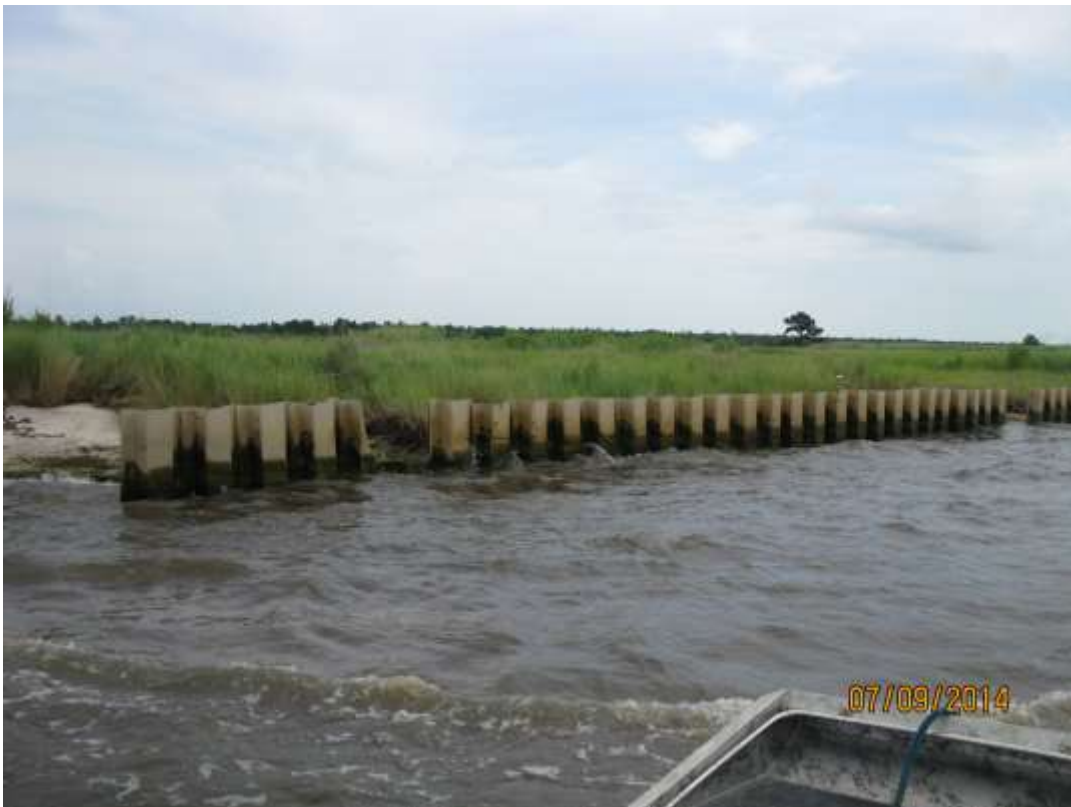
Area D – Apparent vandalism; sheet piles appear to have been cut

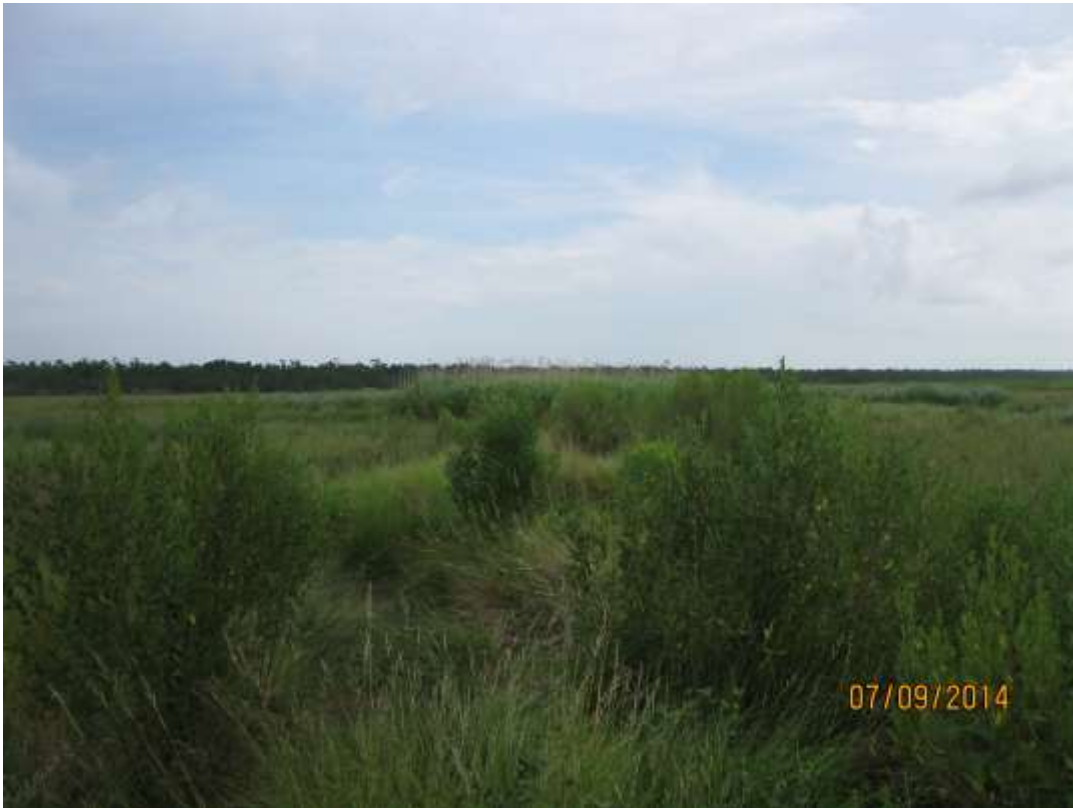
Area E – Vegetated containment berm at northwest end of fill cell

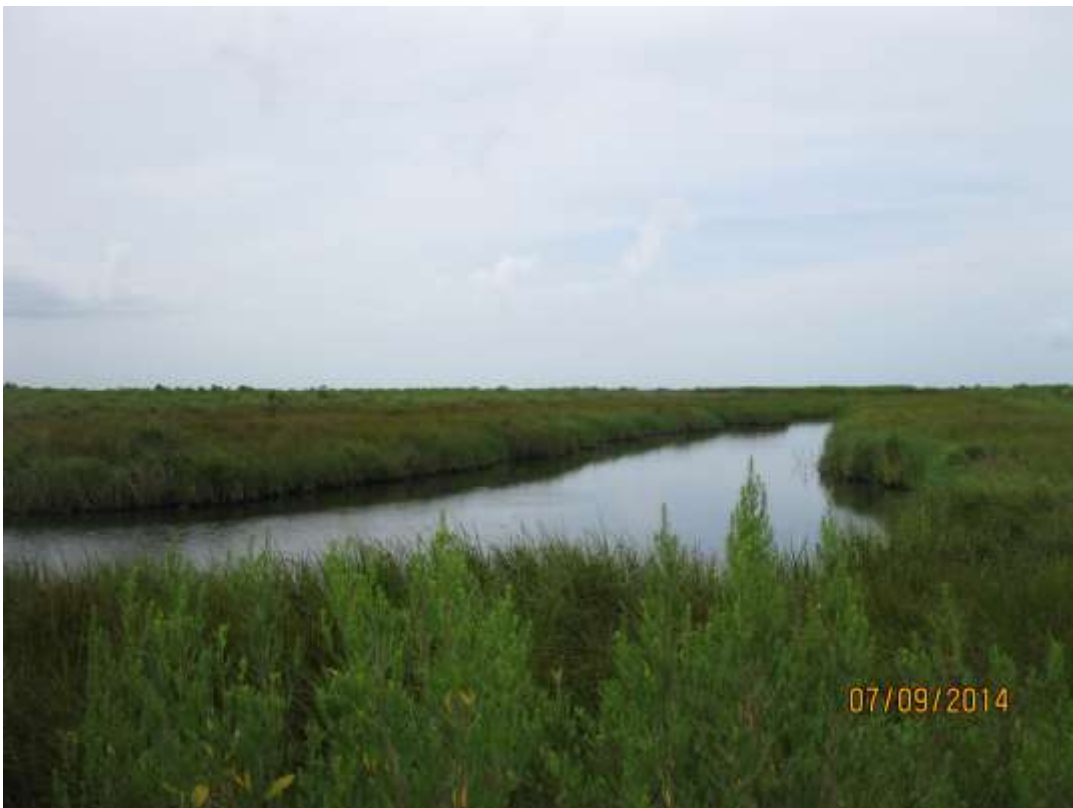
Area E – Shallow water in containment borrow area with marsh fill beyond
