**State of Louisiana  
Department of Natural Resources  
Coastal Engineering Division**

**2005 Bi-Annual Inspection  
Report**

**BIG ISLAND MINING**

State Project Number AT-03  
Priority Project List 2

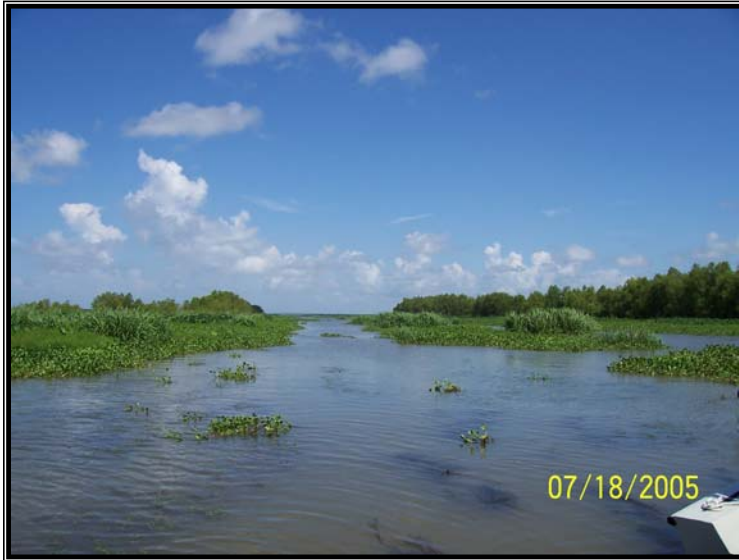
AT-03 Big Island Mining – Photo at the mouth of Channel “B” looking northwest from Breaux’s Pass (Photo 1)

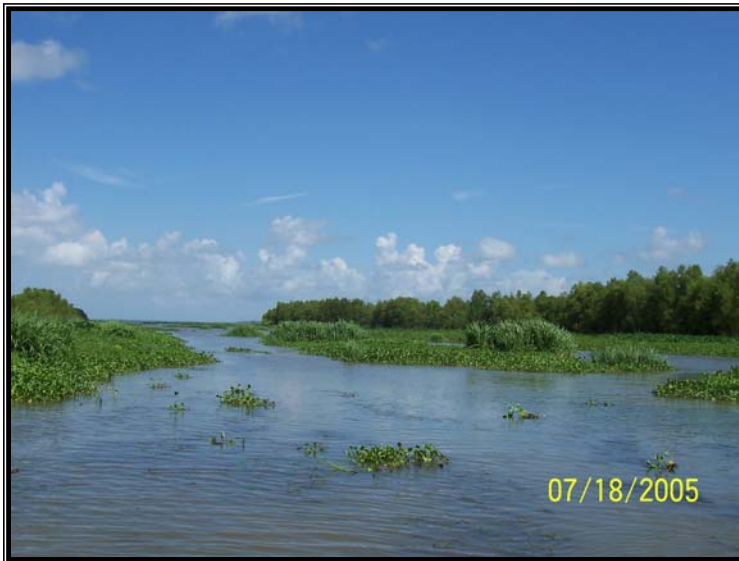
AT-03 Big Island Mining – Photo at the mouth of Channel “B” looking northwest from Breaux’s Pass. (Photo 2)

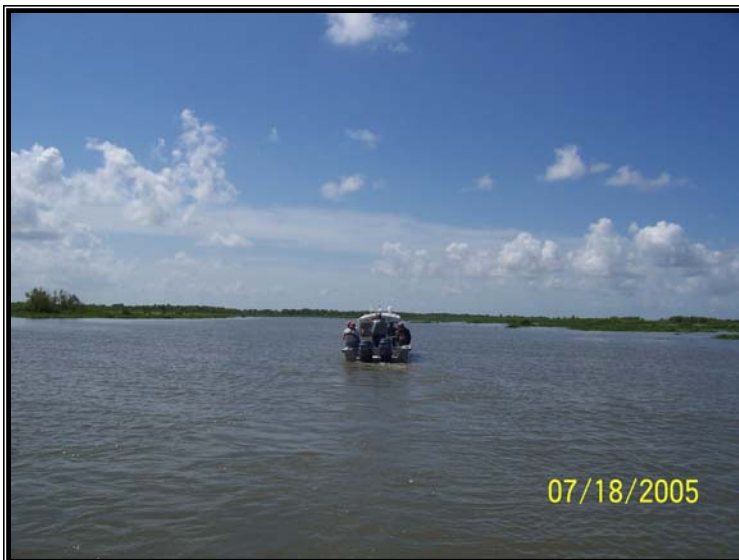
Prior to this inspection, LDWF had reminded the inspection team that Channel “E”, near the mouth, had silted in to the extent that the channel has become impassable. The depth measurements taken at the time of the inspection showed that the depths were approximately 3.9’ at the mouth of Channel “E” near Breaux’s pass, 4.2’ deep 200’ into the channel and 5.0’ deep 500’ into the channel. The major deposition has taken place at the mouth of the channel. Possible hydraulic dredging will be required to re-open the existing channel near the cul-de-sac in the near future. A previously permitted disposal area is available on the southwest side of the channel. At this time, it is recommended that no maintenance dredging be performed until a re-evaluation and bathymetric survey is conducted next year to ascertain the extent of shoaling in this channel.

AT-03 Big Island Mining – Photo along Channel “E” looking southeast from Breaux’s Pass (Photo 3)

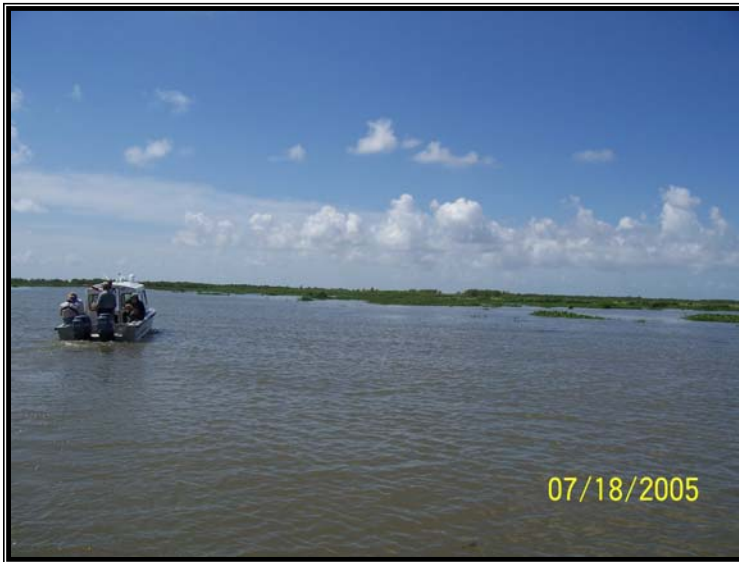
AT-03 Big Island Mining – Photo of disposal area no. 9 adjacent to Channel “E” looking in a southerly direction. (Photo 4)

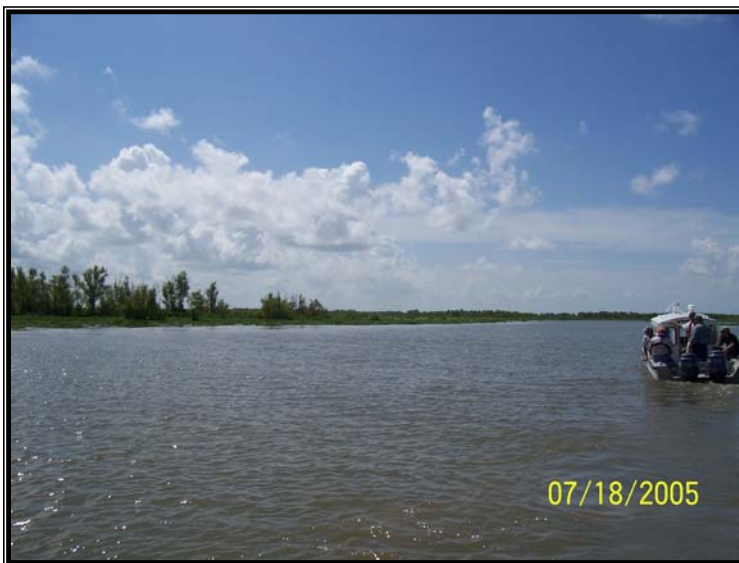
AT-03 Big Island Mining – Photo of disposal area no.8 located on the east side of Channel “E” looking in a southeasterly direction. (Photo 5)

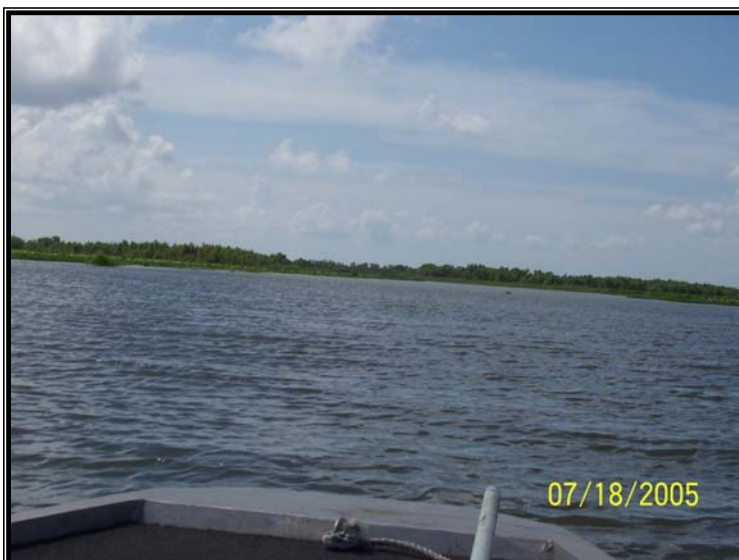
AT-03 Big Island Mining – Photo looking down Channel “E” to the dead end “Cult-a-sak” looking in a southeasterly direction. (Photo 6)

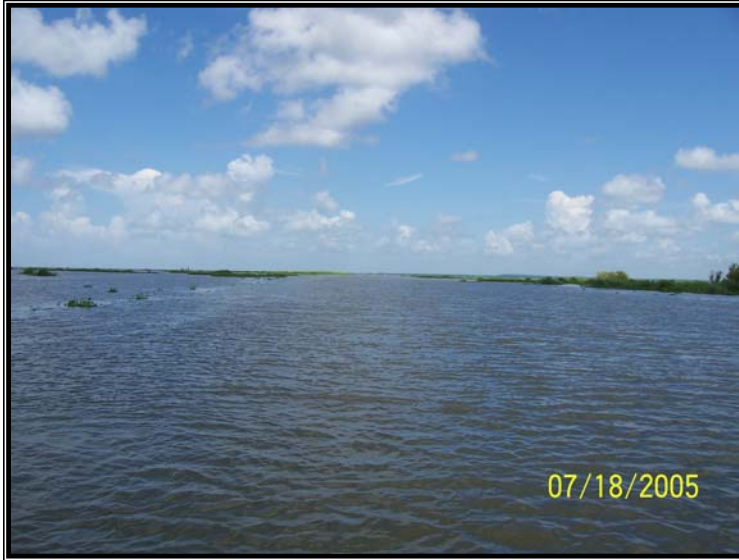
Channel “F” appears to be in good condition with no serious silting or shoaling. The estimated depth at the time of the inspection was approximately 7’ deep 100’ into the channel from Breaux’s Pass. From visual observations, it appears that an available disposal site for potential dredge material from Channel “E” is located on the west side of Channel “F”.

AT-03 Big Island Mining – photo of Channel “F” from Breaux’s Pass (Channel “A”) looking in a northwesterly direction. (Photo 7)

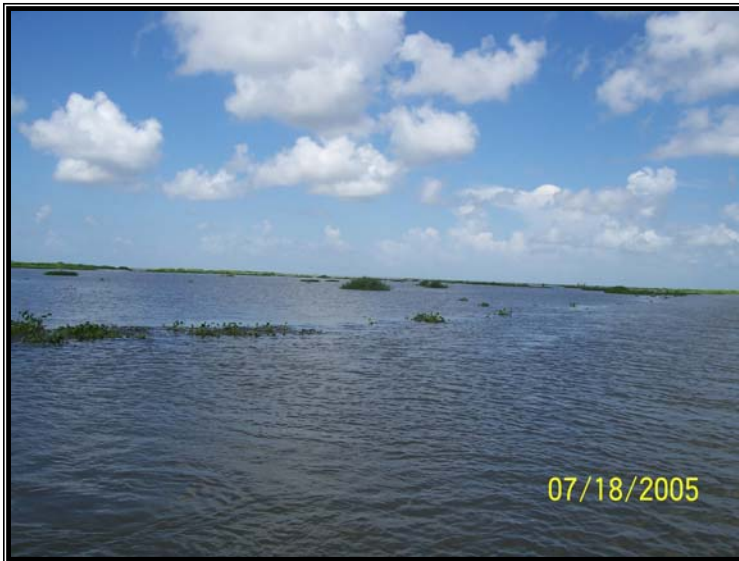
AT-03 Big Island Mining – photo along Channel “F” of remaining marsh on the west side of the channel looking in a westerly direction (Photo 8)

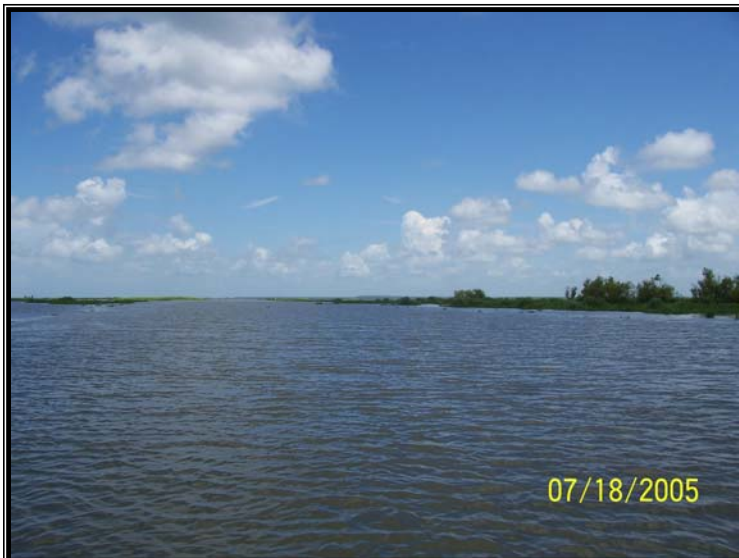
AT-03 Big Island Mining – photo down Channel “F” of disposal area no. 6, on the right of the photo, looking in a northerly direction. (Photo 9)

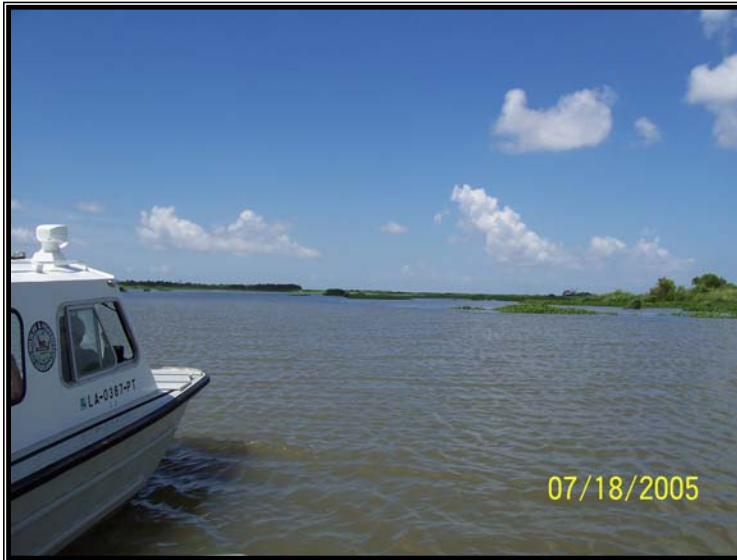
AT-03 Big Island Mining – photo along Breaux’s Pass (Channel “A”) looking in the direction of Channel “C” Catfish Pass in a southwesterly direction. (Photo 10)

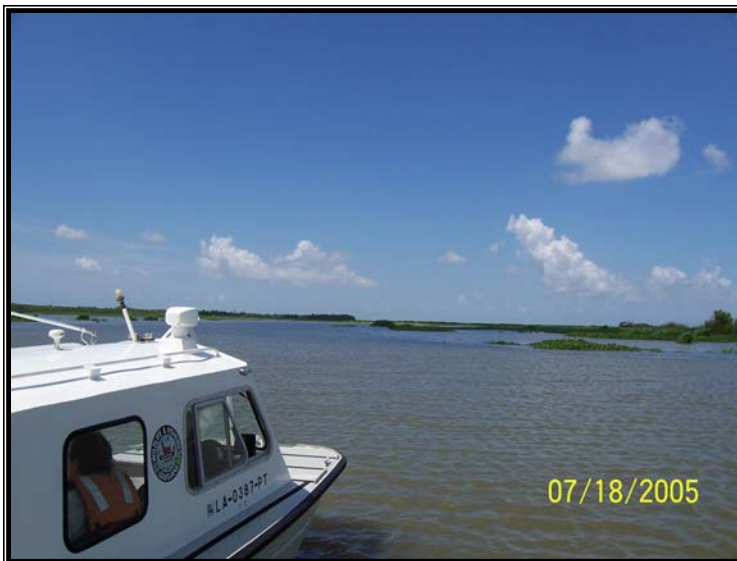
AT – 03 Big Island Mining – photo along Breaux’s Pass (Channel “A”) looking in a the direction of Channel “C” Catfish Pass in a southwesterly direction. (Photo 11)

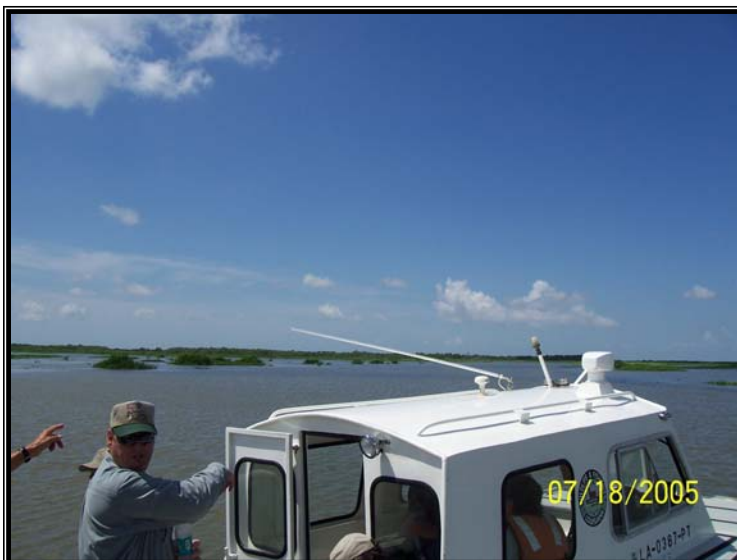
AT-03 Big Island Mining – photo of disposal area no. 9 adjacent to Channel “C” Catfish Pass looking in a southeasterly direction. (Photo 12)
