2014 Annual Inspection Report

**GIWW/ CLOVELLY HYDROLOGIC
RESTORATION**

State Project Number BA-02
Priority Project List 1

May 6, 2013
Lafourche Parish

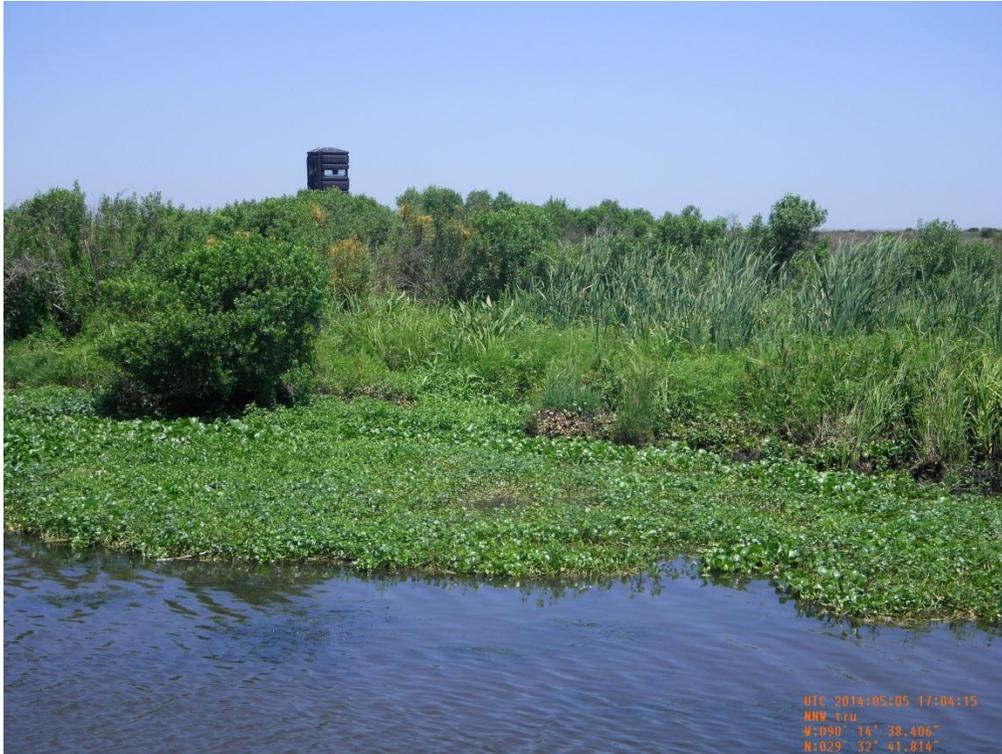
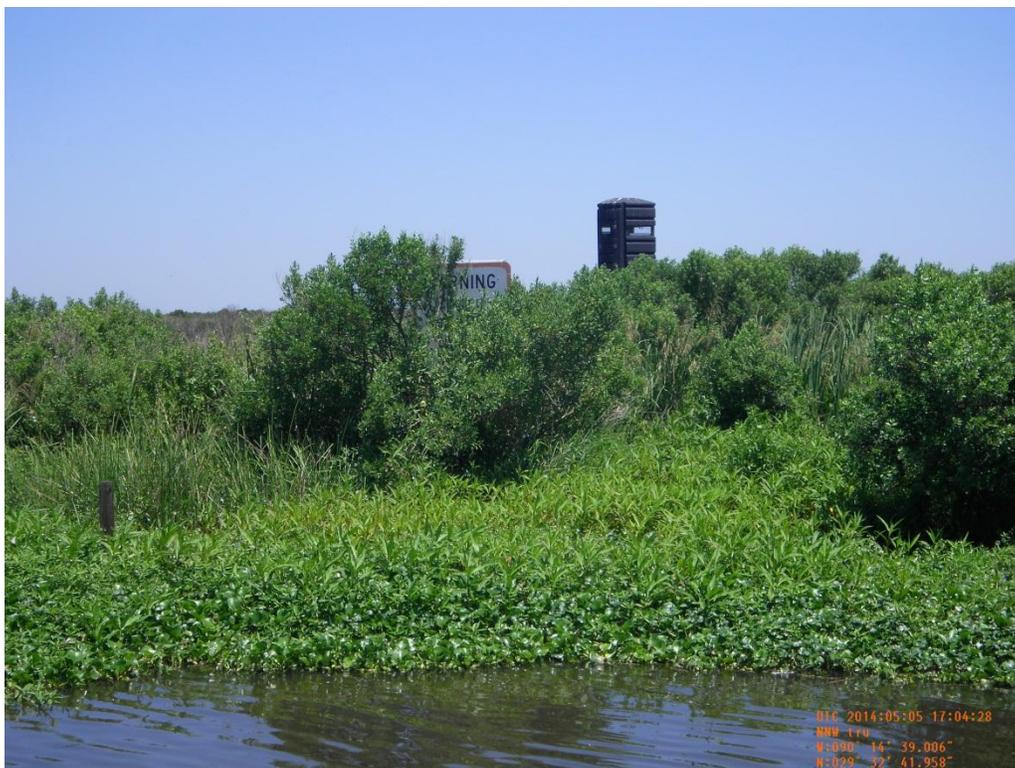
We were unable to visually inspect Structure 43 due to vegetation blocking the visibility of the structure. A small breach that had formed around the eastern end of the rock plug allowing water to flow around the structure was identified during previous inspections. This breach was unable to be located due to the vegetation that has grown on the structure, but will continue to be monitored during future inspections. All warning signs and support structures appear to be in good condition, and at this time, there are no recommendations for maintenance.

Photo 1: View of vegetation covering Structure 43 looking north.

Photo 2:View of Structure 43 looking north. The rock plug is not visible through the vegetation.

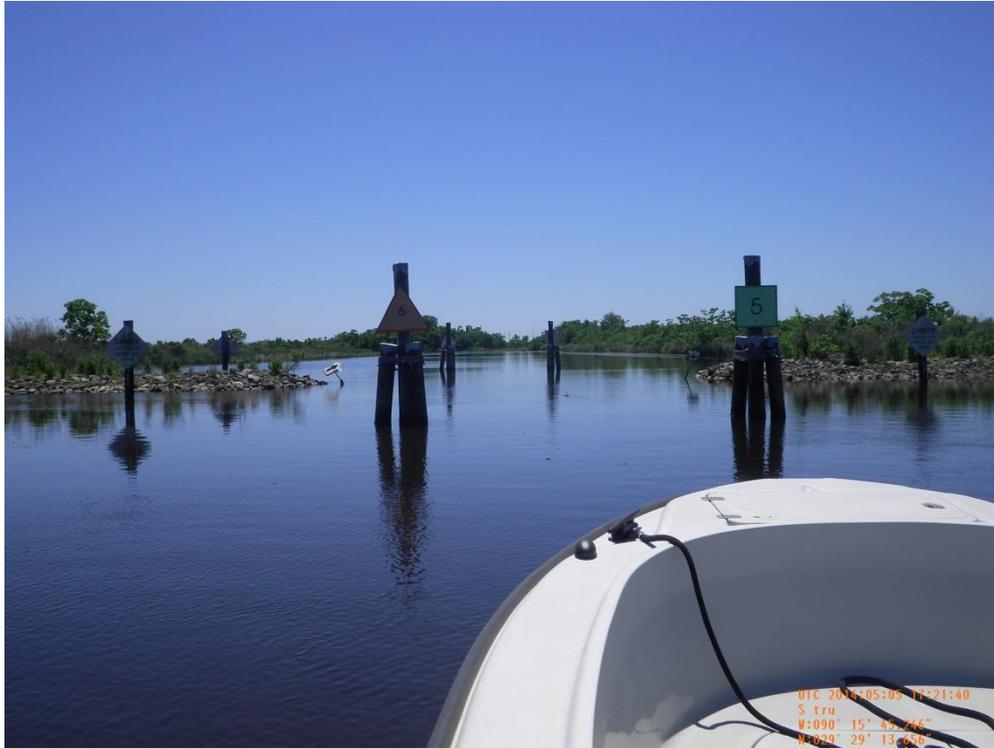
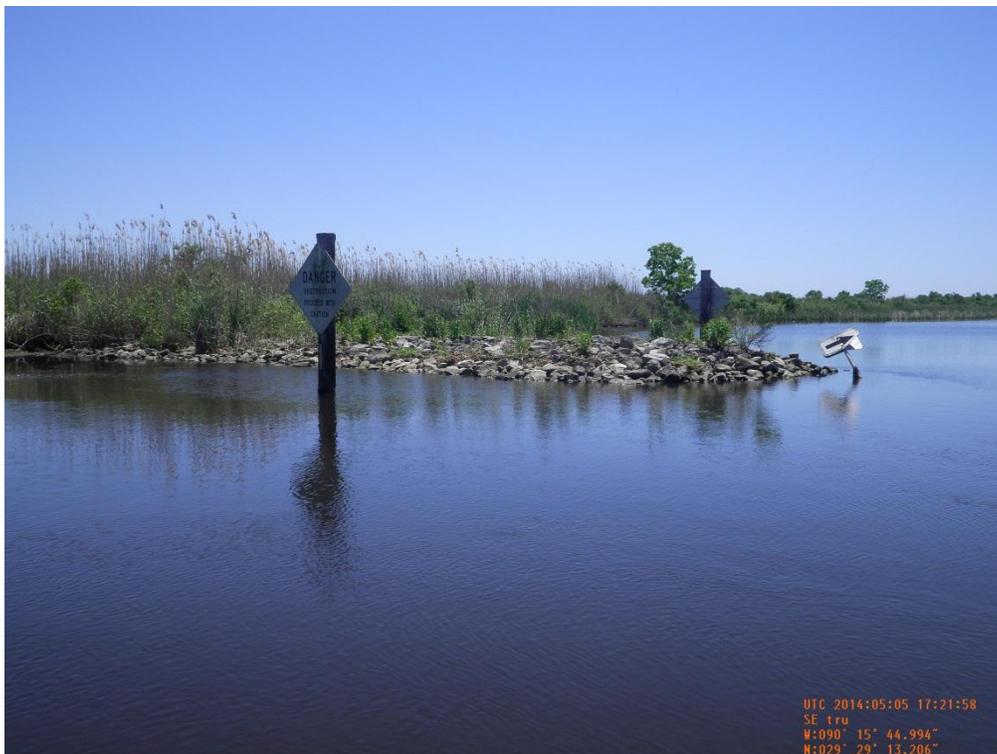
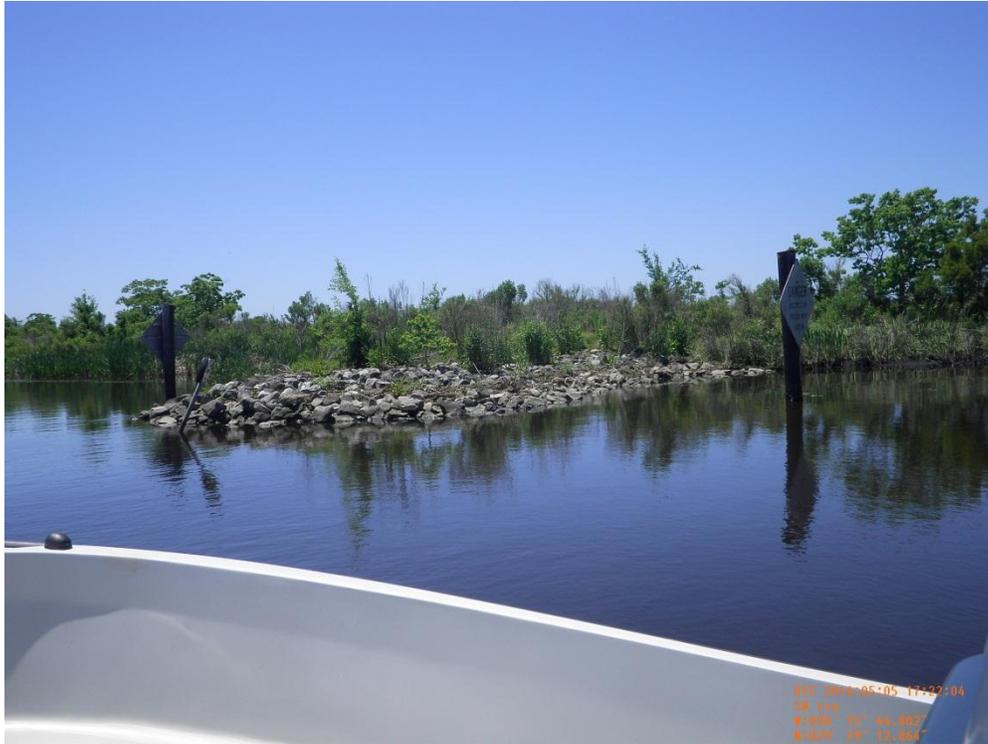
Structure 1 appeared to be in good overall condition with no observable settlement or displacement of the rock riprap material. Previous inspections had found considerable damage to the four (4) timber pile dolphins at the opening of the barge bay. This damage was believed to be caused by an oilfield barge navigating the opening of the structure and includes the vertical piles splitting, piles displaced from original position, scarring on the surface of the piles, and the complete destruction of one of the four dolphin structures. Due to the poor condition of the timber dolphins, they were replaced and fitted with new signs as part of the 2012 Maintenance Project. Also, as a precaution, the timber dolphins were installed one (1) foot further apart to allow barges to move more freely through the barge bay without future damage to the structure. At the time of the inspection, the timber pile dolphins appeared to be in good condition with no signs of damage. There are no recommendations for maintenance at this time.

Photo 3: Overall view of Structure 1 rock riprap weir, looking southwest

Photo 4: Close up view of the embankment tie-ins on the east side of Structure 1

Photo 5: Close up view of the embankment tie-ins on the west side of Structure 1

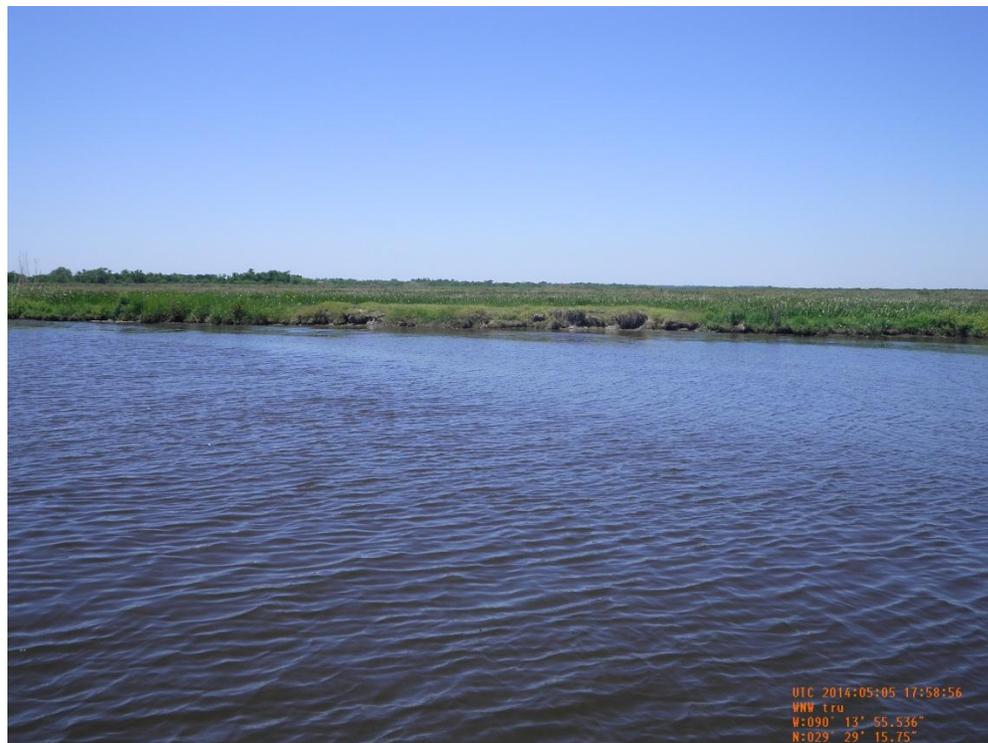
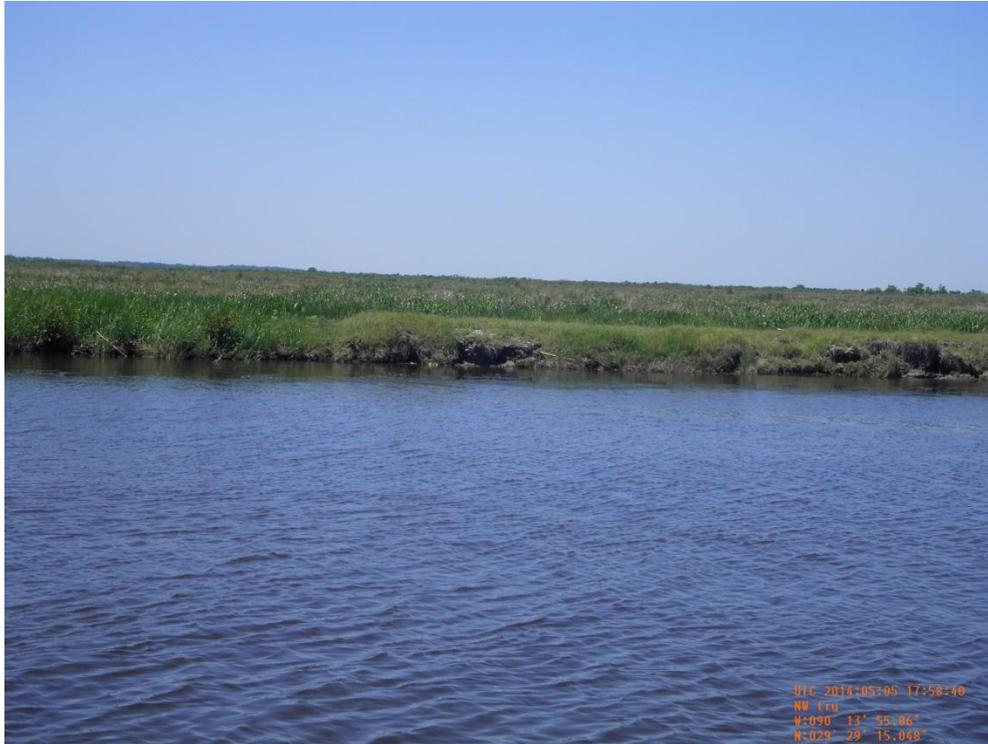
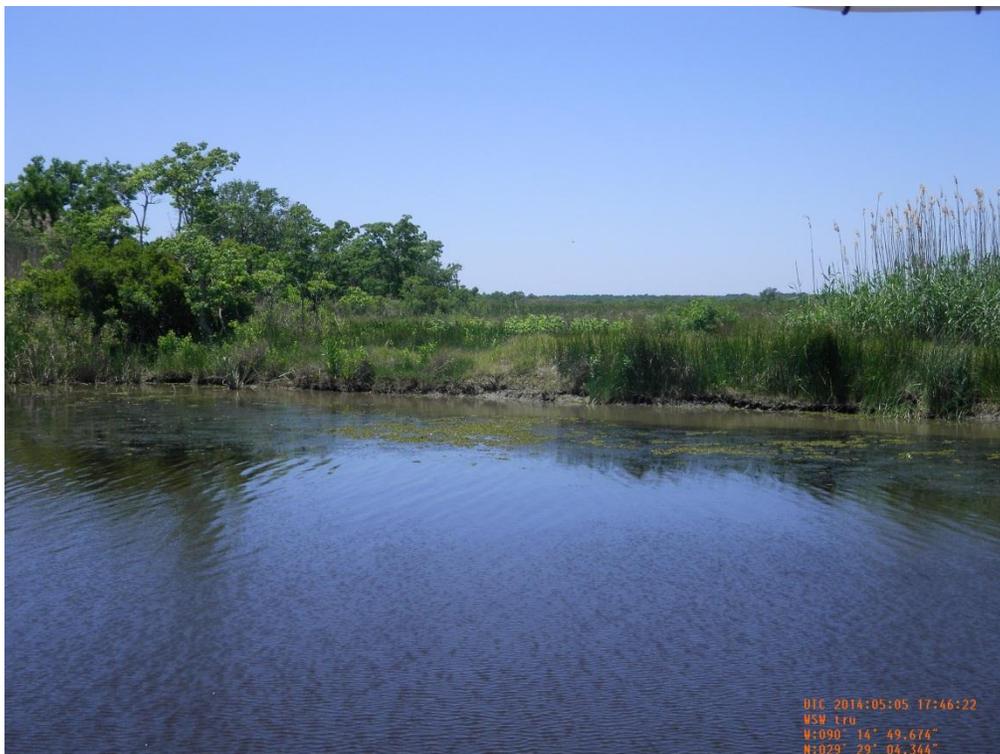
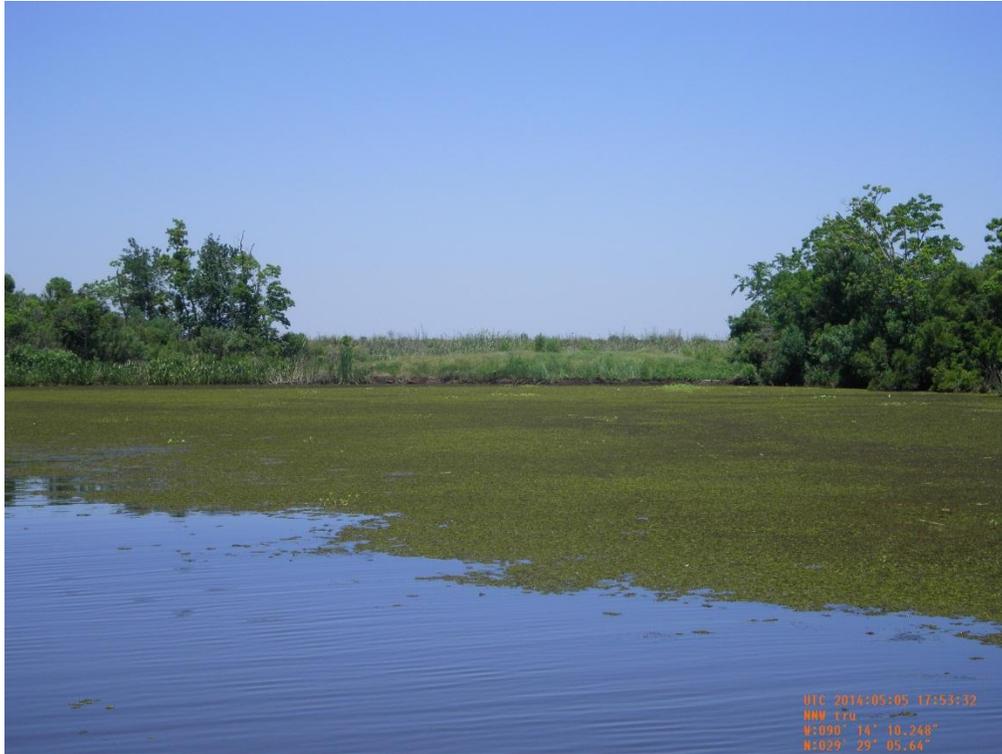
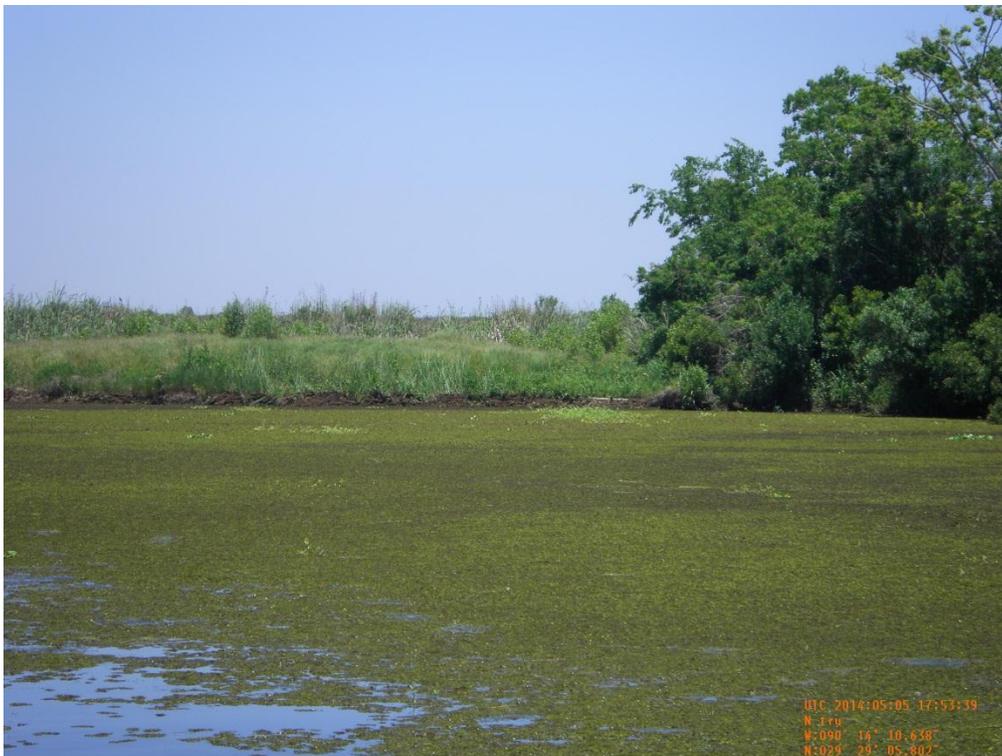
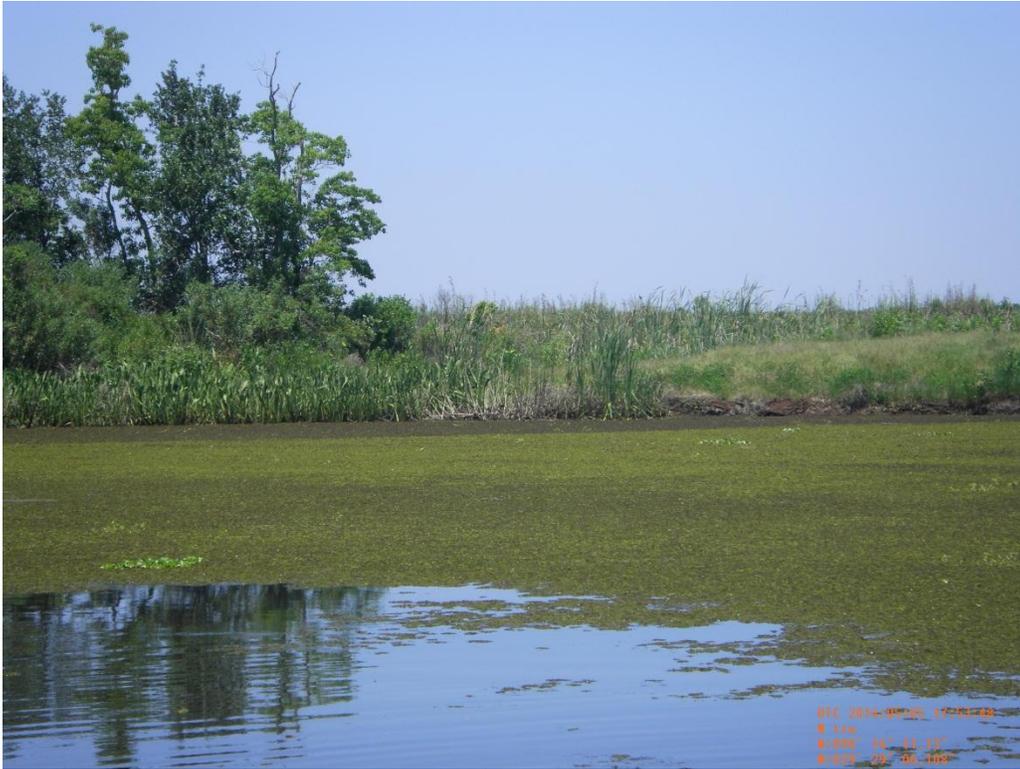
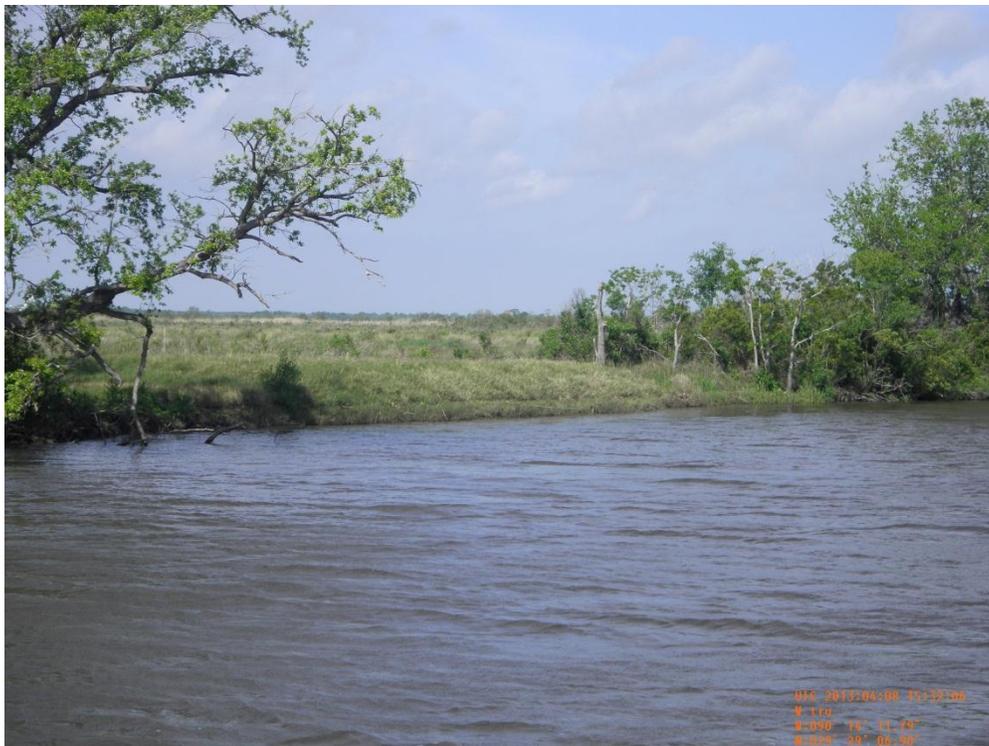
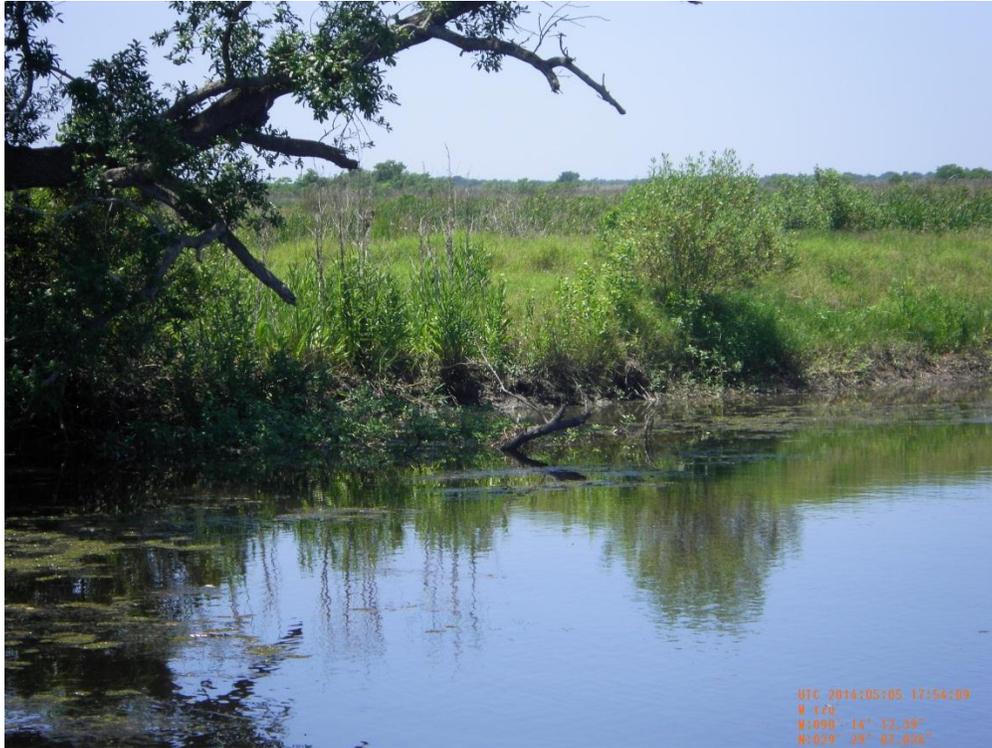
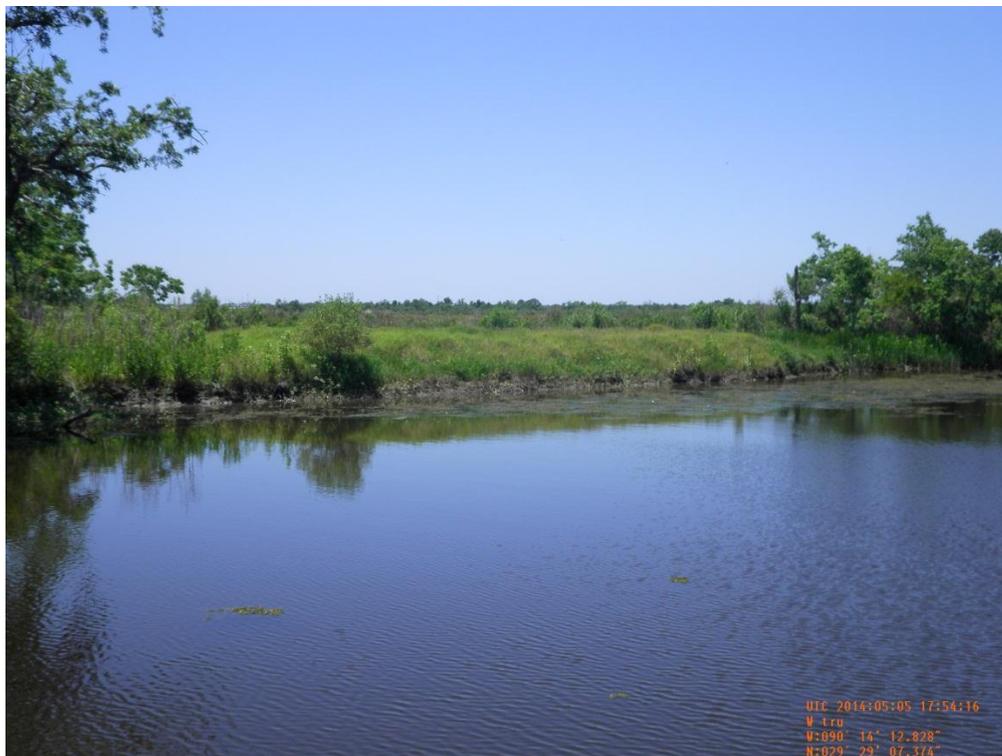
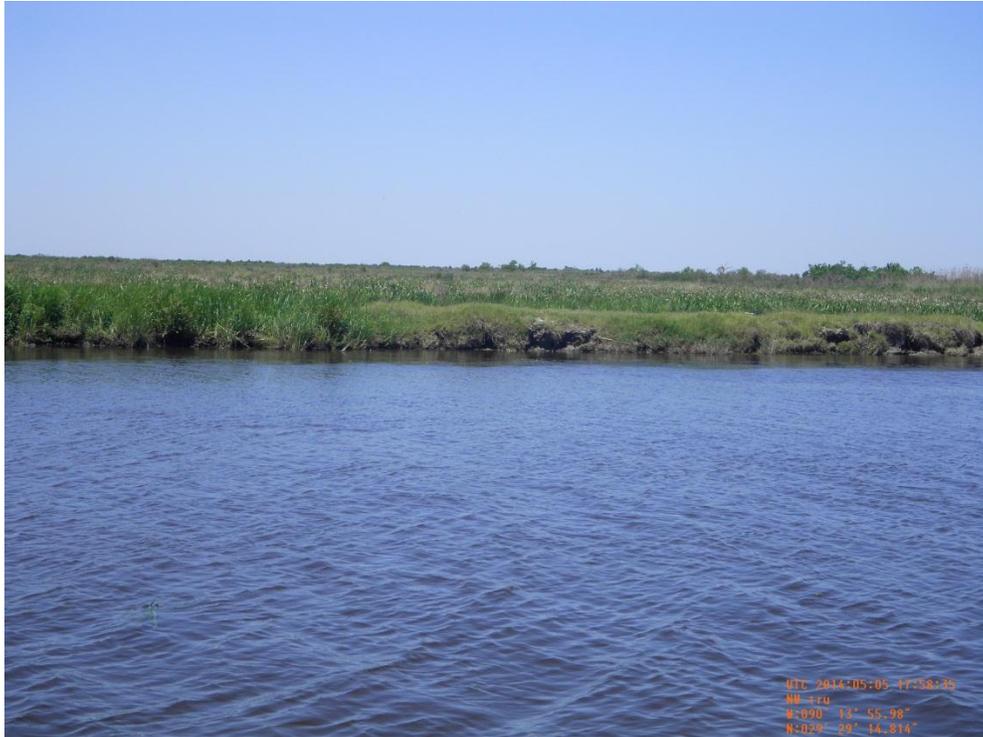
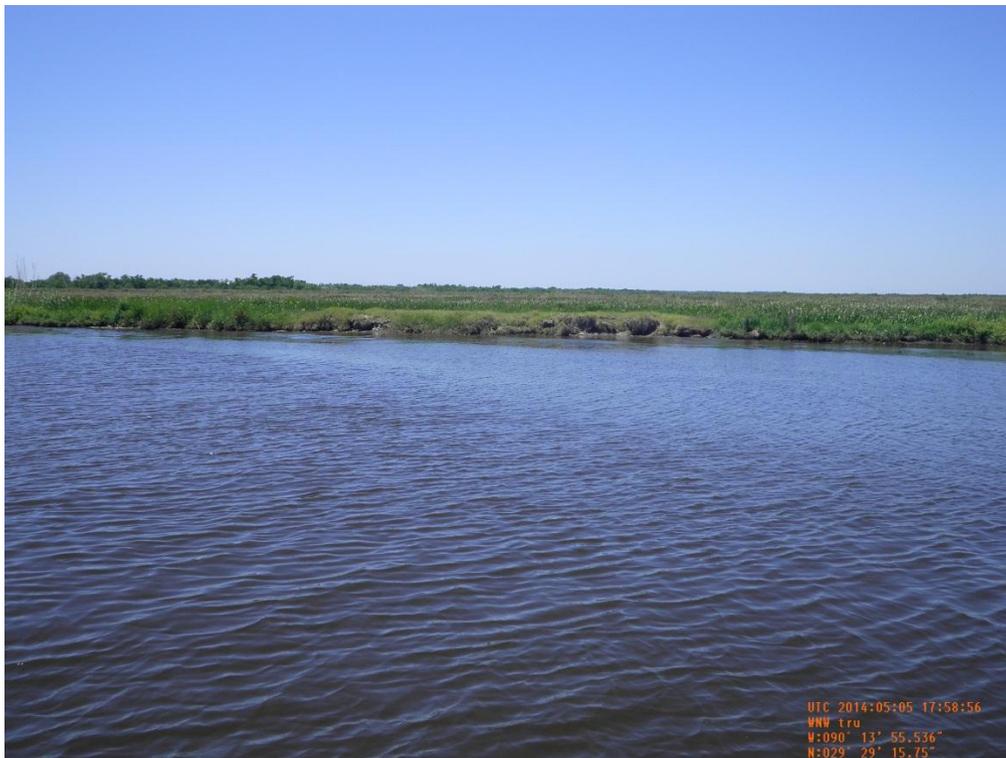
There were five (5) breaches included in the 2012 Maintenance Project. Breach 1 is located along the north bank of Breton Canal just southwest of the first location canal from Bay L' Ours and is approximately 20' wide. Breach 2 is located along the northeast bank of the second location canal north of Breton Canal and is approximately 10' wide. Breach 3 is located on the south bank of the same location canal as Breach 2 and is approximately 25' wide. Breach 4 is located on the west bank of an oilfield canal that intersects Breton Canal east of Structure No. 1 and is approximately 30' wide. Another breach, designated as Breach 5, was discovered at the end of a dead end oilfield slip south of Breach 4. The breaches were closed by using in situ material from the adjacent canal bottoms to reconstruct the earthen dike. The material was allowed to dry before it was shaped, seeded, and fertilized. At the time of the inspection all of the breach repairs appeared to be in good condition with full vegetation and no signs of settlement. Breach 1 did show some signs of erosion on its northeast side facing Breton Canal. This erosion does not seem to be worsening since the last inspection. Due to the minor erosion not affecting the overall stability of the breach repair, there are no recommendations for maintenance at this time; however this location will continue to be monitored on future annual inspections.

Photo 6: View of Breach Closure No. 5 which was part of the 2012 Maintenance Project

Photo 7: View of Breach Closure No. 5 which was part of the 2012 Maintenance Project

Photo 8: View of Breach Closure No. 4 which was part of the 2012 Maintenance Project

Photo 15: View of Breach Closure No. 2 which was part of the 2012 Maintenance Project

Photo 16: View of Breach Closure No. 2 which was part of the 2012 Maintenance Project

Photo 17: View of Breach Closure No. 2 which was part of the 2012 Maintenance Project

Photo 18: View of Breach Closure No. 3 which was part of the 2012 Maintenance Project

Photo 19: View of Breach Closure No. 3 which was part of the 2012 Maintenance Project

Photo 20: View of Breach Closure No. 3 which was part of the 2012 Maintenance Project

Photo 21: View of Breach Closure No. 1 which was part of the 2012 Maintenance Project

Photo 22: View of Breach Closure No. 1 which was part of the 2012 Maintenance Project

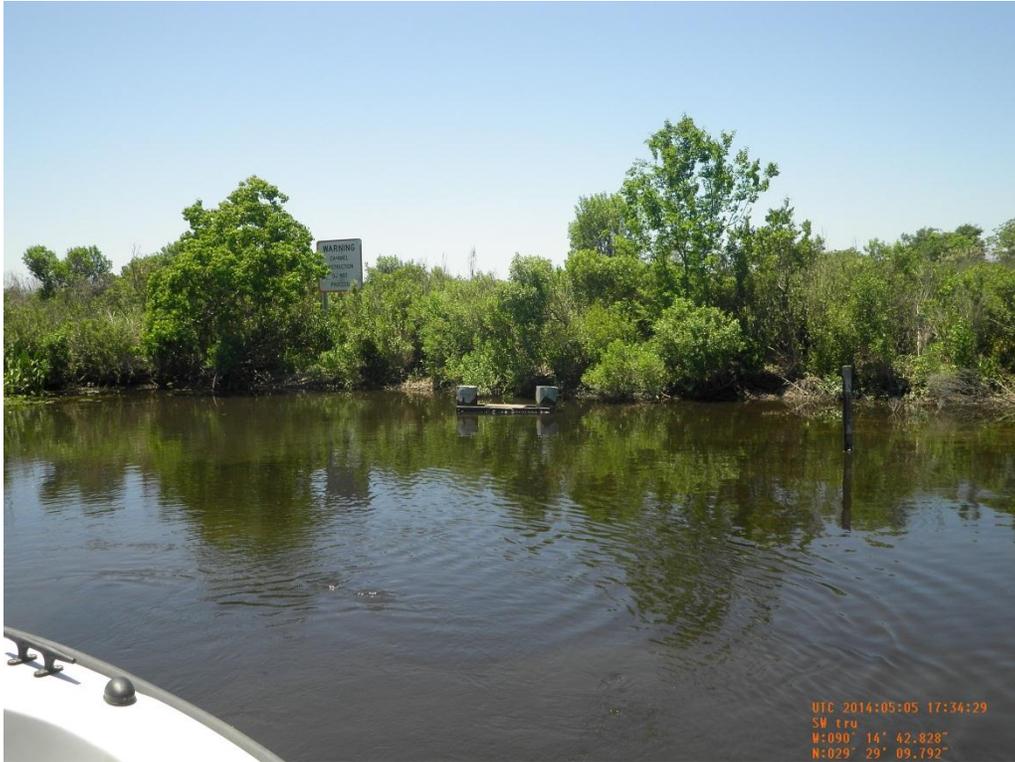
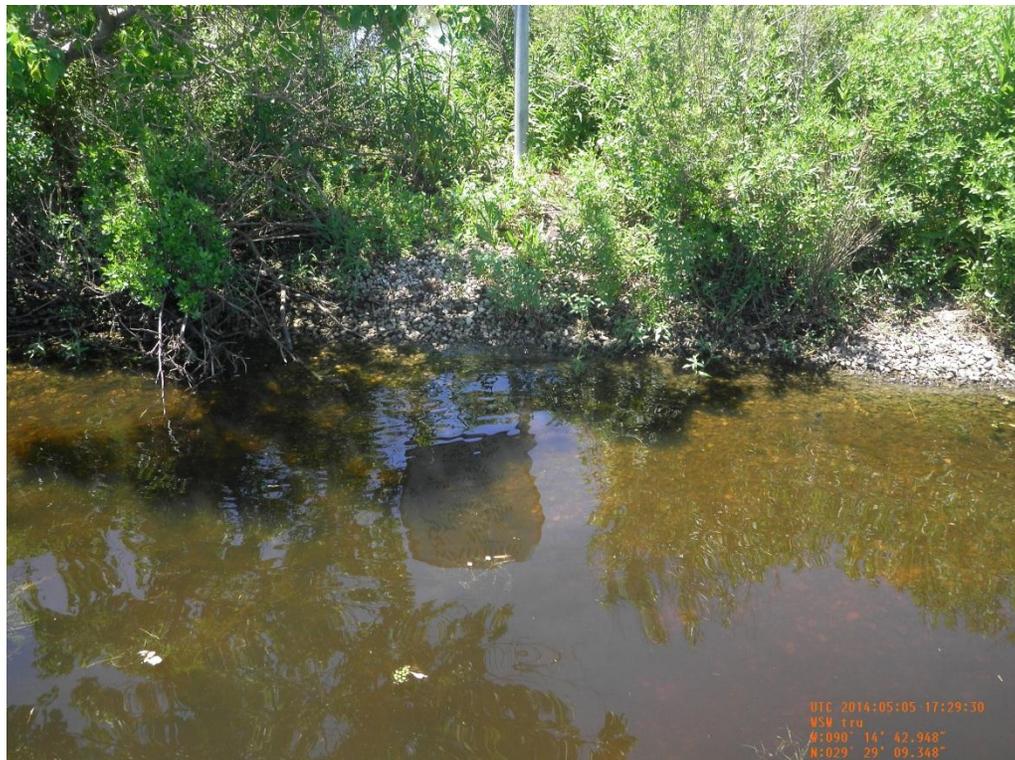
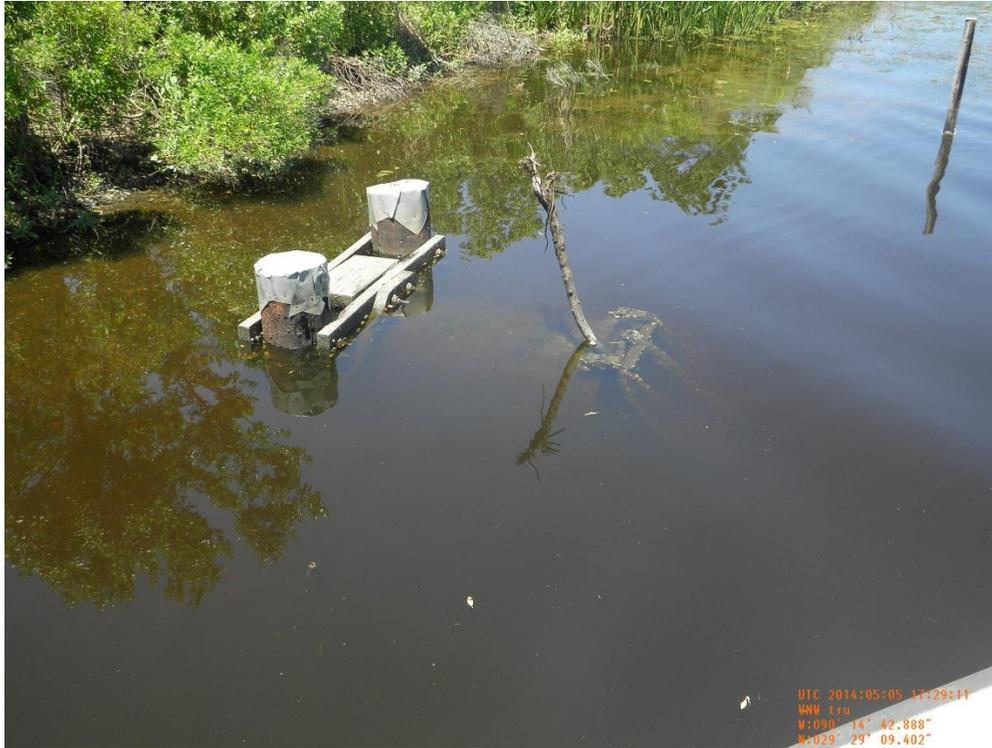
Structure 91 rock plug appeared to be in good overall condition. There were no signs of rock settlement or erosion around the embankment tie-ins. Previous inspections revealed the sheet metal covering the timber piles supporting the corrugated metal pipe were rusted and corroded. The newly installed galvanized timber pile caps that were installed as part of the 2012 Maintenance project appeared to be in good condition. A large piece of debris was holding the flap gate in the open position. We attempted to remove the debris as best as possible so that the gate could return to the closed position. Also, the warning sign for the structure has been damaged by vandals as it appears the sign has endured several shots from a shotgun. Because the sign is still legible, there are no recommendations for maintenance at this time, but it will continue to be monitored on future inspections for further damage.

Photo 9: Overall view of Structure 91 rock plug with culvert and flap gate, looking southwest

Photo 10: Close up view of Structure rock plug

Photo 11: Close up of gated culvert at Structure 91. Debris has the gate blocked open.

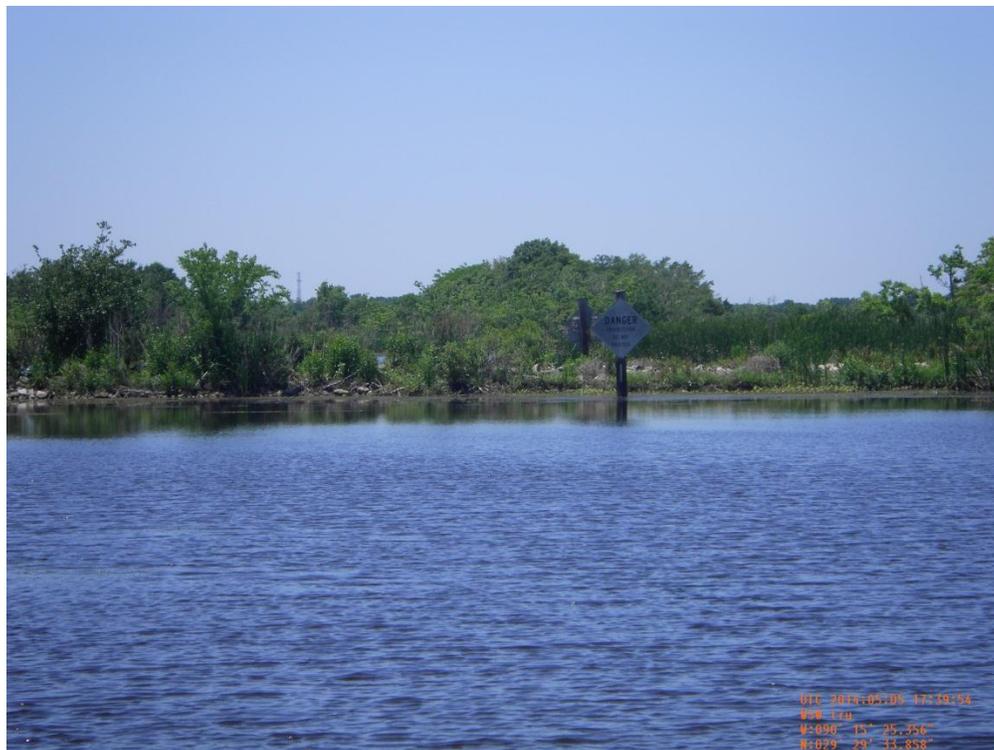
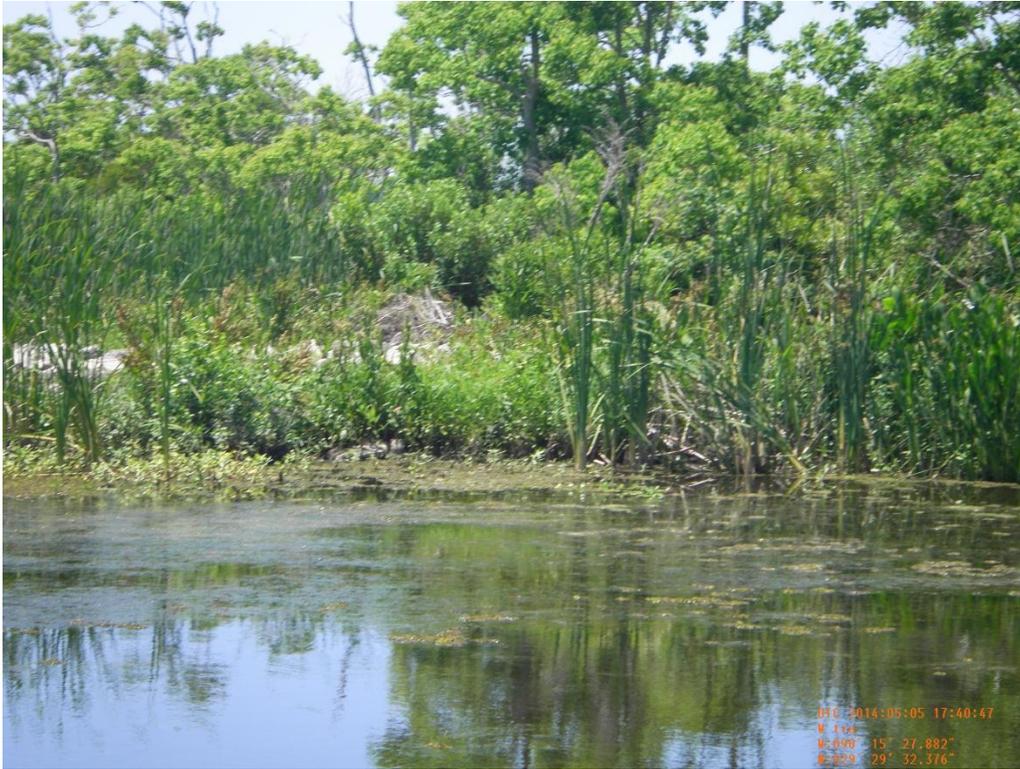
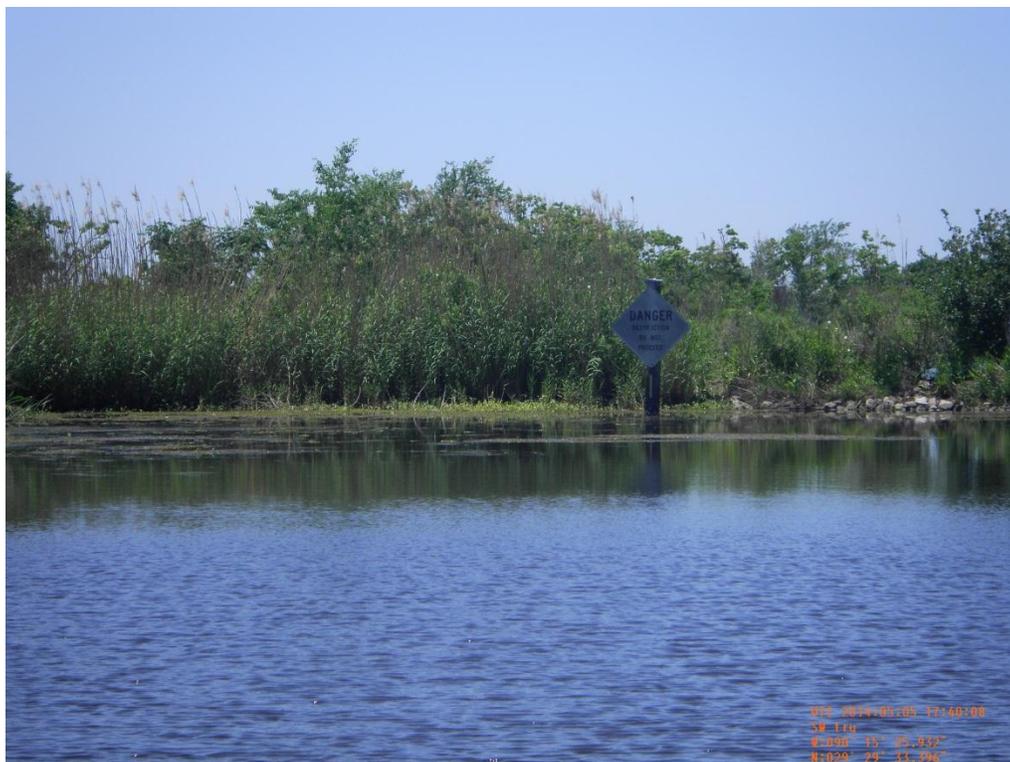
Structure 90 appears to be in overall good condition with no rock settlement/ displacement or erosion around the embankment tie-ins. All warning signs and supports are in good condition also. There are no recommended corrective actions at this time.

Photo 12: Overall view of Structure 90 rock plug, looking southwest

Photo 13: Close up view of the embankment tie-in on the southeast side of Structure 90

Photo 14: Close up view of the embankment tie-in on the northwest side of Structure 90

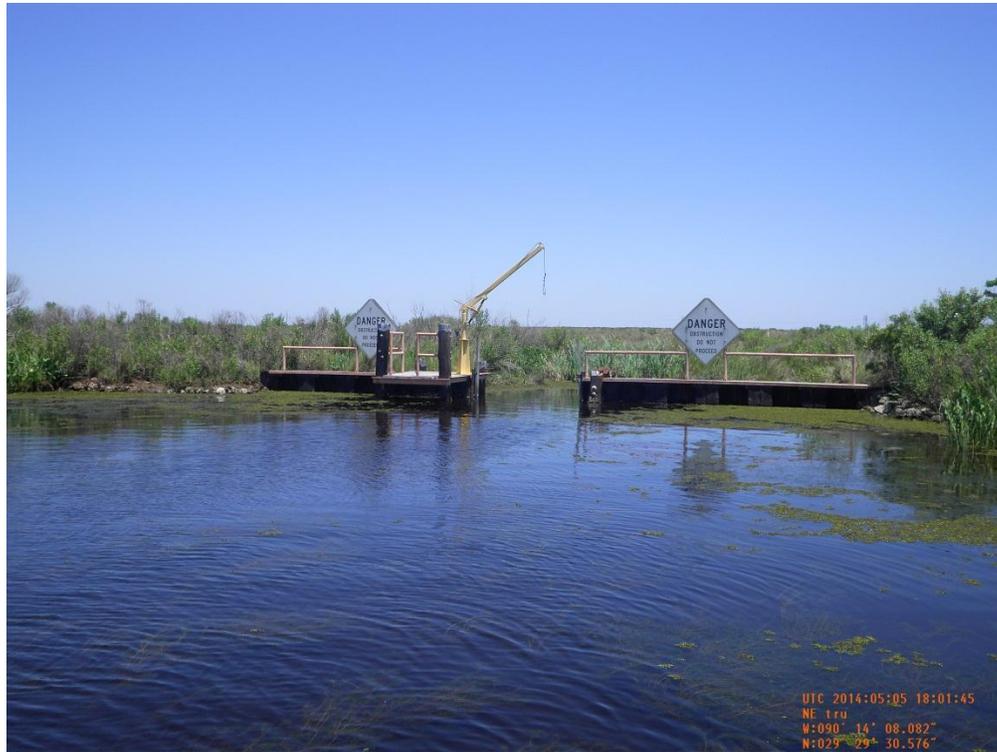
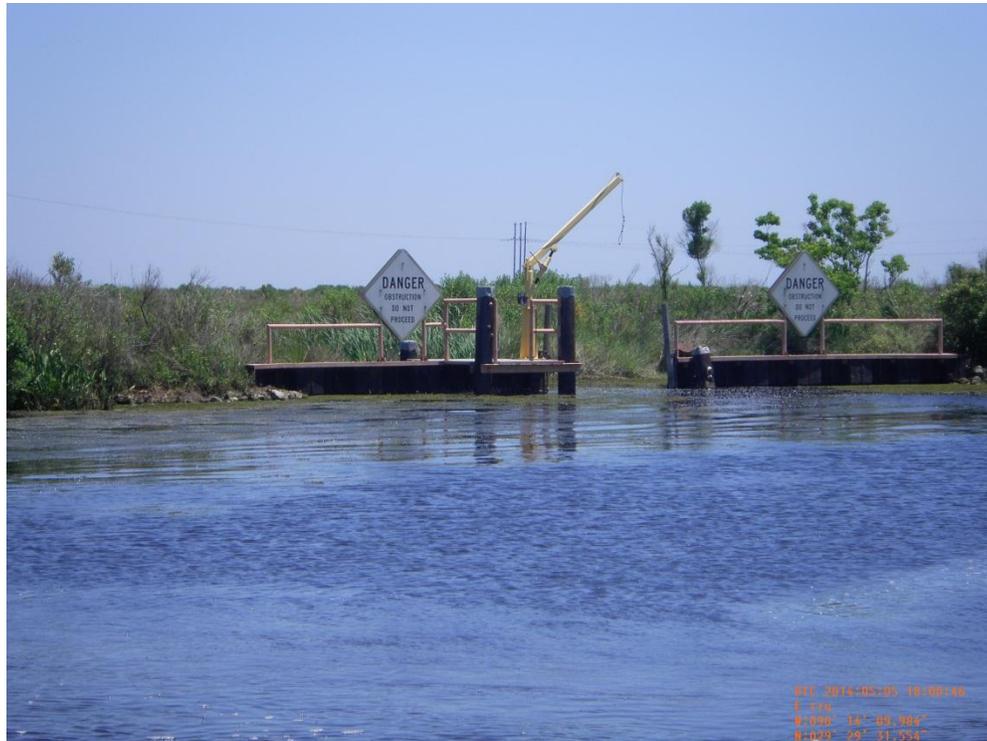
Structure 35 is in overall good condition with some signs of minor corrosion on the bulkhead cap, handrails and deck. The stop logs, cables, signs and supports appear to be in good condition and operable. At the time of inspection the channel from the weir to the interior marsh was open and there appeared to be adequate flow through the interior marsh and structure. The embankment tie-ins also appear to be in good condition with no erosion or washouts. We are not recommending any repairs or corrective actions at this time.

Photo 23: Overall view of Structure 35 variable crest weir, looking northeast

Photo 24: Close up view of Structure 35 warning signs, railings, steel bulkhead, and operating crane
