2014 Annual Inspection Report

**GIWW/ CLOVELLY HYDROLOGIC
RESTORATION**

State Project Number BA-02
Priority Project List 1

May 6, 2013
Lafourche Parish

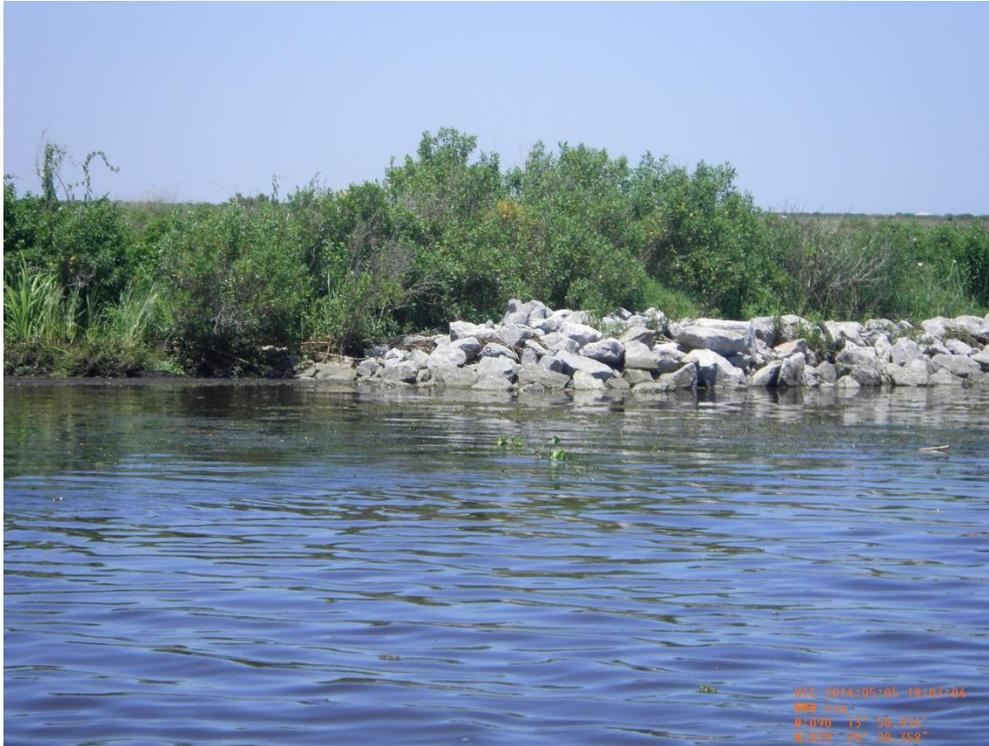
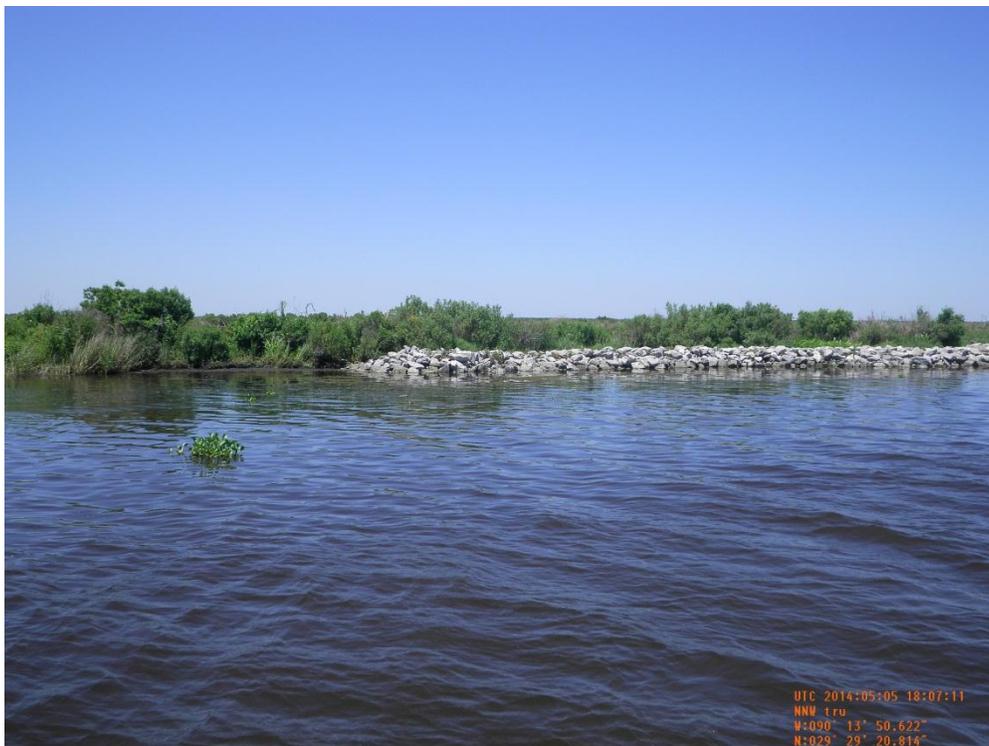
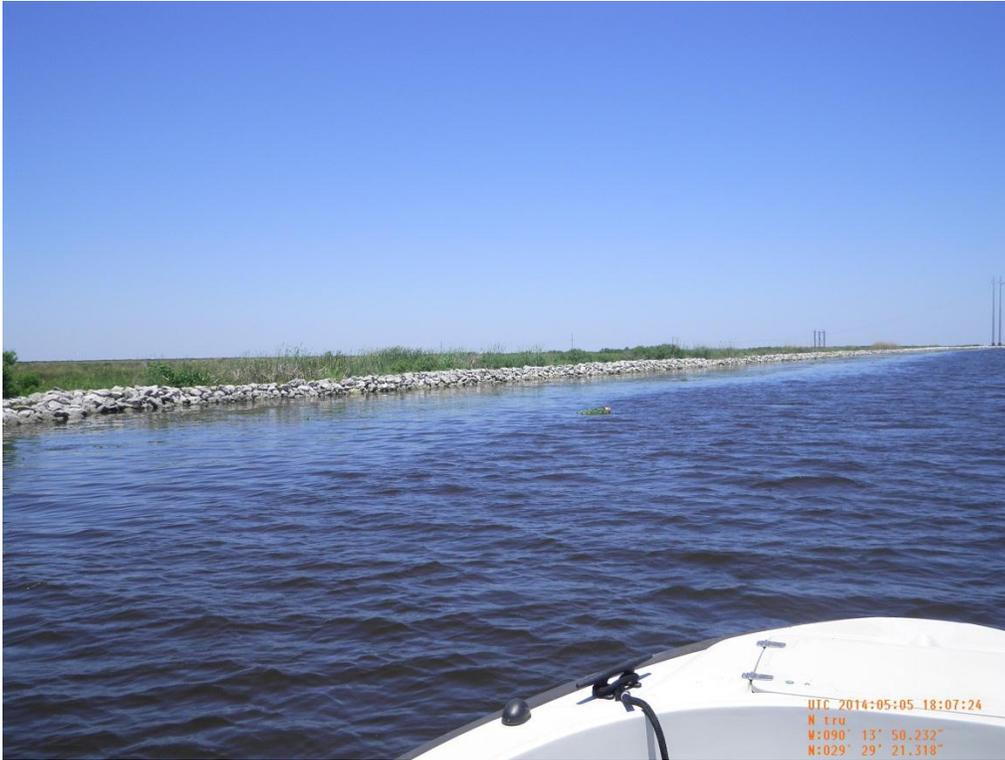
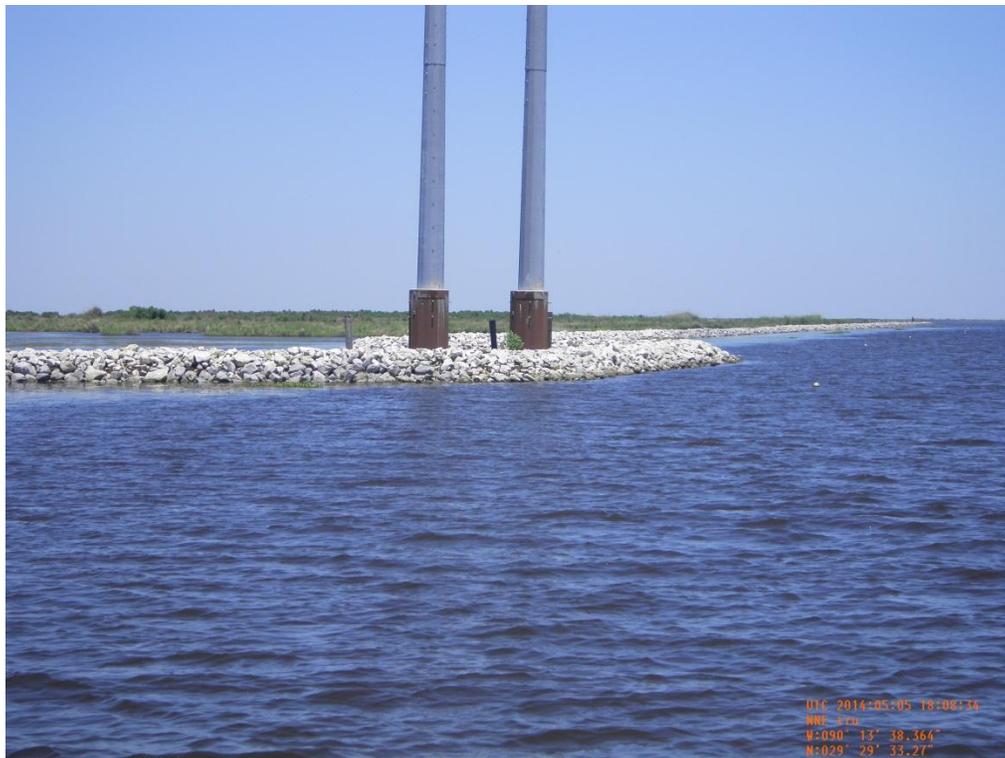
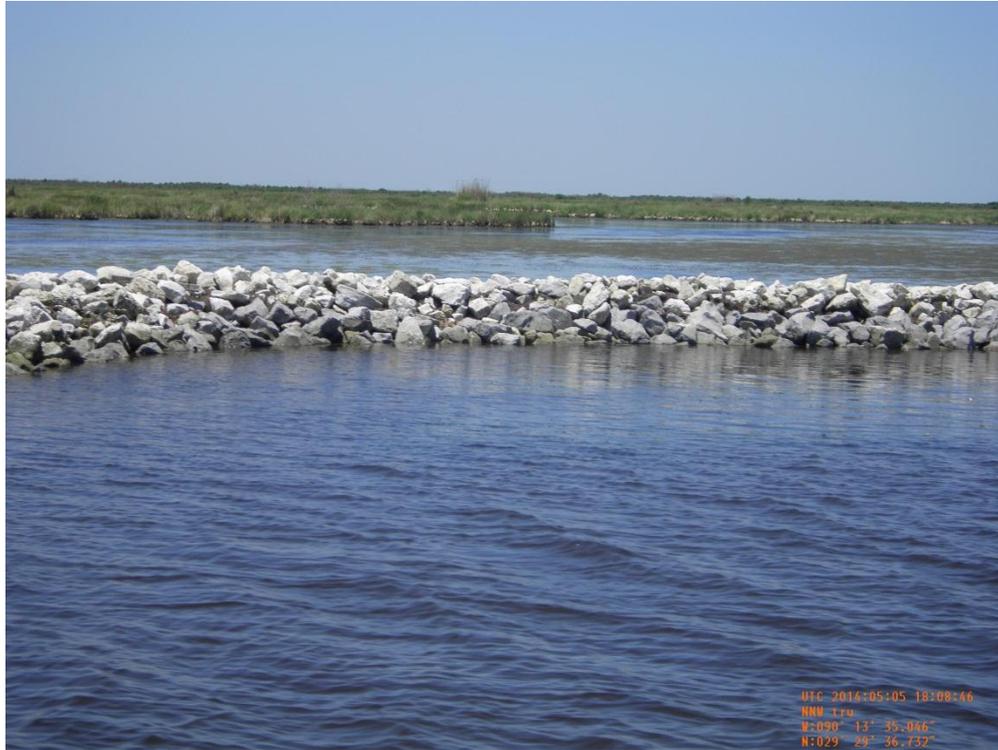
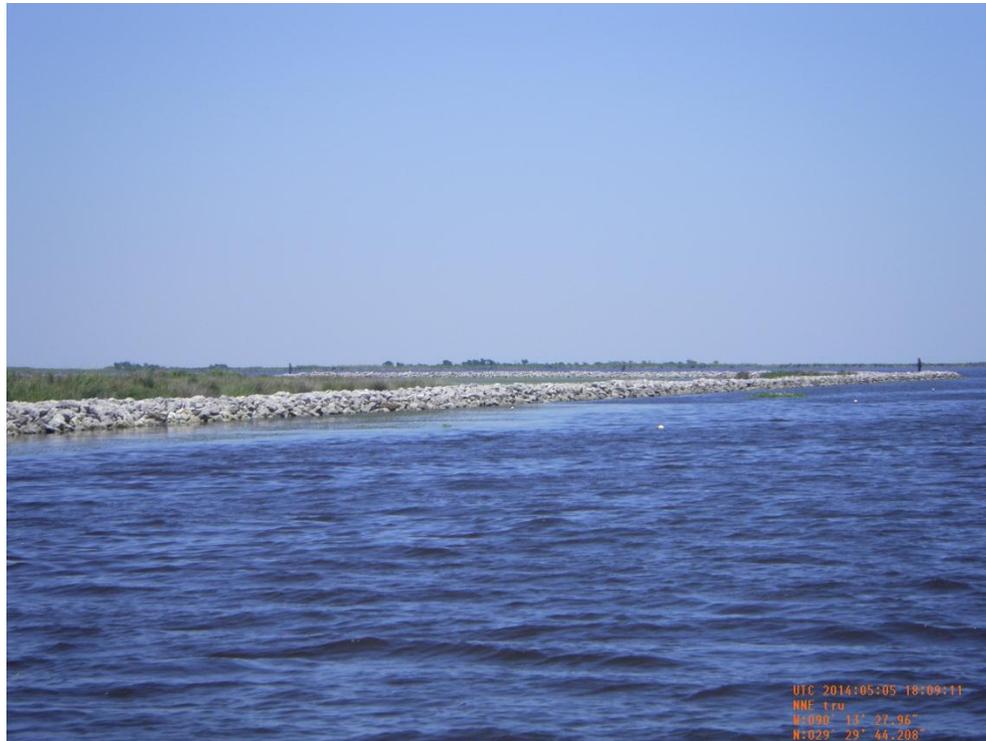
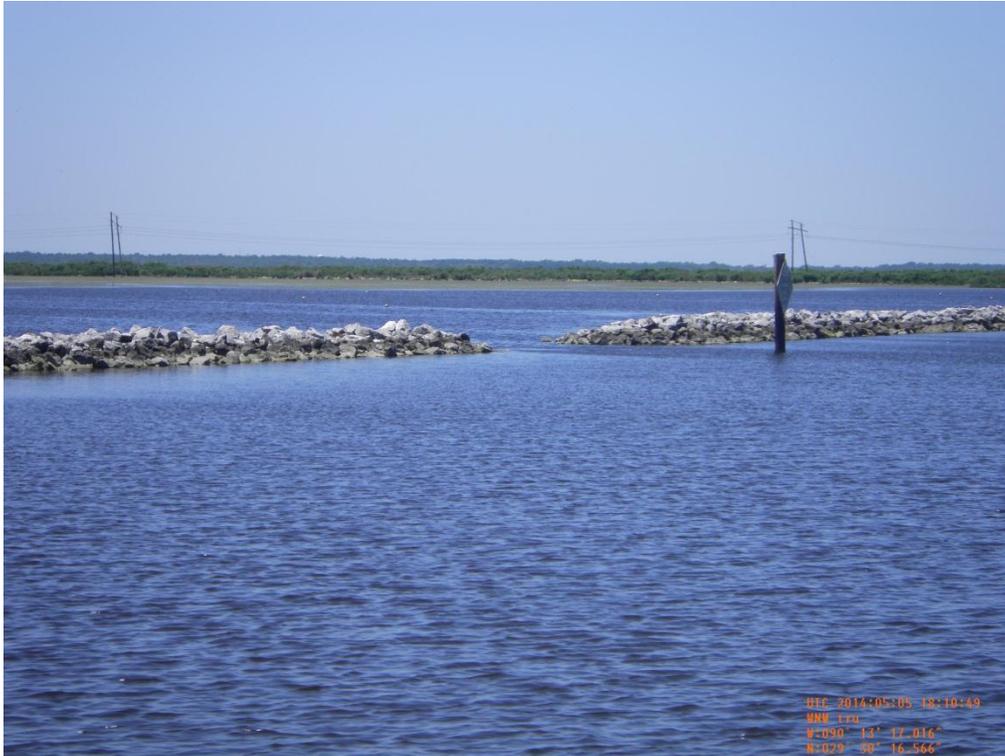
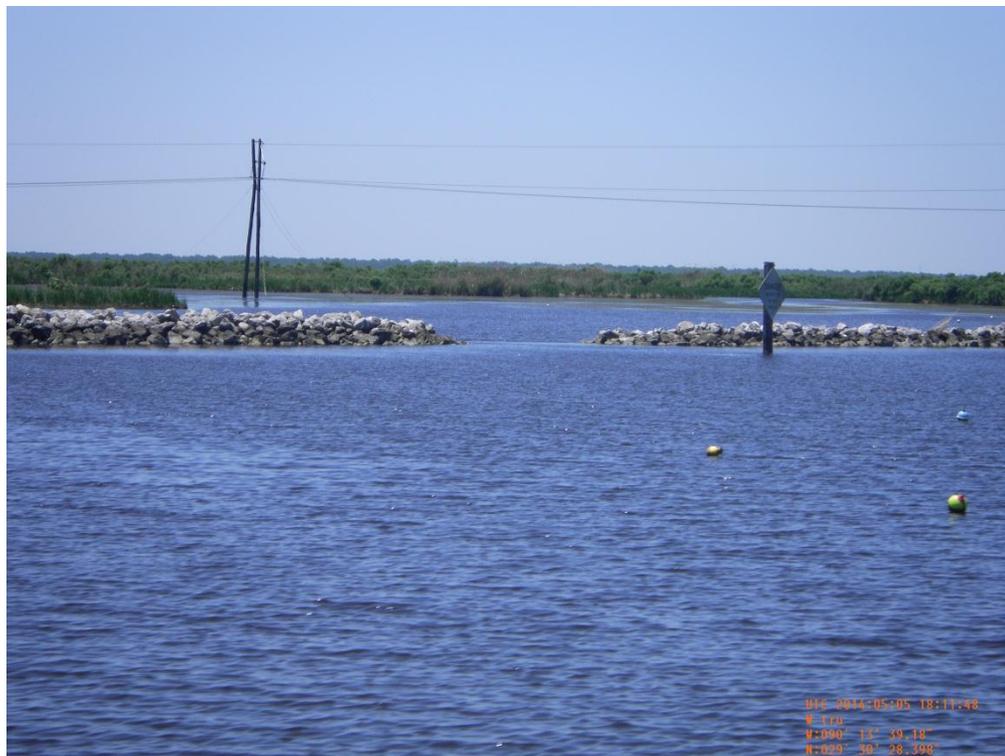
The Lake Rim structure was recapped as part of the 2012 Maintenance Project. As indicated on previous inspections and surveys, the rock dike has displayed minor to moderate settlement along the entire length of the structure. The most notable segments included segments between Stations 7+00 and 13+00, 36+00 and 41+00, and the intersection near the mouth of Breton Canal. As part of the maintenance project, the Lake Rim structure was recapped with 130# class rock riprap to its original design elevation of +3.0' NAVD88 from the north bank along Breton Canal to southern embankment tie-in of Structure 2. During construction, the Lake Rim structure did not settle from the weight of the extra rock as much as anticipated, which left the contractor with an excess of rock riprap inside of the bid quantity. This additional rock was used to place a second lift of rock along the north bank of Breton Canal, Structure 4, and the Lake Rim structure. The 2012 Maintenance Project as-built drawings show the constructed elevation of the Lake Rim structure to be approximately +3.5' NAVD88 to +4.0' NAVD88 after the second lift. At the time of inspection, there appeared to be no further settlement of the structure since the end of maintenance. There are no recommendations for maintenance at this time.

Photo 25: View of the southernmost end of the Lake Rim rock dike refurbishment in Breton Canal

Photo 26: View of the Lake Rim rock dike refurbishment from Breton Canal, looking north

Photo 27: View of the Lake Rim rock dike refurbishment from Breton Canal, looking north

Photo 28: View of the Lake Rim rock dike refurbishment from Breton Canal, looking northwest

Photo 29: View of the Lake Rim rock dike refurbishment from Breton Canal, looking northwest

Photo 30: View of the Lake Rim rock dike refurbishment from Breton Canal, looking north

Photo 31: View of Lake Rim fish dip and warning sign from Little Lake, looking west

Photo 32: View of Lake Rim fish dip and warning sign from Little Lake, looking southwest

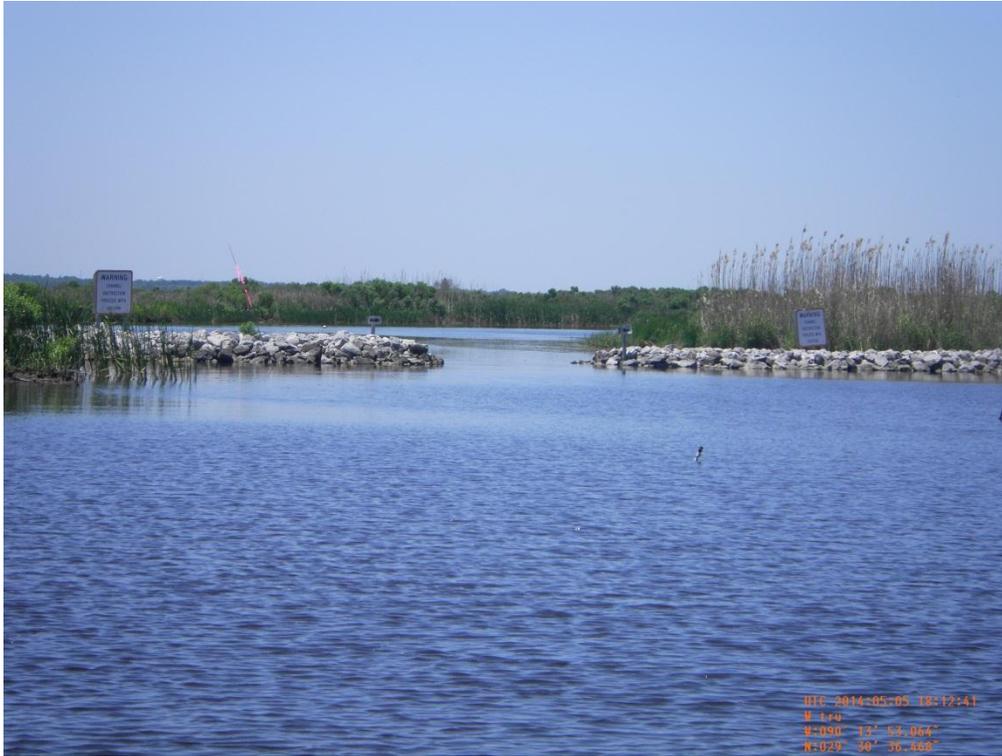
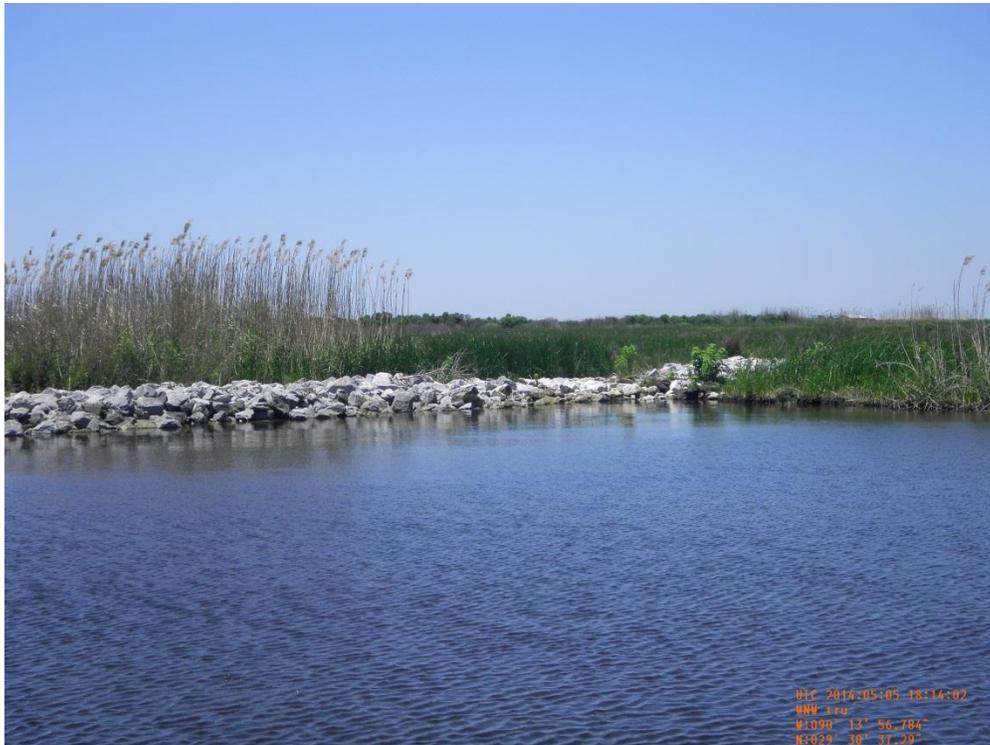
Structure 2 is a three (3) level fixed crest weir constructed of rock riprap material. Previous inspections have shown that settlement has occurred along the structure, in both of the sections between the bank and the boat bay, and also the bottom sill of the boat bay. This structure was recapped with 130# class rip-rap to its original design elevation as part of the 2012 Maintenance Project. During the inspection, there were no areas where settlement was observed since the end of 2012 Maintenance Project. The warning signs and navigational aids on Structure 2 are in good condition and do not require maintenance at this time.

Photo 33: Overall view of Structure 2 fixed crest rock weir with boat bay, looking west

Photo 34: View of warning sign and rock recap on the northern side of Structure 2

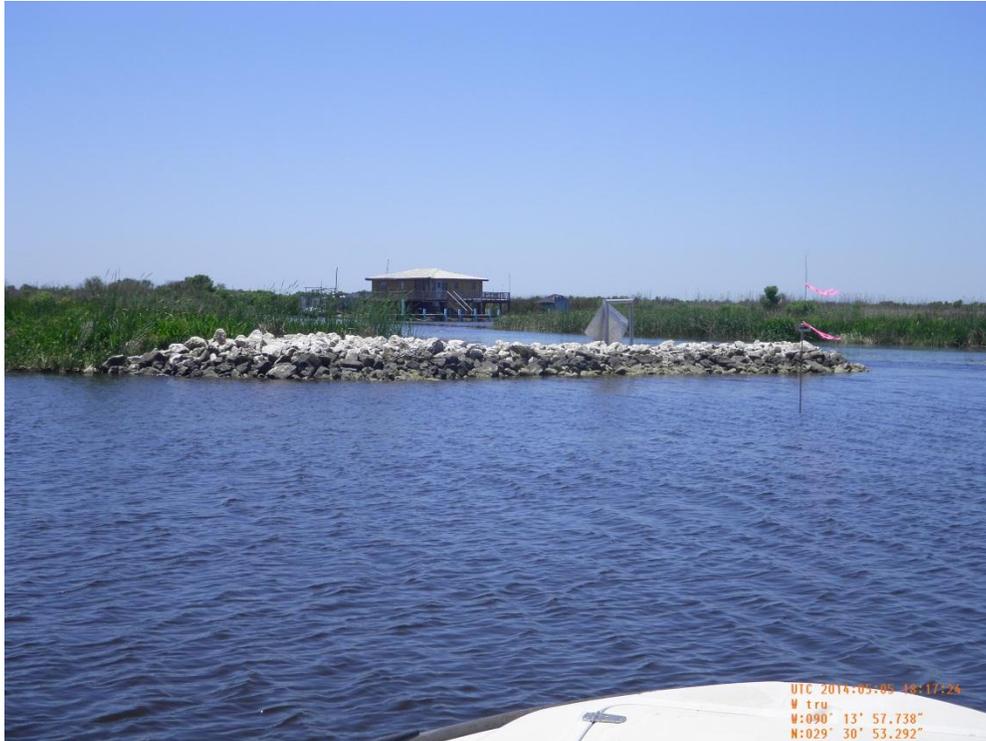
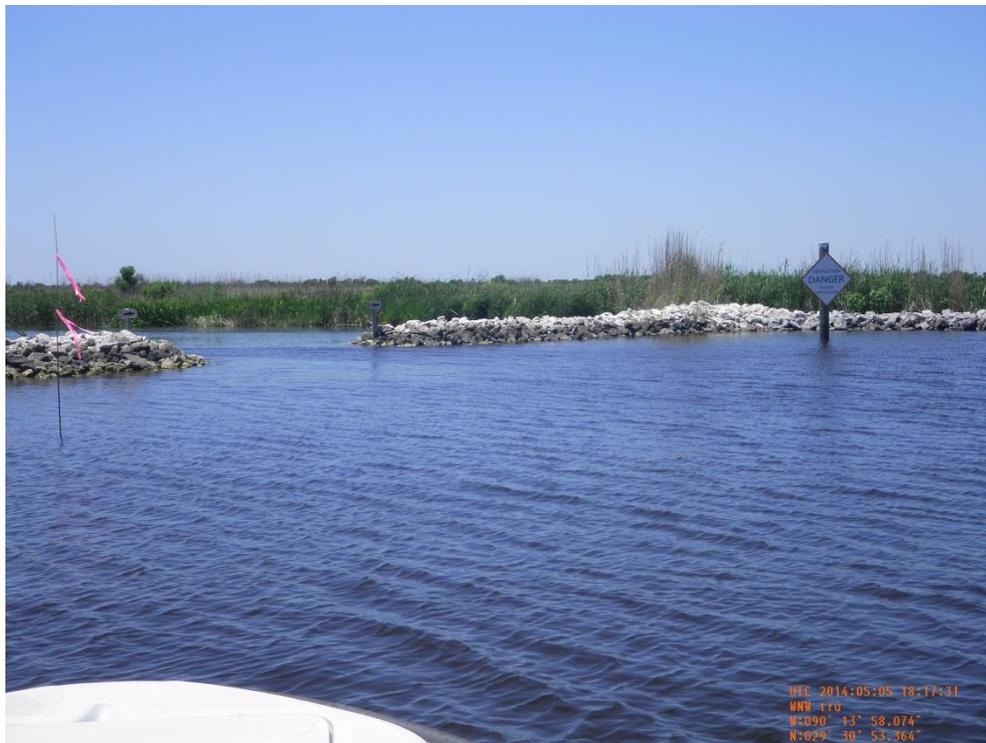
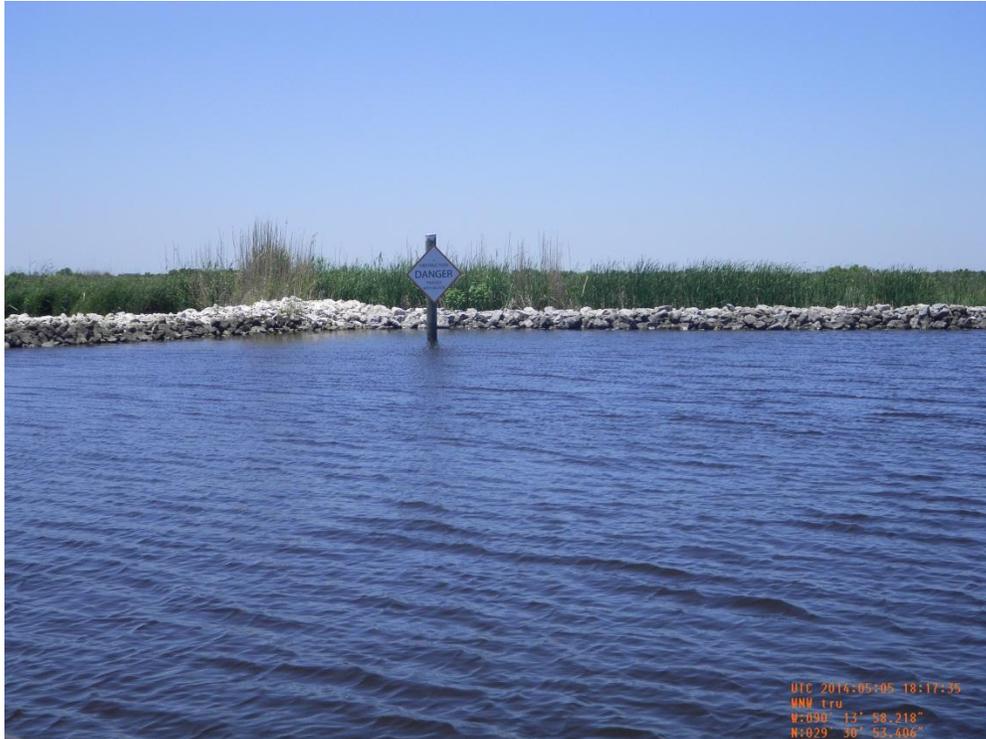
Structure 4 is also a three (3) level fixed crest weir constructed of rock riprap material. The structure was recapped with 130# class rip-rap to its original design elevation as part of the 2012 Maintenance Project. During the inspection, there were no areas where settlement was observed since the completion of the 2012 Maintenance Project. There has been significant erosion observed on the southern end of the structure since the end of the 2012 Maintenance Project. Only a small strip of marsh embankment approximately 30 feet wide is preventing the structure from a full breach on the south side. This potential breach will be addressed by the 2014 Maintenance Project has been authorized. The warning sign on the southern end of the structure appears to be partially disconnected from its supports, as the top of the sign remained secure to the support but the bottom of the sign could be observed moving with the wind. It is recommended this warning sign be refastened to the support before it becomes completely detached. The other newly installed warning sign and its support timber are in good condition and do not require maintenance at this time.

Photo 35: View of the warning sign and embankment tie-in on the south side of Structure 4

Photo 36: View along the rock recap of Structure 4, looking northwest

Photo 37: View of new warning sign and transition between Structure 4 and Rock Dike Extension

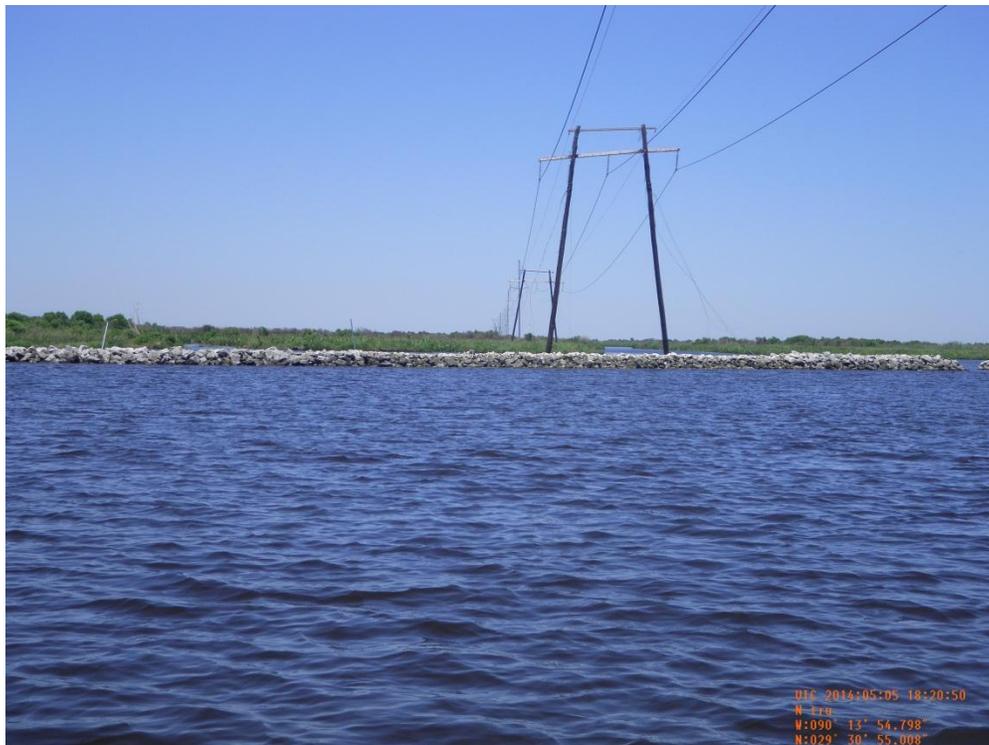
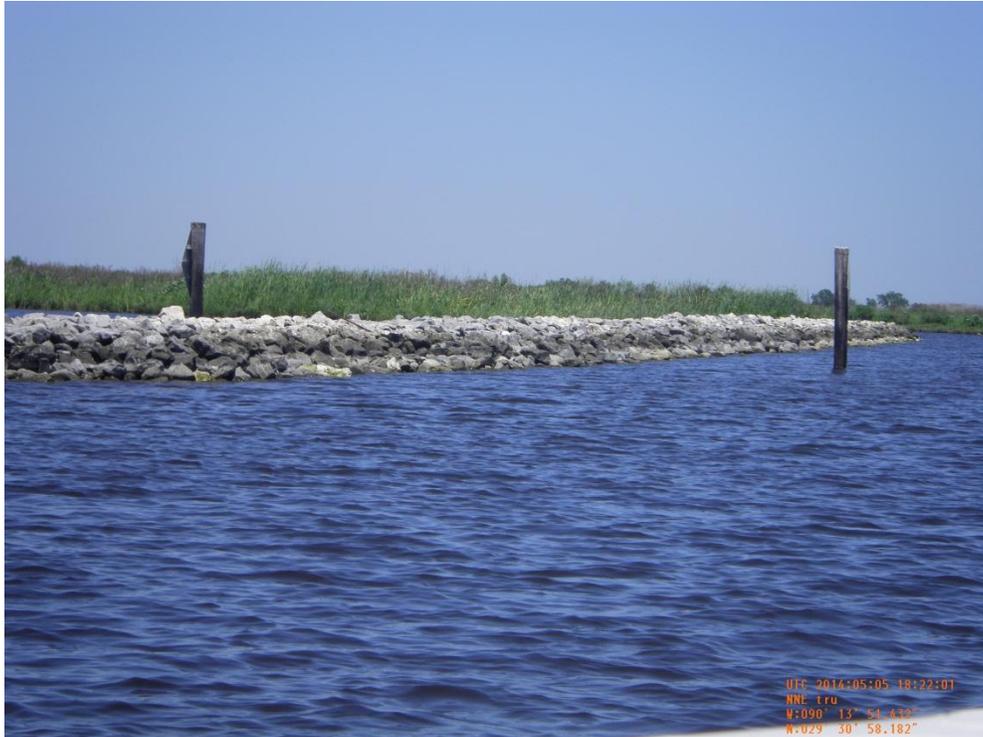
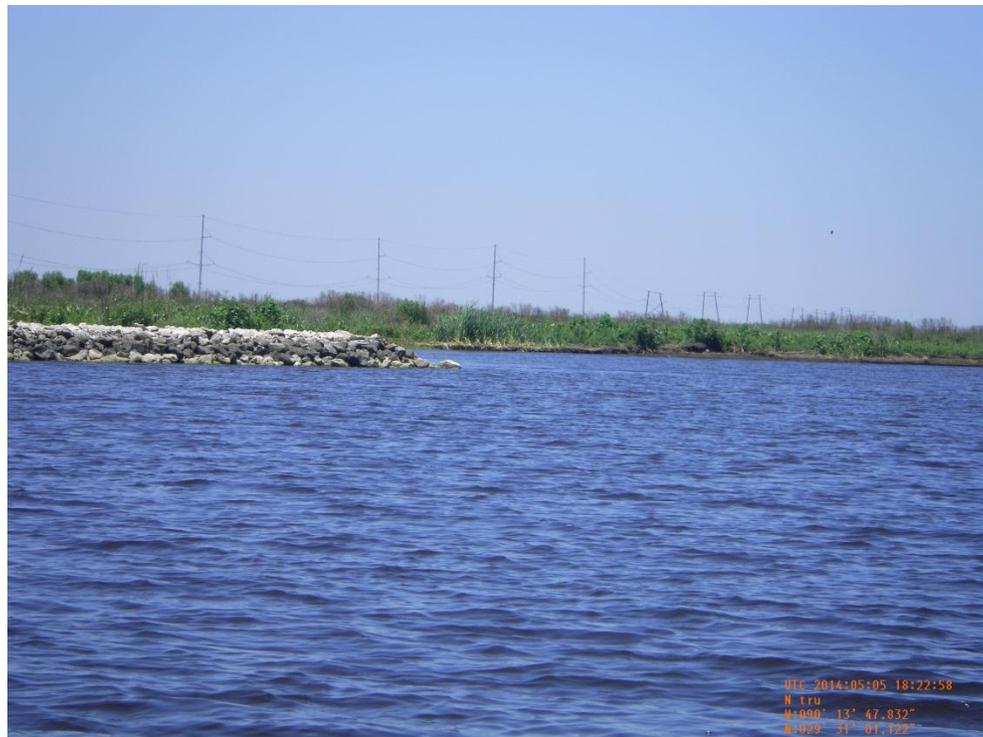
As part of the 2012 Maintenance Project, Structure 4A & 4B was recapped to its original design elevation and extended to Structure 4. The 2008 survey profile showed this structure had settled approximately 1.5' to 2.0' along the entire length of the structure. In addition to the settlement, and partially caused by hurricanes Gustav and Ike, the marsh around the plug had suffered extensive erosion. On the south side of the plug there was a very large opening in the shore line approximately 1,000 feet wide. The Maintenance Project recapped the existing structure to an elevation of 3.5' NAVD88 using 130# class rock riprap and also closed the opening by extending the structure approximately 1,000 linear feet to the embankment tie-in of Structure 4 at an elevation of 3.5' NAVD88 using 130# class rock riprap. During construction of the extension, a change order allowed the contractor to install two warning signs with timber supports in the location of the fish dips. At the time of inspection, there was no observed settlement or displacement of Structure 4A & 4B or the extension since the end of the 2012 Maintenance Project. There are no recommendations for maintenance at this time.

Photo 38: View of Rock Dike Extension from Little Lake, looking north

Photo 39: View of warning signs and transition from Rock Dike Extension to Structure 4A&4B

Photo 40: View of the northernmost end of Structure 4A&4B, looking north

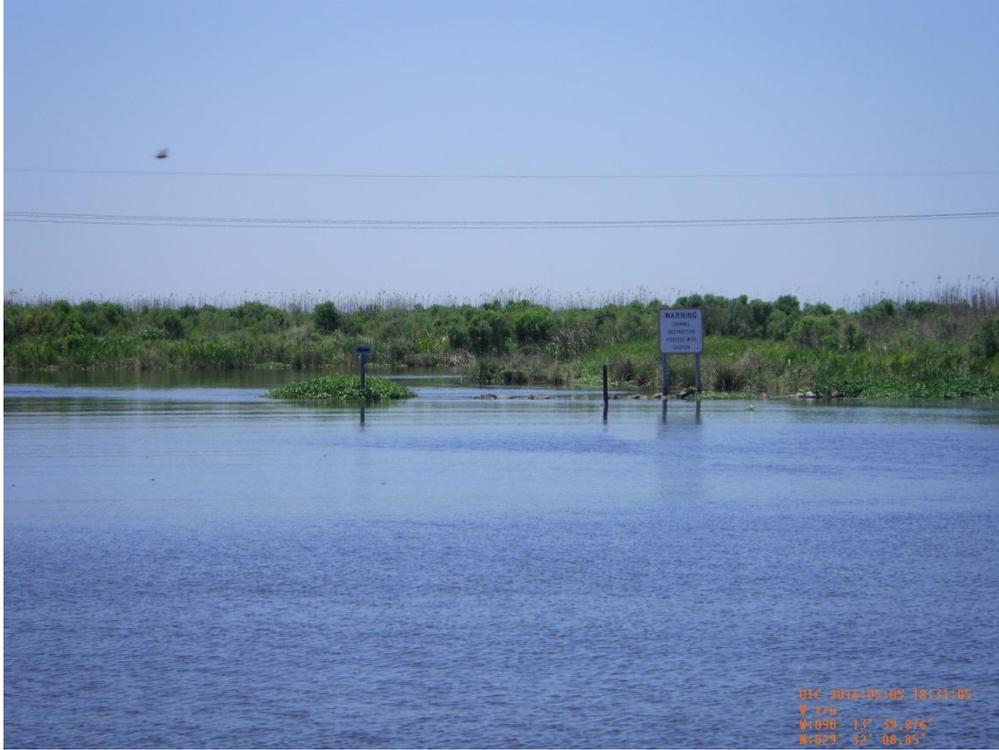
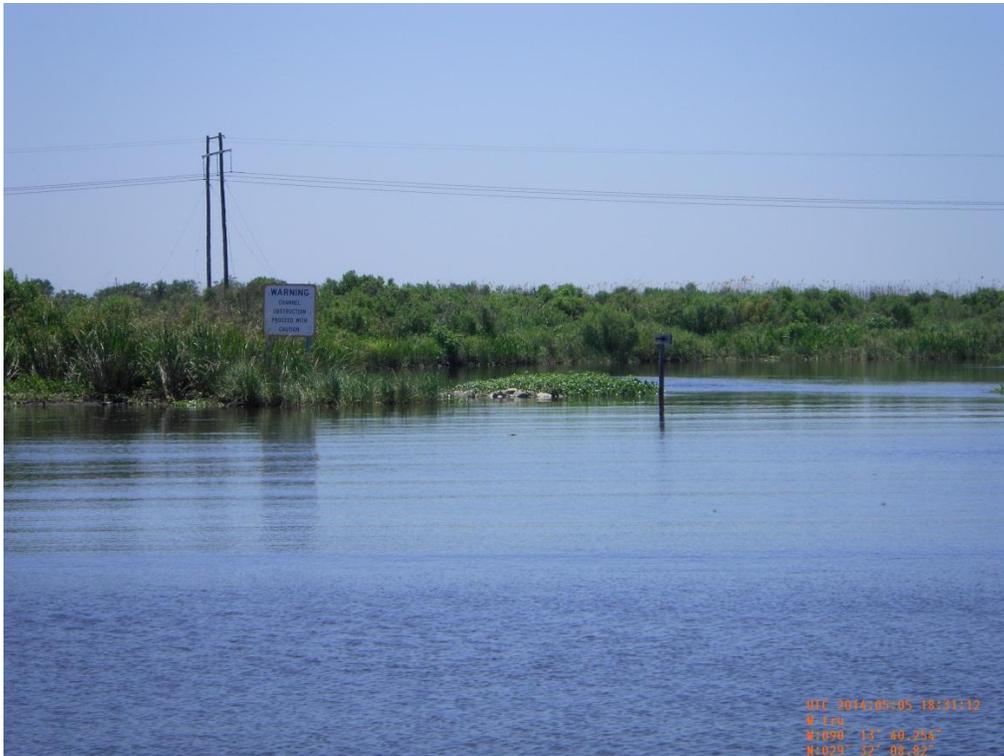
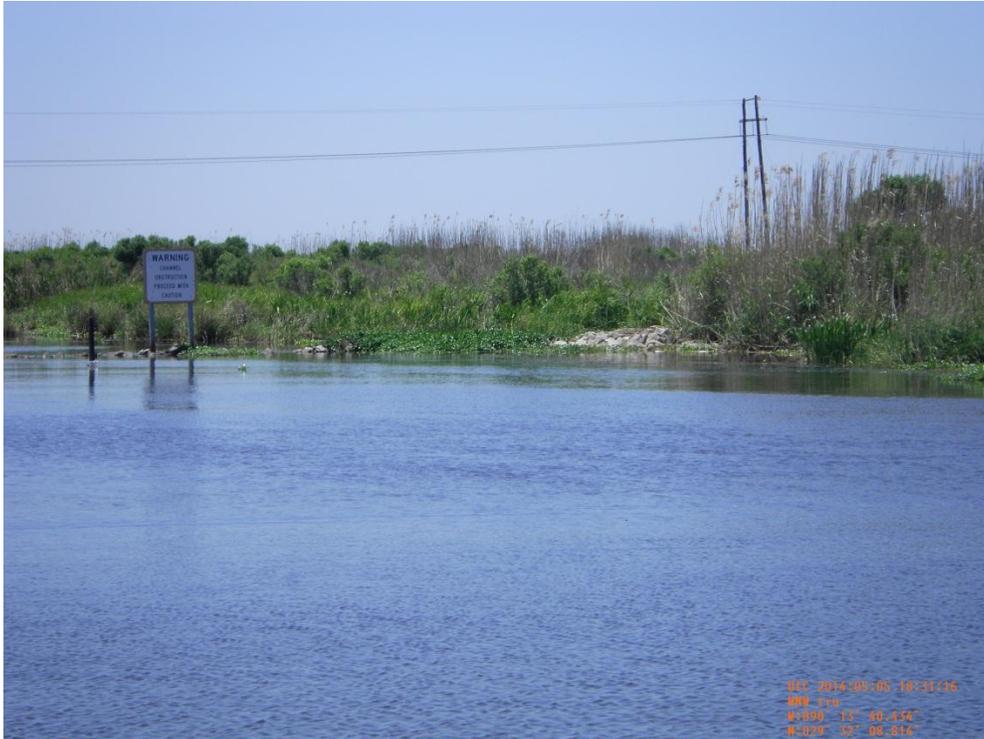
Structure 7 appeared to be in fair condition with some settlement of the rock riprap material but no visual damage to the weir or erosion around the embankment tie-ins. Because the settlement of the Structure 7 has been minor and uniform causing no breaching of the structure, it was not included in the 2012 Maintenance Project, but the structure will continue to be monitored during future inspections. All warning and navigational signs and their supports appear to be in good condition.

Photo 41: Overall View of Structure 7 fixed crest rock weir with boat bay, looking west

Photo 42: View of the warning sign and embankment tie-in on the southern end of Structure 7

Photo 43: View of the warning sign and embankment tie-in on the northern end of Structure 7

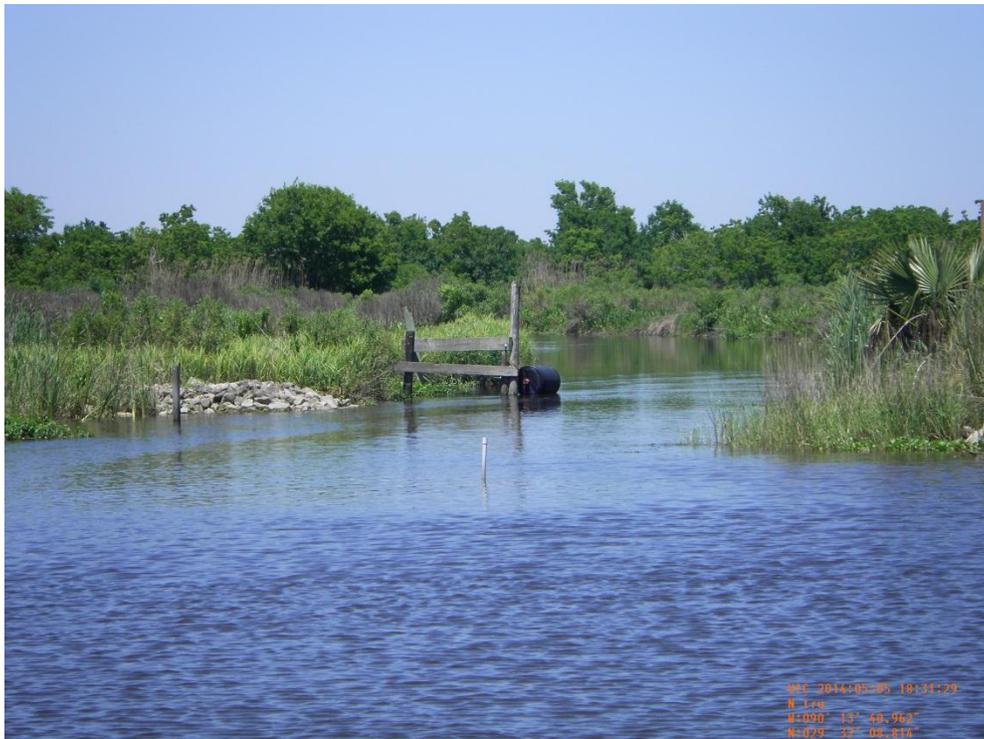
Structure 8 is a small rock weir with a boat bay located just north of Structure 7. This structure appears to be in fair condition with minimal settlement of the riprap material and no erosion or washouts around the bank tie-ins. This structure was originally constructed with a steel gate to prevent access into the interior marsh, but this gate was destroyed during Hurricanes Gustav and Ike. Since the gate was destroyed, the landowner has installed a series of floating barrels to restrict access. At the time of this inspection, the floating barrels were not in place to restrict access. These floating barrels will continue to be monitored during future inspections.

Photo 44: View of Structure 8 rock riprap channel plug, looking north

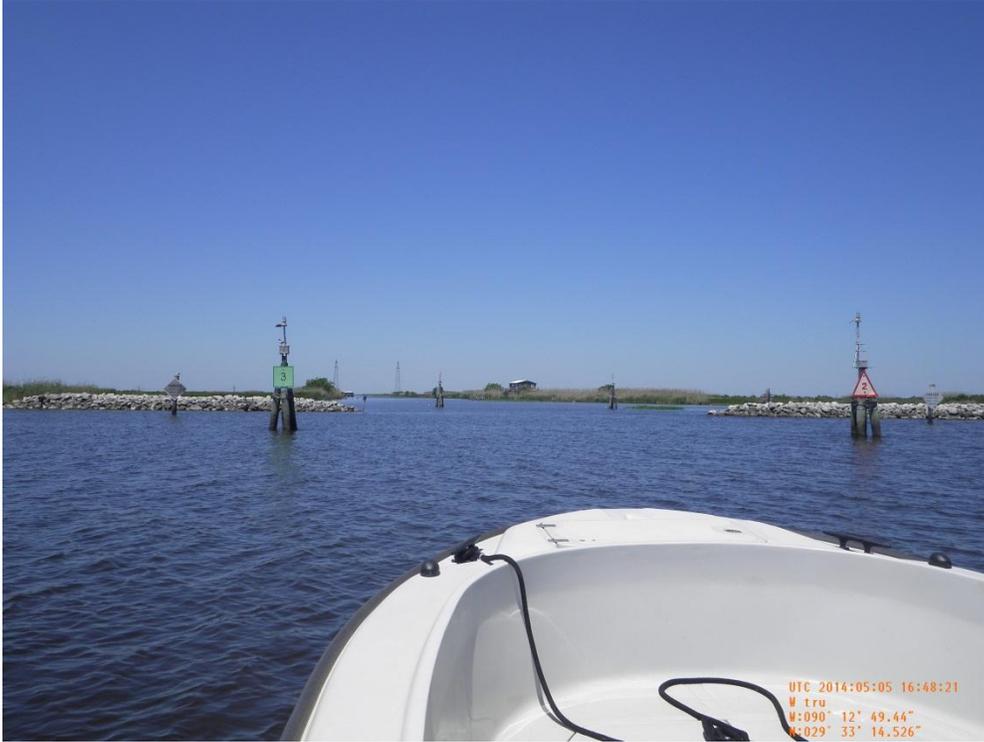
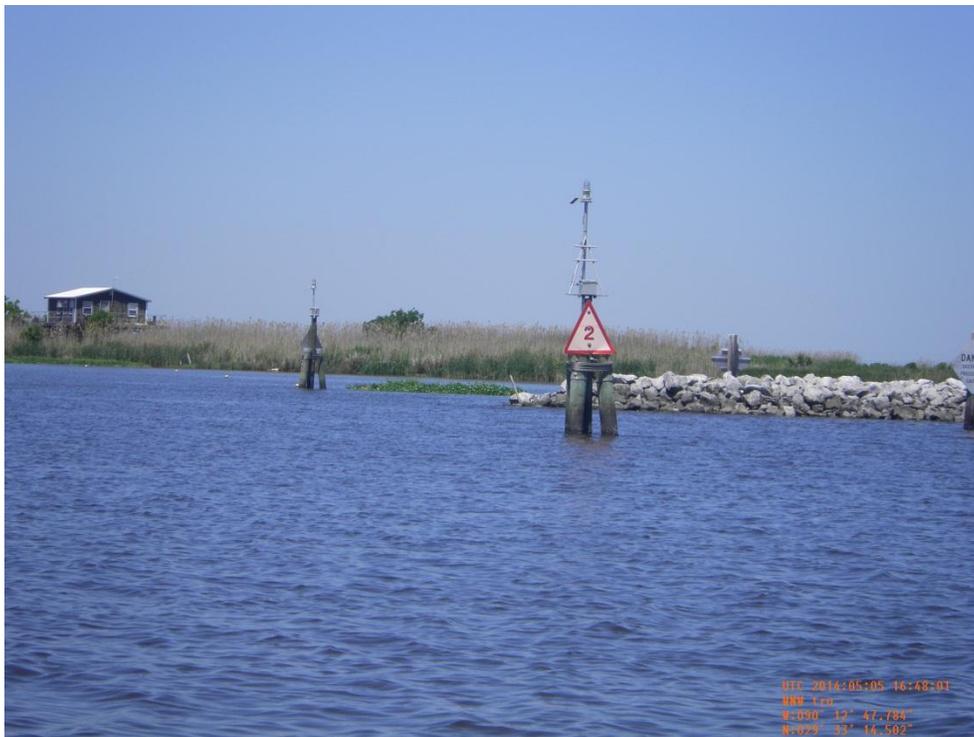
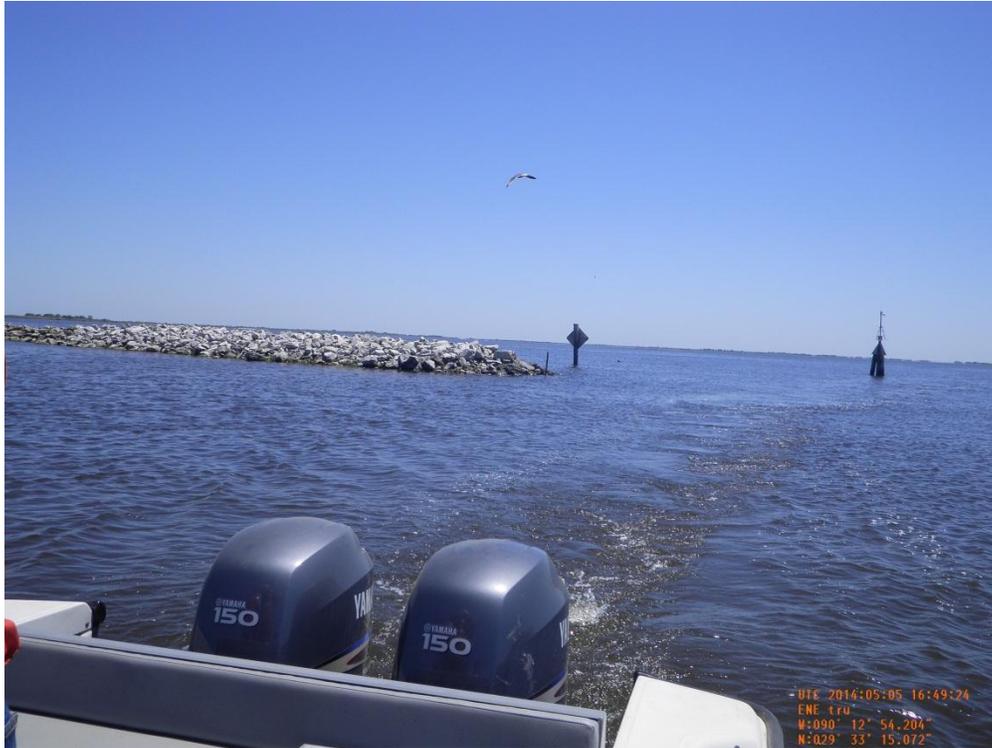
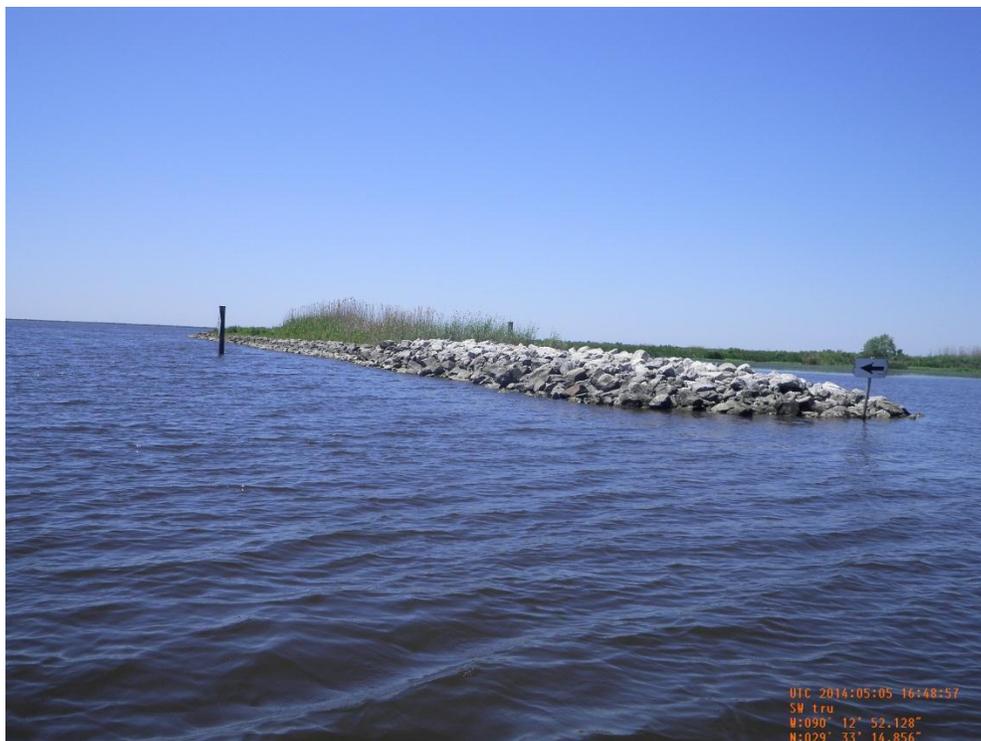
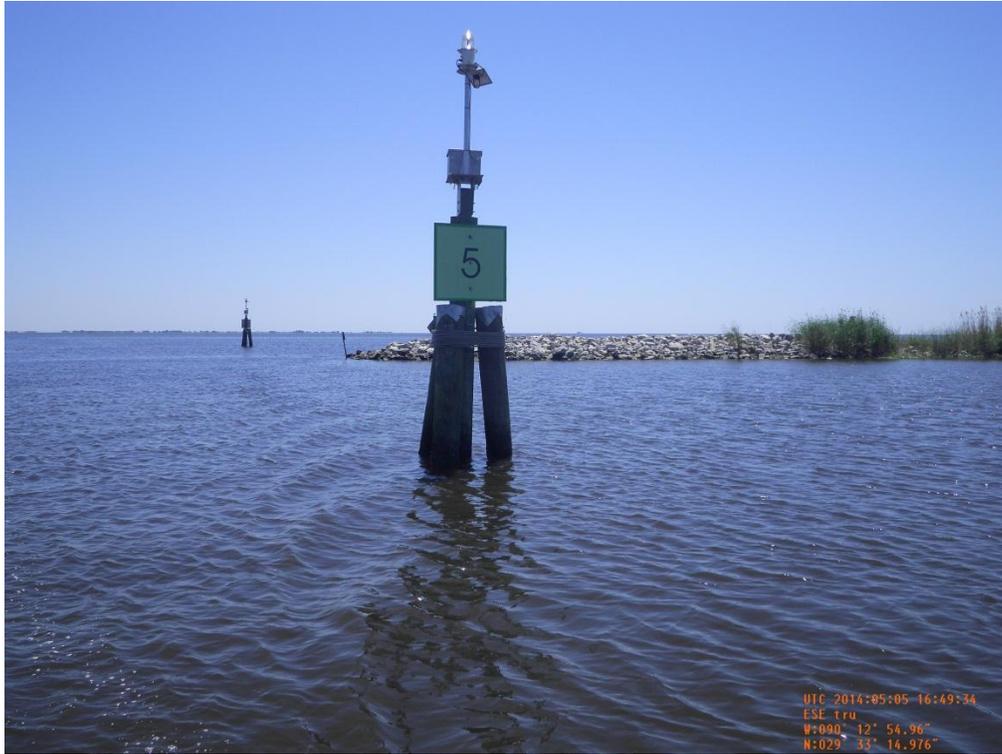
Structure 14A was also rehabilitated during the 2012 Maintenance Project. Observations from previous annual inspections and supporting data from the 2008 survey showed severe settlement and scour near the bottom of the barge bay with depths ranging from the original constructed height of -6.5' NAVD88 to as low as -15.0' NAVD88. During the Maintenance Project, the structure was recapped with a heavier 250# class rock riprap to prevent further scouring to the original design elevation of -6.5' NAVD88 at the bottom of the barge bay and +4.0 at the crest of the weir. At the time of the inspection the structure appears to be in good condition, as there is no observed settlement of the rock since the end of construction. As mentioned in previous inspections, the timber dolphin piles were in poor condition with visible cracks and surface damage. Three of the timber dolphin piles and their navigational aids were replaced as part of the 2012 Maintenance Project. The timber pile on the southeast side of the structure was replaced in 2006 and remains in good condition. There are no recommendations for maintenance at this time.

Photo 45: Overall view of Structure 14 fixed crest rock weir with barge bay from Little Lake looking west

Photo 46: View of the rock recap on the northern side of Structure 14 from Little Lake, looking northwest

Photo 47: View along the rock recap on the northern side of Structure 14 from the barge bay, looking northeast

Photo 48: View of the rock recap on the southern side of Structure 14, looking southwest

Photo 49: View along the southern side of Structure 14 from Clovelly Canal, looking southeast
