2016 Annual Inspection Report

**GIWW/ CLOVELLY HYDROLOGIC
RESTORATION**

State Project Number BA-02
Priority Project List 1

May 03, 2016
Lafourche Parish

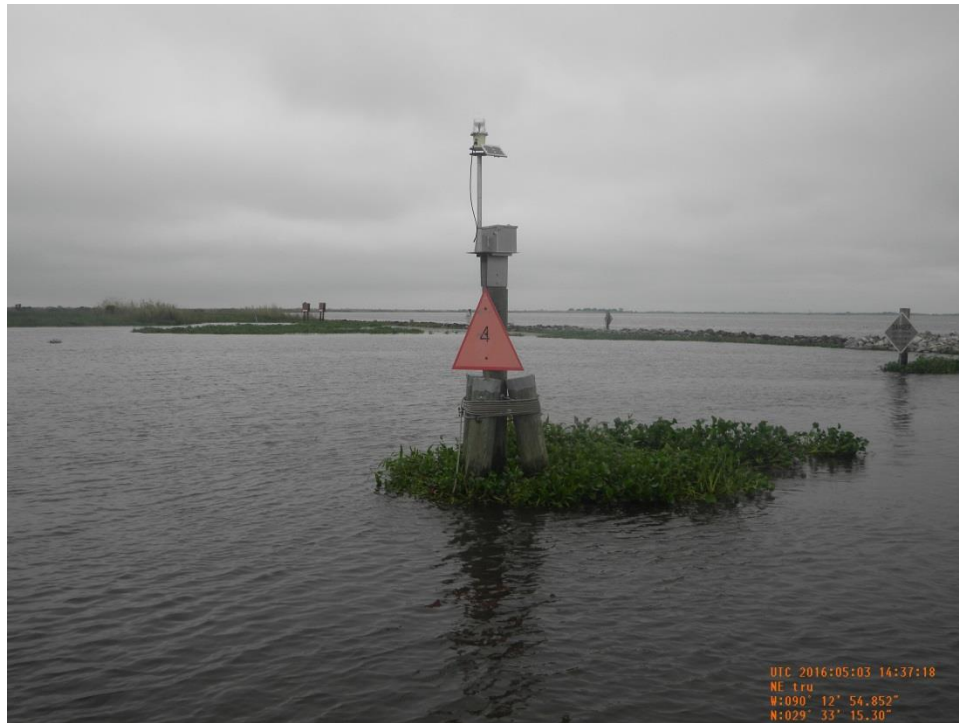
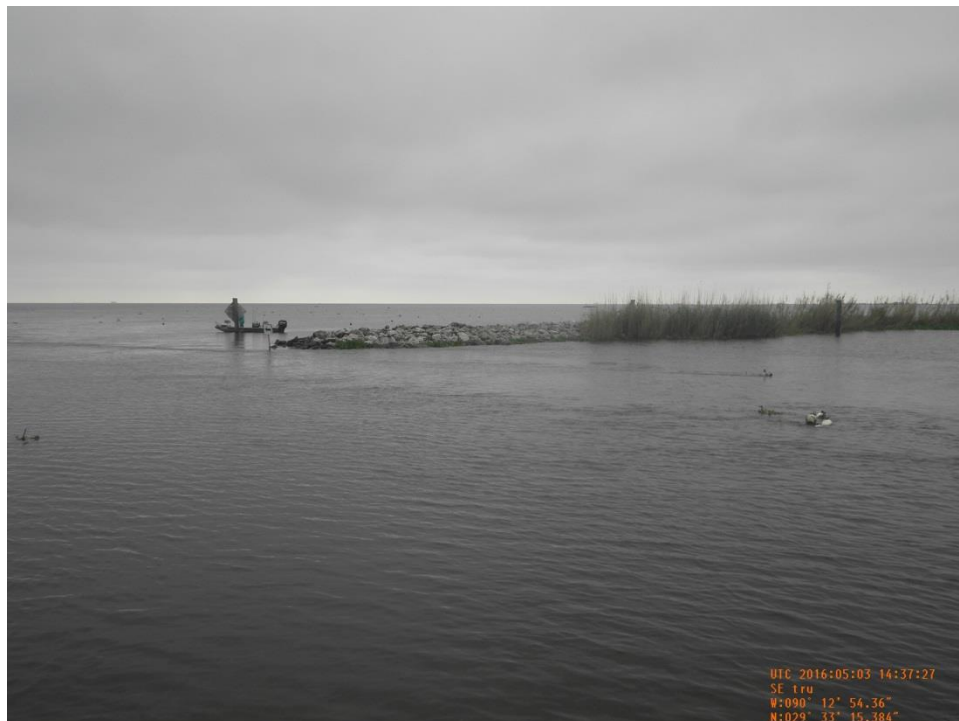
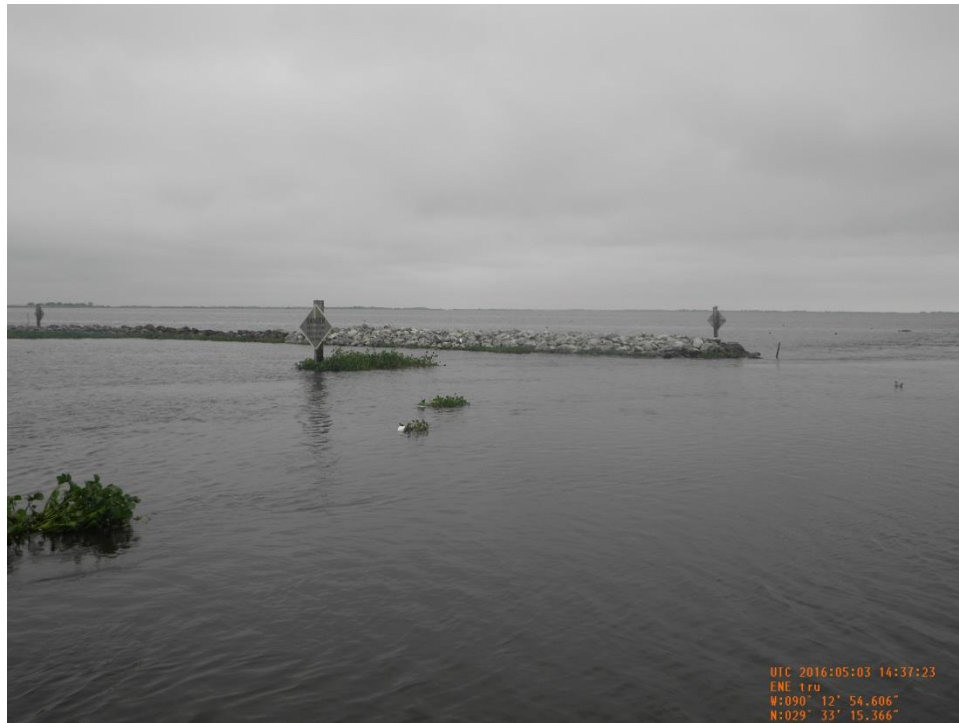
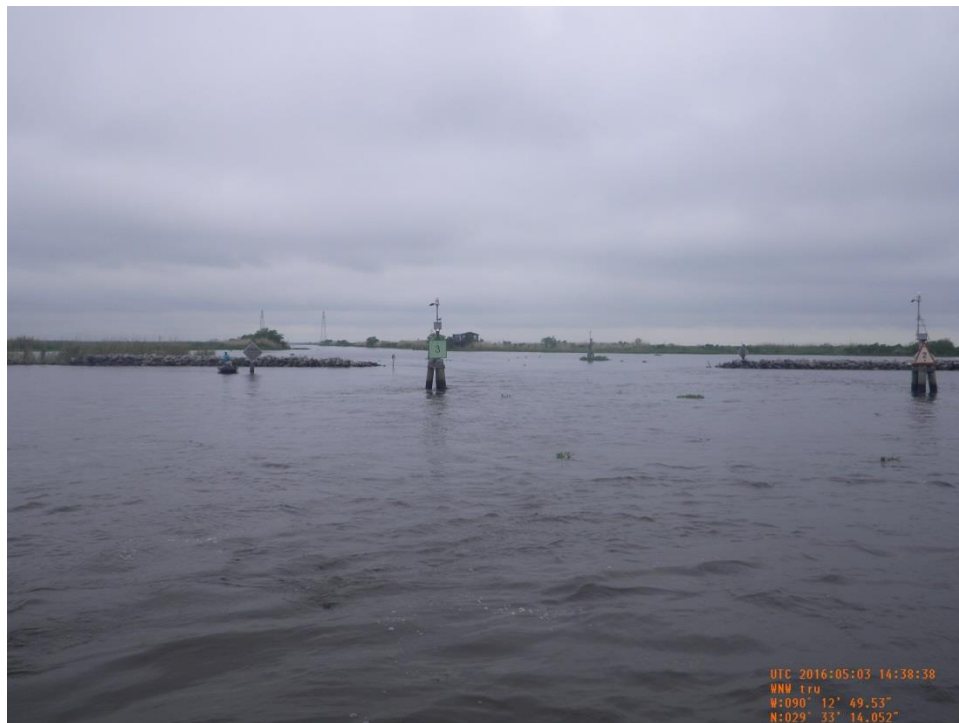
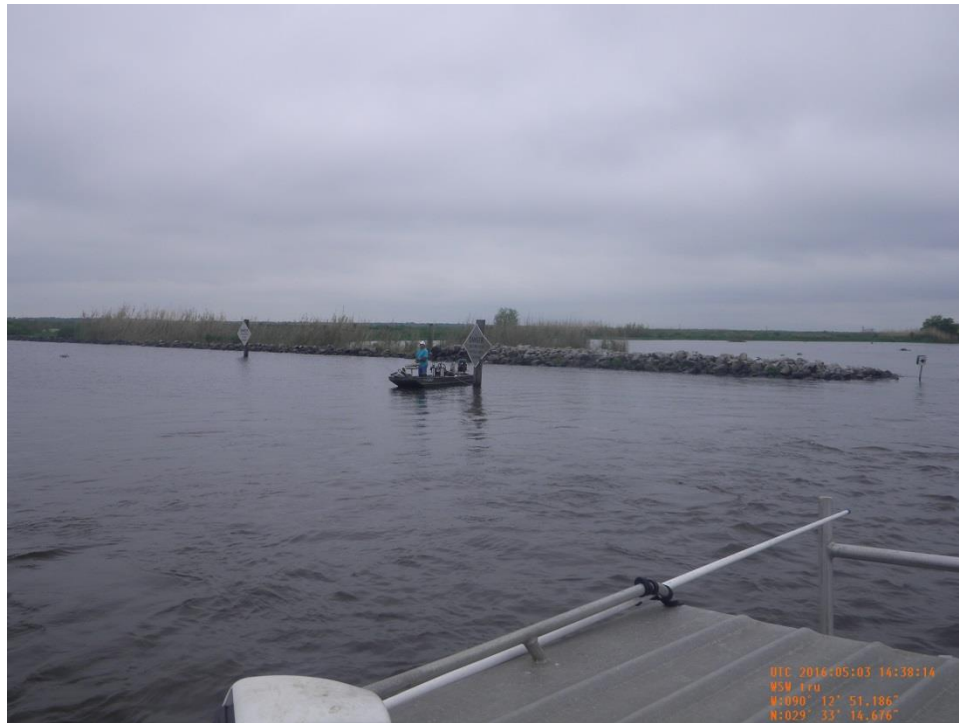
Structure 14A was also rehabilitated during the 2012 Maintenance Project. The structure was recapped with a heavier 250# class rock riprap to the original design elevation of -6.5' NAVD 88 at the barge bay to prevent further scouring of the channel bottom, and +4.0' NAVD88 along the crest of the weir. Depth soundings were taken along the center of the barge bay which indicated that the average depths ranged from 5.0' on the north side to 6.0' on the south side. Based on these depths, the average bottom sill elevation of the barge bay ranged between -4.0' to -5.0 NAVD 88, a questionable measurement that suggests shoaling. Soundings will be repeated next inspection to measure an accurate depth. Based on our observations, the structure appears to be in good condition, as there is no visible settlement of the rock since the end of construction. Also, three (3) of the navigation aid timber pile supports and daymark signs were replaced under the 2012 Maintenance Project and are in good condition with the exception of direction arrow signs missing or turned 180 degrees. The rock weir and navigation aid structures are in good condition and the only recommendation for maintenance at this time is for replacing the erroneous sign. (See Appendix B, Photos 1 through 5)

Photo 1: View of navigational aid on SW side of Structure 14 A and rock weir in background.

Photo 2: View of rock weir on the south side of the barge bay on Structure 14A.

Photo 3: View of rock Weir at the barge bay on the north side of Structure 14A.

Photo 4: View of navigation aid lights on the NE side of Structure 14a and rock weir in background.

Photo 5: view of the rock weir on the south side of Structure No. 14A.

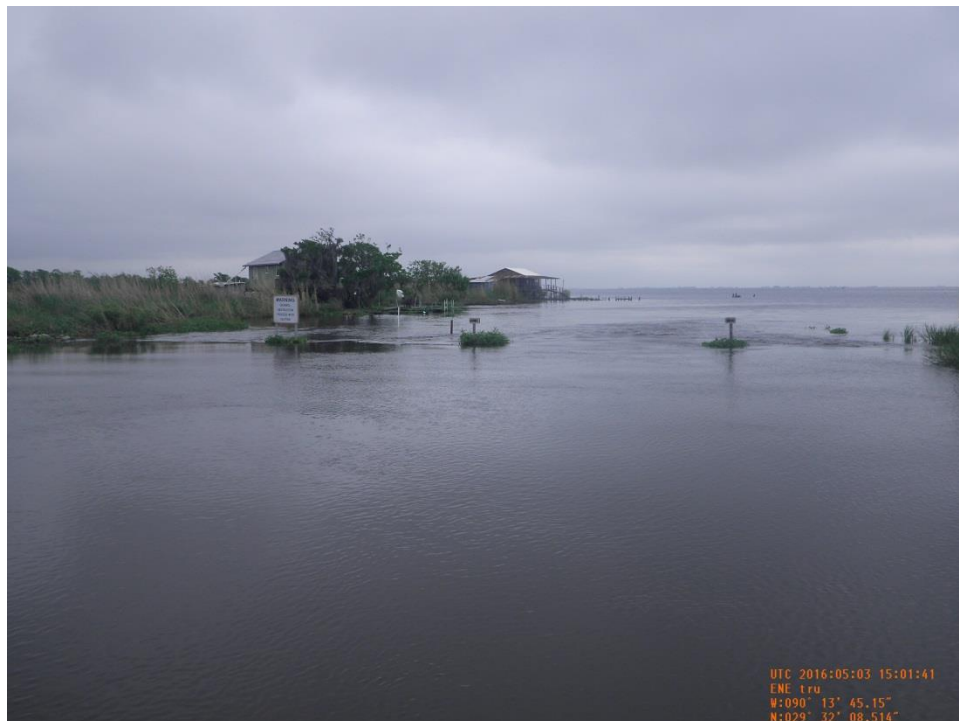
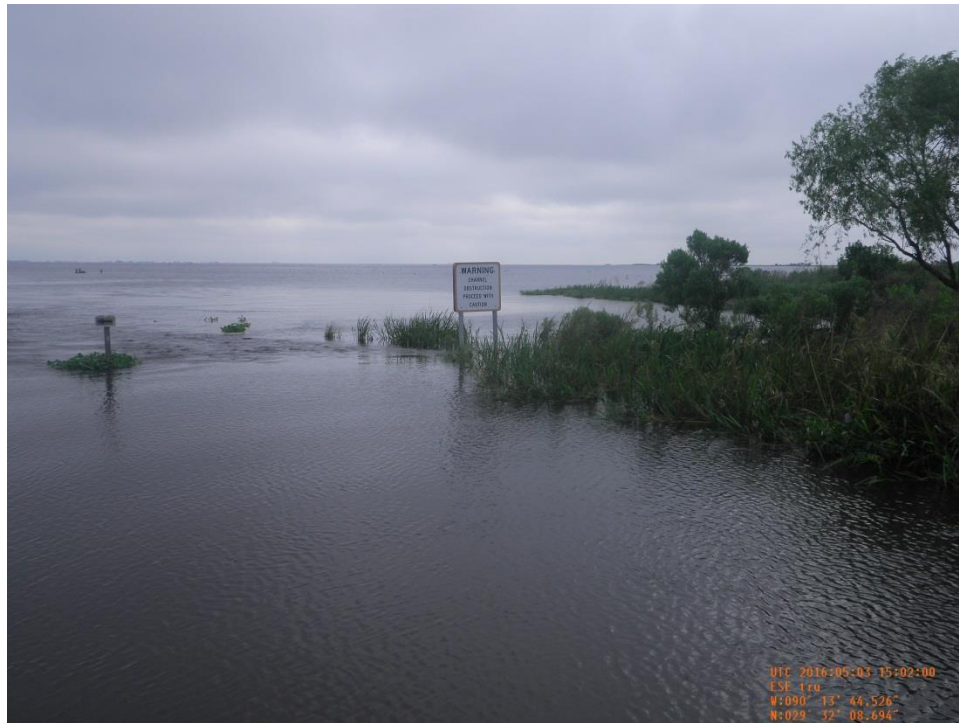
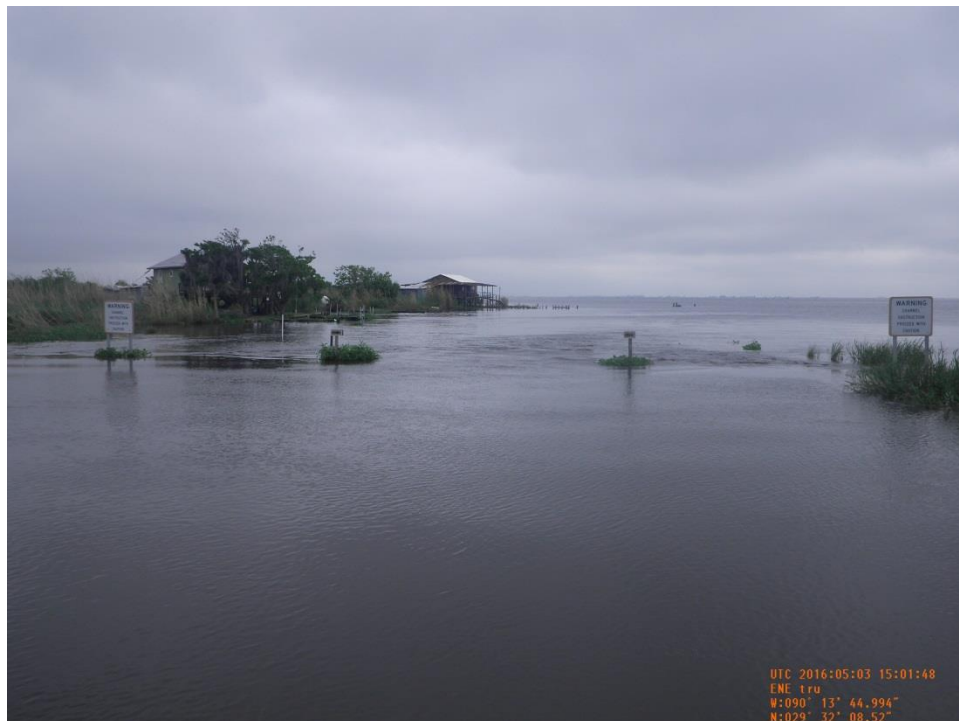
Structure 7 appeared to be in fair condition with some settlement of the rock riprap material but no visual damage to the weir or erosion around the embankment tie-ins. The settlement of Structure 7 has been uniform with no breaches of the bank tie-ins. Soundings indicate a depth of 7.0' which would correspond to an elevation of -5.0' NAVD88. We are not recommending maintenance of Structure 7 at this time. All warning signs and their supports appear to be in good condition. (See Appendix B, Photos 6 through 8)

Photo 6: View of the rock weir on the north side of the boat bay on Structure No7.

Photo 7: View of rock weir on the south side of boat bay on Structure No.7.

Photo 8: Overall view of the rock weir with boat bay of Structure No.7.

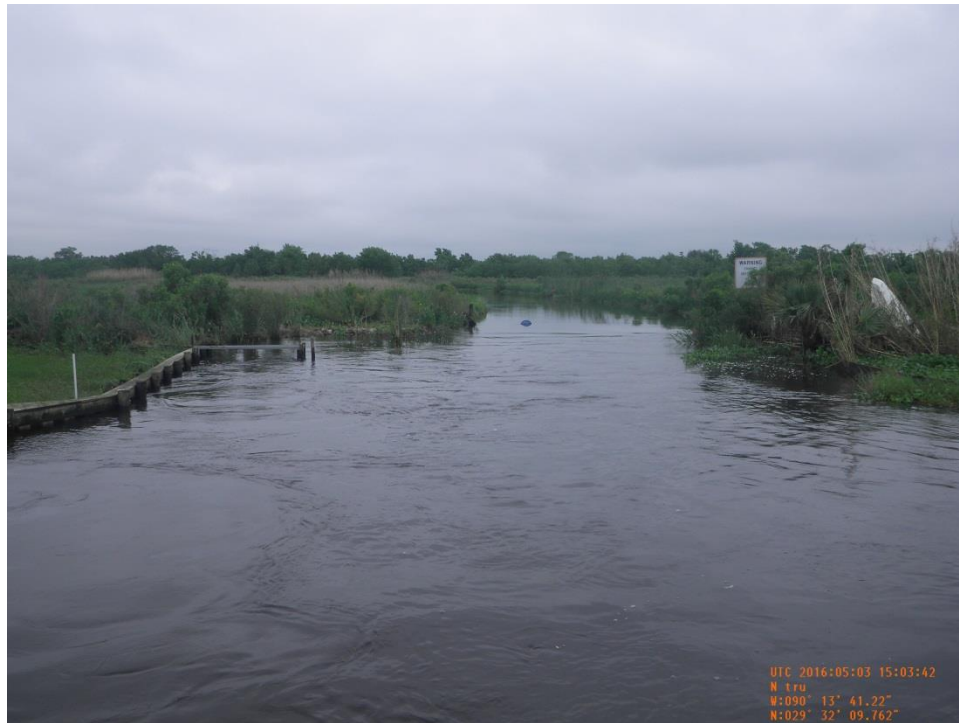
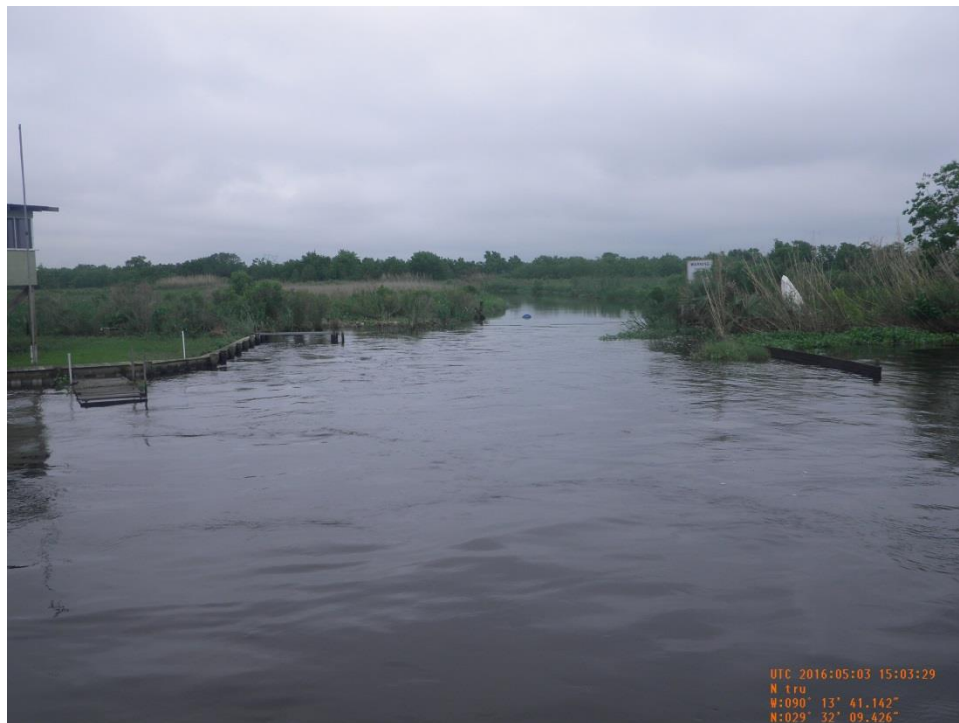
Structure 8 is a small rock weir with a boat bay located just north of Structure 7. This structure appears to be in fair condition with minimal settlement of the riprap material and no erosion or washouts around the bank tie-ins. This structure was originally constructed with a steel gate to prevent access into the interior marsh, but this gate was destroyed during Hurricanes Gustav and Ike. Since the gate was destroyed, the landowner has installed a series of floating barrels to restrict access. During the inspection, it was observed that some of the barrels were either sunken or removed. There are no plans to replace the gate at this time. (See Appendix B, Photos 9 through 11)

Photo 9: View of rock weir and floating barrel gate at Structure No. 8.

Photo 10: View of rock weir and floating barrel gate at Structure No.8.

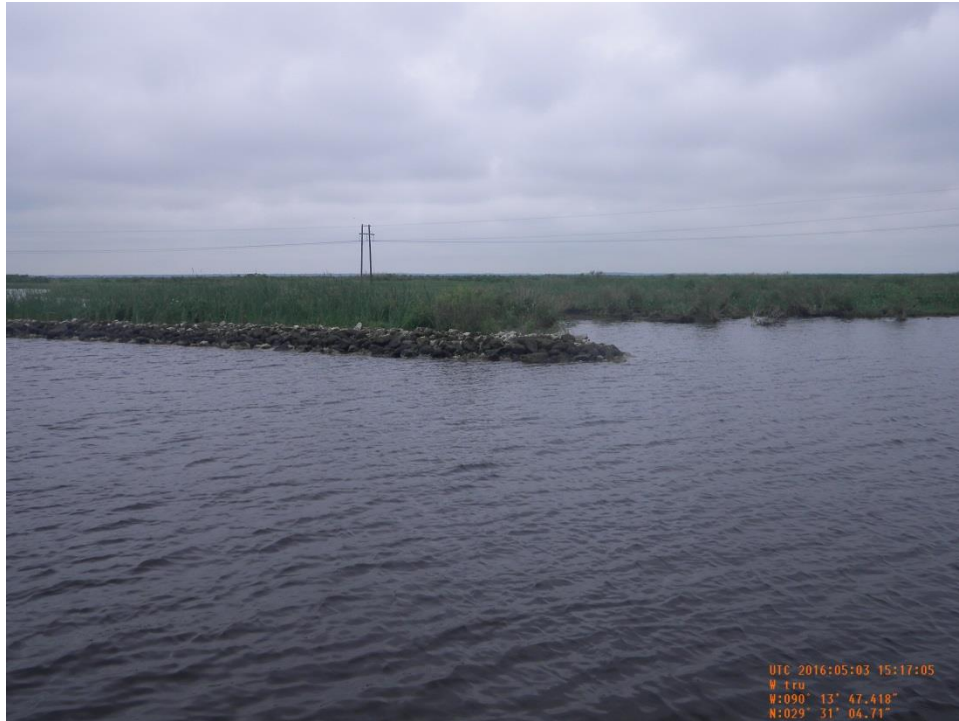
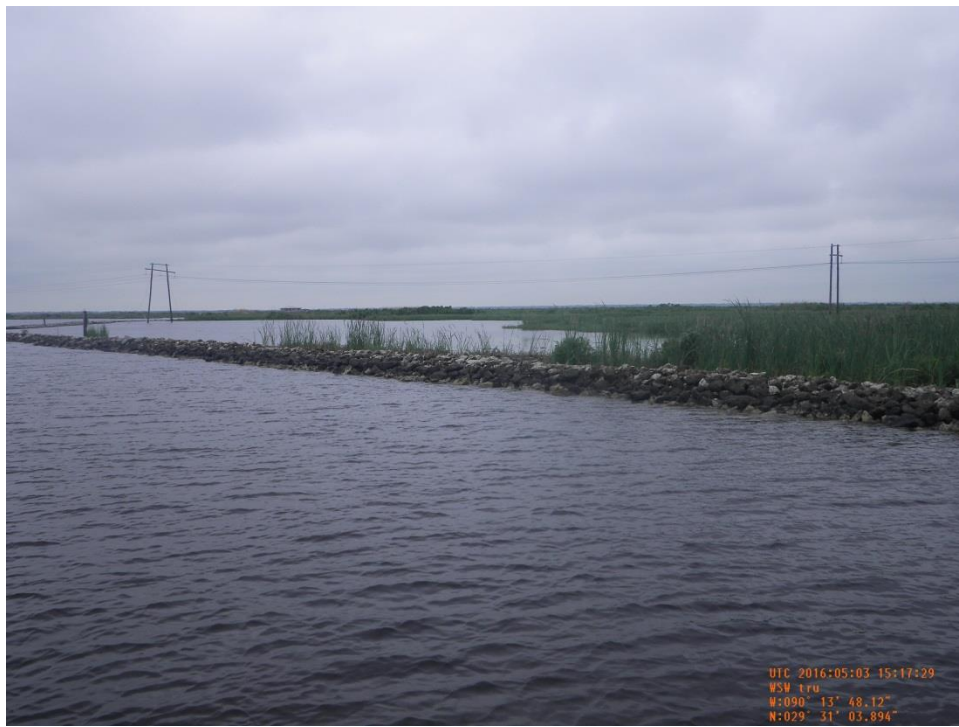
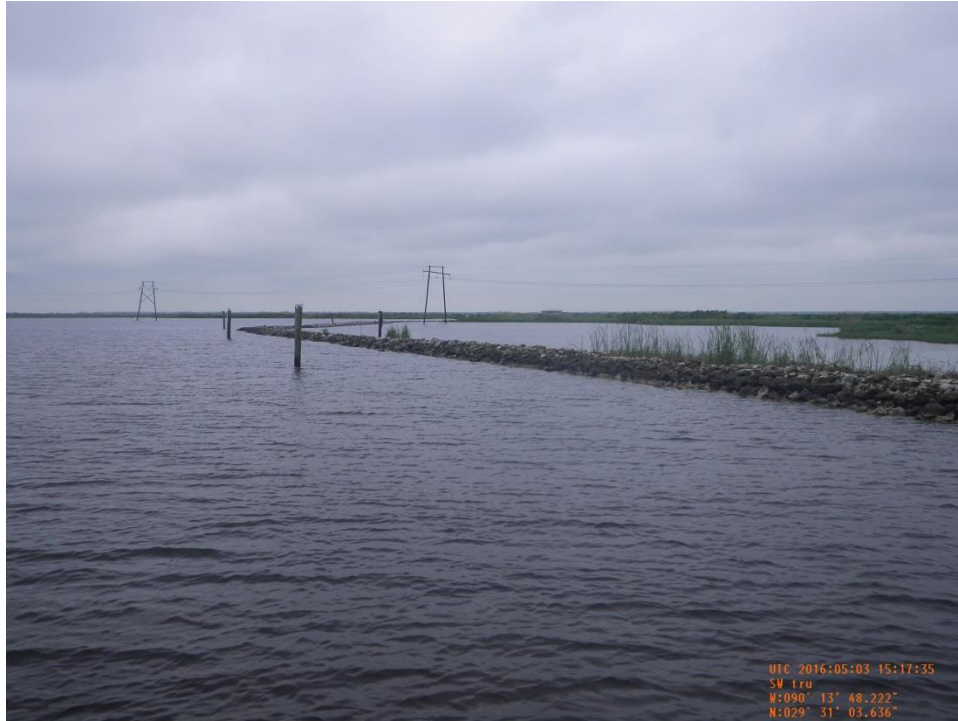
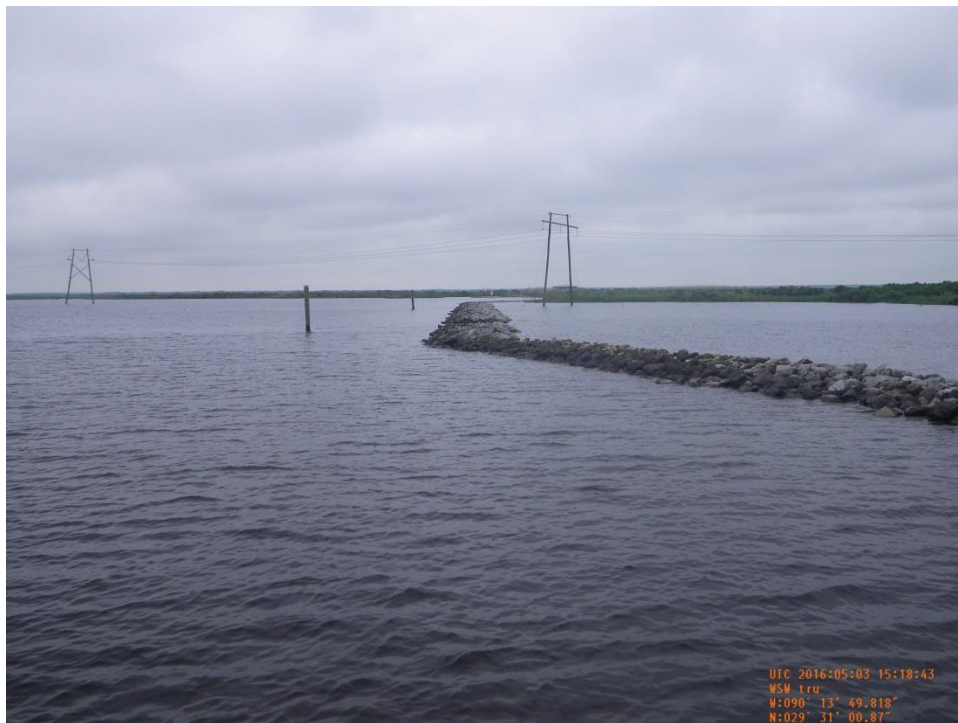
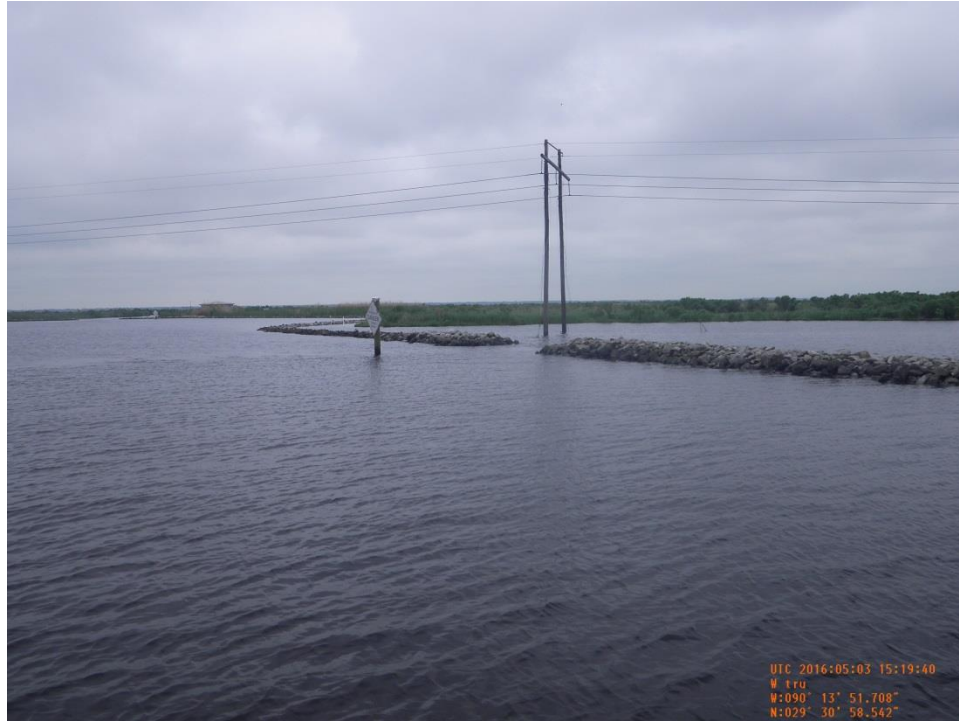
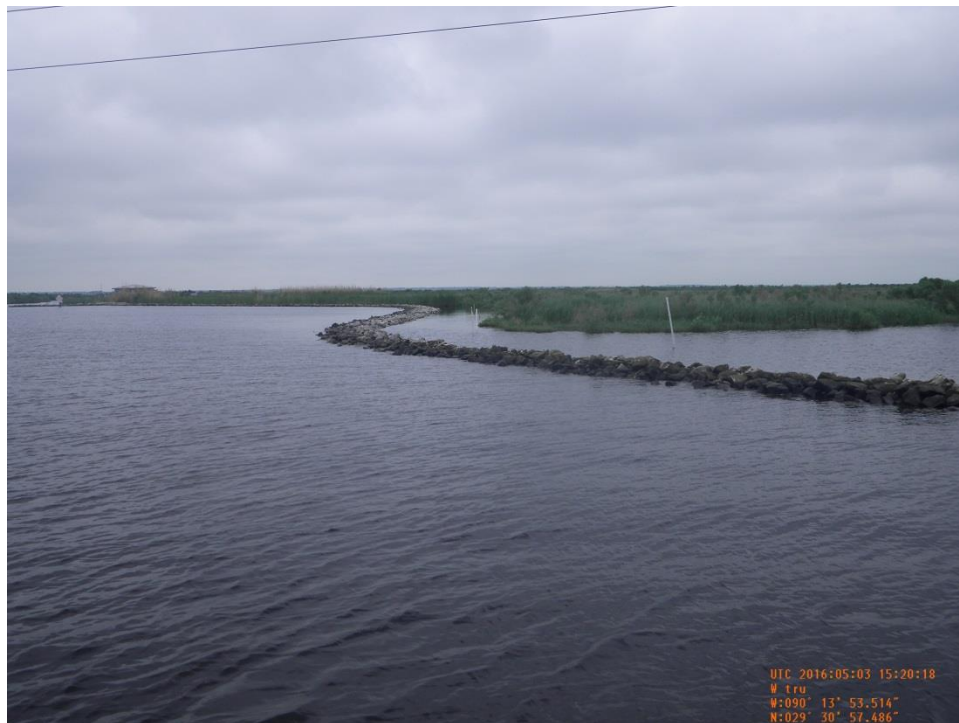
As part of the 2012 Maintenance Project, Structure 4, 4A & 4B was recapped to its original design elevation and rock dike closure was extended to Structure 4. The existing structures and 1,000 linear feet dike closure were built to an elevation of +3.5' NAVD88 using 130# class rock riprap. Structures 4 and 4A/4B, and the dike closure appear to be in very good condition with no noticeable settlement or degradation of riprap material. Currently, there is some erosion near the start of the rock while the backside of the tie-in has some overtopping. At the time of the inspection, we did notice that several of the wooden signs installed along the structure were missing or in poor shape. Under the 2016 Maintenance Project schedule to begin mid to late June 2016 we have included provisions for the replacing all wood signs with aluminum signs. There are no recommendations additional maintenance at this time. (See Appendix B, Photos 12 through 17)

Photo 11: View of the north end of rock plug tie-in at Structures 4A and 4B.

Photo 12: rock plug (Structure 4A & 4B) and rock dike extension to Structure 4 construction in 2012.

Photo 13: rock plug (Structure 4A & 4B) and rock dike extension to Structure 4 construction in 2012.

Photo 14: View of rock dike closure between Structure No.4B and Structure No.4 constructed in 2012.

Photo 15: View of rock dike closure between Structure 4B and Structure 4 constructed in 2012.

Photo 16: View of rock dike closure between Structure 4B and Structure 4 constructed in 2012.

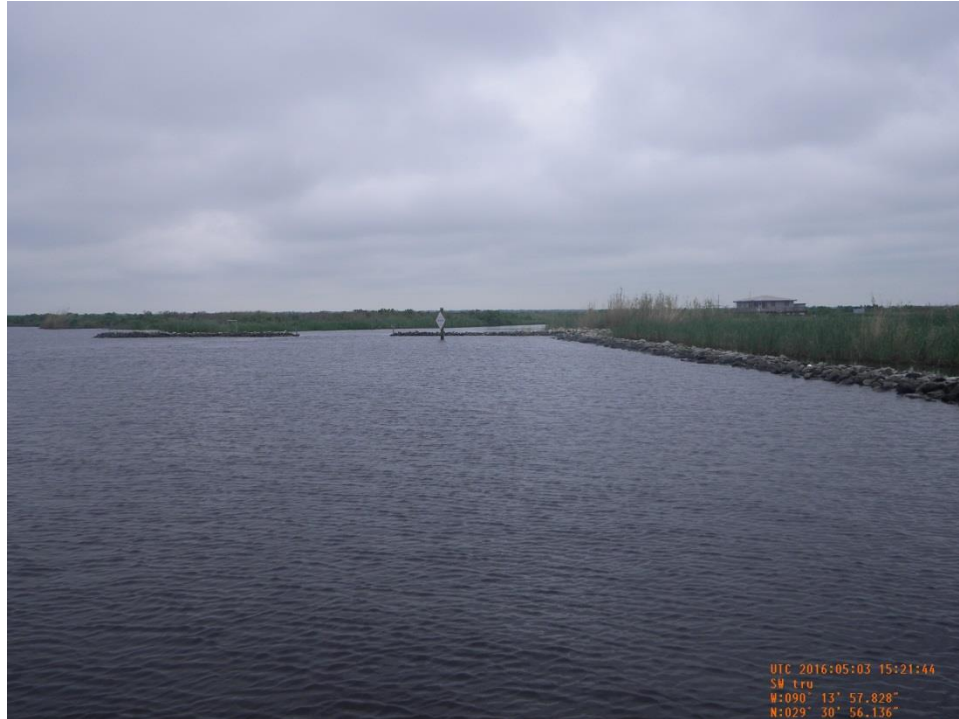
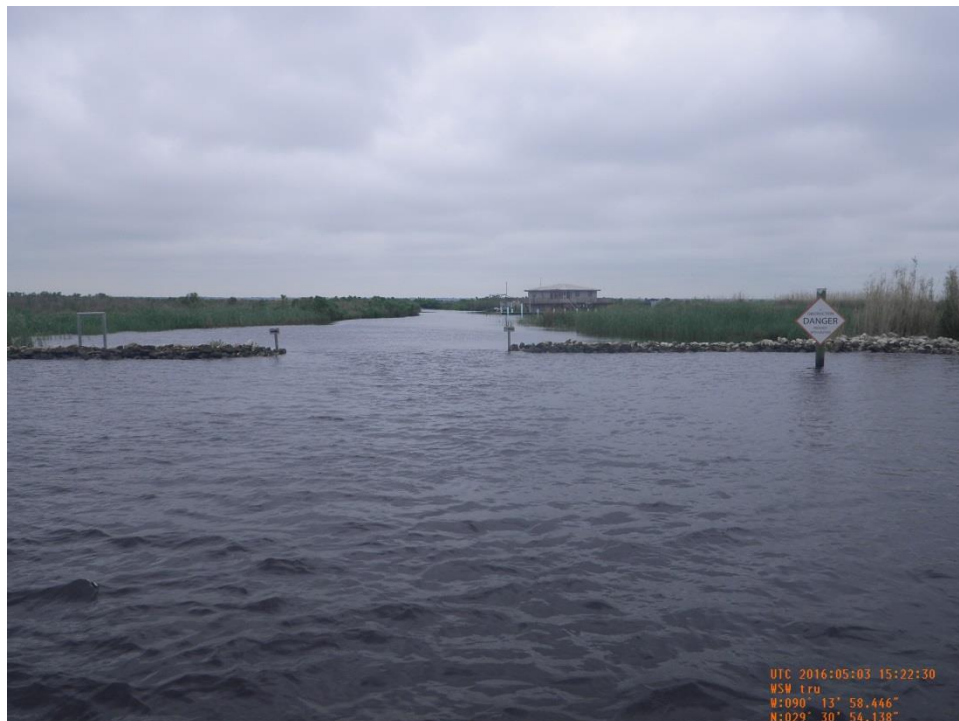
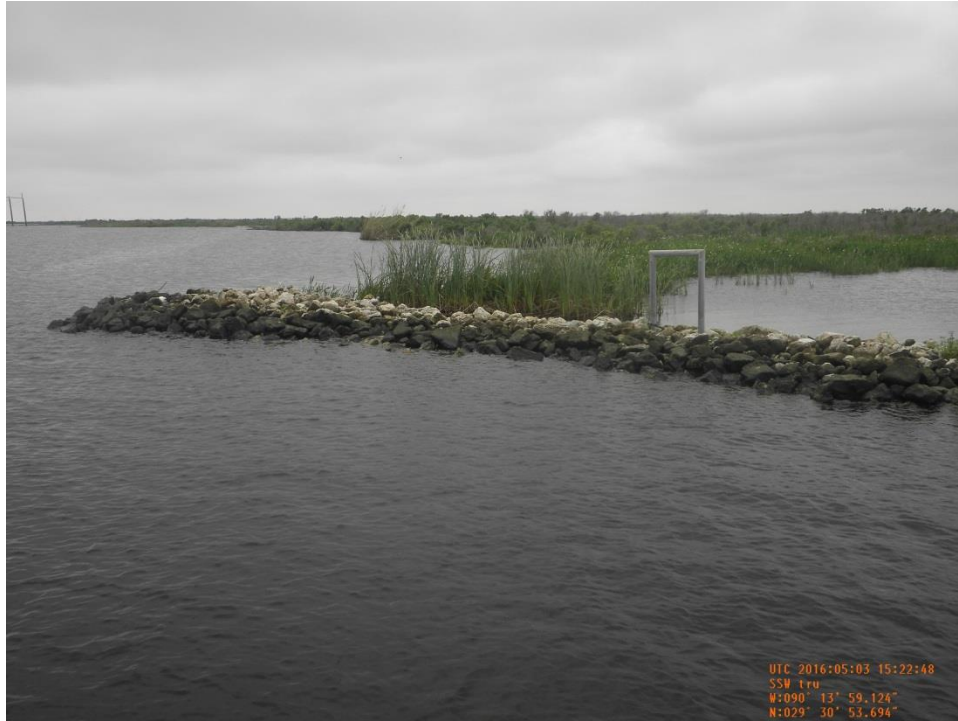
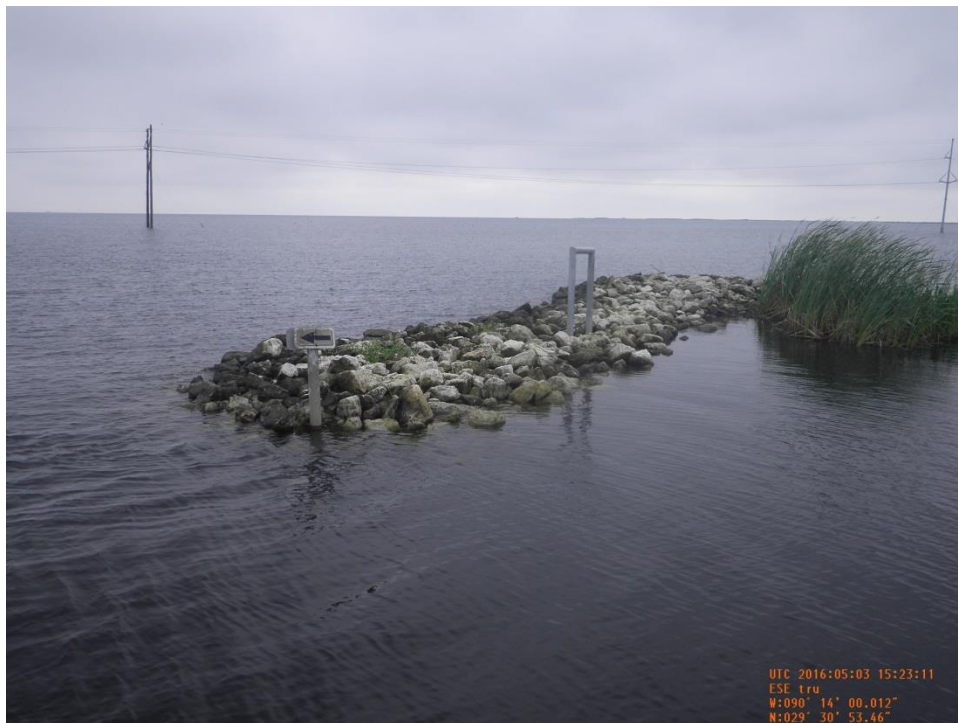
Structure 4 is also a three (3) level fixed crest weir constructed of rock riprap material. The structure was recapped with 130# class rip-rap to its original design elevation as part of the 2012 Maintenance Project. We did note that the marsh on the southern tie-in continues to erode and has detached from the rock weir. We recently completed the plans and specifications to extend the rock dike from the southern end of Structure 2 to the north end of Structure 4; construction is anticipated to begin in mid to late June 2016. Once completed, the shoreline will be protected and erosion should be halted. The signs along the structure; as part of the 2016 Maintenance Project, we will replace signs installed during the 2012 maintenance event with new aluminum signs. Overall, the structure is in good condition with

exception of the breach on the south side and the missing signs. These deficiencies will be repaired during the upcoming 2016 Maintenance Project. (See Appendix B, Photos 17 through 20)

Photo 17: View of rock dike closure tie-in to the north side of Structure No.4 constructed in 2012.

Photo 18: Overall view of rock weir with boat bay at Structure No.4.

Photo 19: View of the rock weir on the south side of the boat bay of Structure No.4.

Photo 20: View of the rock weir on the south side of the boat bay of Structure No.4.

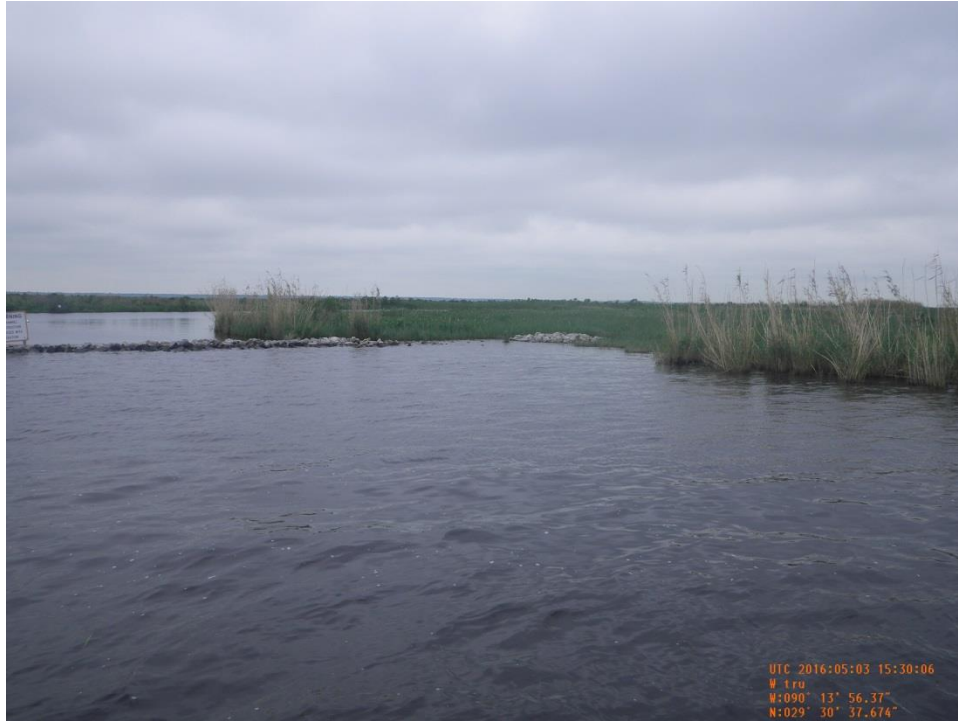
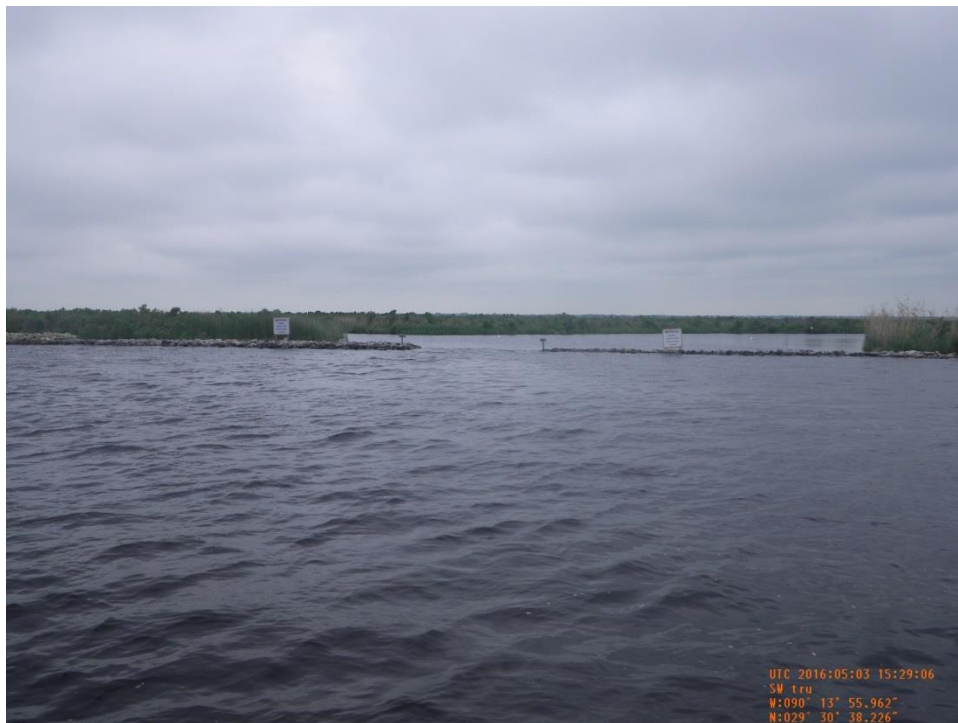
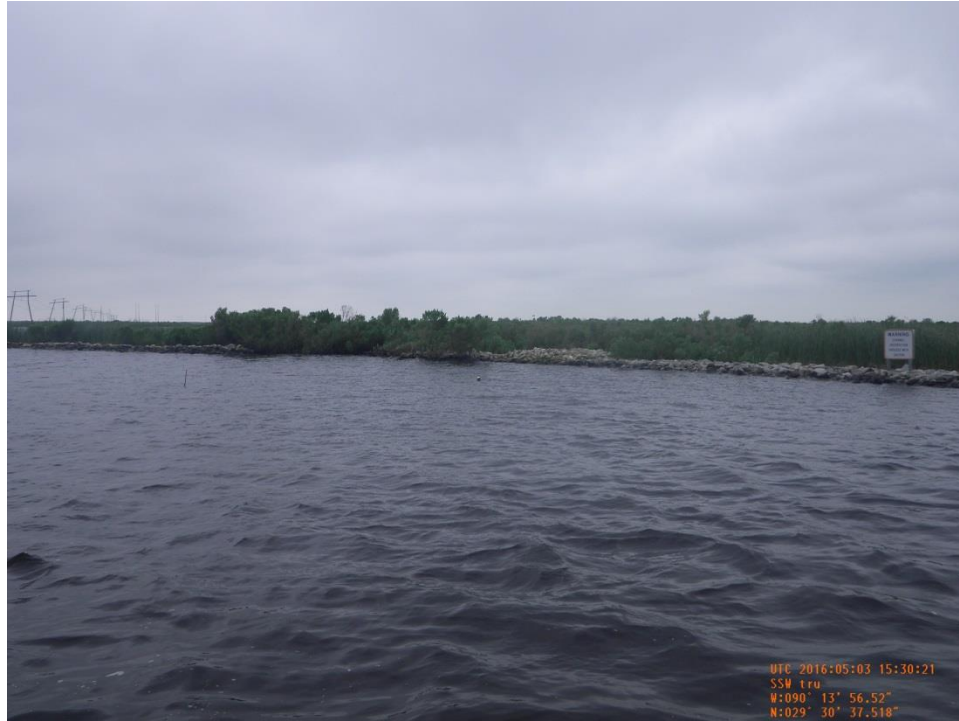
Structure 2 is a three (3) level Fixed Crest Weir constructed of rock riprap material. This structure was recapped with 130# class riprap to its original design elevation as part of the 2012 Maintenance Project. Soundings taken during the inspection along the center section of weir averaged 7.1'. Based on the staff gauge reading in Superior Canal and soundings taken over the structure, an average elevation is estimated between -5.0 and -6.0' NAVD. The as-built drawings show a final constructed elevation of -5.0' NAVD, which would indicate the center section had settled nearly 0.7' since completion of the 2012 Maintenance Project. The sections located closest to the banks on each side of the structure appeared to be stable and no obvious settlement was observed. The warning signs on Structure 2 are in good condition and do not require replacement. The overall structure was in good condition and no maintenance will be required at this time. (See Appendix B, Photos 20 through 23)

Photo 21: View of the rock weir on the north side of the boat bay of Structure No.2.

Photo 22: Overall view of the rock weir with boat bay at Structure No.2

Photo 23: View of the south side of the rock weir at Structure No.2

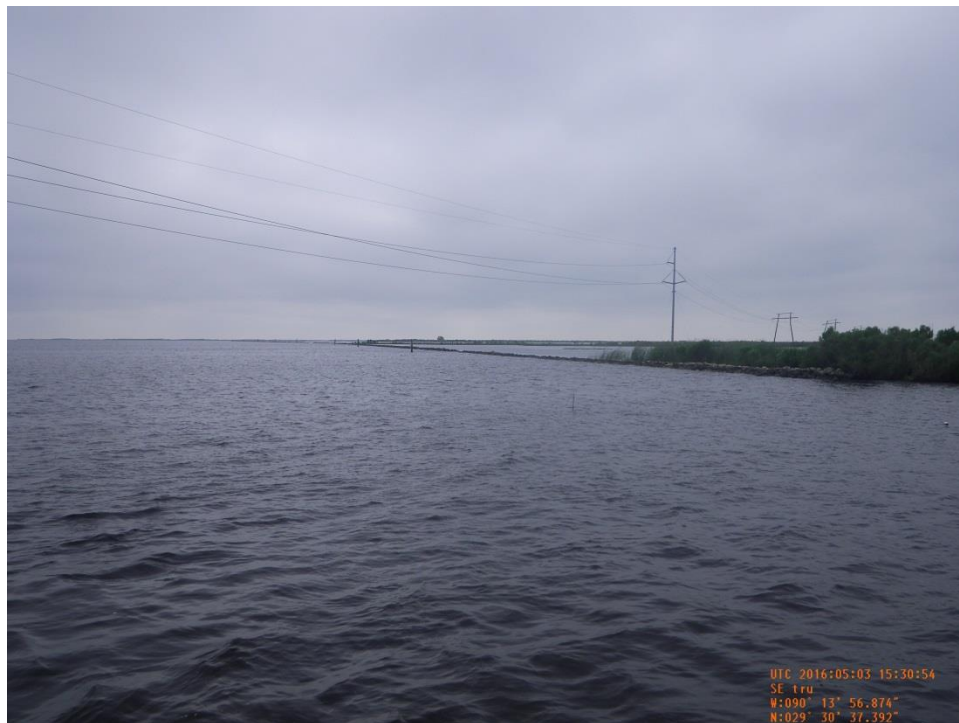
The Lake Rim structure was recapped as part of the 2012 Maintenance Project. The project included the recapping of the entire lake rim with 130# class rock riprap to its original design elevation of +3.0' NAVD88 from the north bank along Breton Canal to southern embankment tie-in of Structure 2. During construction, the Lake Rim structure did not settle from the weight of the extra rock as much as anticipated, which left the contractor with an excess bid quantity of rock riprap. This additional rock was used to place a second lift of rock along the north bank of Breton Canal, Structure 4, and the Lake Rim structure. The 2012 Maintenance Project as-built drawings show the constructed elevation of the Lake Rim structure to be approximately +3.5' NAVD88 to +4.0' NAVD88 after the second lift. At the time of the inspection, there appeared to be no further settlement of the structure since the end of 2012 maintenance project. There are no recommendations for maintenance at this time. (See Appendix B, Photos 24)

Photo 24: View of the rock dike lake rim along the south shoreline of Bay L' Ours.

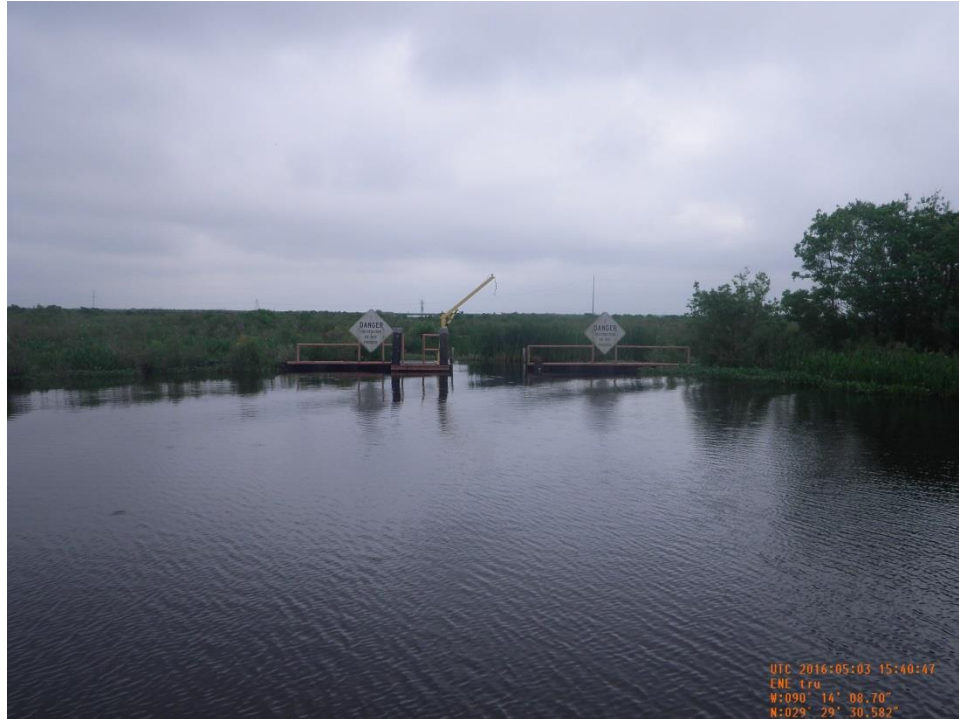
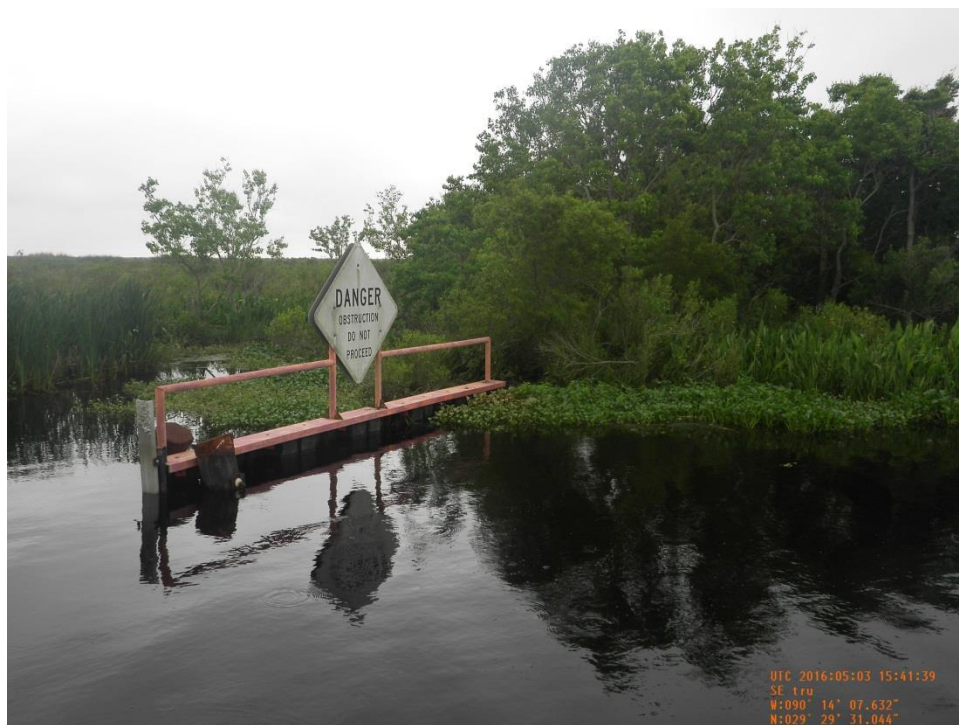
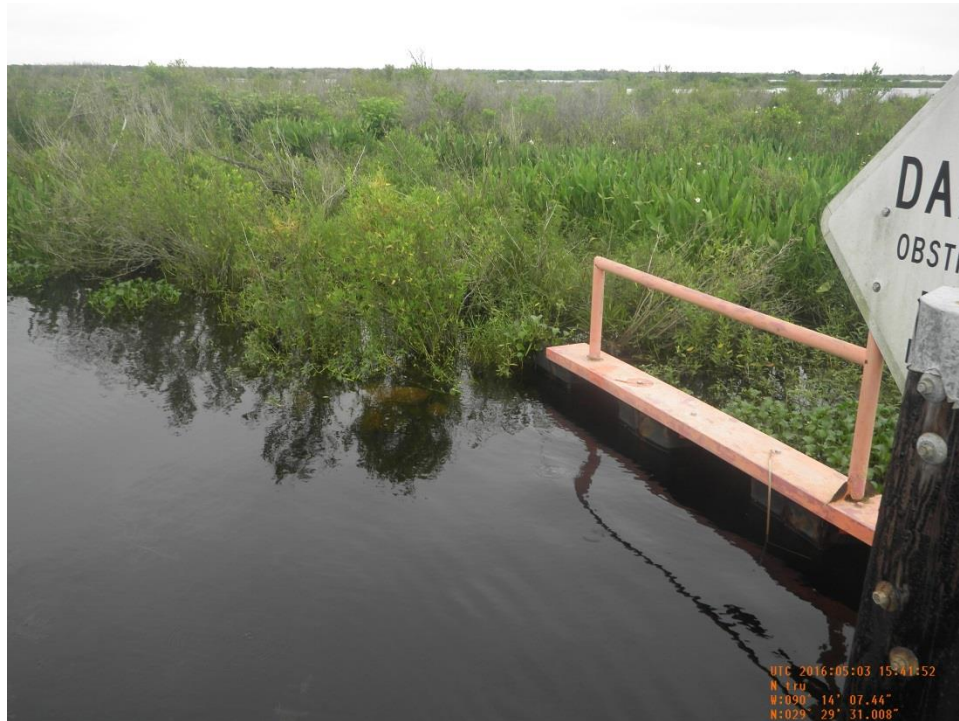
Overall, Structure 35 has moderate corrosion on the bulkhead cap, handrails and deck. The stop logs, cables, signs and supports appear to be in good condition and operable. At the time of inspection the channel from the weir to the interior marsh was open and there appeared to be adequate flow through the interior marsh and structure. The embankment tie-ins also appear to be in good condition with no erosion or washouts. We are not recommending any repairs or corrective actions at this time. (See Appendix B, Photos 25 through 27)

Photo 25: View of variable crest weir Structure No.35 on north bank of location canal off of Breton Canal.

Photo 26: view of sheet pile weir and bank tie-in on the SW side of Structure No.35.

Photo 27: View of steel sheet pile weir and bank tie-in on the NE side of Structure No.35.
