2016 Annual Inspection Report

**GIWW/ CLOVELLY HYDROLOGIC
RESTORATION**

State Project Number BA-02
Priority Project List 1

May 03, 2016
Lafourche Parish

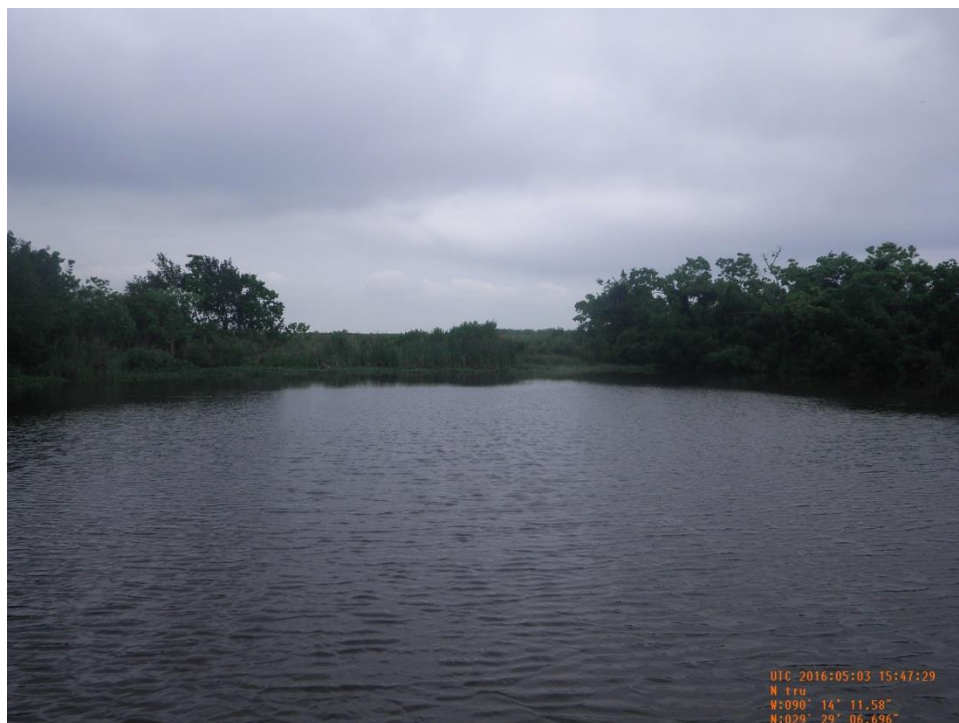
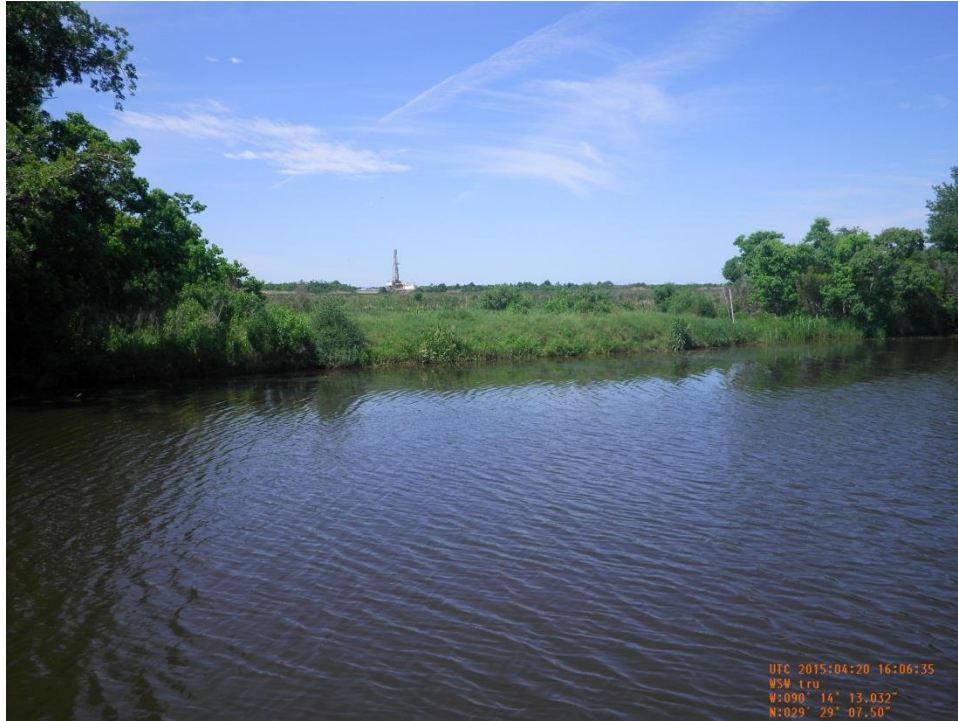
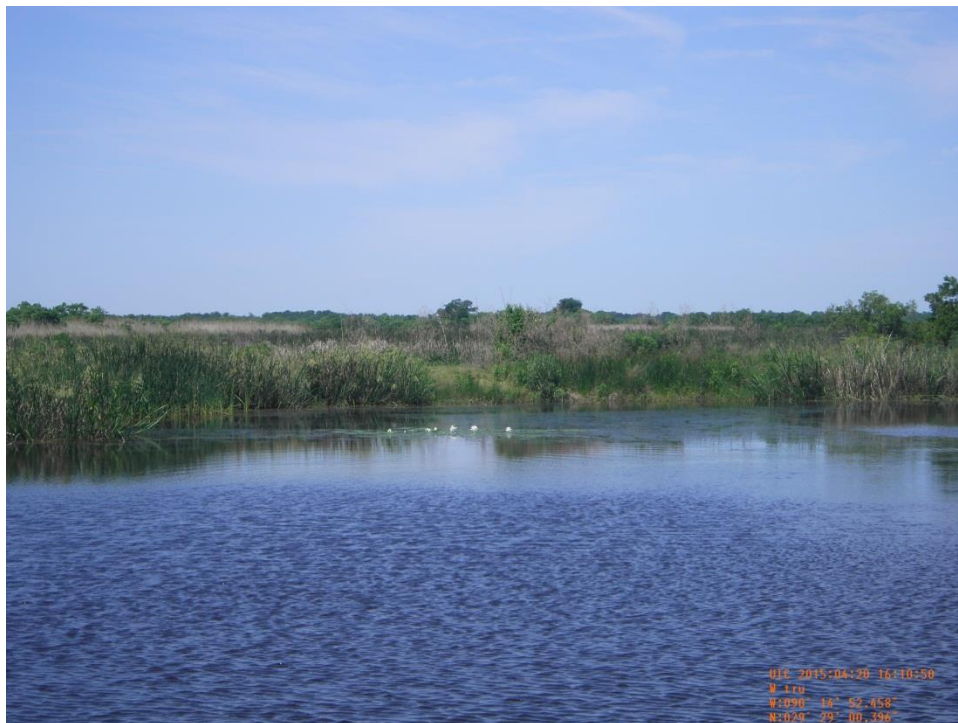
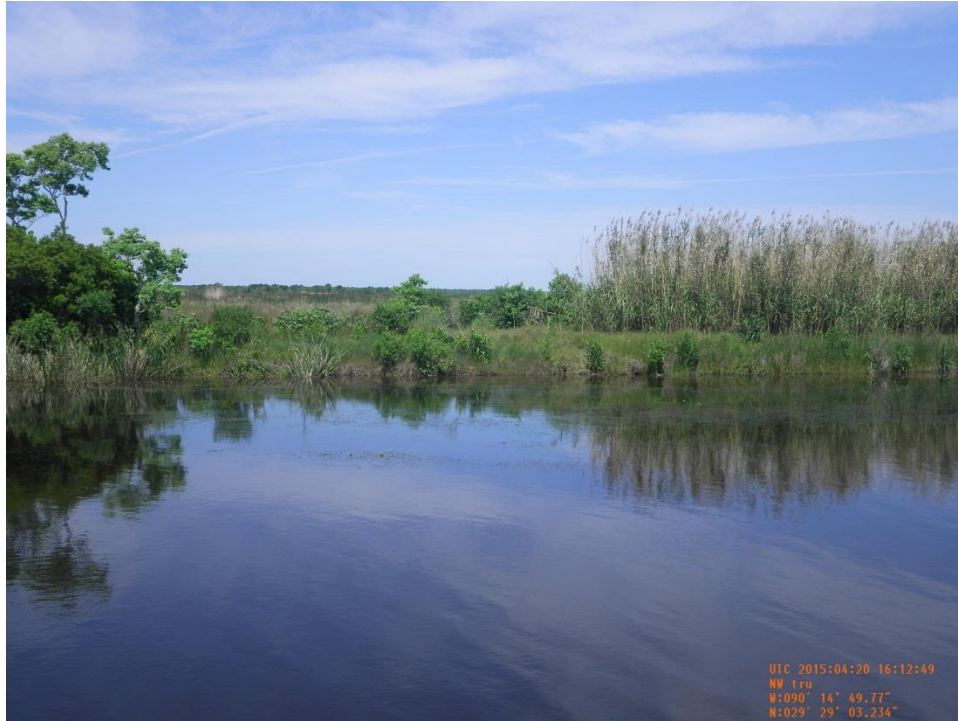
There were five (5) breaches repaired during the 2012 Maintenance Project. Breach 1 was located along the north bank of Breton Canal just southwest of the first location canal from Bay L' Ours and is approximately 20' wide. Breach 2 was located along the northeast bank of the second location canal north of Breton Canal and was approximately 10' wide. Breach 3 was located on the south bank of the same location canal as Breach 2 and was approximately 25' wide. Breach 4 was located on the west bank of an oilfield canal that intersects Breton Canal east of Structure No. 1 and was approximately 30' wide. Another breach, designated as Breach 5, was discovered at the end of a dead end oilfield slip south of Breach 4. The breaches were closed by using material from the adjacent canal bottoms to reconstruct the earthen dike. The material was allowed to dry before it was shaped, seeded, and fertilized. At the time of the inspection, all of the breach repairs appeared to be in good condition with full vegetation and no signs of settlement. Breach 1 did show some signs of erosion on its northeast side facing Breton Canal. Due to the minor erosion, not affecting the overall stability of the breach repair, there are no recommendations for maintenance at this time; however this location will continue to be monitored on future inspections. (See Appendix B, Photos 28 through 31)

Photo 28: Breach location (Identified in as-built drawings as Breach 2) repaired in 2012 along the second location canal from Bay L' Ours via Breton Canal.

Photo 29: Breach repaired in 2012 (identified as Breach 3) off of third location along Breton Canal from
By L' Ours.

Photo 30: Breach repaired in 2012 (labeled Breach 4) off of third location along Breton Canal from Bay L'
Ours.

Photo 31: - Breach repaired in 2012 (labeled Breach 5) off of third location along Breton Canal from Bay L' Ours.

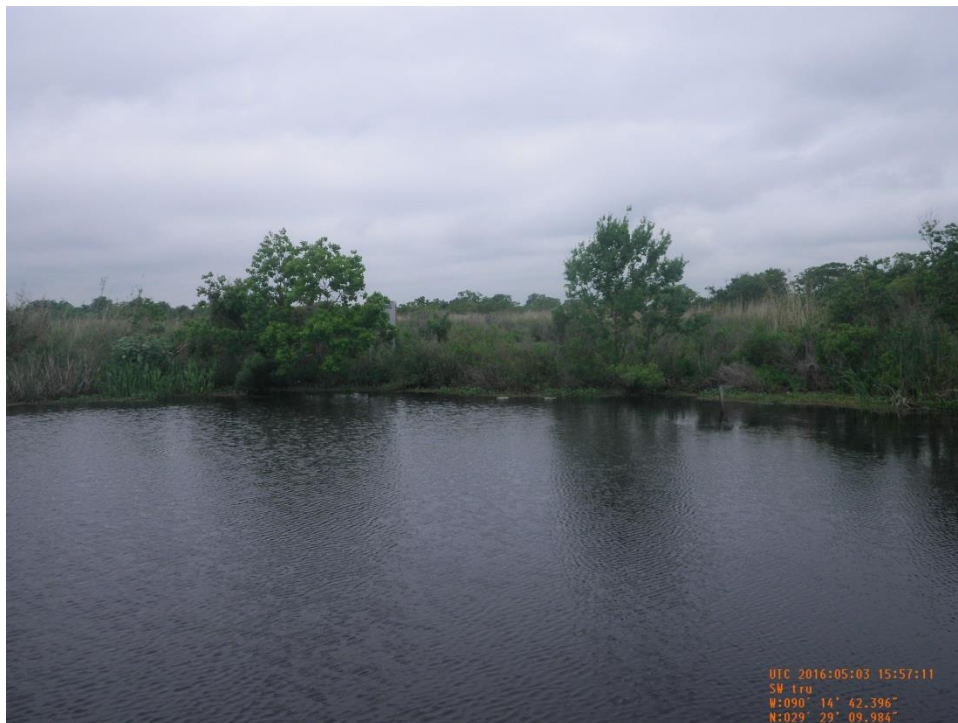
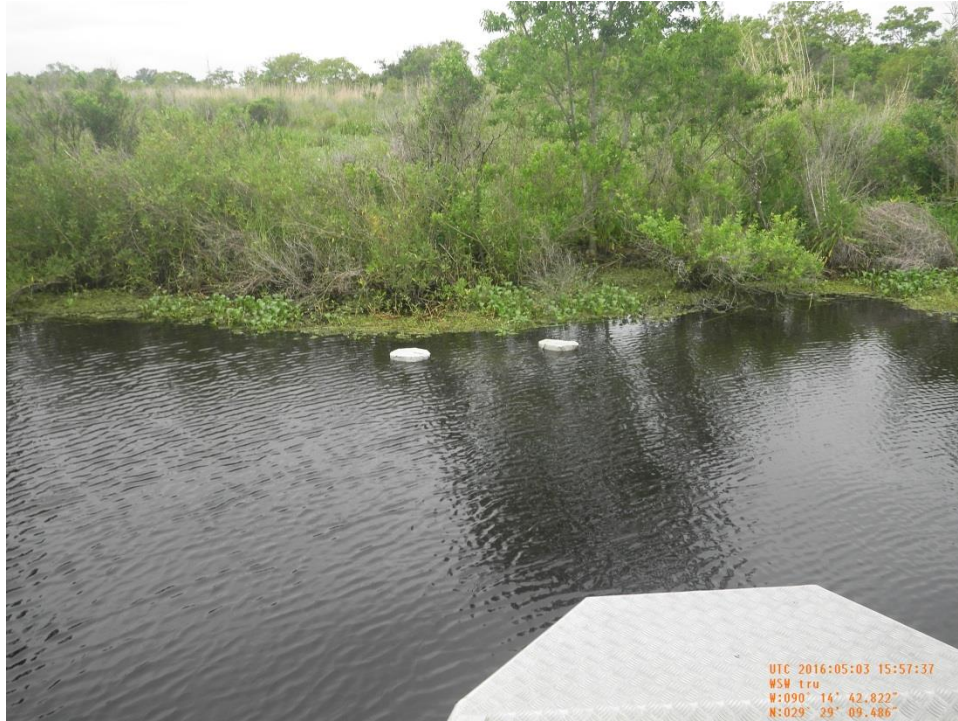
Structure 91 rock plug appeared to be in good overall condition. It was also difficult to inspect this structure due to the thick woody vegetation covering the entire structure. Additionally, thick marsh vegetation has covered the backside of the marsh area. From what we were able to view, it appears that the structure was in good condition with no obvious settlement or breaches around the structure. The timber piles supporting the corrugated metal pipe and flap gate was in good condition as well. New galvanized timber pile caps were installed as part of the 2012 Maintenance project to protect the head of the piling. Also, the warning sign for the structure has been damaged by vandals as it appears the sign has endured several shots from a shotgun. Because the sign is still legible, there are no recommendations for replacement at this time, but it will continue to be monitored on future inspections for further damage. (See Appendix B, Photos 32 and 33)

Photo 32: View of rock weir (Structure 91) with corrugated metal pile and flap gate through embankment.

Photo 33: View of corrugated metal pipe support and flap gate at Structure No.91.

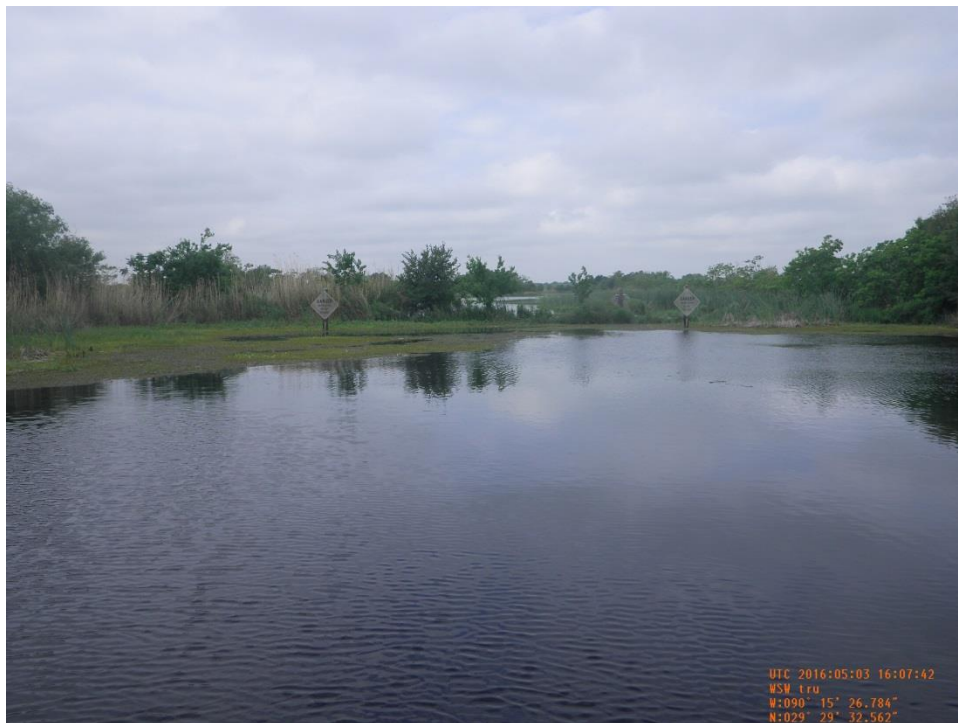
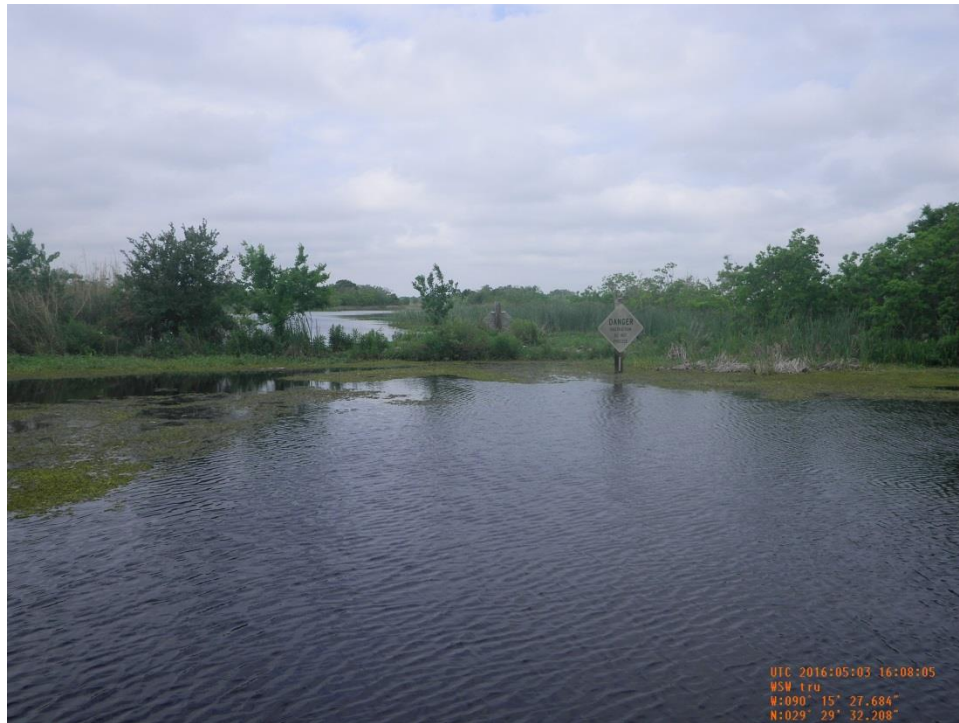
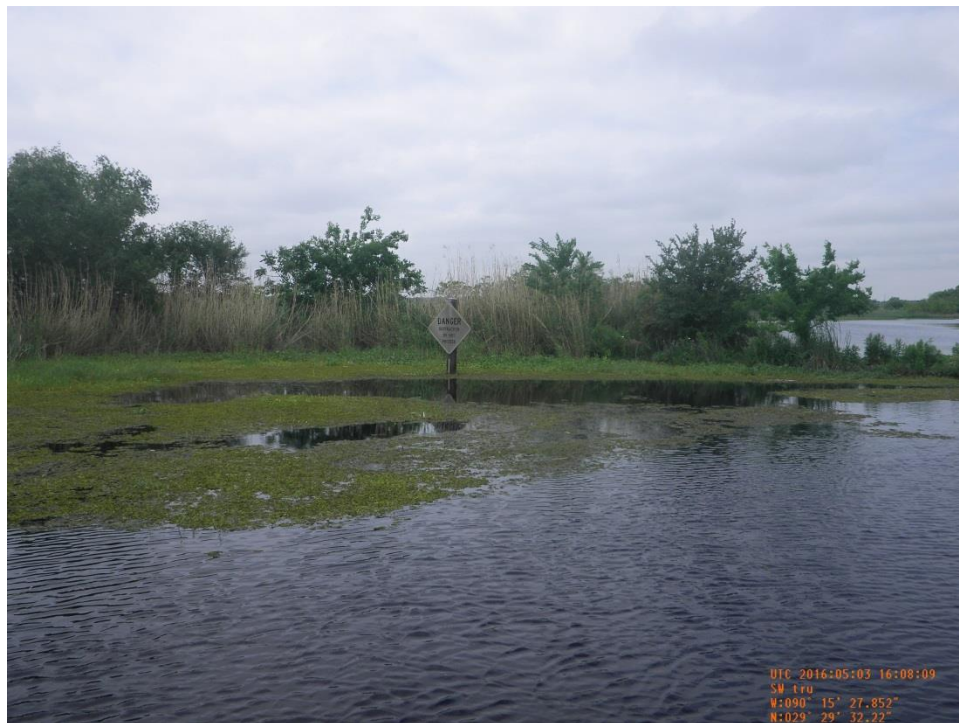
Structure 90 appears to be in good condition with no obvious rock settlement/ displacement or erosion around the embankment tie-ins. The structure and surrounding area are vegetated with 1.0' of freeboard. All warning signs and supports are in good condition also. There are no recommended corrective actions at this time. (See Appendix B, Photos 34 through 36)

Photo 34: Overall View of Structure 90, a rock rip rap channel plug located in the second location canal on the east bank of Superior Canal from the Hurricane Protection Levee.

Photo 35: View of rock dike plug and warning signs at Structure No.90.

Photo 36: View of rock dike plug and warning signs at Structure No.90.

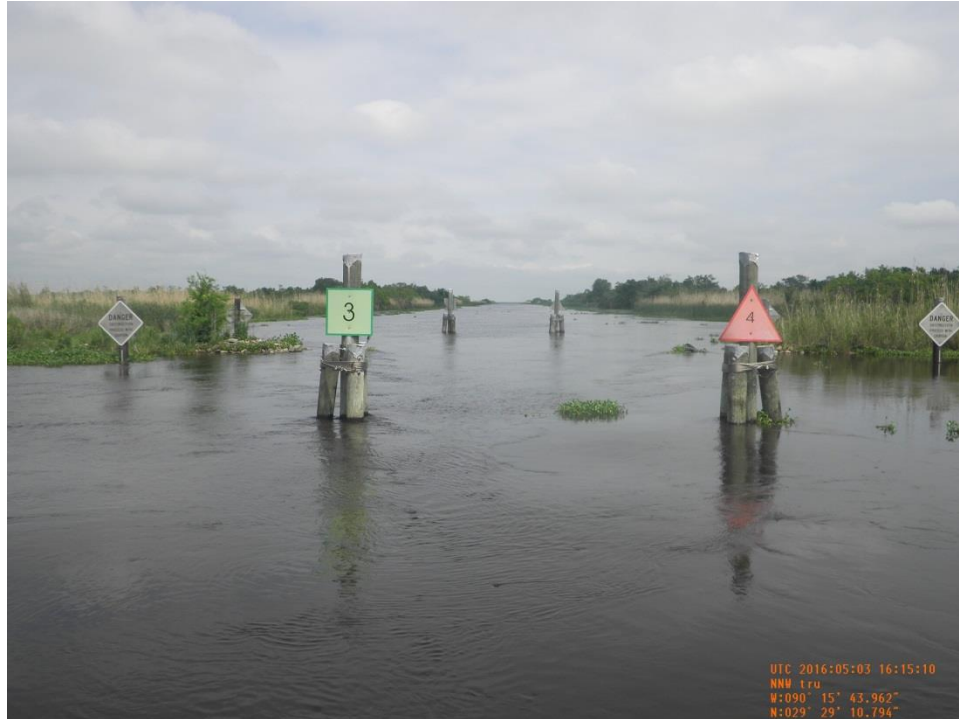
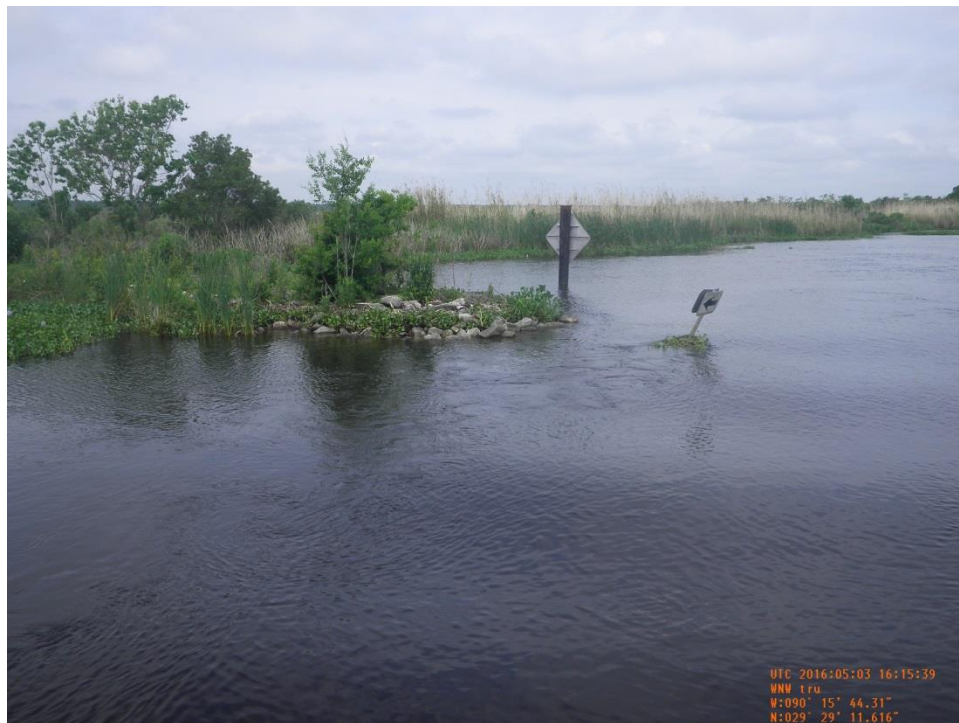
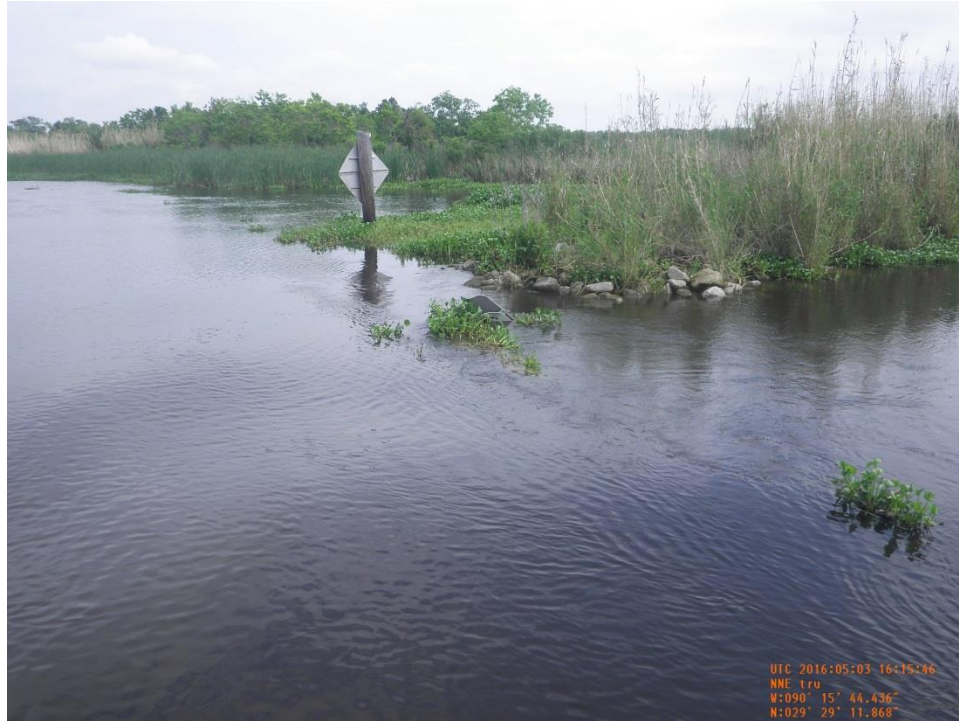
Structure 1 appeared to be in good overall condition with no obvious settlement or displacement of the rock riprap material or erosion along the bank tie-ins of the structure. The four (4) timber dolphin structures at the entrance of the barge bay opening were replaced during the 2012 Maintenance Event and are currently in good condition. The directional arrow signs are knocked down or turned inward and will need to be replaced during the next maintenance event. (See Appendix B, Photos 37 through 38)

Photo 37: View of rock weir on the west side, warning signs and barge bay opening at Structure No.1 located along Superior Canal.

Photo 38: view of the rock weir on the east side of Structure No.1 and warning signs.

Photo 39: View of barge bay opening and timber warning signs at Structure No.1.

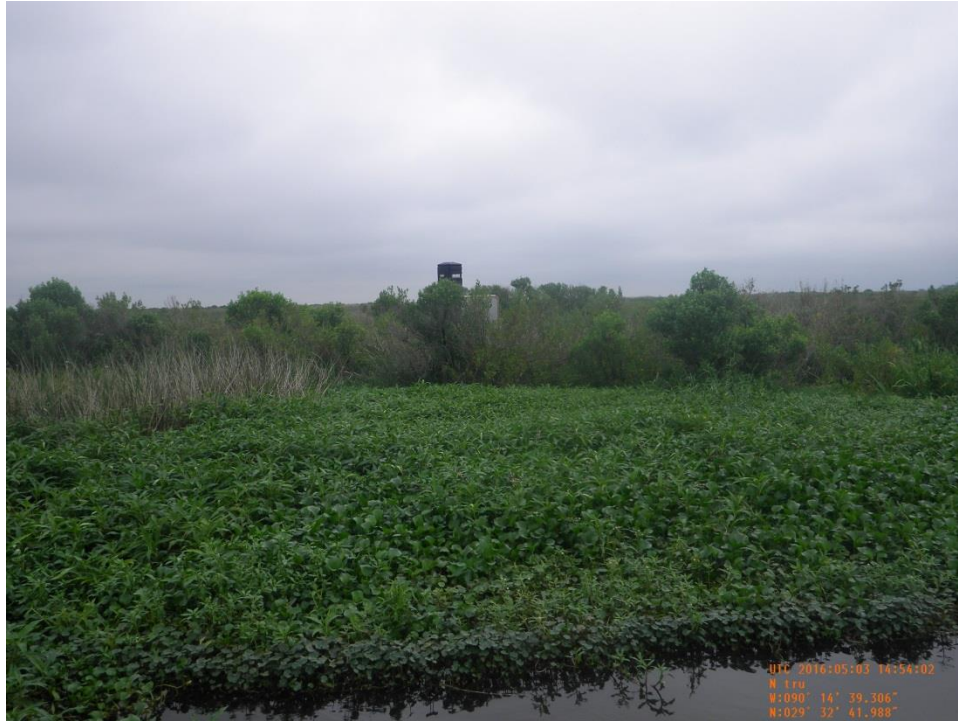
We were unable to visually inspect Structure 43 due to the woody vegetation and floating water hyacinth blocking access and the visibility of the structure. During prior inspections, there was a small breach identified on the eastern end of the rock plug which allowed water to flow around the structure. As in the 2015 inspection, we did not notice the breach or water bypassing the structure. It's possible that the vegetation has plugged the breach, thereby reducing the flow of water around the structure. Since the breach has been identified on previous inspections, we will continue to look for water flow around the structure on future inspections. All warning signs and support structures appear to be in good condition, and at this time, there are no recommendations for maintenance. (See Appendix B, Photo 41)

Photo 41: View rock rip rap channel plug (Structure 43) located along Bayou Des Amoreaux.
