**State of Louisiana
Coastal Protection and Restoration
Authority**

2017 Annual Inspection Report

**GIWW/ CLOVELLY HYDROLOGIC
RESTORATION**

State Project Number BA-02
Priority Project List 1

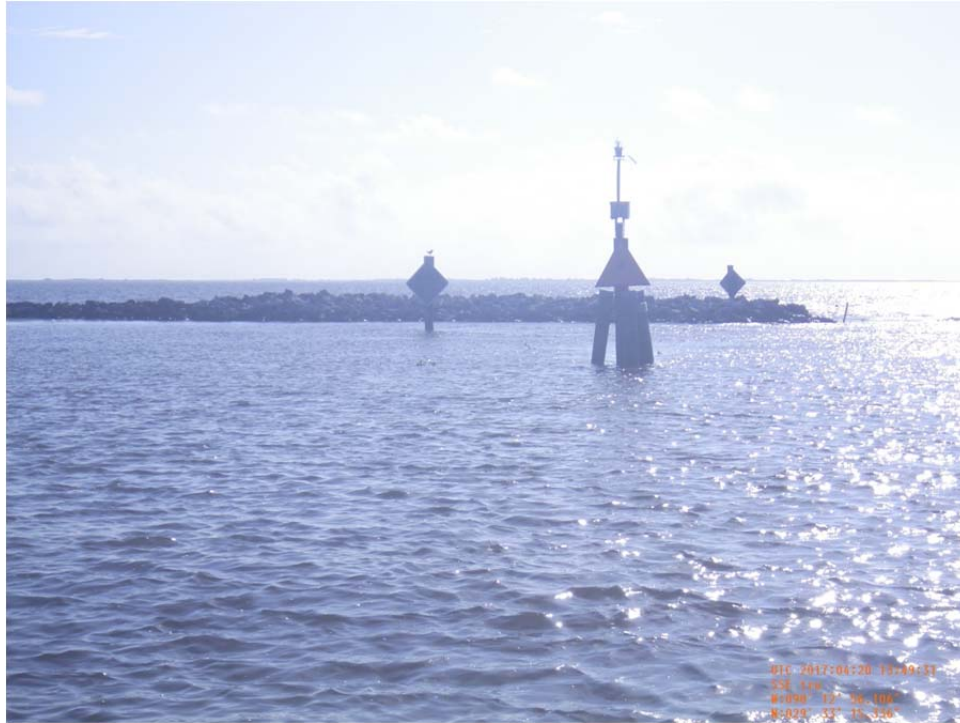
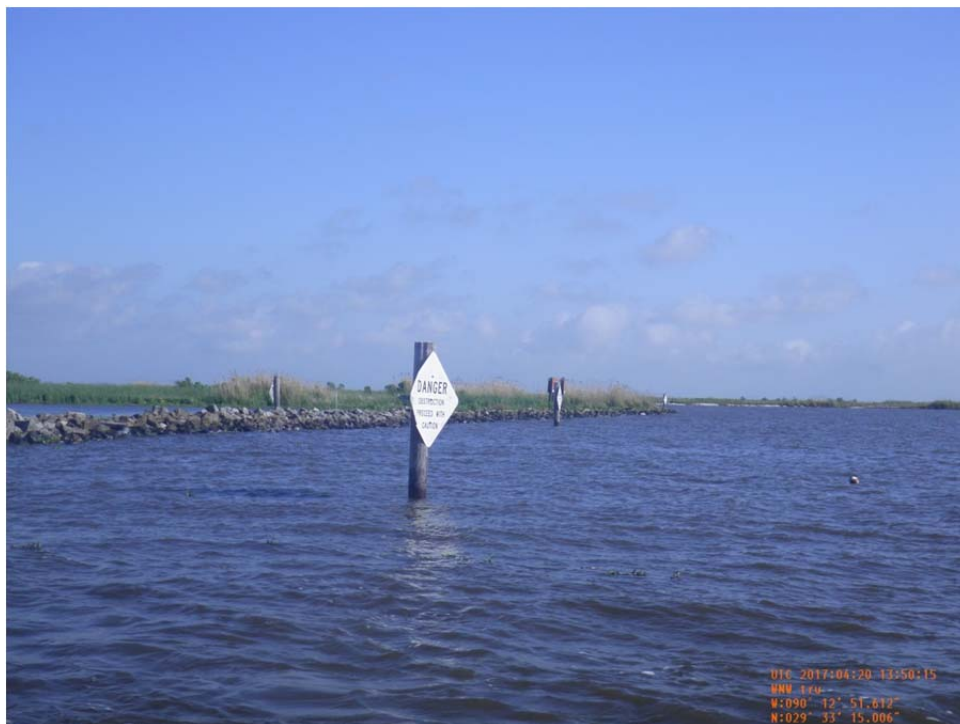
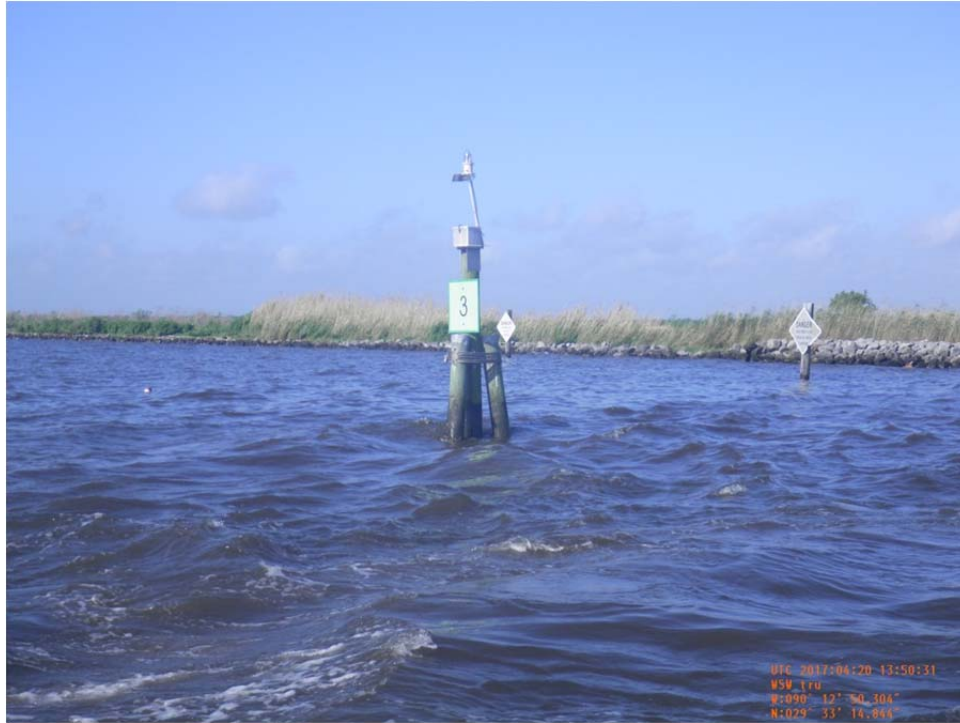
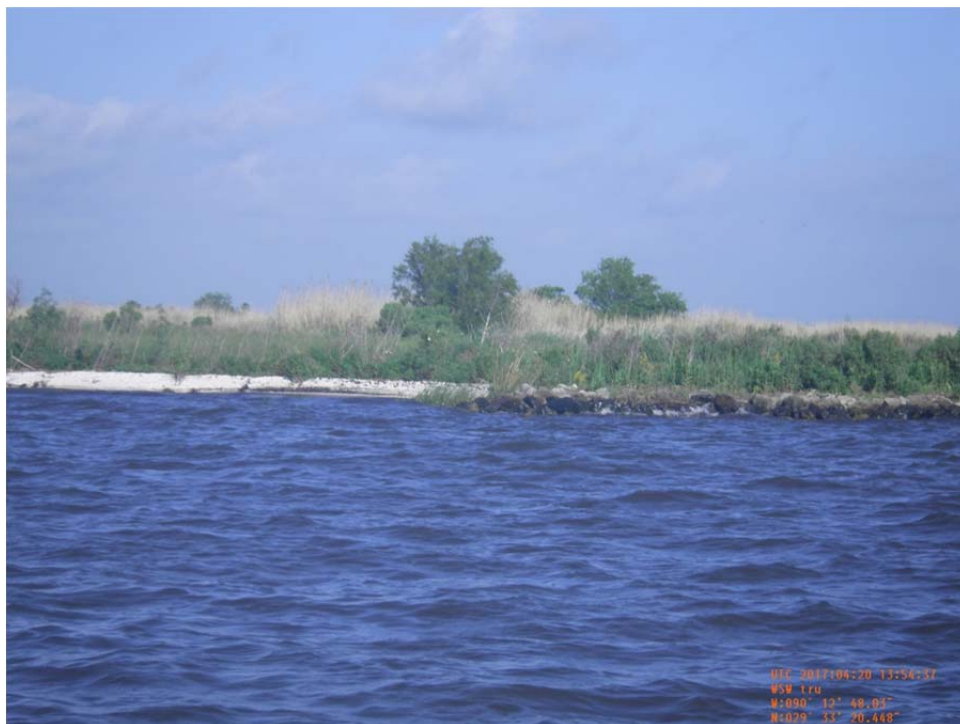
Structure 14A was also rehabilitated in 2012. The structure was recapped with a heavier 250# class rock riprap to the original design elevation of -6.5' at the barge bay to prevent further scouring of the channel bottom, and +4.0' along the first 100' of the crest on both sides of the barge bay. Depth soundings were taken along the center of the barge bay which indicated that the water depths were approximately 6.8'. Based on this depth, the adjusted bottom sill elevation of the barge bay was approximately -6.2'. Based on our observations, the structure appears to be in good condition, as there is no visible settlement of the rock since 2012. The

navigation aid structures and warning signs also appear to be in good condition. The south bank tie-in to the shoreline is experiencing slight erosion, but appears to be stable. There are no recommendations for maintenance of Structure 14A at this time. (See Appendix B, Photos 1 through 4)

Photo No.1 – view of navigational aid and rock weir with barge bay across Clovelly Canal at Little Lake.

Photo No.2 – view of rock weir along Little Lake on the north side of Structure 14A.

Photo No.3 – view of rock weir and navigational aid along shoreline of Little Lake on south side of Structure 14A.

Photo No.4 – view of rock weir to bank tie-in on the south side of Structure No.14A.

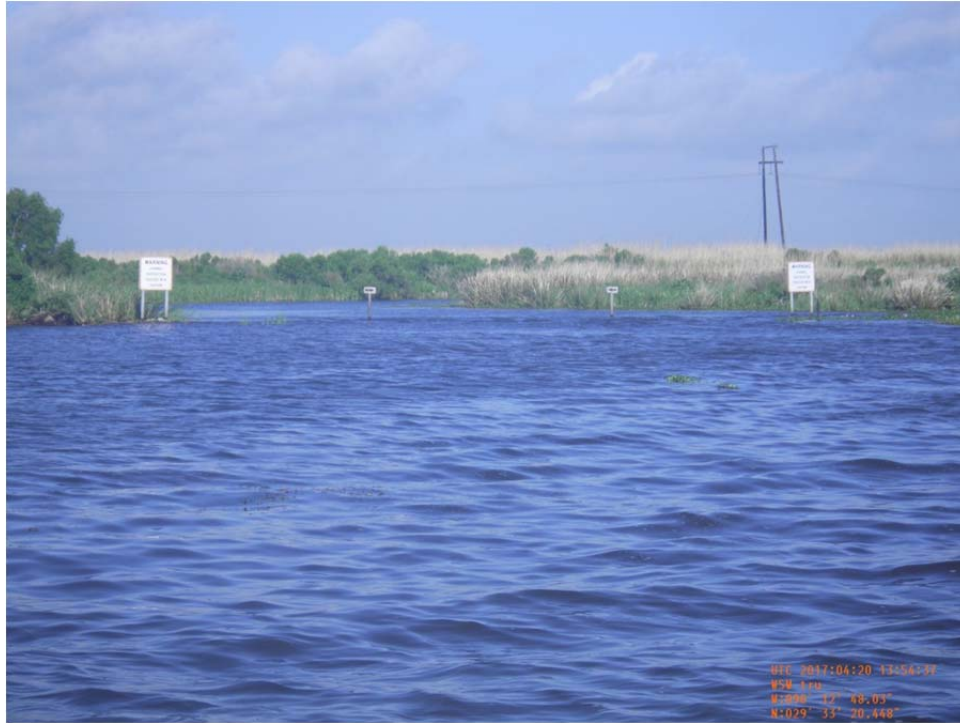
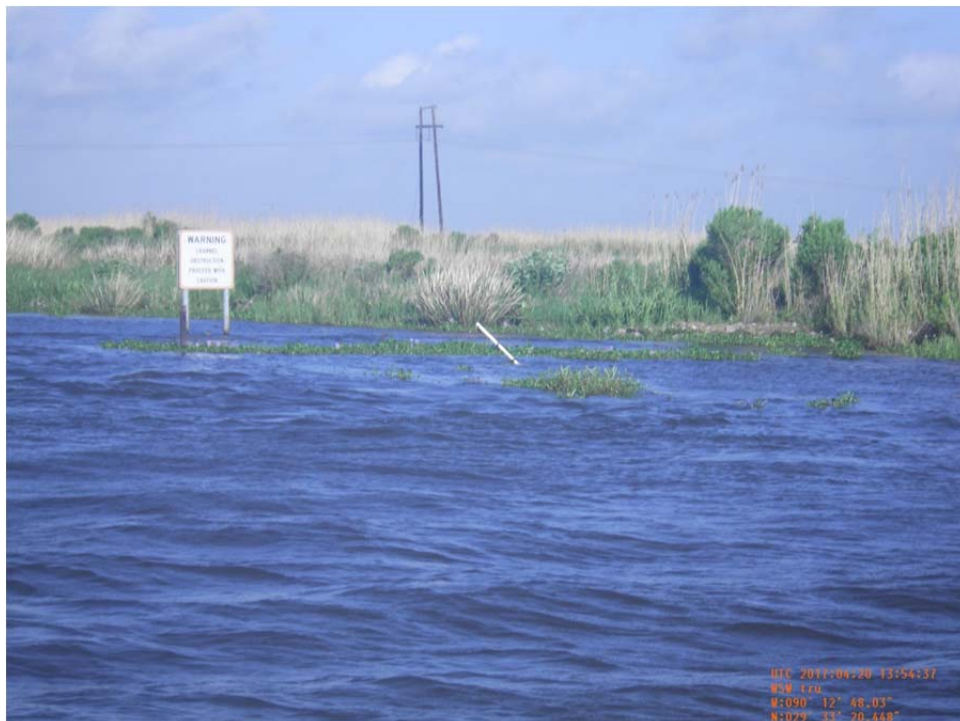
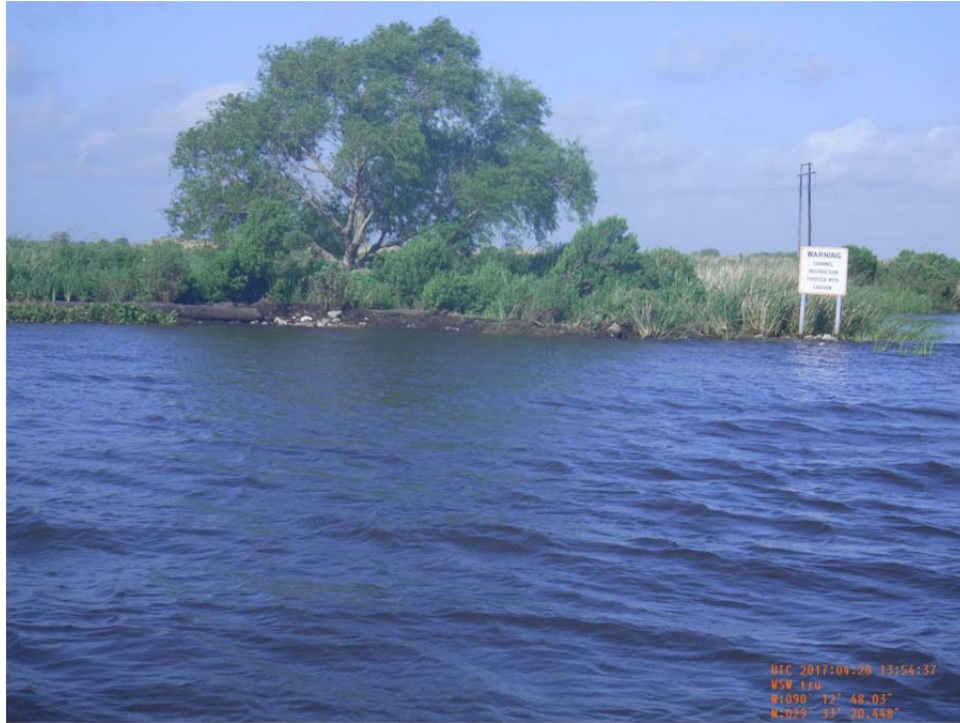
Structure 7 appeared to be in fair condition with noticeable settlement of the rock riprap material on each side of the boat bay. Based on water elevations from the CRMS station along Superior Canal, we estimated the crest elevation of the rock weir on both sides of the boat bay to be between 1.5' and 1.6'. There was no visual damage to the weir or erosion around the embankment tie-ins. Soundings taken at the boat bay indicated a water depth of approximately 6.8', which would correspond to an elevation of -5.2' after adjustments. The original as-built drawings show the crest elevation at the boat bay was constructed to -4.4'. Settlement since construction of Structure 7 is estimated to be approximately 1.0'. We are not recommending maintenance of Structure 7 at this time. All warning signs and their supports appear to be in good condition. (See Appendix B, Photos 5 through 7)

Photo No.5 – view of rock weir with boat bay (Structure 7) from Little Lake.

Photo No.6- view of the rock weir to shore tie-in on the north side of Structure No.7.

Photo No.7 – view of the rock weir to shore tie-in on the south side of Structure No.7.

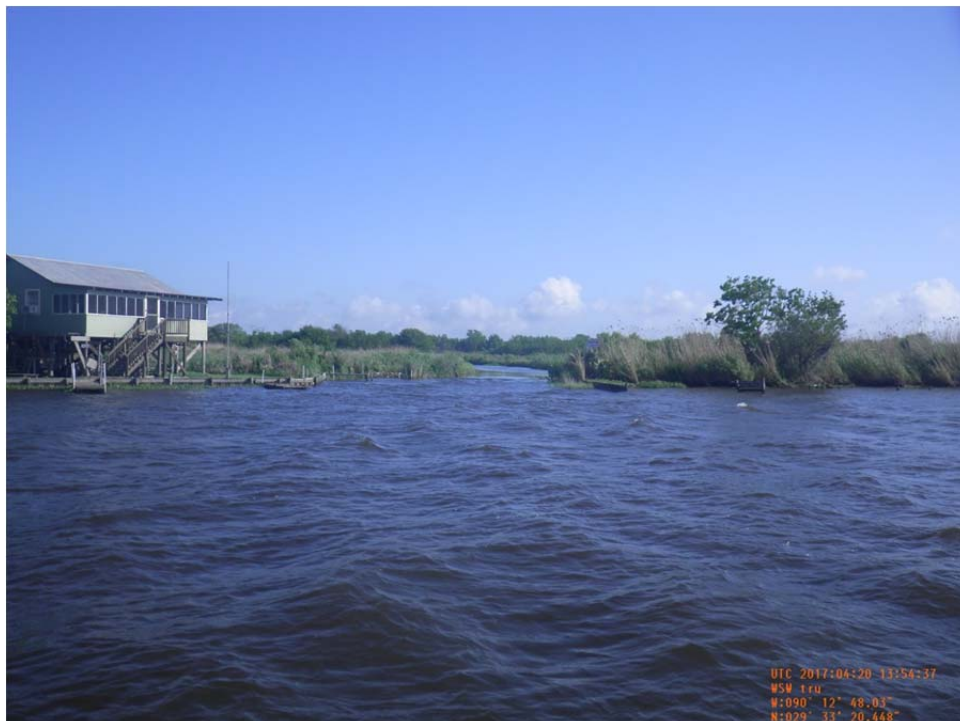
Structure 8 is a small rock weir with a boat bay located just north of Structure 7. The existing channel is very narrow and access is limited. From a distance, the structure appears to be in fair condition with minimal settlement of the riprap material and no erosion or washouts around the bank tie-ins. This structure was originally constructed with a steel gate to prevent access into the interior marsh, but this gate was destroyed during Hurricanes Gustav and Ike. The landowner had replaced the steel gate with floating barrels. Currently, the barrels are gone and the structure is open to access. There are no plans for maintenance of the structure or to replace the gate or barrels. (See Appendix B, Photos 8)

Photo No.8 – view of the small rock weir (Structure 8) along a channel from the interior marsh.

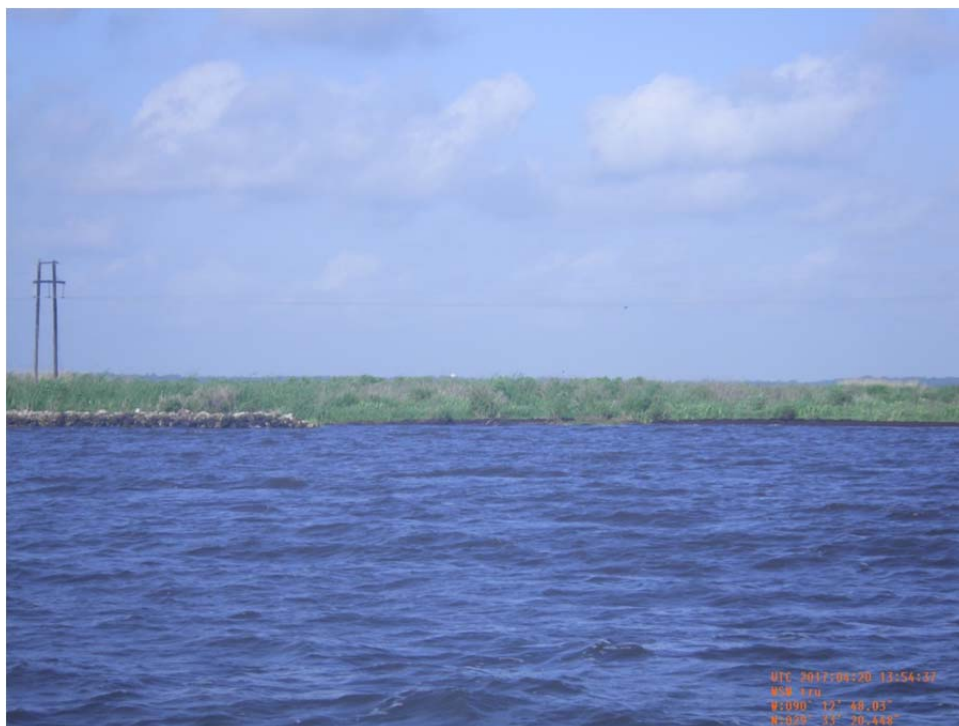
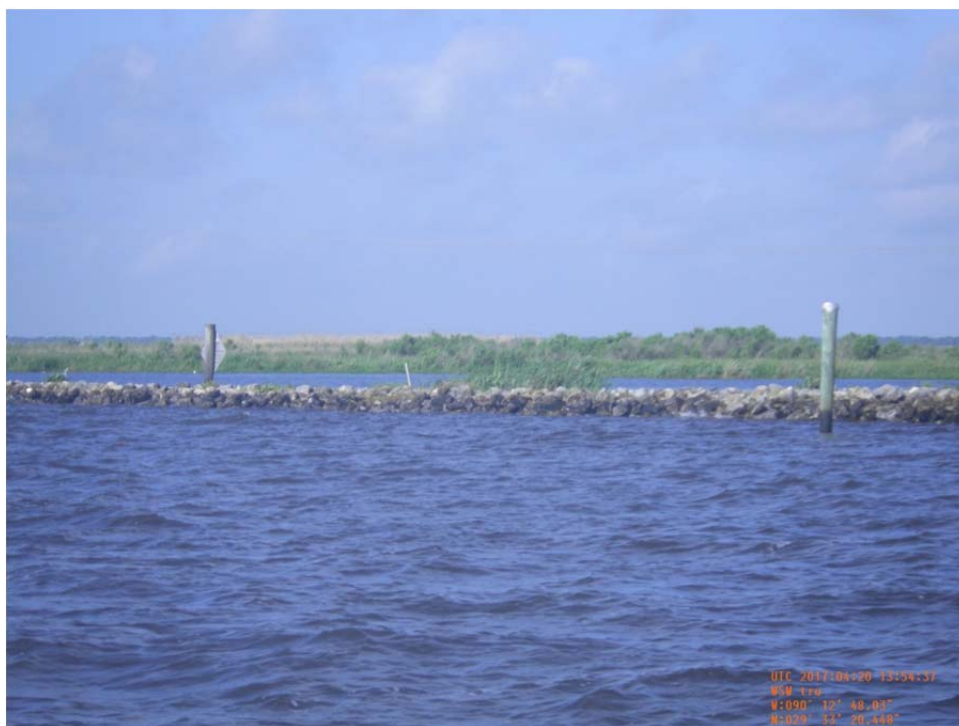
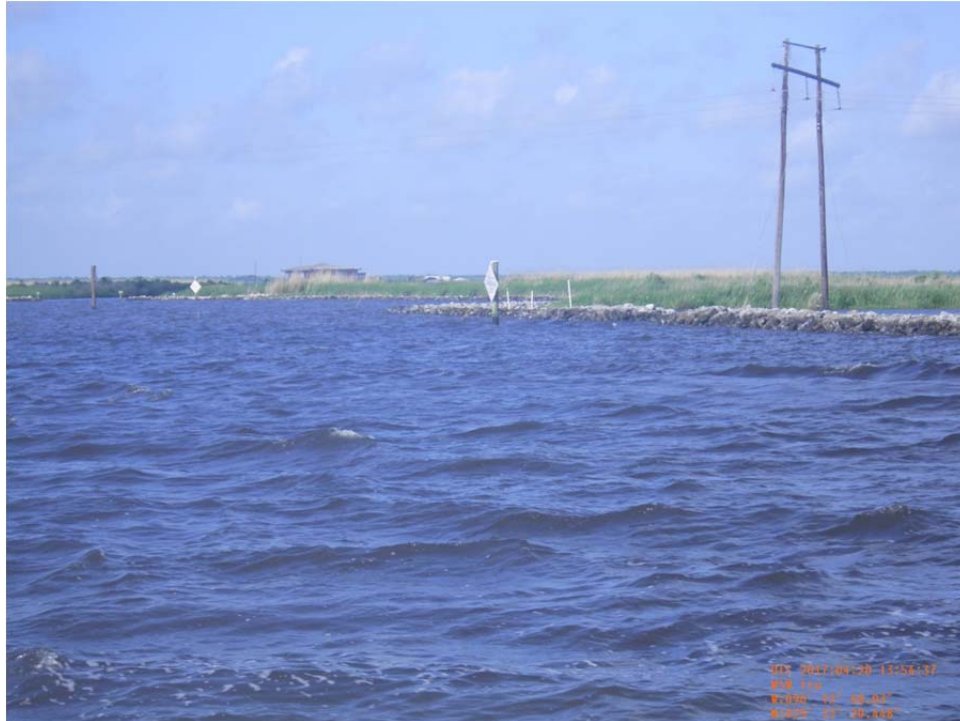
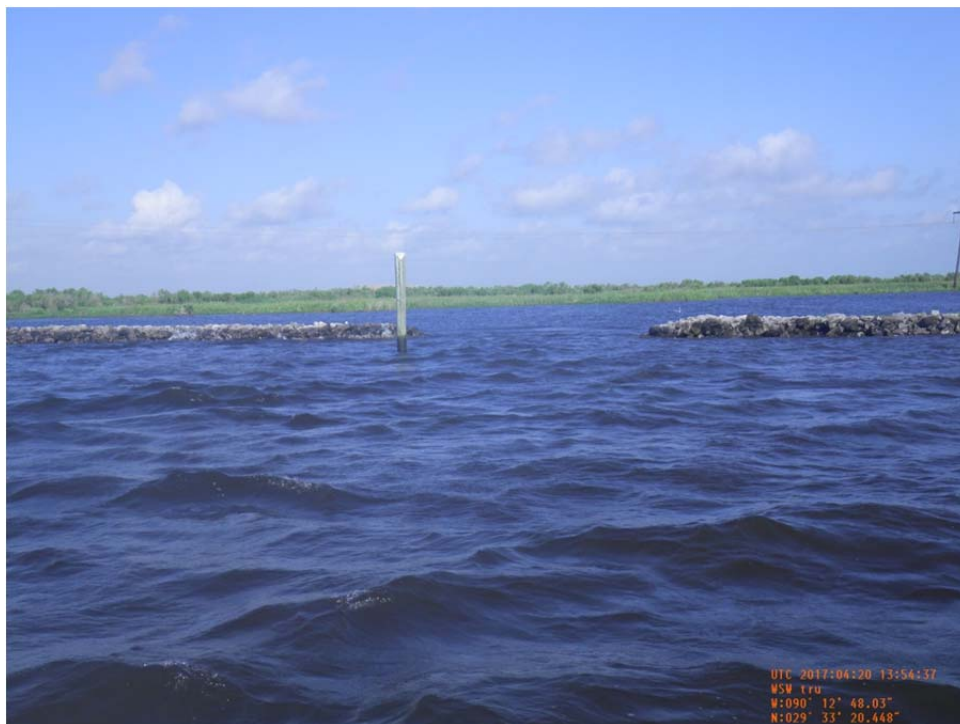
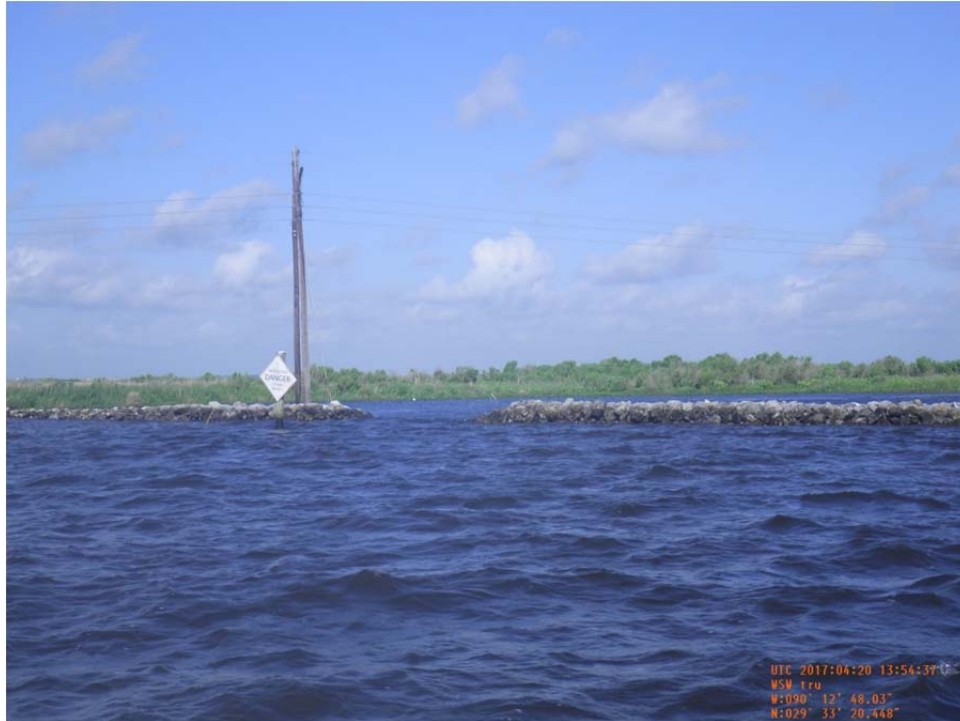
Structures 4A and 4B were recapped in 2012 to its original design elevation. A rock dike closure was also constructed from Structure 4A to Structure 4 to close a large opening in the marsh. The rock dike closure was approximately 1,000 linear feet long and was built to a +3.5 elevation. Structure 4A, 4B and the rock dike closure were all in good condition with little or no visual signs of settlement. We did notice erosion on the north side of Structure 4B where the marsh has retreated. This is a normal occurrence where a hardened structure abruptly ends. We will continue to monitor the northern end of Structure 4B on future site visits. The warning signs have deteriorated and are in need of replacement. CPRA is currently bidding a sign replacement project which includes the replacement of these signs. There are no recommendations for additional maintenance at this time. (See Appendix B, Photos 9 through 13)

Photo No.9 – view of the northern end of the rock plug (Structure 4A and 4B) along the shoreline of Bay L' Ours.

Photo No.10 – view of the rock plug (Structures 4A and 4B) along the shoreline of Bay L' Ours.

Photo No. 11 – view of the rock closure structure between Structures (4A/4B) and the rock weir with boat bay (Structure 4).

Photo No.12 – view of the warning sign at the fish dip along the rock closure structure between Structures 4A/4B and 4.

Photo No.13 – view of the warning sign at the fish dip along the rock closure structure between Structures 4A/4B and 4.

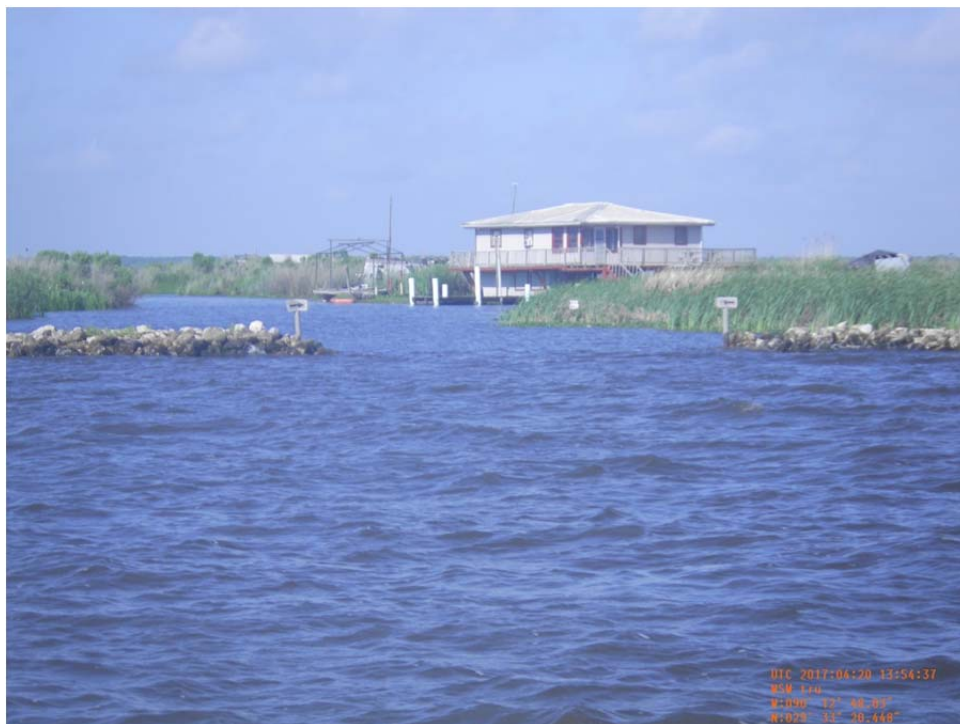
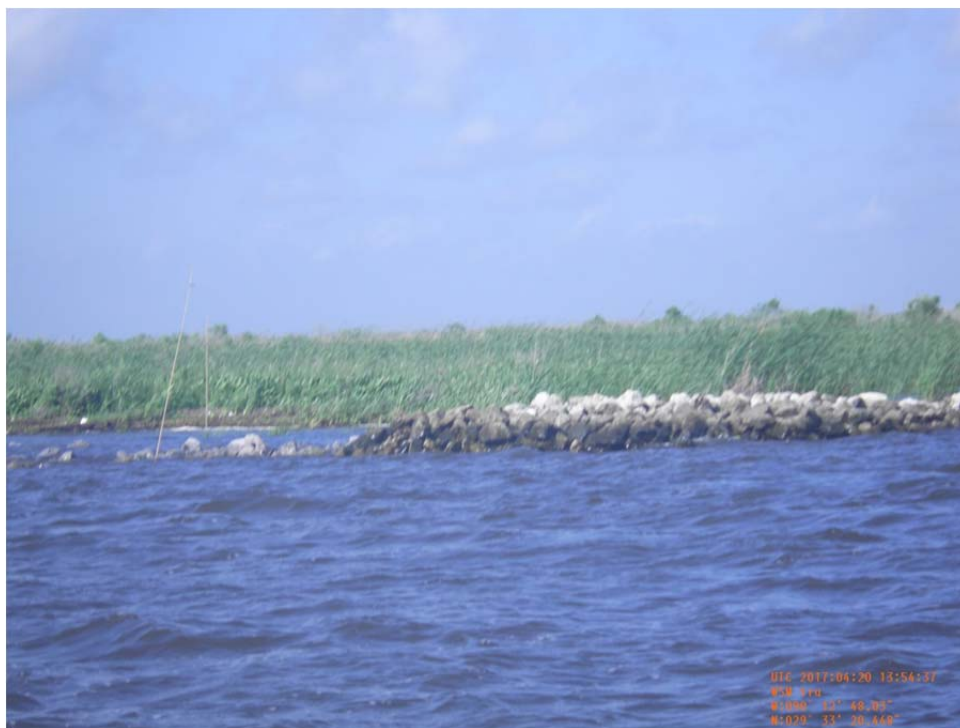
Structure 4 was also capped with riprap in 2012 to bring the crest to its original elevation. At the inspection, Structure 4 was in good condition with no visual signs of settlement or rock displacement. On previous inspections, it was noted that the marsh on the southern tie-in continues to erode and has detached from the rock weir. The southern tie-in has been repaired and the rock dike extended along the shoreline to connect to Structure 2 under the 2015 Maintenance Project. It was also noted previously that the warning signs have deteriorated and need replacement. CPRA is currently receiving bids for a multi-project sign replacement project which includes signs along Structure 4 and 4A of the GIWW to Clovelly (BA-02) project. We expect the sign replacement project to be completed by the end of September 2017. (See Appendix B, Photo 14 and 15)

Photo No.14 – view of the rock weir with boat bay at Structure 4 from Bay L' Ours.

Photo No.15 – view of the southern end of Structure 4 and new dike under construction.

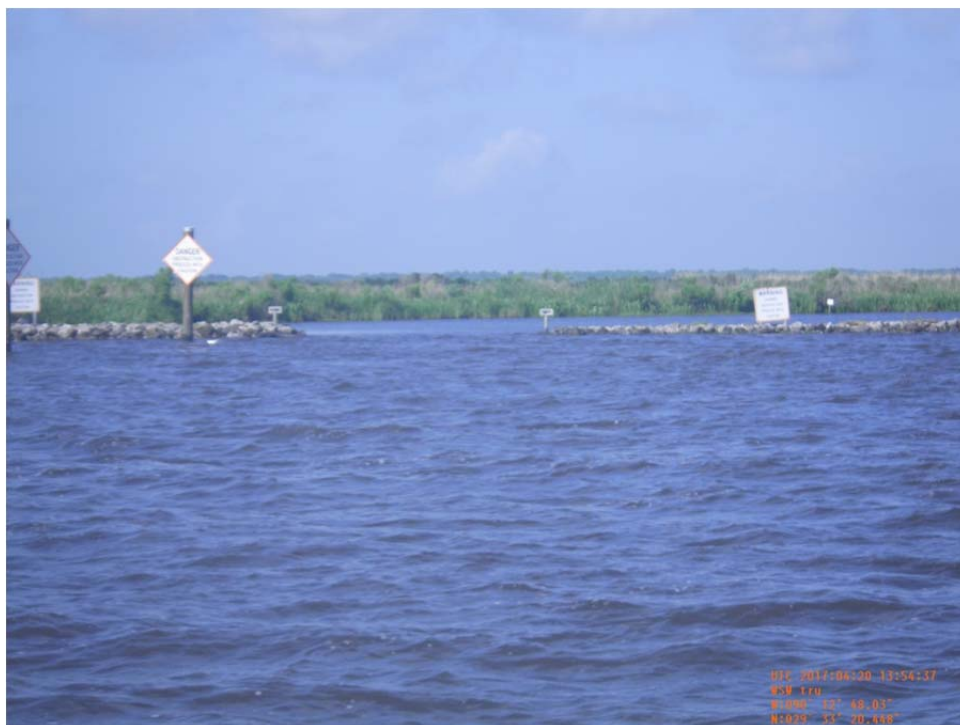
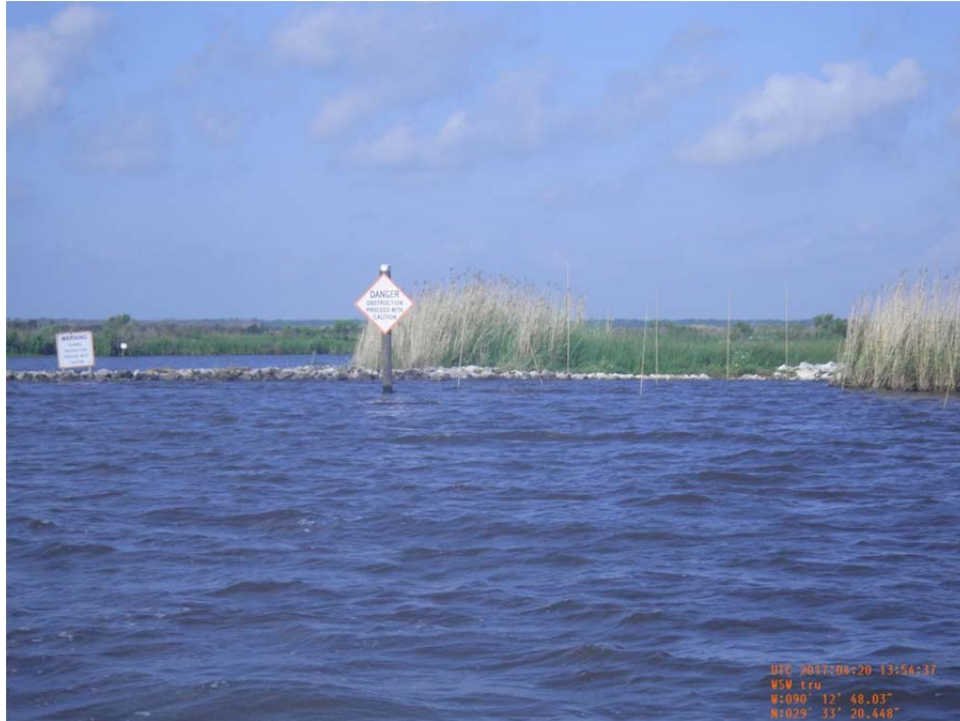
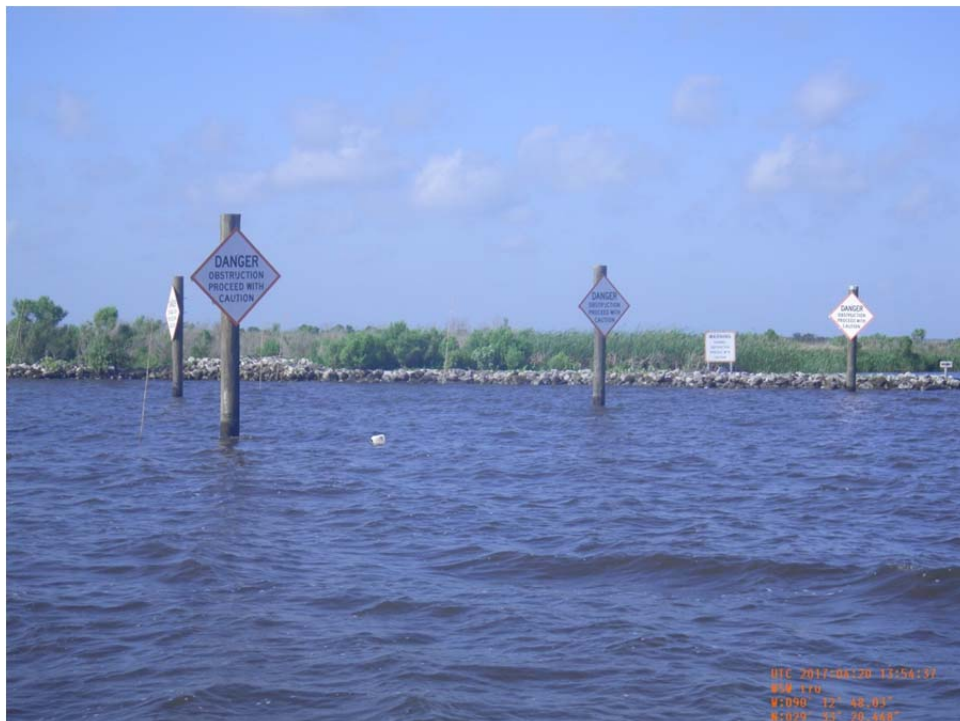
Structure 2 was recapped with 130# class riprap to its original design elevation as part of the 2012 Maintenance Project. Soundings taken during the inspection along the boat bay section of weir averaged 5.0' depth. Based on the staff gauge reading in Superior Canal and soundings taken over the structure, the adjusted elevation is estimated to be -4.4' NAVD. The as-built drawings from 2012 show a final constructed elevation of -5.0' NAVD. Since it is

unlikely that the elevation has increased since the previous inspection, we believe that there was an error in the elevation reading from the handheld fathometer and that the data is incorrect. The weir section located closest to the south bank of the structure appears to be stable and no obvious settlement was observed since the structure was capped in 2012. Based on staff gauge readings, the crest of the south section was approximately 3.0'. The north weir section did seem to settle slightly since it was recapped in 2012. Based on the existing staff gauge, it appears that the elevation of the crest of north weir section was approximately +2.5'. The warning signs on Structure 2 are in good condition and do not require replacement. The structure was in fair to good overall condition and no maintenance will be required at this time. (See Appendix B, Photos 16 through 18)

Photo No.16 – view of rock weir with boat bay at Structure 2 from Bay L' Ours.

Photo No. 17 – view of the northern side of the rock weir with boat bay at Structure 2.

Photo No. 18 – view of the southern side of the rock weir with boat bay at Structure 2.

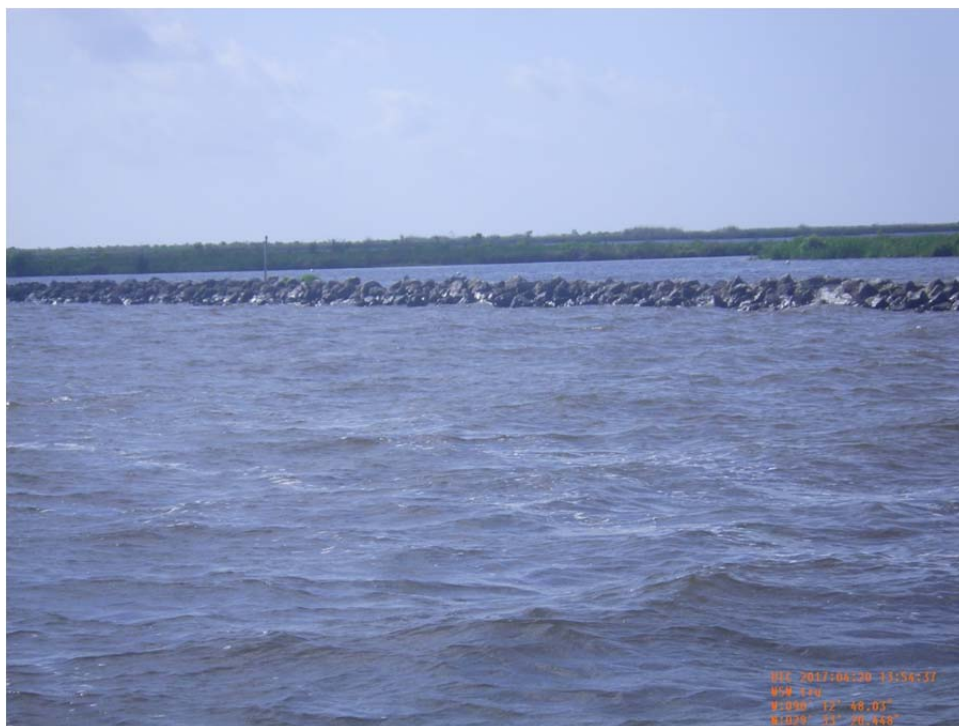
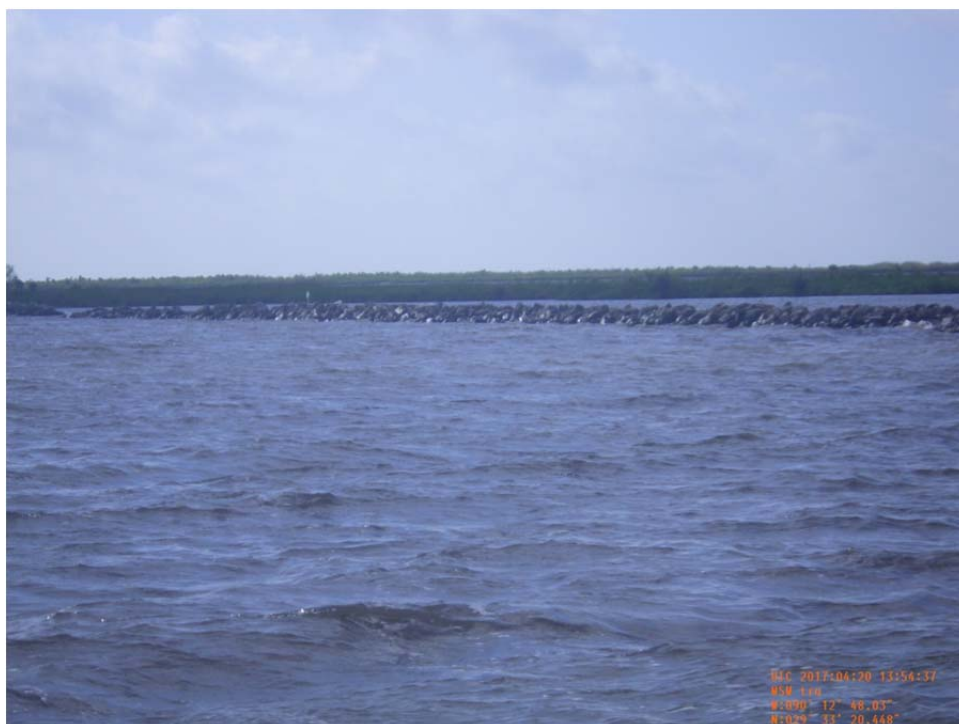
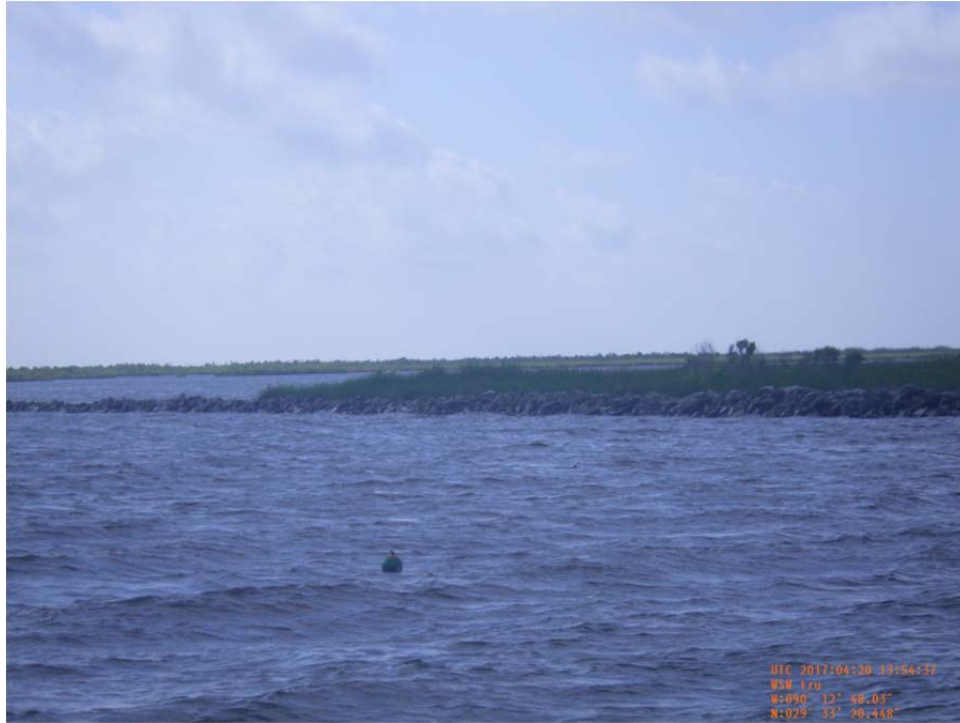
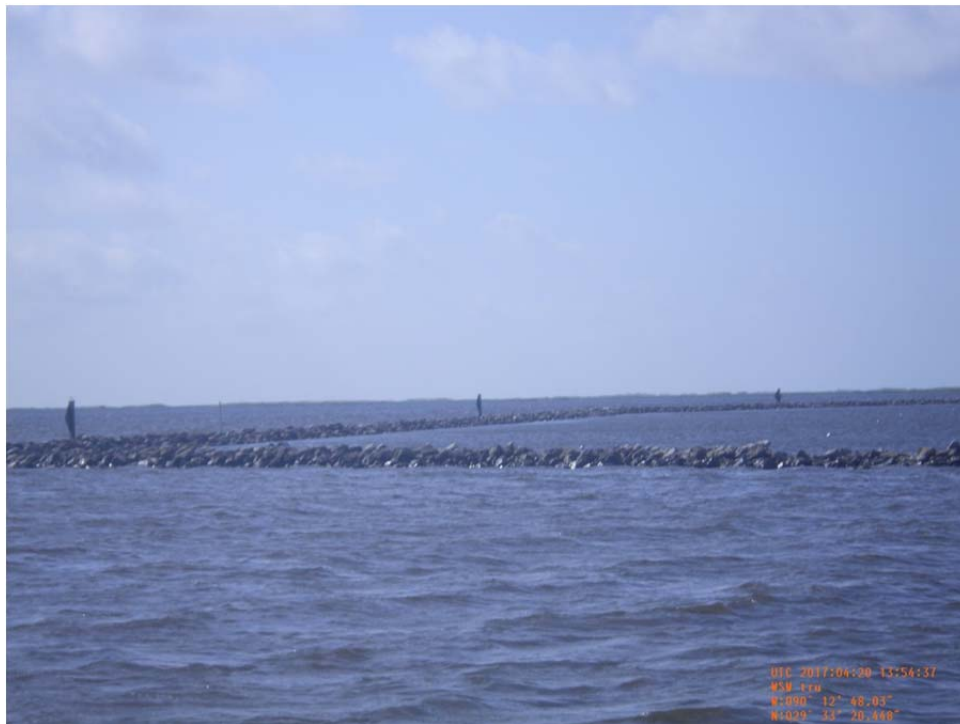
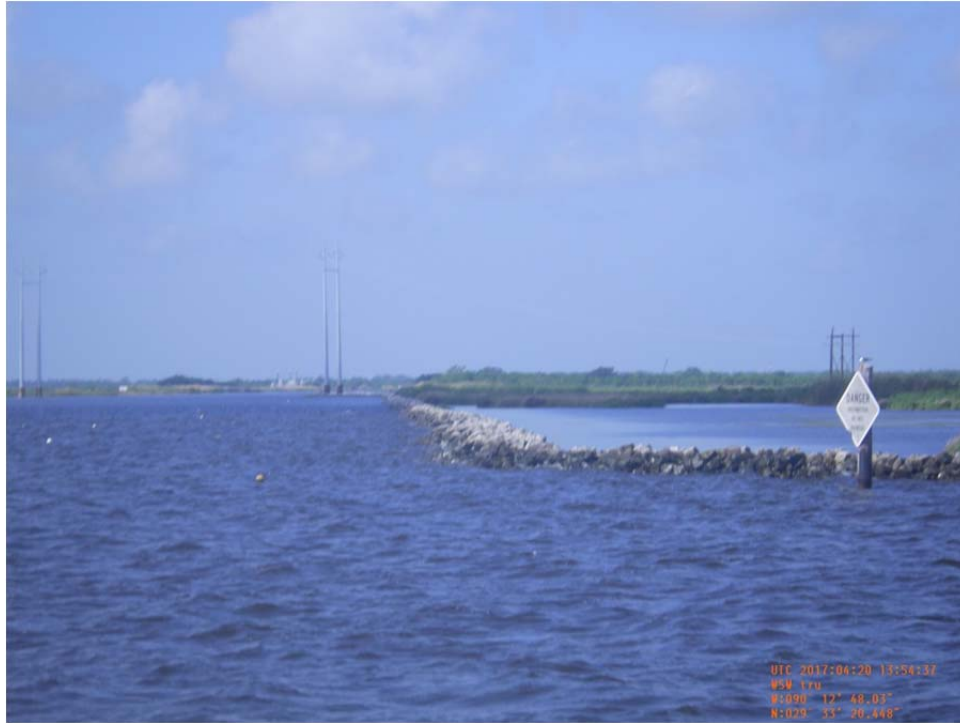
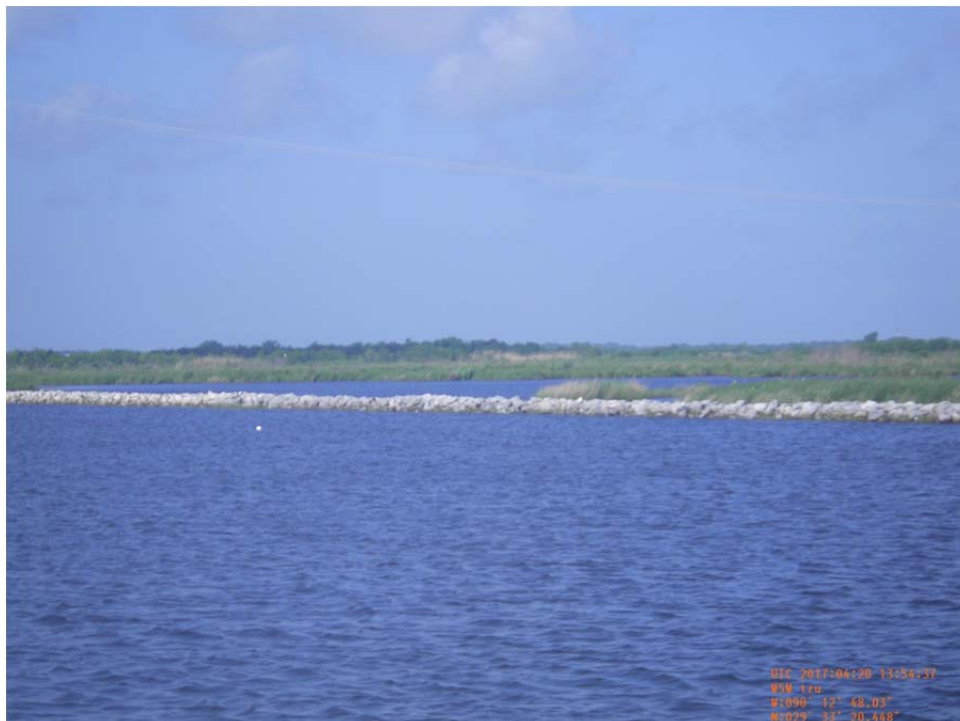
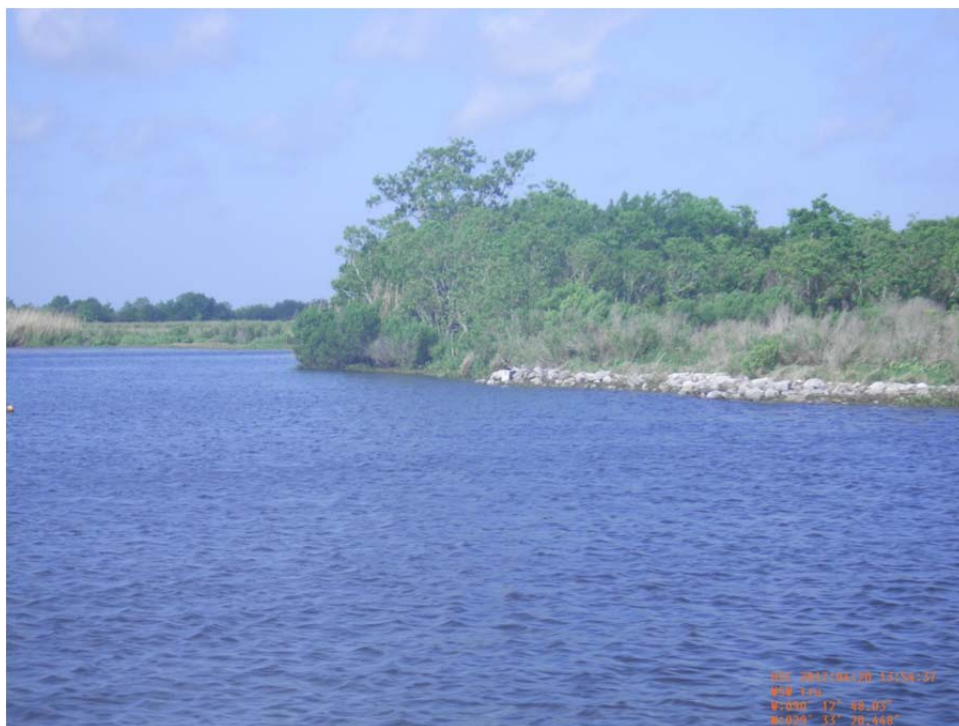
The lake rim structure was also refurbished in 2012 and appeared to be in good condition. The existing rock structure was recapped to a crest elevation of +3.5' to 4.0' along the north bank of Breton Canal and Bay L' Ours to Structure 2. There are no visual signs of settlement or displacement of the rock along the structure and the warning signs are in good condition. There are no recommendations for maintenance at this time. (See Appendix B, Photos 18 through 25)

Photo No. 19 – view of the shoreline protection (lake rim) between Structure 2 and Breton canal.

Photo No. 20 – view of the shoreline protection (lake rim) between Structure 2 and Breton canal.

Photo No. 21 – view of the shoreline protection (lake rim) between Structure 2 and Breton canal.

Photo No. 22 – view of the shoreline protection (lake rim) between Structure 2 and Breton Canal.

Photo No. 23 – view of the shoreline protection (lake rim) along Breton Canal.

Photo No. 24 – view of the shoreline protection (lake rim) along Breton Canal.

Photo No. 25 – view of the north termination of the shoreline protection (lake rim) along Breton Canal.

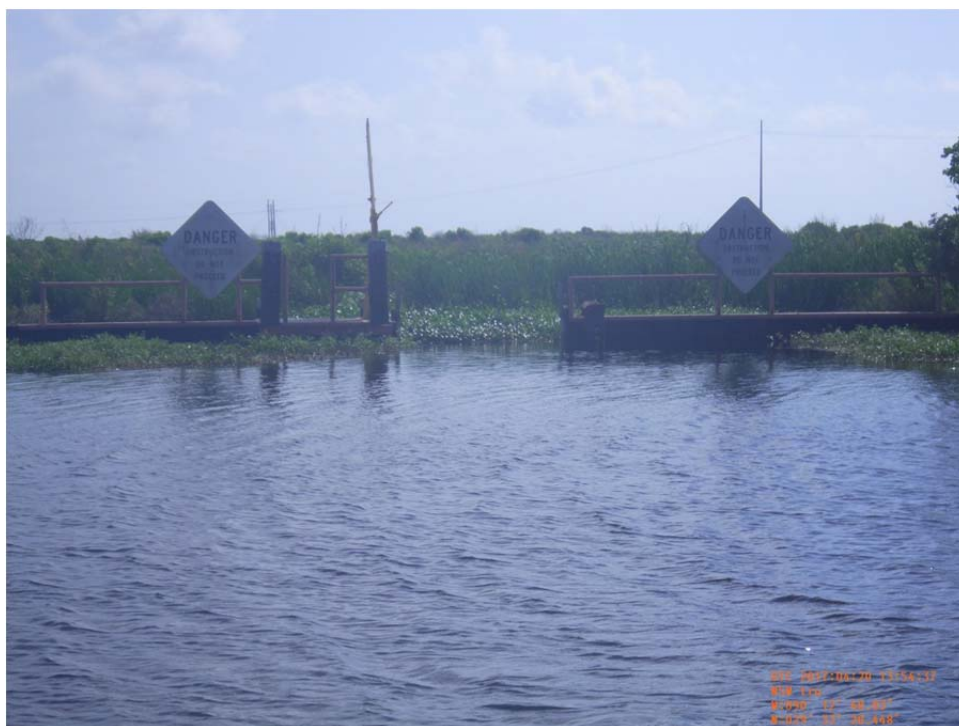
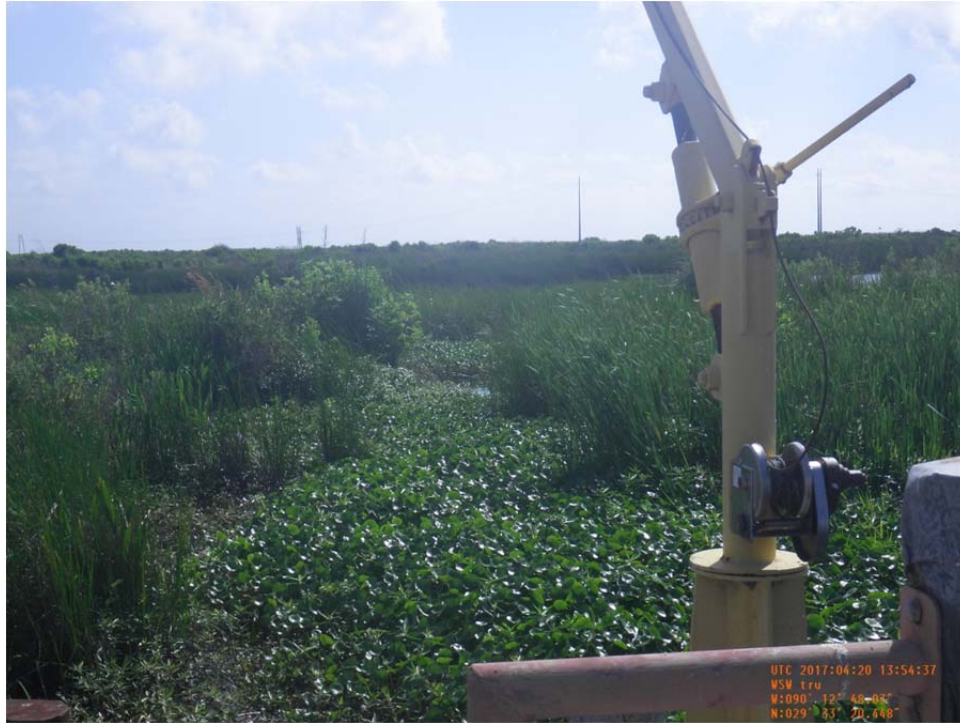
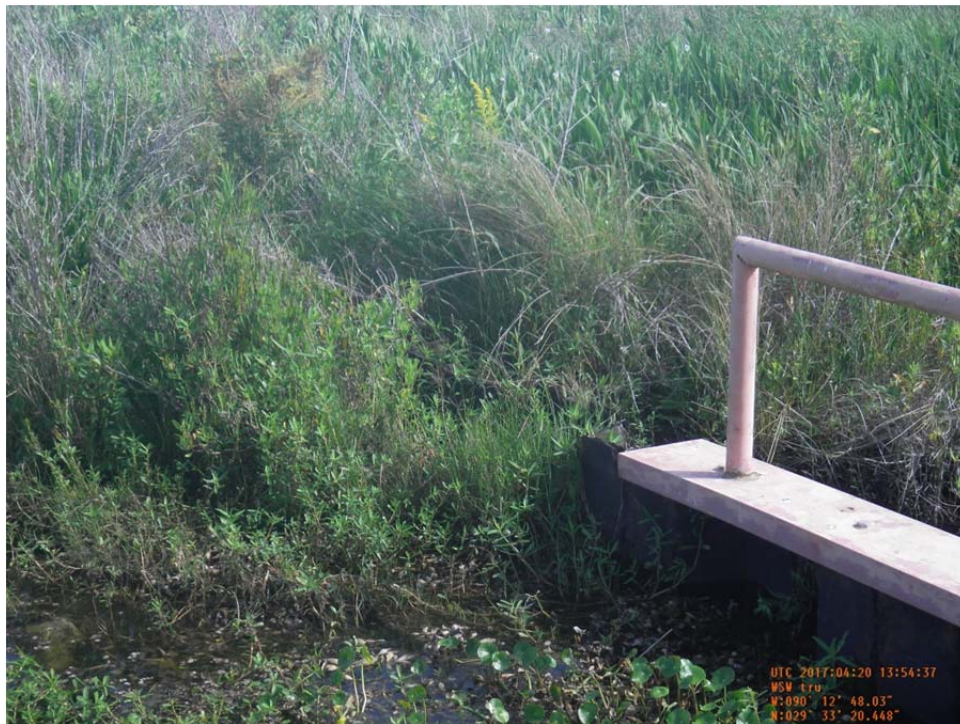
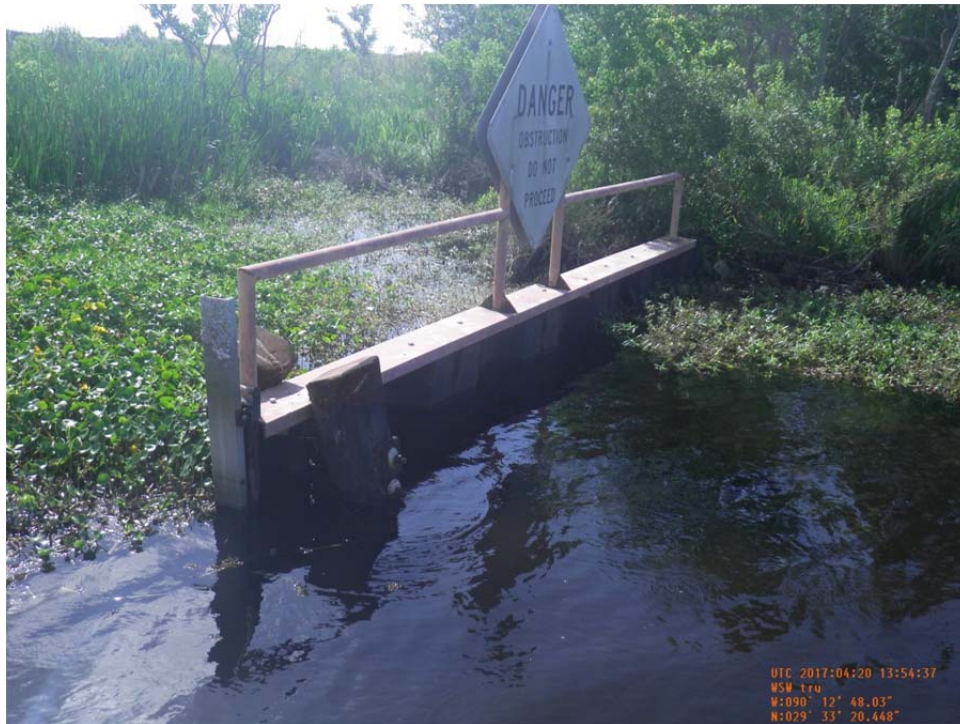
Overall, Structure 35 has moderate corrosion on the bulkhead cap, handrails and deck. The stop logs, cables, signs and supports appear to be in good condition and operable. At the time of inspection the channel from the weir to the interior marsh was open and there appeared to be adequate flow through the interior marsh and structure. The embankment tie-ins also appear to be in good condition with no erosion or washouts. We are not recommending any repairs or corrective actions at this time. (See Appendix B, Photos 26 through 29)

Photo No.26 – view of the variable crest weir (Structure 35) located along an existing location canal off of Breton Canal.

Photo No.27 – view of boom system for moving stop logs and the interior marsh behind Structure 35.

Photo No.28 – view of the sheet pile wall tie-in to bank on the north side of Structure 35.

Photo No.29 – view of the stop log bay and sheet pile wall tie-in to bank on the south side of Structure 35.
