**State of Louisiana
Coastal Protection and Restoration
Authority**

2017 Annual Inspection Report

**GIWW/ CLOVELLY HYDROLOGIC
RESTORATION**

State Project Number BA-02
Priority Project List 1

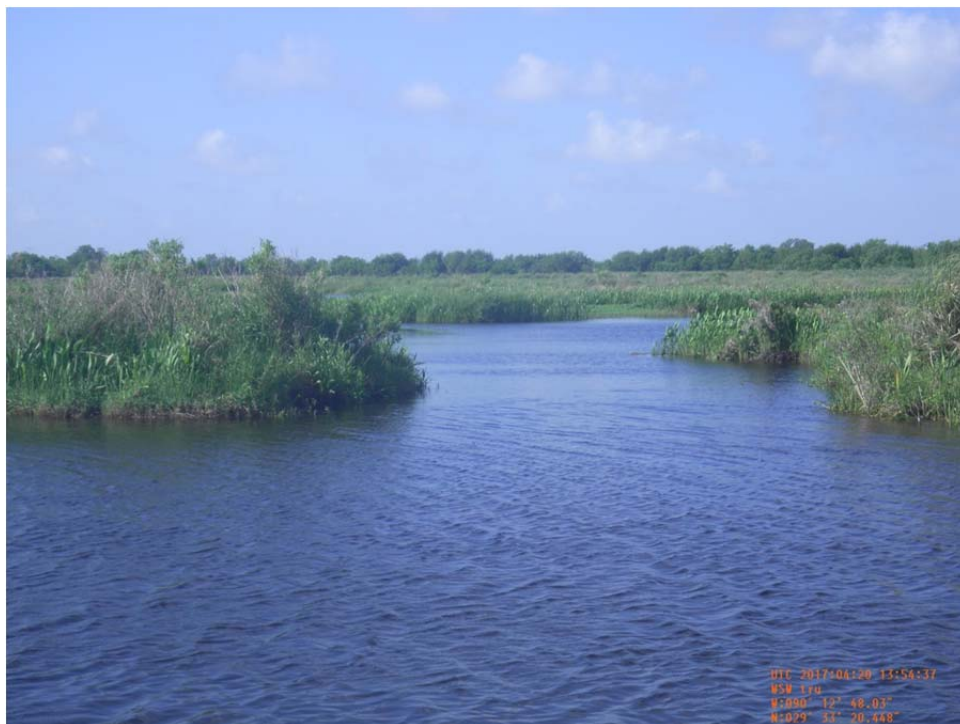
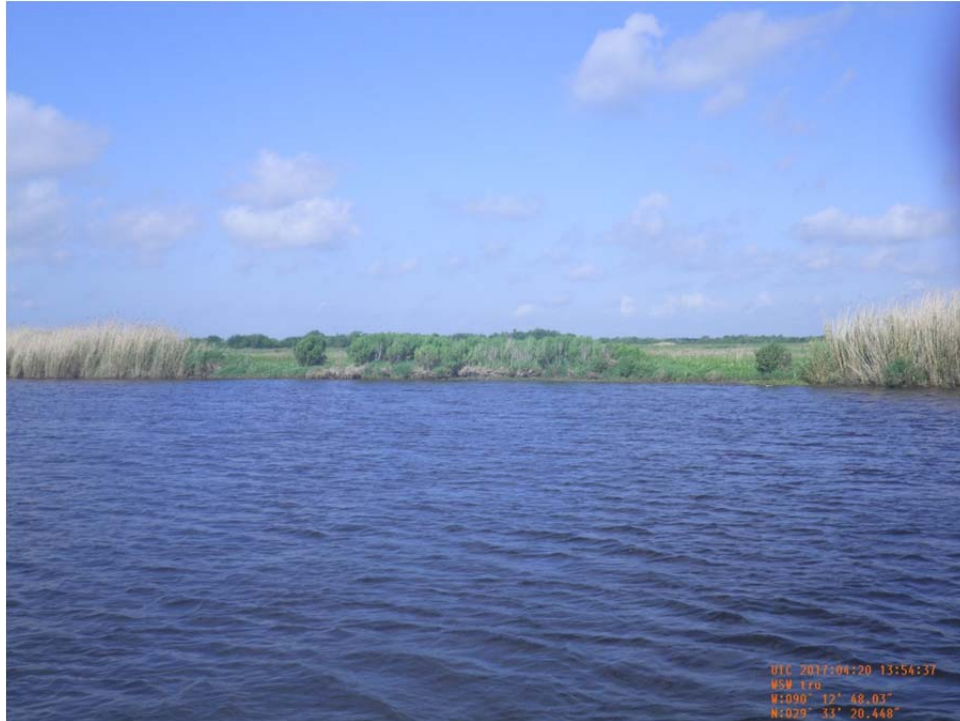
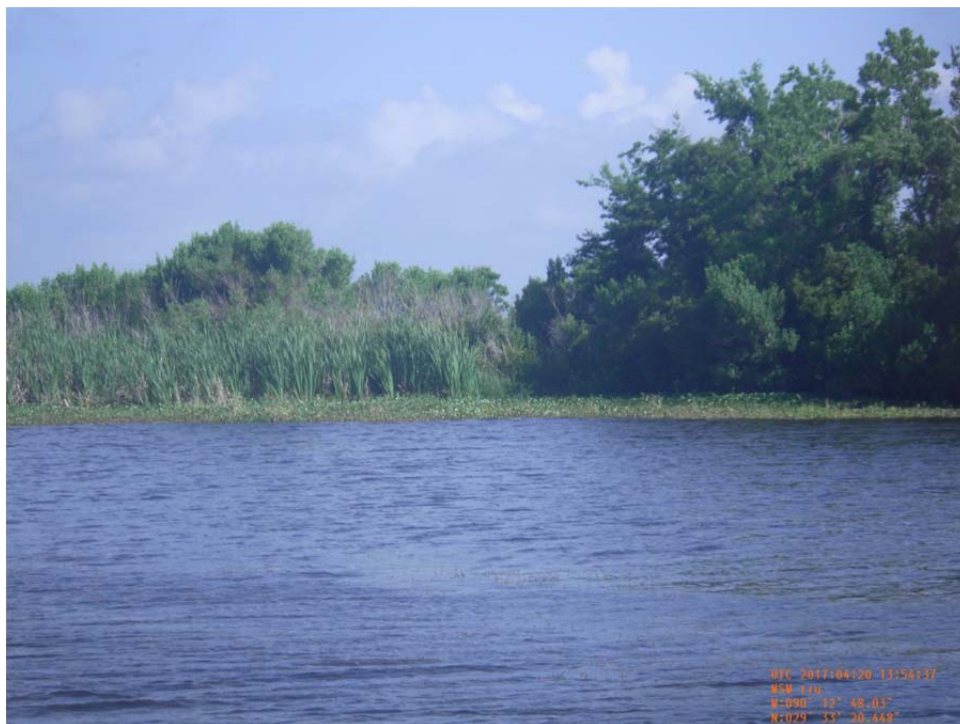
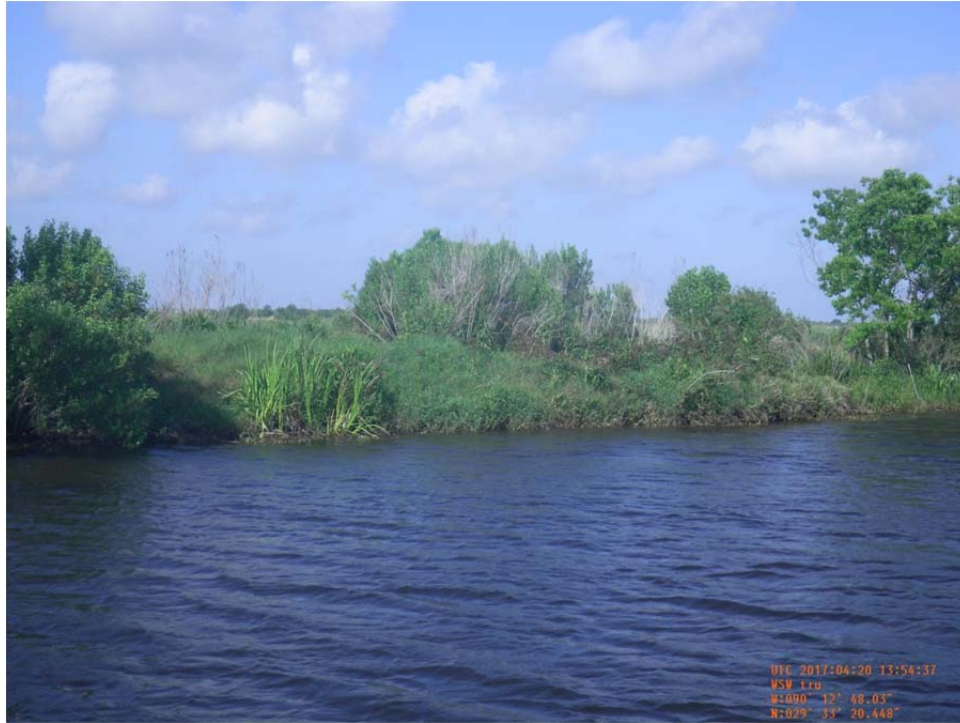
There were five (5) breaches repaired during the 2012 Maintenance Project. Breach 1 was located along the north bank of Breton Canal just southwest of the first location canal from Bay L' Ours and was approximately 20' wide. Breach 2 was located along the northeast bank of the second location canal north of Breton Canal and was approximately 10' wide. Breach 3 was located on the south bank of the same location canal as Breach 2 and was approximately 25' wide. Breach 4 was located on the west bank of an oilfield canal that intersects Breton Canal east of Structure No. 1 and was approximately 30' wide. Another breach, designated as Breach 5, was discovered at the end of a dead end oilfield slip south of Breach 4. The breaches were closed by using material from the adjacent canal bottoms to reconstruct the earthen dike. The material was allowed to dry before it was shaped, seeded, and fertilized. All breach repairs appear to be in good condition with no signs of settlement or erosion. We did note a large breach along the north bank of Breton Canal east of Breach Repair 1. Since this is the one of the only deficiency noted during this inspection, we will continue to monitor this area and offer recommendations at a later date as to necessary remedial action. (See Appendix B, Photos 30 through 33)

Structure No.30 – view of breach in the north bank of Breton Canal near the location canal where Structure 35 is located.

Photo No.31 – view of the breach repair performed in 2012 along the north bank of Breton Canal.

Photo No.32 – view of breach repair along north bank of second location canal from Bay L' Ours.

Photo No.33 – view of breach repair along south bank of second location canal from Bay L' Ours.

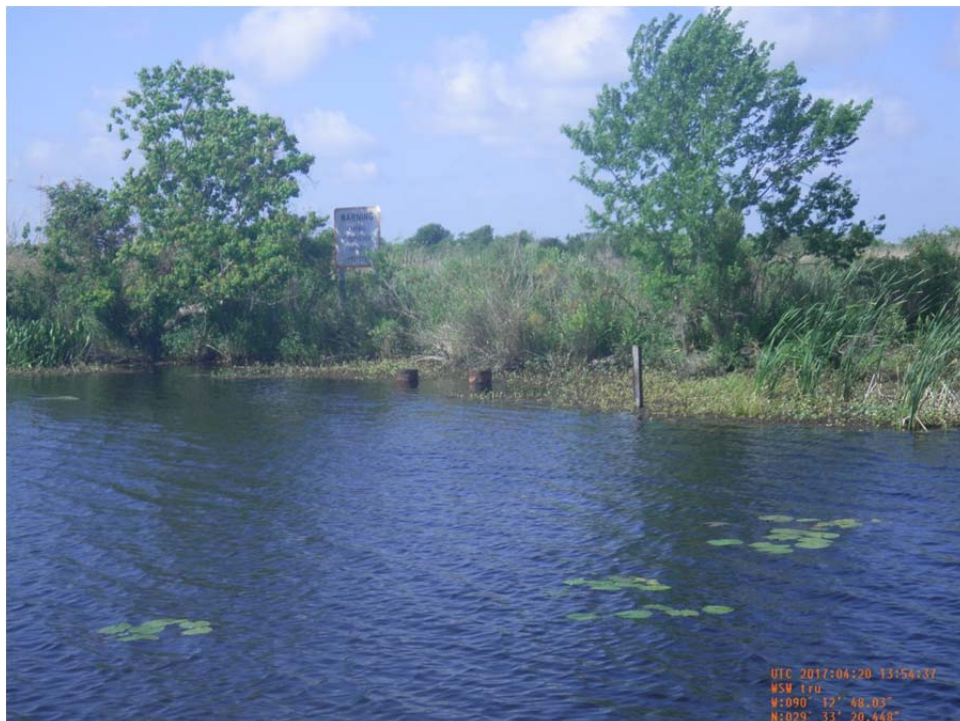
Overall, Structure 91 rock plug appeared to be in good condition. The rock structure was covered with heavy vegetation and woody debris; however, it appears to be in good condition with no obvious settlement or breaches around the structure. The timber piles supporting the corrugated metal pipe and flap gate was in fair condition and appeared to be operational. There are no plans for maintenance of Structure 91 at this time. (See Appendix B, Photos 34)

Photo No.34 – view of rock plug with flap-gated culvert (Structure 91) along an interior channel.

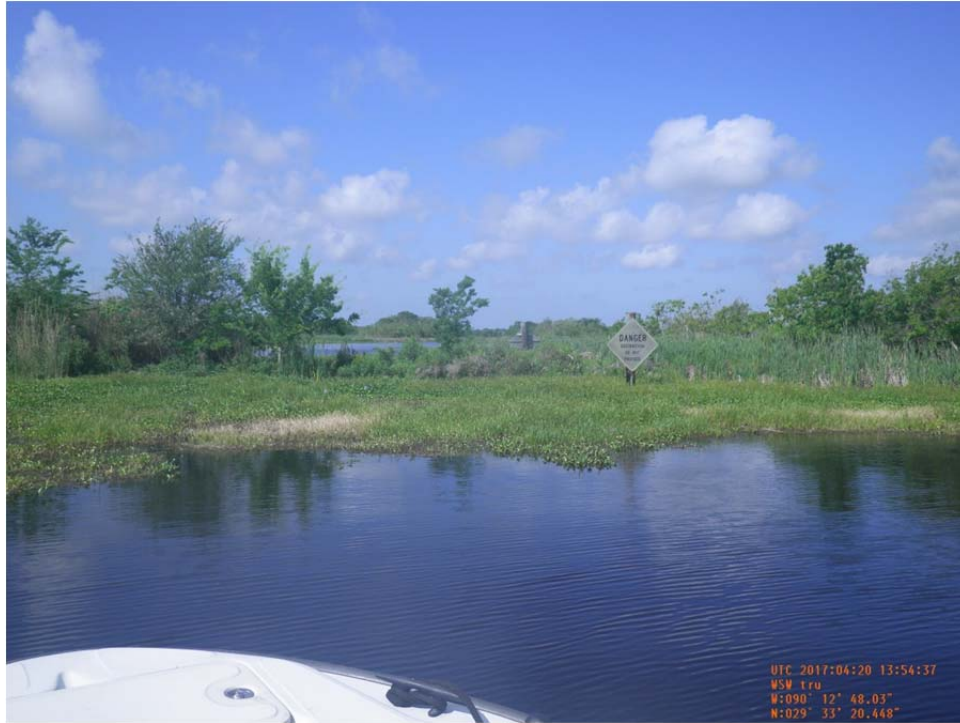
Structure 90 was difficult to access and view due to heavy vegetation on the structure and in the canal leading to the structure. From what we were able to view, the structure appeared to be in good condition with no obvious settlement or breach around the bank tie-ins. The warning signs and supports were also in good condition. There are no recommendations for maintenance of Structure 90 at this time. (See Appendix B, Photos 35)

Photo No. 35 – view of rock plug (Structure 90) along interior channel near southern boundary of project.

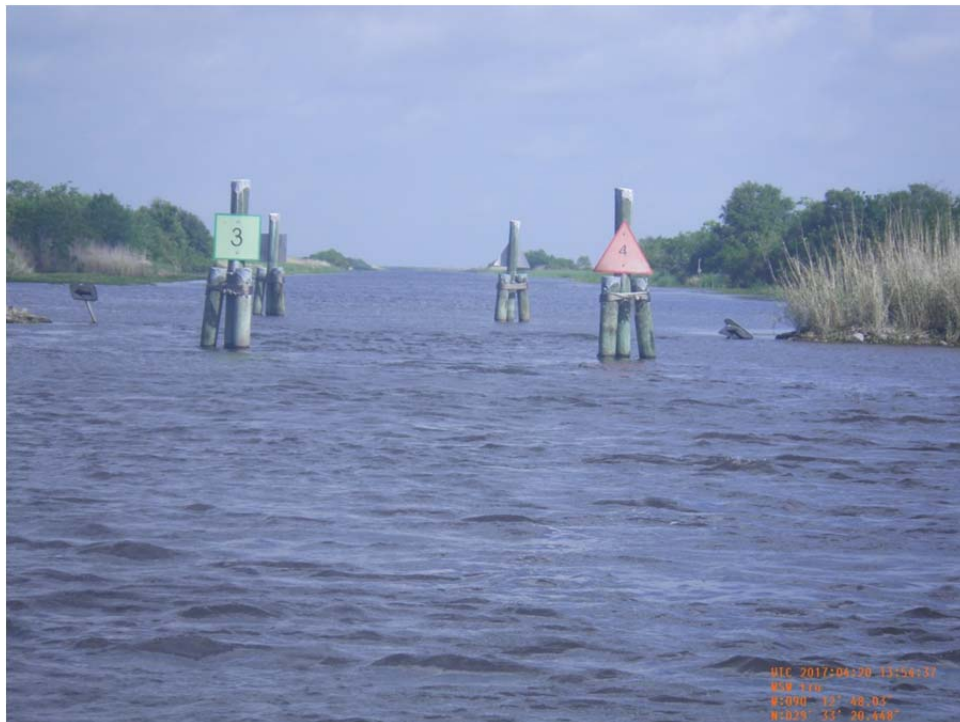
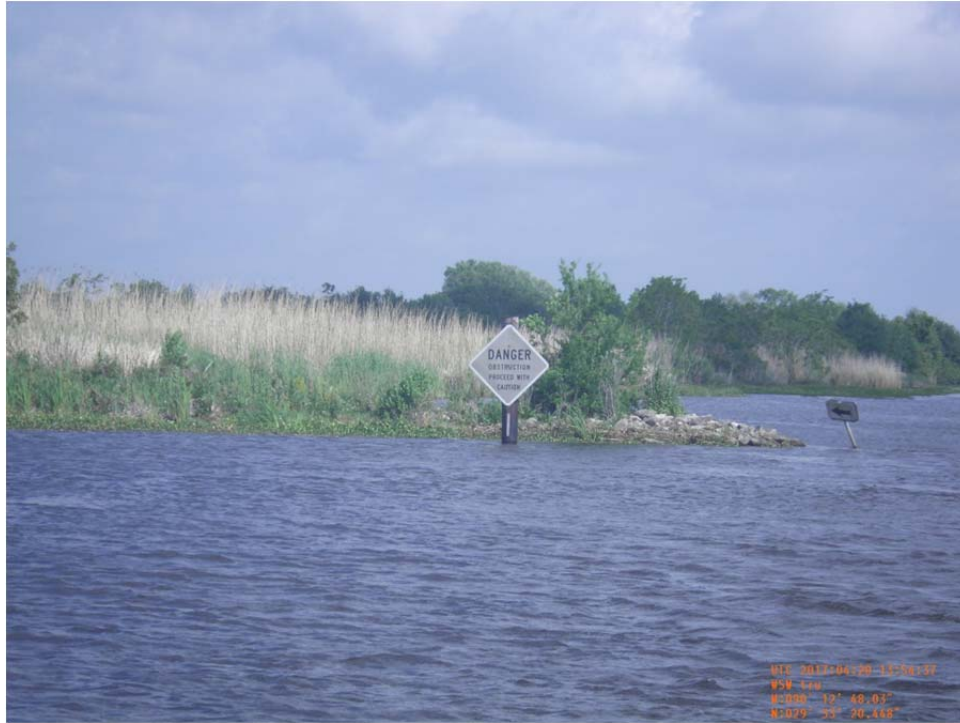
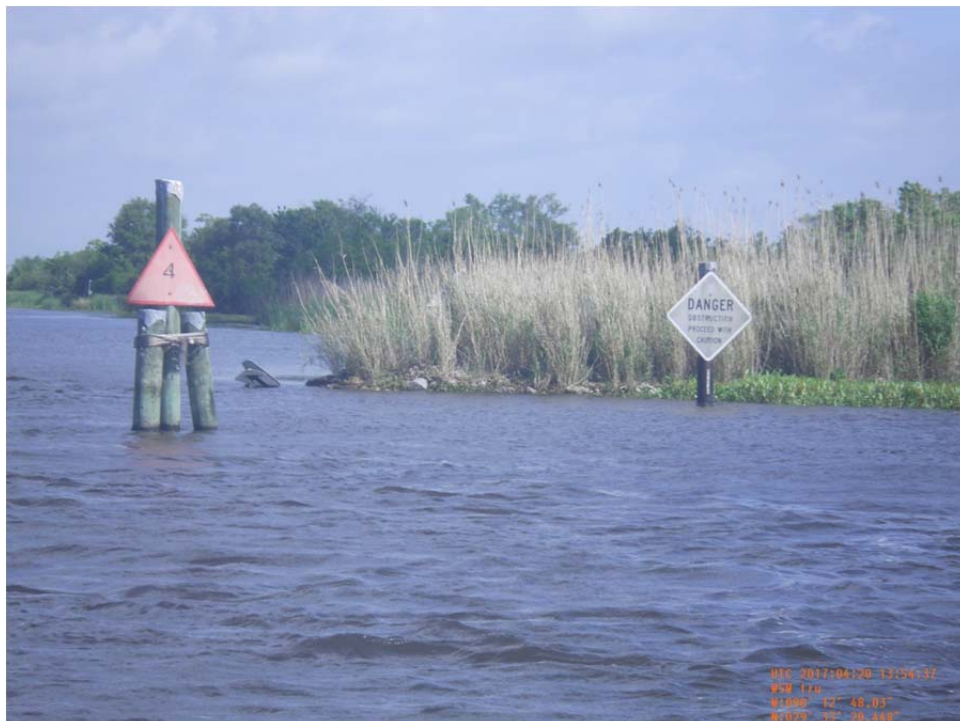
Overall, Structure 1 appeared to be in good condition with no visual signs of settlement or damage of the rock structure or erosion along the bank tie-ins. The four (4) timber dolphin structures at the entrance of the barge bay opening were replaced in 2012 and are in good condition. The directional arrow signs are knocked down or turned inward and should be replaced during the next maintenance event. (See Appendix B, Photos 36 through 38)

Photo No.36 – view of timber pile dolphins and signs at the entrance to the barge bay at Structure 1.

Photo No.37 – view of west side bank tie-in of rock weir at Structure 1.

Photo No.38 – view of east side bank tie-in of rock weir at Structure 1.

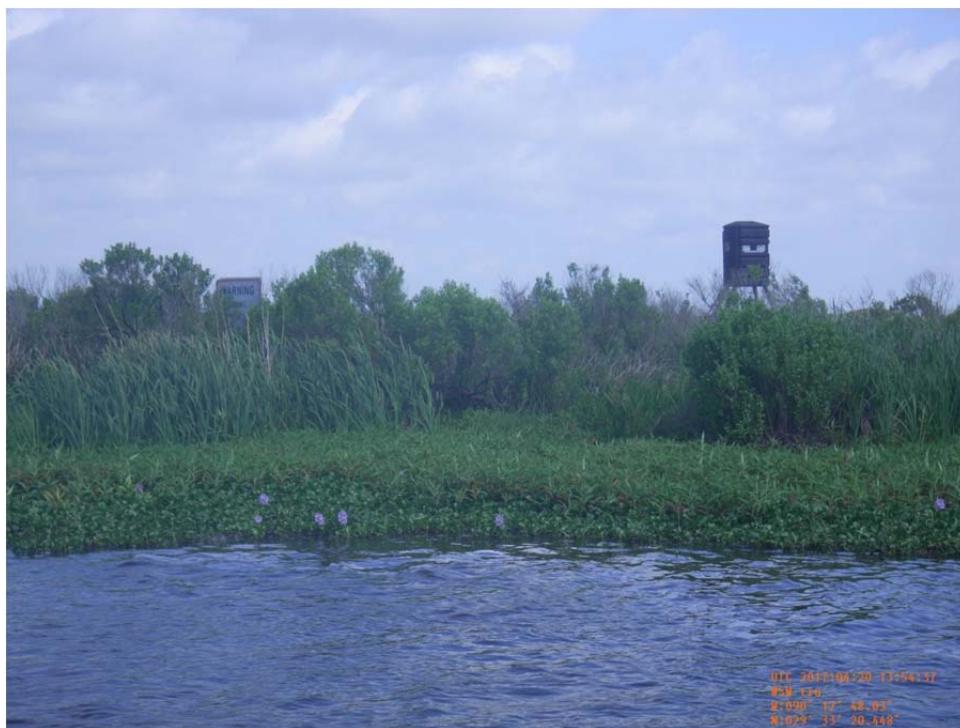
Structure 43 is not visible from the canal due to heavy vegetation and water hyacinth blocking the structure. During past inspections, it was noted that a small opening had developed on the east side of the structure connecting the interior marsh to the canal. We were unable to locate the opening or see any water flow around the structure. Since the breach has been identified on previous inspections, we will continue to look for water flow around the structure on future inspections. All warning signs and support structures appear to be in good condition, and at this time, there are no recommendations for maintenance. (See Appendix B, Photo 39)

Photo No.39 – view of rock plug and warning sign at Structure 43.
