State of Louisiana Coastal Protection and Restoration Authority

2014 Operations, Maintenance, and Monitoring Report

Jonathan Davis Wetland Restoration (BA-20)

September 2014 Jefferson Parish

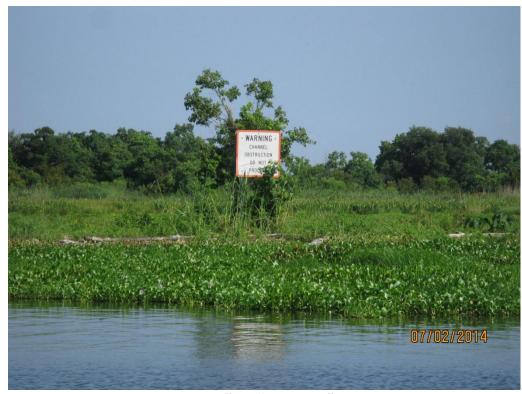
Photo #1 – Structure #12

The structure was in good condition; some slight settling was observed. All of the signs and supports were in good condition. No maintenance needs were identified for this location at this time.

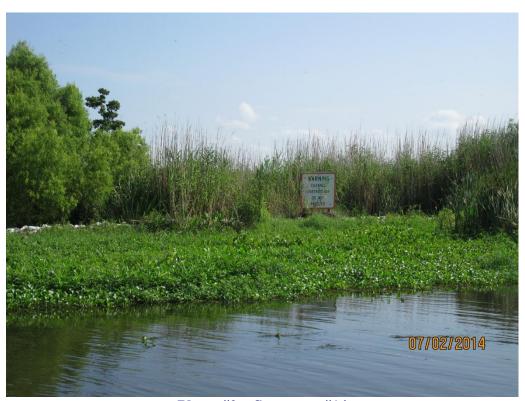
Photo #2 – Structure #14

Due to the water level and structure settlement, the structure was not visible. Signs and supports were generally in good condition. No maintenance will be required at this time.

Item	Condition	Pysical Damage	Corrosion	Photo #		ations and Remark	(S
Signage and					Observations:		
supports	Good			#2			
Armored Plug							
	Good			#2	Slight settlement noted, but no repair	s needed at this time	э.
Earthen							
Embankment	Fair						
	1						
Construction U	_ nit No.1						
Structure Descri	ption: 138 linear ft.	of rock rip-rap armore	ed rock filled ch	annel plug			
		of Bayou Perot, west o					
		the plug was construc					
NGVD. The rock	filled plug contains	2,580 tons of rock fill	and 1,346 tons	of rock			
rip-rap armor. Alı	uminum warning si	igns are located throug	h the rock emb	oankment.

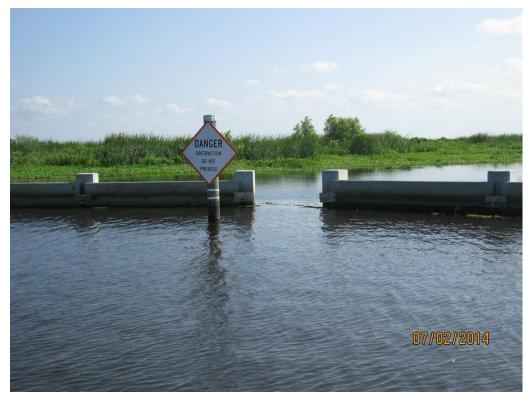
Photo #3 – CU #4 Concrete Panel Wall

The concrete panel wall sections along the north end of Bayou Perot and Bayou Rigolettes were in good condition. There was no observed damage to the concrete panels, piles, or stainless steel fastening hardware. Warning signs and support piles were also in generally good condition.
