**State of Louisiana  
Coastal Protection and Restoration  
Authority**

**2019 Annual Inspection Report**

**Jonathan Davis Wetland Restoration  
Project**

State Project Number BA-20  
Priority Project List 2

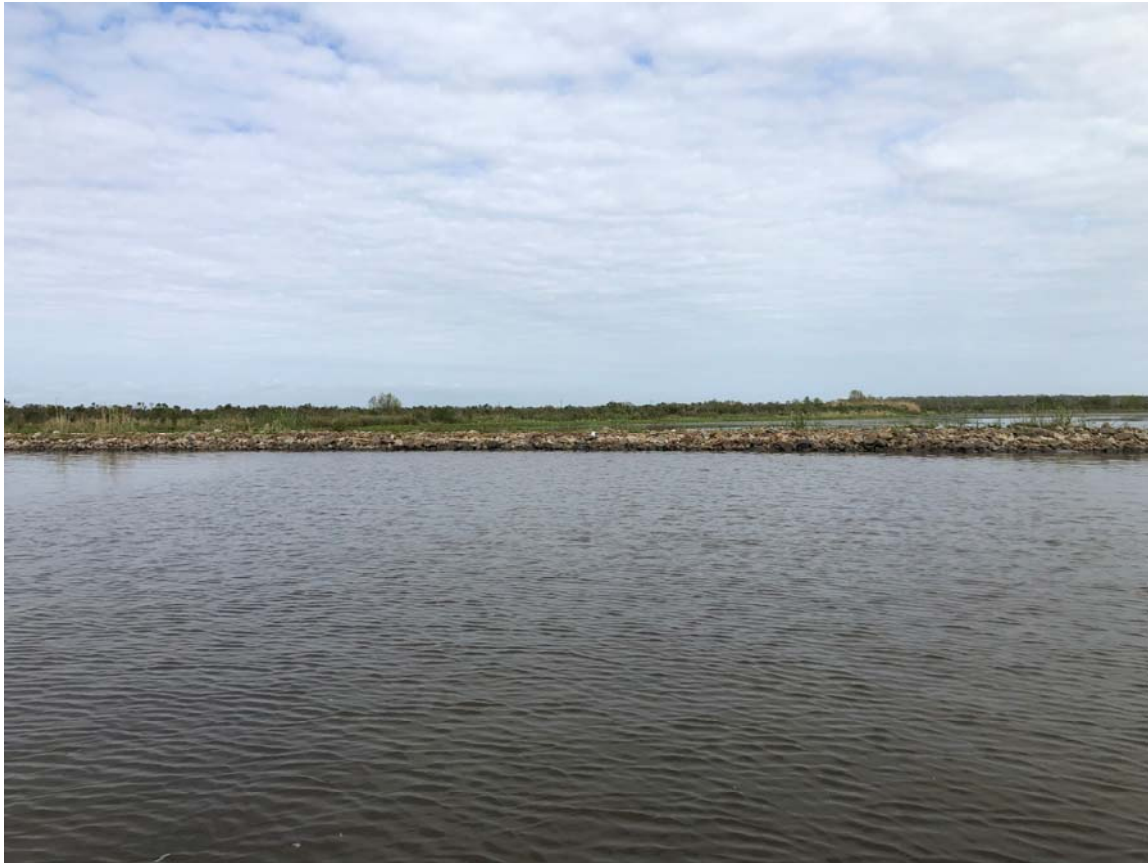
**Photo #1 – Bayou Perot Shoreline Protection (CU3)**

No significant changes were noted since the last inspection. The rock shoreline protection appeared to be in good condition, with minor settlement in some areas. The areas of lower elevation deserve continued observation on future inspections, but no maintenance needs were identified at this time.

Item	Condition	Physical Damage	Corrosion	Photo #	Observations and Remarks
Rock Dike	Good; see remarks	None	N/A	1	Minor settlement observed in some areas, no repairs needed at this time.
<b>Construction Unit No.3</b> Structure Description: The rock dike consist of 13,088 linear ft. of rock dike with a 6 ft. top width and a crest elevation of +3.5 ft. NGVD. The shoreline stabilization extends from Site 12 west to the Gulf Intracoastal Waterway.

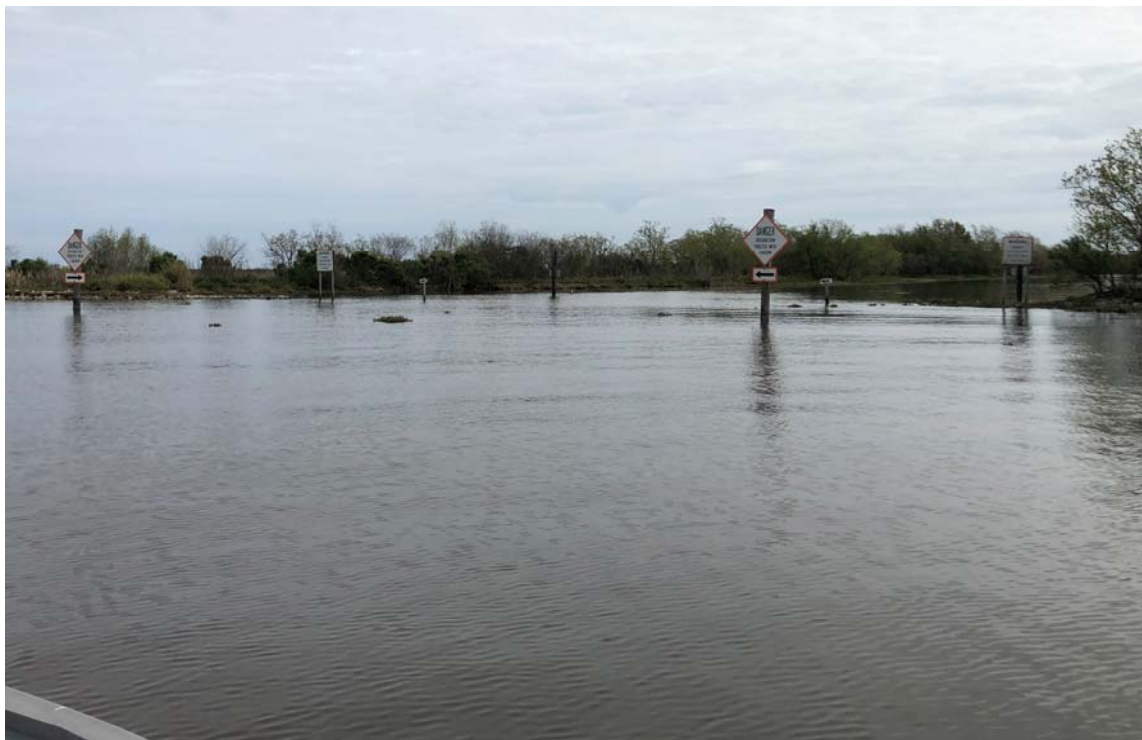
**Photo #2 – Structure #13**

Settlement in the structure prevented a detailed inspection of the weir. Signs and timber supports were generally in good condition. No maintenance will be required at this time.

Item	Condition	Physical Damage	Corrosion	Photo #	Observations and Remarks
Signage and supports	Good			2	
Armored Weir	Fair			2	Structure has experienced some settlement, but maintenance is not required at this time.
<b>Construction Unit No.1</b> Structure Description: 300 linear ft. of rock rip-rap armored rock filled weir with a 50 ft. wide boat bay located north of Bayou Perot and Site 12, west of Bayou Barataria, and east of the GIWW. The crest of the weir is set at an elevation of +1.0 ft. NGVD. The invert of the boat bay is set at an elevation of -5.0 ft NGVD. Rock wingwalls were constructed to an elevation of +3.6 ft. NGVD. On the west side and +4.0 ft. NGVD on the east side of the weir. The rock filled weir contains 1,093 tons of rock filled with 772 tons of rip-rap armor. Aluminum warning signs are located adjacent to the structure.

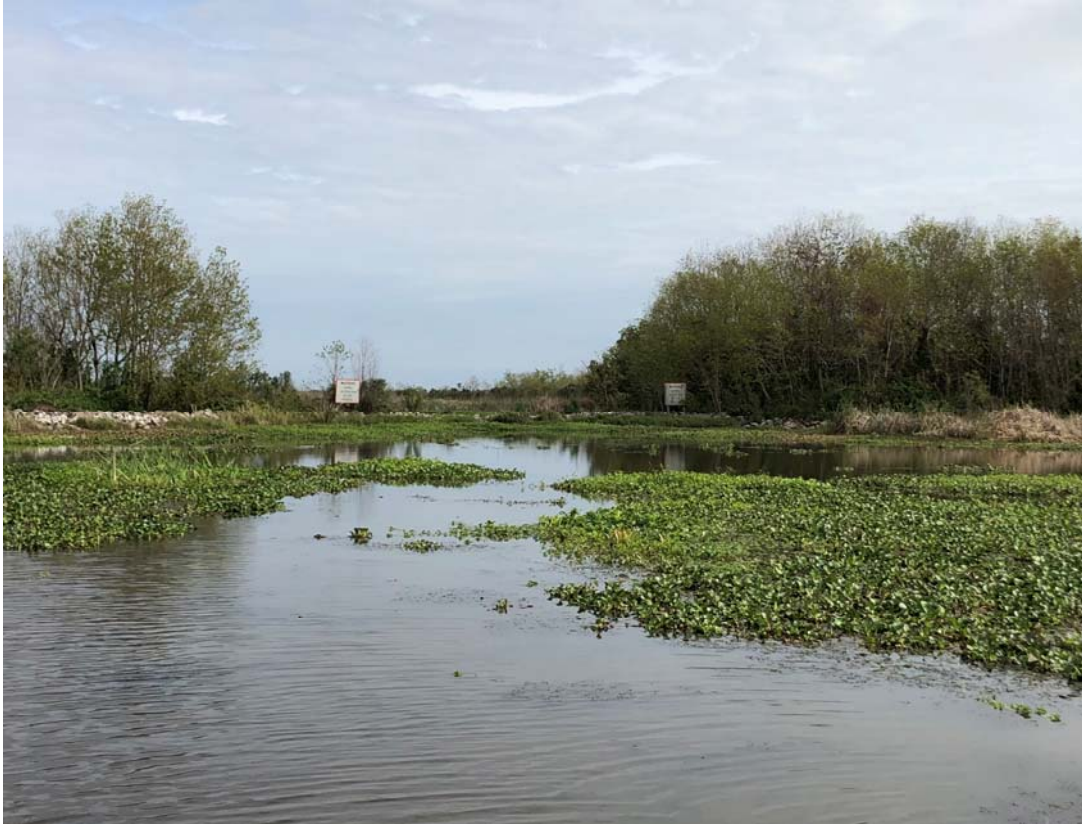
**Photo #3 – Structure #15**

The original weir was converted to a rock plug structure as part of the work effort for Construction Unit 4. No defects were noted during the inspection.

Item	Condition	Physical Damage	Corrosion	Photo #	Observations and Remarks
Signage and supports	Good	None	None	3	
Armored Plug	Good	None	N/A	3	This structure was converted into a channel plug as part of the completed CU4 maintenance work.
<b>Construction Unit No.1</b> Structure Description: 132 linear ft. of rock rip-rap armored weir with a 50 ft. wide boat bay located in a pipeline channel north of Bayou Perot, west of Bayou Barataria and east of the GIWW and Site 14. The crest of the rock weir was constructed to an elevation of +4.0 ft. NGVD. The invert of the boat bay is at an elevation of -3.0 ft. The rock filled weir contains 1,248 tons of rock filled with 728 tons of rock-rip armor. Two (2) aluminum warning signs are located through the rock armored embankment on each side of the boat bay.

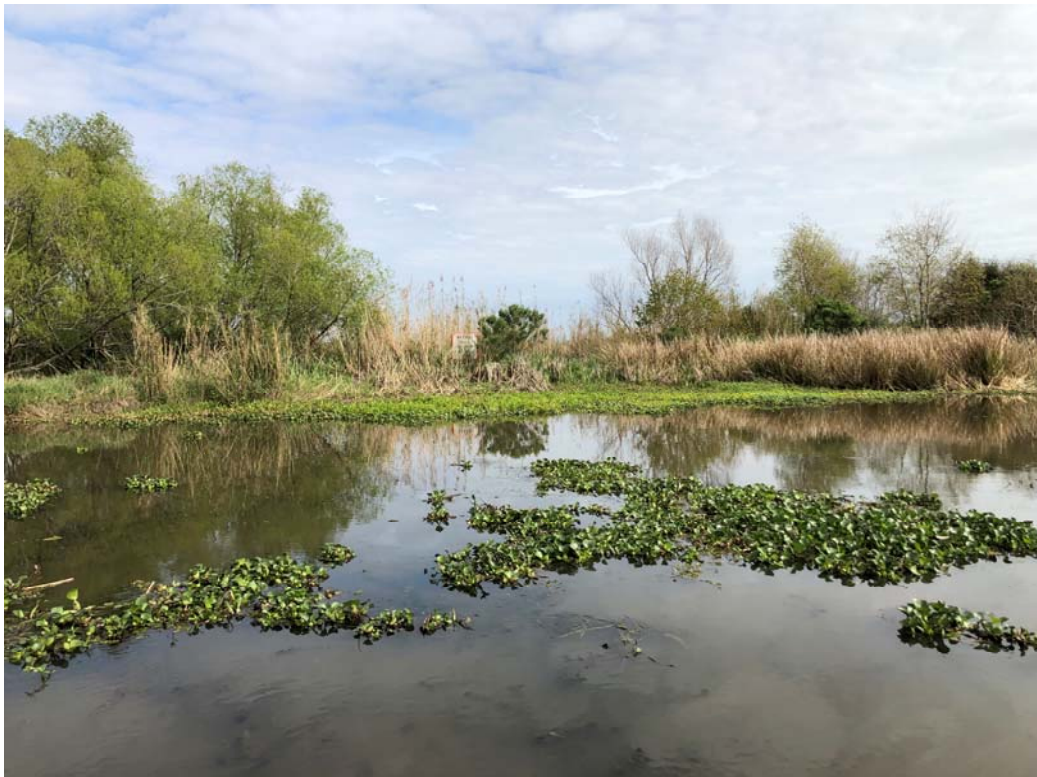
**Photo #4 – Structure #16**

Rip-rap and warning signs appeared to be in good condition. No immediate maintenance requirements were identified at this structure.

Item	Condition	Physical Damage	Corrosion	Photo #	Observations and Remarks
Signage and supports	Good	None	None	4	
Armored Plug	Fair	None	N/A	4	No maintenance needs identified at this time.
<b>Construction Unit No.1</b> Structure Description: 303 linear ft. of rock rip-rap armored rock filled plug located in a pipeline channel north of Bayou Perot, west of Bayou Barataria, east of the GIWW and Site 15. The crest of the plug was constructed to an elevation of +4.0 ft. NGVD. The rock fill plug contains 6,483 tons of rock filled with 1,766 tons of rock rip-rap armor. Two (2) aluminum warning signs are located through the rock plug embankment.

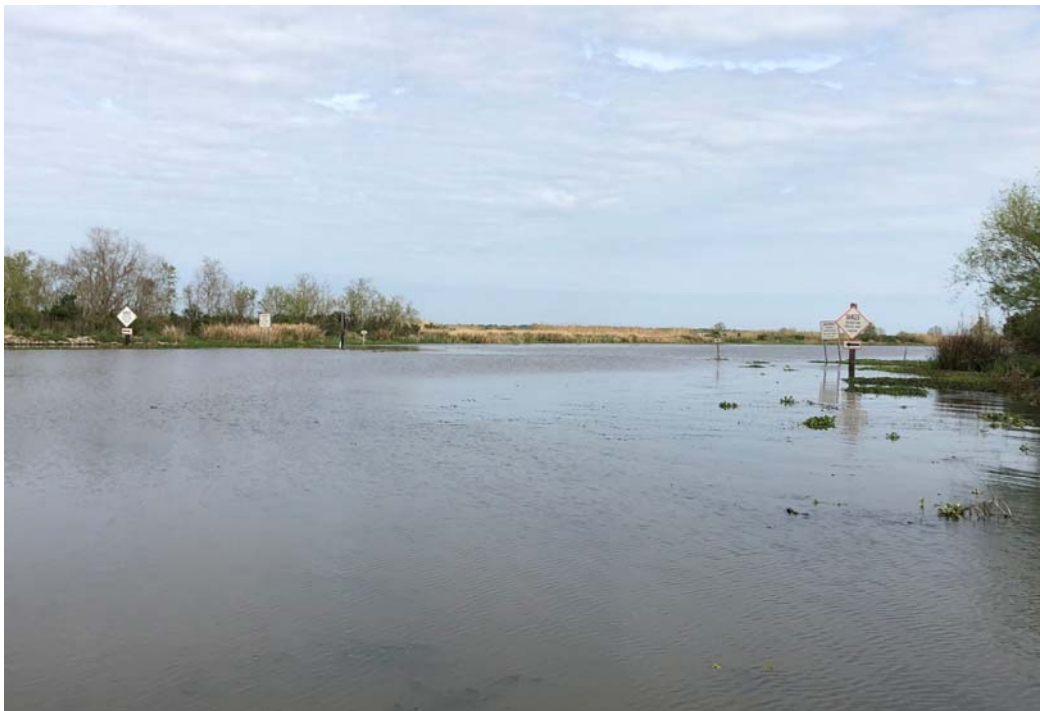
**Photo #5 – Structure #19**

Weir has experienced some settlement, but is performing as designed. Signs and timber supports were generally in good condition. No maintenance will be required at this time.

Item	Condition	Physical Damage	Corrosion	Photo #	Observations and Remarks
Signage and supports	Fair	See remarks	Minor	5	Signage replaced since last inspection; no maintenance needs were identified.
Armored Weir	Good	None	N/A	5	No change since last inspection; no maintenance needs were identified.
<b>Construction Unit No.1</b> Structure Description: 239 linear ft. of rock rip-rap armored rock filled fixed crest weir with a 60 ft. wide boat bay located in a pipeline channel east of the GIWW, north of Bayou Perot, and west of Bayou Barataria. The crest of the weir was constructed to an elevation of +1.9 ft. NGVD on the north side and +2.0 ft. NGVD on the south. The boat bay invert was constructed to an elevation of -2.5 ft. NGVD. The rock-fill plug contains 1,014 tons of rock filled with 572 tons of rock rip-rap armor. Aluminum warning signs are located on each side of the barge bay through the rock embankment.

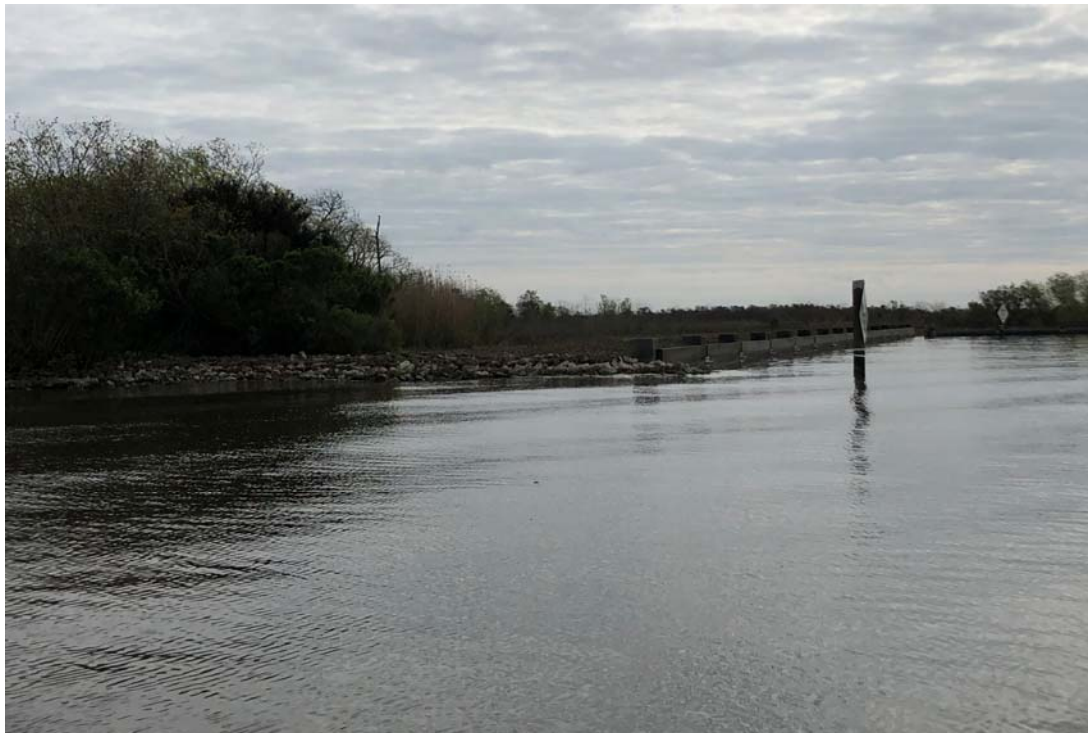
**Photo #6 – Panel Wall Shoreline Protection (CU4)**

No defects in the concrete panel wall sections were noted; the structure appeared to be in good condition. Minor damage/vandalism to some warning signs are noted, as in previous inspections, and one sign was missing, but all other signs and timber supports are in place and performing as designed. No immediate maintenance needs were identified at this construction unit.

Item	Condition	Physical Damage	Corrosion	Photo #	Observations and Remarks
Signage and supports	Good	See remarks	Minor	6	Some fading noted, minor spray-paint vandalism to border of one sign was observed, and one sign was missing. Sign faces and text were legible; no repairs needed at this time.
Concrete wall panels, piles, hardware	Good	None	None	6	No defects noted; structure was performing as designed.
Rock Dike	Good	None	N/A	6	No defects noted; structure was performing as designed.
<b>Construction Unit No.4</b> Structure Description: The wall consists of approx. 12,850 linear ft. of pre-cast concrete wall sections supported by 848 pre-cast concrete piles, in addition to approx. 4,290 linear feet of rock rip-rap bank stabilization/shoreline protection. C.U. #4 extends across the northern edge of Bayou Rigolettes and Bayou Perot, from just east of Structure #12 to Structure #20.

All project features were serving their intended purpose. Monitor signs along concrete panel wall for any additional vandalism or missing signs. Continue to inspect and assess project conditions annually.
