**State of Louisiana
Coastal Protection and Restoration
Authority**

2016 Annual Inspection Report

**BARATARIA LANDBRIDGE
SHORELINE PROTECTION PROJECT
Phase 1, 2, 3 & 4 (Construction Units 1, 2,
3, 4, 5 and 6)**

State Project Number (BA-27), (BA-27c) and (BA-27d)
Priority Project Lists 7, 9 and 11

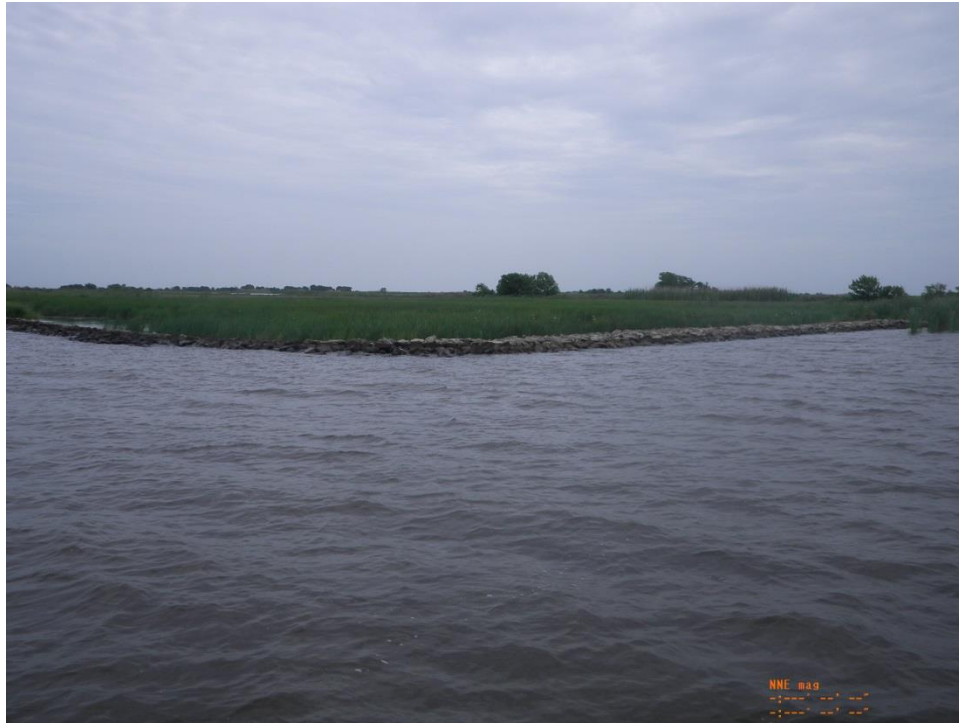
The inspection of CU #3 began on the east bank of Little Lake at Sta. 108+65 and progressed along the northeast bank of Little Lake to the mouth of Bayou Perot at Sta. 0+00. As noted during previous inspections, the rock dike is in good condition with only minor settlement near the BP pipeline crossing near Sta. 67+00. The embankment tie-ins on both ends of the project appear to be in good condition with no obvious erosion or breaching. Overall, the rock revetment (CU #3) is in good condition and marsh behind the structure is very healthy. Despite the settlement that we have observed over the past few years near the BP pipeline, we consider this a minor defect and will not be recommending repairs or maintenance at this time. (Appendix A, Photos 1 through 8)

Photo 1: View of the rock revetment (CU#3) along the east bank of Little Lake near Sta. 106+00

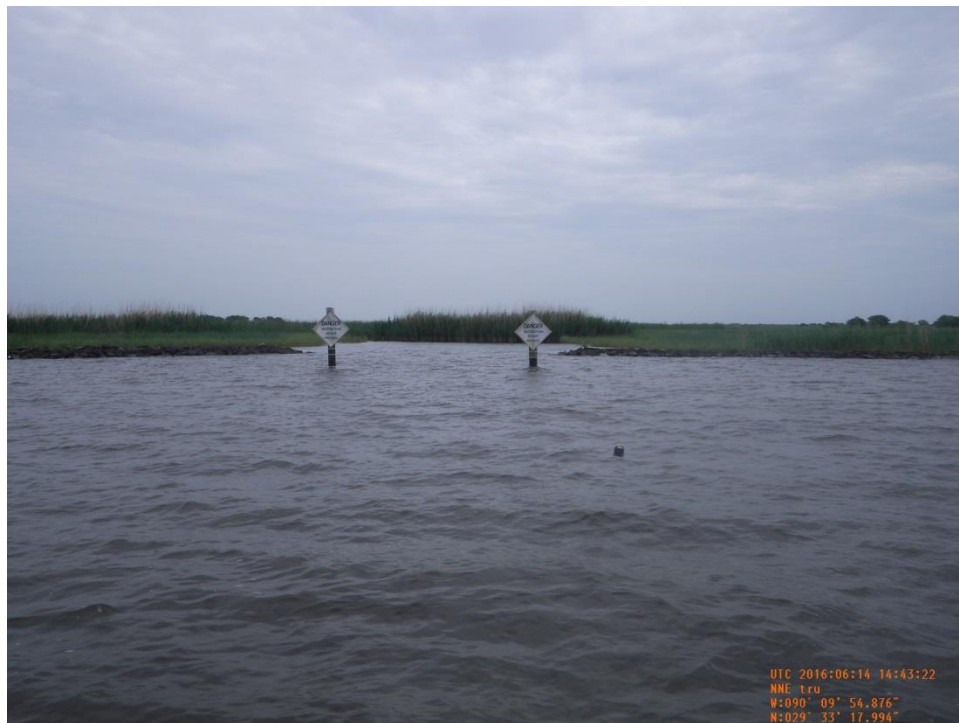
Photo 4: View of fish dip in rock revetment (CU#3) near Sta. 74+00.

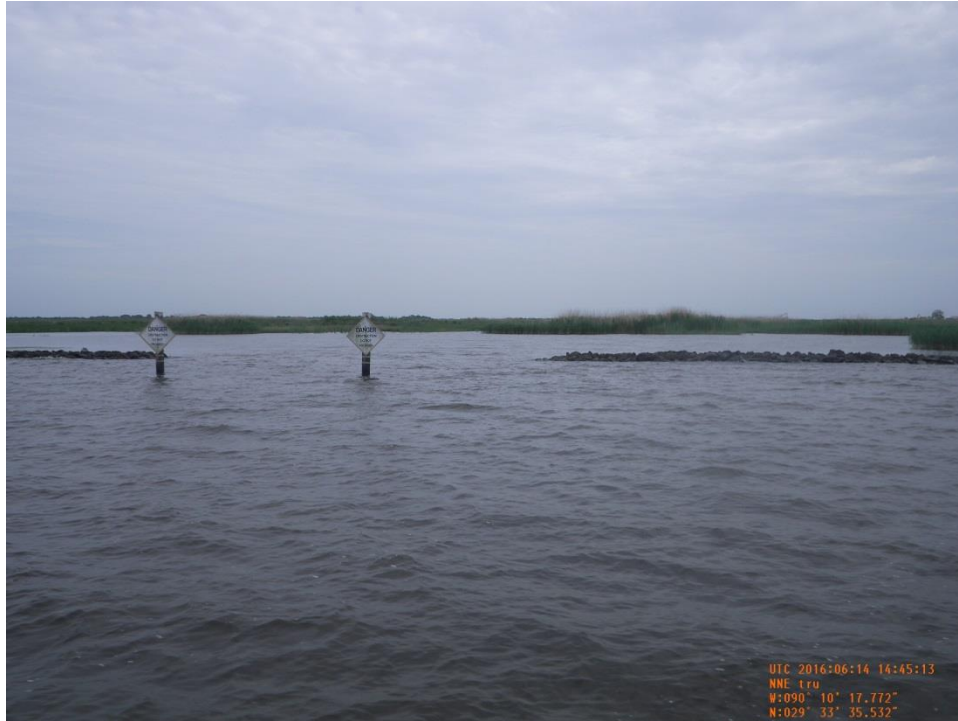
Photo 5: View of fish dip in rock revetment (CU#3) near Sta. 43+00

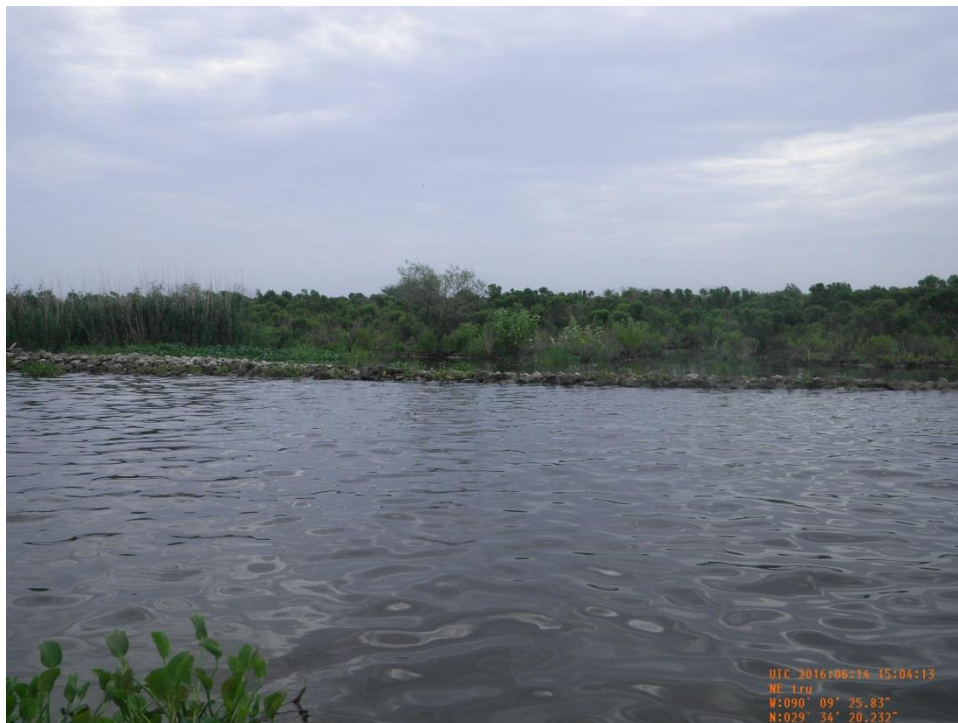
The inspection of CU #2 began at the west end near Sta. 0+42 and proceeded to the east end of the reach near Sta. 36+83. As previously reported, a low area of the rock dike approximately 200 feet wide exists from Sta. 31+50 to Sta. 29+50. We have been monitoring this area for several years now and have not noticed any further settlement or erosion of the marsh behind the structure. Also previously reported was a slight dip in the rock dike above the Exxon/Humble pipeline right-of-way located near Sta. 12+33. Again, there is no indication of further settlement of the rock dike or deterioration of the containment dike directly behind it. Since there is no noticeable change in the condition of the rock dike or the marsh behind the structure at these two (2) locations, we are not recommending corrective actions at this time. (Appendix A, Photos 15 through 22)

Photo 16: CU#2 Low section along rock revetment neat Sta. 1+00.

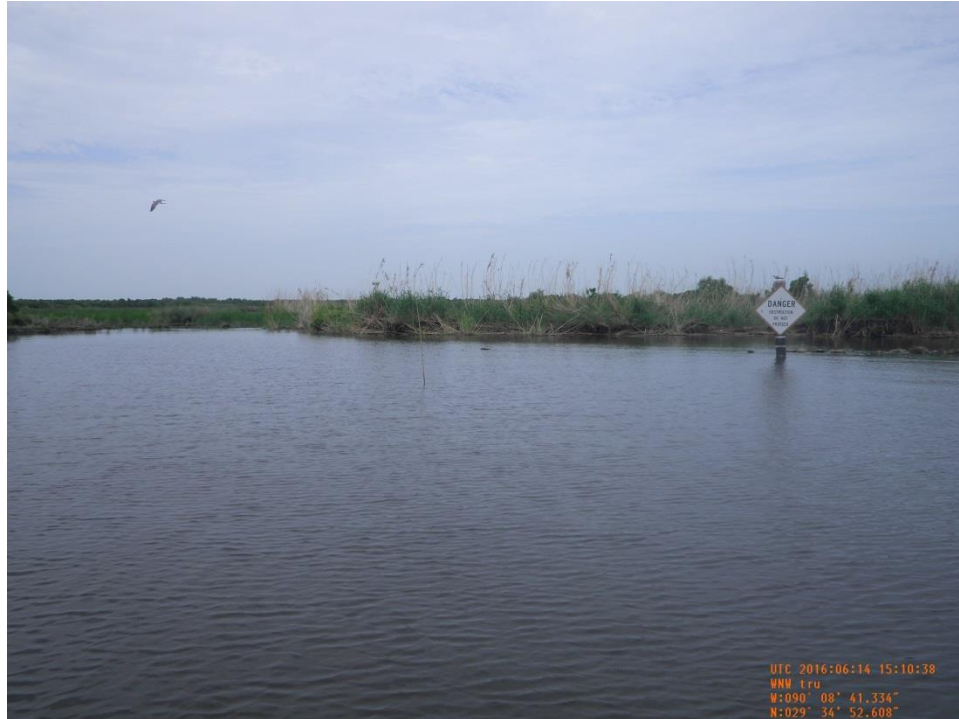
Photo 21: View of low area along rock dike of CU#2 near Sta. 30+00.

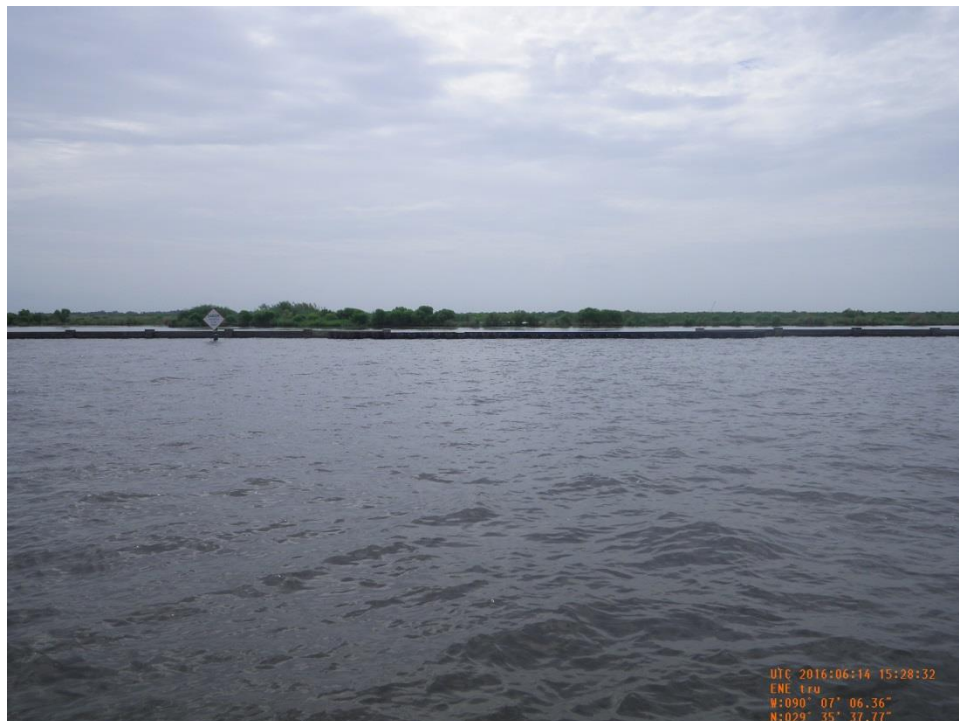
Photo 32: Steel sheet pile wall installed by subcontractor after concrete panels

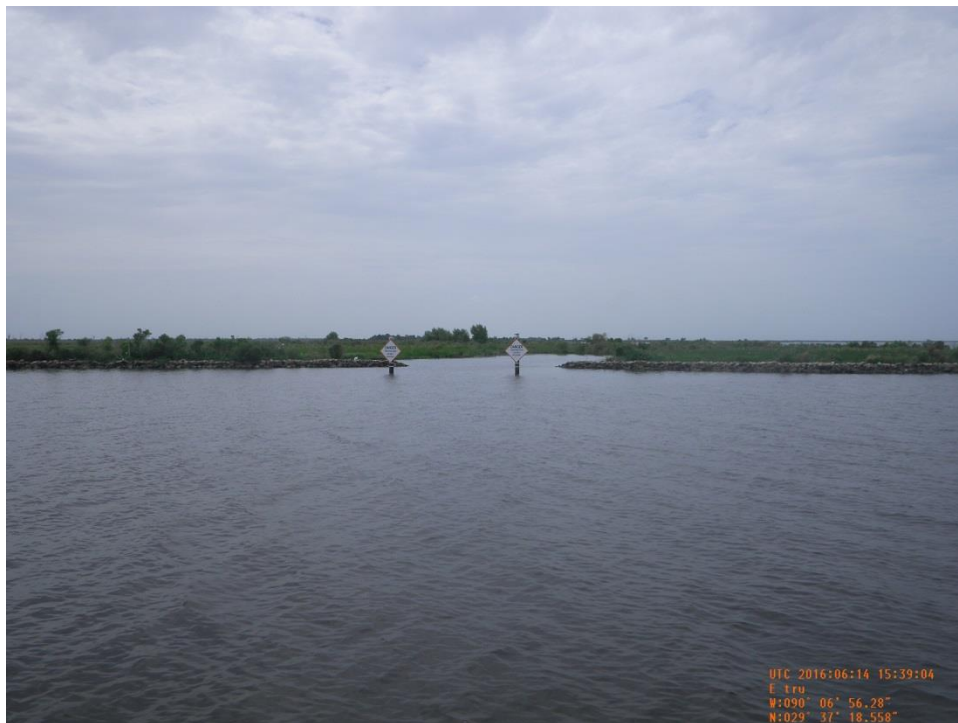
Photo 36: CU#6 view of fish dip and warning signs near Sta. 40+80.

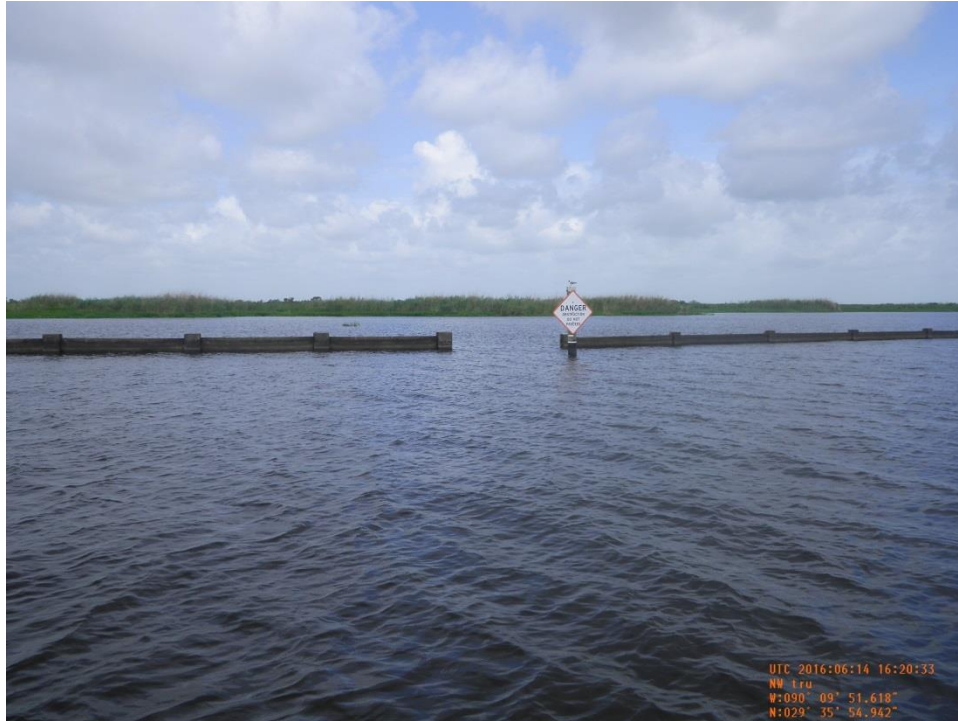
shoreline to the southernmost point of CU #5 at an existing canal. Overall, CU #5 is in good condition with only one (1) concrete panel that had slipped from the channel guide and was positioned lower on one side near the intersection of wall 5 and 6a. The rock to concrete panels and earthen embankments tie-ins were in very good condition with no obvious washouts or erosion. We will continue to monitor the condition of the concrete panel that has slipped from its guide channel and recommend repairs if the condition worsens. There are no recommendations for maintenance of CU #5 at this time. (Appendix A, Photos 48 through 53)

Photo 51: CU#5 view of gap in concrete wall between wall 5 and 6A.
