**2017 Annual Inspection Report**

**BARATARIA LANDBRIDGE  
SHORELINE PROTECTION PROJECT  
Phase 1, 2, 3 & 4 (Construction Units 1, 2,  
3, 4, 5, 6, 7 & 8)**

State Project Number (BA-27), (BA-27c) and (BA-27d)  
Priority Project Lists 7, 9 and 11

September 7, 2017  
Lafourche and Jefferson Parishes

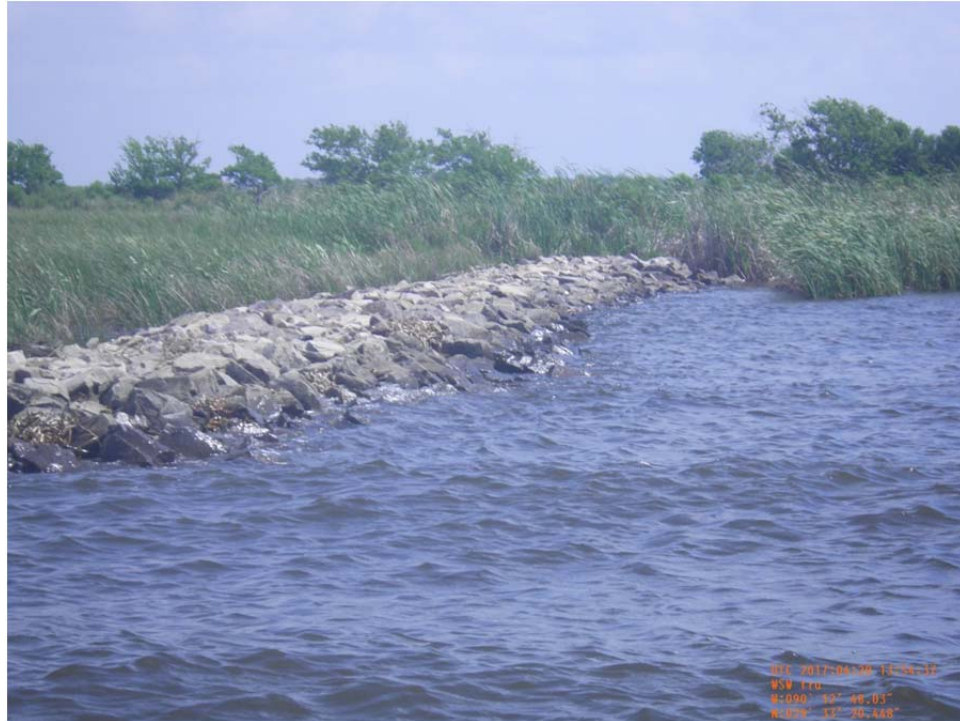
Photo No.1 – view of rock revetment to bank tie-in on southern end of CU#3 near Sta. 108+65.

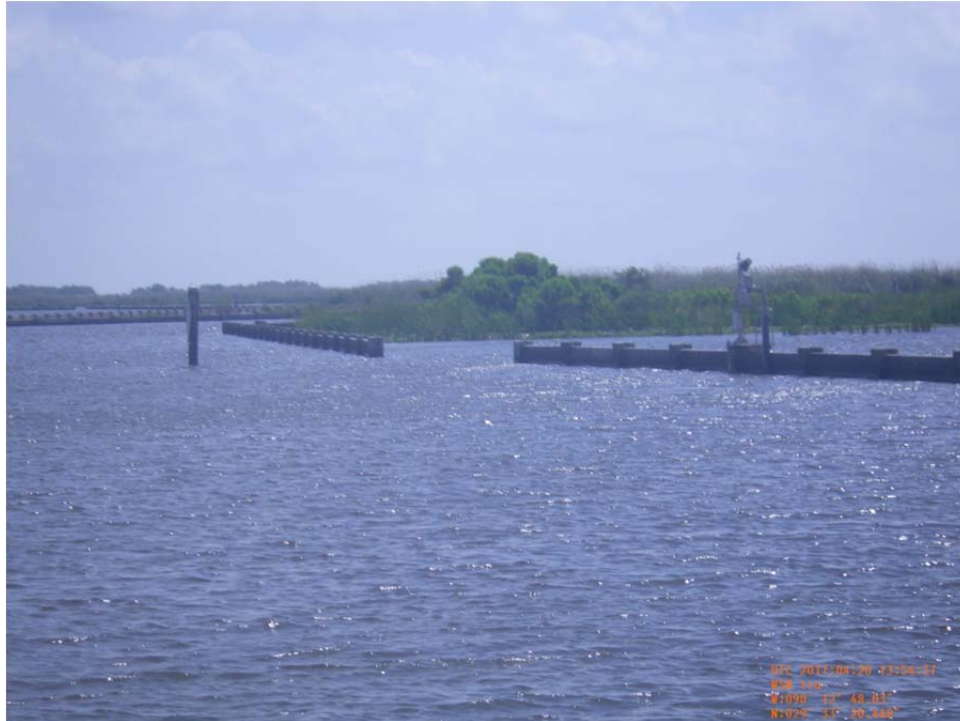
Photo No.7 – view of the concrete pile wall (CU#4) along the south bank of Bayou Perot connecting to Little Lake.

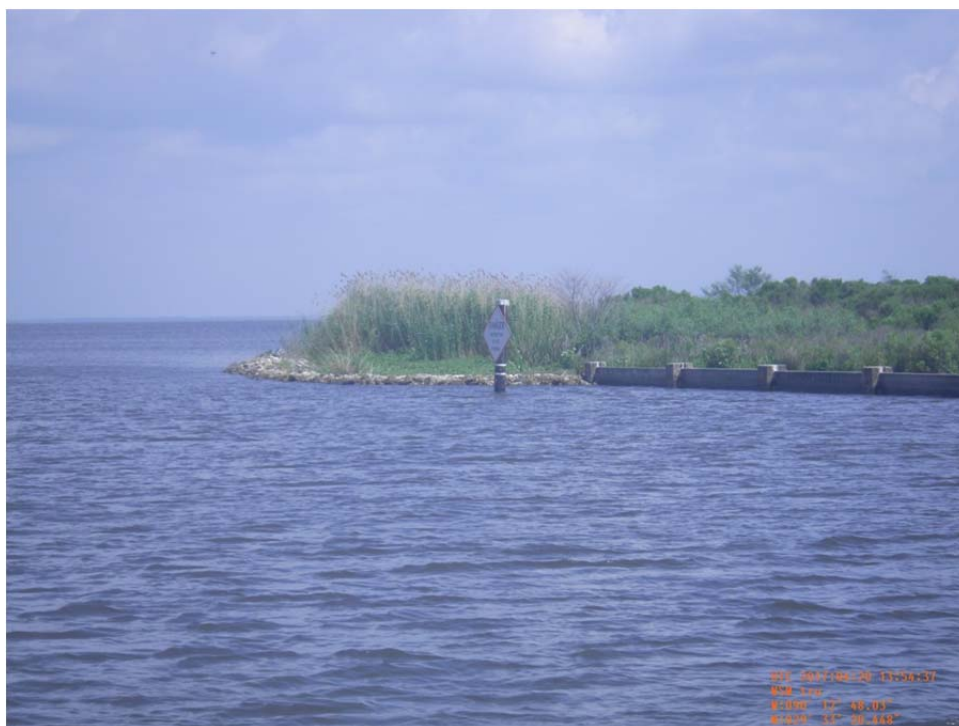
Photo No.12 – view of Concrete Wall (Reach 3) along the south bank of Bayou Perot at CU#2.

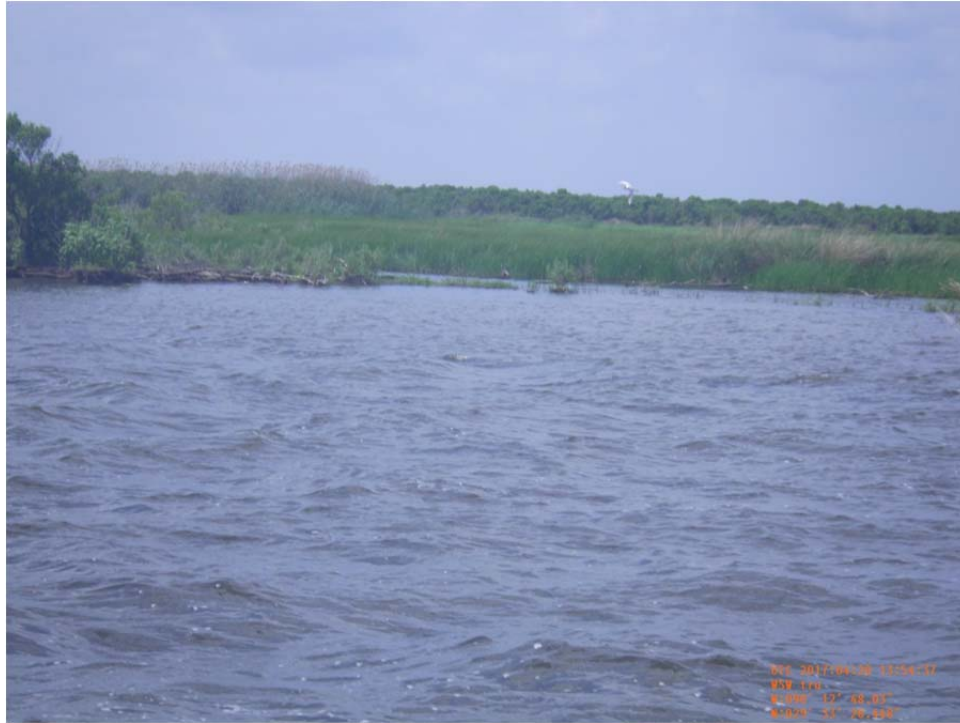
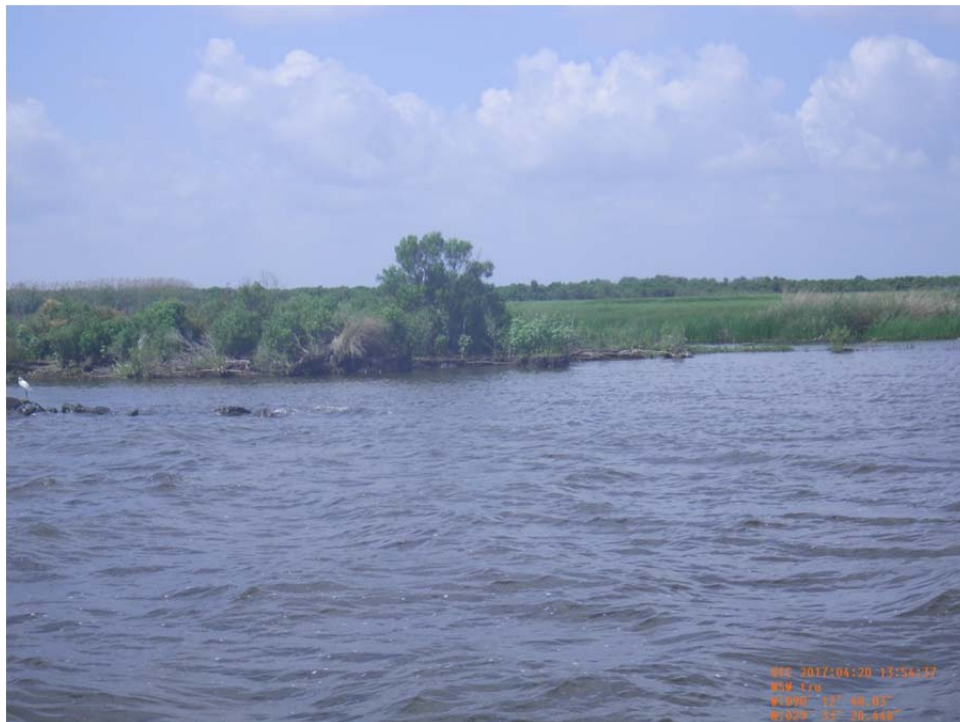
The inspection of CU #2 began at the west end near Sta. 0+42 and proceeded to the east end of the reach near Sta. 36+83. As previously reported, a low area of the rock dike approximately 200 feet wide exists from Sta. 31+50 to Sta. 29+50. We have been monitoring this area for several years now and have not noticed any further settlement or erosion of the marsh behind the structure. Also previously reported was a slight dip in the rock dike above the Exxon/Humble pipeline right-of-way located near Sta. 12+33. Again, there is no indication of further settlement of the rock dike or deterioration of the containment dike directly behind it. (Appendix A, Photos 13 through 22)

Photo No. 19 – view of low area along rock revetment (CU#2 – East Site) around Sta. 30+00 near the Harvey Cutoff Canal.

Photo No. 20 – view of low area along rock revetment (CU#2 – East Site) around Sta. 30+00 near the Harvey Cutoff Canal.

Overall, the Barataria Landbridge Shoreline Protection Project (BA-27, BA-27c, and BA-27d) was in good condition with only minor deficiencies in isolated locations. These deficiencies included a low area approximately 200 ft. wide in the rock dike along CU #2 near Sta. 30+00 at the Harvey Cutoff Canal, a single warning sign down from broken timber support on CU #4, a concrete panel that had slipped from its guide channel along CU #5, and a 300 ft. wide section along Revetment 2 of CU #7&8 near Sta. 39+00 that has settled below the water surface. Although these defects are not considered serious, we will coordinate with NRCS to come up with a work plan that is economically feasible for addressing the items described above.

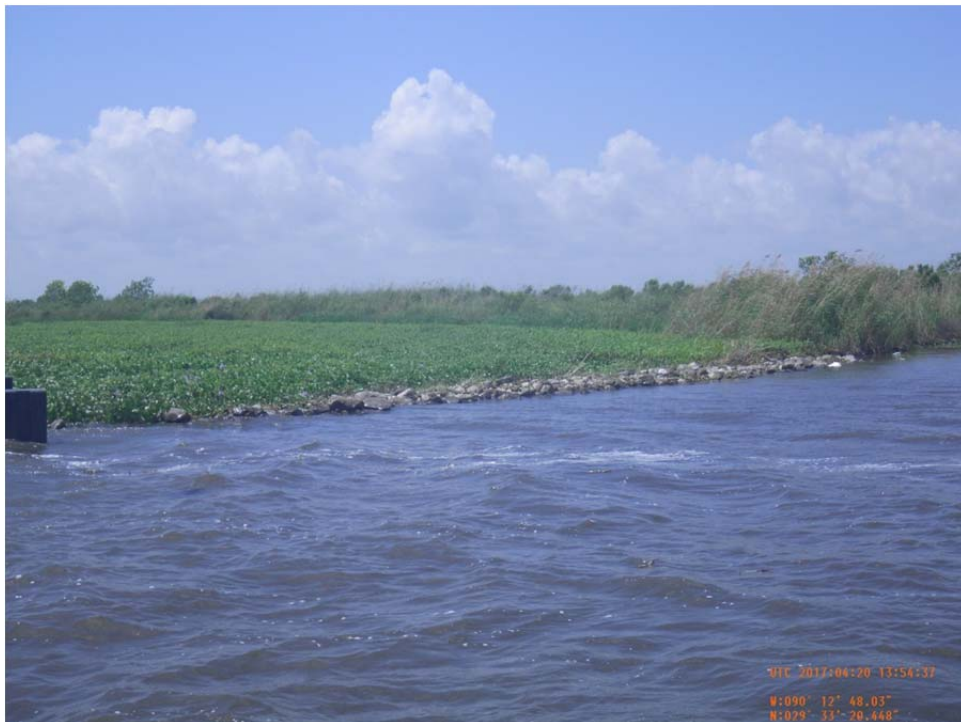
The inspection of Construction Unit #5 began at the northernmost point of CU #5 on the west bank of Bayou Perot near the Enbridge Pipeline Canal and progressed southward along the shoreline to the southernmost point of CU #5 at an existing canal. Overall, CU #5 is in good condition with only one (1) concrete panel that had slipped from the channel guide and was positioned lower on one side near the intersection of wall 5 and 6a. The rock to concrete panels and earthen embankments tie-ins were in very good condition with no obvious washouts or erosion. We will continue to monitor the condition of the concrete panel that has slipped from its guide channel and recommend repairs if the condition worsens. (Appendix A, Photos 43 through 46)

Photo No. 43 – view of rock dike tie-in from Concrete Wall (CU#5) to existing shoreline along the west bank of Bayou Perot near Sta. 4+50.

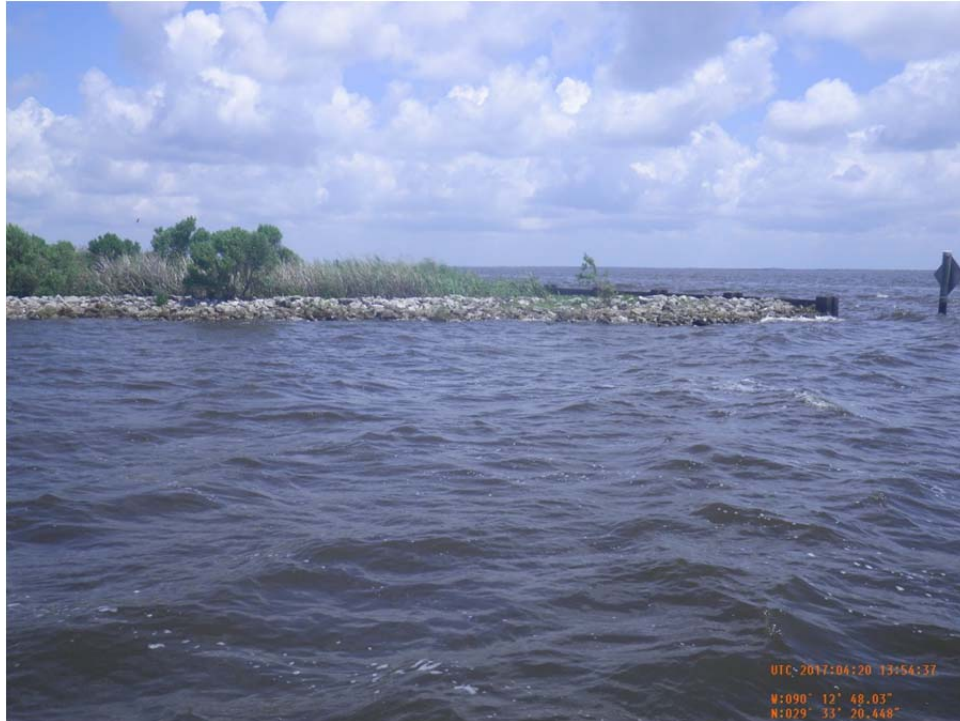
Photo No. 46 – view of rock dike tie-in from Concrete Wall (CU#5) to existing shoreline along the west bank of Bayou Perot near Sta. 0+50.

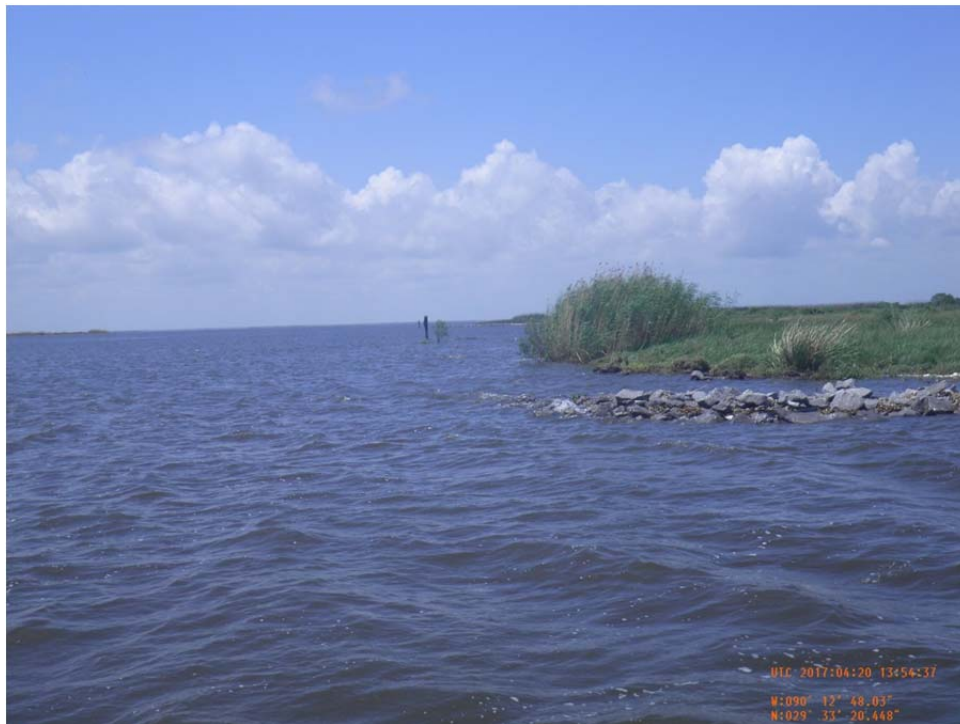
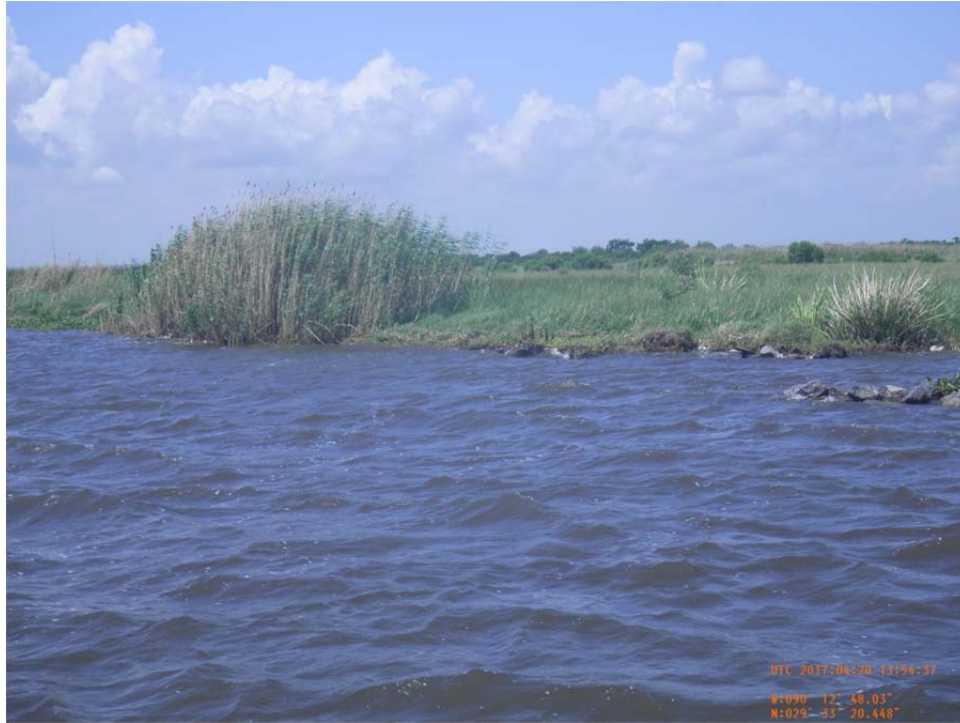
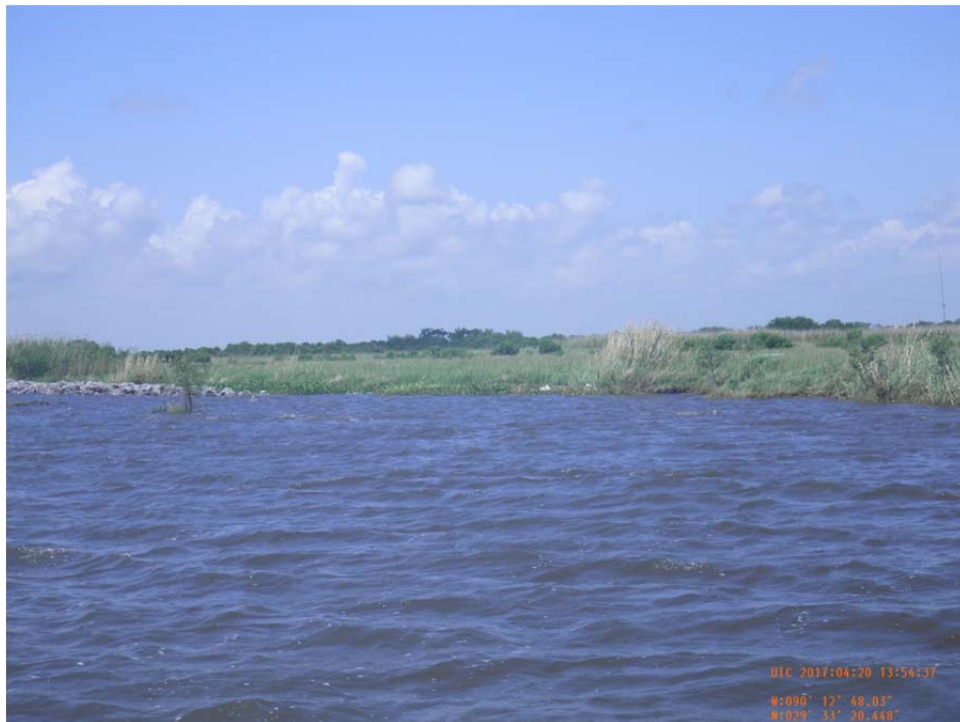
The inspection of Construction Unit #7 & #8 began at Sta. 19+31 of Revetment 6, along the western bank of Bayou Perot near an existing access canal near the beginning of CU#5, and proceeded along the west bank of Bayou Perot southward covering Revetments 6, 5, 4, and 3; then around to the northern bank of Little Lake along Revetment 2 and 1 and the rock dike. Overall, the rock revetments (1 through 6) and the rock dike appeared to be in good condition with only one section along Revetment 2 that had settled immediately following construction. This section appears to be approximately 300 ft. long near Sta. 39+00 with the crest below the water line. All the bank tie-ins at each end of the revetments were in stable condition with no obvious washouts. The signs, supports and navigation aids were also in good condition (Appendix A, Photos 47 through 63)

Photo No. 55 - view of low area of the rock revetment along CU # 7&8 (Revetment #2) near Sta. 40+90.

Photo No. 56 - view of low area of the rock revetment along CU # 7&8 (Revetment #2) near Sta. 40+90.

Photo No. 57 - view of low area of the rock revetment along CU # 7&8 (Revetment #2) between Sta. 37+97 and Sta. 40+90.
