**State of Louisiana  
Coastal Protection and Restoration  
Authority**

**2015 Annual Inspection Report**

**BARATARIA LANDBRIDGE  
SHORELINE PROTECTION PROJECT  
Phase 1, 2, 3 & 4 (Construction Units 1, 2,  
3, 4, 5 and 6)**

State Project Number (BA-27), (BA-27c) and (BA-27d)  
Priority Project Lists 7, 9 and 11

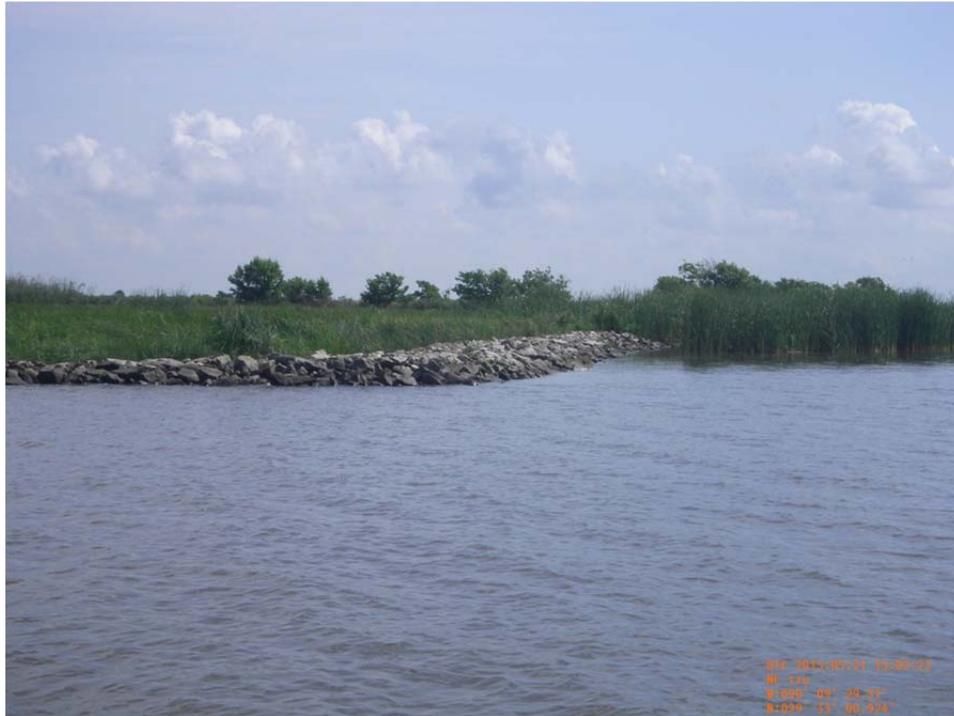
The inspection of CU #3 began on the east bank of Little Lake at Sta. 108+65 and progressed along the northeast bank of Little Lake to the mouth of Bayou Perot at Sta. 0+00. As noted during previous inspections, the rock dike is in good condition with only minor settlement near the BP pipeline crossing near Sta. 67+00. The embankment tie-ins on both ends of the project appear to be in good condition with no obvious erosion or breaching. Overall, the rock revetment (CU #3) is in good condition and marsh behind the structure is very healthy. Despite the settlement that we have observed over the past few years near the BP pipeline, we consider this a minor defect and will not be recommending repairs or maintenance at this time. (Appendix A, Photos 1 through 8)

Photo 1: View of the rock revetment (CU#3) along the east bank of Little Lake near Sta. 106+00

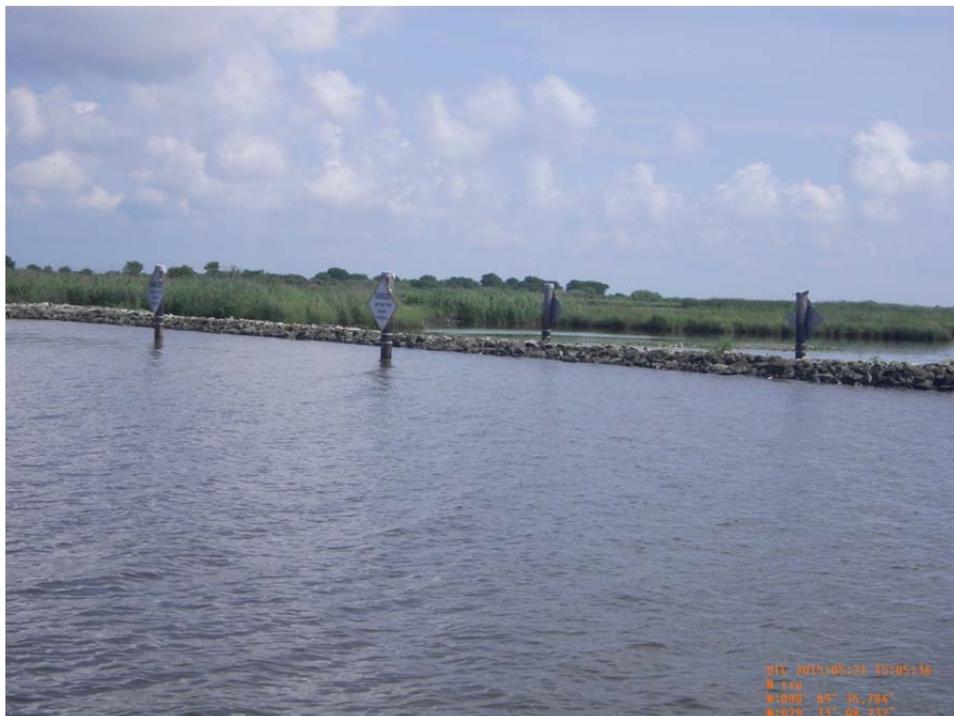
Photo 2: View of rock revetment (CU#3) crossing the opening in the marsh near Sta. 96+00.

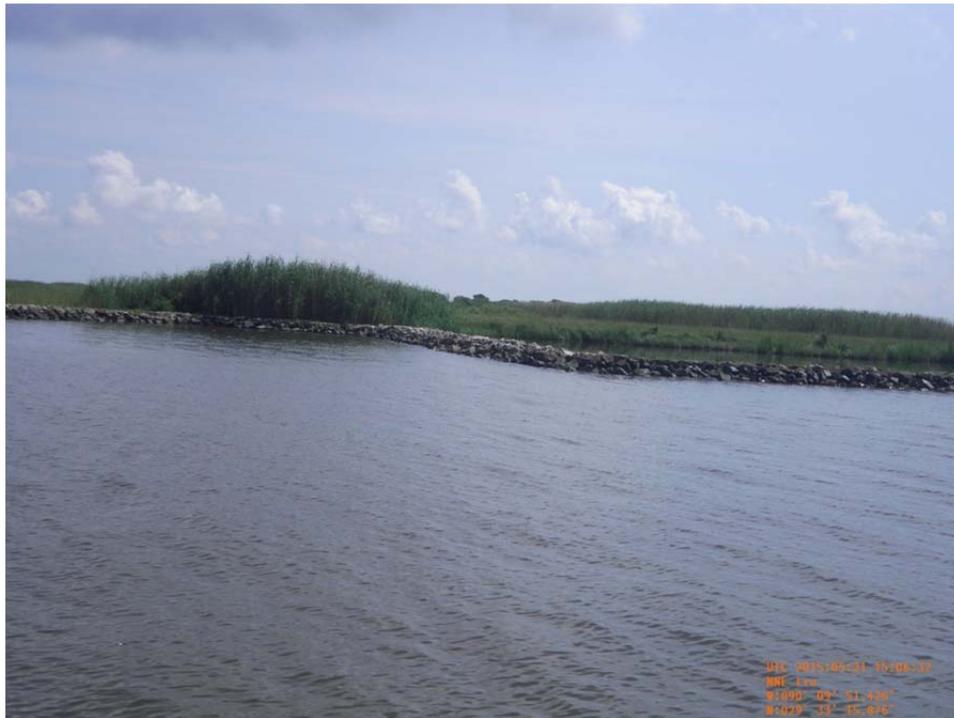
Photo 3: View of rock revetment (CU#3) along east shoreline of Little Lake near Sta. 95+00.

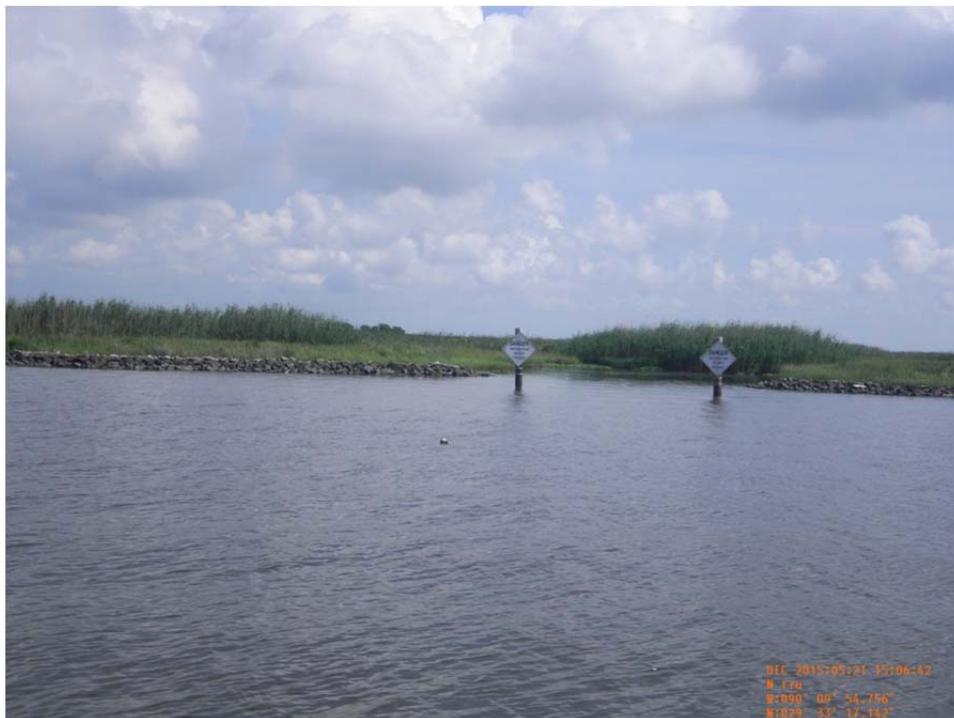
Photo 4: View of fish dip in rock revetment (CU#3) near Sta. 74+00.

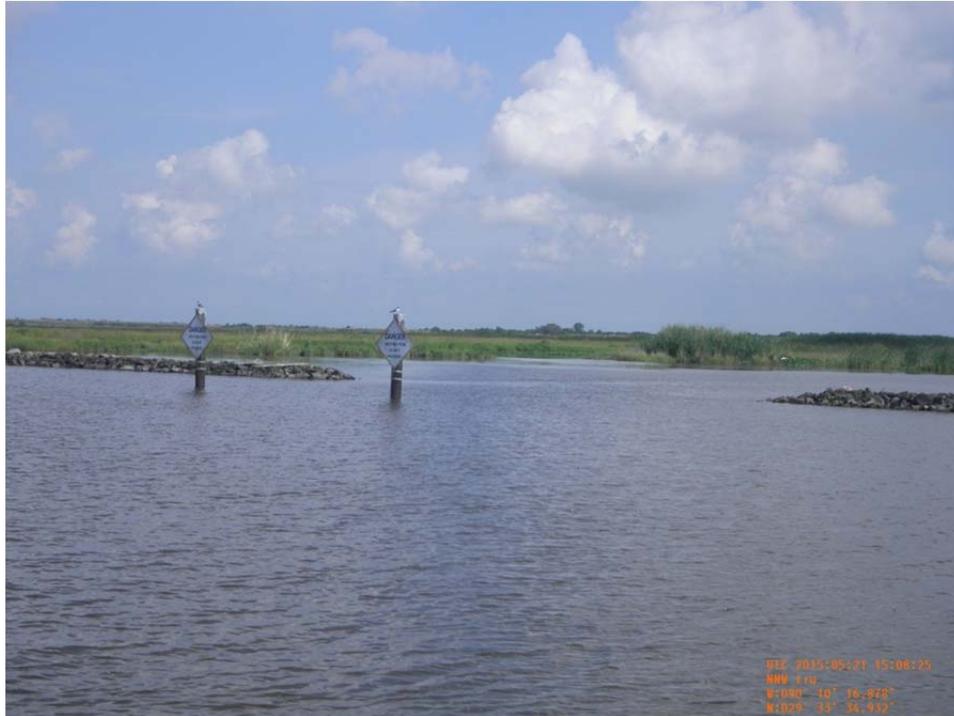
Photo 5: View of fish dip in rock revetment (CU#3) near Sta. 43+00

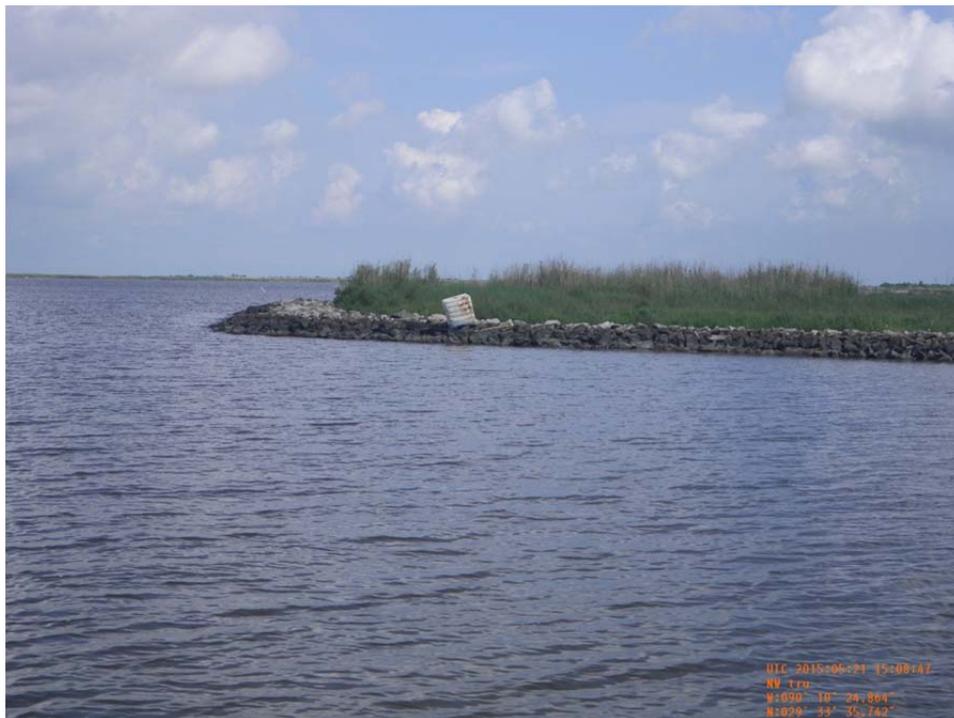
Photo 6: View of rock revetment (CU#3) along east bank of Little Lake near Sta. 35+00.

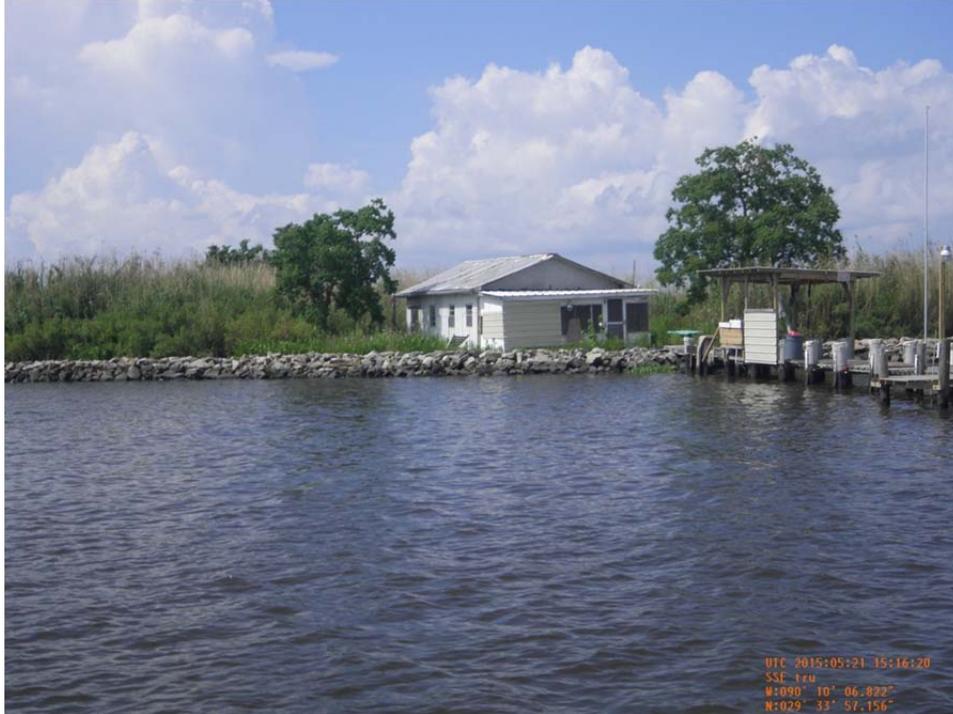
Photo 7: View of rock revetment (CU#3) on east side of camp near Sta. 01+00.

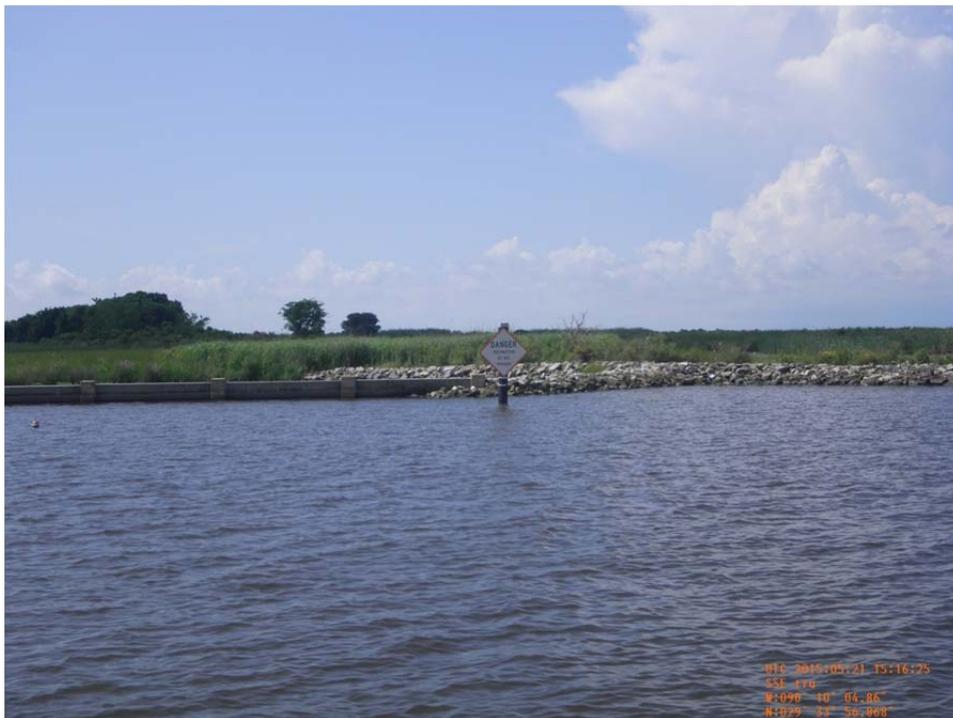
Photo 8: View of the end of CU#3 rock revetment along south bank of Bayou Rigolettes near Sta. 0+00.

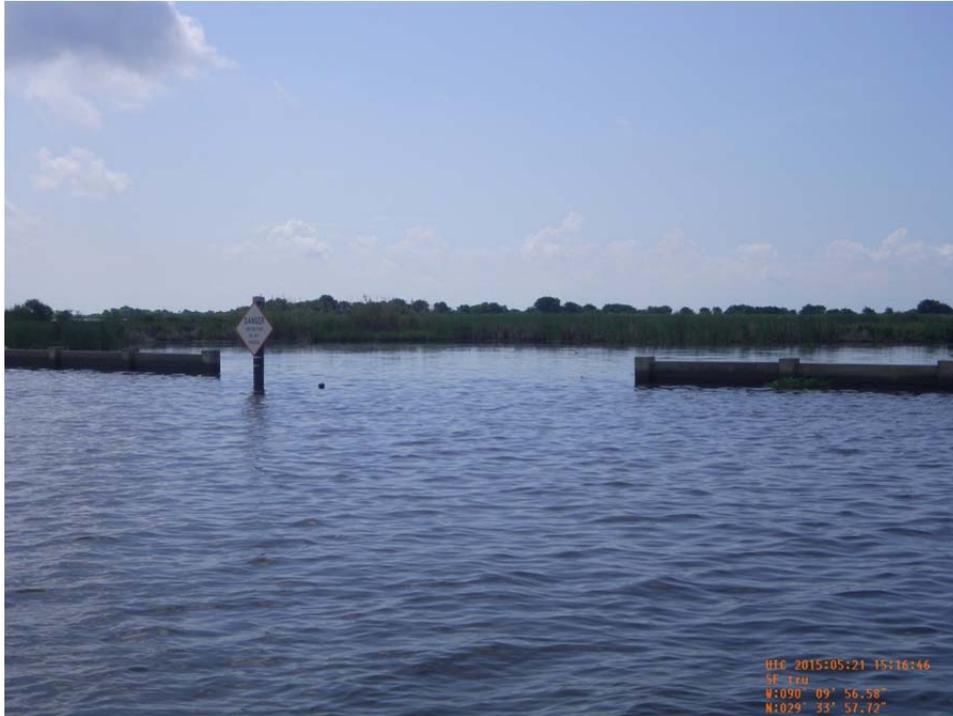
The inspection of CU #4 began with the concrete pile and wall structure of Reach 3 located between CU #2 and CU #3. From there the inspection continued along the south bank of Bayou Rigolettes and the west bank of Harvey Cutoff at Reach 2. The inspection of CU #4 concluded as we traveled north from the east bank of Harvey Cutoff and the east bank of Bayou Rigolettes along Reach 1. All of the transitions from rock riprap to concrete wall were in good condition. The rock riprap embankment tie-ins were also in good condition. A warning sign and support marking the concrete pile on the west side of the oilfield canal in Reach 3 is missing. Due to the extremely high cost for mobilizing equipment to repair a single timber piling and sign, we are recommending that reflective tape be placed directly on the concrete pile and pile wall in this location to notify boaters of impending danger until a new pile and sign can be installed. CPRA shall install the reflective tape during our next site visit. (Appendix A, Photos 9 through 12, and 21 through 29)

Photo 9: CU#4 Concrete wall along south bank of Bayou Perot.

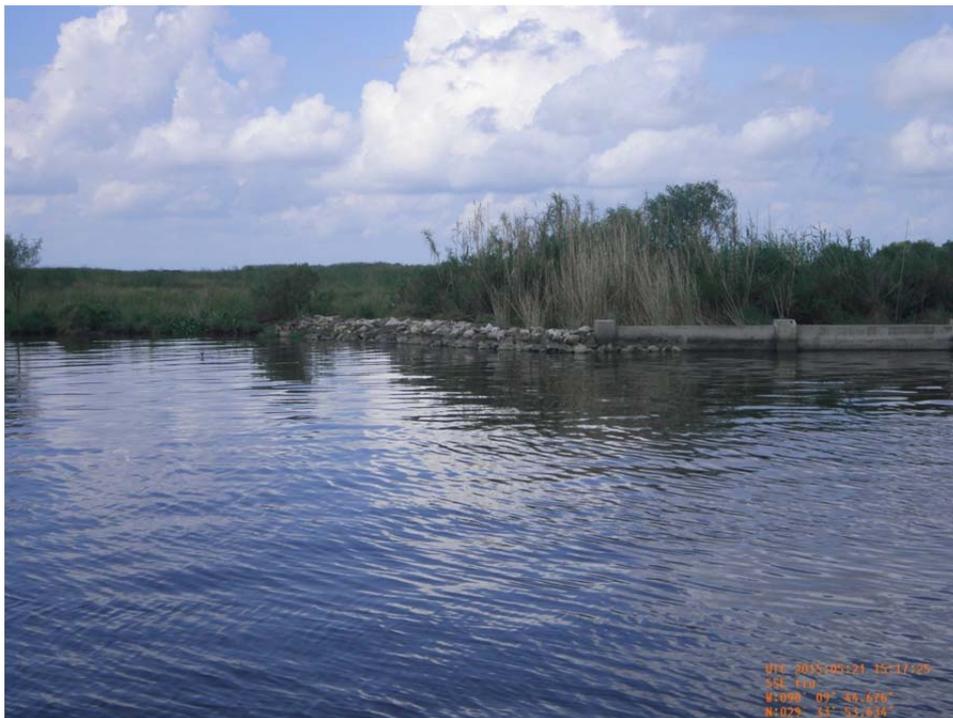
Photo 10: CU#4 Rock revetment closure along south bank of unnamed canal.

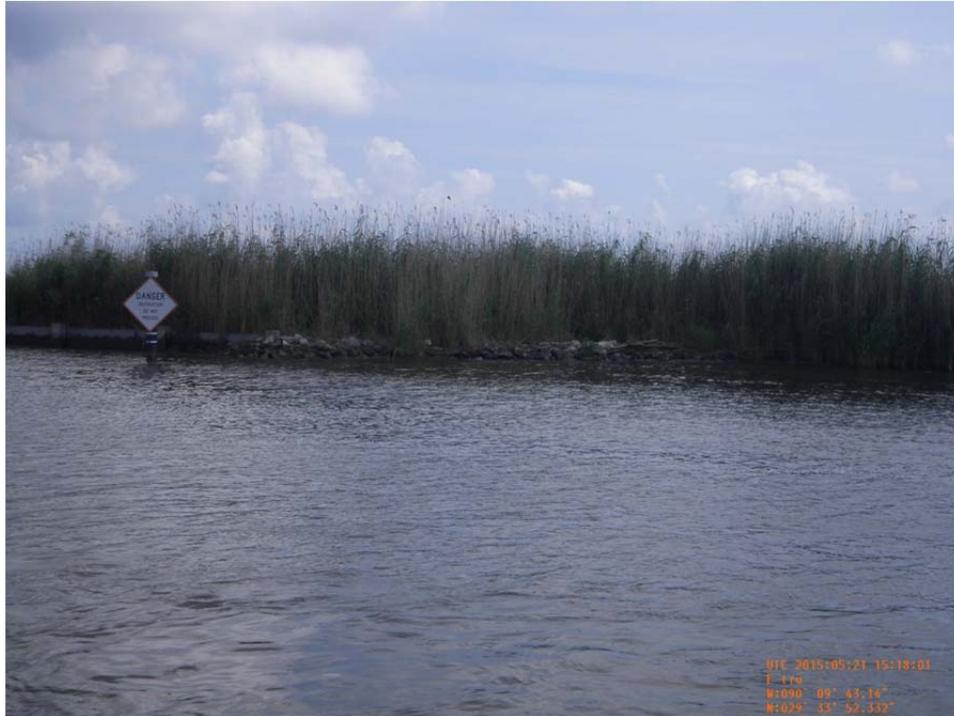
Photo 11: CU#4 Rock revetment closure along north bank of unnamed canal.

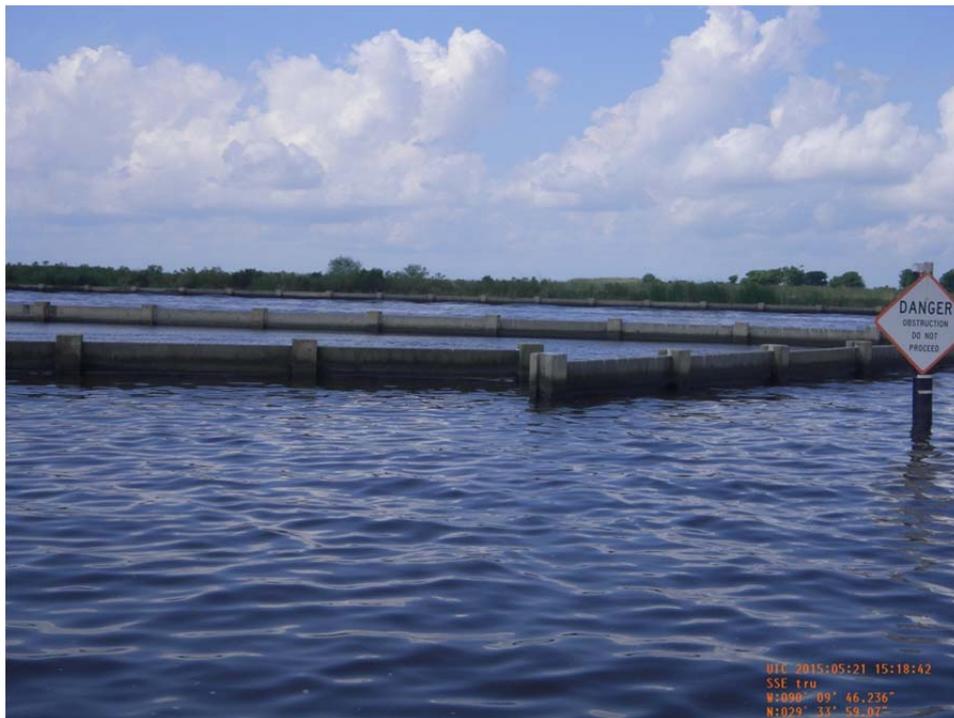
Photo 12: CU#4 Concrete wall near the entrance to unnamed canal.

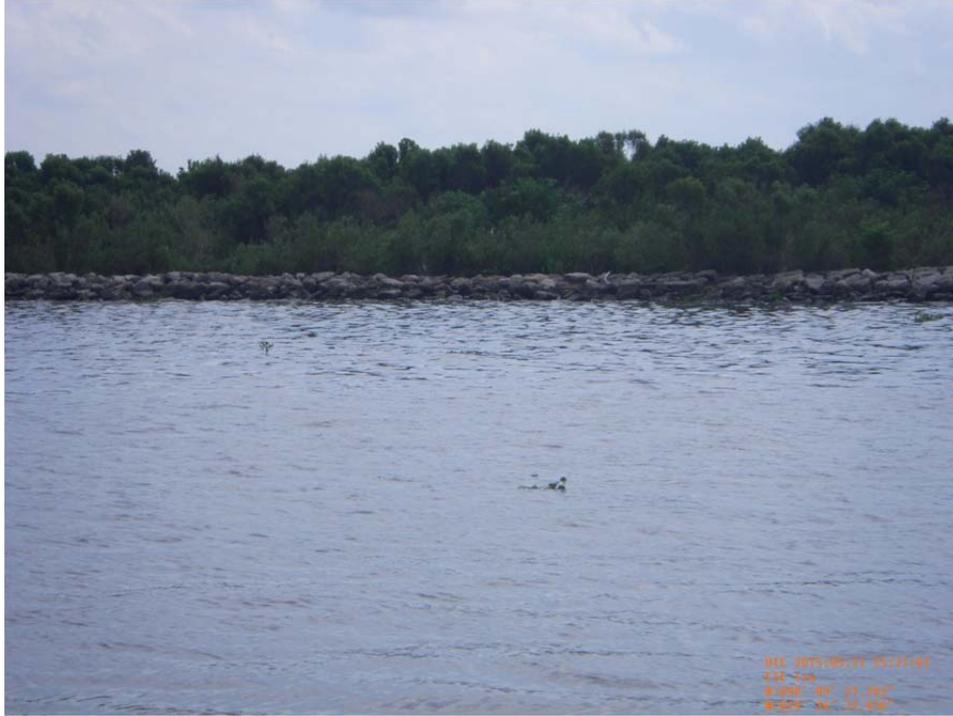
The inspection of CU #2 began at the west end near Sta. 0+42 and proceeded to the east end of the reach near Sta. 36+83. As previously reported, a low area of the rock dike approximately 200 feet wide exists from Sta. 31+50 to Sta. 29+50. We have been monitoring this area for several years now and have not noticed any further settlement or erosion of the marsh behind the structure. Also previously reported was a slight dip in the rock dike above the Exxon/Humble pipeline right-of-way located near Sta. 12+33. Again, there is no indication of further settlement of the rock dike or deterioration of the containment dike directly behind it. Since there is no noticeable change in the condition of the rock dike or the marsh behind the structure at these two (2) locations, we are not recommending corrective actions at this time. (Appendix A, Photos 13 through 20)

Photo 13: Rock revetment (CU#2 – west side) along south bank of Bayou Rigolettes near Sta. 12+00.

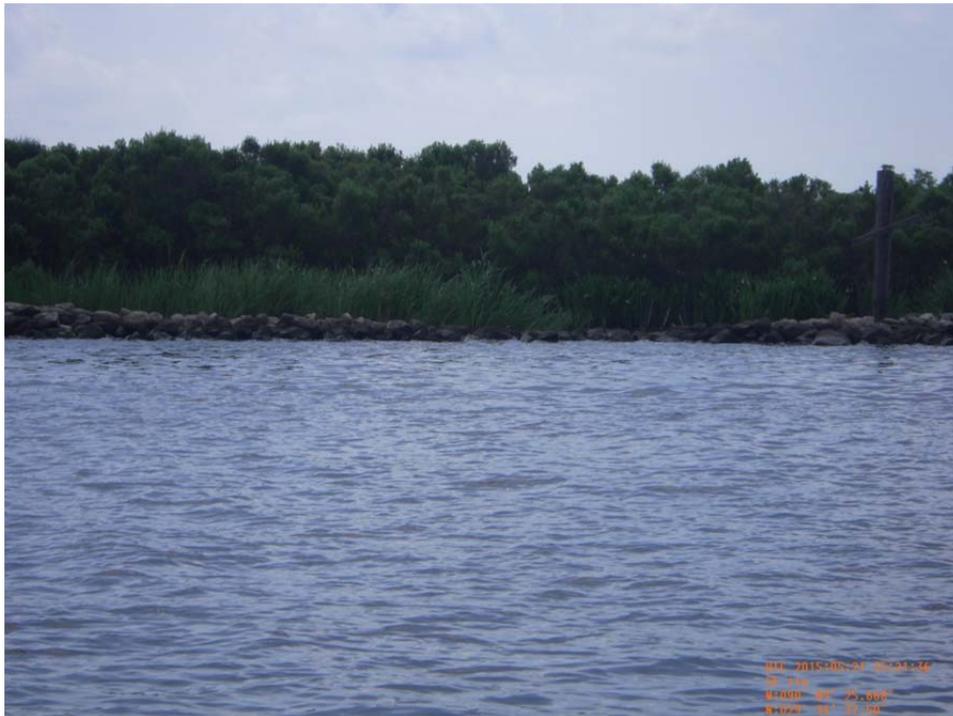
Photo 14: Rock revetment (CU#2 – west side) near Chevron pipeline along south bank of Bayou Rigolettes near Sta. 17+00.

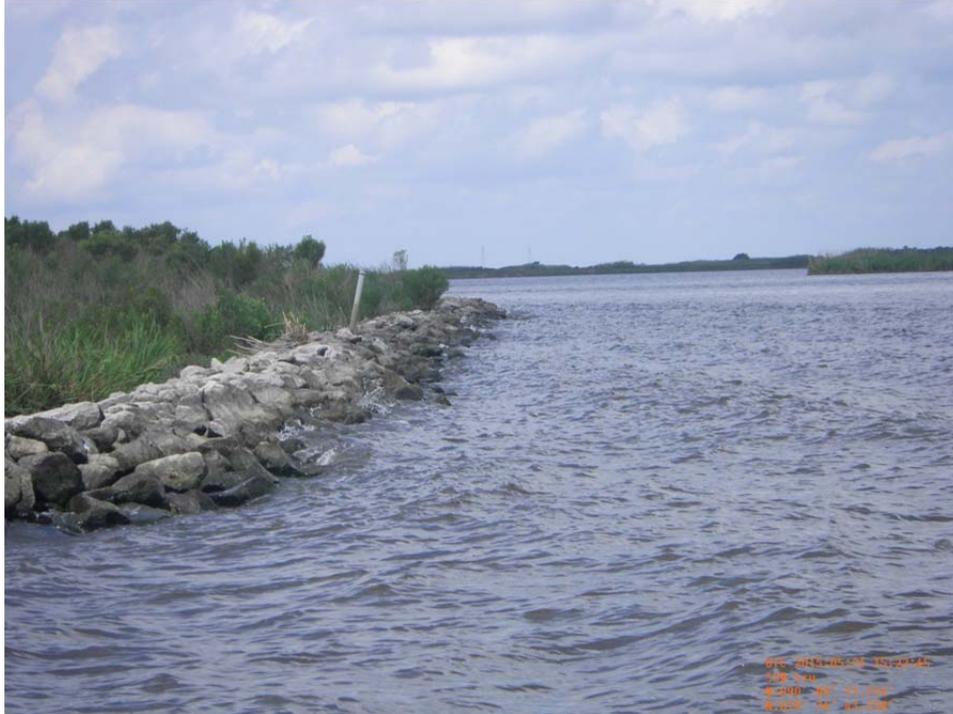
Photo 15: Rock revetment (CU#2 – east side) along south bank of Bayou Rigolettes near mouth of unnamed canal at Sta. 3+00.

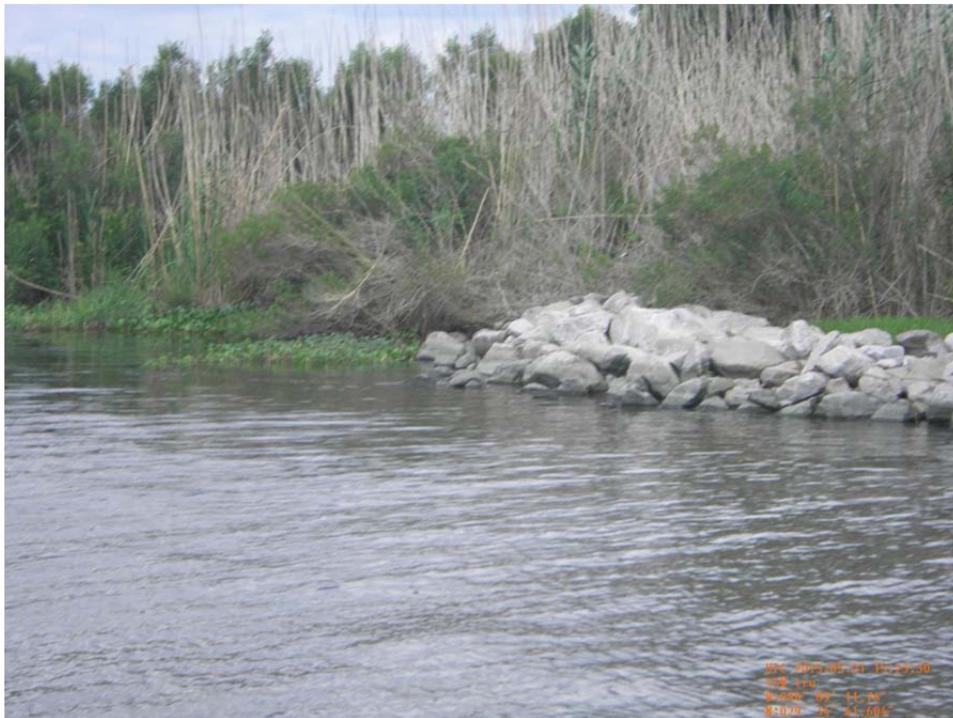
Photo 16: Rock revetment (CU#2- west side) tie-into bank on the west side of unnamed canal near Sta. 26+70.

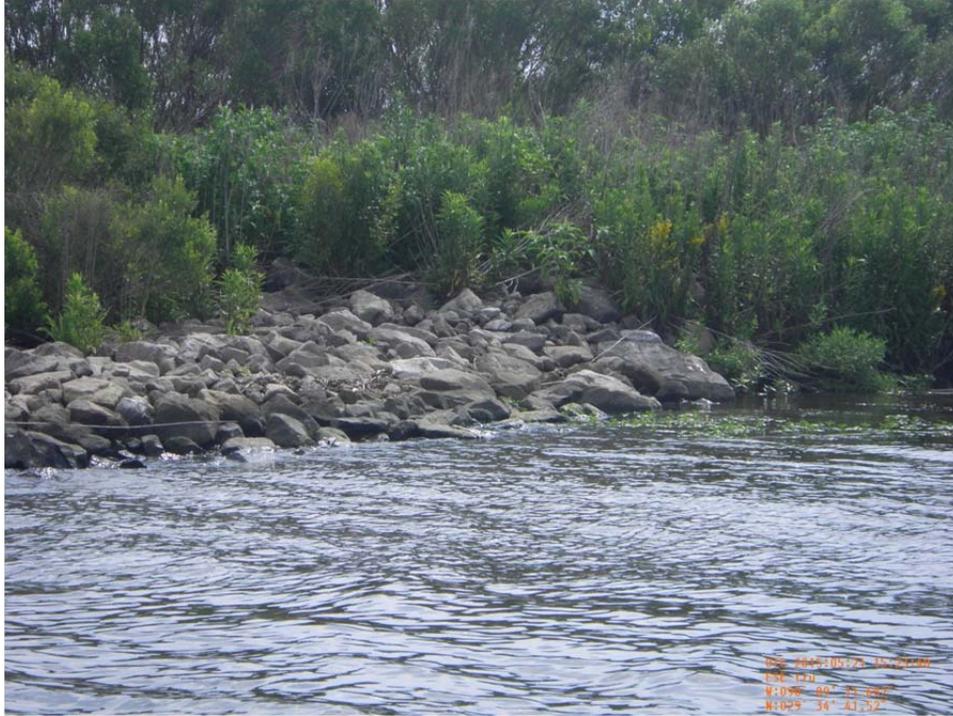
Photo 17: Rock revetment (CU#2- east side) tie-in to the east side of unnamed canal near Sta. 0+00.

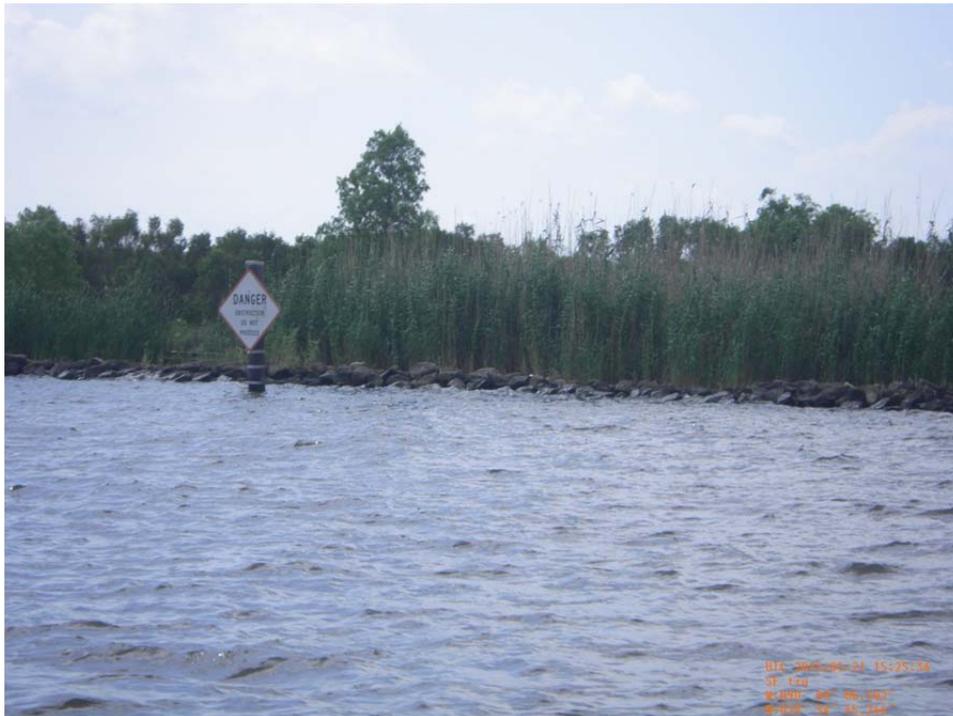
Photo 18: Rock revetment (CU#2-east side) near Sta. 8+00.

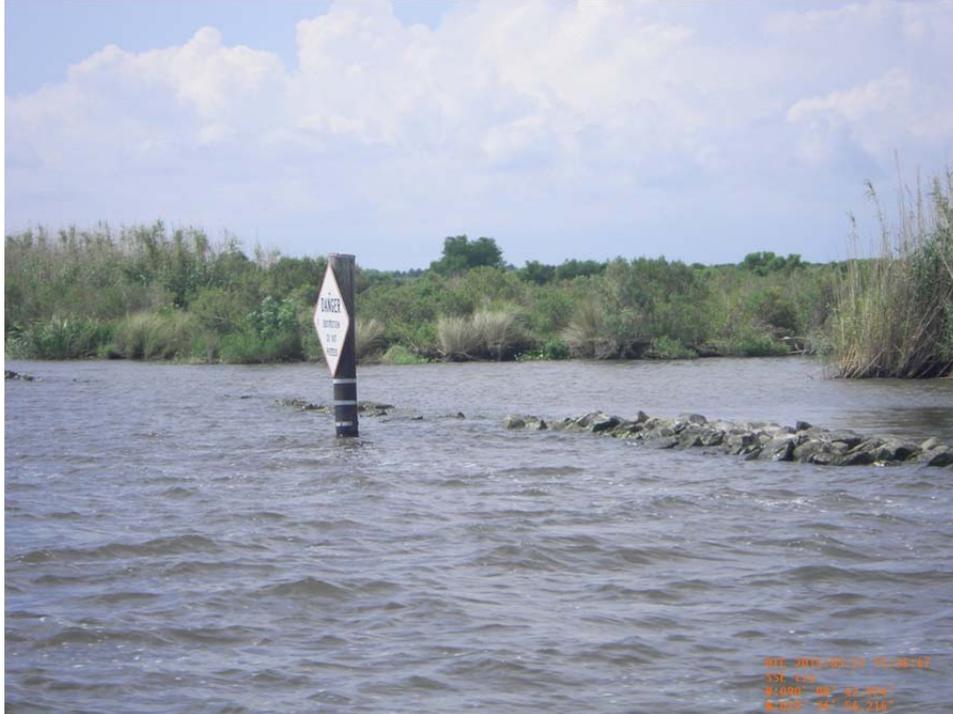
Photo 19: View of low area along rock dike of CU#2 near Sta. 30+00.

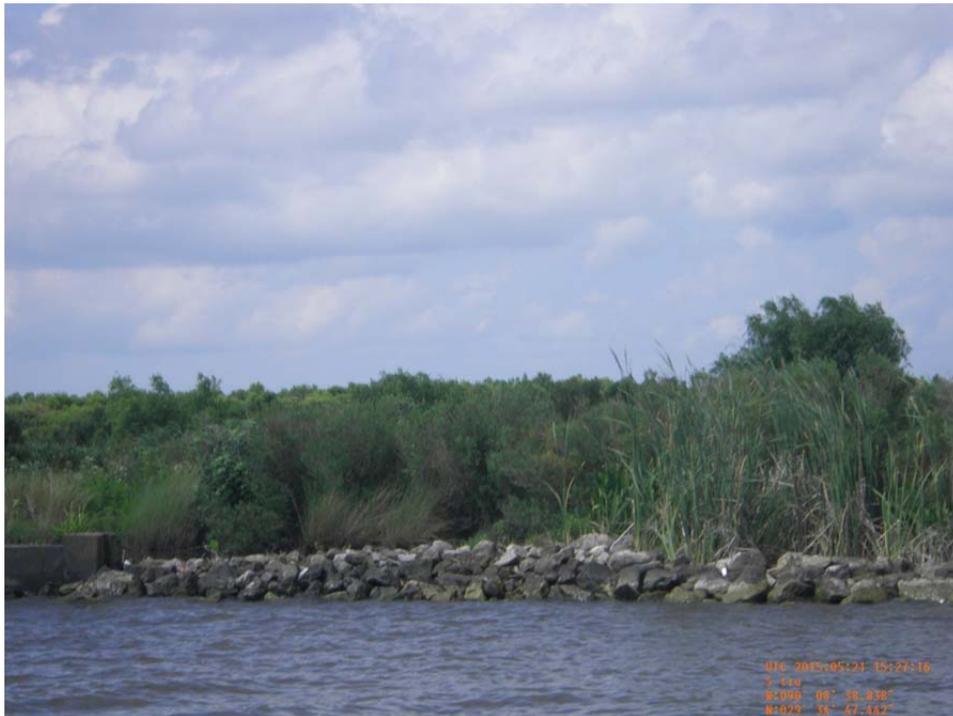
Photo 20: CU# 4 Concrete wall and rock revetment (CU#2)on east bank of Bayou Perot.

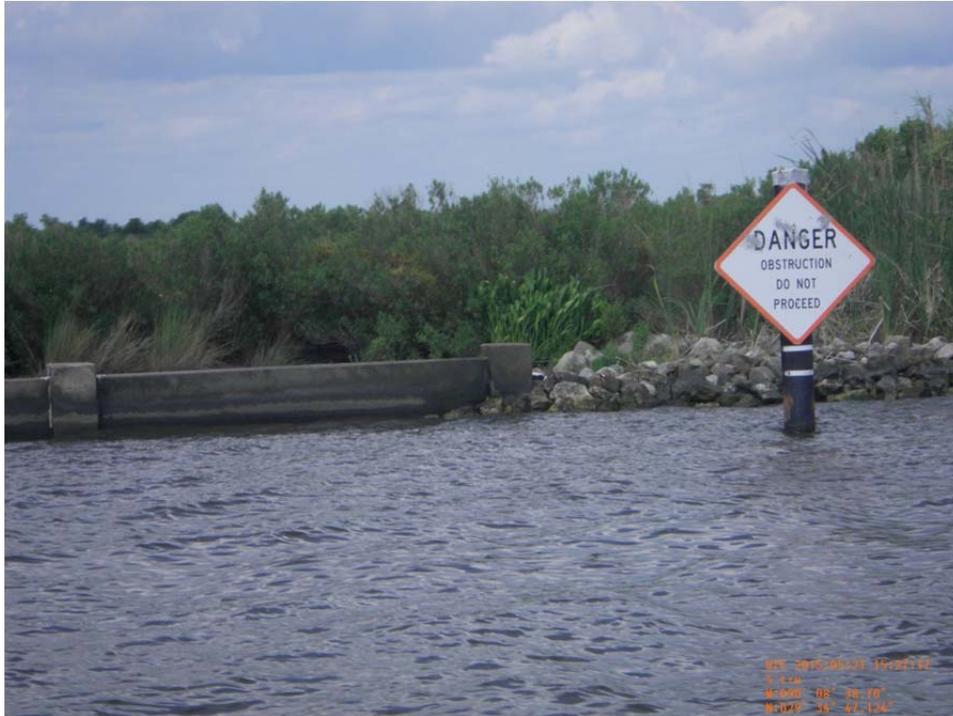
Photo 21: CU# 4 Concrete wall and rock revetment on east bank of Bayou Perot.

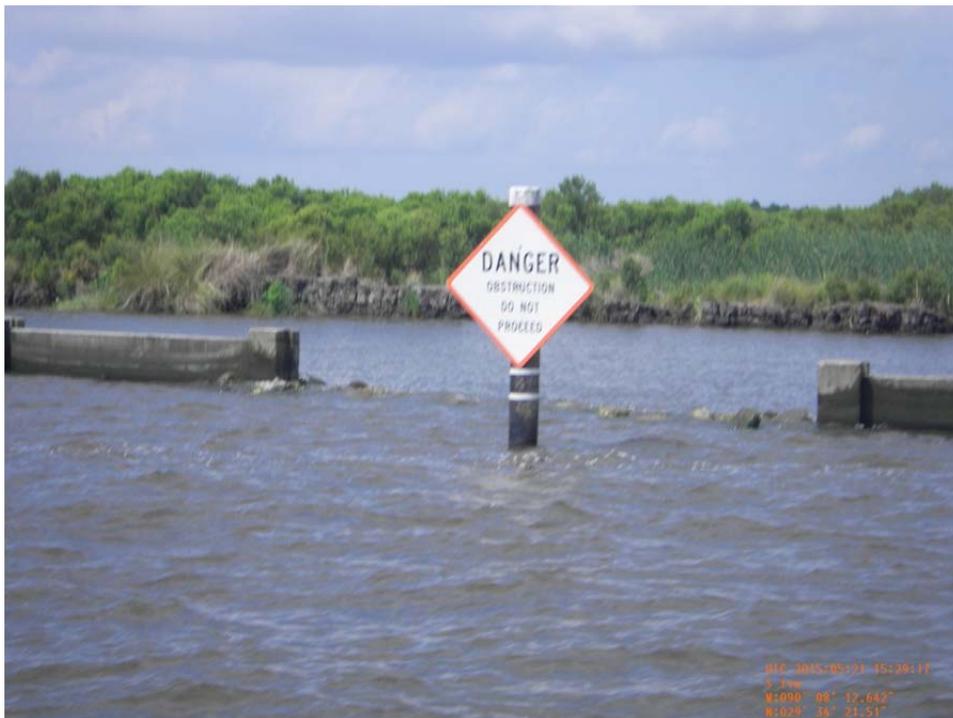
Photo 22: CU# 4 Concrete wall at the Chevron Pipeline along west bank of Harvey Cutoff Canal.

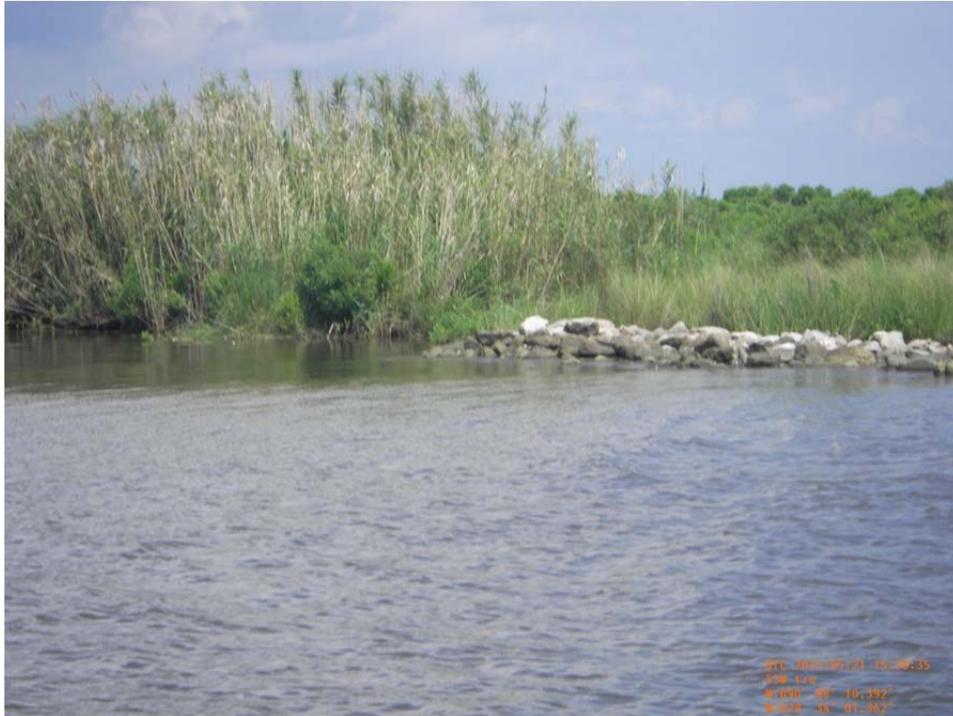
Photo 23: CU# 4 Rock tie-in from Reach 2 to west bank of Harvey Cutoff Canal.

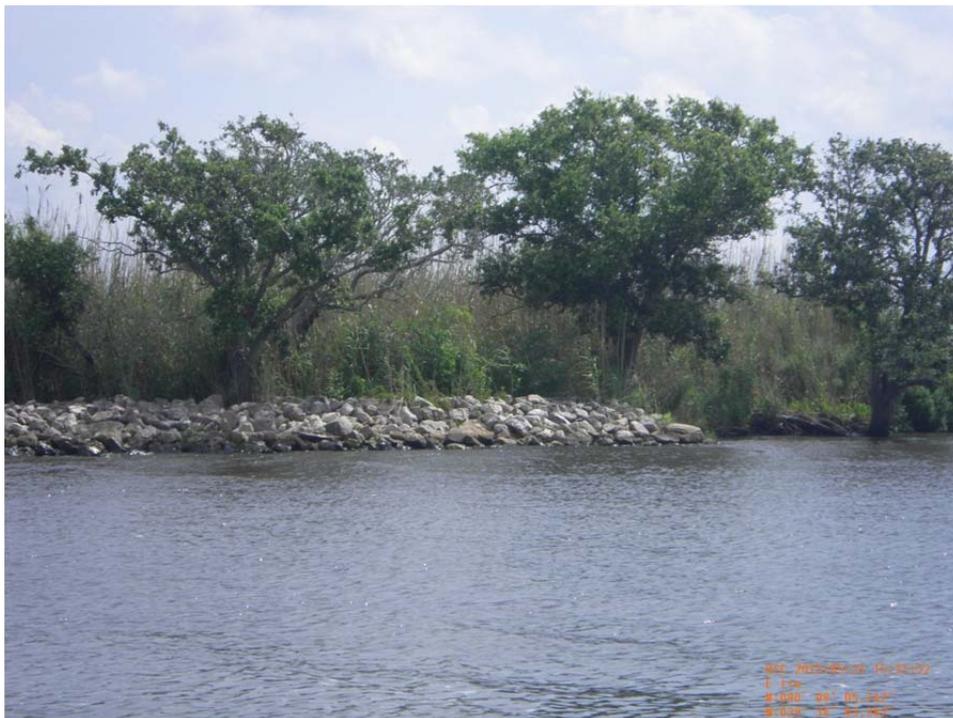
Photo 24: CU# 4 Concrete wall (Reach 1) rock tie-in to bank along east bank of the Harvey Cutoff Canal.

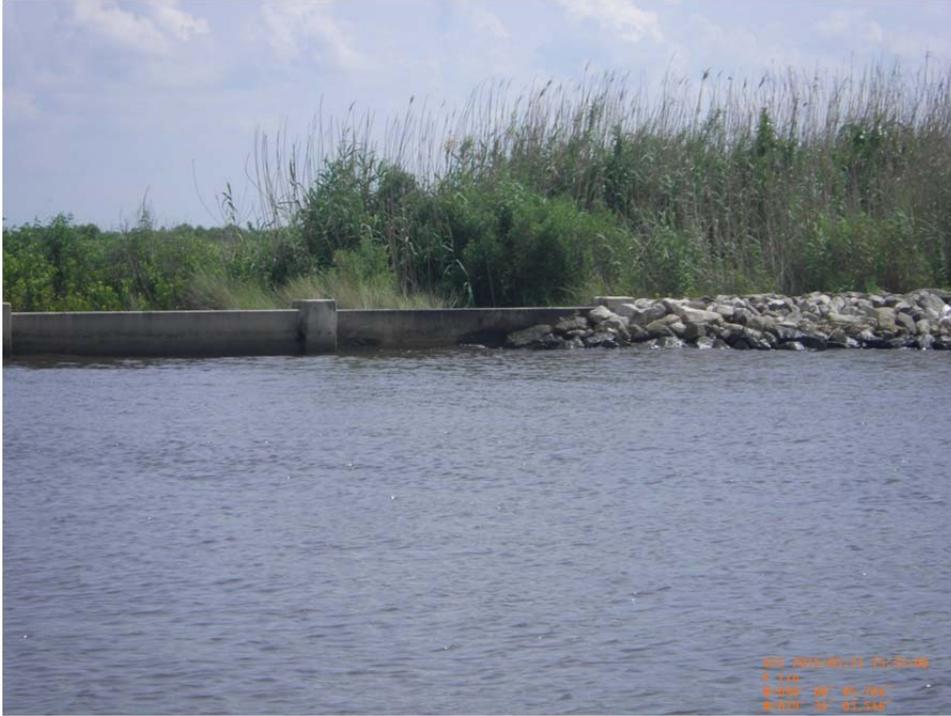
Photo 25: CU# 4 Concrete wall (Reach 1) rock tie-in to bank along east bank of the Harvey Cutoff Canal.

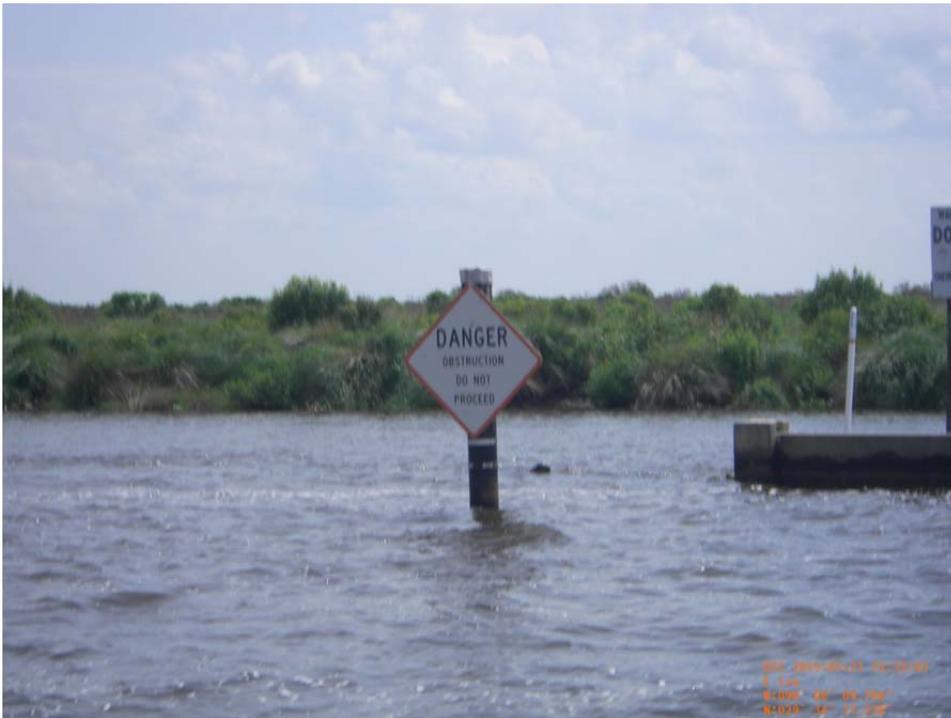
Photo 26: CU# 4 Concrete wall (Reach 1) at the Chevron Pipeline along east bank of Harvey Cutoff Canal.

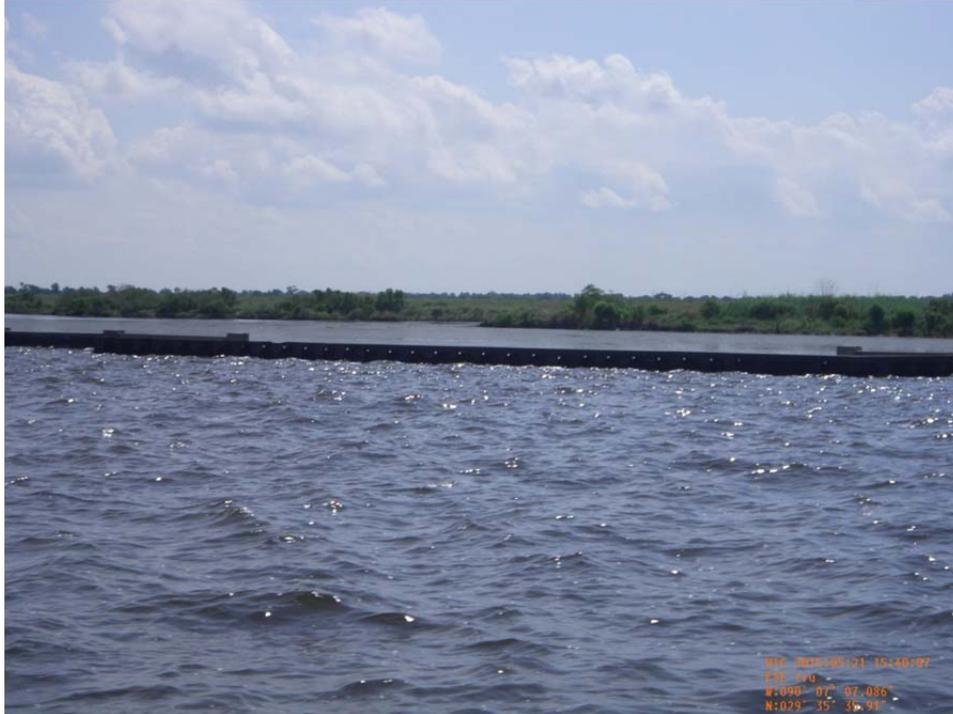
Photo 27: CU# 4 Concrete wall (Reach 1, Sections 13a & 13b) along east bank of Bayou Rigolettes.

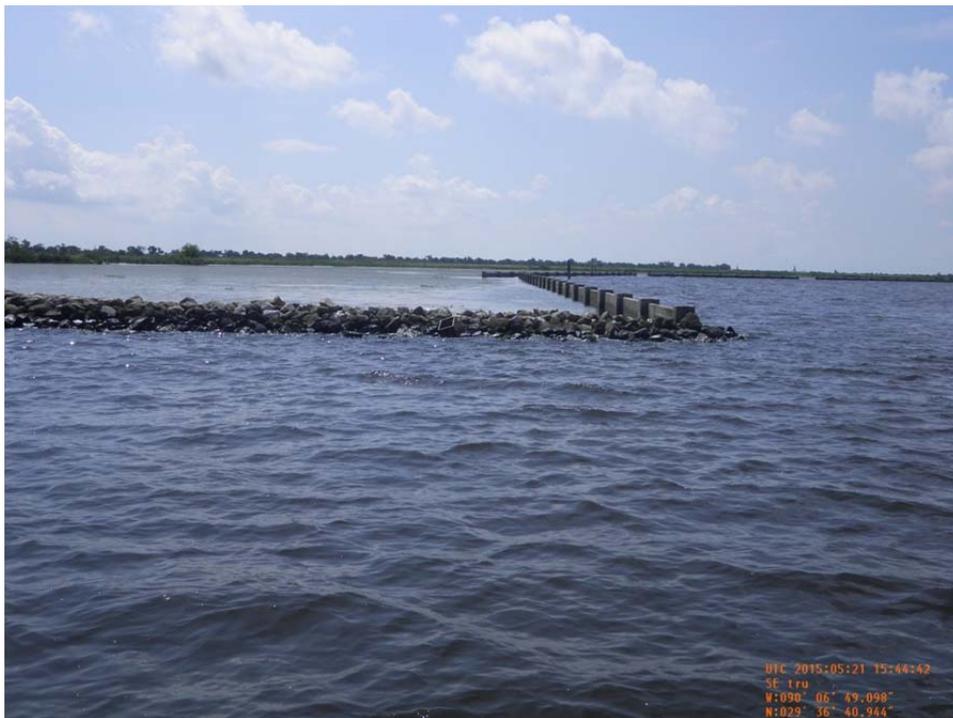
Photo 28: CU# 4 Rock revetment to concrete wall (Reach 1) tie-in near an existing canal.

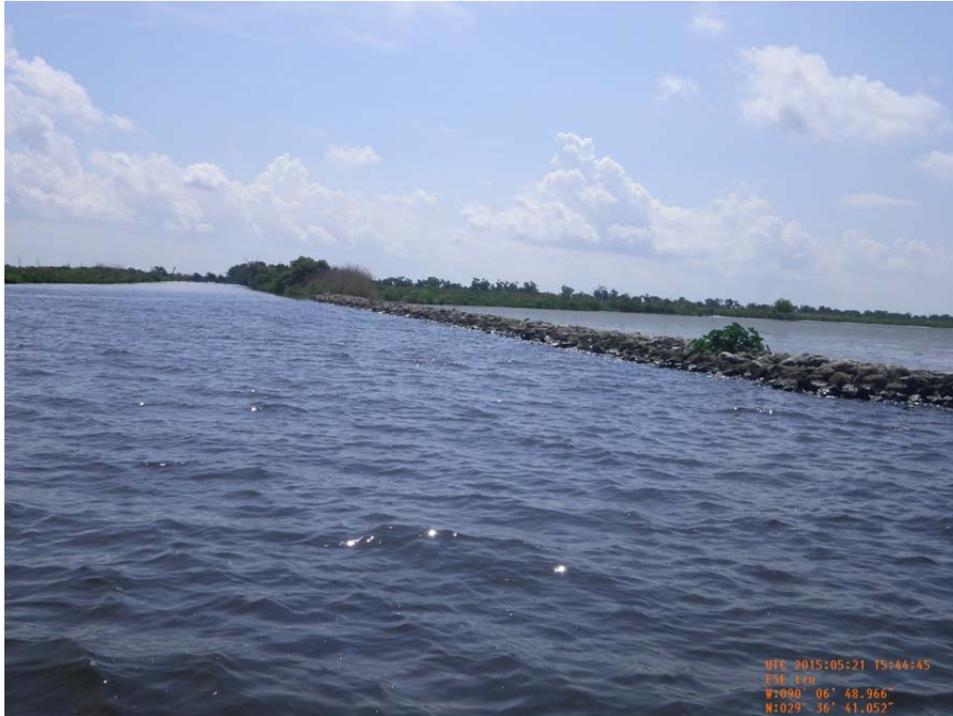
Photo 29: CU# 4 rock revetment tie-in to an existing canal bank at the beginning of Reach 1.

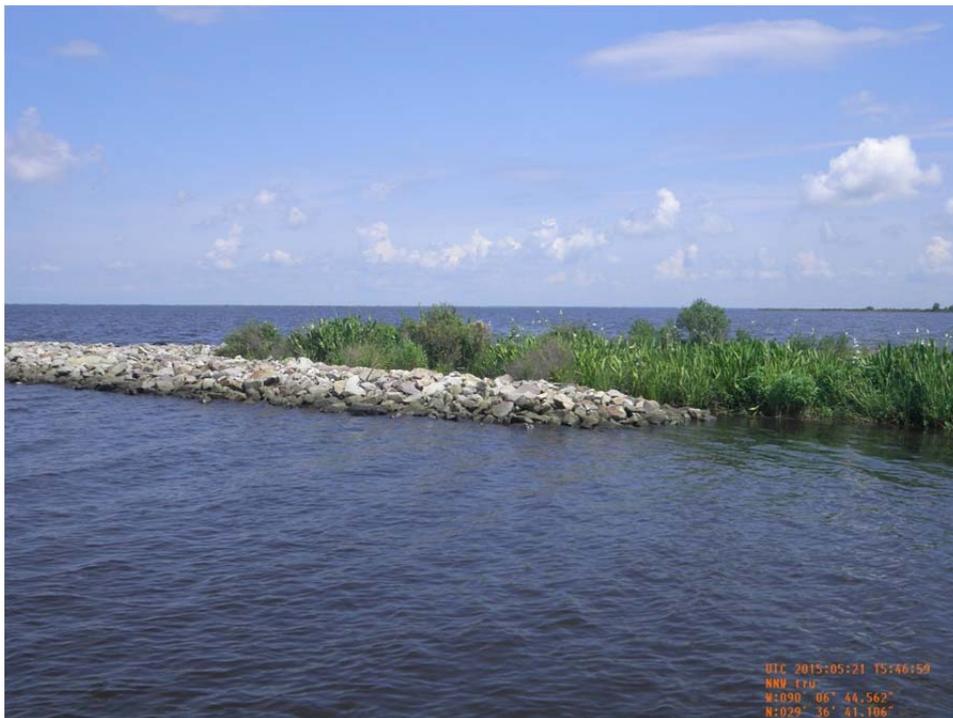
The inspection of Construction Unit #6 began at Sta. 0+00 near an existing oilfield access canal and proceeded along the east bank of Bayou Rigolettes to Sta. 307+78 near the Barataria Waterway. Overall, the rock dike appeared to be in good condition with no visual displacement or settlement of rock material. All signs and supports at the fish dip locations are also in good condition. We are not recommending any corrective actions at this time. (Appendix A, Photos 30 through 42)

Photo 30: CU#6 rock revetment tie-in to bank at existing canal near Sta. 0+00.

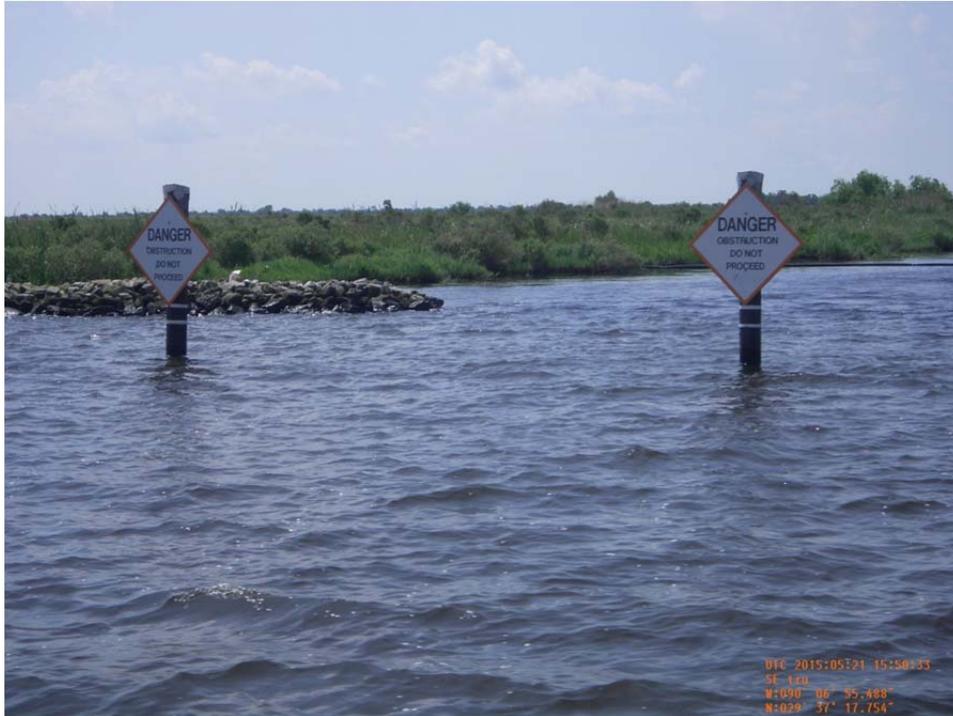
Photo 31: CU#6- view of fish dip and warning signs near Sta. 40+80.
