**State of Louisiana  
Coastal Protection and Restoration  
Authority**

**2015 Annual Inspection Report**

**BARATARIA LANDBRIDGE  
SHORELINE PROTECTION PROJECT  
Phase 1, 2, 3 & 4 (Construction Units 1, 2,  
3, 4, 5 and 6)**

State Project Number (BA-27), (BA-27c) and (BA-27d)  
Priority Project Lists 7, 9 and 11

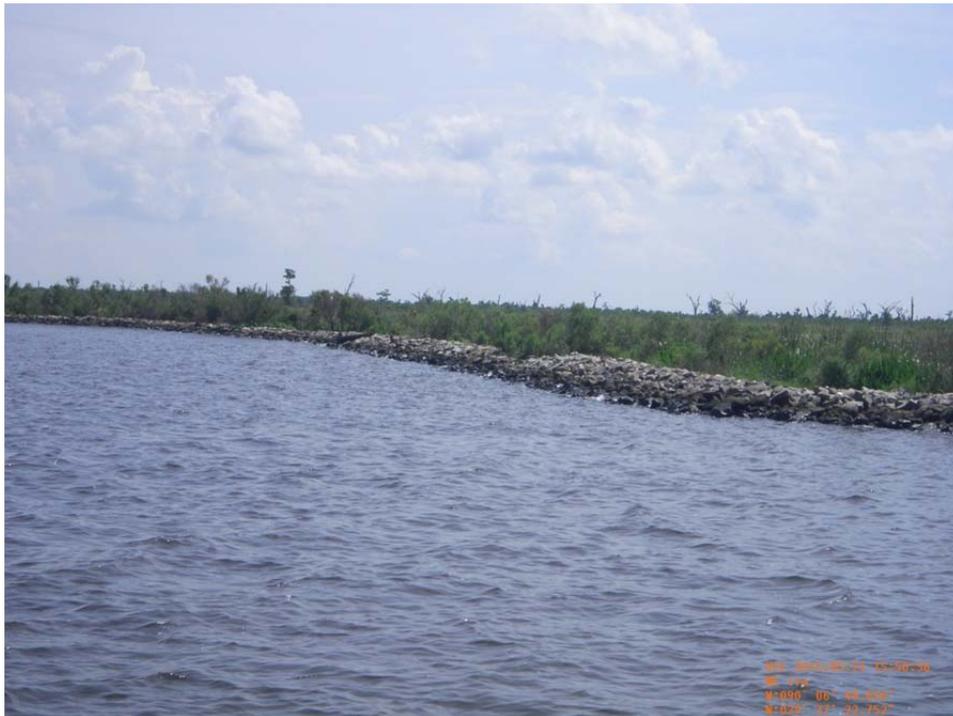
The inspection of Construction Unit #6 began at Sta. 0+00 near an existing oilfield access canal and proceeded along the east bank of Bayou Rigolettes to Sta. 307+78 near the Barataria Waterway. Overall, the rock dike appeared to be in good condition with no visual displacement or settlement of rock material. All signs and supports at the fish dip locations are also in good condition. We are not recommending any corrective actions at this time. (Appendix A, Photos 30 through 42)

Photo 32: CU#6 rock revetment along east bank of Bayou Rigolettes near Sta. 58+00.

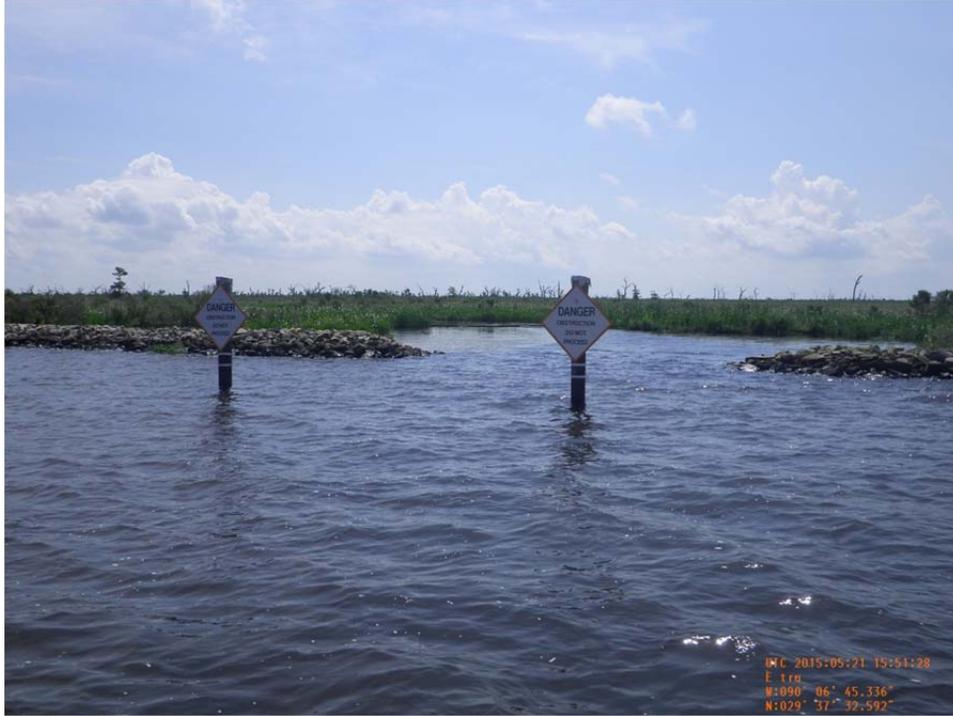
Photo 33: Cu#6 – view of fish dip along east bank of Bayou Rigolettes near Sta. 68+00.

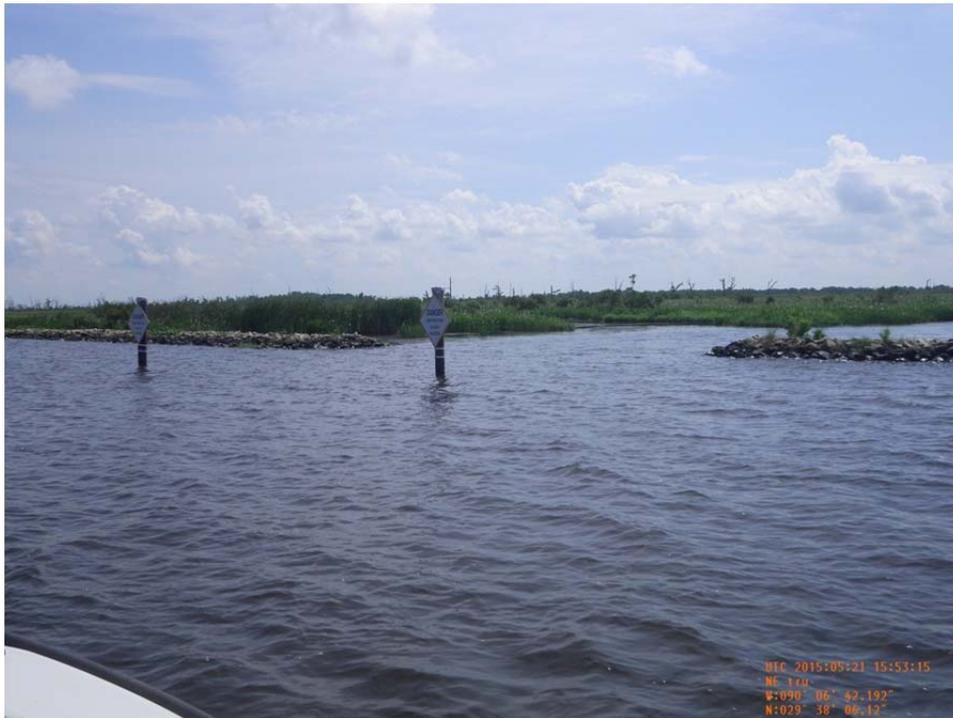
Photo 34: CU#6 – view of fish dip along east bank of Bayou Rigolettes near Sta. 107+00.

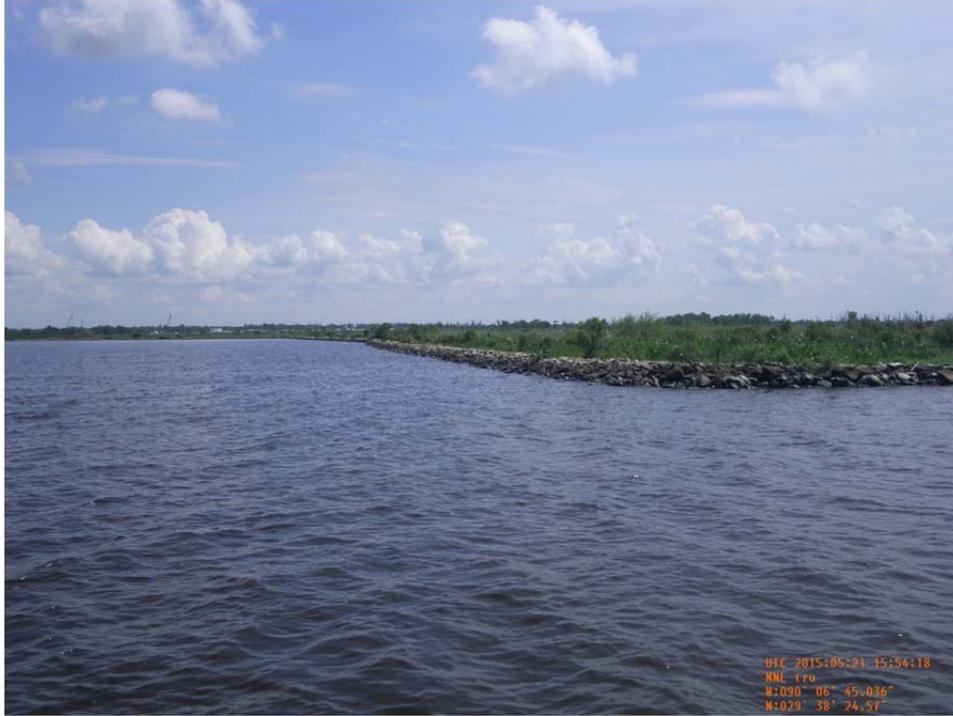
Photo 35: CU#6 rock revetment along east bank of Bayou Rigolettes near Sta. 130+00

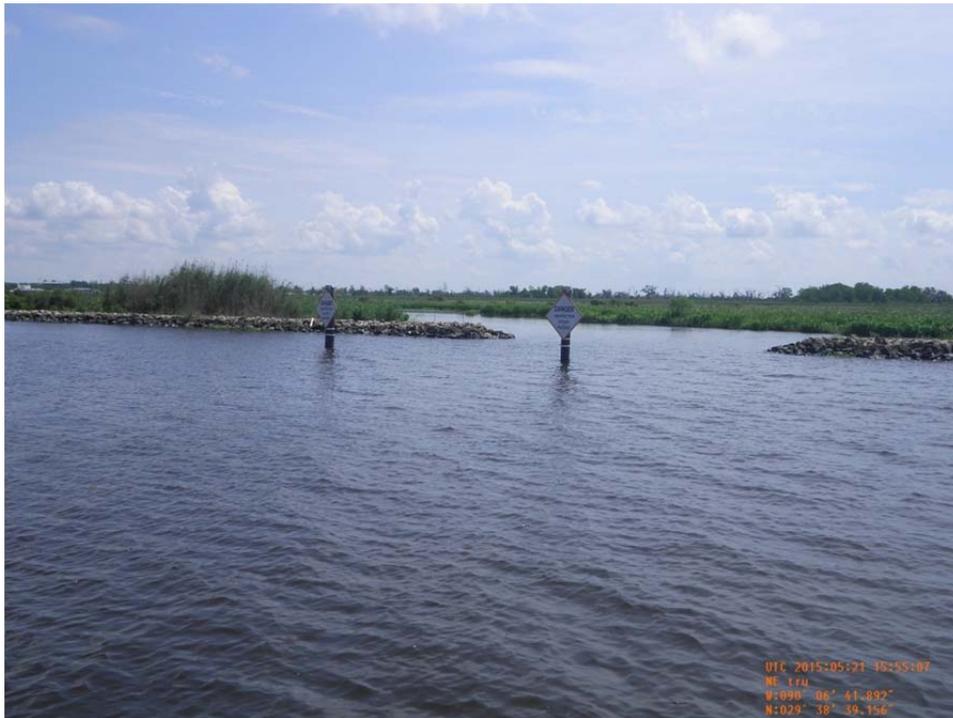
Photo 36: CU#6 – view of fish dip along east bank of Bayou Rigolettes near Sta. 146+00.

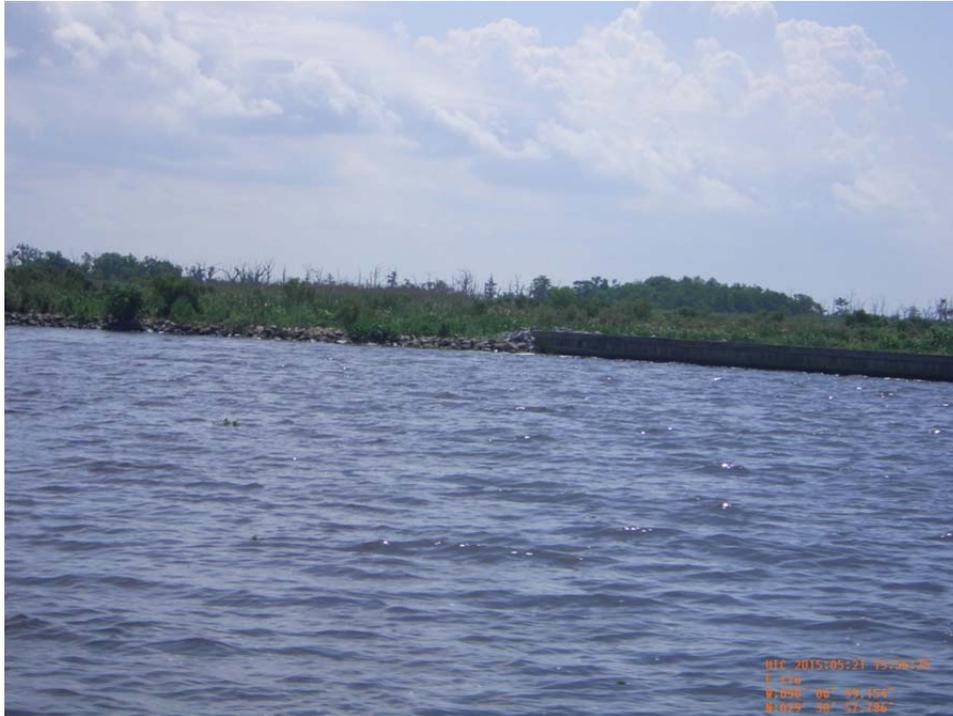
Photo 37: CU#6 rock revetment tie-in to timber bulkhead near Sta. 200+00.

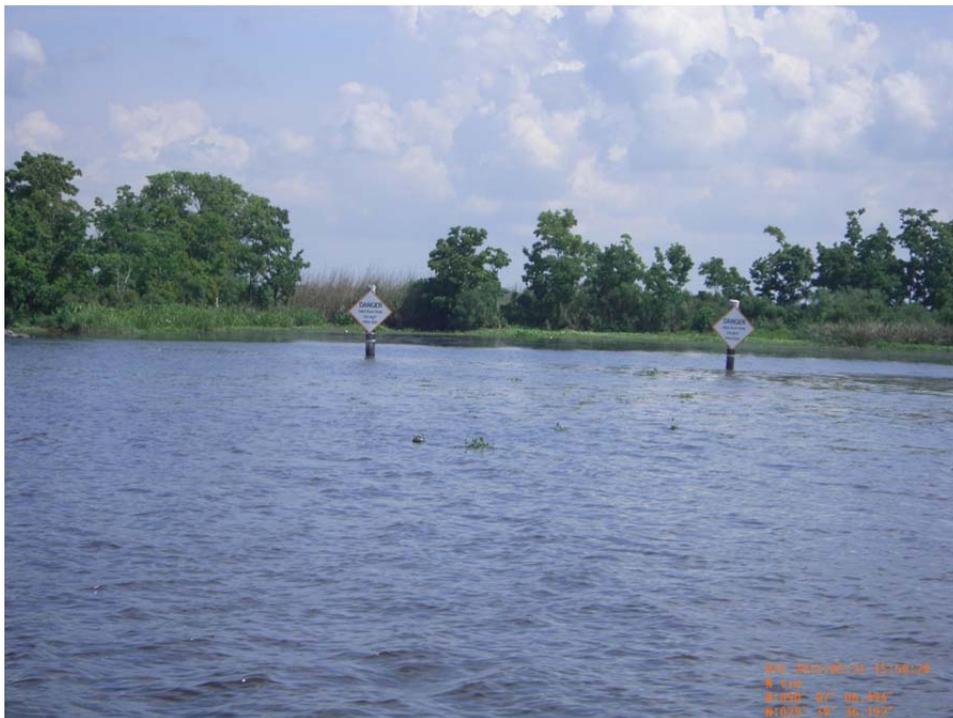
Photo 38: CU#6 – view of fish dip along east bank of Bayou Rigolettes near Sta. 250+00.

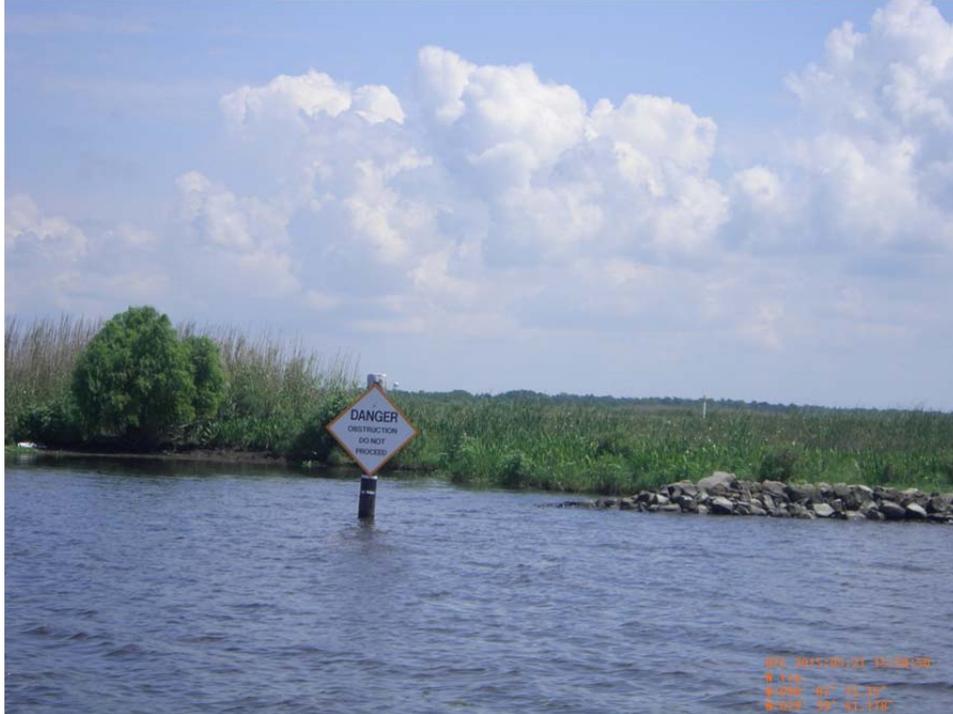
Photo 39: CU#6 – view of fish dip near Sta. 258+00.

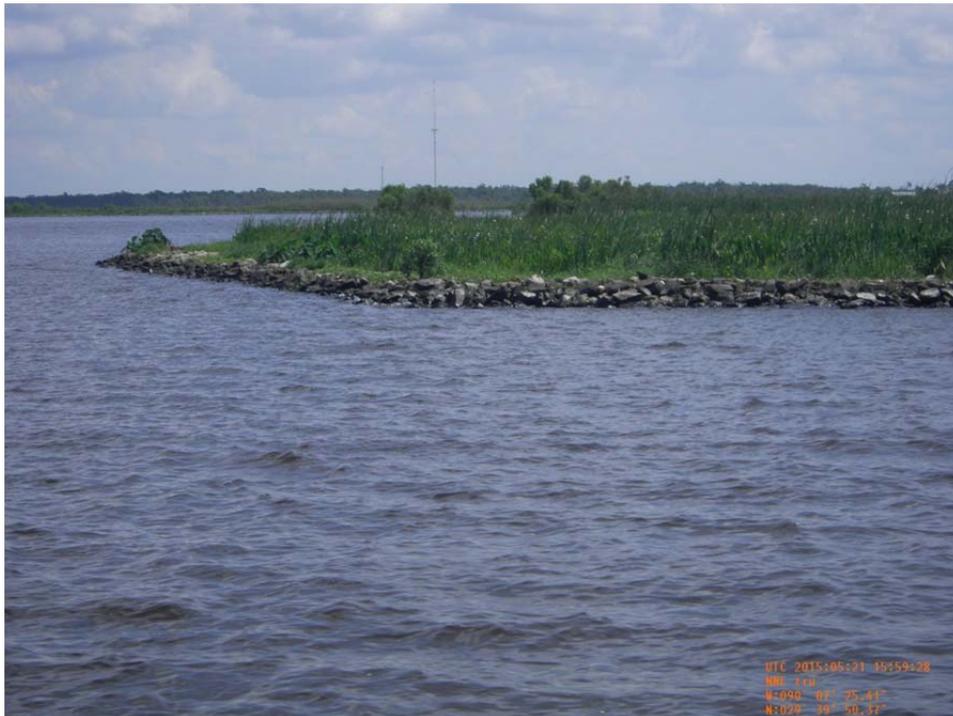
Photo 40: CU#6 rock revetment near Sta. 277+50.

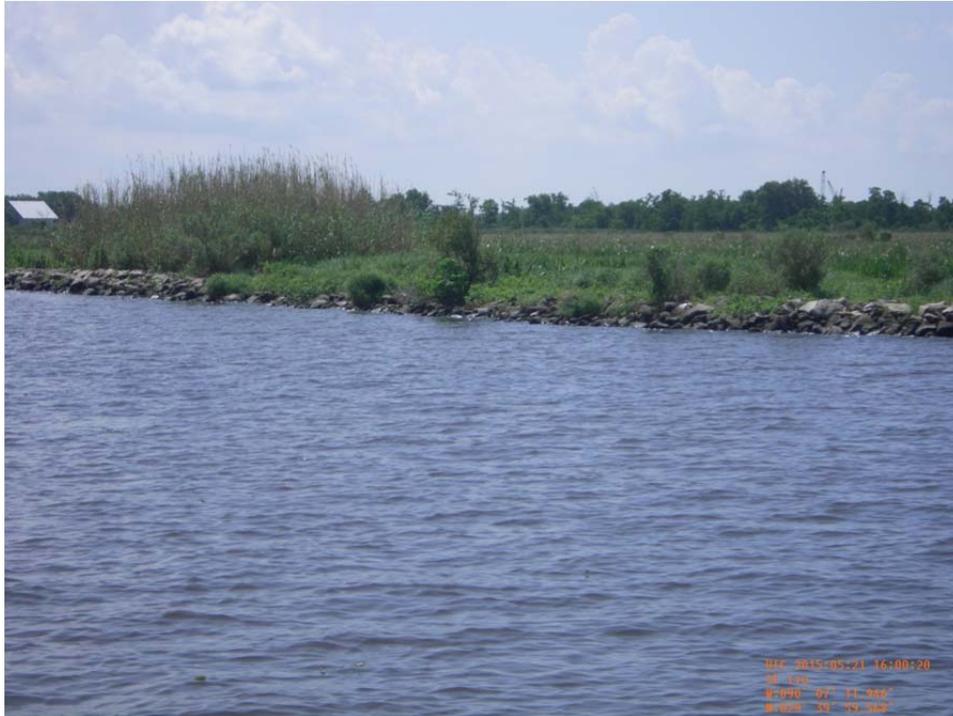
Photo 41: CU#6 rock revetment along Bayou Rigolettes near Sta. 285+00.

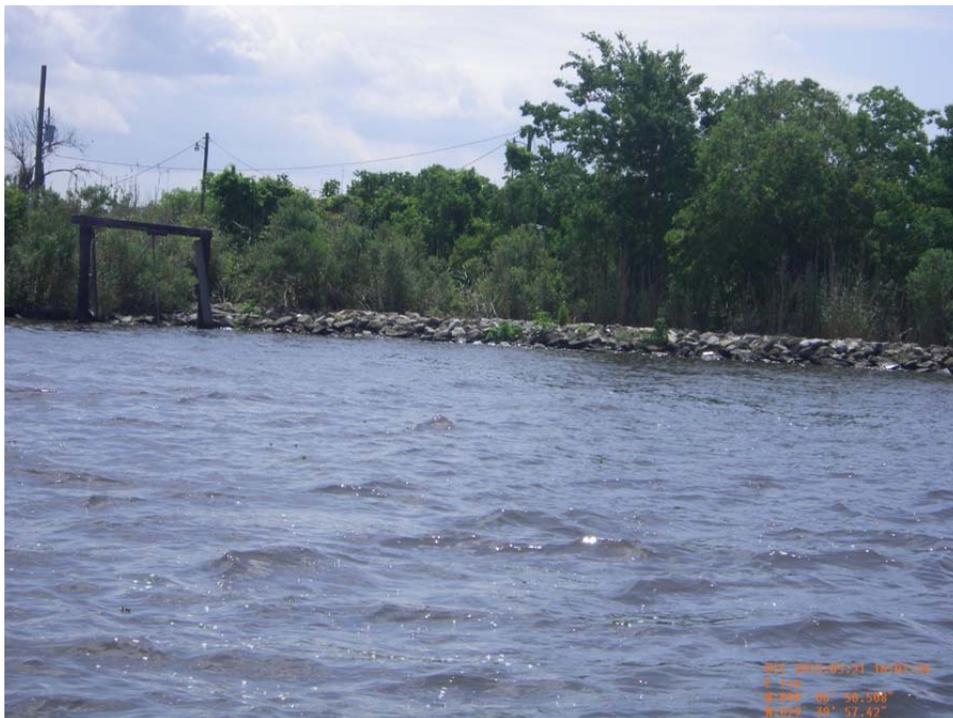
Photo 42: CU#6 rock revetment at end of project near Sta. 305+00.

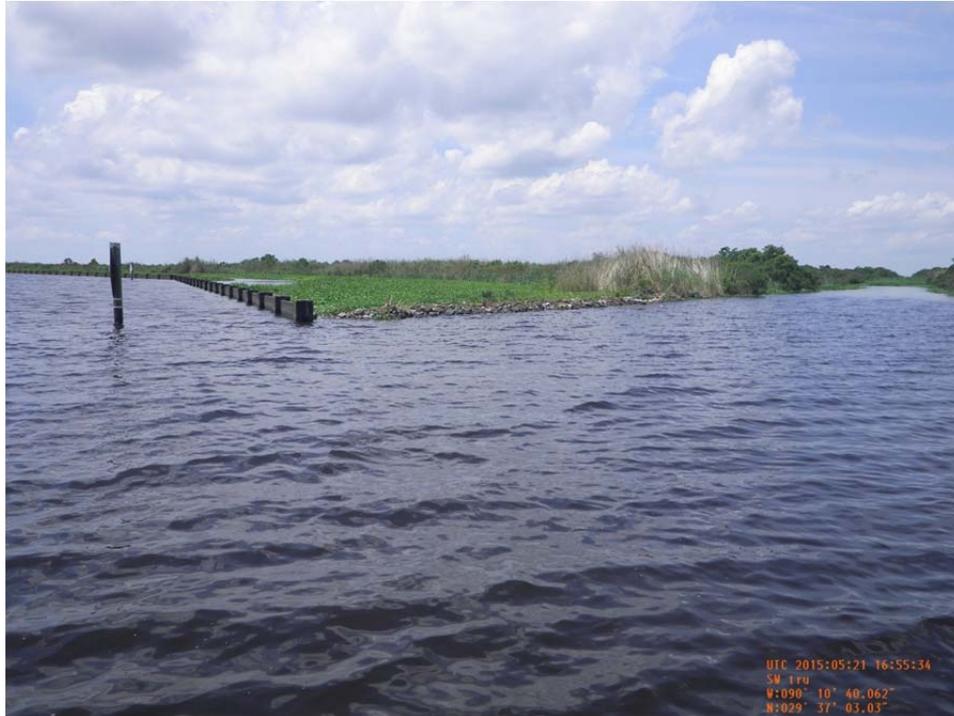
The inspection of Construction Unit #5 began at the northernmost point of CU #5 on the west bank of Bayou Perot near the Enbridge Pipeline Canal and progressed southward along the shoreline to the southernmost point of CU #5 at an existing canal. Overall, CU #5 is in good condition with only one (1) concrete panel that had slipped from the channel guide and was positioned lower on one side near the intersection of wall 5 and 6a. The rock to concrete panels and earthen embankments tie-ins were in very good condition with no obvious washouts or erosion. We will continue to monitor the condition of the concrete panel that has slipped from its guide channel and recommend repairs if the condition worsens. There are no recommendations for maintenance of CU #5 at this time. (Appendix A, Photos 43 through 51)

Photo 43: CU#5 rock revetment to rock tie-in near beginning of project.

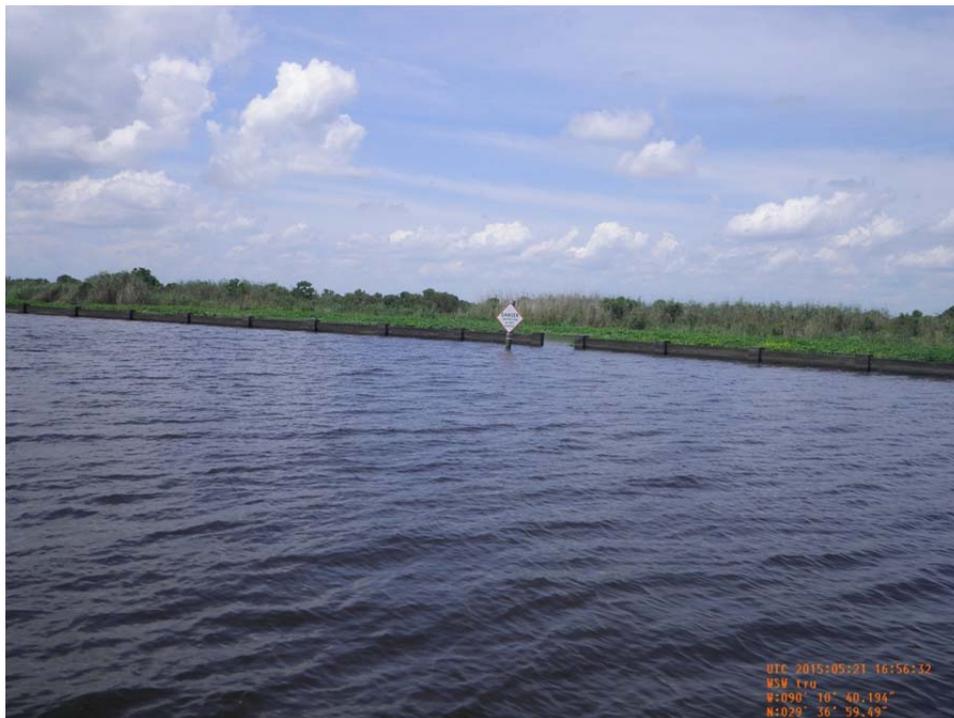
Photo 44: CU#5 – view of concrete wall between wall 1 and wall 2.

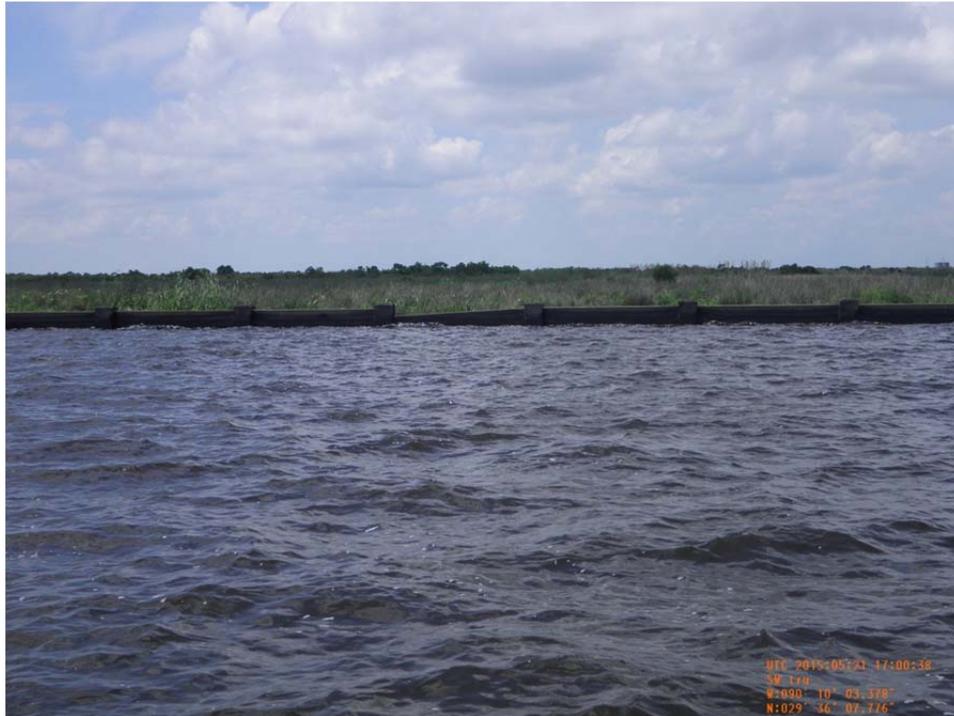
Photo 45: CU#5 – view of existing concrete wall between wall 4 and 5.

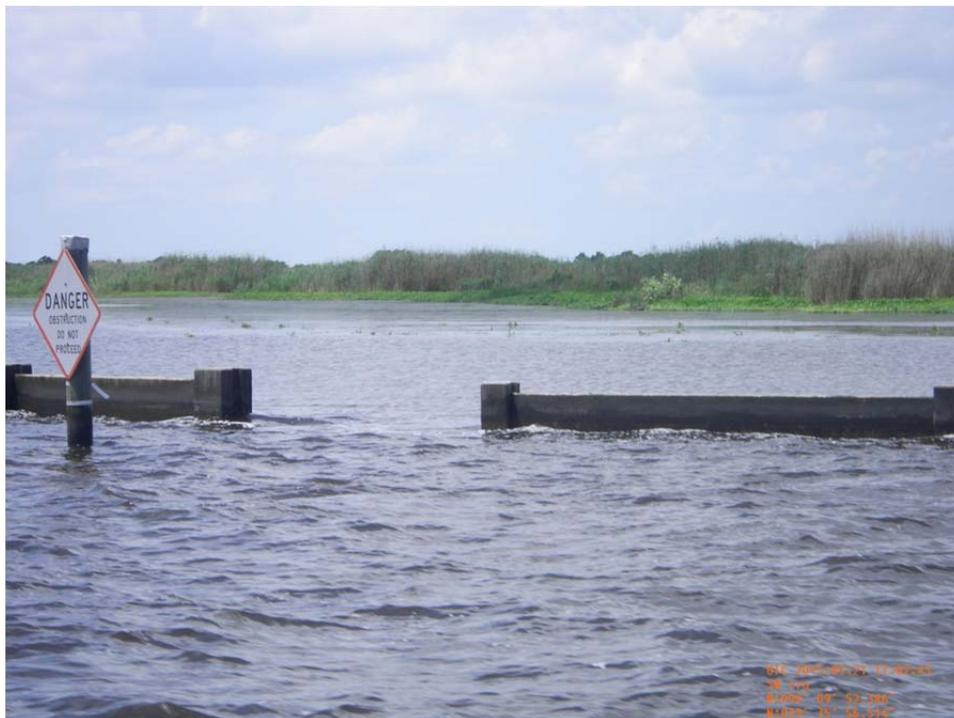
Photo 46: CU#5 – view of gap in concrete wall between wall 5 and 6A.

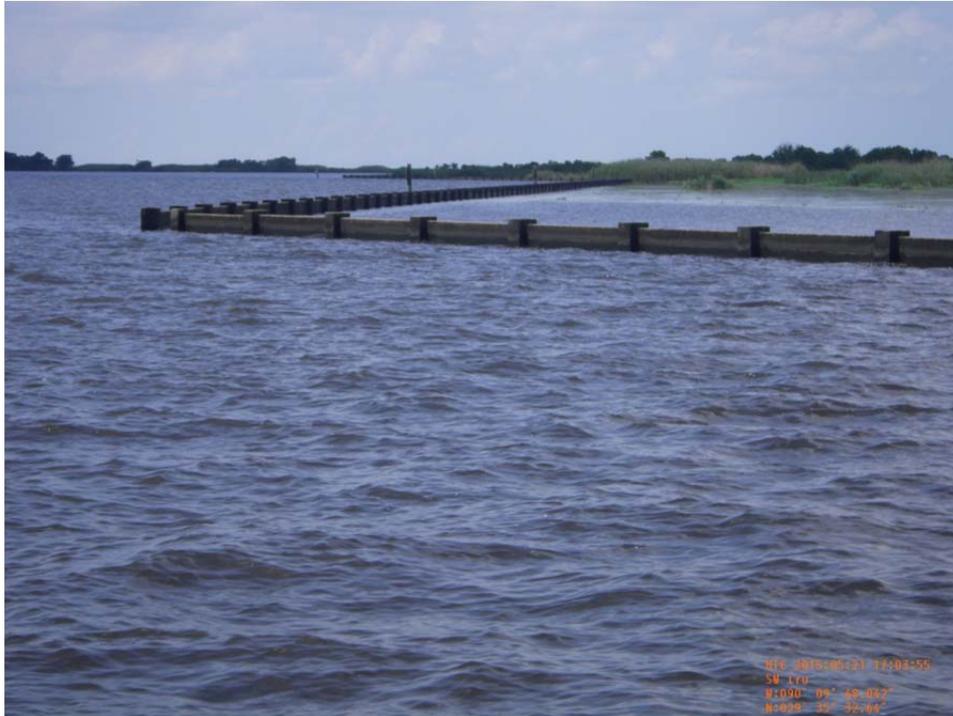
Photo 47: CU#5 – view of concrete wall 7B and 8 in background.

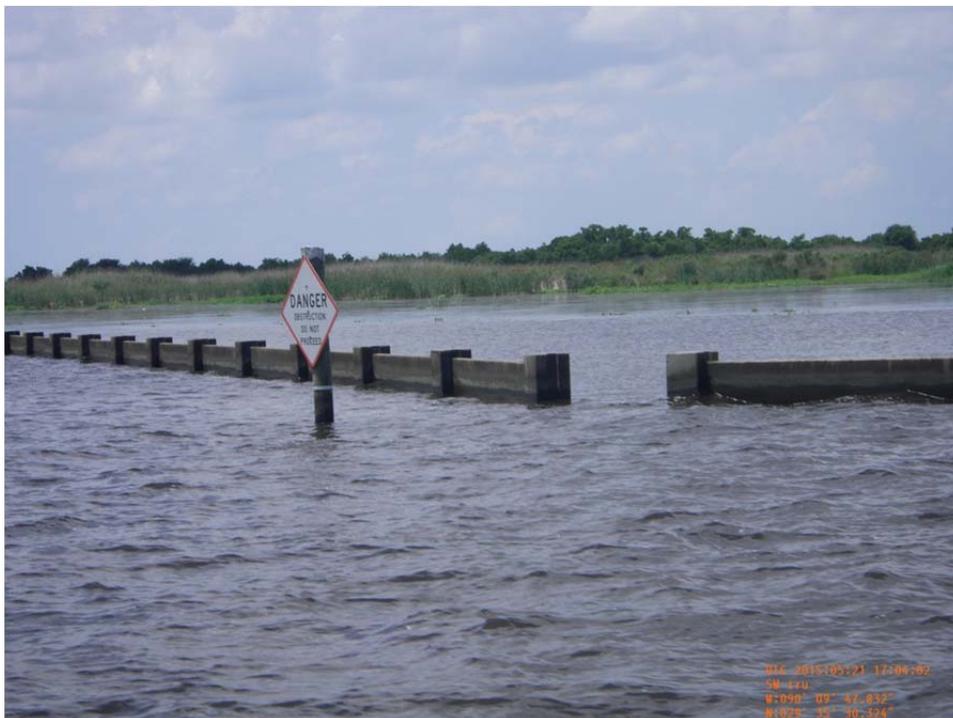
Photo 48: CU#5 – view of gap in concrete wall between walls 7B & 8.

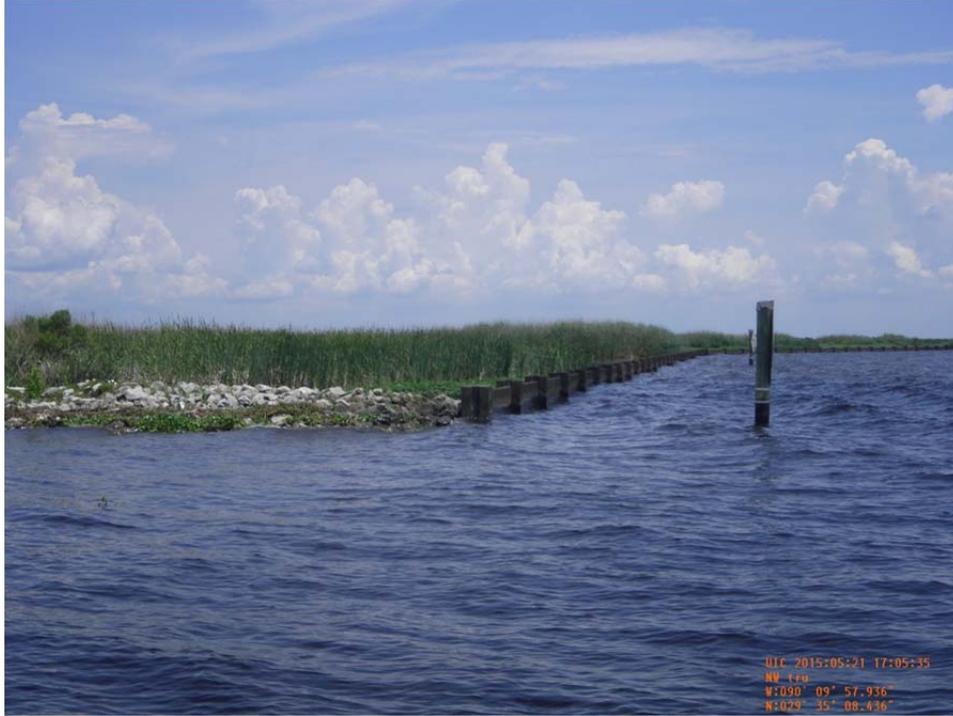
Photo 49: CU#5 – view of concrete wall tie-in to rock revetment at southern end of wall 9.

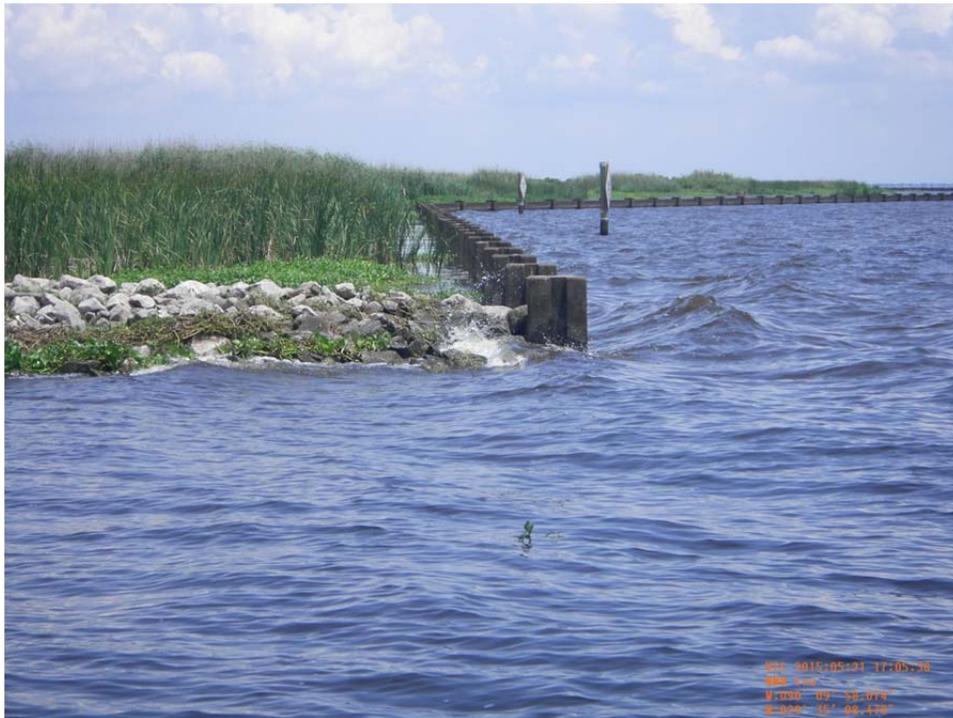
Photo 50: CU#5 - view of concrete wall tie-in to rock revetment at southern end of wall 9.

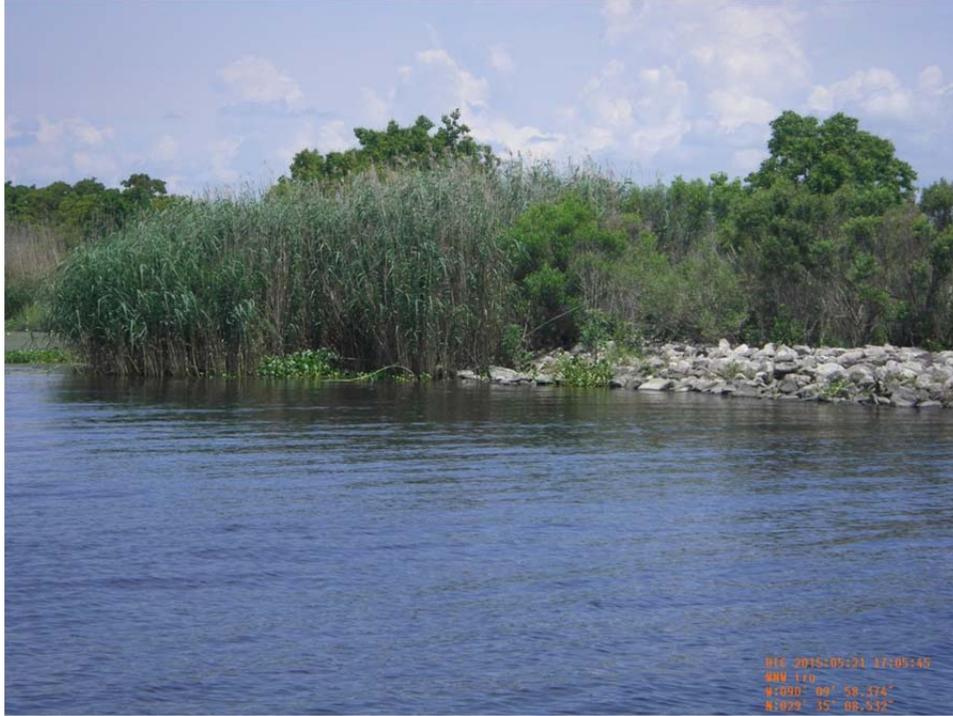
Photo 51: View of rock revetment tie-in to existing marsh on southern end of CU#5.
