Project Completion Report

**Hydrologic Restoration and
Vegetative Plantings in the Des
Allemands Swamp (BA-34-2)**

State Project Number BA-34-2

July 12th, 2018

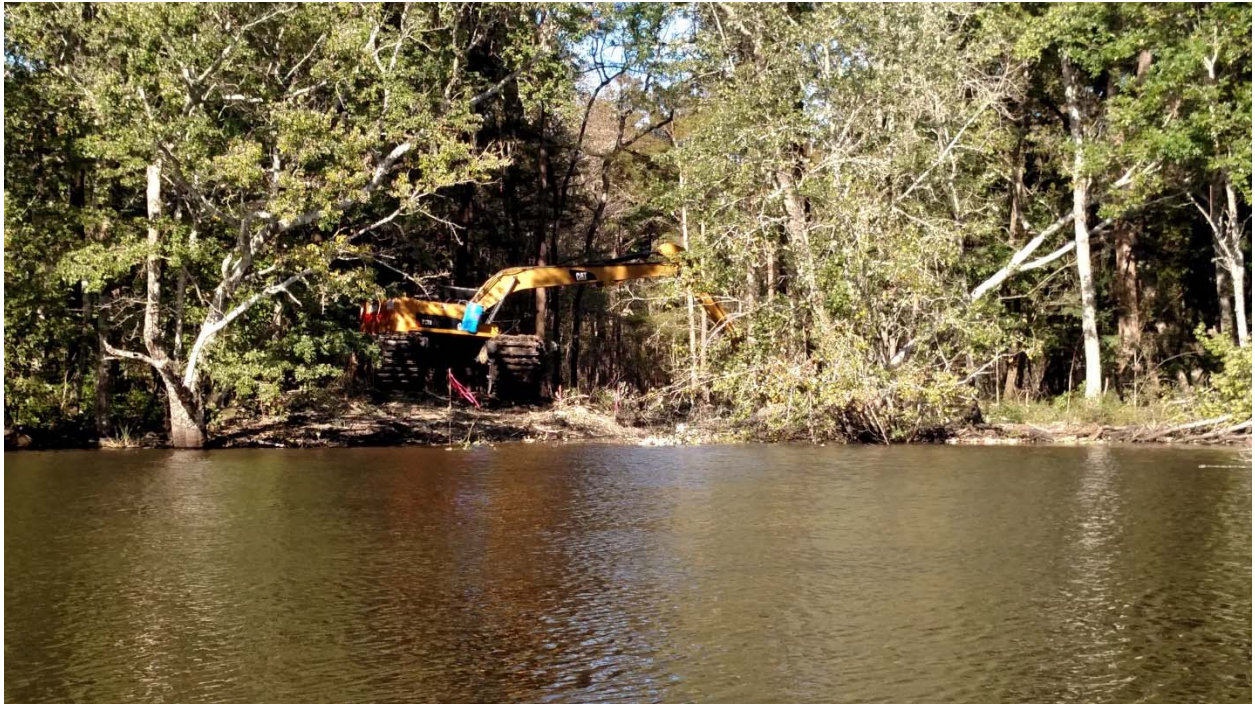
Photograph 1 - Initial Chipping Activities Begin on Gap #1.

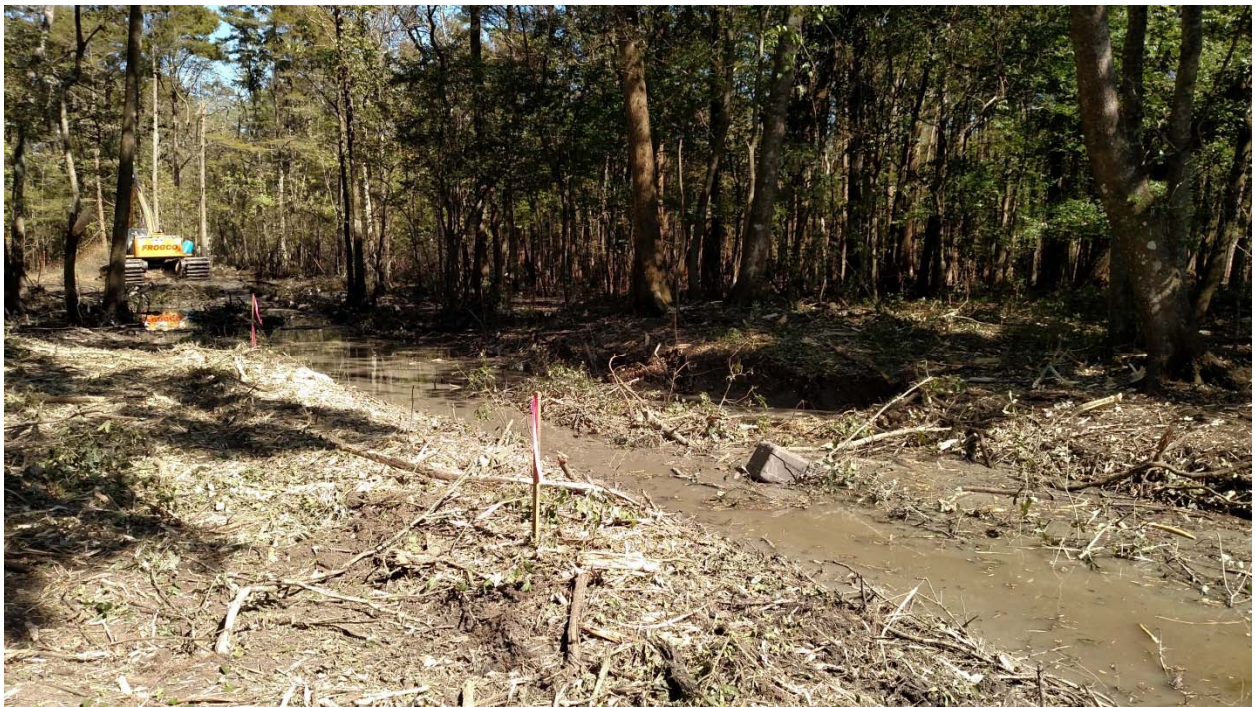
Photograph 2 - Contractor clears a path to backside of gap and then works back to front.

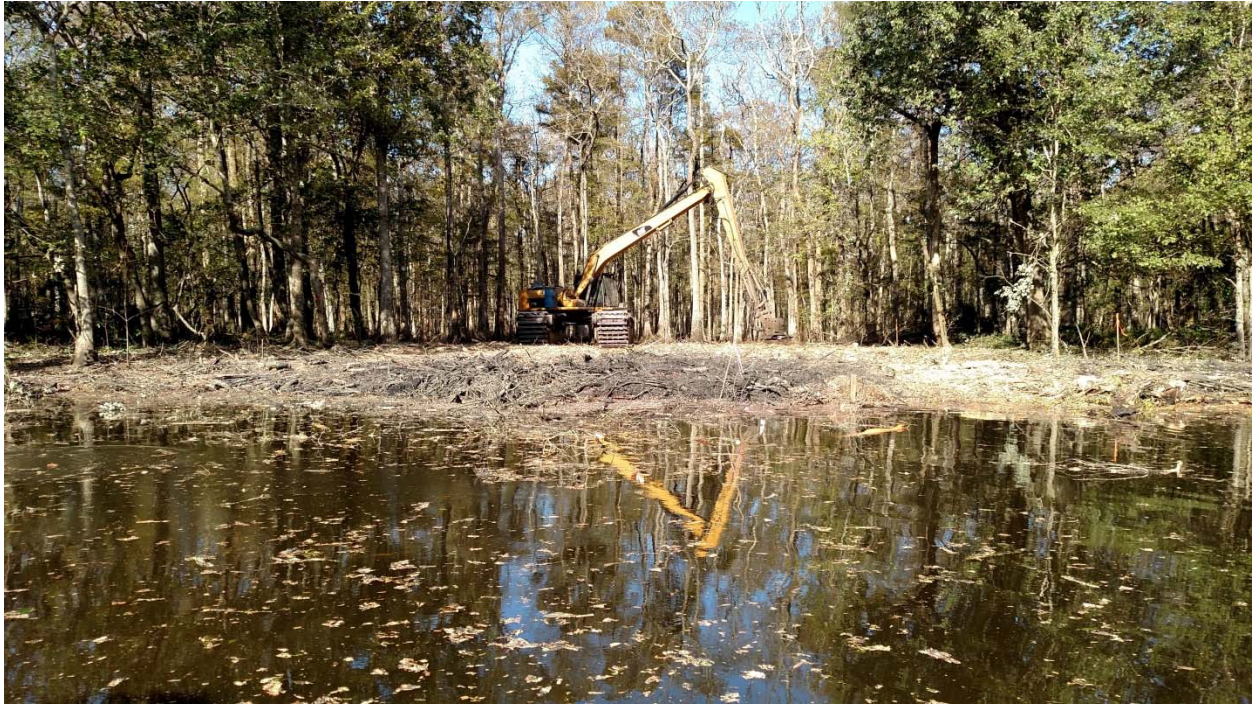
Photograph 3 - Image of cleared gap looking from Bayou Chevreuil.

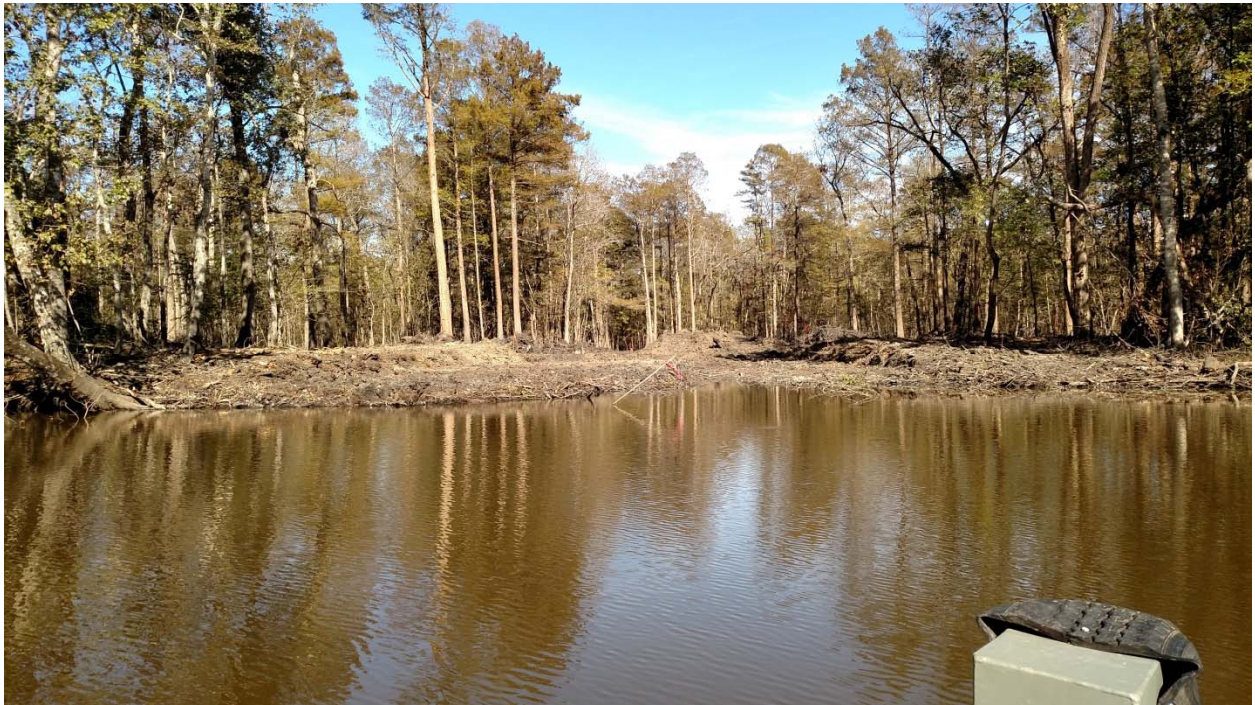
Photograph 4 - Gap #1 post stump clearing.

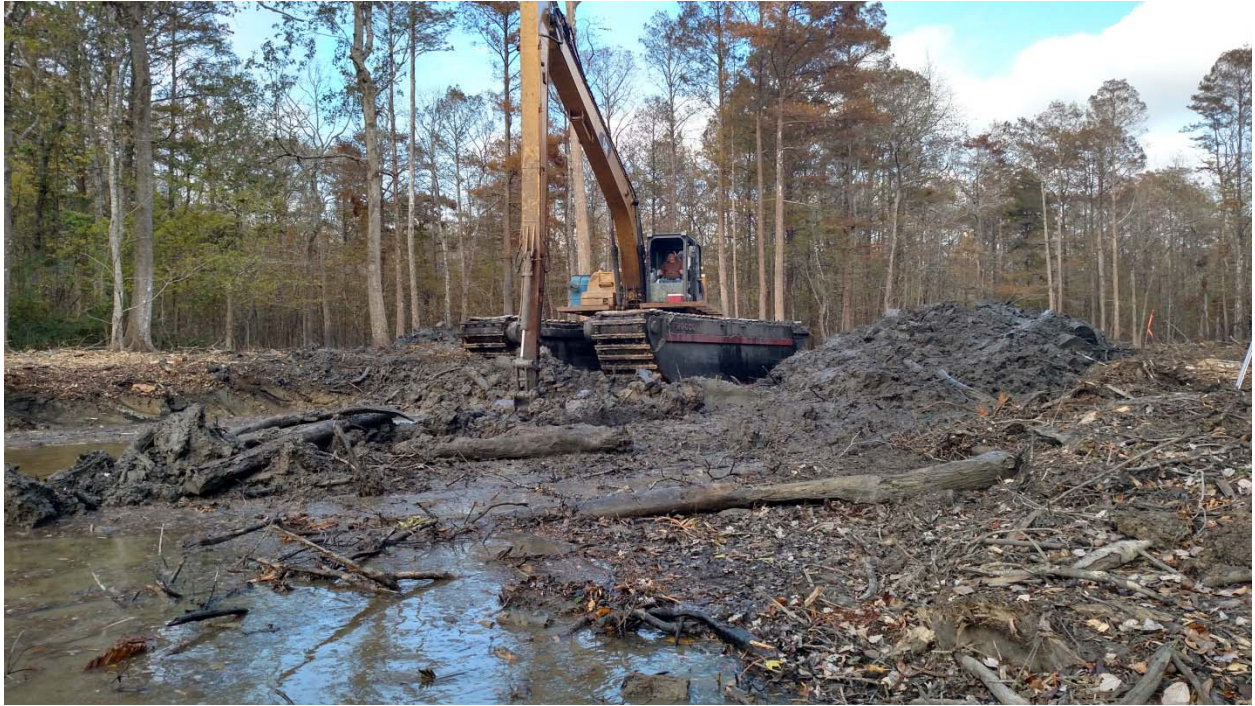
Photograph 5 - Long Reach Excavator excavating spoil while encountering submerged logs.

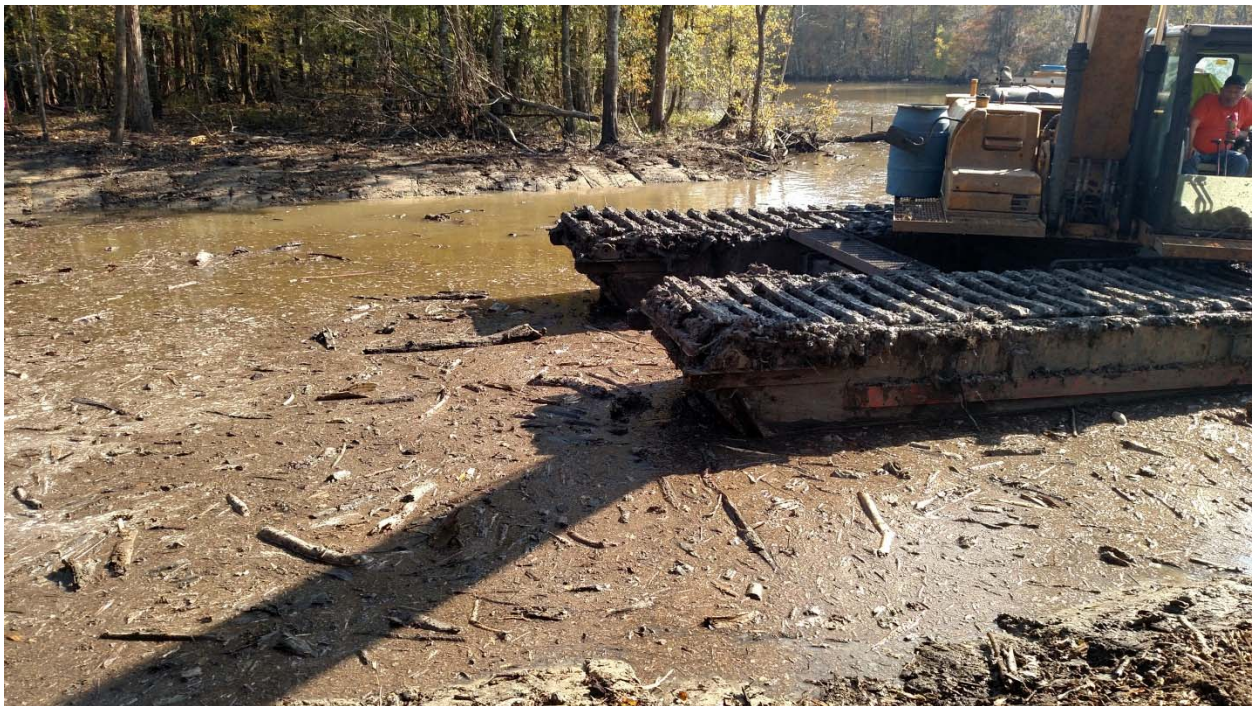
An excessive amount of floating woody debris (Photograph 6) remained in the channels after clearing and excavation was completed. This was noticed at all gaps before flushing (due to rainfall) pushed nearly all refuse out of most of the gaps. Weeks later, floating woody debris remained in Gaps No. 5 and No. 6, indicating poor connectivity. This may attributed to higher elevations in the surrounding vicinity, greater energy loss (higher roughness coefficients, longer hydraulic lengths), or less of an established channel. Also, the existence of an internal tree ridge may be funneling water to the four western most gaps. Removal of such material should be included in future contracts. The presence and eventual degradation of floating woody debris will not be a long term issue as shifting water levels will provide oxygen for bacterial decay.

Photograph 6 - Buoyant woody debris left over from excavation activities.

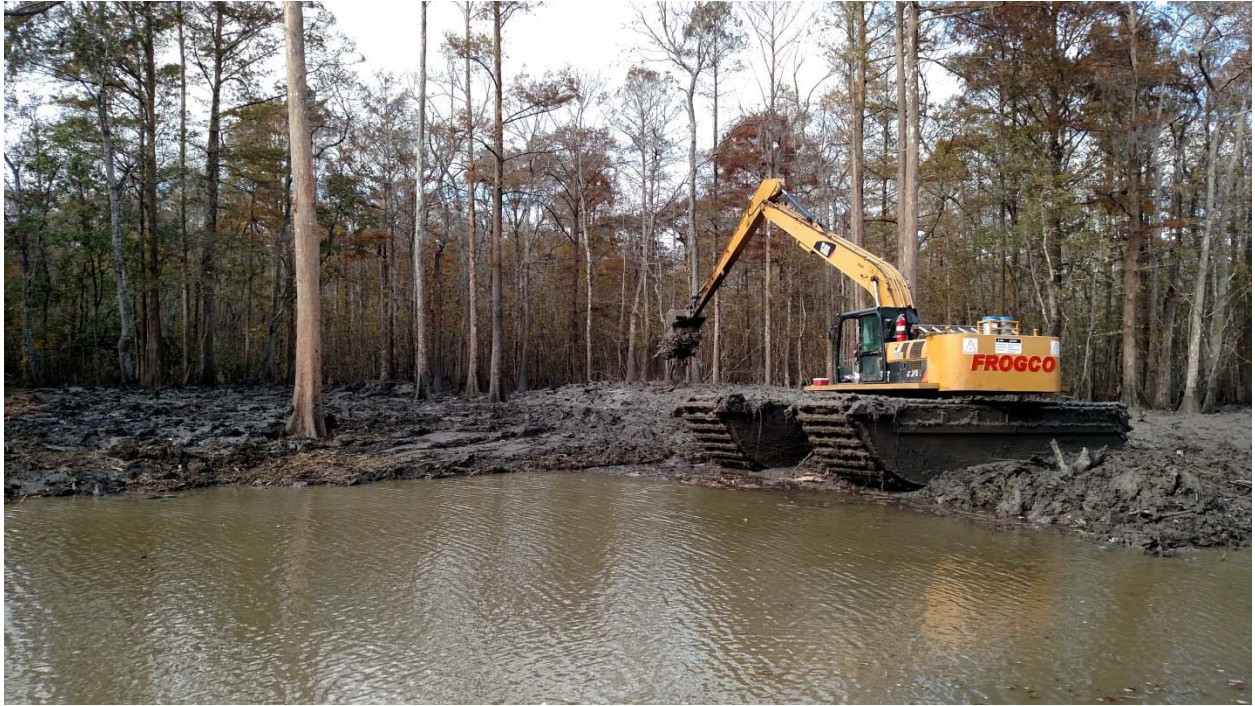
Photograph 7 - Contractor placing excavated material.

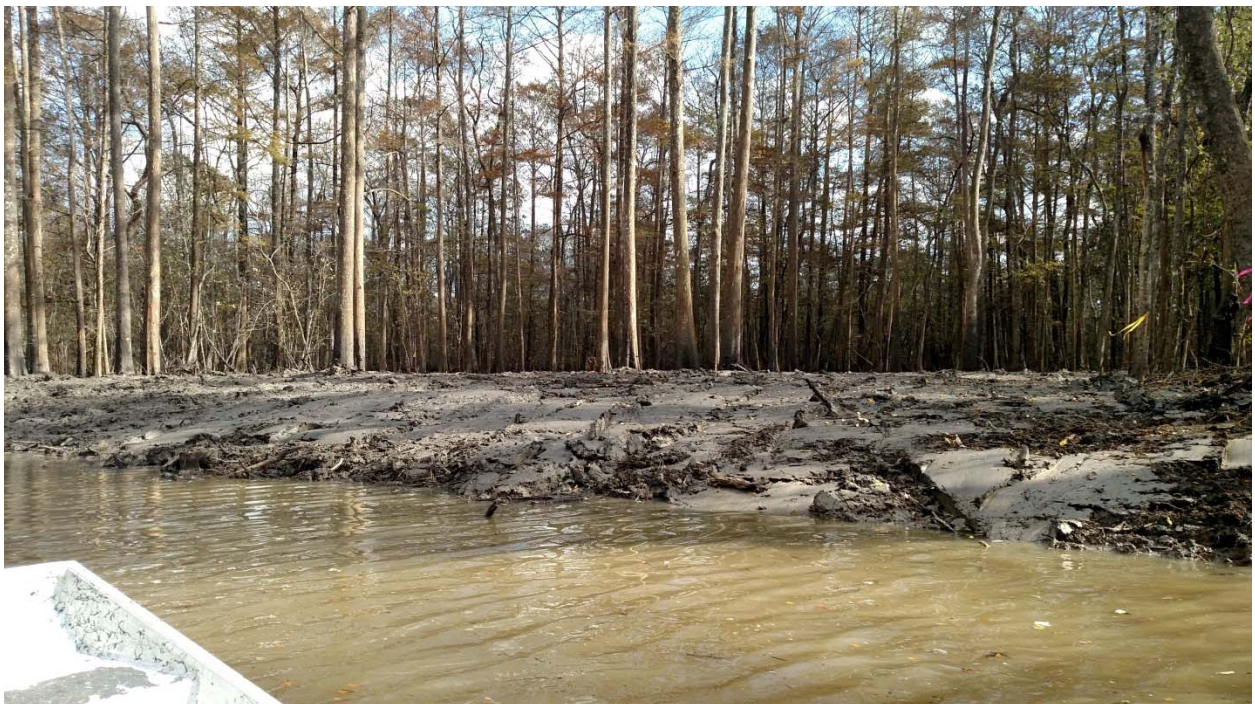
Photograph 8 - Finished East Spoil Placement Area on Gap #1.

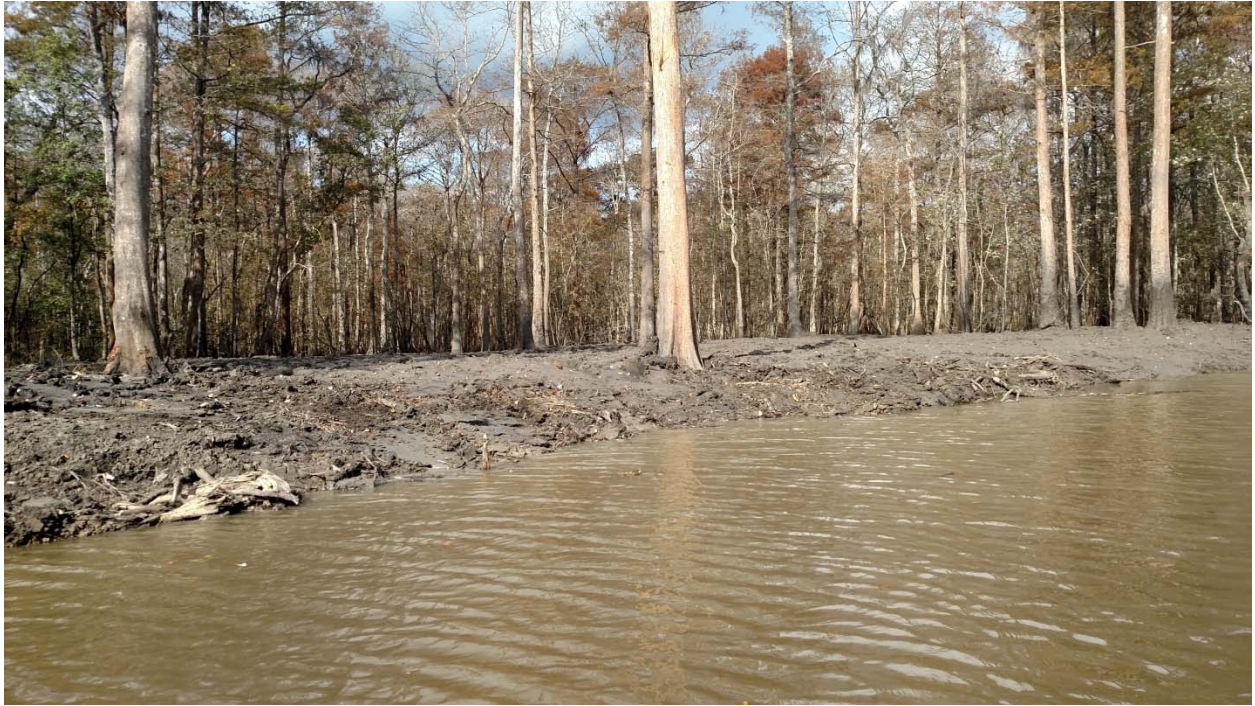
Photograph 9 - Finished West Spoil Placement Area on Gap #1.

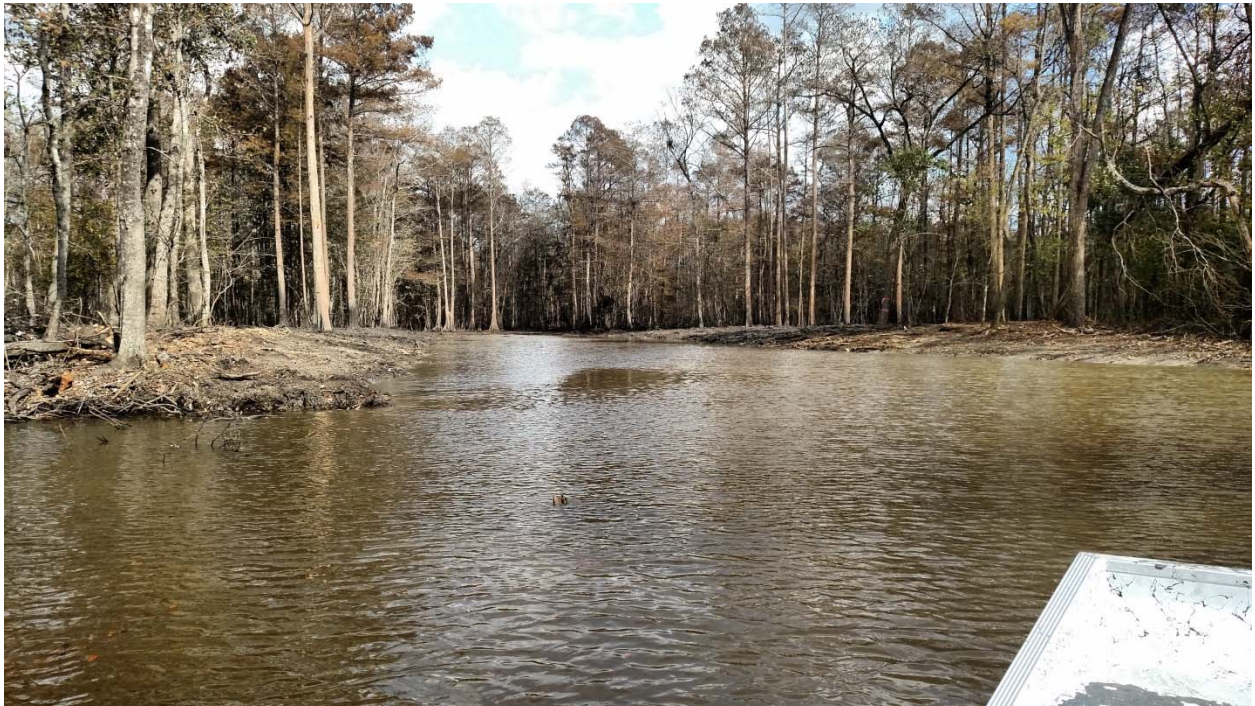
Photograph 10 - Perspective of finished channel on Gap #1 from Bayou Chevreuil.

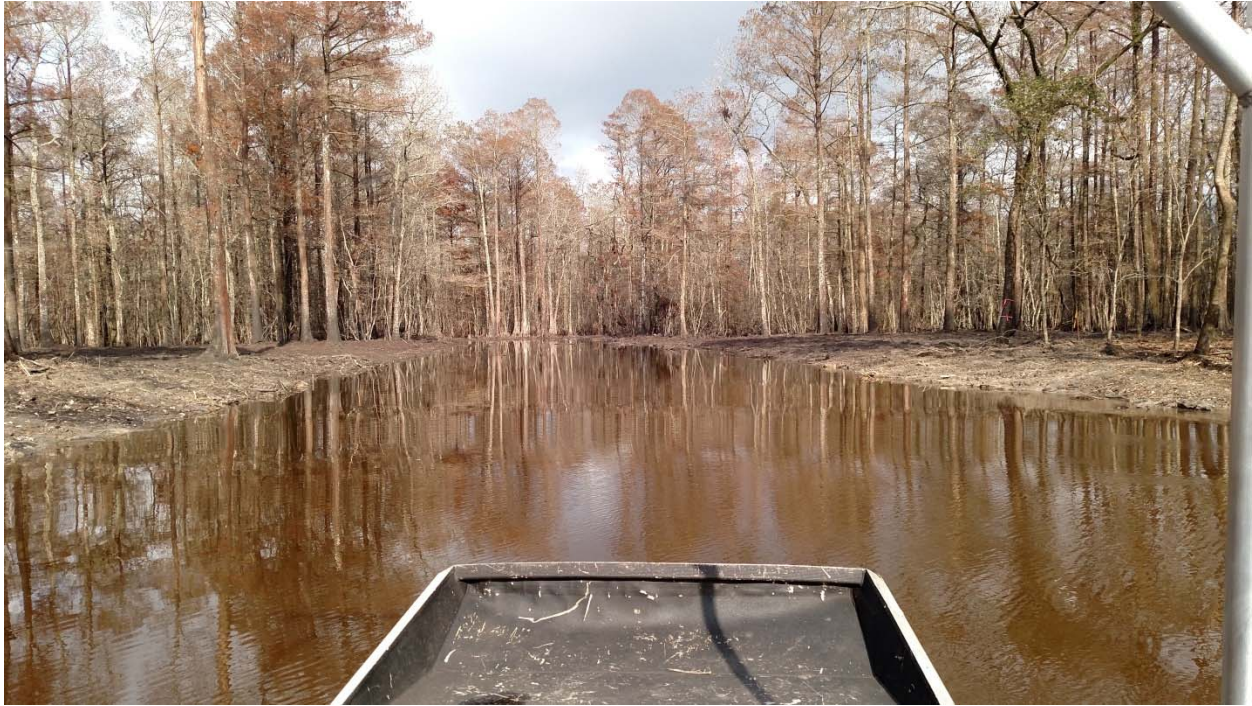
Photograph 11 - Perspective of Gap #1 from Bayou Chevreuil showing swamp draining clear dark water.

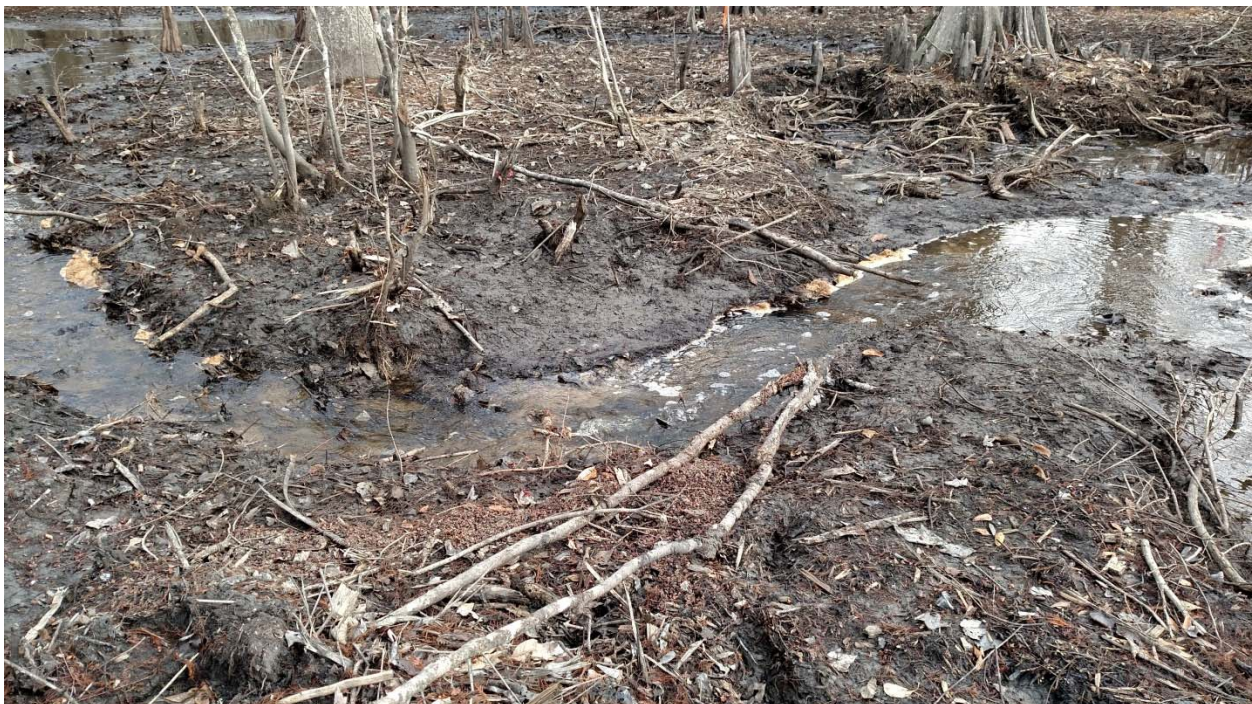
Photograph 12 - Evolving connection between the backside of Gap #1 and the swamp.

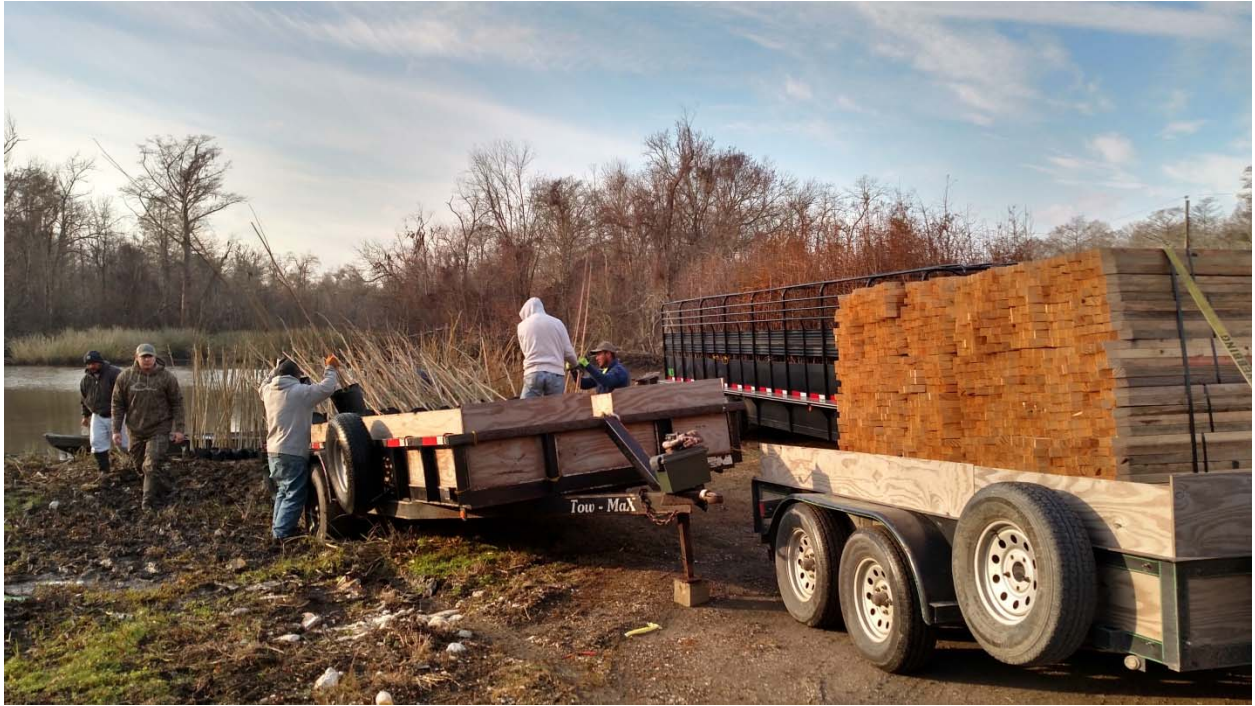
Photograph 13 - Subcontractor RES mobilizing Trees & Field Crew.

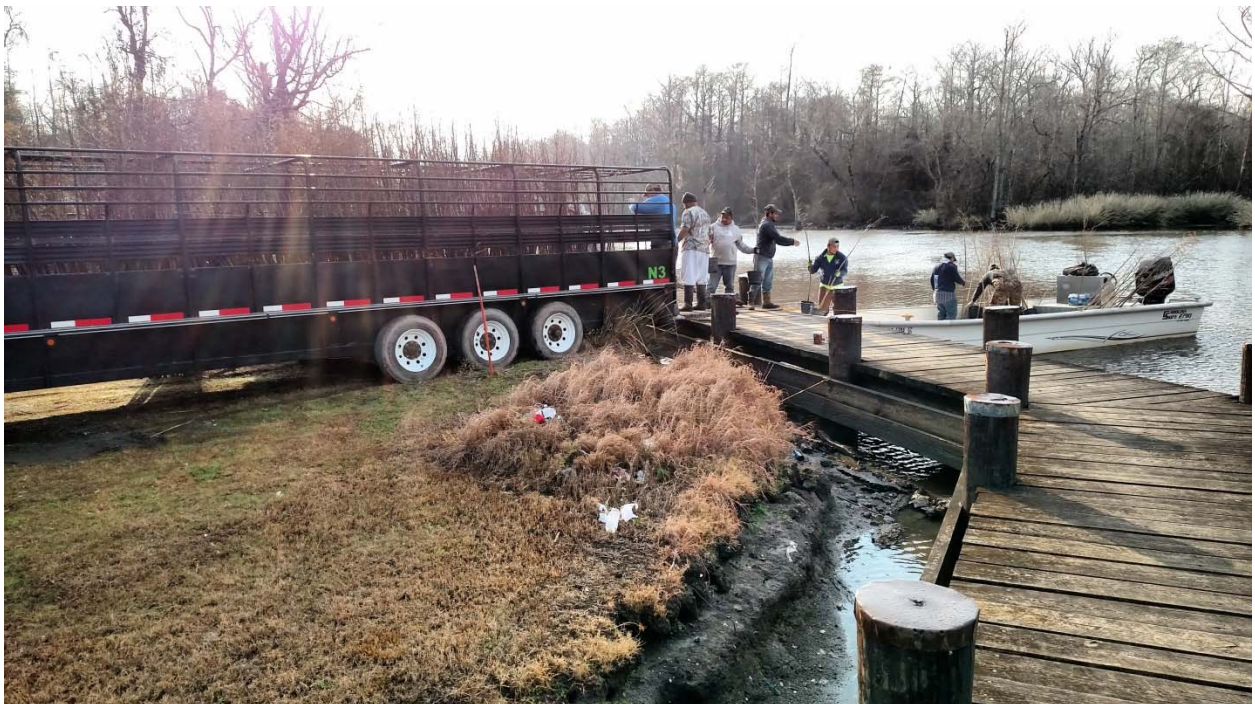
Photograph 14 - Subcontractor loading plants from trailer to skiff.

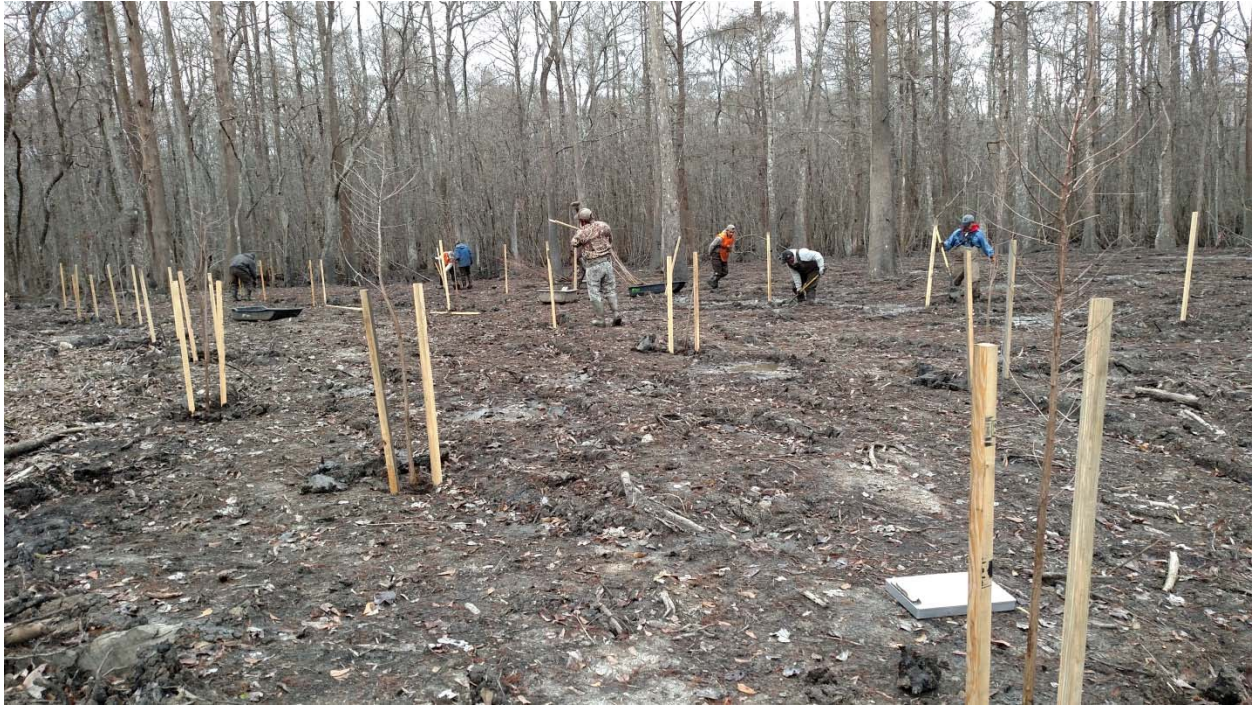
Photograph 15 - Field Crew performing initial tree planting and layout on Gap #1.

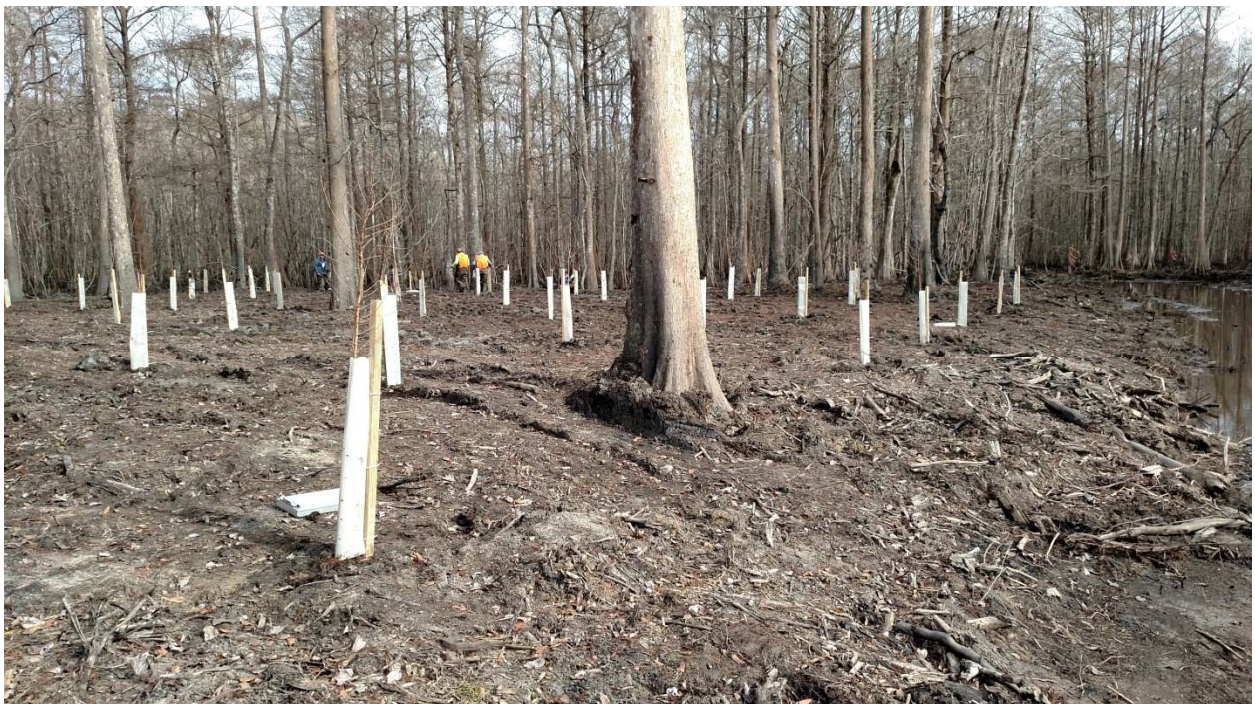
Photograph 16 - Completed Bald Cypress installation on West Spoil Placement Area of Gap #1.

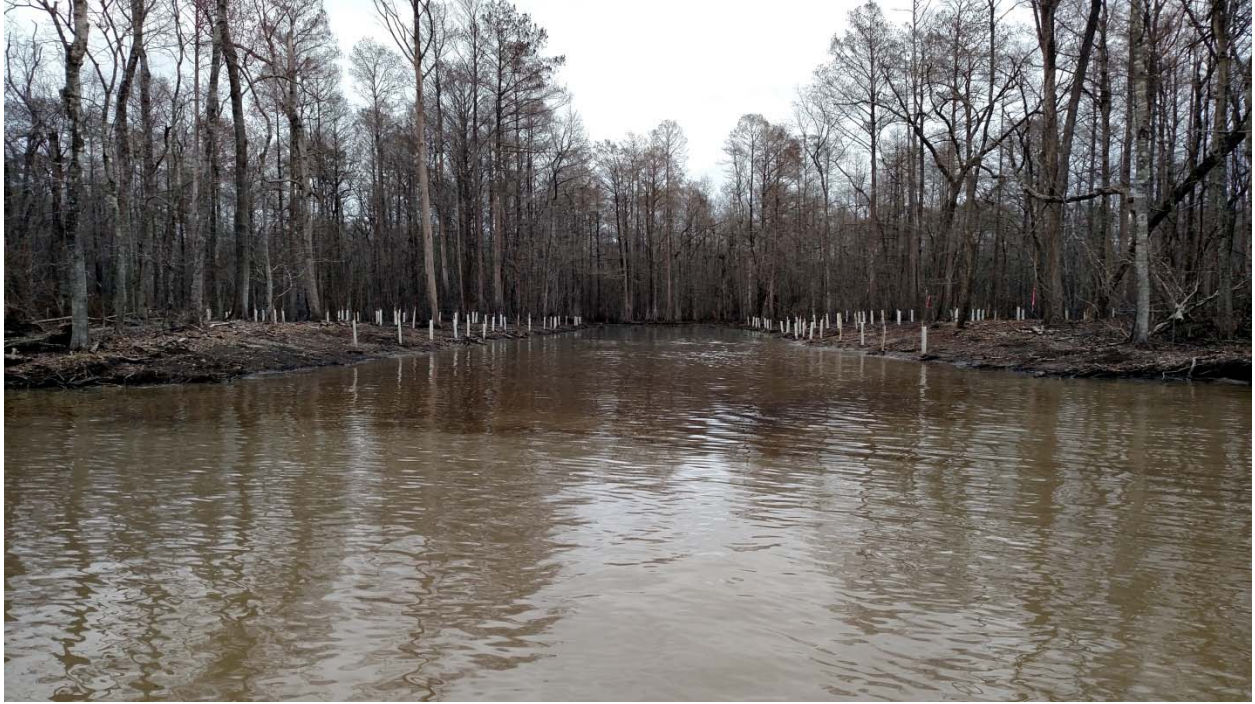
Photograph 17 - Entrance to Gap #1 showing freshly installed tree saplings.

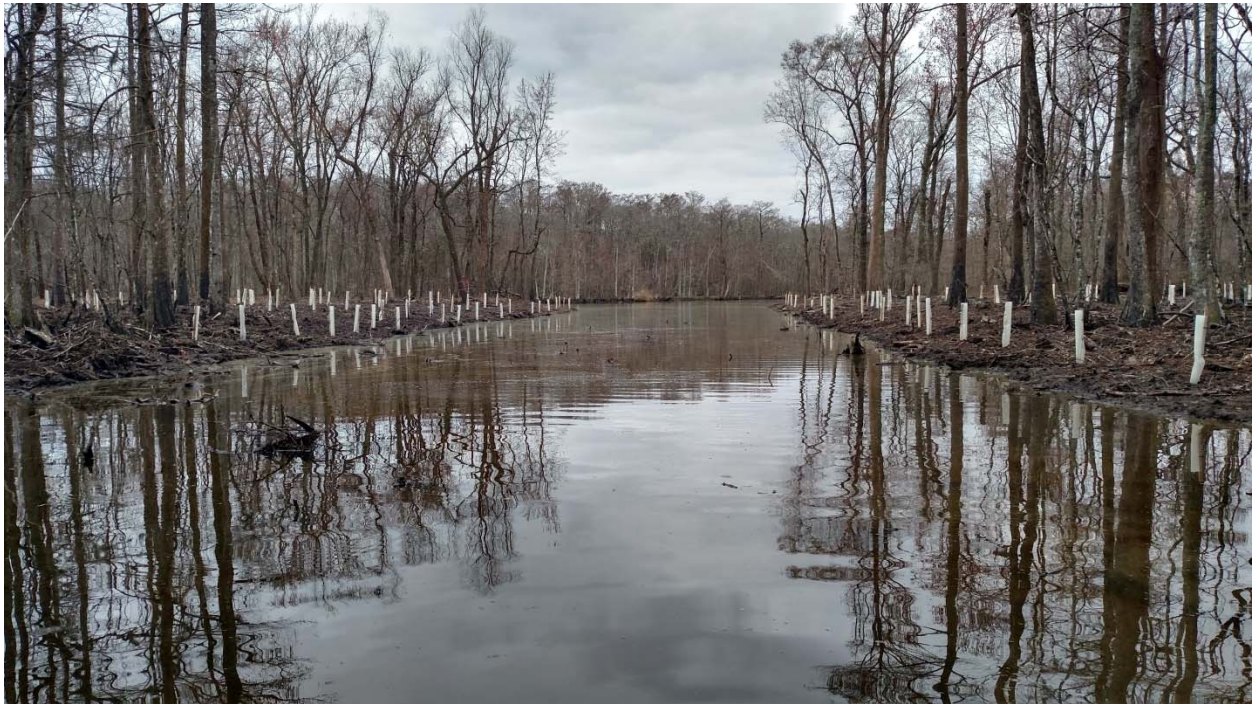
Photograph 18 - Backside of Gap #1 showing freshly installed tree saplings.

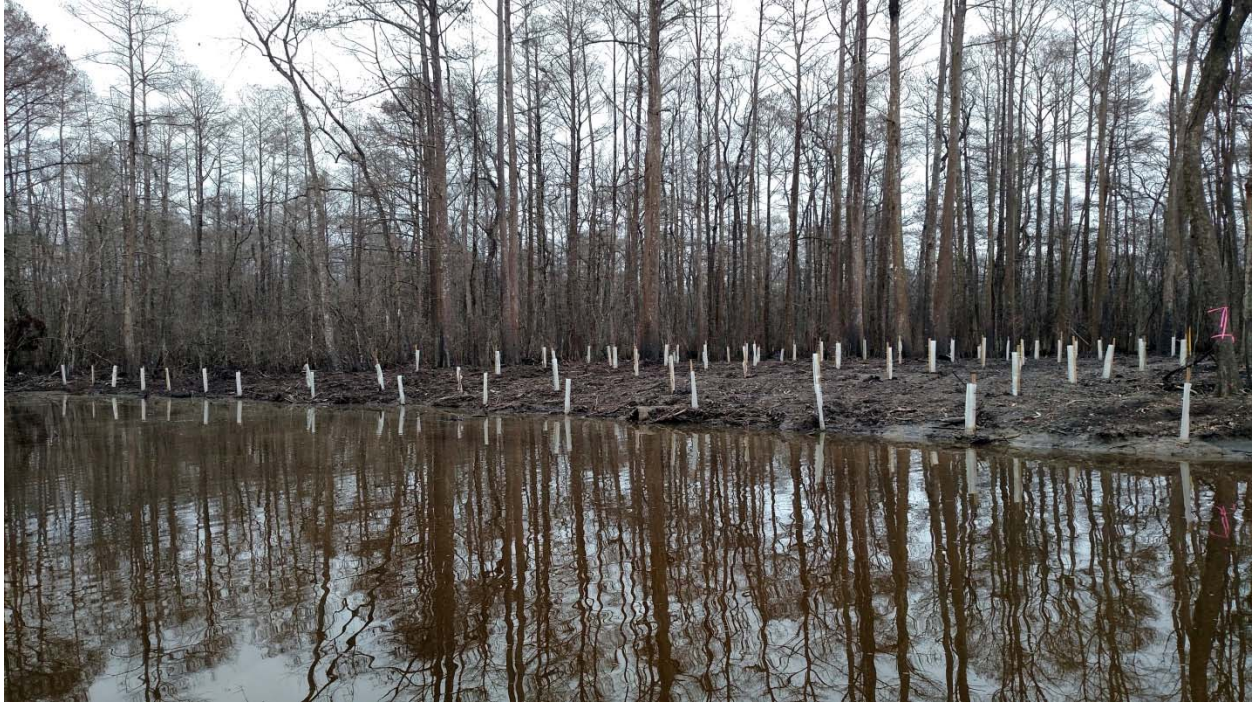
Photograph 19 - East Spoil Placement Area of Gap #1 showing freshly installed tree saplings.

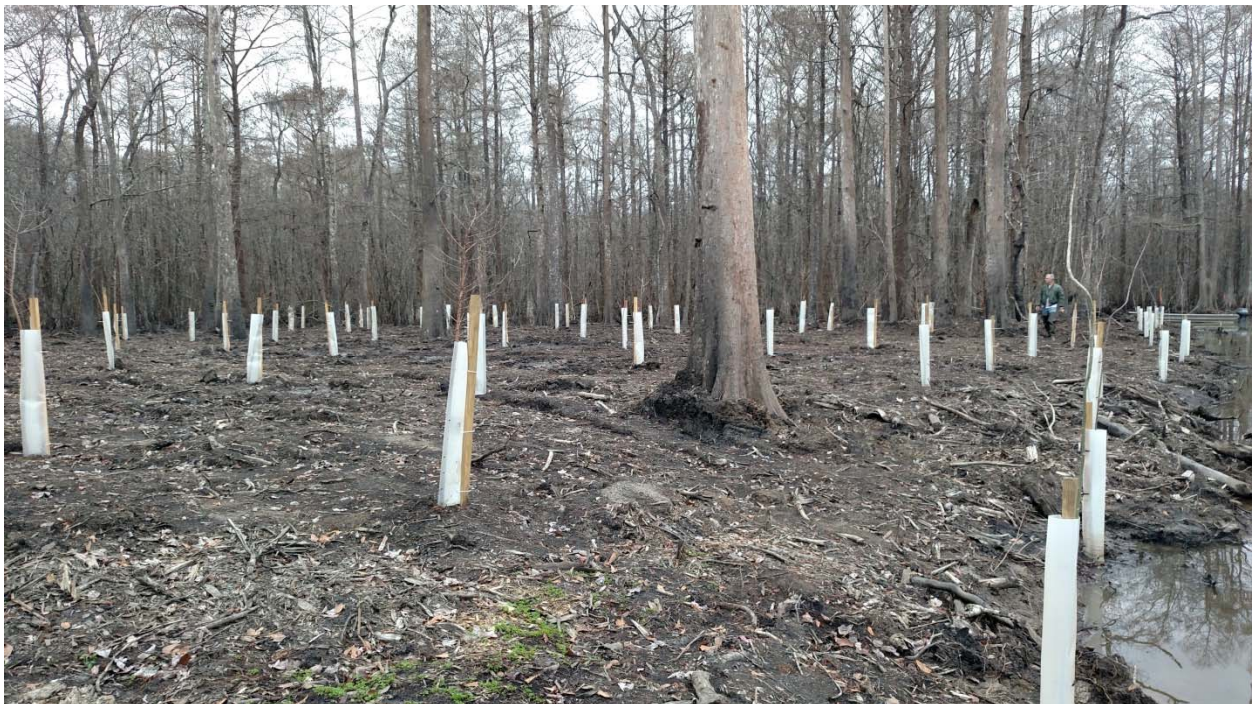
Photograph 20 - West Spoil Placement Area of Gap #1 showing freshly installed tree saplings.

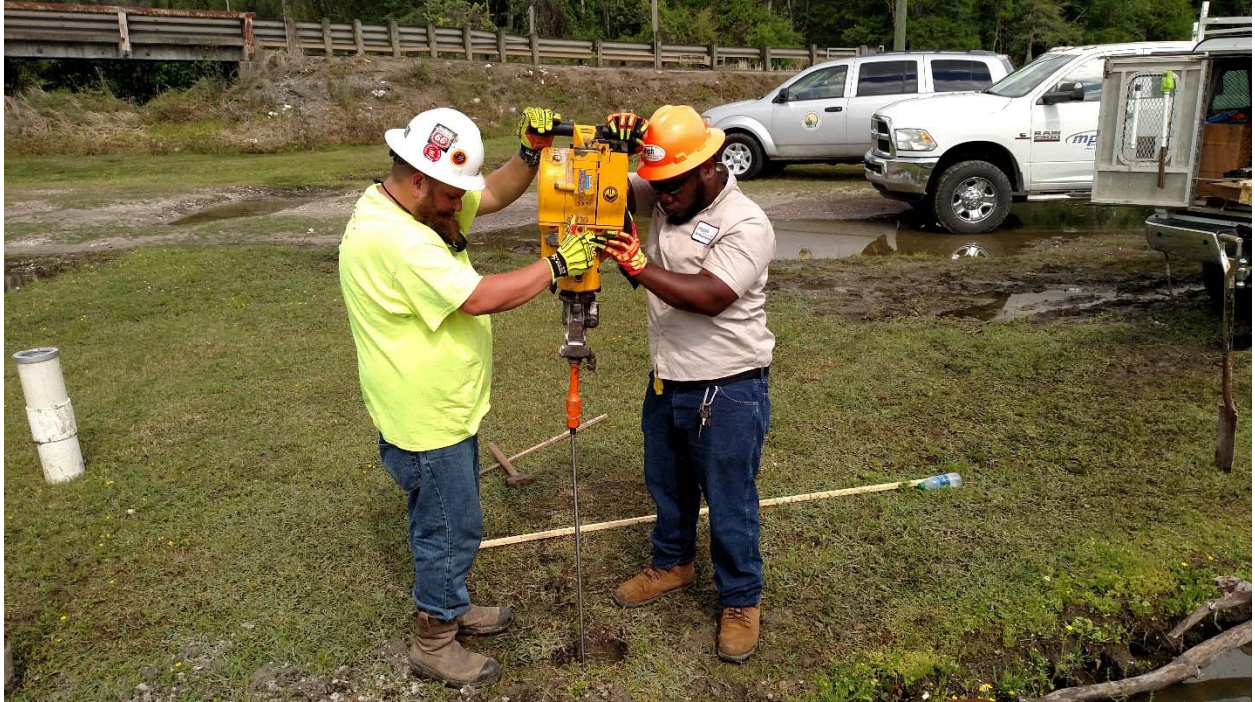
Photograph 21 – MPH crew using a jackhammer to drive rods to refusal.

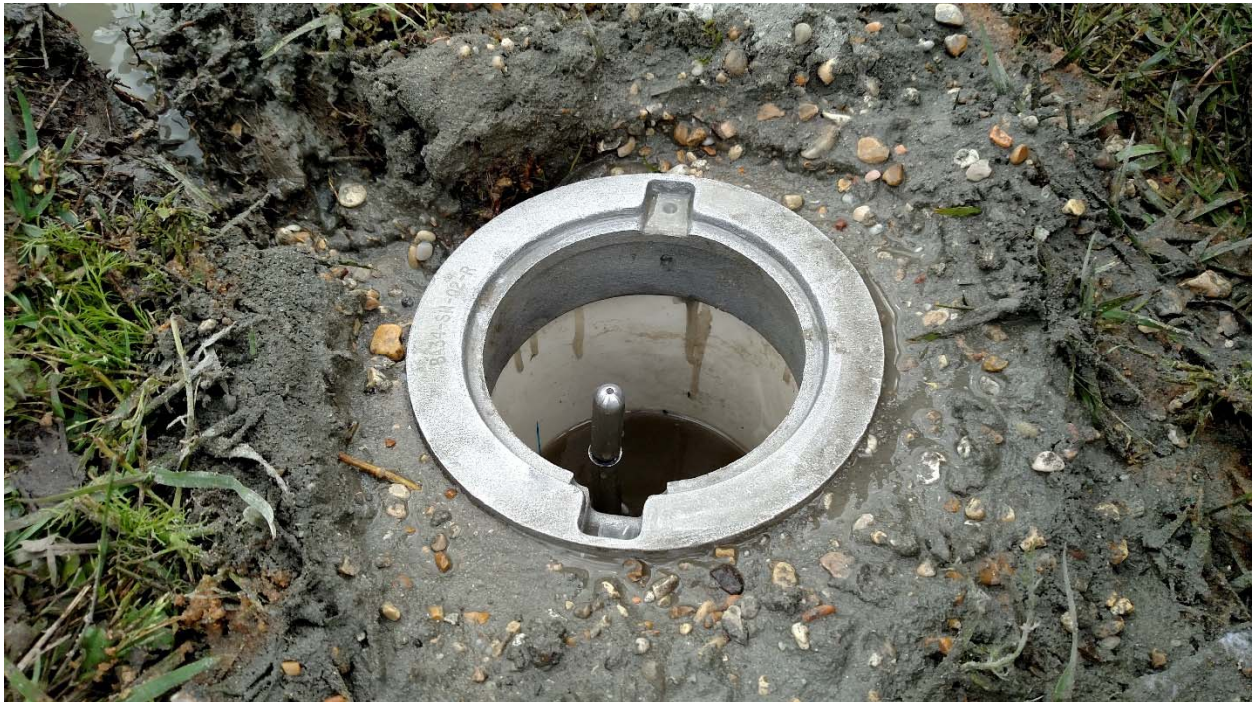
Photograph 22 – Bullet cap screwed onto the last rod with concrete drying around the PVC shell.

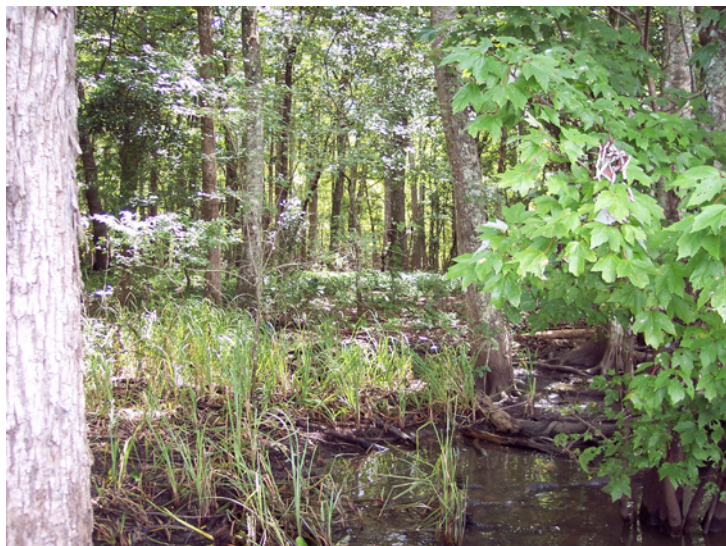
Recent photo at the edge of the swamp. The impoundment has led to a negative effect on cypress and tupelo trees and encouraged the growth of herbaceous marsh plants.
