**State of Louisiana
Coastal Protection and Restoration
Authority**

2013 Annual Inspection Report

**LITTLE LAKE SHORELINE
PROTECTION / DEDICATED
DREDGING NEAR ROUND LAKE
(BA-37)**

State Project Number BA-37
Priority Project List 11

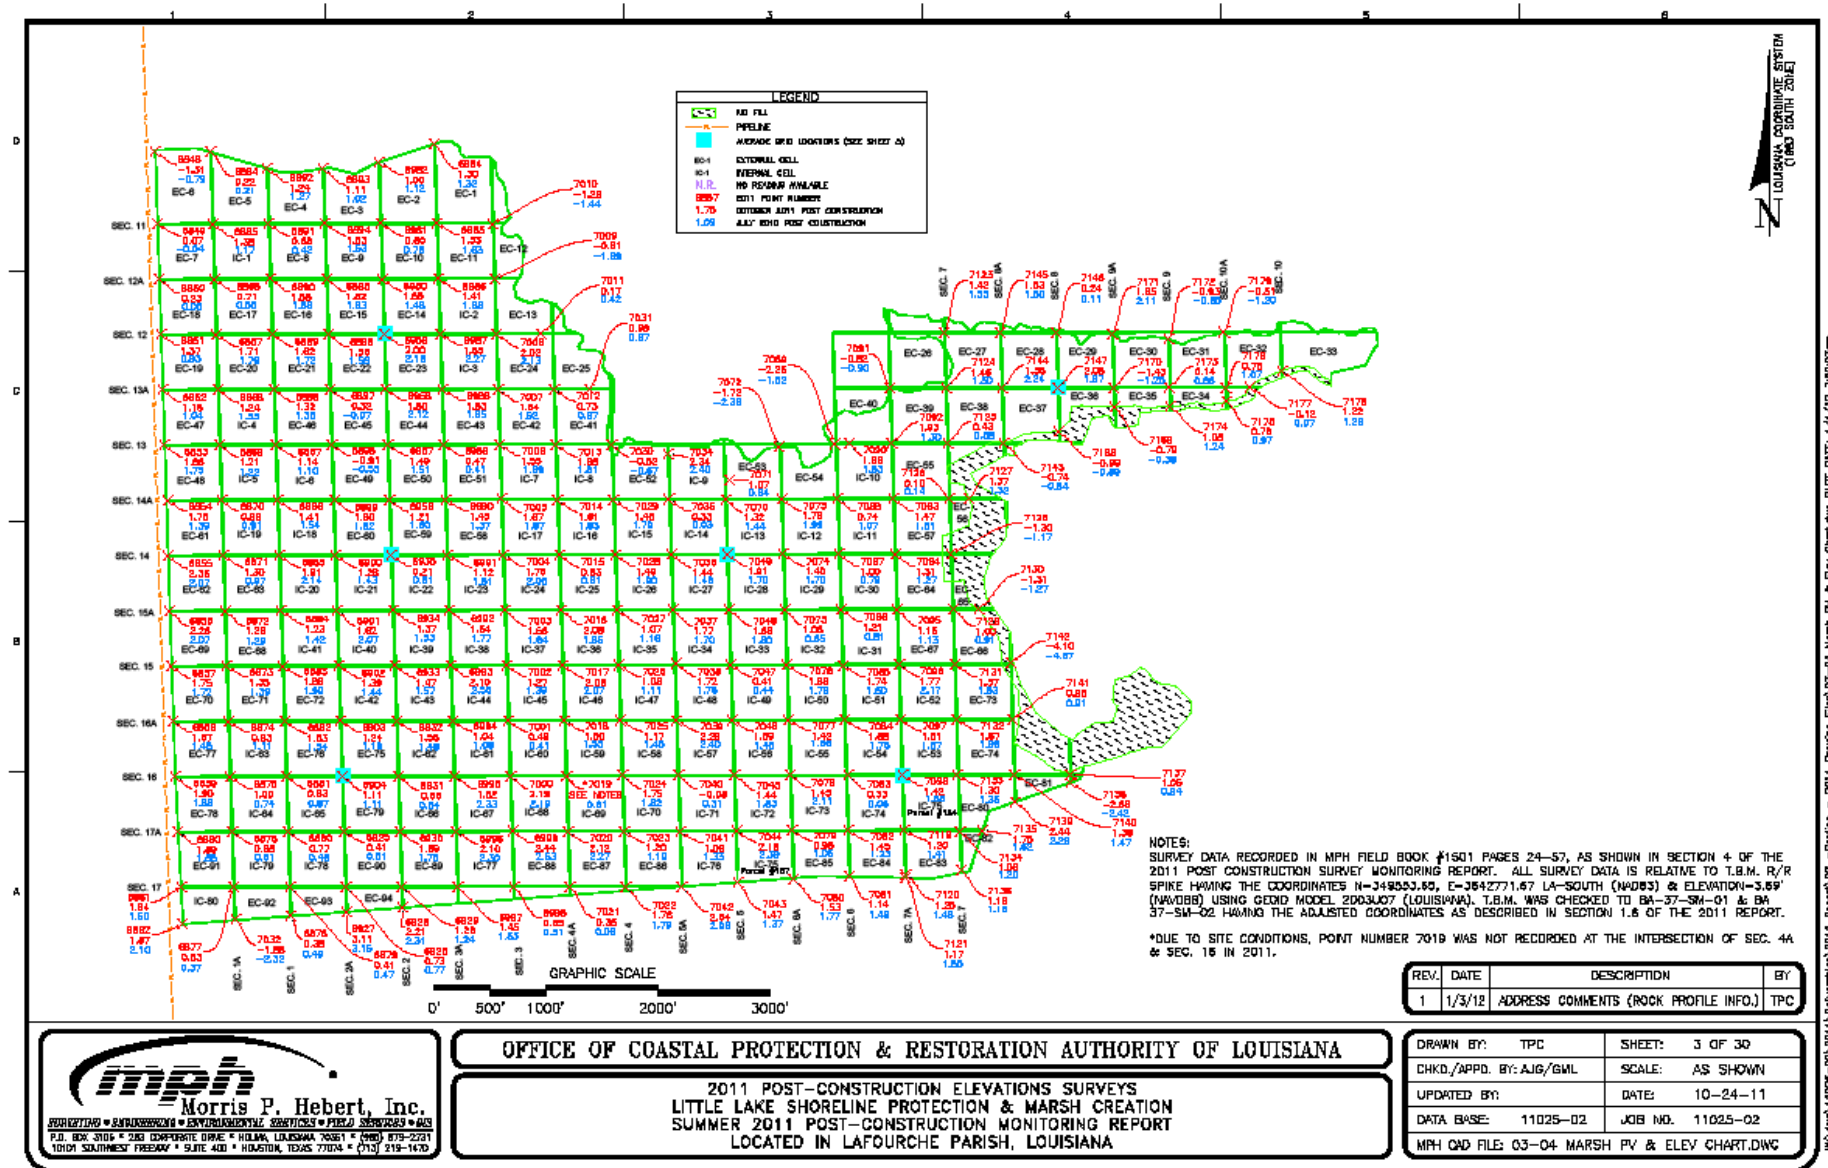
Figure 3. Marsh Creation Area Grid Survey showing June 2009 and July 2010 Elevations

The fill material in the marsh creation area has fully vegetated. As mentioned above, marsh creation area grid point "O&M" surveys were performed in May 2008, June 2009, July 2010, and September 2011 as well as "as-built" and 9-month post-placement (May 2007) surveys. Figure 2 through Figure 4 displays the change in marsh creation elevation from the time of construction to the time of the latest available data (September 2011).

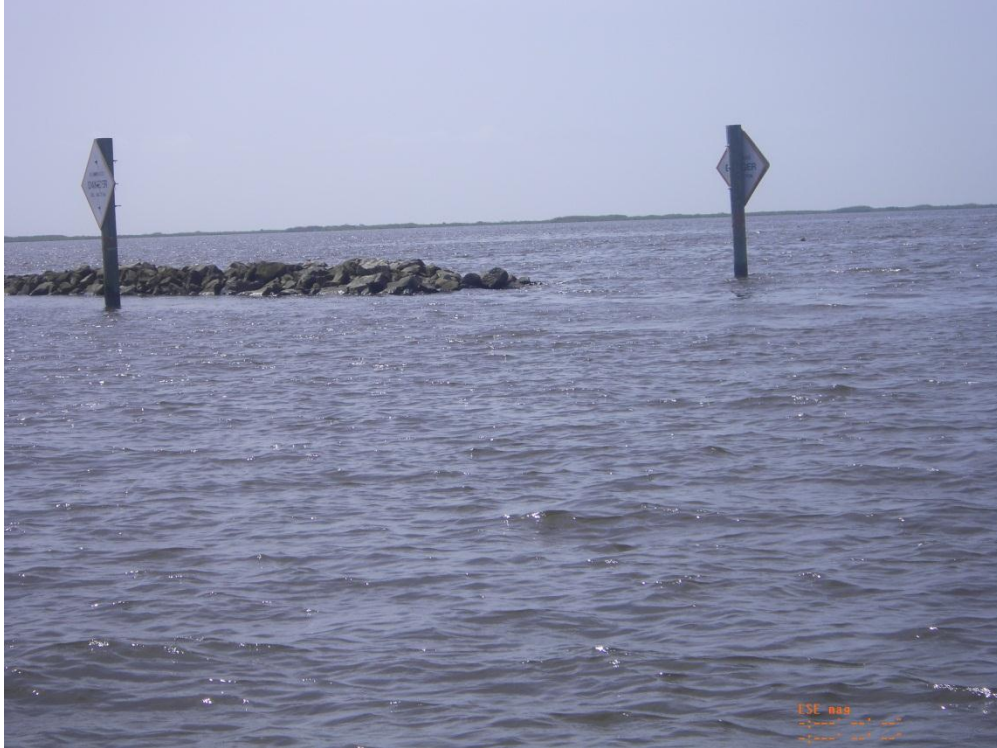
Currently, Rock Segments 1 and 2 have no marsh or vegetation along their southern edge, only open water. The fringe marsh that once separated Brusle Lake and Bay L'Ours, located along Rock Segments 1 and 2, has been eroded below the water level by Hurricane Katrina. This land loss occurred during construction of the project and the rock segments were put in place as designed and contracted. There are no recommendations for maintenance at this time; however this site will continue to be monitored to determine if the rock segments have become a hazard, and corrective actions will be conducted as needed.

Photo 1: View of the end of Rock Segment 1 from Bay L'Ours, looking southeast

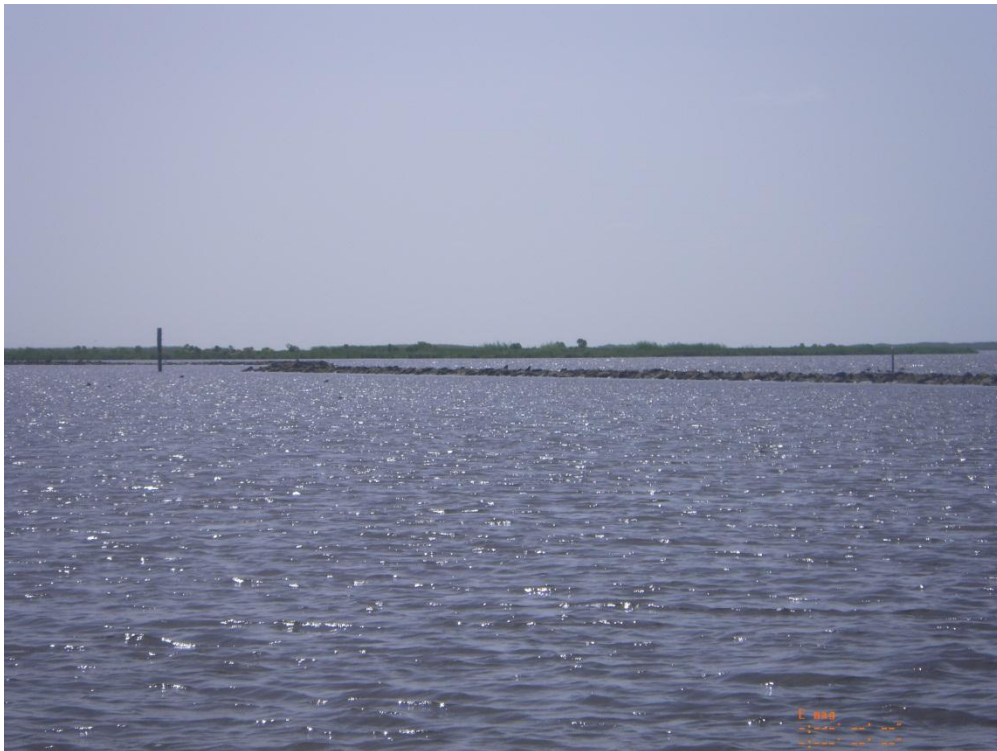
Photo 2: View of Rock Segment 1 from Bay L'Ours, looking southeast

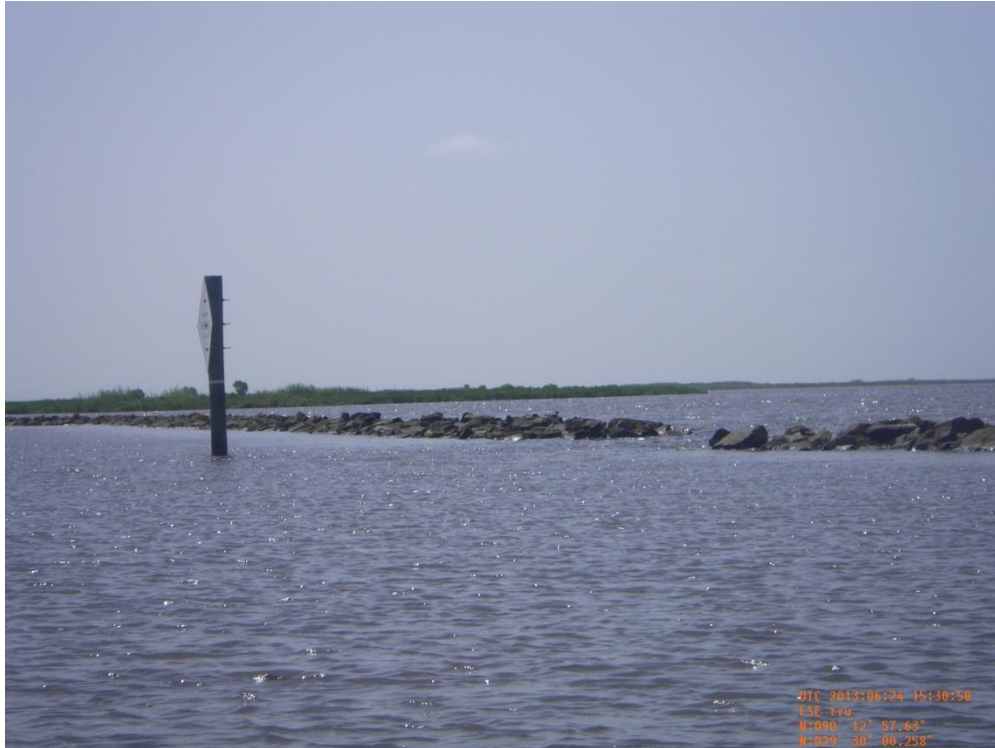
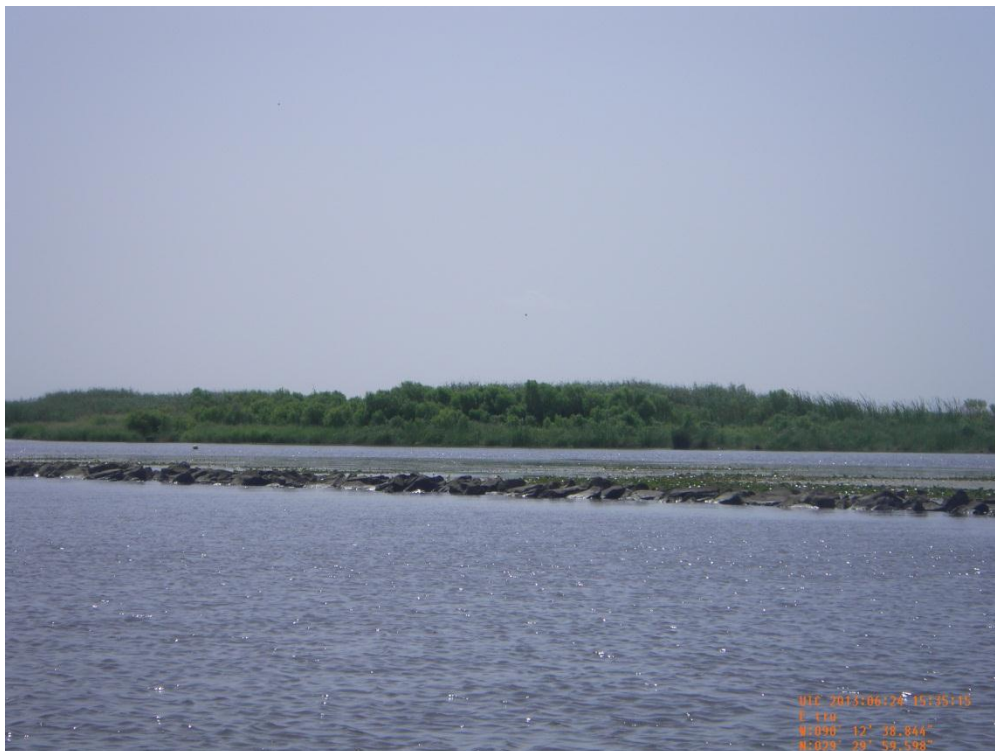
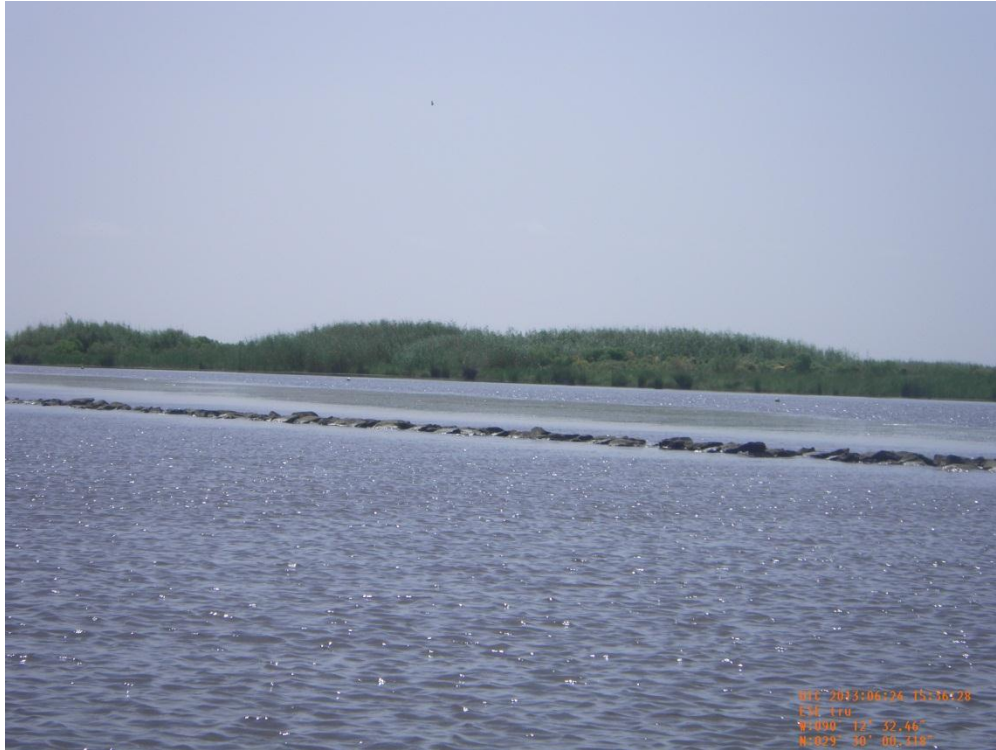
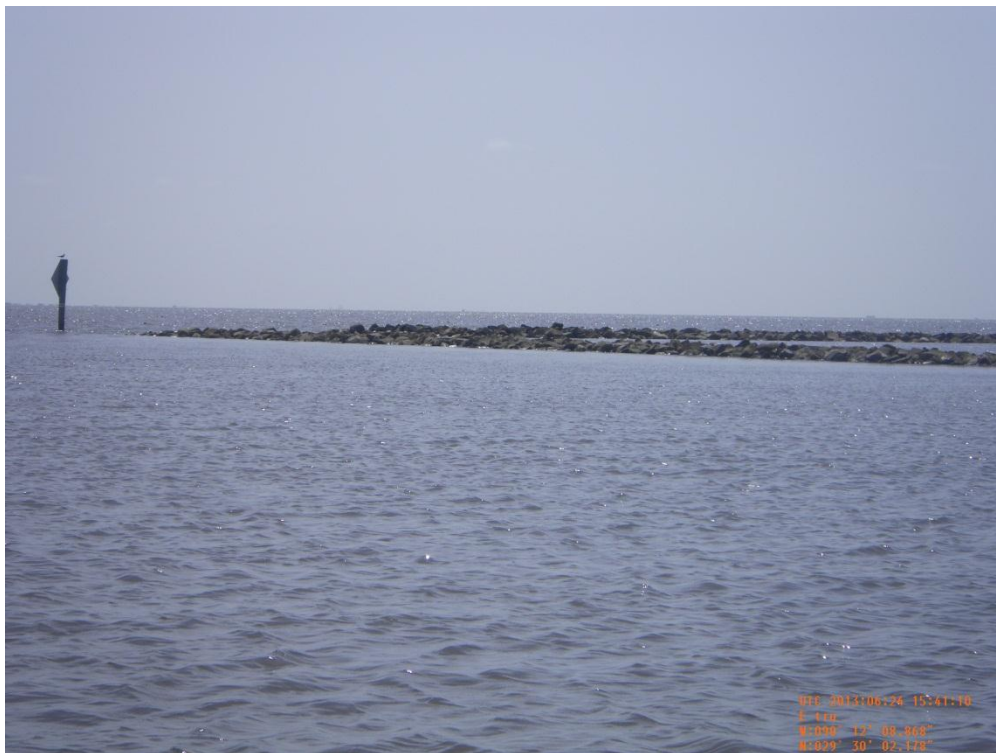
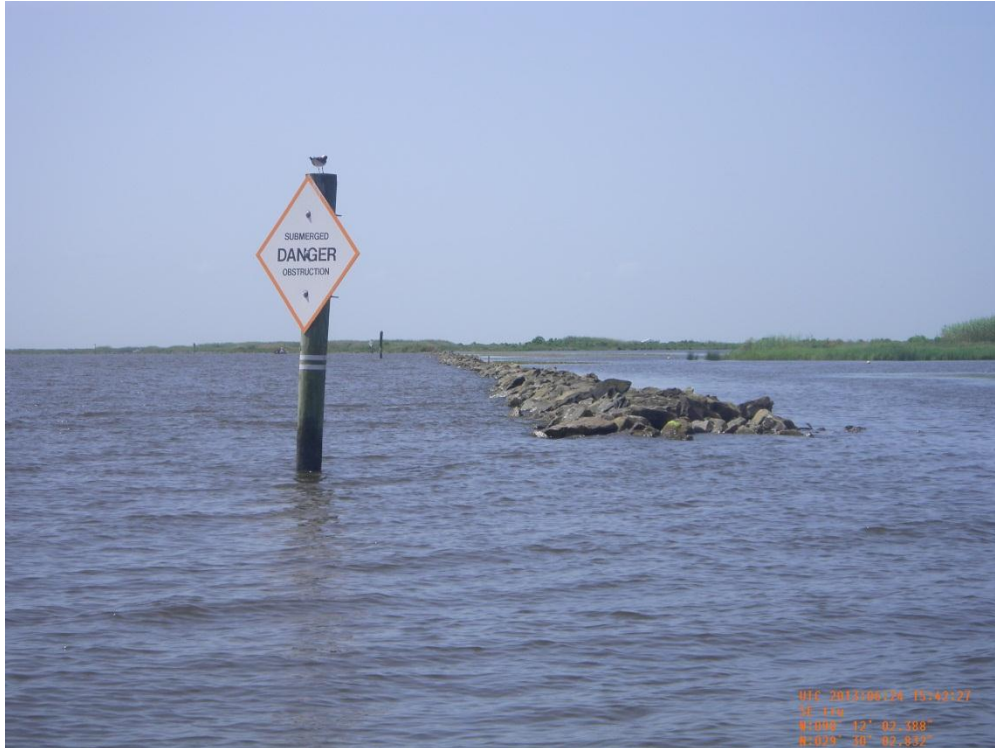
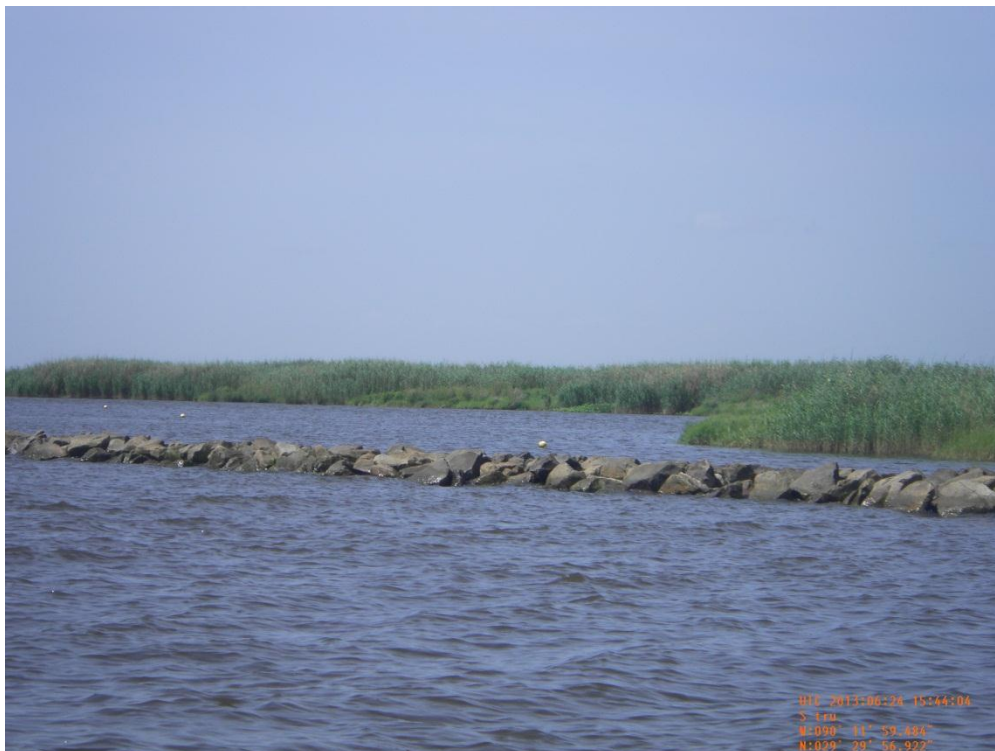
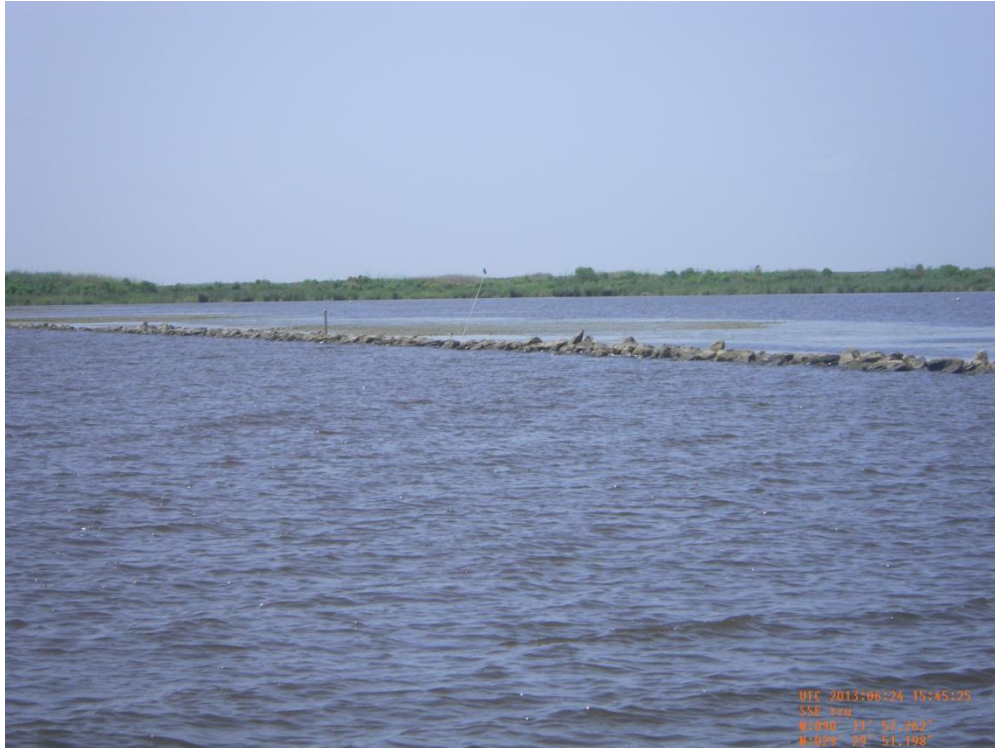
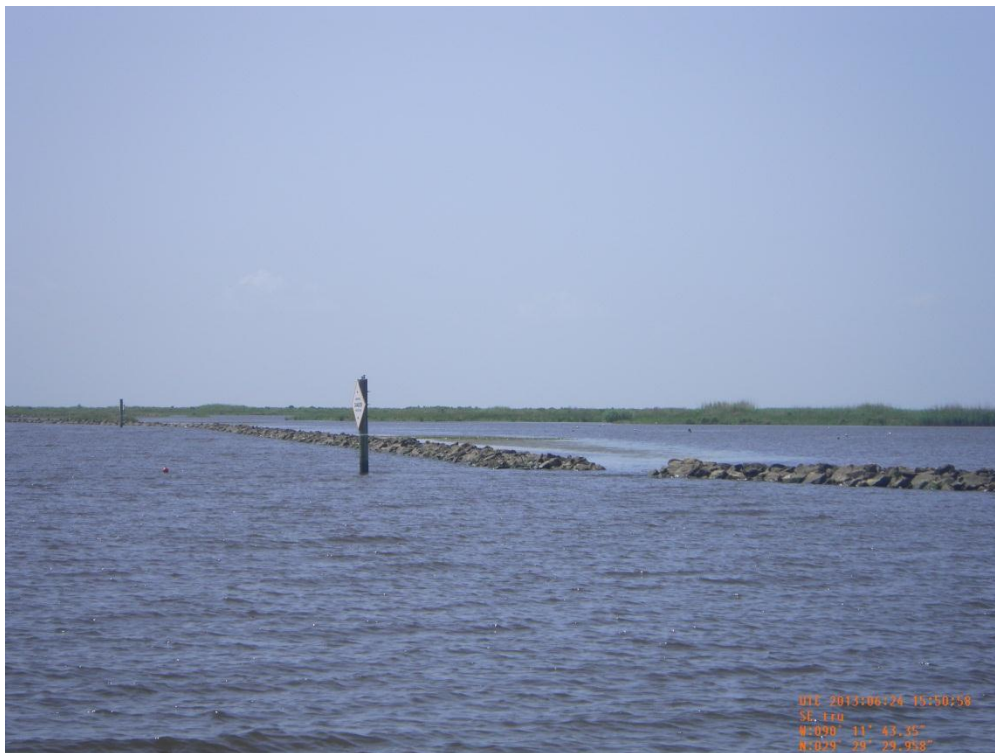
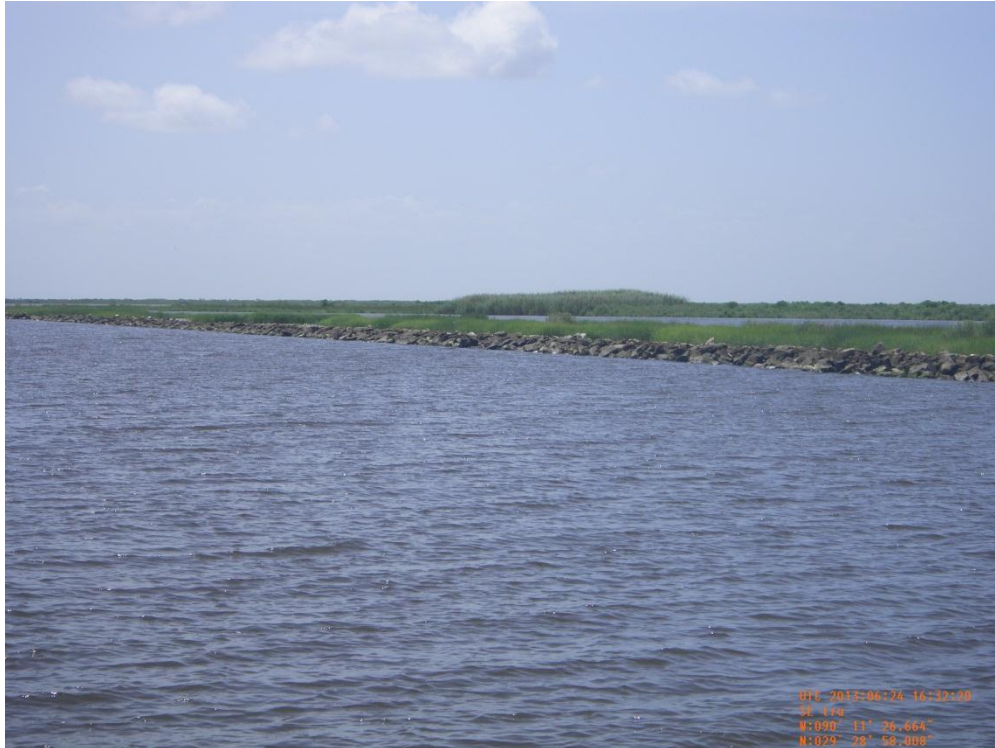
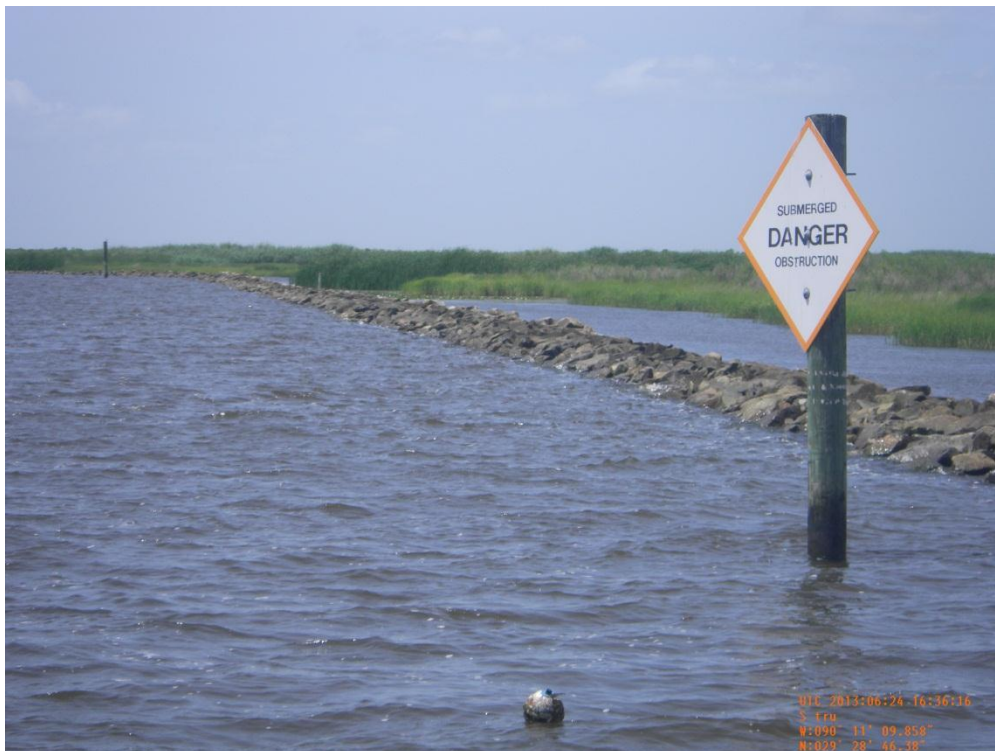
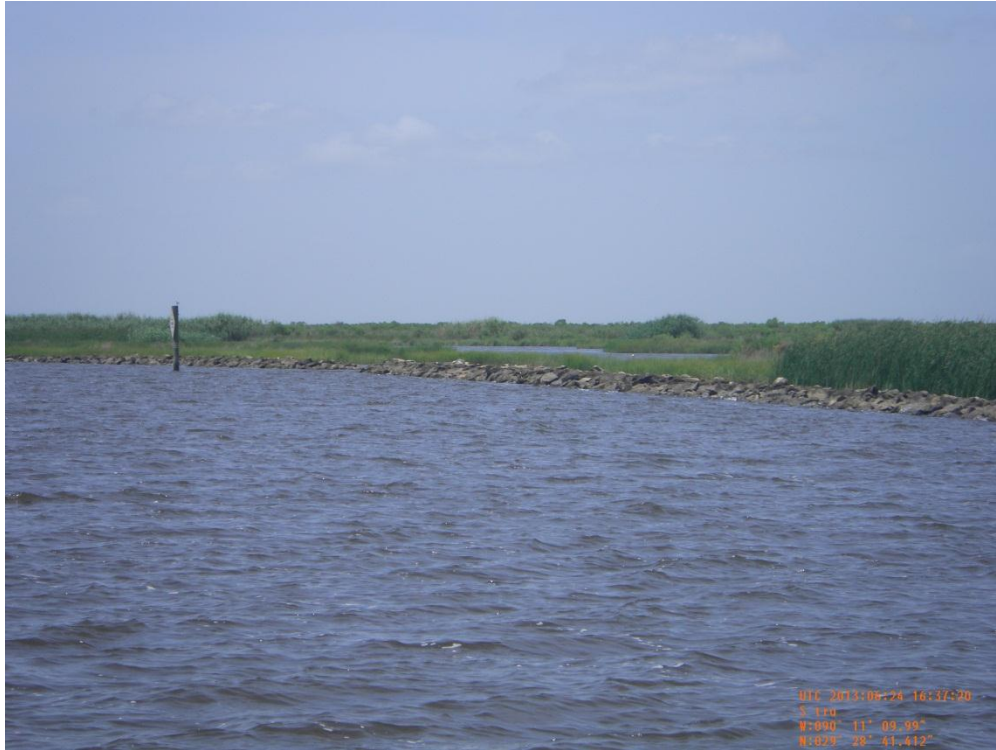
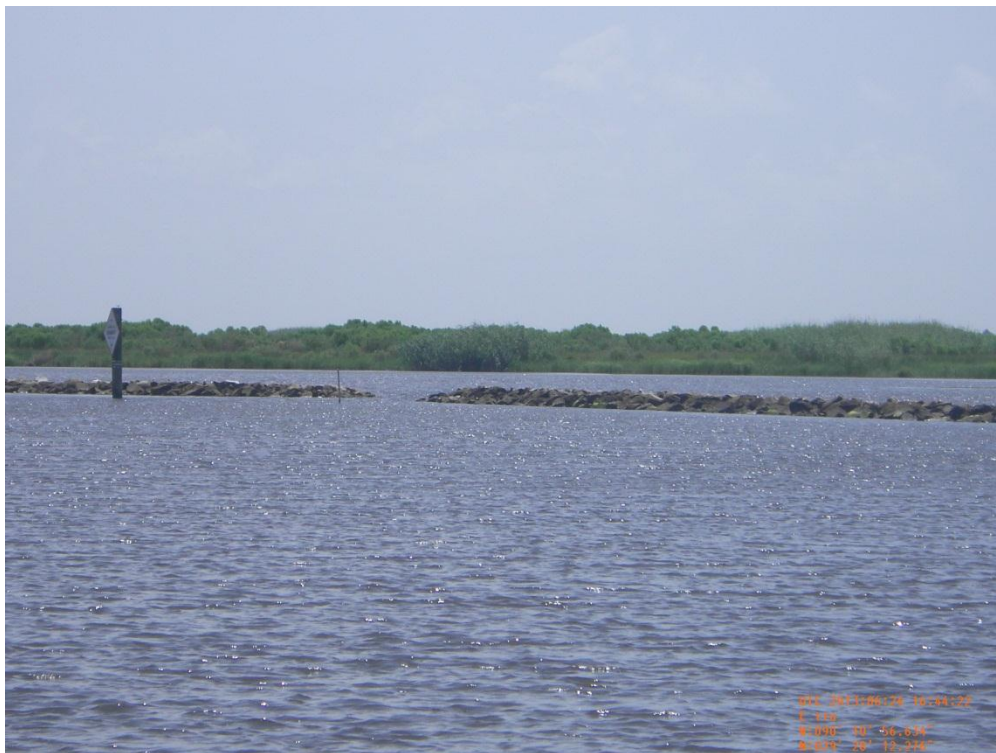
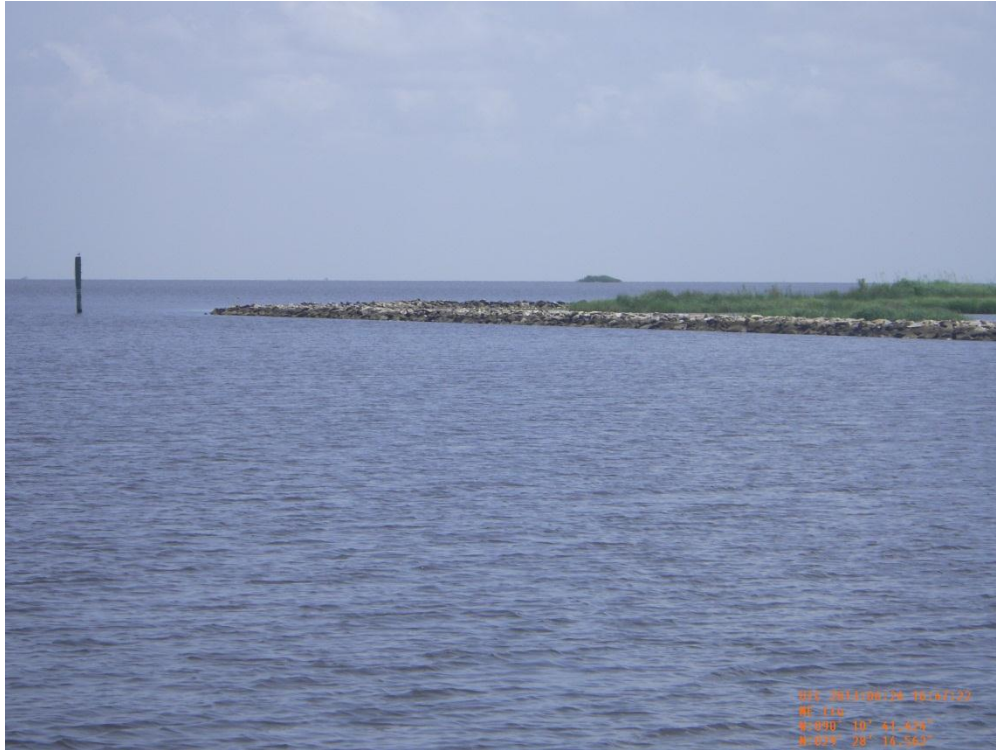
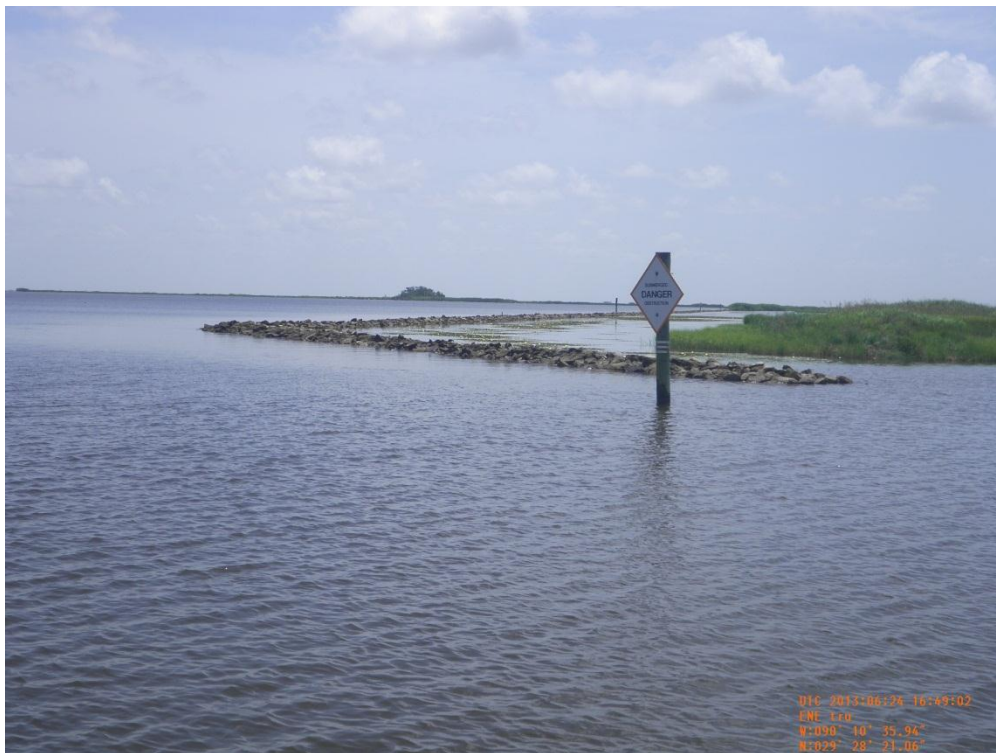
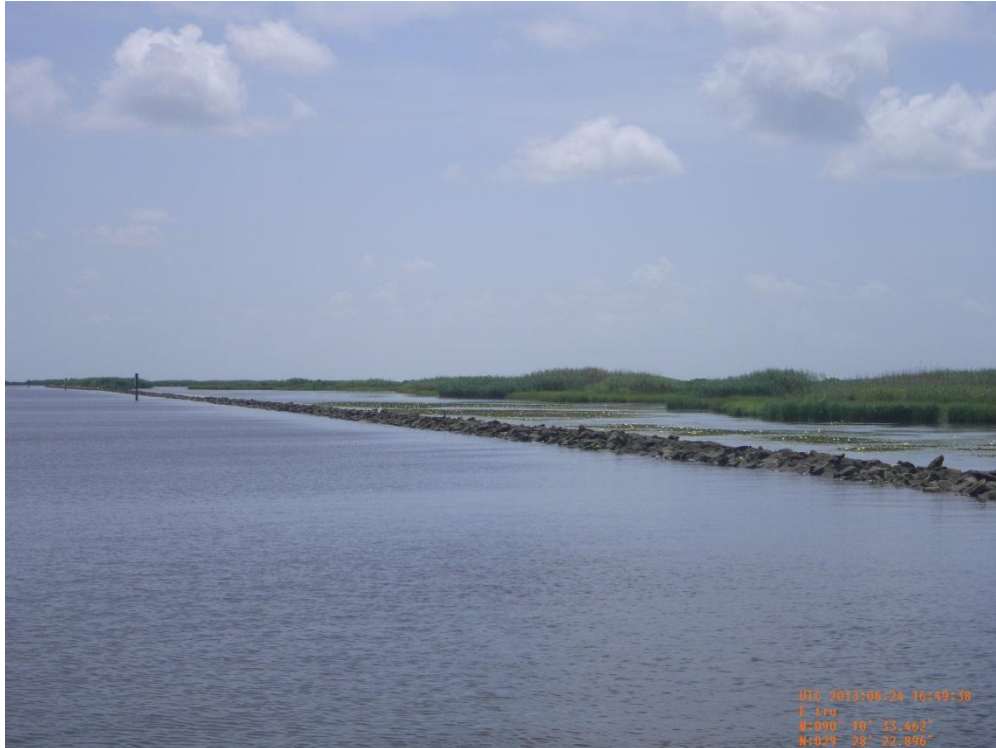
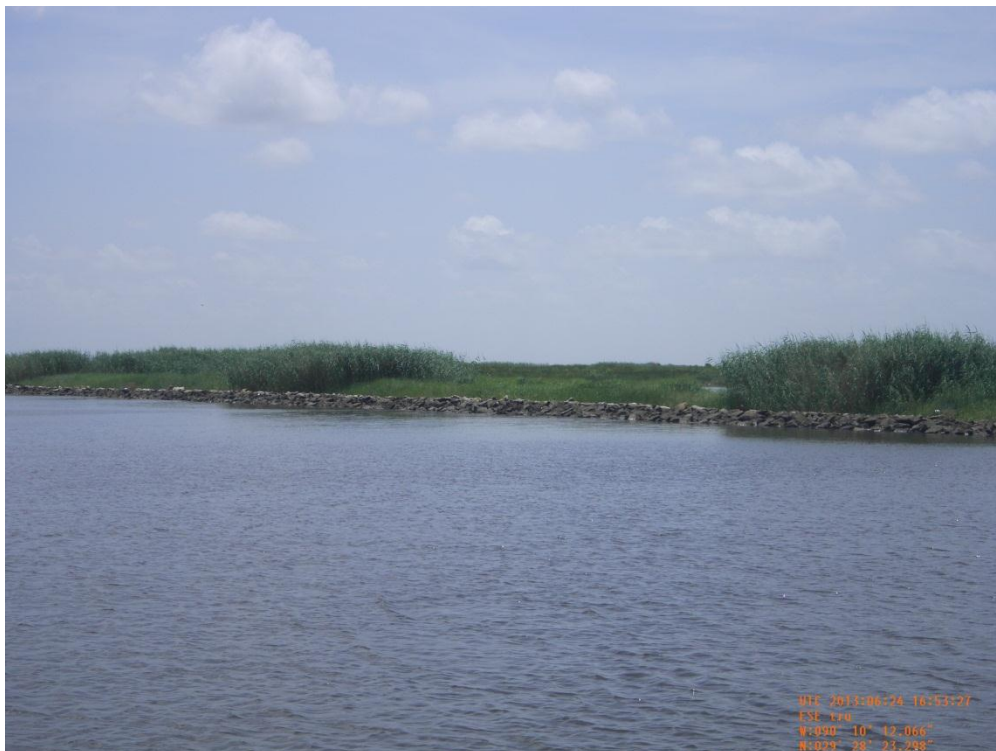
Rock Segments 1 – 24 (Photos 1 – 10 & 15 – 24, Appendix B)

All rock segments were visually inspected by boat. It appears all rock segments have experienced some amount of rock settlement. Some segments have portions that are below EL 2.5 FT including those that did not receive a third lift during construction (1-5, 8, 9). The elevation of the settlement plates were initially surveyed after construction in 2007 and then again every year until 2011. Comparing the final construction survey elevations of the settlement plates (February 2007) to the latest settlement plate survey (September 2011) shows an average settlement of 0.42 feet across the 24 segments, with the most extreme settlement being 0.70 feet. The survey conducted in 2011 (year 4) was the latest of the five surveys done since construction. During the visual inspection, it was observed that some areas were approaching the waterline. It is recommended that an additional survey is conducted to obtain survey profile of the rock segments. Based on the survey data it can be determined if a maintenance rock lift is necessary at this time. All warning signs and supports along the rock segments appear to be in good condition. There are no other recommendations for maintenance at this time.

Spoil that was placed behind the rock segments has fully vegetated. Also, it appears that the SAV (submerged aquatic vegetation) behind the rock segments continues to increase from past inspections. This can be seen in the inspection photos located in Appendix B.

Based on the visual observations during past annual inspections and the settlement plate data from the post-construction surveys, all of the rock dike segments have experienced some settlement. During the 2013 annual inspection it was observed that some segments were approaching the waterline and could become submerged during high tide events. In order to quantify the amount of settlement, it is recommended that an additional survey is conducted at this time to obtain survey profile of the rock segments. With this data it can be determined if a rock lift maintenance event is necessary. There are no other recommendations for maintenance at this time.

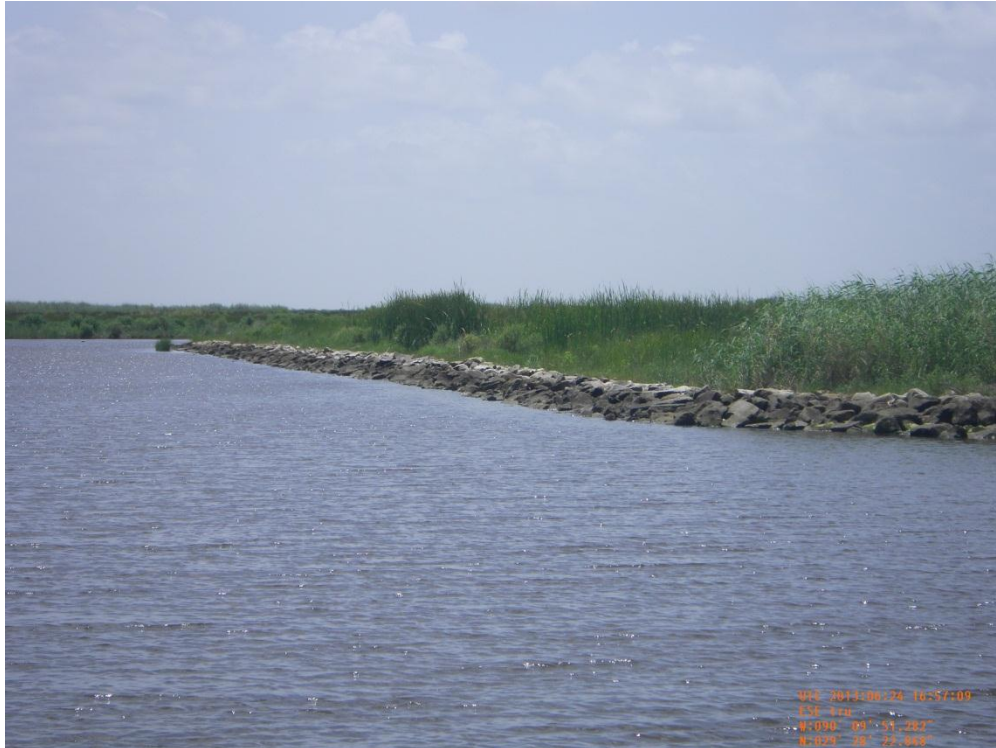
Photo 23: View of Rock Segment 24 near John the Fool Bayou, looking southeast

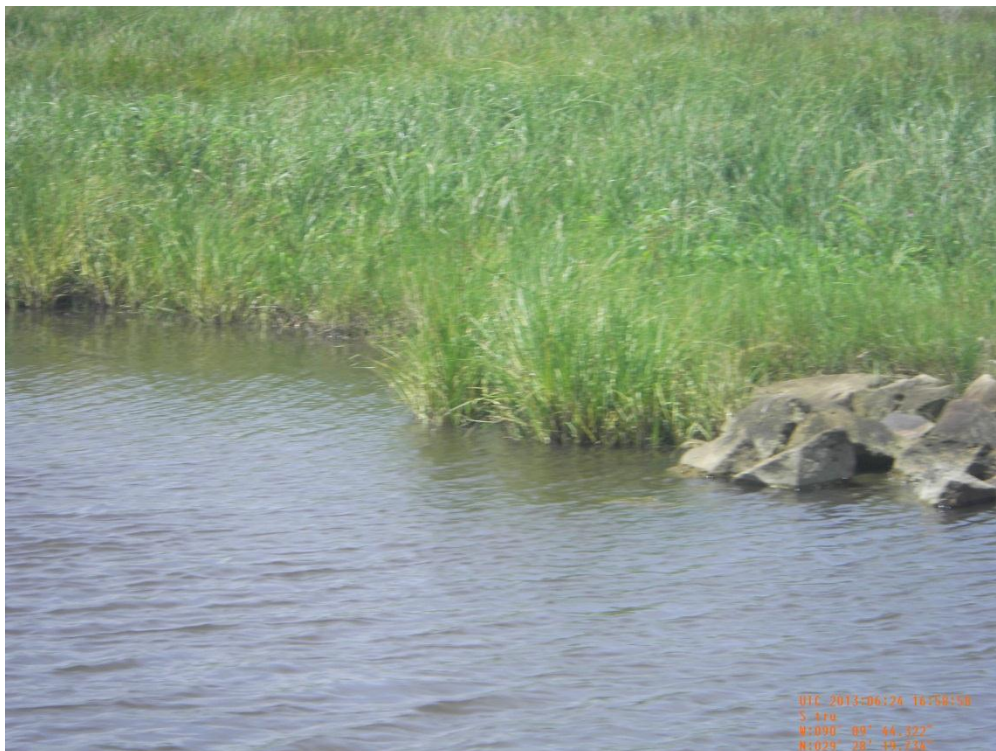
Photo 24: End of Rock segment 24 near John the Fool Bayou, looking southeast
