2016 Annual Inspection Report

**LITTLE LAKE SHORELINE
PROTECTION / DEDICATED
DREDGING NEAR ROUND LAKE
(BA-37)**

State Project Number BA-37
Priority Project List 11

May 19, 2016
Lafourche Parish

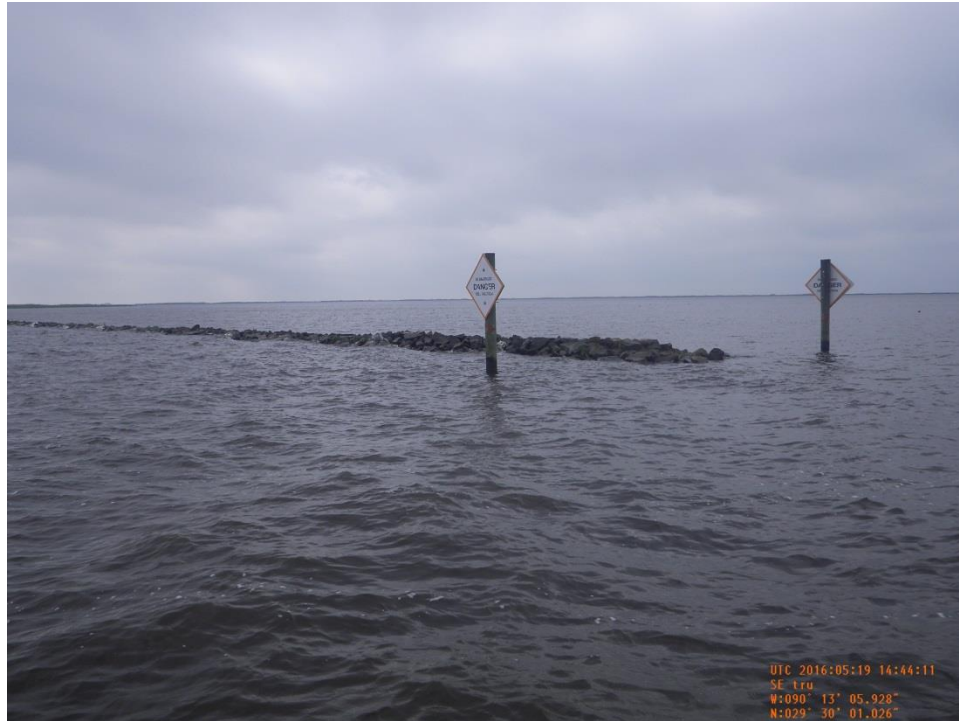
Currently, Rock Segments 1 and 2 have no marsh or vegetation along its southern edge, only open water. The fringe marsh that once separated Brusle Lake and Bay L'Ours, located just south of Segments 1 and 2 had eroded following Hurricane Katrina in 2005. This land loss occurred during construction of the project and the rock segments were installed as designed and contracted. Due to the liability associated with the rock dike being below the water surface during high tides and the lack of existing marsh behind the structure, NMFS and CPRA had decided to degrade Segment 1 and part of Segment 2, because the eastern edge of Segment 2 still protects the marsh behind Segment 3 from wave action. In the 2015 inspection report, CPRA had decided against recovering the rock riprap and installing at another location, instead electing to degrade the rock dike to a safe elevation along the lake bottom. This method was seen as more cost effective than recovering the rock riprap. However, recent discussions between the NOAA representative and CPRA have rehashed the possibility of recovering the rock and building a small jetty branching off Segment 2 where the degrading terminates. The increased cost (although shared) of additional surveying and obvious alternative construction will have to be considered. The last survey of the entire rock shoreline was conducted in 2011. A complete Pre-Design survey of the rock dike on Segments 1 & 2 was concluded in February and will be added to the future surveying to be used for permitting and construction plans. The cost of additional surveying for the terminal rock jetty has been included in the 3 year budget.

Photo 1: Beginning of the rock dike (Segment 1) near Sta. 10+00 at the entrance of Breton Canal.

As observed during post-construction surveys and visual inspections of the rock dike structure along the southern marsh of Little Lake and Round Lake, all of the rock dike segments have experienced some settlement. Over time, the settlement of the rock dike in the vicinity of Segments 1 and 2 has presented potential hazardous navigation conditions because the dike extends out into open water in an area without land behind it. A combination of high tides causing the rock dike to become submerged and the lack of a marsh shoreline behind both segments has resulted in a decision by NMFS and CPRA to degrade Segment 1 and part of Segment 2. Design surveys for degrading these segments were completed in February 2016. The current plan is to recover the rock rip rap for beneficial use in the construction of a terminal jetty near Segment 3; additional surveys for the creation of the jetty are expected to begin in July 2016. Construction is anticipated to start in November 2016.

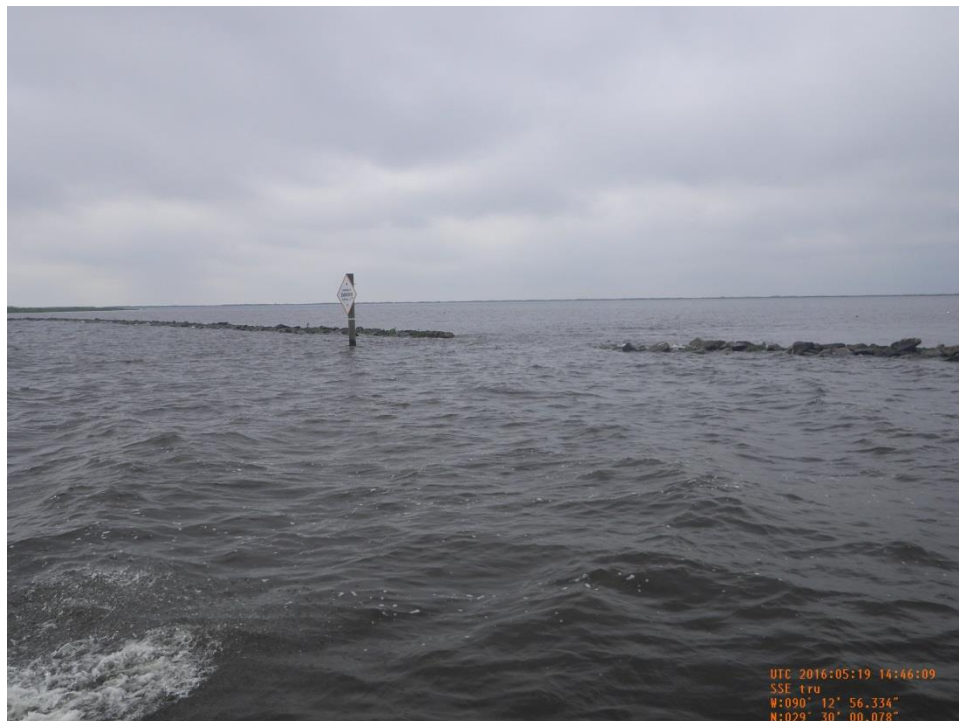
Photo 2: Beginning of rock dike (Segment No.2) looking southward.

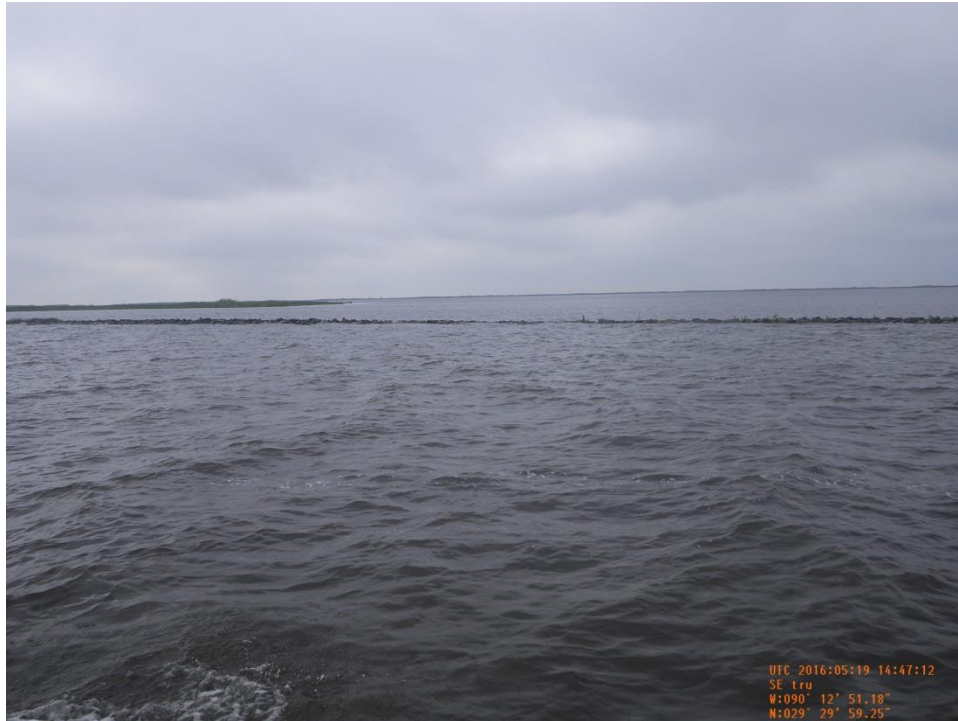
All rock segments were visually inspected by boat. It appears that all rock segments have experienced some degree of settlement with the most obvious settlement on the western end of the project (Segments 1 through 8), where only two (2) rock lifts were made during construction. Segments 10 through 24 received a third lift during construction and appear to be in good to fair condition.

Photo 3: Low area along the rock dike (Segment No.2) near Sta. 23+93.

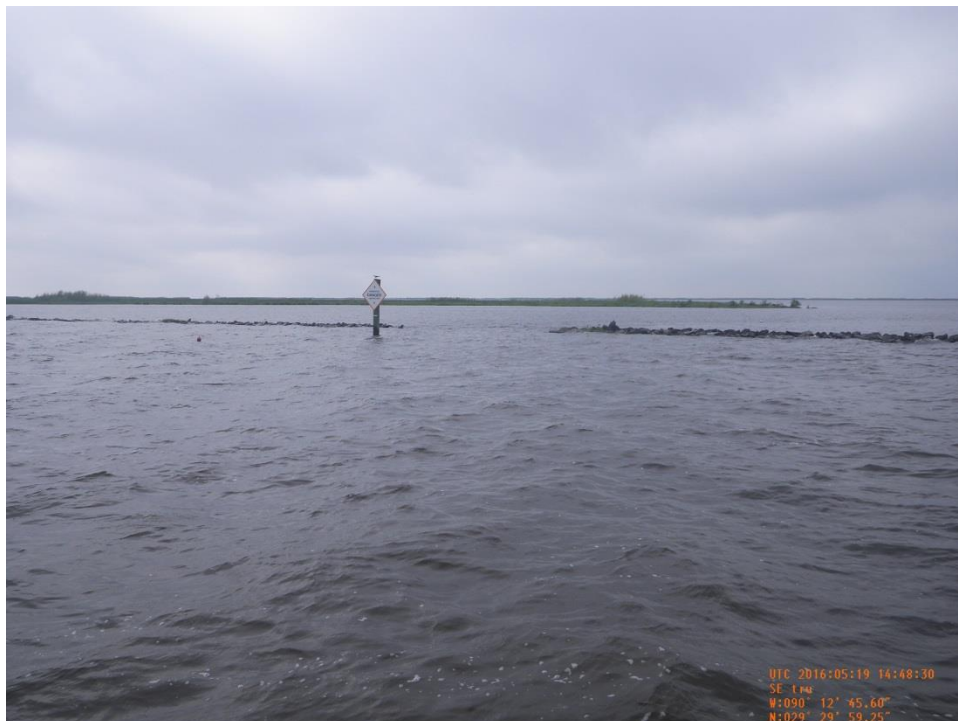
Photo 4: View of the end of rock dike (Segment No.2) and beginning of Segment No.3.

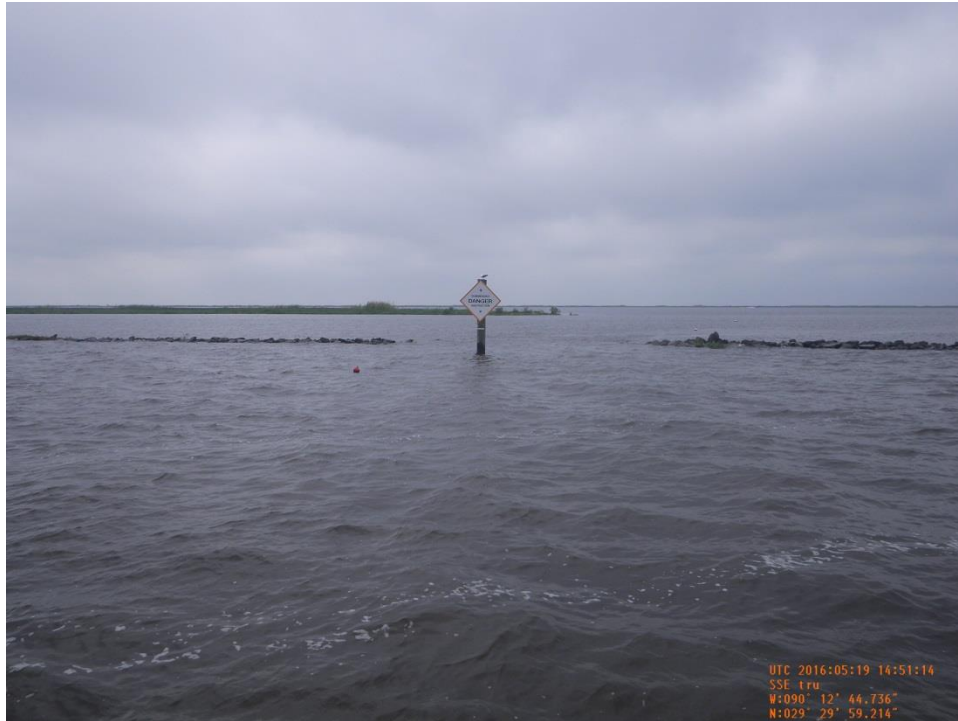
Photo 5: View of the rock dike Segment No.2 and No.3 and timber warning signs.

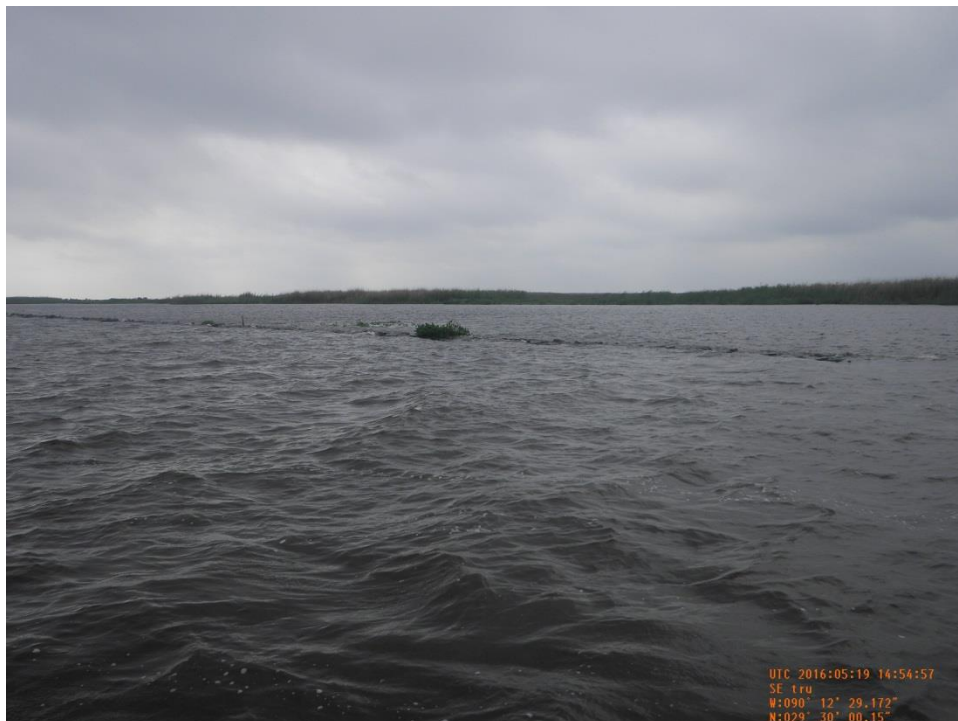
Photo 6: View of low area along the rock dike at the beginning of Segment No.4.

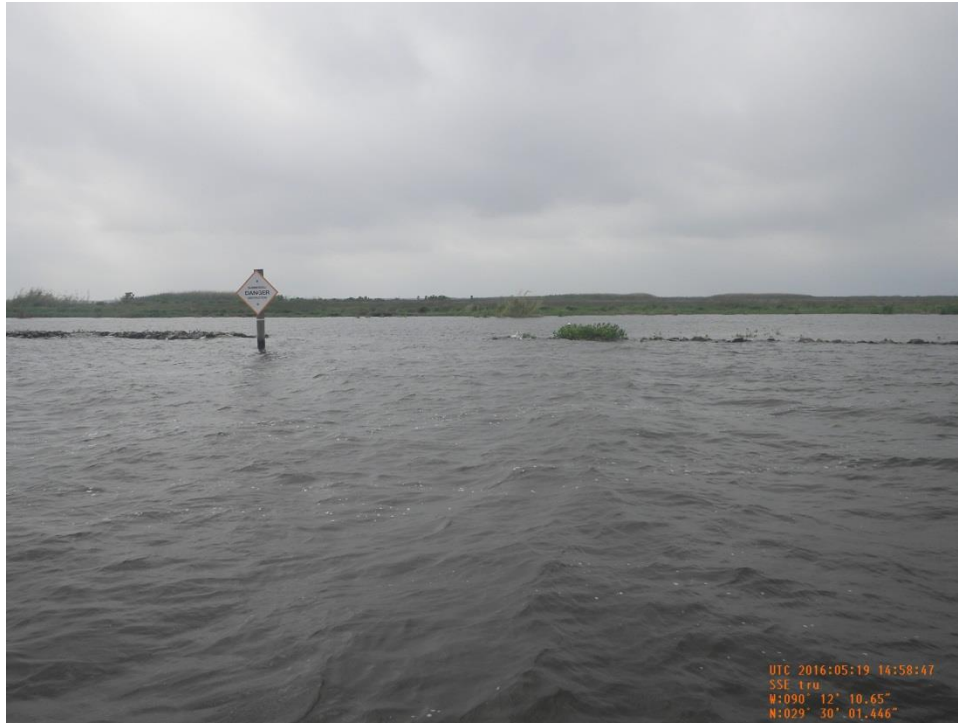
Photo 7: View of the rock dike (Segments 5 and 6) and warning sign looking eastward.

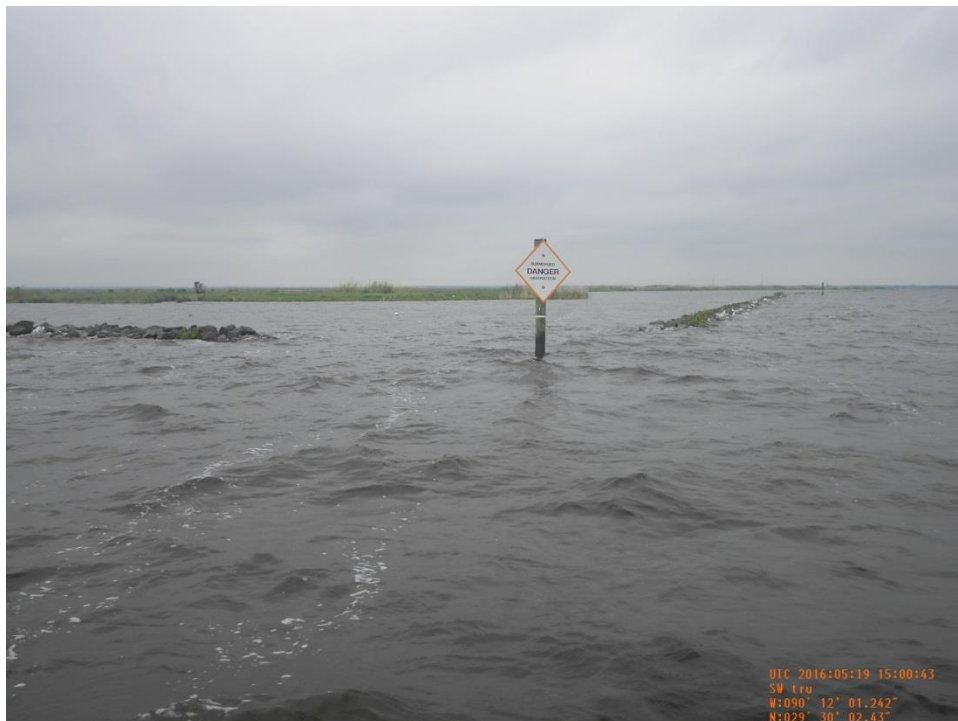
Photo 8: View of the rock dike (Segments 6 and 7) looking southwest near Sta. 66+60.

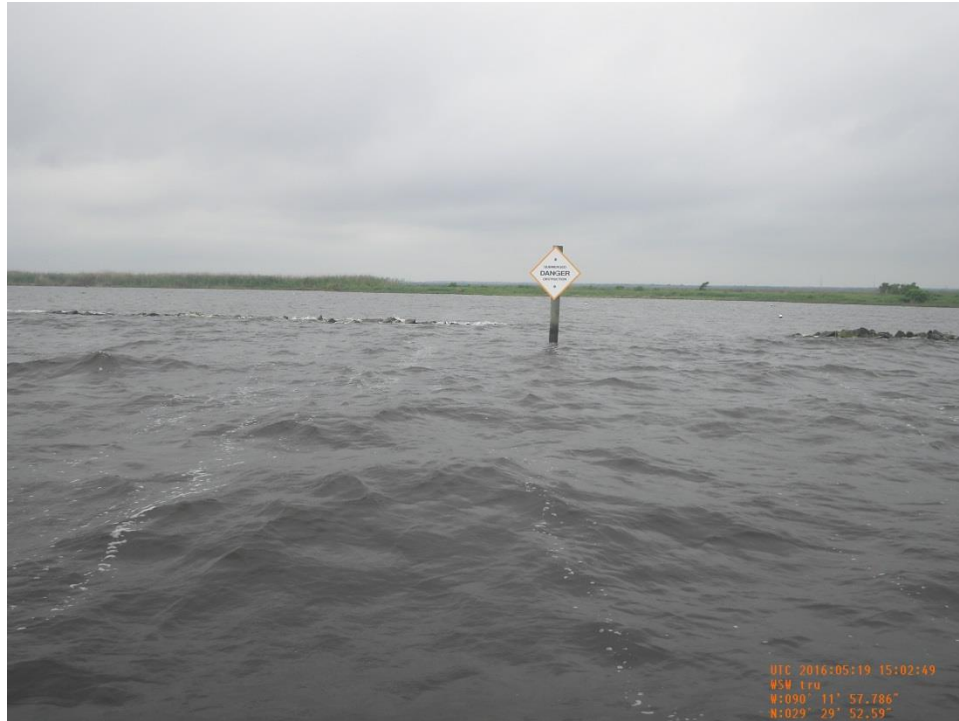
Photo 9: View of the rock dike (Segment No.8) and warning sign looking west.

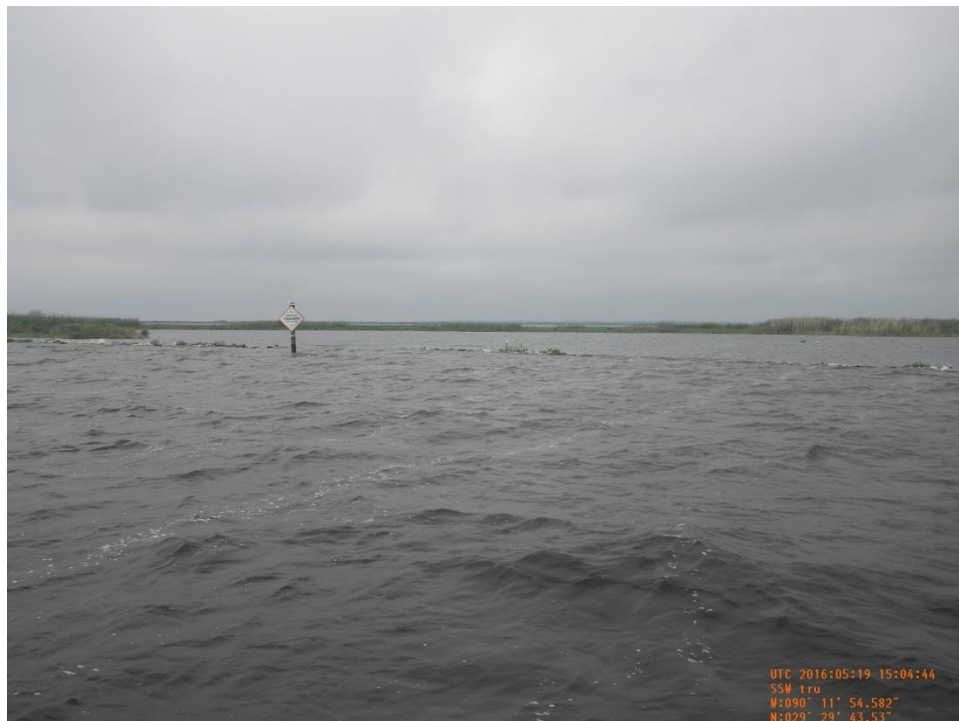
Photo 10: View of the rock dike (Segment No. 8 and 9) looking southward.

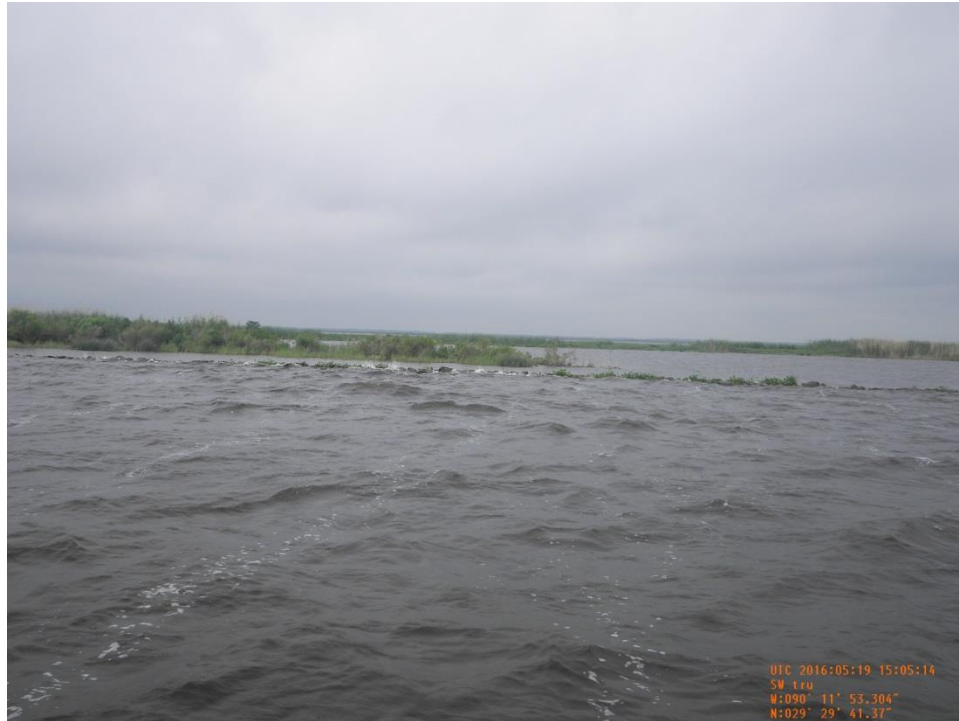
Photo 11: View of the rock dike (Segment No. 9) looking southwest.

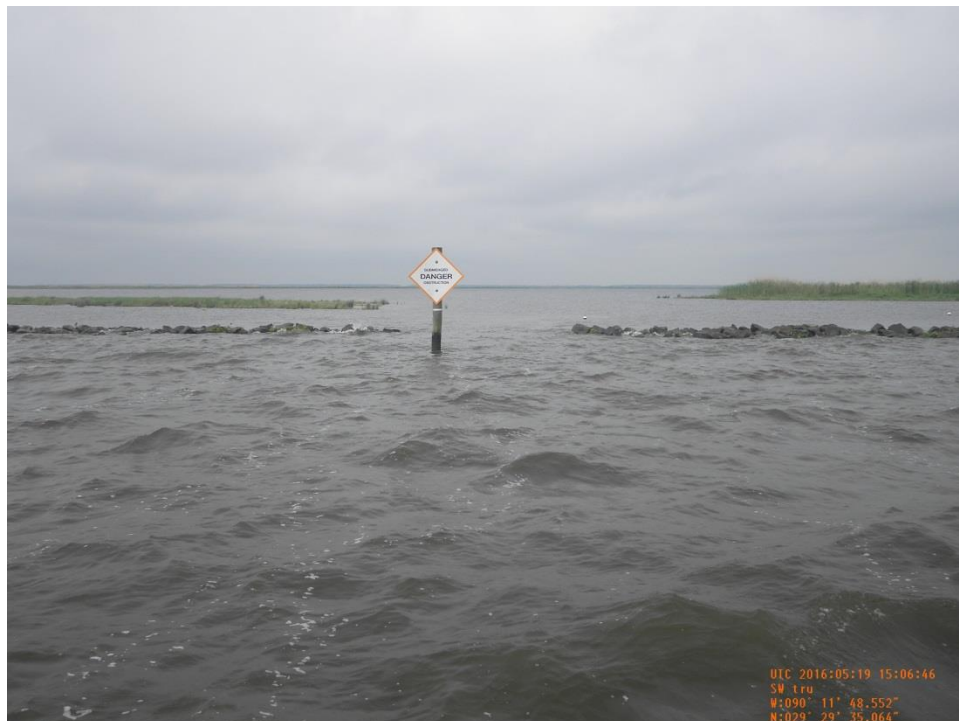
Photo 12: View of the rock dike (Segment No.9 and 10) looking southwest.

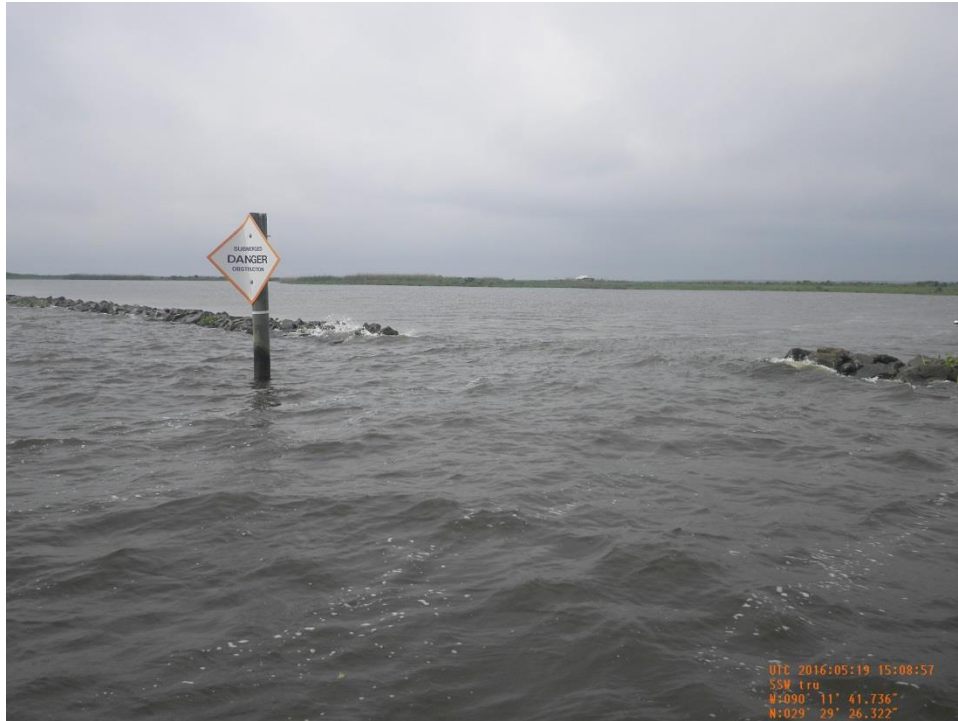
Photo 13: View of the rock dike and bent warning sign (Segment No.10 and 11) looking southwest.

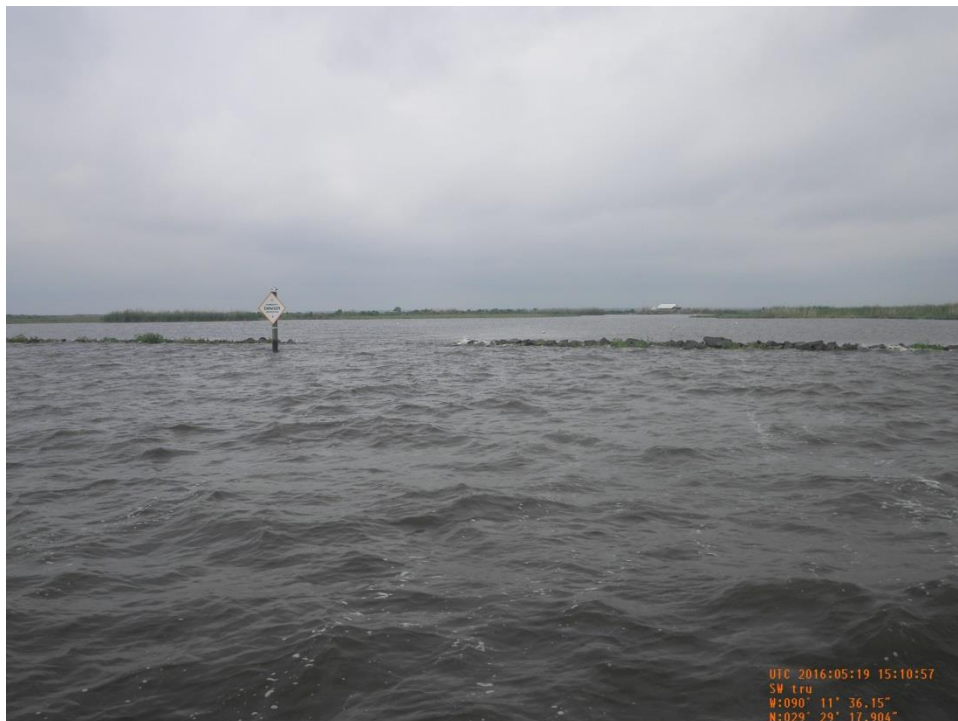
Photo 14: View of the rock dike (Segment No. 11 and 12) looking southwest.

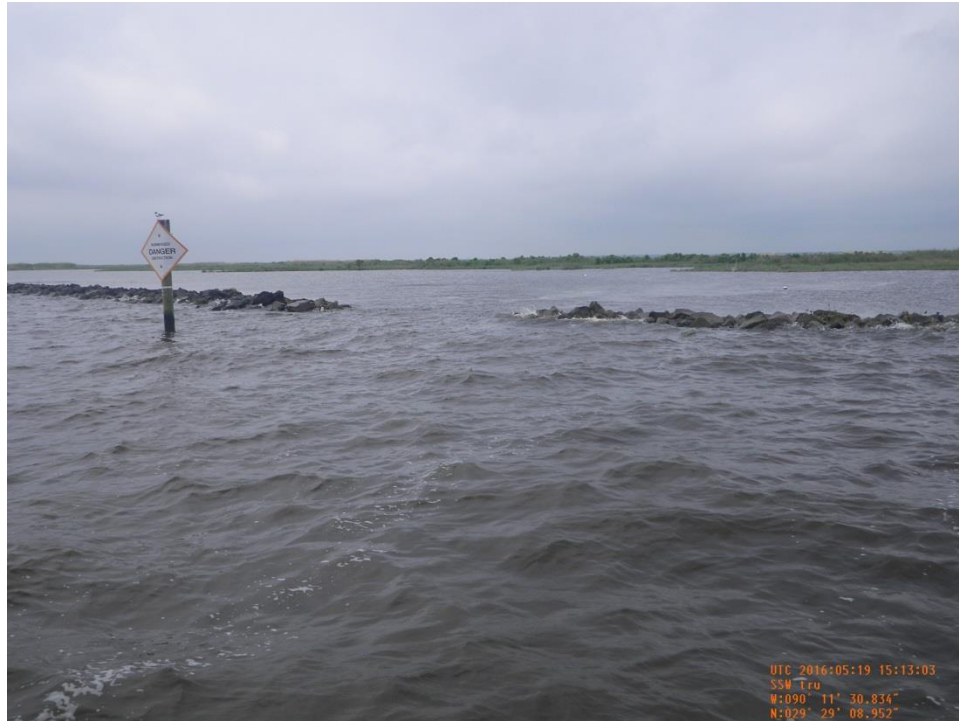
Photo 15: View of the rock dike (Segment No. 12 and 13) looking southwest.

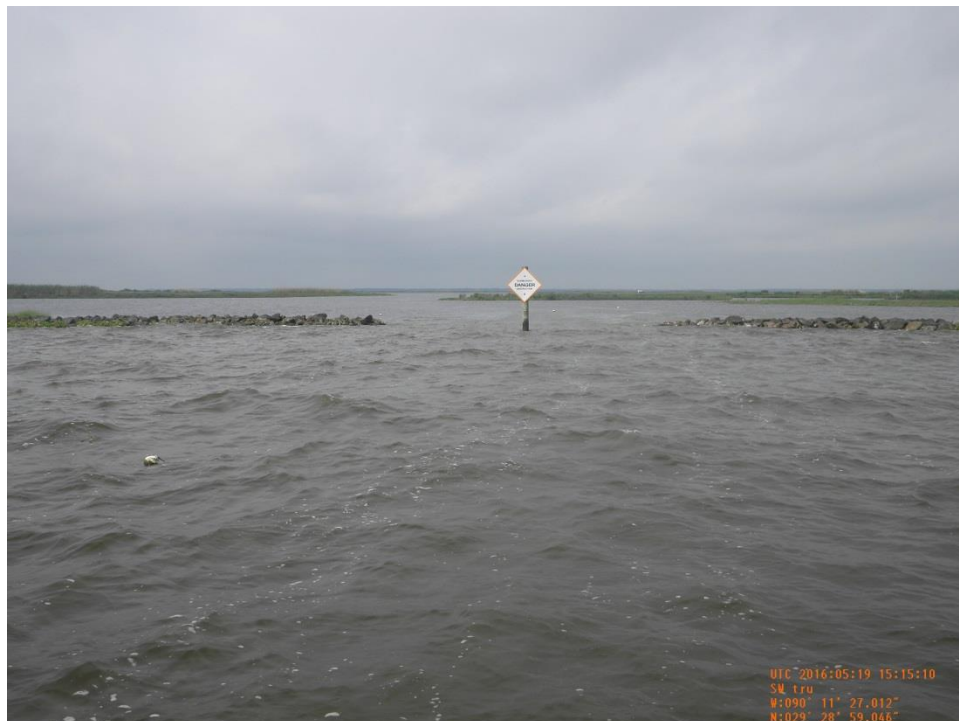
Photo 16: View of the rock dike and warning sign between Segment No. 13 and 14.

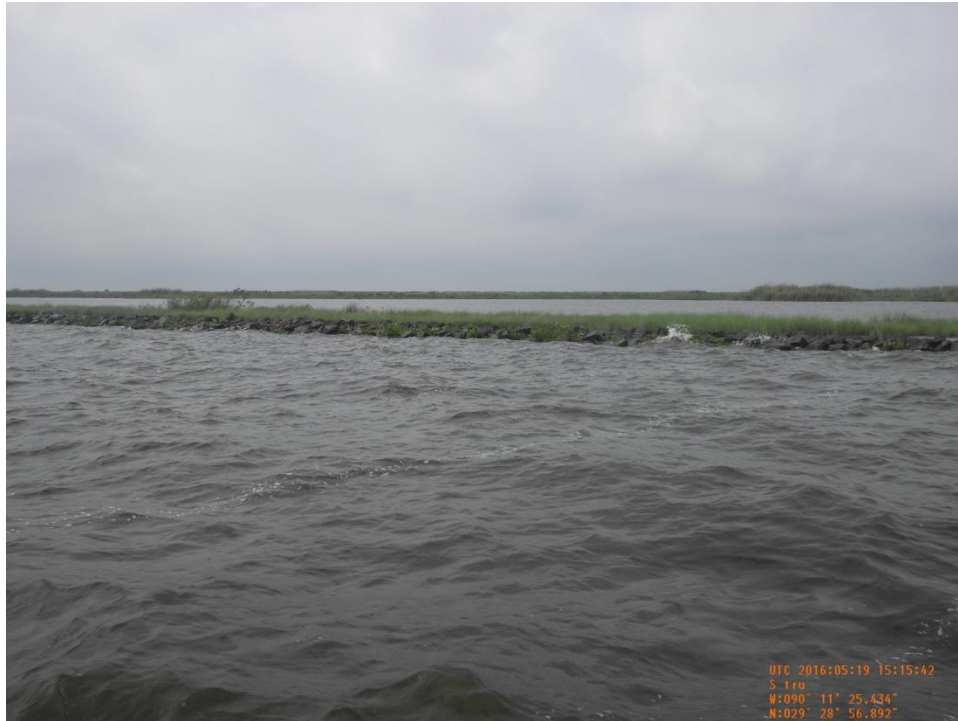
Photo 17: View of the rock dike (Segment No. 14) looking southward.

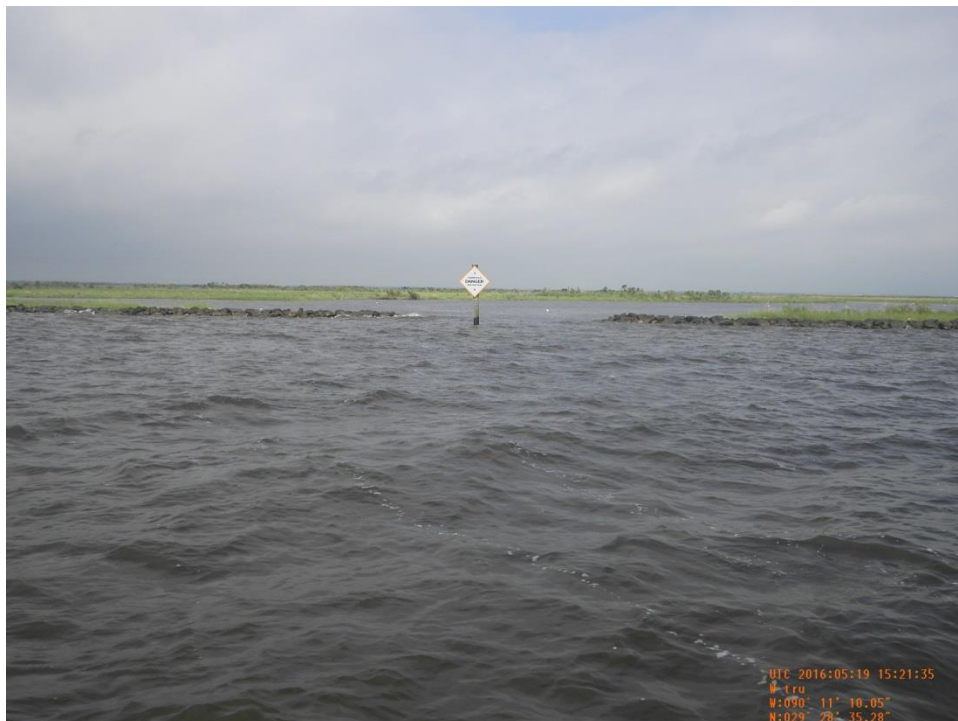
Photo 18: View of the rock dike (Segment No. 14 & 15) looking southward.

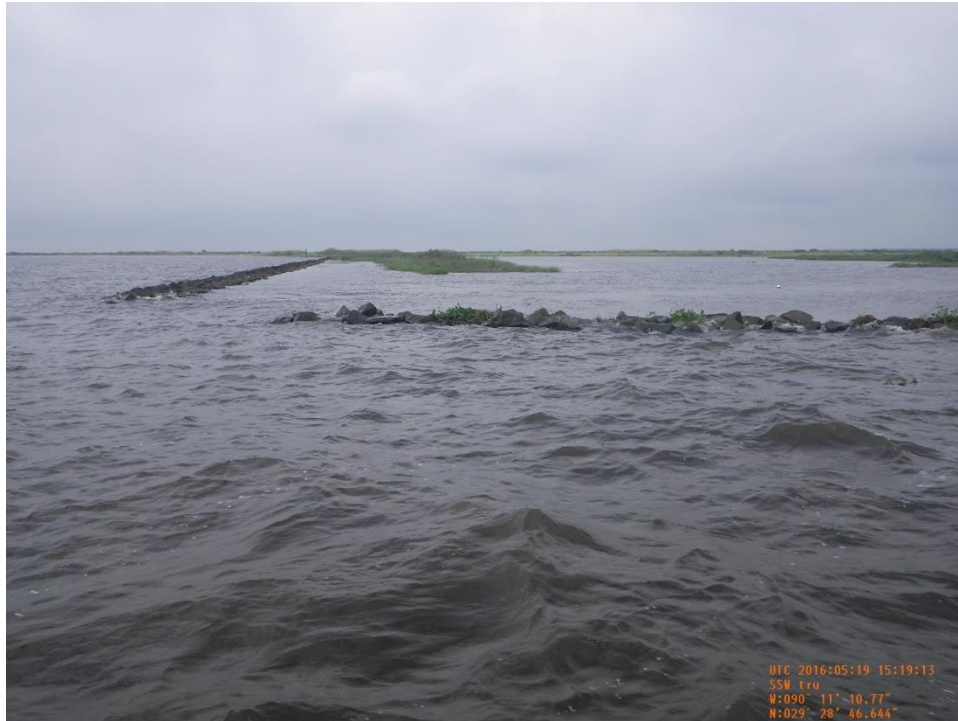
Photo 19: View of the rock dike near Segment No. 15 and 16 looking southward.

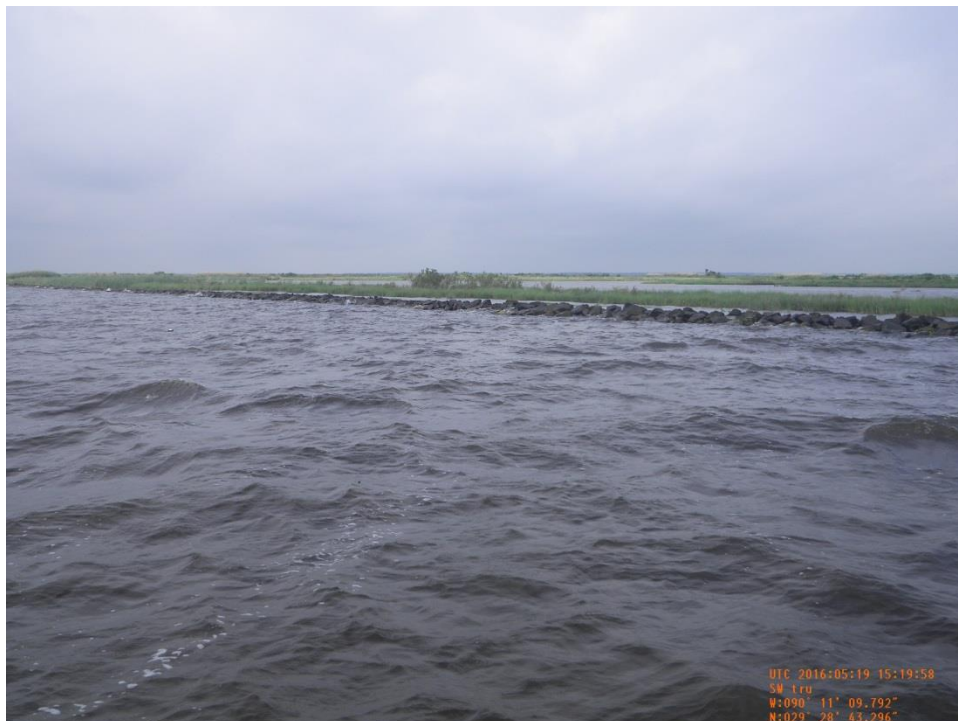
Photo 20: View of the rock dike (Segment No. 16) looking southwest.

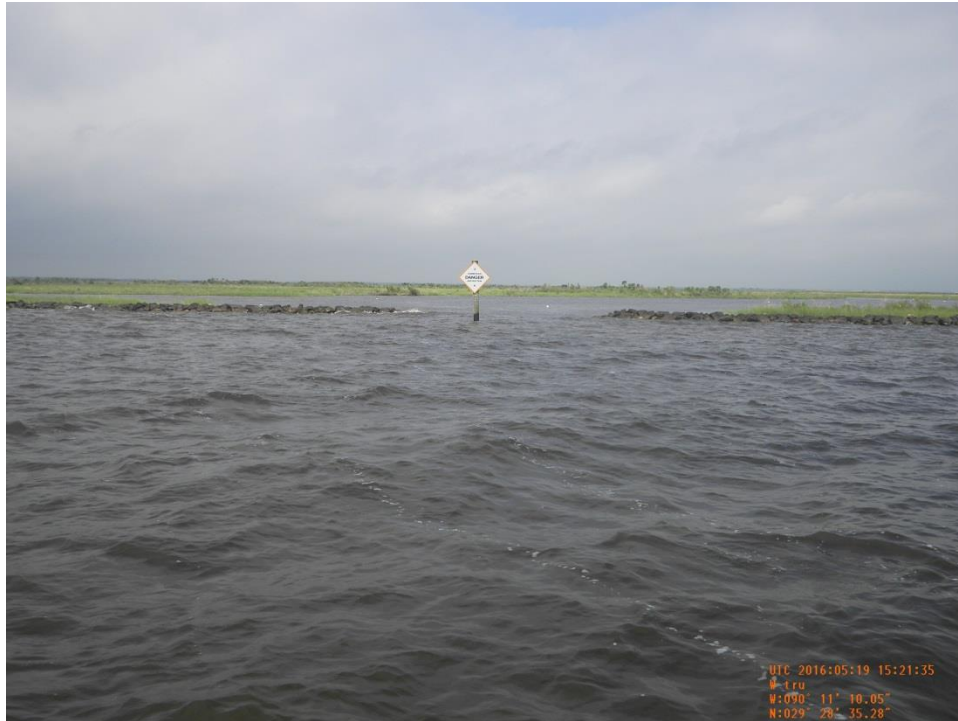
Photo 21: View of the rock dike between Segment No. 16 & 17 looking southwest.

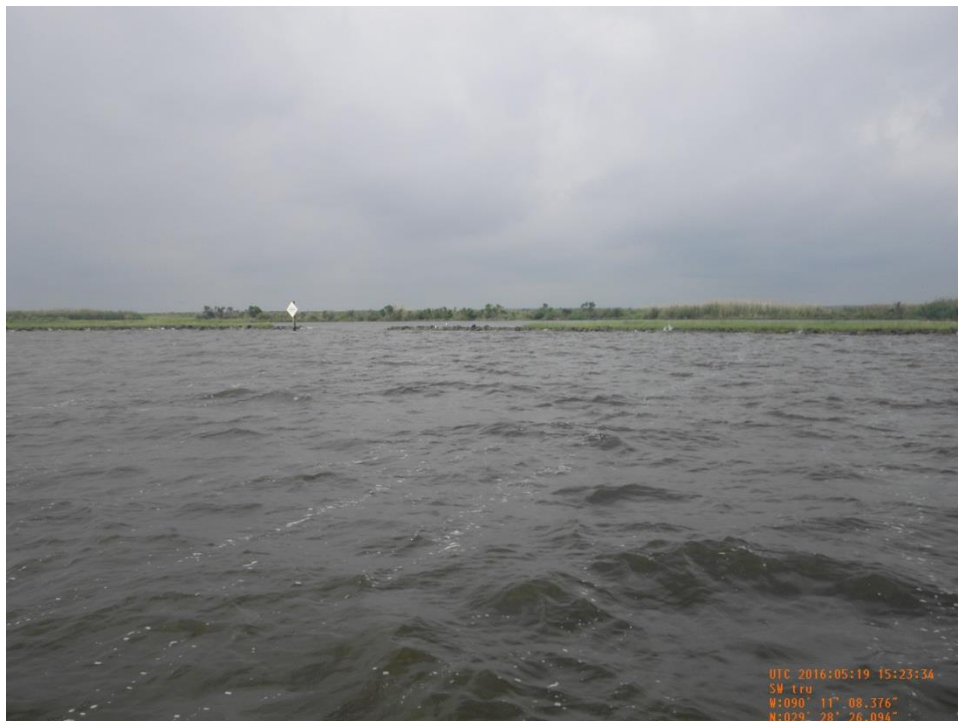
Photo 22: View of the rock dike between Segment No. 17 & 18 looking southwest.

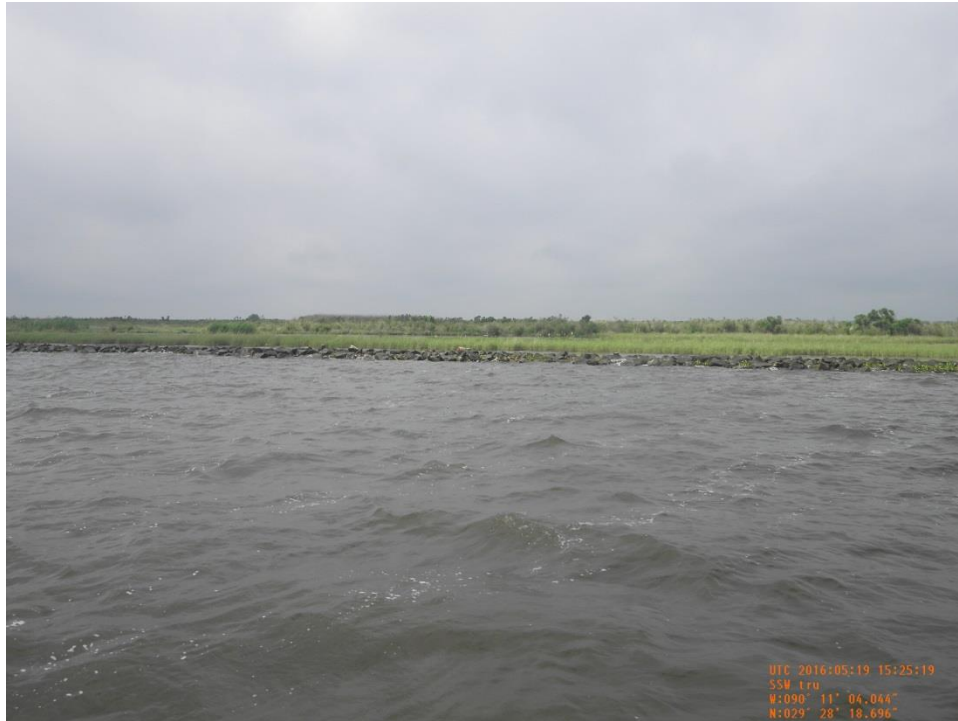
Photo 23: View of the rock dike (Segment No. 18) looking southward.

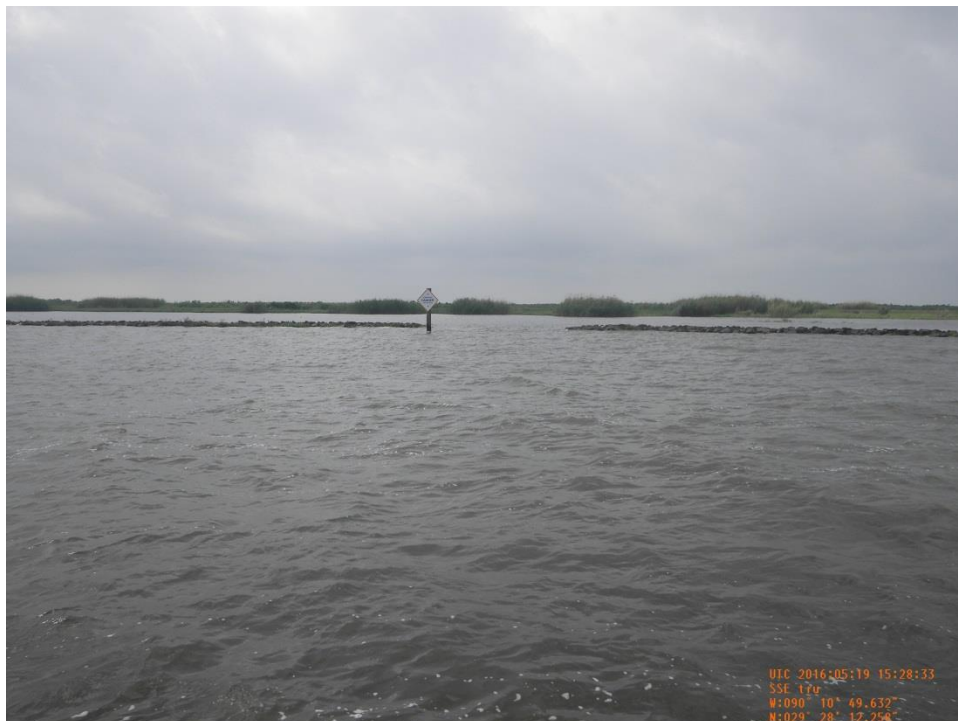
Photo 24: View of the rock dike between Segment No. 19 & 20 looking southward.

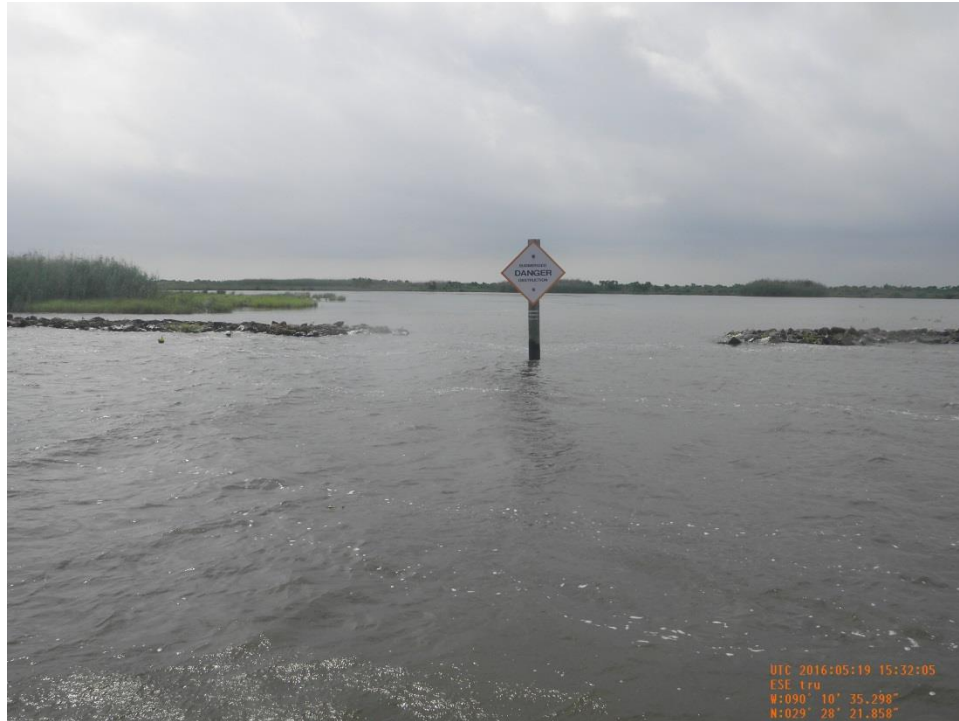
Photo 25: View of the rock dike between Segment No. 20 & 21 looking eastward.

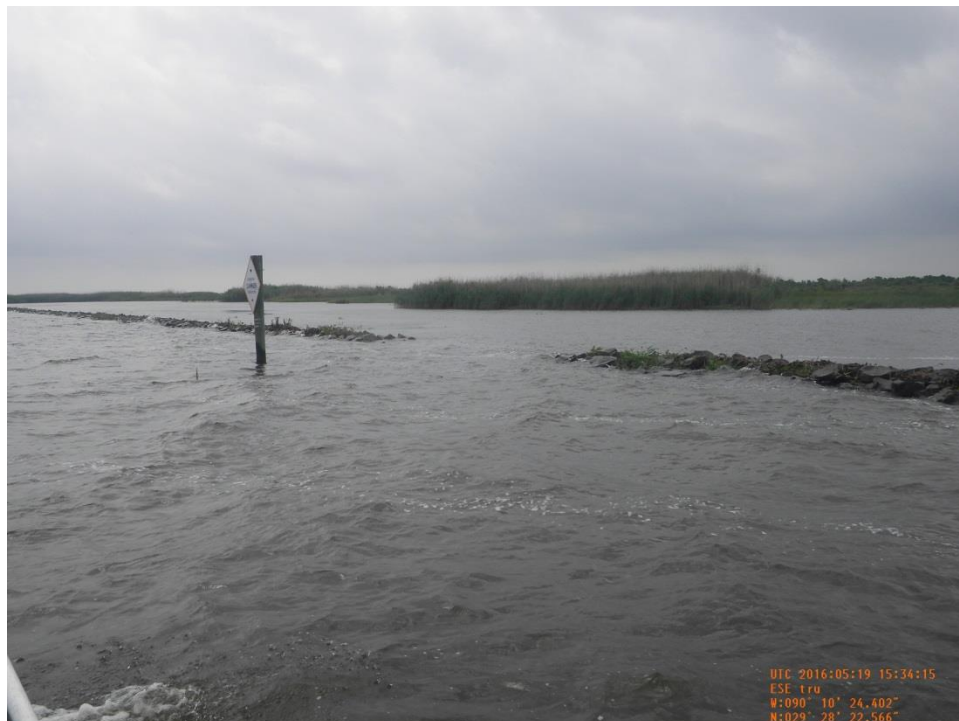
Photo 26: View of the rock dike between Segment No. 21 & 22 looking eastward.

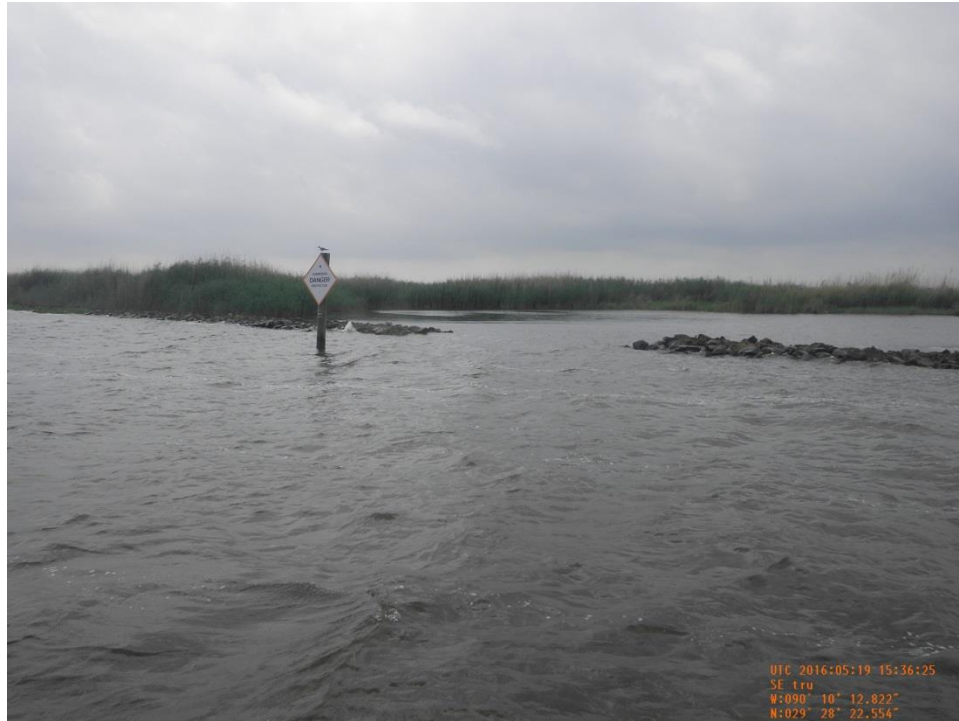
Photo 27: View of the rock dike between Segment No. 22 & 23 looking south east.

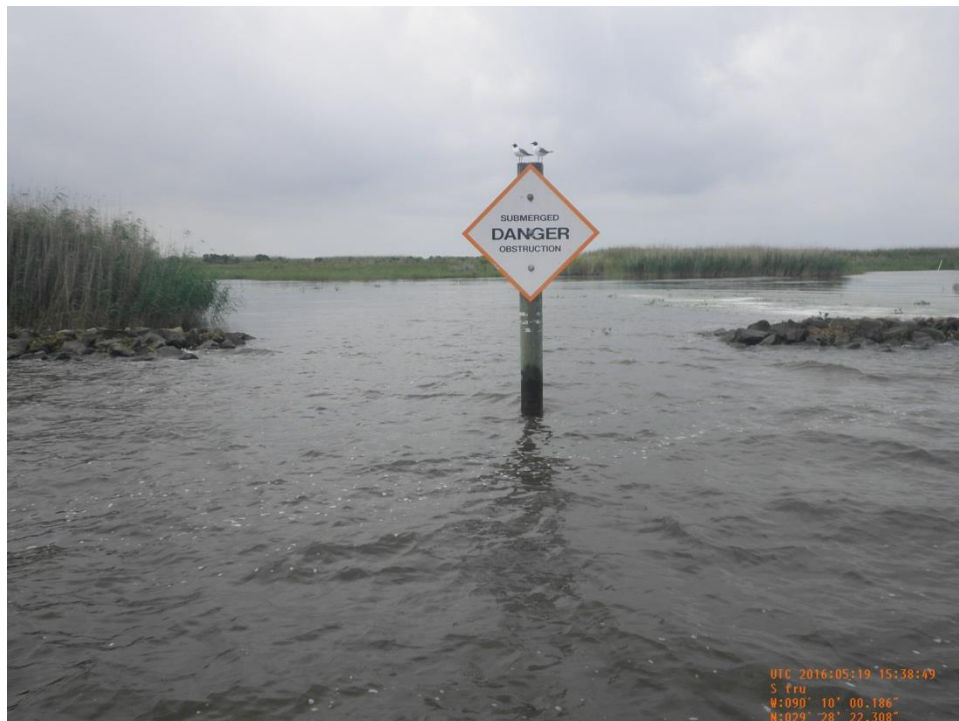
Photo 28: View of the rock dike & warning sign between Segment No. 23 & 24 looking south.

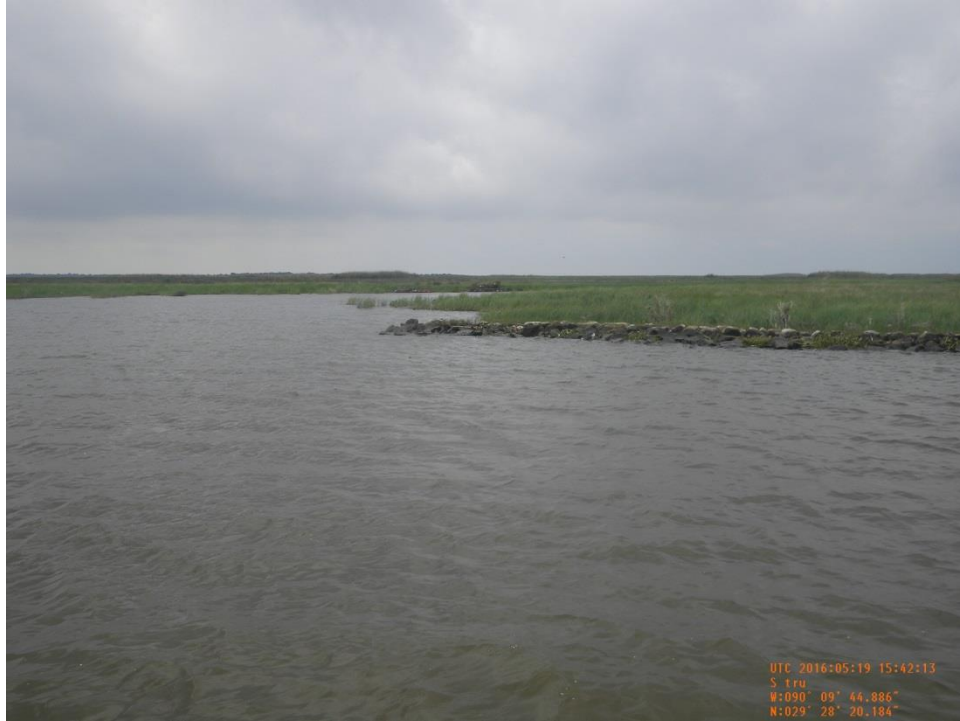
We were only able to visually inspect the marsh creation area from the perimeter of the project and marsh fringe along Round Lake and the southern containment dike. The fill material in the marsh creation area appeared to be in very good condition and fully vegetated. The latest post construction survey of the fill area was completed in 2011. Below is a table showing the average grid elevations from 2006, the year construction was completed, through 2010. The final post construction survey of the marsh fill area was conducted in 2011 and is shown in Figure 1. The next scheduled post-construction survey of the marsh creation area is recommended for 2017. Since we will be conducting design surveys for degrading Segment 1 and 2 dikes, we would also recommend that the planned marsh surveys for 2017 be included as well. There is a cost savings to performing this work at the same time as surveying for the maintenance event and profiling of the rock dike.

Photo 29: View of the rock dike, marsh, and open water just inside the opening of the southern containment dike (Segment No. 24) looking southward.
