**State of Louisiana
Coastal Protection and Restoration
Authority**

2017 Annual Inspection Report

**LITTLE LAKE SHORELINE
PROTECTION / DEDICATED
DREDGING NEAR ROUND LAKE
(BA-37)**

October 31st, 2017
Lafourche Parish

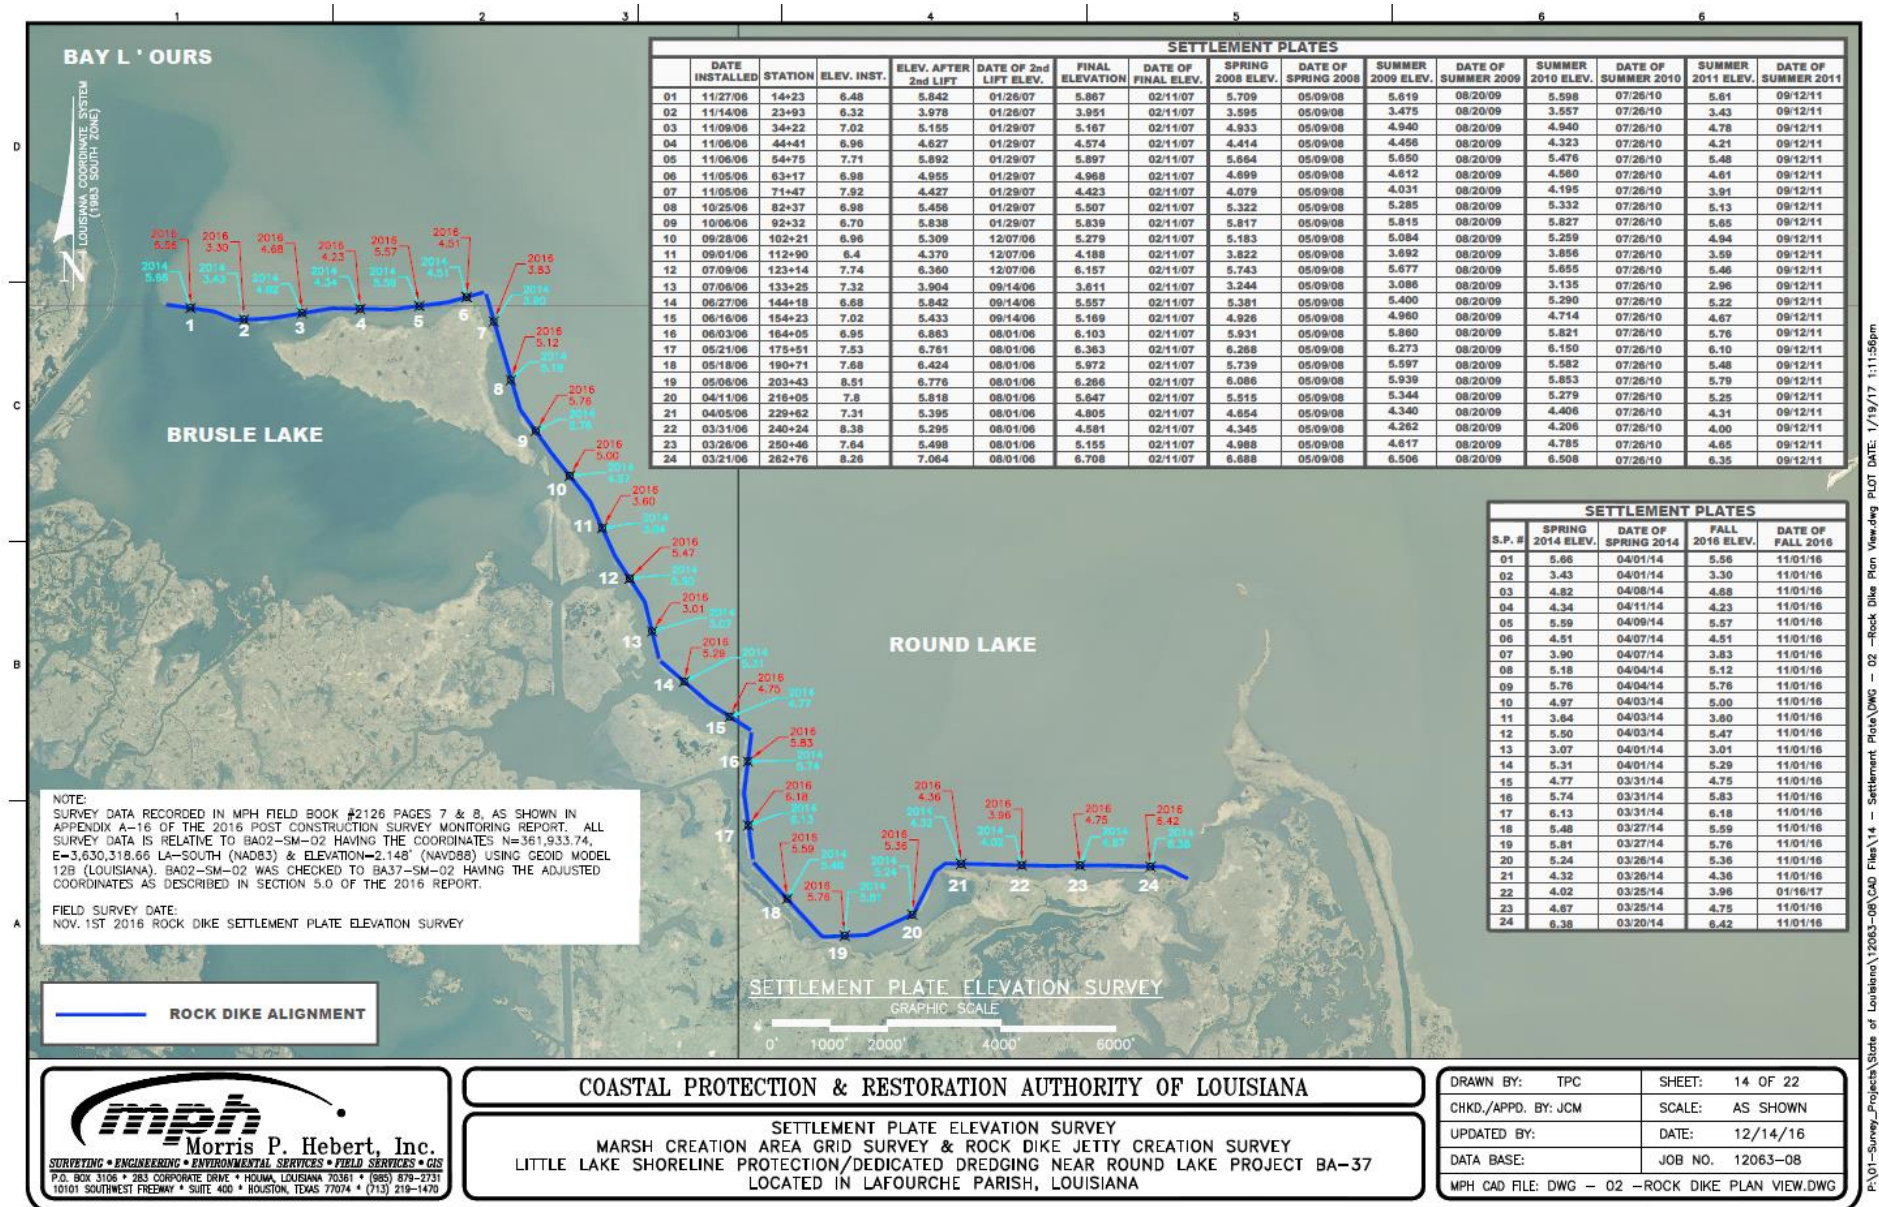
Figure 1. Rock Dike Settlement Plate Data

All rock segments were visually inspected by boat. It appears that all rock segments have experienced some degree of settlement with the most obvious settlement on the western end of the project (Segments 1 through 8), where only two (2) rock lifts were made during construction. Segments 10 through 24 received a third lift during construction and appear to be in good to fair condition.

As observed during post-construction surveys and visual inspections of the rock dike structure along the southern marsh of Little Lake and Round Lake, all of the rock dike segments have experienced some settlement. Over time, the settlement of the rock dike in the vicinity of Segments 1 and 2 has presented potential hazardous navigation conditions because the dike extends out into open water in an area without land behind it. A combination of high tides causing the rock dike to become submerged and the lack of a marsh shoreline behind both segments has resulted in a decision by NMFS and CPRA to degrade Segment 1 and part of Segment 2. Design surveys for degrading these segments were completed in February 2016. The current plan is to recover the rock rip rap for use in the construction of a Perpendicular Rock Dike near Segment 3; additional surveys for the creation of the new feature were completed in November 2016. Construction is anticipated to start in late 2017 to early 2018.

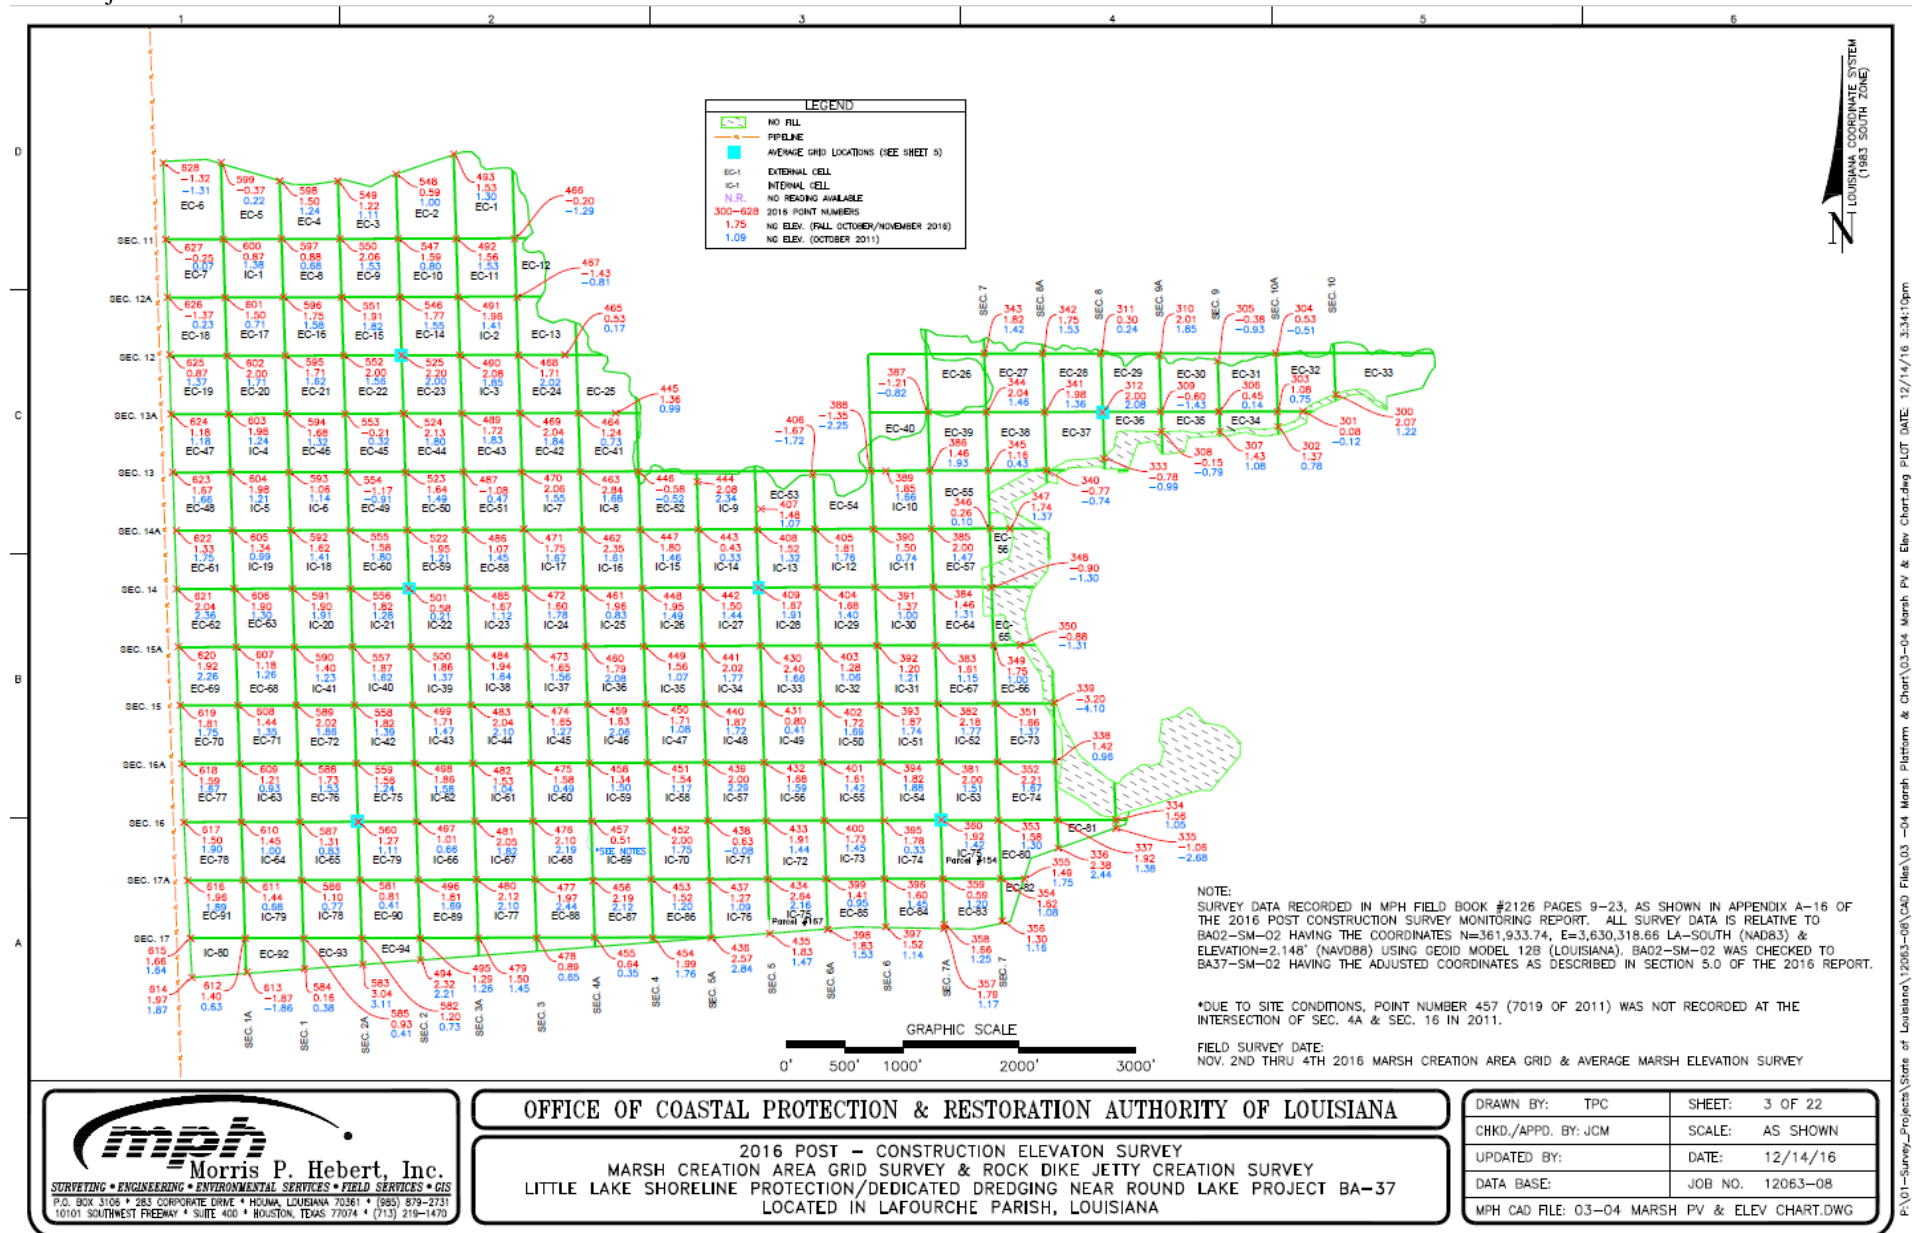
Figure 2. Marsh Creation Area Grid Surveying showing October 2011 and November 2016 Elevations

We were only able to visually inspect the marsh creation area from the perimeter of the project and marsh fringe along Round Lake and the southern containment dike. The fill material in the marsh creation area appeared to be in very good condition and fully vegetated. The latest post-construction survey of the fill area was completed in 2016. Below is a table showing the average grid elevations from 2006, the year construction was completed, through 2016. The final post-construction survey of the marsh fill area was conducted in 2016 and is shown in Figure 1. In 2016, CPRA conducted design surveys for degrading Segment 1 and 2 dikes in conjunction with the marsh surveys previously planned for 2017, with cost savings from eliminating additional administrative & mobilization/demobilization costs.

The marsh creation area appears to be completely vegetated and the post-construction surveys indicate elevations are approaching the average marsh elevation for the area. The final post-construction survey for the marsh creation area is scheduled for year 15 (2022) of the project life. There are no other funds allocated for the marsh creation portion of the project other than the surveying of the area grid points.

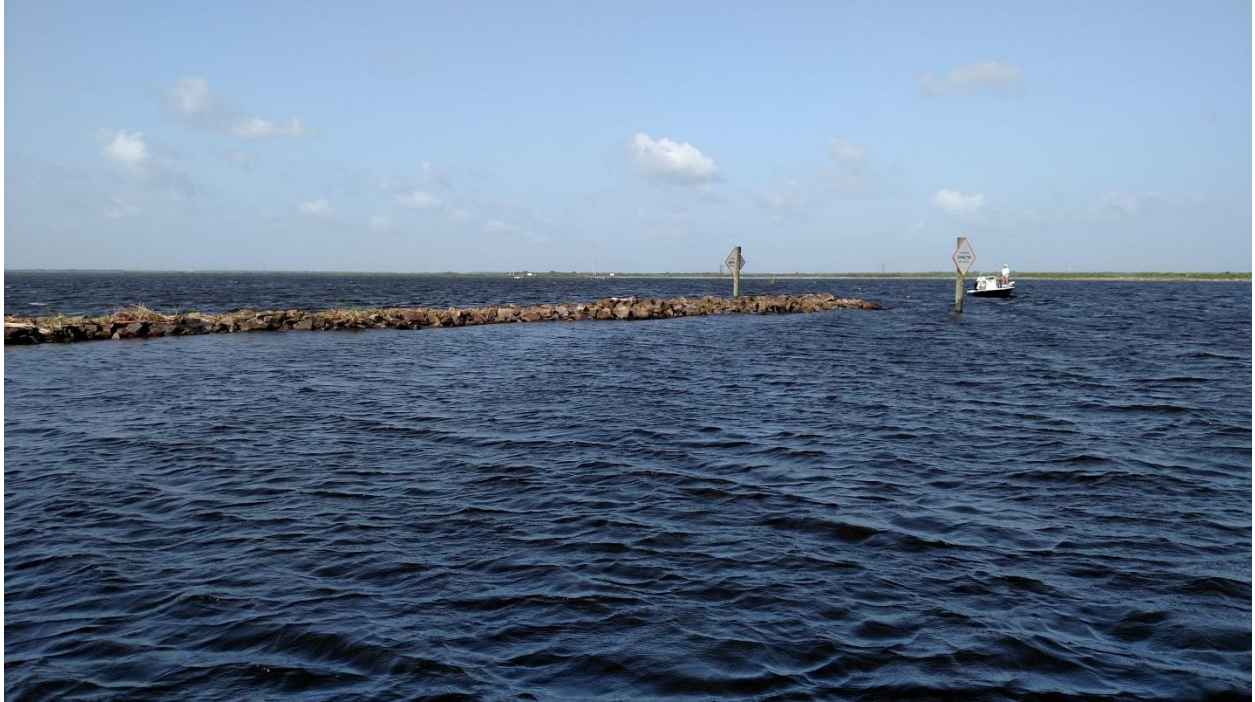
Currently, Rock Segments 1 and 2 have no marsh or vegetation along its southern edge, only open water. The fringe marsh that once separated Brusle Lake and Bay L’Ours, located just south of Segments 1 and 2 had eroded following Hurricane Katrina in 2005. This land loss occurred during construction of the project and the rock segments were installed as designed and contracted. Due to the liability associated with the rock dike being below the water surface during high tides and the lack of existing marsh behind the structure, NMFS and CPRA had decided to degrade Segment 1 and part of Segment 2, because the eastern edge of Segment 2 still protects the marsh behind Segment 3 from wave action. In the 2015 inspection report, CPRA had decided against recovering the rock riprap and installing at another location, instead electing to degrade the rock dike to a safe elevation along the lake bottom. This method was seen as more cost effective than recovering the rock riprap. However, 2016 discussions between the NOAA representative and CPRA rehashed the possibility of recovering the rock and building a Perpendicular Rock Dike branching off Segment 2 where the degrading terminates. The increased cost (although shared) of additional surveying and obvious alternative construction has been considered and deemed justifiable. The last survey of the entire rock shoreline was conducted in 2011. A complete Pre-Design survey of the rock on Segments 1 & 2 was concluded in February 2016 and with additional surveying conducted November 2016. The cost of constructing this project feature is reflected in the 3-year budget.

Photo 1: Beginning of the rock dike (Segment 1) near Sta. 10+00 at the entrance of Breton Canal.

Winter 2017 – A maintenance event is tentatively scheduled 2017-2018 winter. This scope will include removing rock from Rock Dike No. 1 and 2 to construct a nearby project feature named “Perpendicular Rock Dike”, which will provide protection to adjacent land and reduce navigational hazards. The rock will be degraded to -2.0 ft NAVD88 (previous natural water bottom contour) on all of Rock Dike No. 1 and 870.00’ of Rock Dike No. 2.

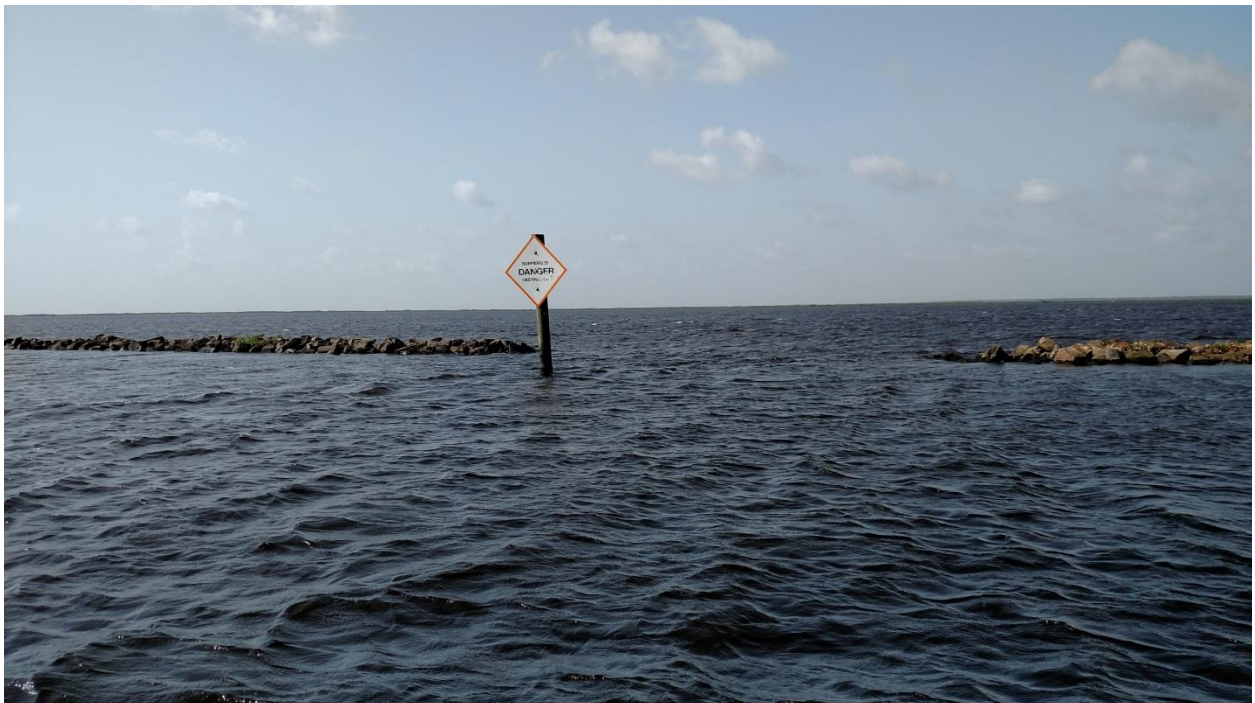
Photo 2: Beginning of rock dike (Segment No.2) looking southward.

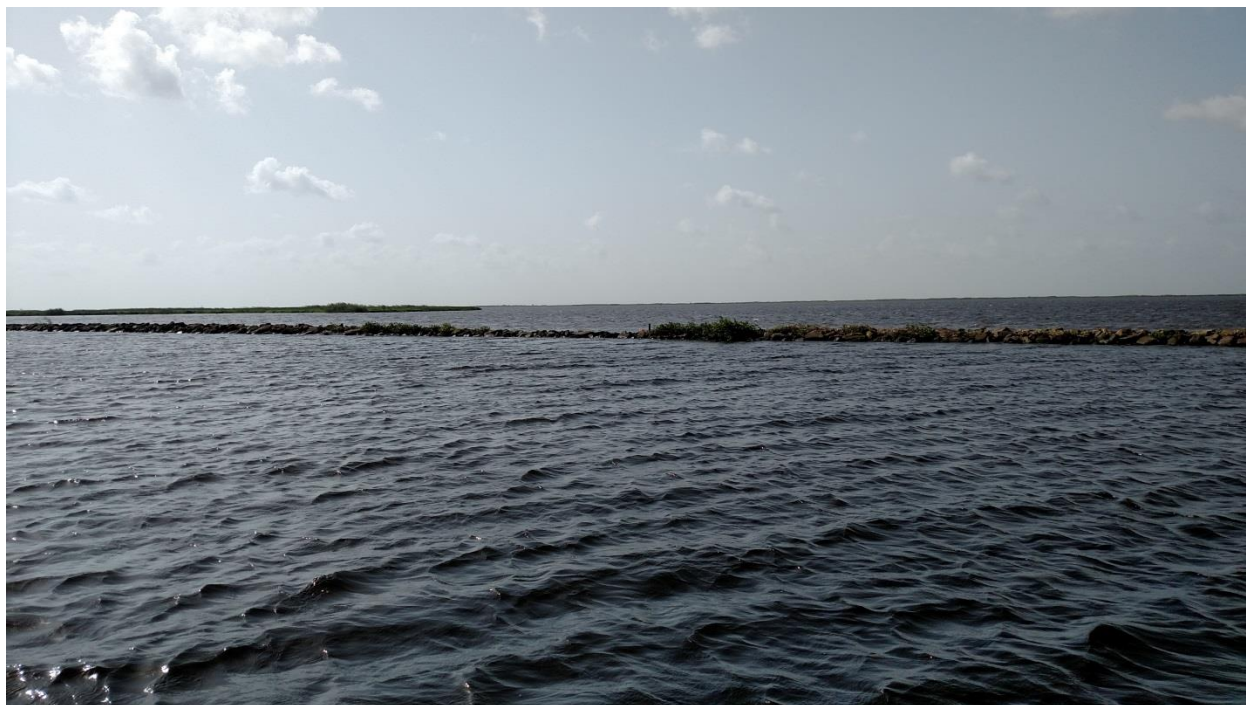
Photo 3: Low area along the rock dike (Segment No.2) near Sta. 23+93.

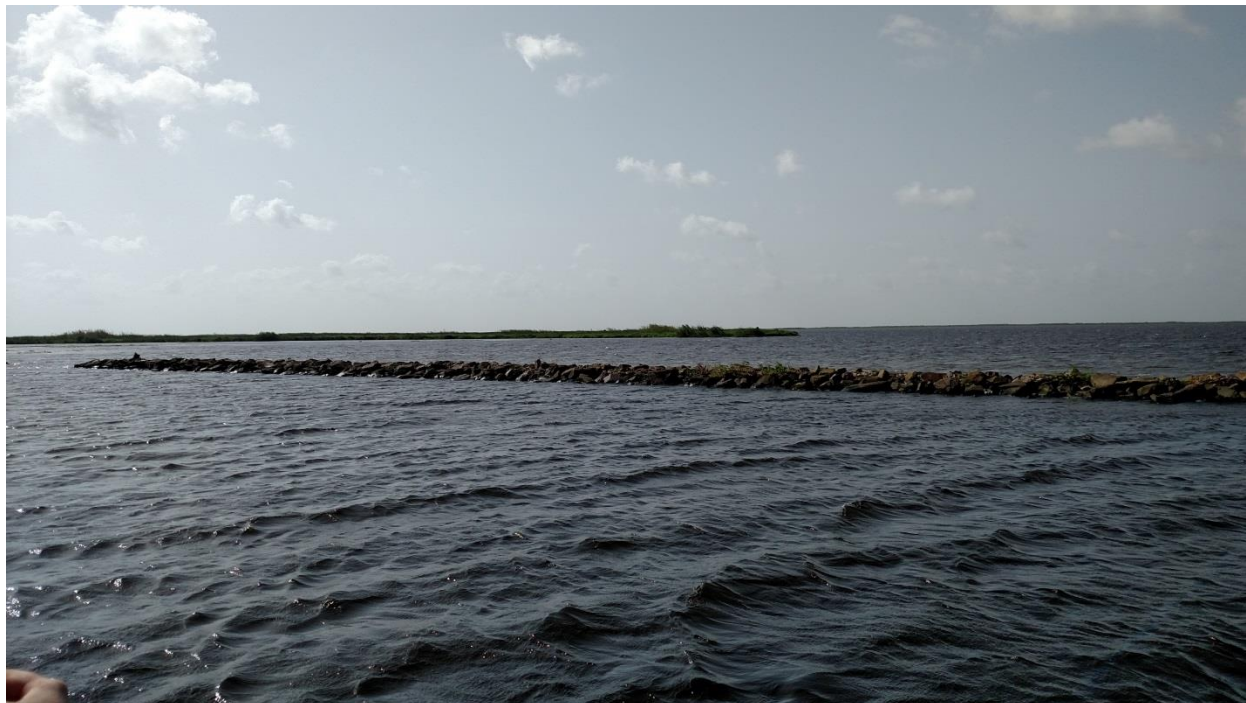
Photo 4: View of the end of rock dike (Segment No.2)

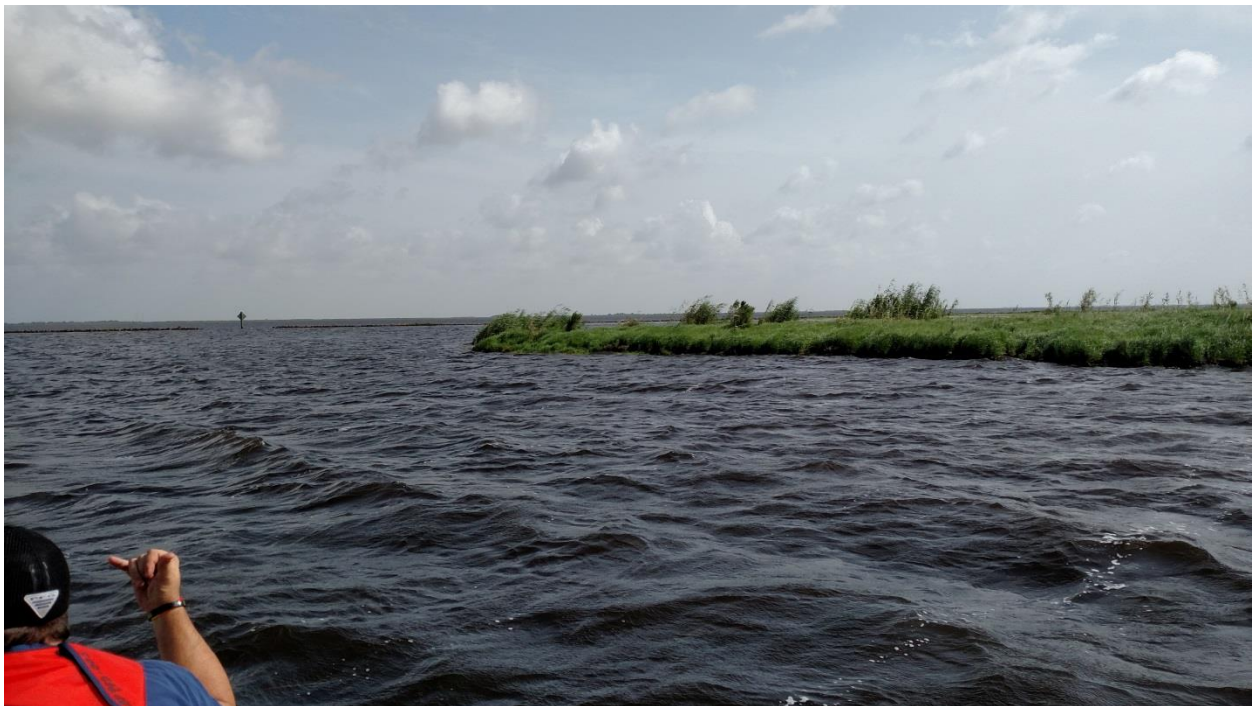
Photo 6: View of land remnants behind rock dike Segments No. 2 & No. 3.

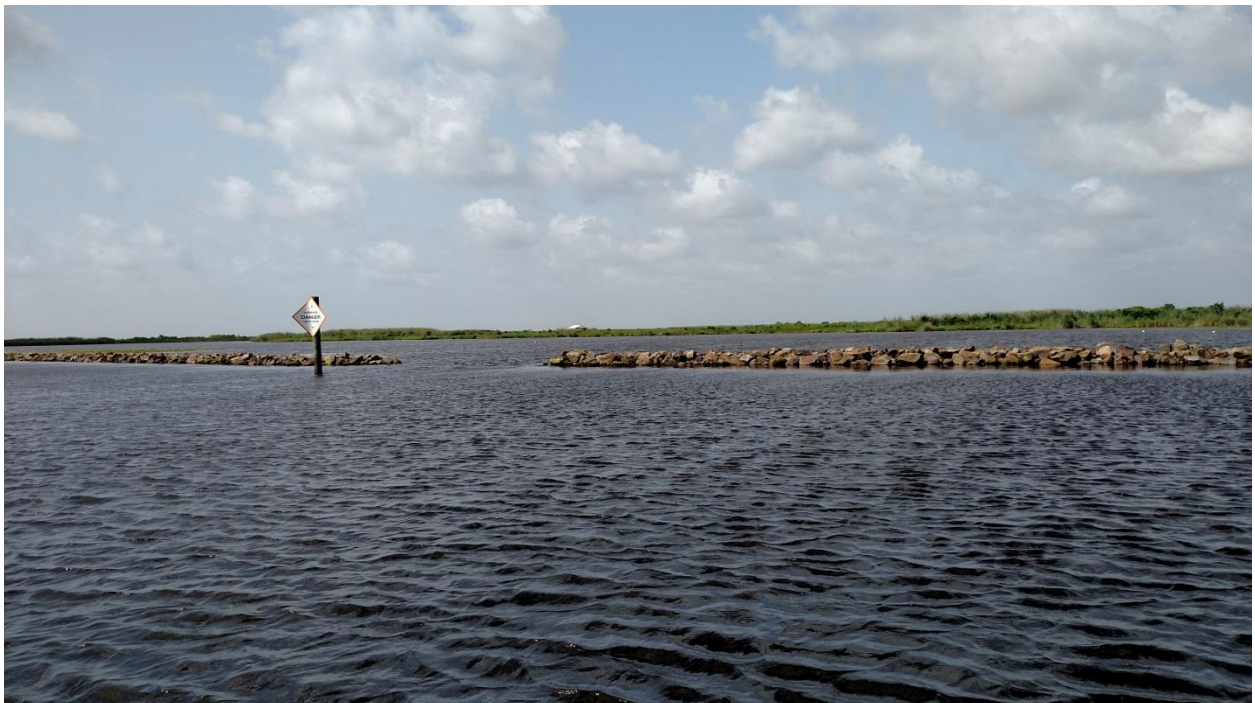
Photo 14: View of the rock dike and bent warning sign (Segment No. 10 & No. 11) looking southwest.

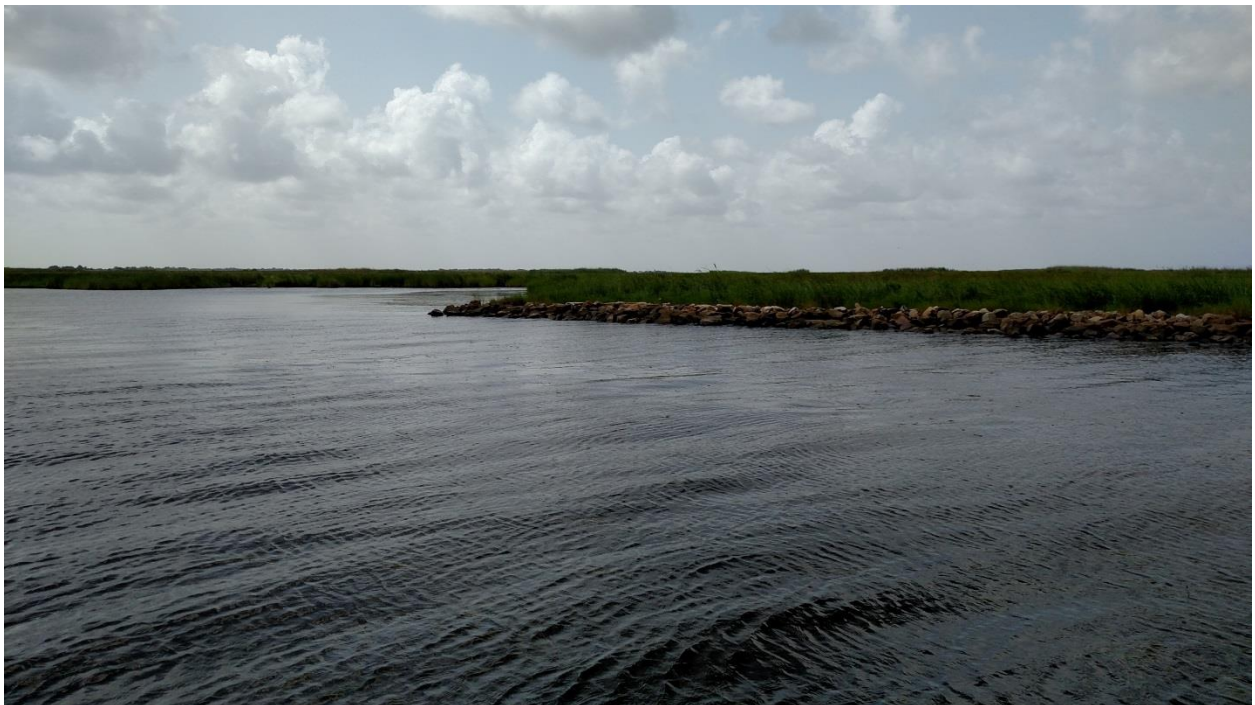
Photo 30: View of the rock dike, marsh, and open water just inside the opening of the southern containment dike (Segment No. 24) looking southward.
