**State of Louisiana
Coastal Protection and Restoration Authority**

2015 Annual Inspection Report

Naomi Outfall Management

State Project Number BA-03c
Priority Project List 5

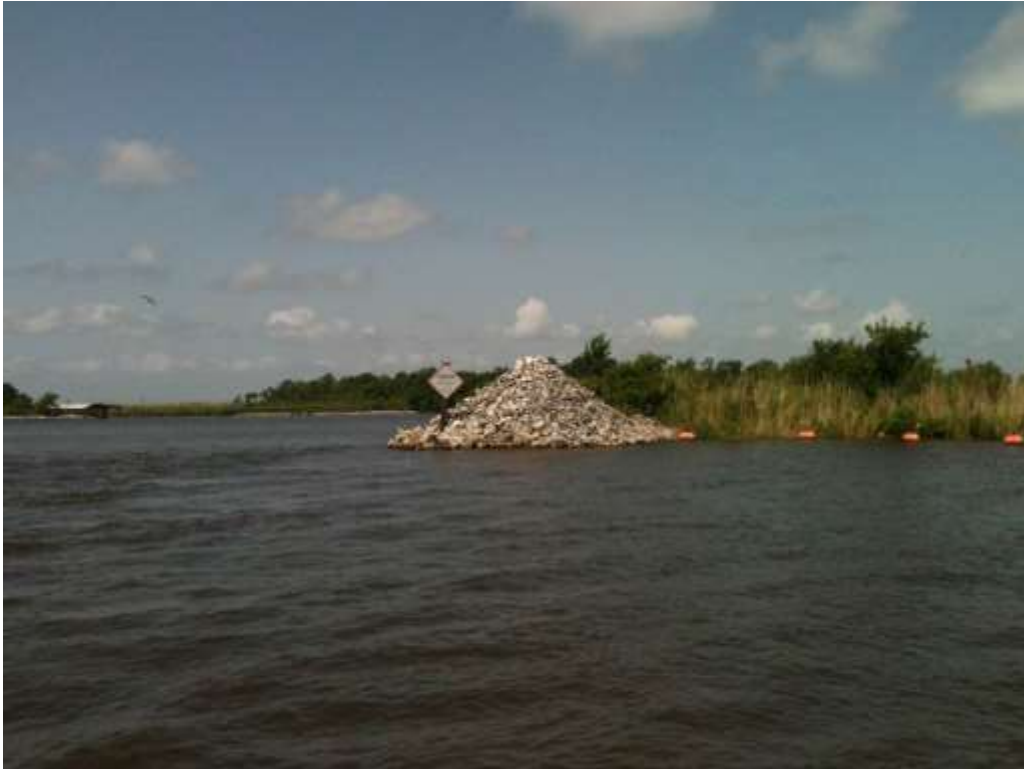
The structure was altered to facilitate construction of the South Shore of the Pen (BA-41) Project, and remains in this temporary condition to allow access for the Long Distance Sediment Pipeline (BA-43 EB) Project and Bayou Dupont Marsh and Ridge Creation (BA-48) Project, both of which are currently in construction. Rock has been temporarily removed from the weir and stored within the footprint of the structure (Photo #1). The structure will be replaced as designed at a later date.

Photo #1 – Bayou Dupont Canal Weir

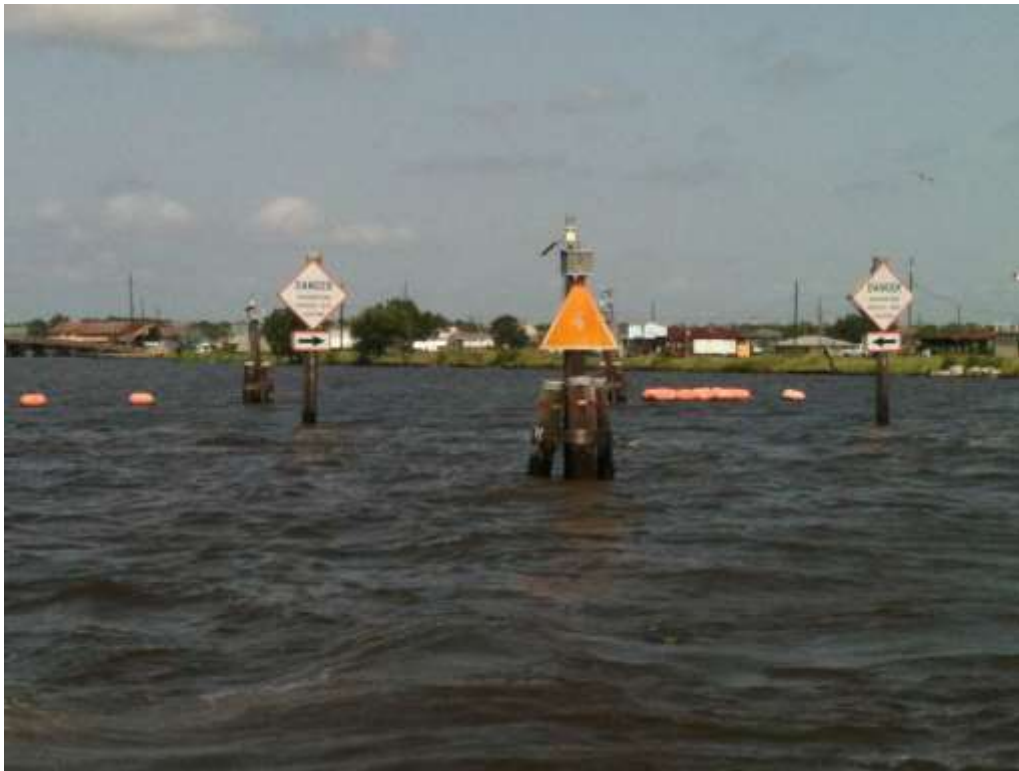
Timber pilings appeared to be in good condition. Some reflective tape is missing or deteriorated and will be replaced as part of the 2015 maintenance event (Photo #2).

The navigation signs exhibited weathering and fading, and are scheduled for replacement (Photo #2). Several barrier float cables were damaged and will be replaced under the 2015 maintenance contract (Photo #2, #3, #4). Warning signs were in good condition (Photo #2).

Photo #2 – Goose Bayou Pile Cluster

- Replacement of navigational aids and buoys at Goose Bayou.

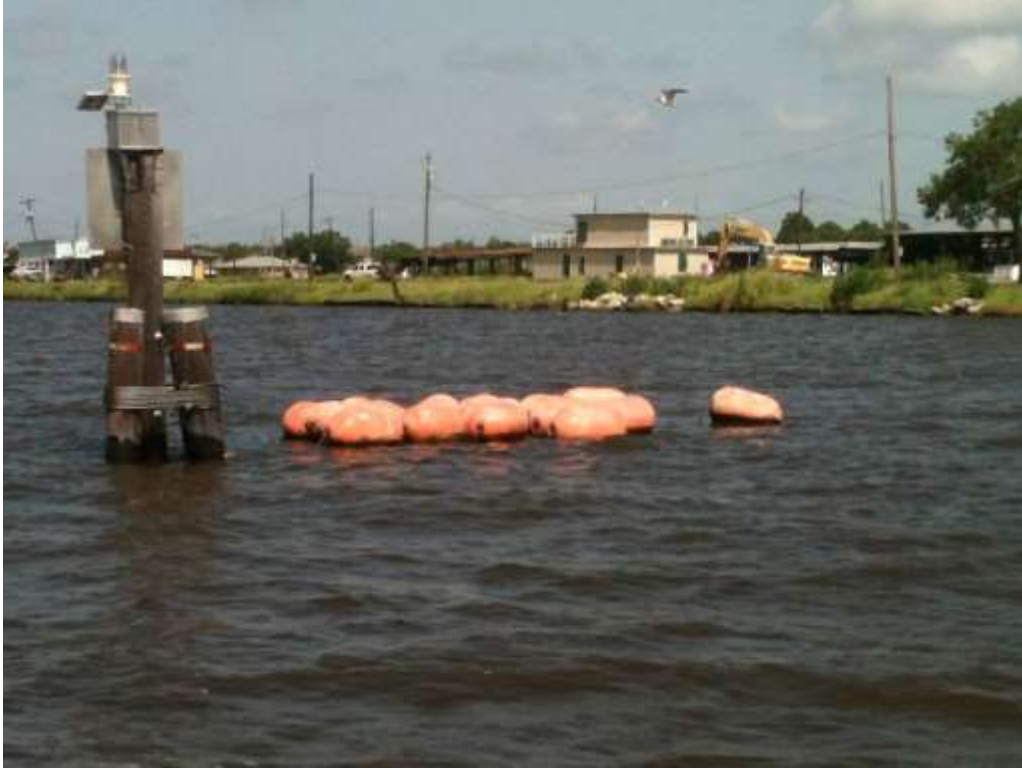
Photo #3 – Buoy Damage at Goose Bayou (North Side)

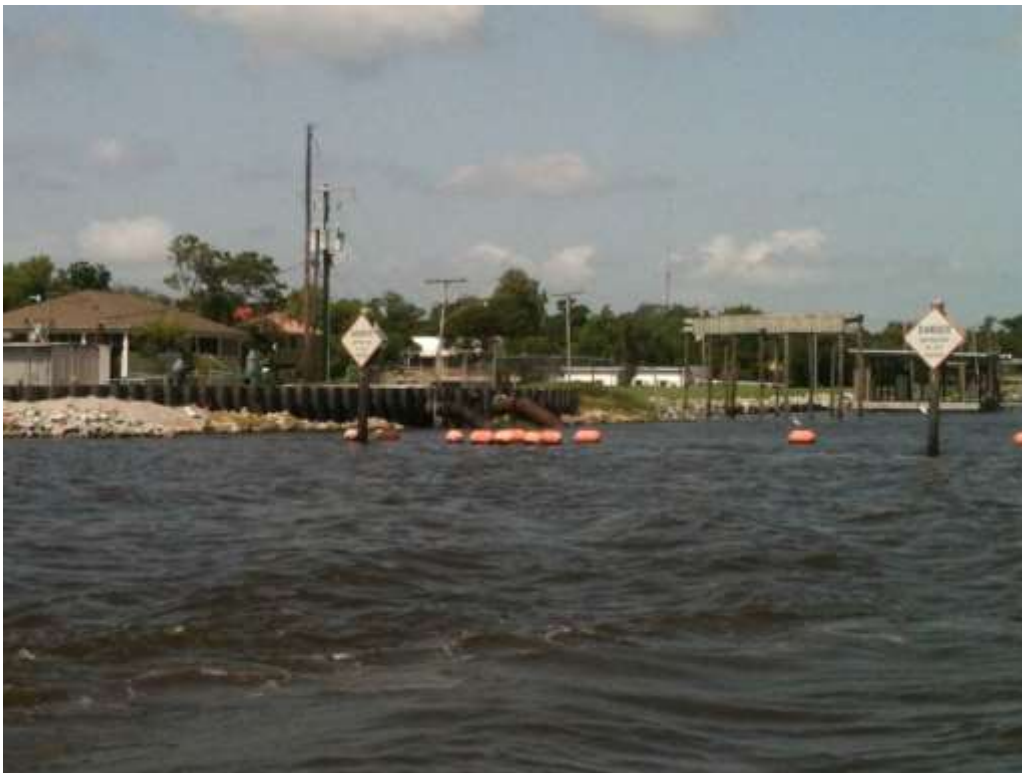
Photo #4 – Buoy Damage at Goose Bayou (South Side)
