**State of Louisiana  
Coastal Protection and Restoration Authority**

**2016 Annual Inspection Report**

**Naomi Outfall Management**

State Project Number BA-03c  
Priority Project List 5

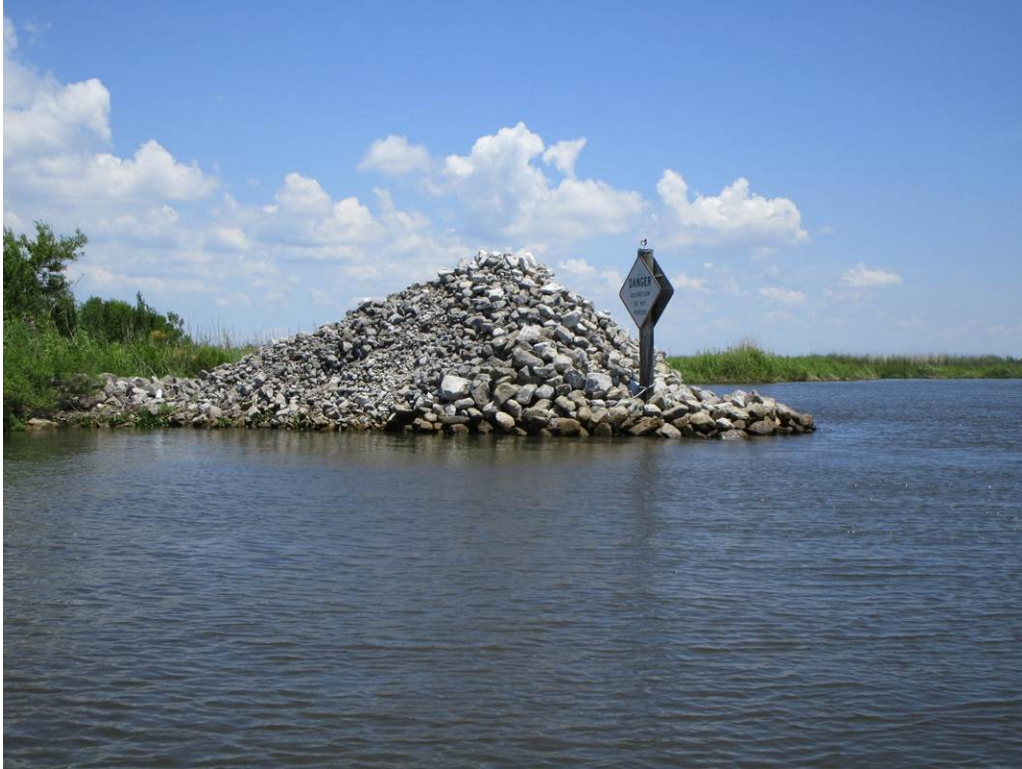
The structure was altered to facilitate construction of the South Shore of the Pen (BA-41) Project, and remains in this temporary condition to allow construction access for the Long Distance Sediment Pipeline (BA-43) Project. Rock has been temporarily removed from the weir and stockpiled within the footprint of the structure (Photo #1). The structure will be restored to design condition as part of the BA-43 construction contract.

**Photo #1 – Riprap stockpile for weir restoration (Bayou Dupont)**

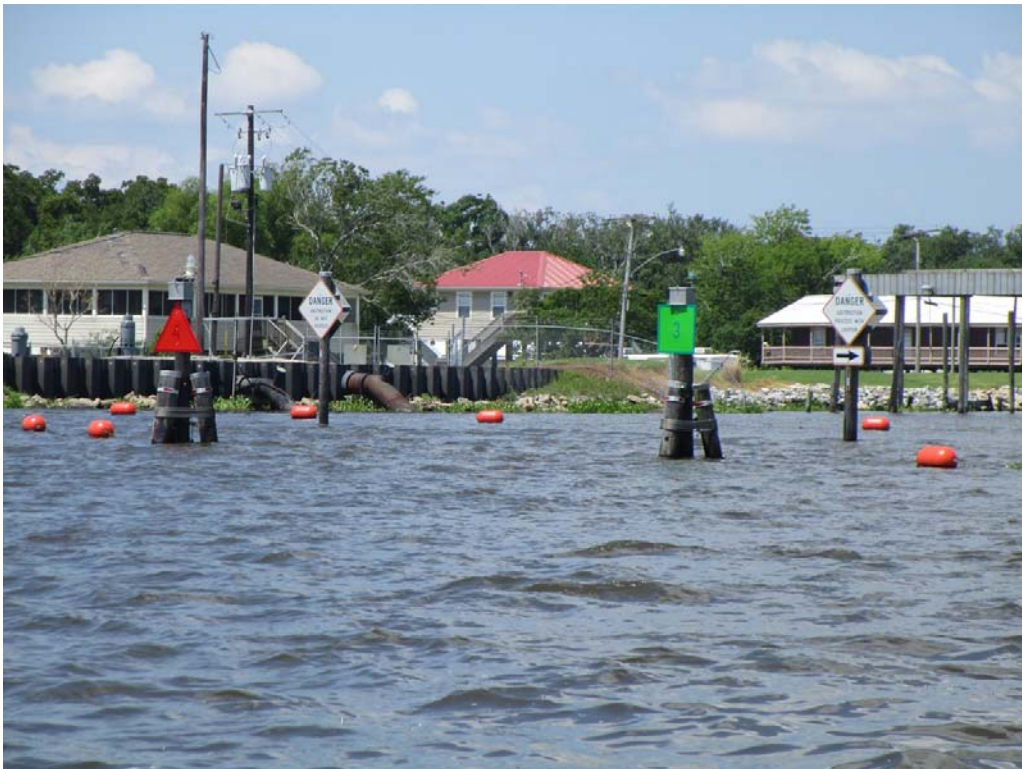
Navigation markers and barrier float cable assemblies were replaced in 2015. Warning signs were in good condition (Photo #2).

**Photo #2 – New navigation markers (Goose Bayou)**

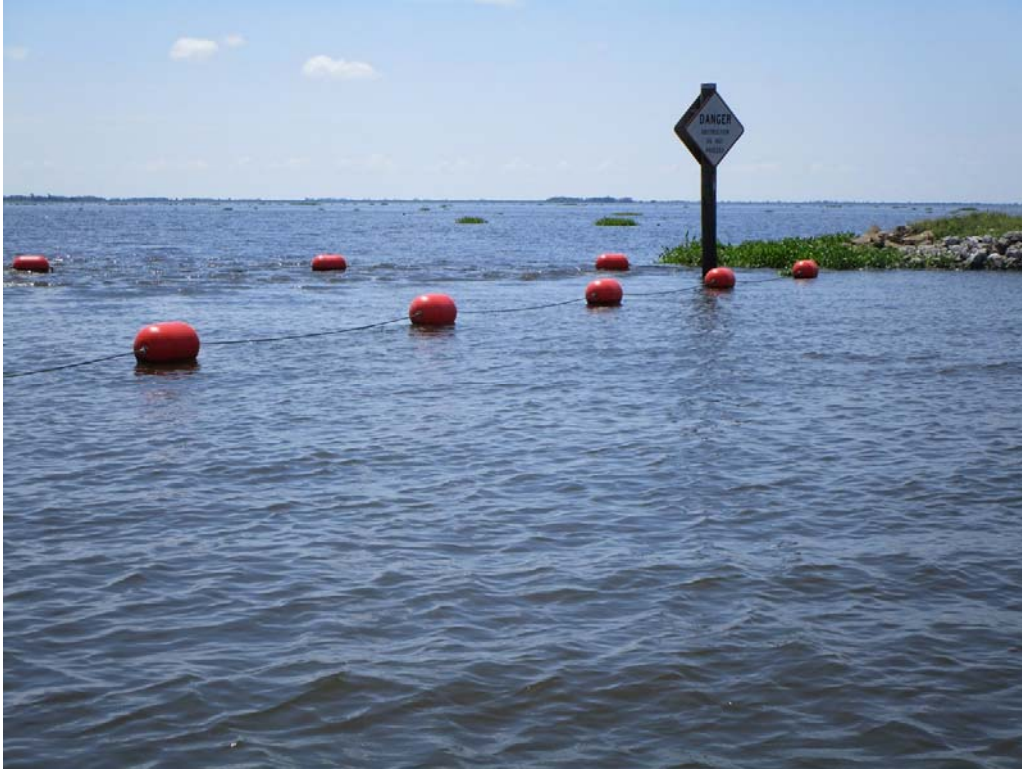
**Photo #3 – New barrier floats and cables (Goose Bayou)**

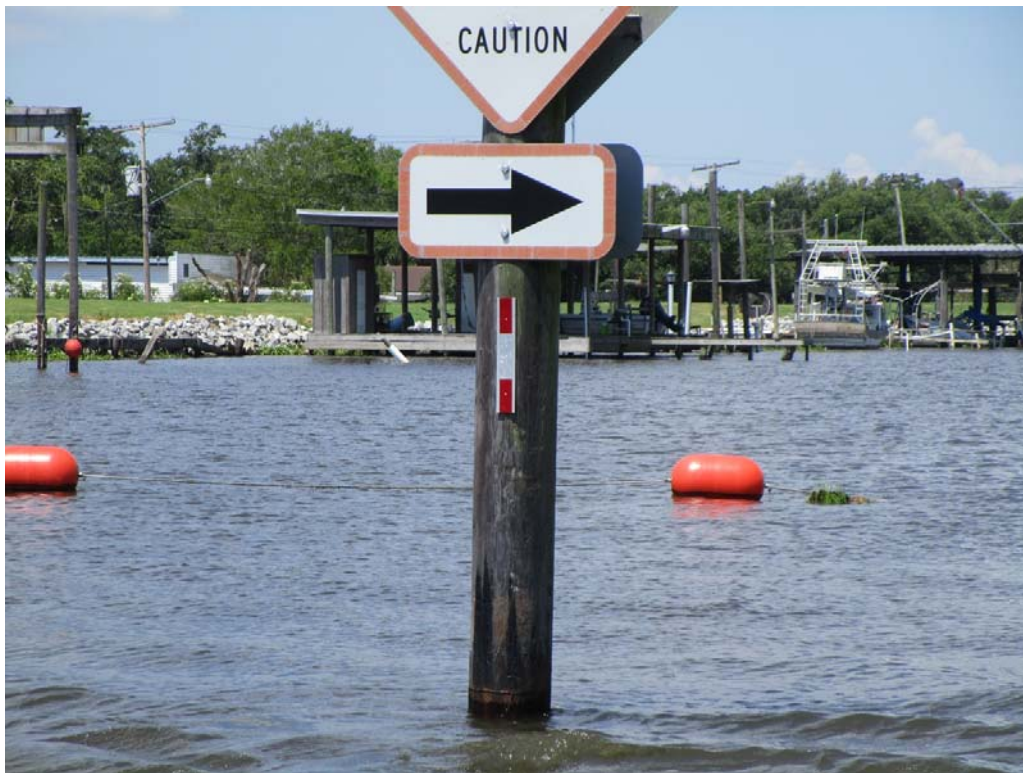
Timber pilings appeared to be in good condition. Reflective tape was replaced as part of the 2015 maintenance event (Photo #2).

**Photo #4 – New reflective tape on piles (Goose Bayou)**
