**State of Louisiana  
Coastal Protection and Restoration Authority**

**2019 Annual Inspection Report**

**Naomi Outfall Management**

State Project Number BA-03c  
Priority Project List 5

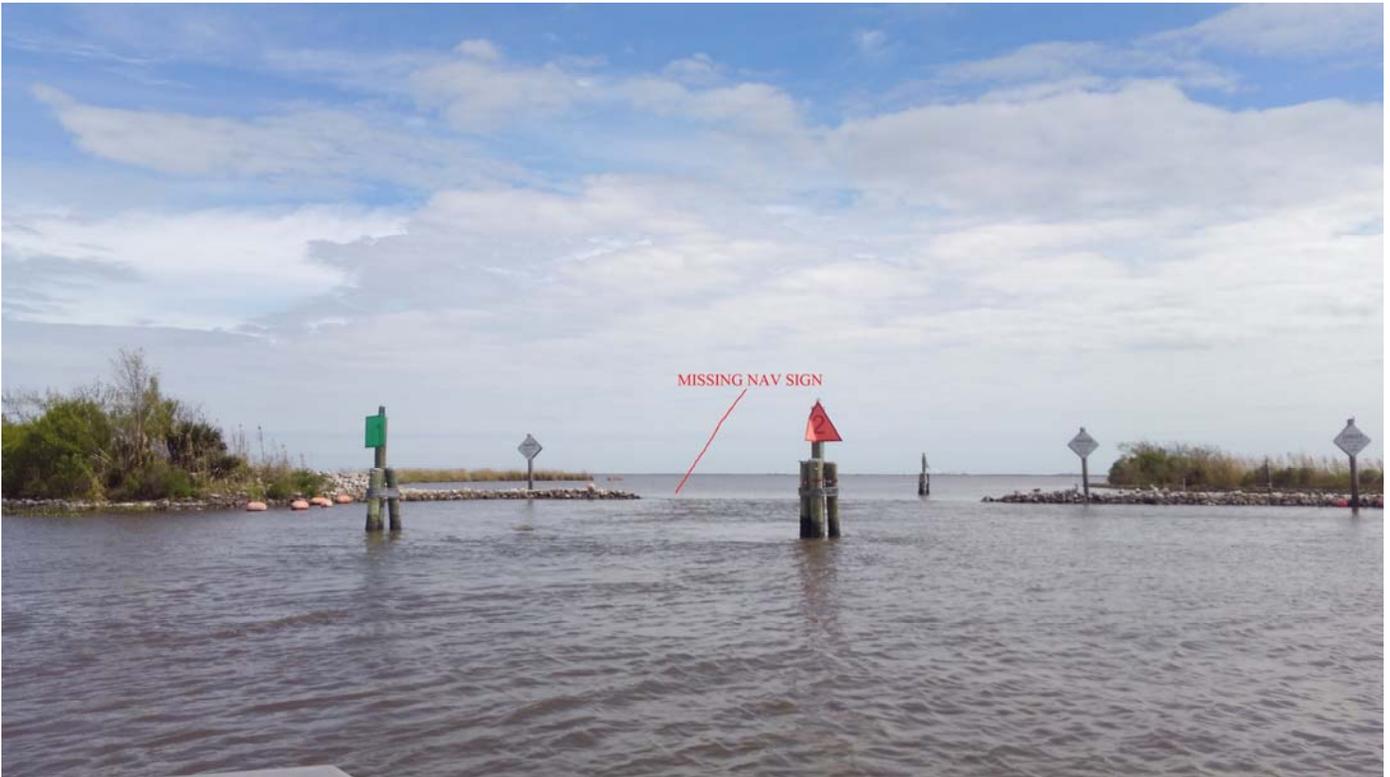
The rock riprap was clearly visible above the water with no sign of major settlement or damage. (Photos #1, 2, and 3)

The remaining three navigation signs appear to have been bent. The two red signs are bent in opposite directions and at almost 90 degree angles on the channel side. The remaining green sign is slightly deflected. While the signs are damaged, they should still be functional in combination with the lights (Photos #1, 2, and 3).

The lights are present on the remaining pile clusters with no defects observed (Photos #1, 2, and 3). Routine navigation light maintenance is performed under a separate state-wide contract.

Neither of these buoys were found near the structure. (Photos #1, 2, and 3)

**Photo #1 – Rock riprap, warning signs, and buoys (Bayou Dupont looking East)**

Item	Condition	Physical Damage	Corrosion	Photo #	Observations and Remarks
Rock Riprap	Good	None	N/A	#1, 2, 3	Good condition
Pile Clusters	Varying	See Remarks	None	#1, 2, 3	One pile cluster was missing.
Warning Signs and Day Board Navigation Signs (Bayou Dupont)	Good	See Remarks	None	#1, 2, 3	All three remaining signs were bent, the two red signs bent at about 90 degree angles while the green sign was less bent.
Navigation Aid Lights	Varying	See Remarks	None	#1, 2, 3	No defects noted. Maintenance of navigation lights is covered under state-wide contract.
Warning Buoys	Varying	See Remarks	None	#1, 2, 3	Both regulatory marker buoys were missing

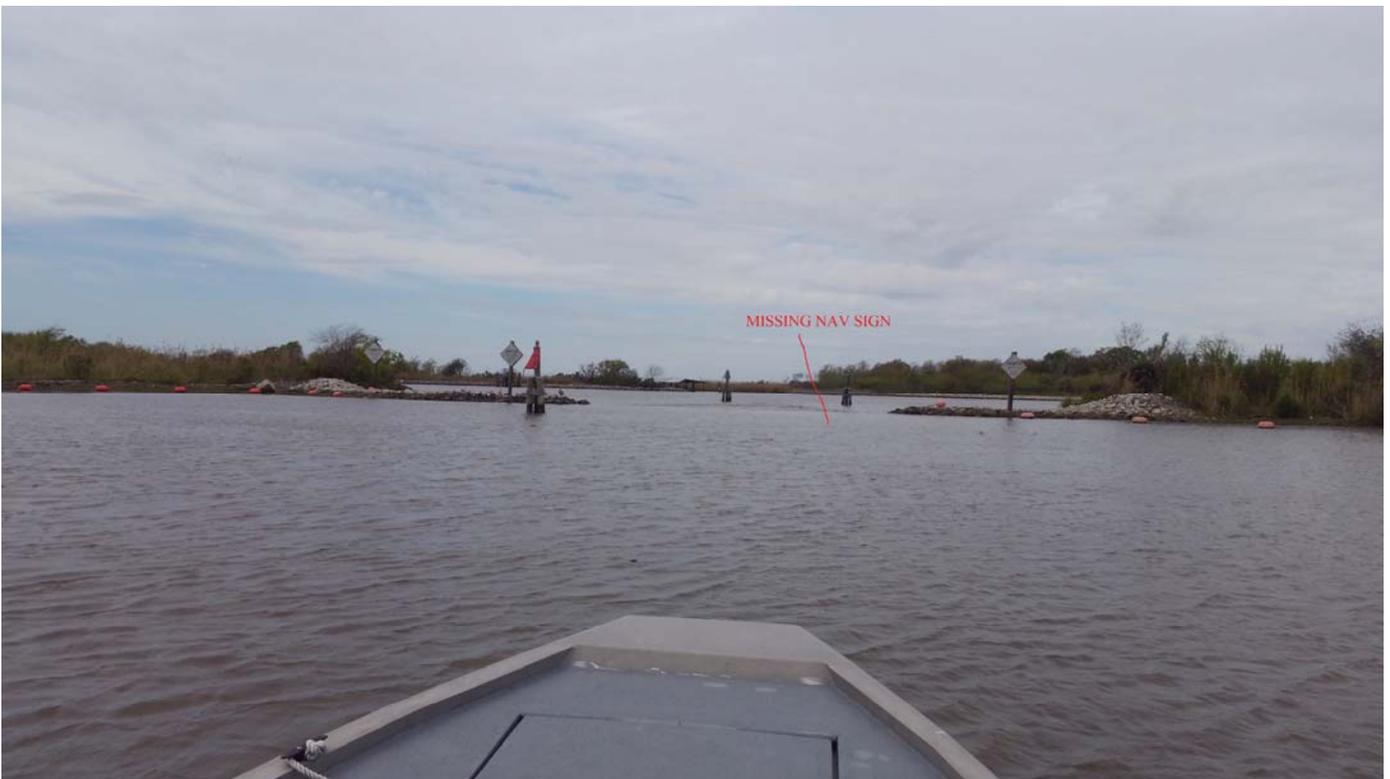
**Photo #2 – Rock riprap, warning signs, and buoys (Bayou Dupont looking West)**

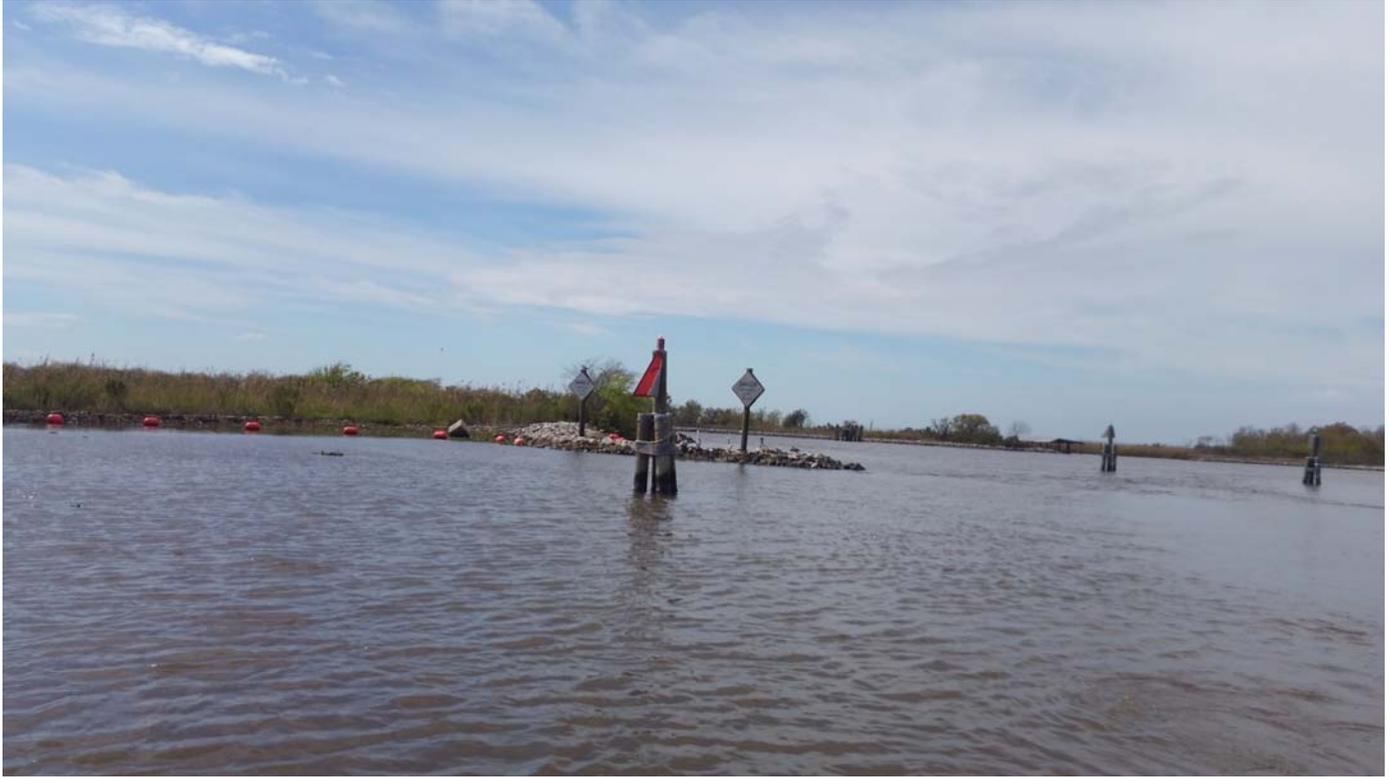
The main structures (two rock weirs) of the Naomi Outfall Management project are in functional condition. The main issues are with the aforementioned signs at the Bayou Dupont Canal Weir.

**Photo #3 – Pile cluster bent sign (Bayou Dupont looking West)**

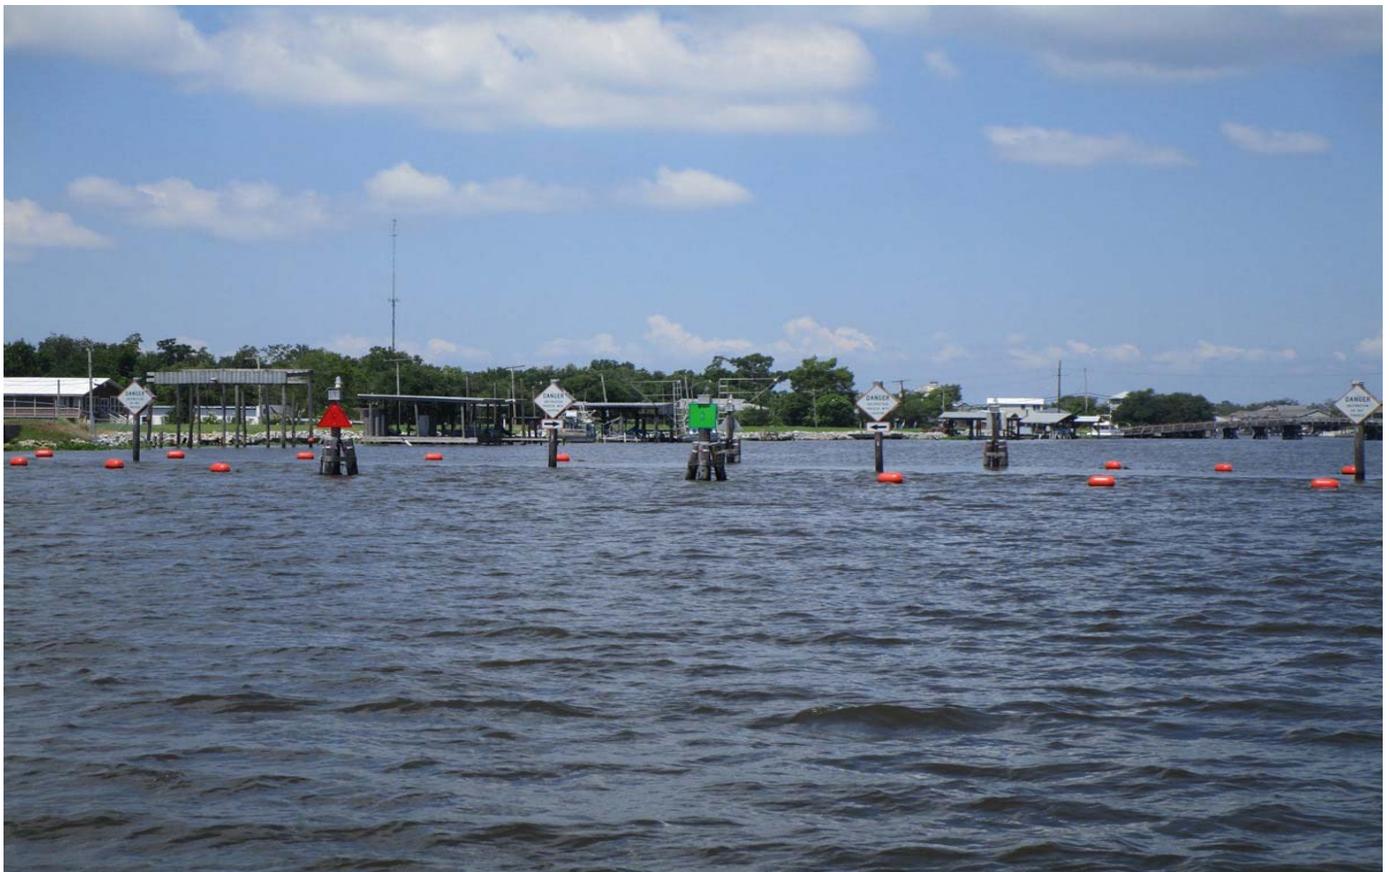
**Photo #4 – Warning Signs and Buoys (Goose Bayou looking West)**

Item	Condition	Physical Damage	Corrosion	Photo #	Observations and Remarks
Rock Riprap	Notable Settlement	None	N/A		Most of rock structure was below water surface elevation.
Creosote Piling	Good	None	N/A	4	No defects noted.
Warning Signs and Day Board Navigation Signs	Good	None	None	4	No defects noted.
Navigation Aid Lights	Good	None	None	4	No defects noted. Maintenance of navigation lights is covered under state-wide contract.
Warning Buoys	Good	None	None	4	No defects noted.
