**2015 Annual Inspection Report**

**Barataria Bay Waterway West  
Shoreline Protection**

State Project Number BA-23  
Priority Project List 4

August 24, 2015  
Jefferson Parish

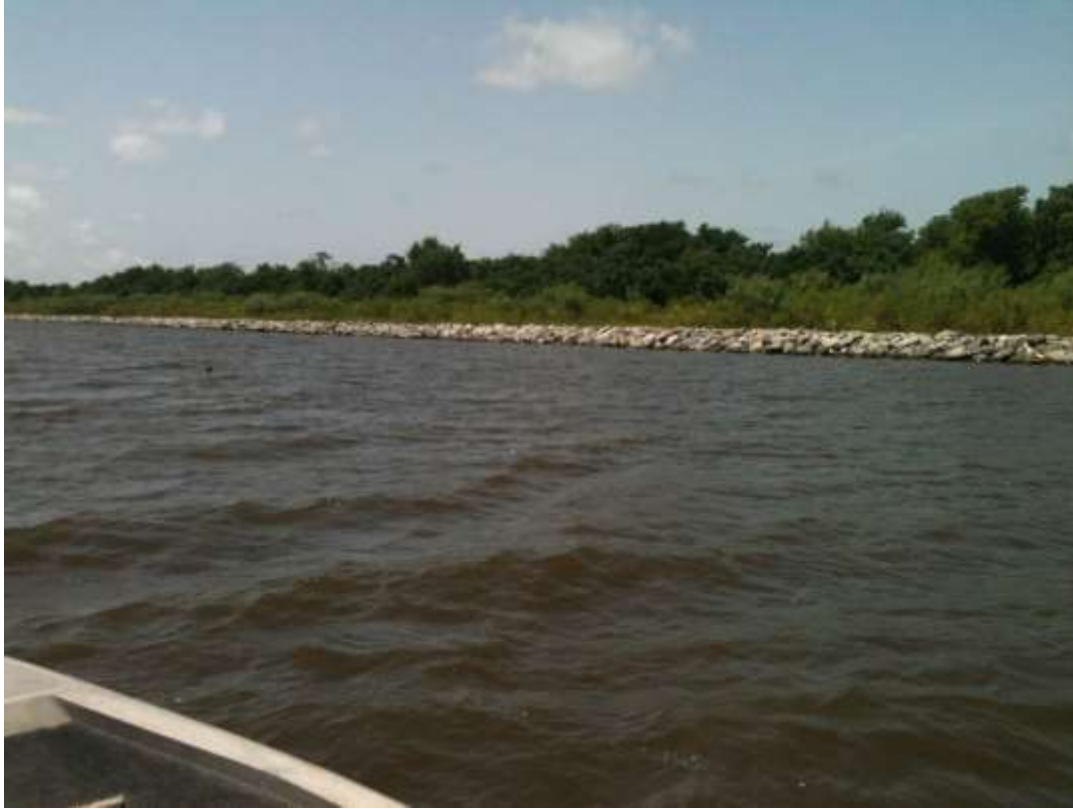
The rock structure appeared to be in good condition at the time of the inspection (Photo #1). There are some sections which have experienced settlement, but the structure is still functioning as designed. These sections will continue to be monitored for maintenance needs.

**Photo #1 – Shoreline Protection**

- Continue to check the WCS during operational procedures.
- Continue to observe rock structure for settlement.

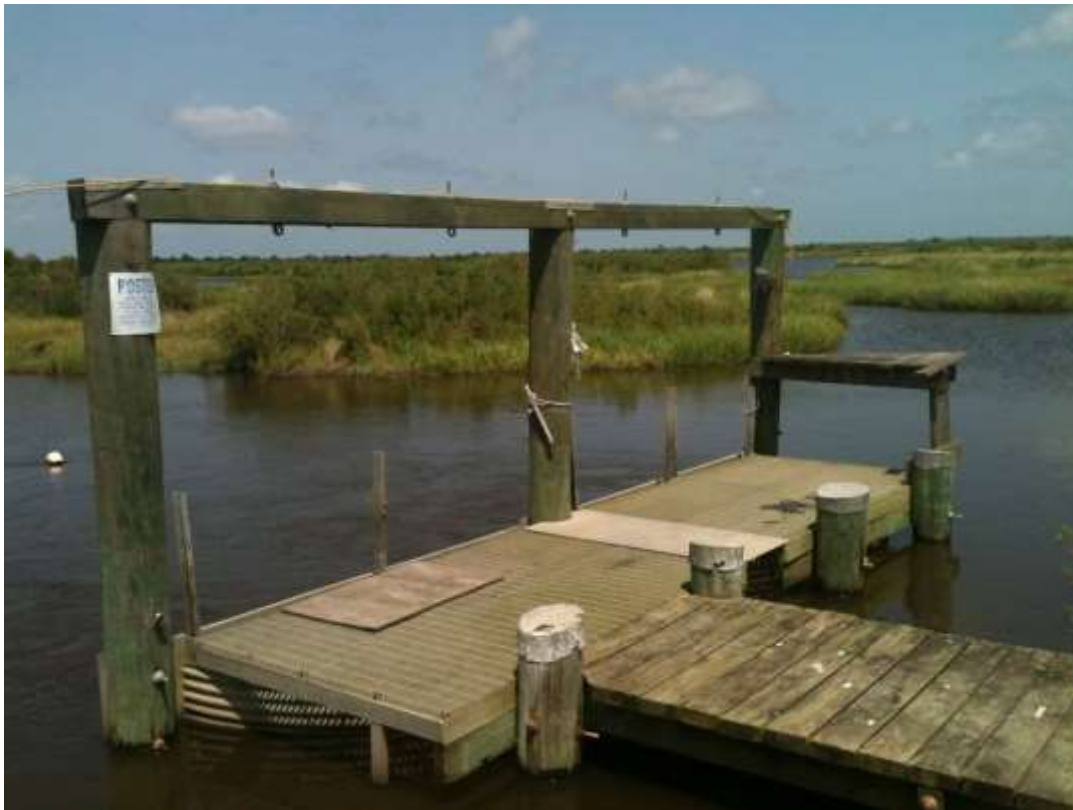
**Photo #2 – Water Control Structure**

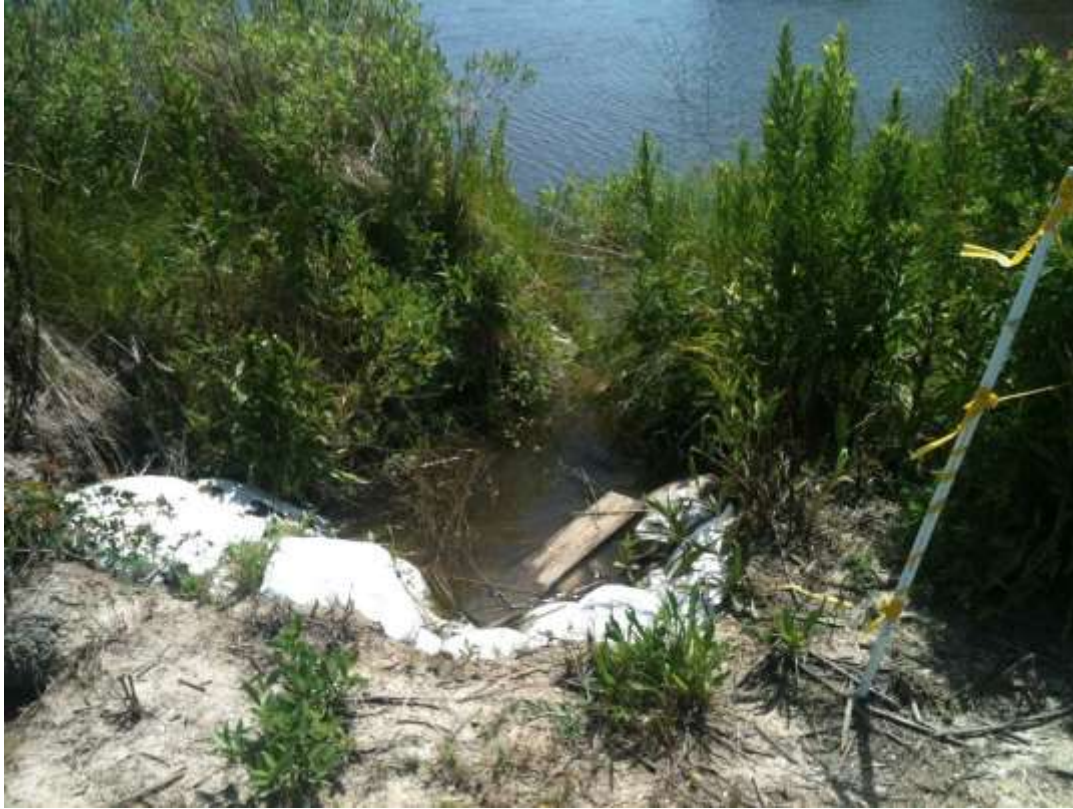
The weir box and supporting timber elements of the WCS appeared to be in good condition (Photo #2); however, significant erosion has occurred in the earthen berm due to perforations in the CMP culverts below the berm (Photos #3 and #4). Stop logs remain in-place to slow the pace of erosion until a permanent repair can be implemented. CPRA has hired a consultant to develop plans and specifications for the repair, and has applied for a permit.

**Photo #3 – WCS Berm Erosion Above Culverts**

Earthen Berm	Poor	See Remarks	N/A	#3, 4	Significant erosion noted in berm covering CMP culverts. Earth fill will be placed following slip-liner installation.
Foreshore Rock Dike	Good	None	N/A	#1	Good condition overall, minor settlement observed.

- Install culvert liners and repair erosion of earthen berm at WCS.

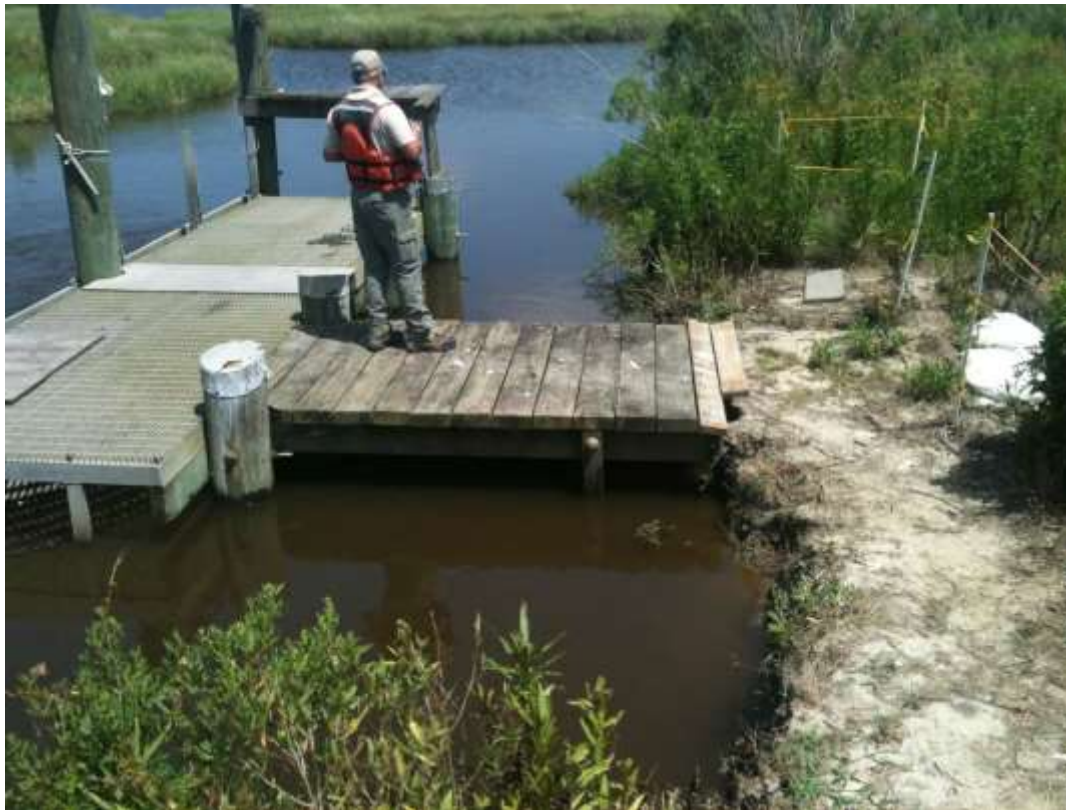
**Photo #4 – Erosion on Marsh Side of WCS Berm**
