**State of Louisiana  
Coastal Protection and Restoration Authority**

**2019 Annual Inspection Report**

**Barataria Bay Waterway West  
Shoreline Protection**

State Project Number BA-23  
Priority Project List 4

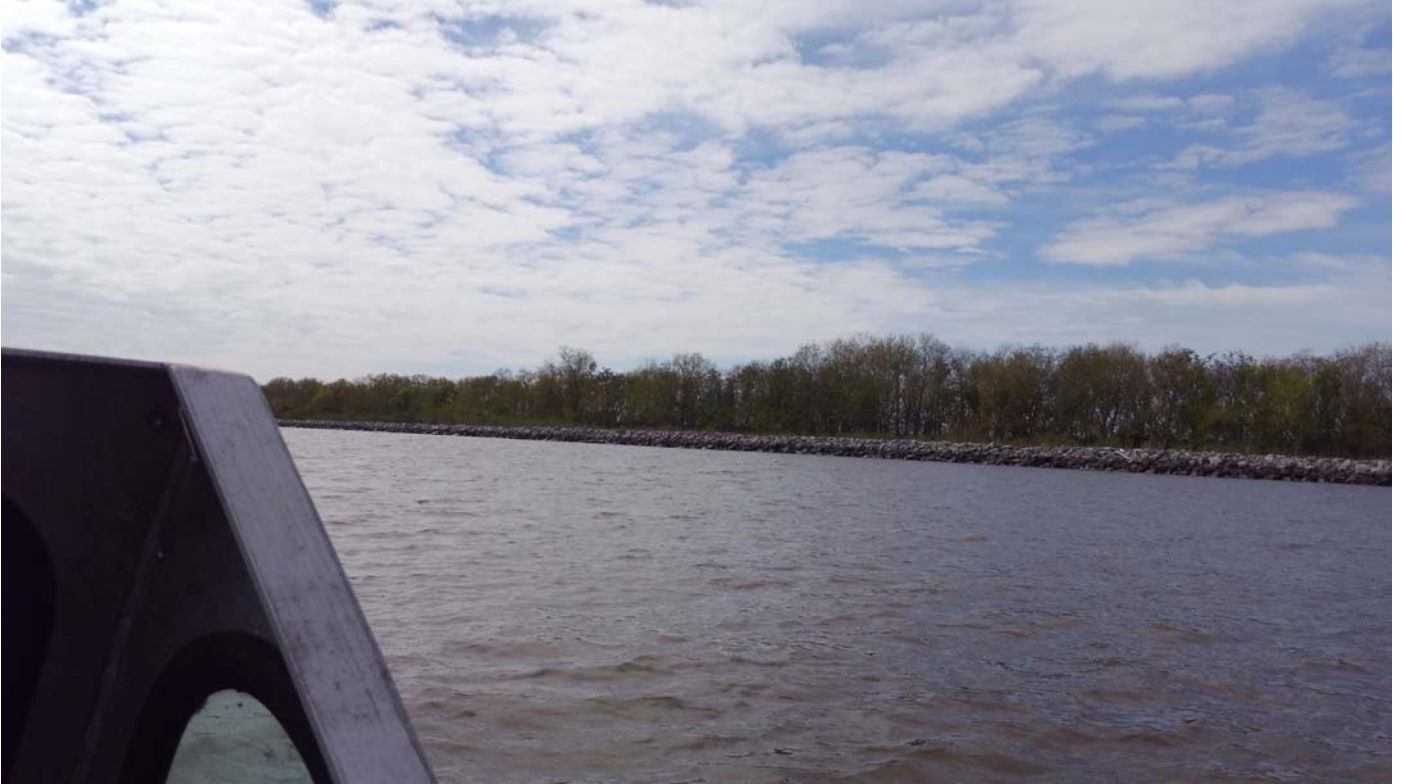
**Photo #1 – Shoreline Protection (North End)**

The rock structure was mostly visible above the water surface and in good condition at the time of the inspection (Photo #1). There are some sections that have experienced settlement but the overall structure is still functioning as designed.

Item	Condition	Physical Damage	Corrosion	Photo #	Observations and Remarks
CMP culverts	Very Good	None	N/A		No significant defects noted.
Weir Bays - logs locks, hoist, supports	Good	None	Minor	#2, 3, 4	No significant defects noted.
Handrails Grating Hardware etc.	Good	None	Minor	#3	No significant defects noted.
Timber Piles	Good	None	N/A	#2, 3, 4	No significant defects noted.
Timber Wales	Good	None	N/A		No significant defects noted.
Galv. Pile Caps	Fair	None	Moderate	#3	Galvanized caps exhibited some weathering.
Signage /Supports	Good	None	None		No significant defects noted.
Riprap	Good	None	N/A	#3, #4	No significant defects noted.
Earthen Berm	Very Good	None	N/A	#2, #4	No significant defects noted.
Foreshore Rock Dike	Fair	None	N/A	#1	Fair condition overall; some minor settlement was observed.

- Continue to check the WCS during operational procedures.
- Continue to observe rock structure for settlement.

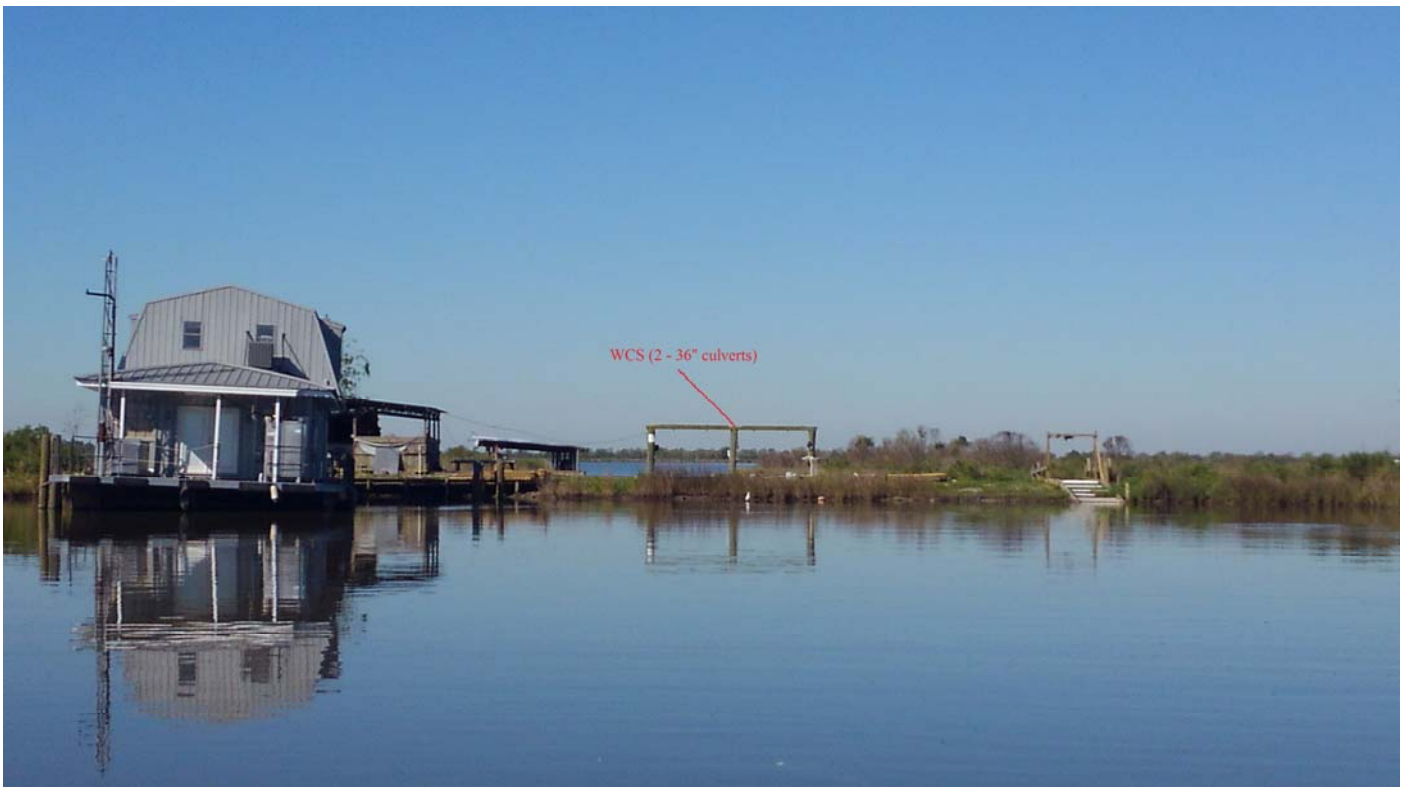
**Photo #2 – Water Control Structure**

The WCS shows little sign of damage. (Photos #2, #3, & #4). There is some minor to moderate corrosion of the steel members; however, the structure is still functioning as designed.
