2015 Annual Inspection Report

Barataria Bay Waterway East Shoreline Protection

State Project Number BA-26
Priority Project List 6

August 24, 2015
Jefferson Parish

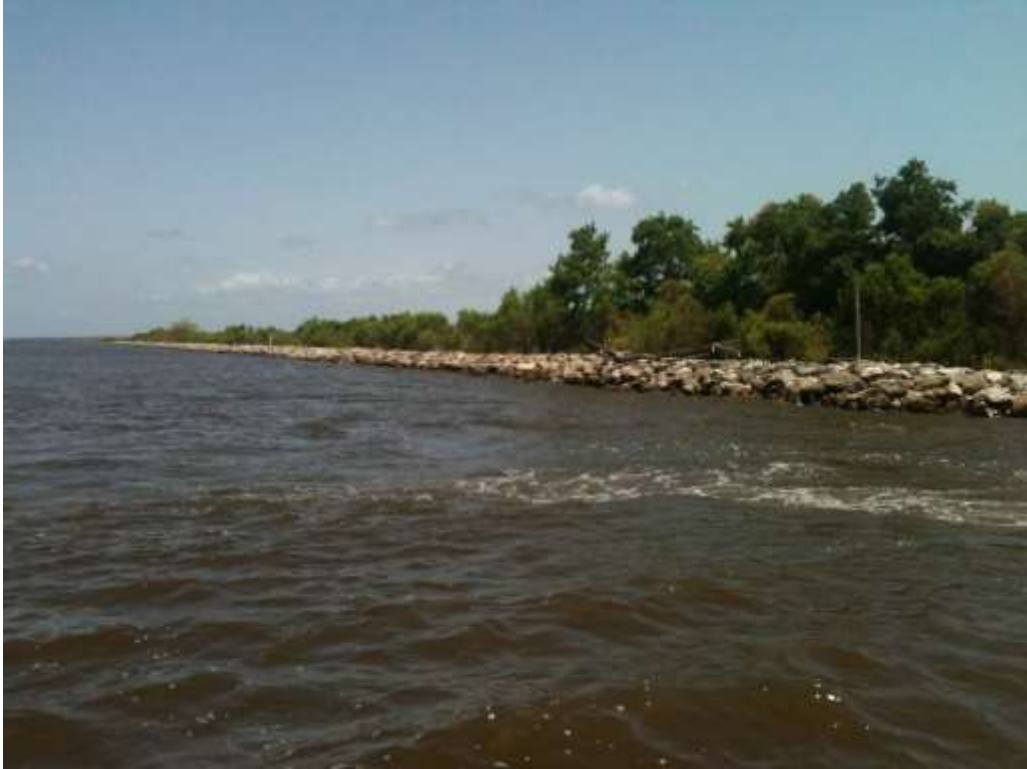
The overall condition of the rock shoreline protection structure was good (Photo #1). Some portions of the rock structure exhibited minor settlement adjacent to and south of the marsh creation portion of the South Shore of the Pen Project (BA-41, Photo #2). Accretion and vegetation were observed behind the rock structure at the north end of the project (Photo #3).

Photo #1 – Shoreline Protection

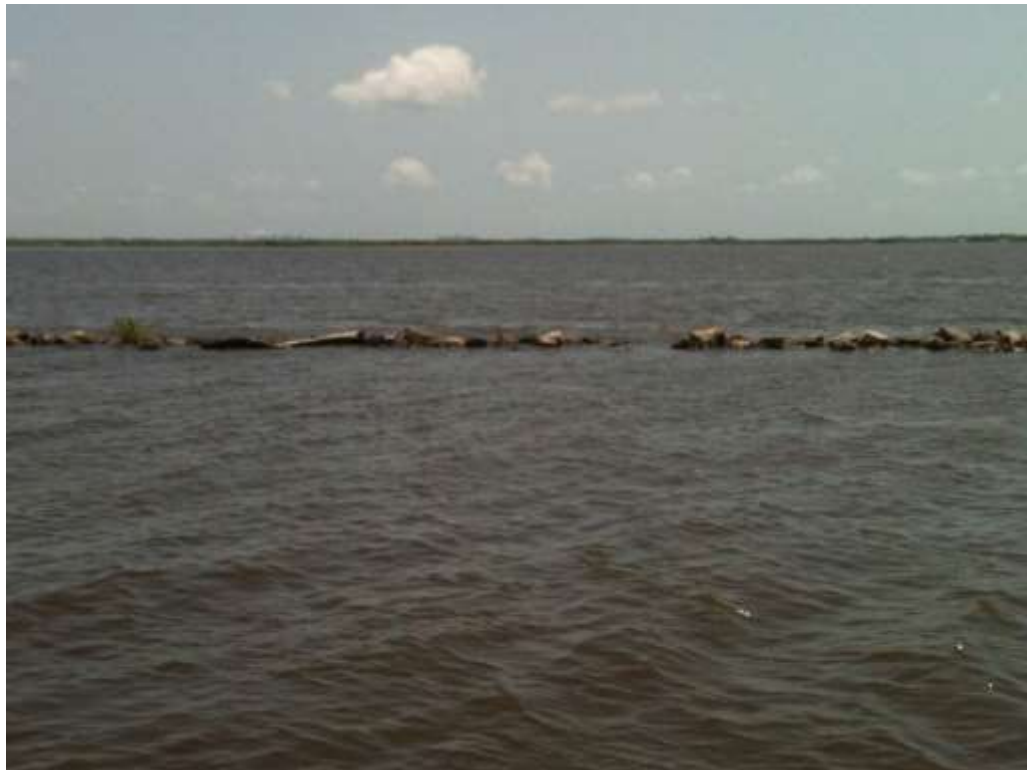
The Barataria Bay Waterway East Protection Project (BA-26) is performing adequately. The rock dike is protecting the existing marsh as designed. Some settlement has been observed and will continue to be monitored; however, no maintenance is required at this time.

Photo # 2 – Some Settlement Noted

- Continue to monitor the settlement of the rock structure.

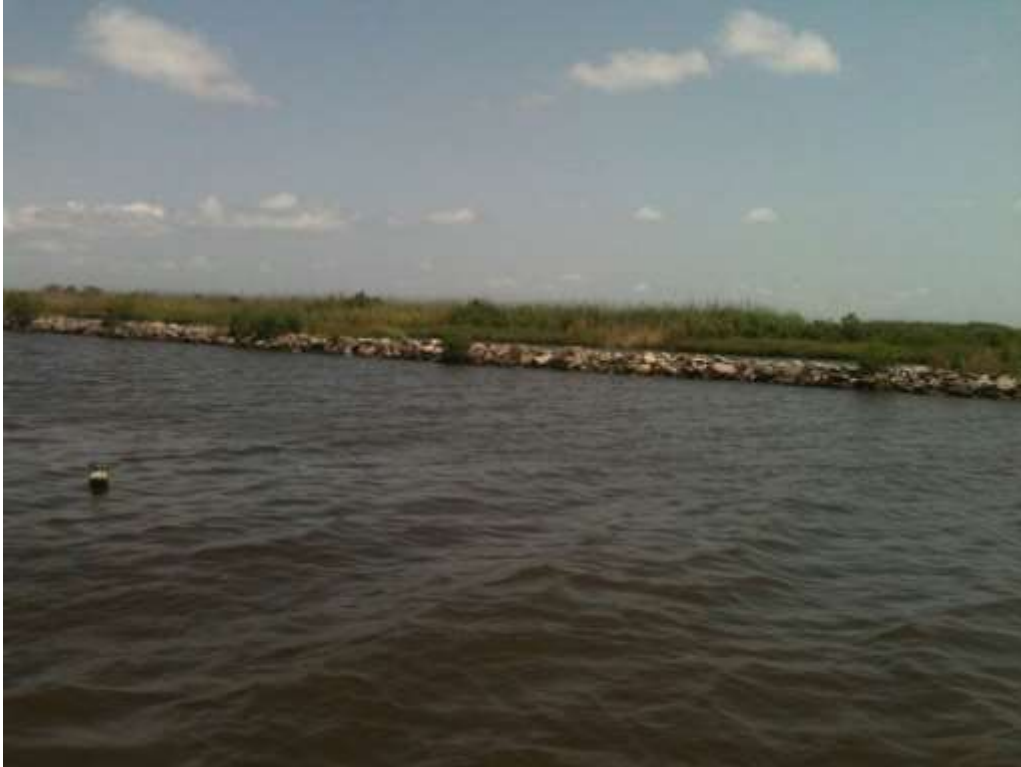
Photo # 3 – Accretion & Vegetation
