**State of Louisiana
Coastal Protection and Restoration Authority**

2016 Annual Inspection Report

**South Shore of The Pen Shoreline
Protection and Marsh Creation**

State Project Number BA-41
Priority Project List 14

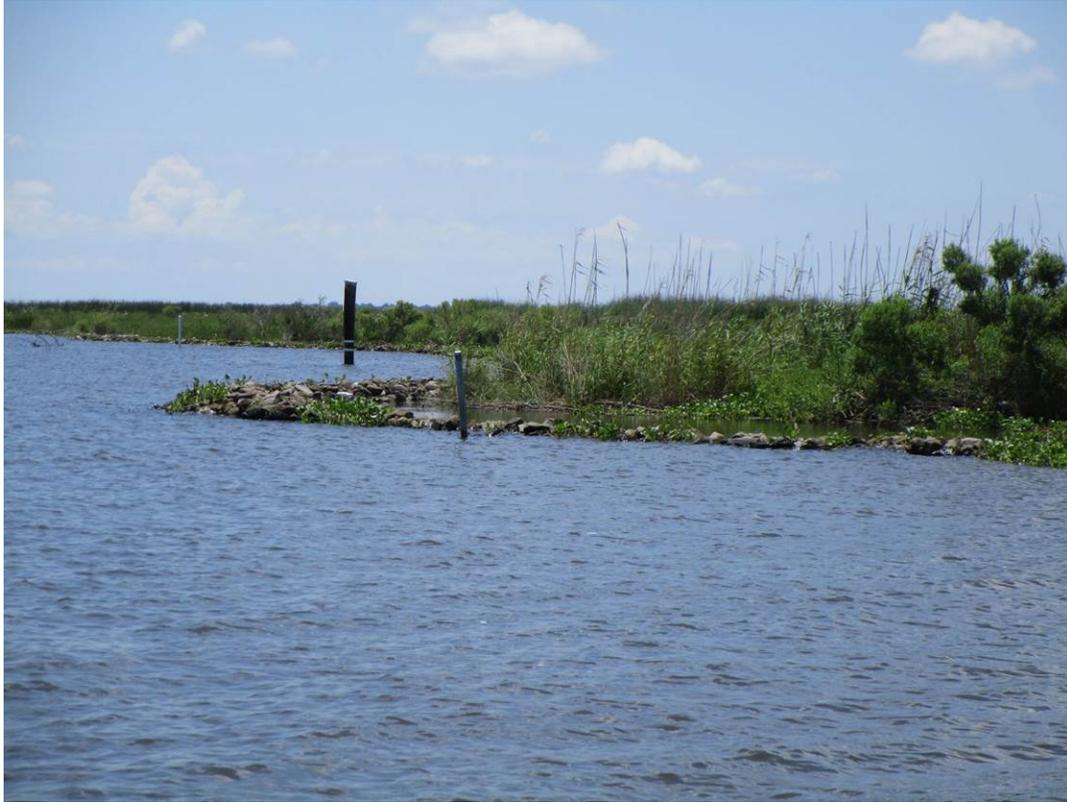
Tides in the project area were abnormally high on the day of the inspection, with water at or near the design elevation of the structure. The exposed areas of riprap were observed to be in good condition, and the project was meeting the goal of protecting the marsh to the south (Photos #1-4).

Photo #1 – Shoreline Protection, West Reach

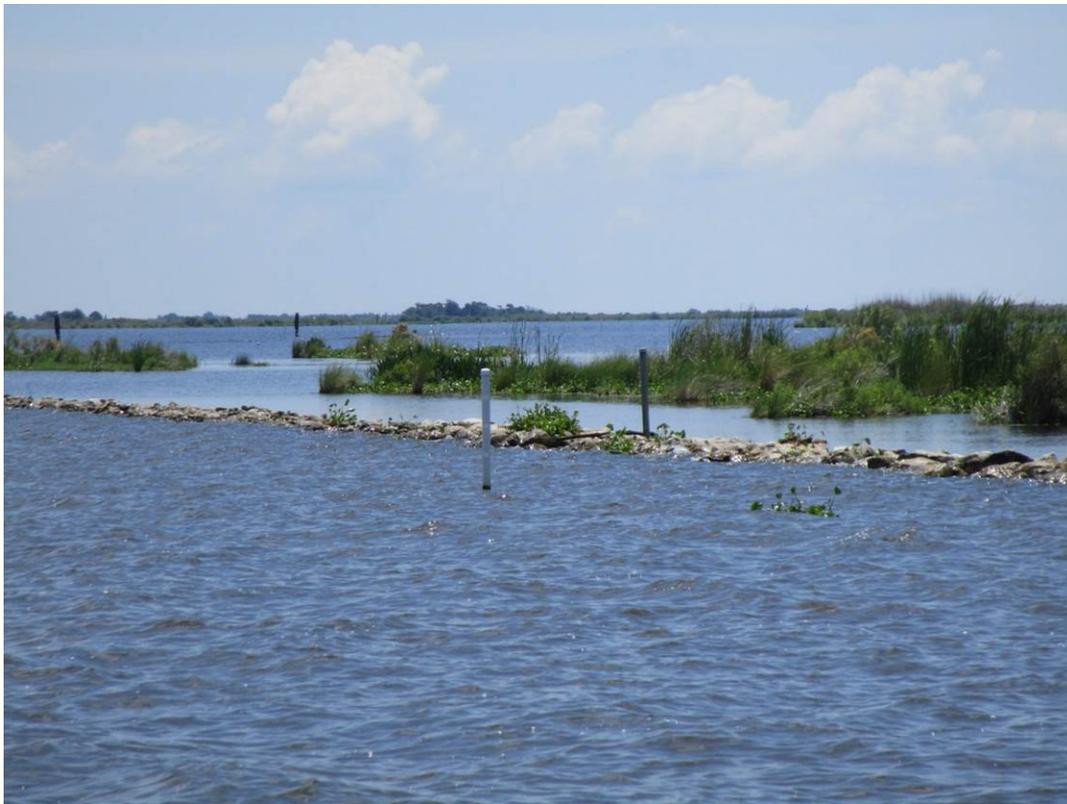
Photo #2 – Shoreline Protection, Central Reach

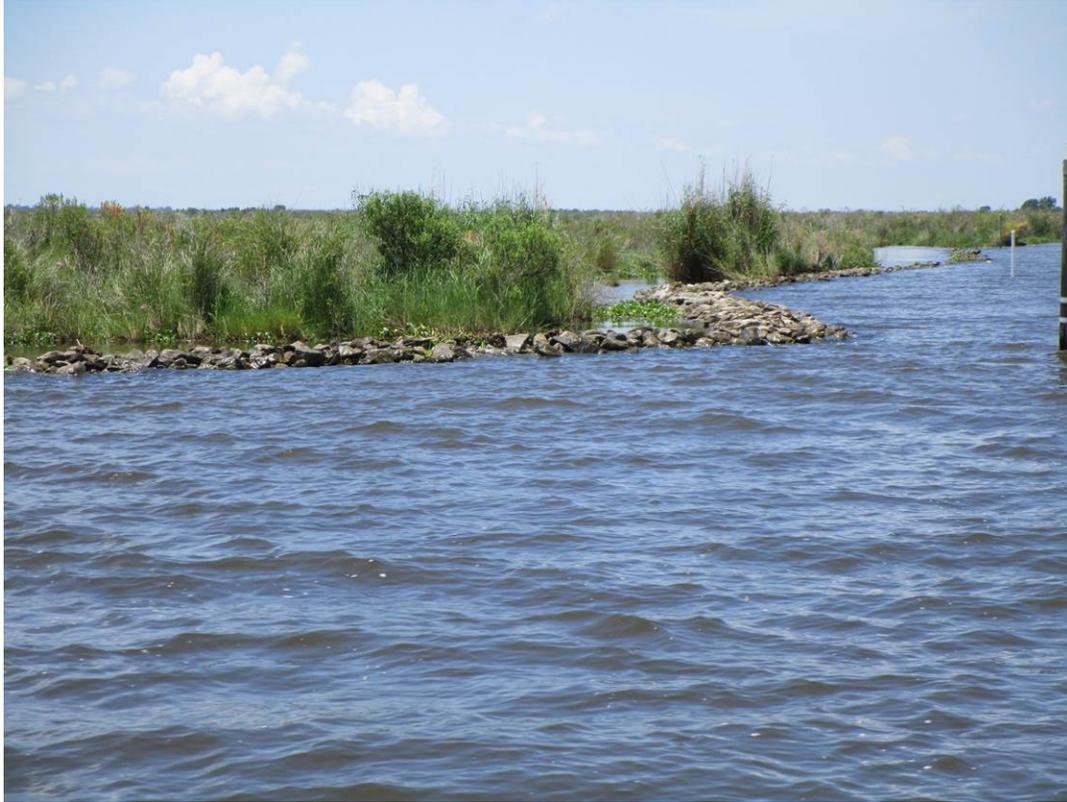
Photo #3 – Shoreline Protection, Central Reach

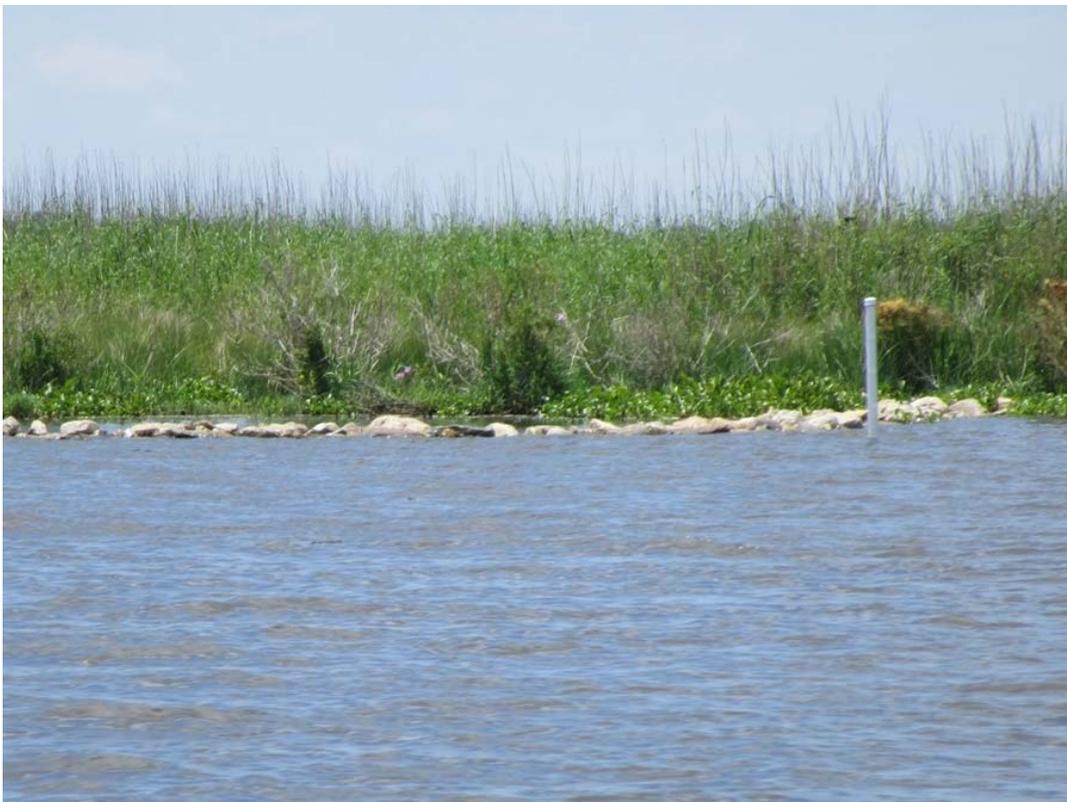
Photo #4 – Shoreline Protection, East Reach

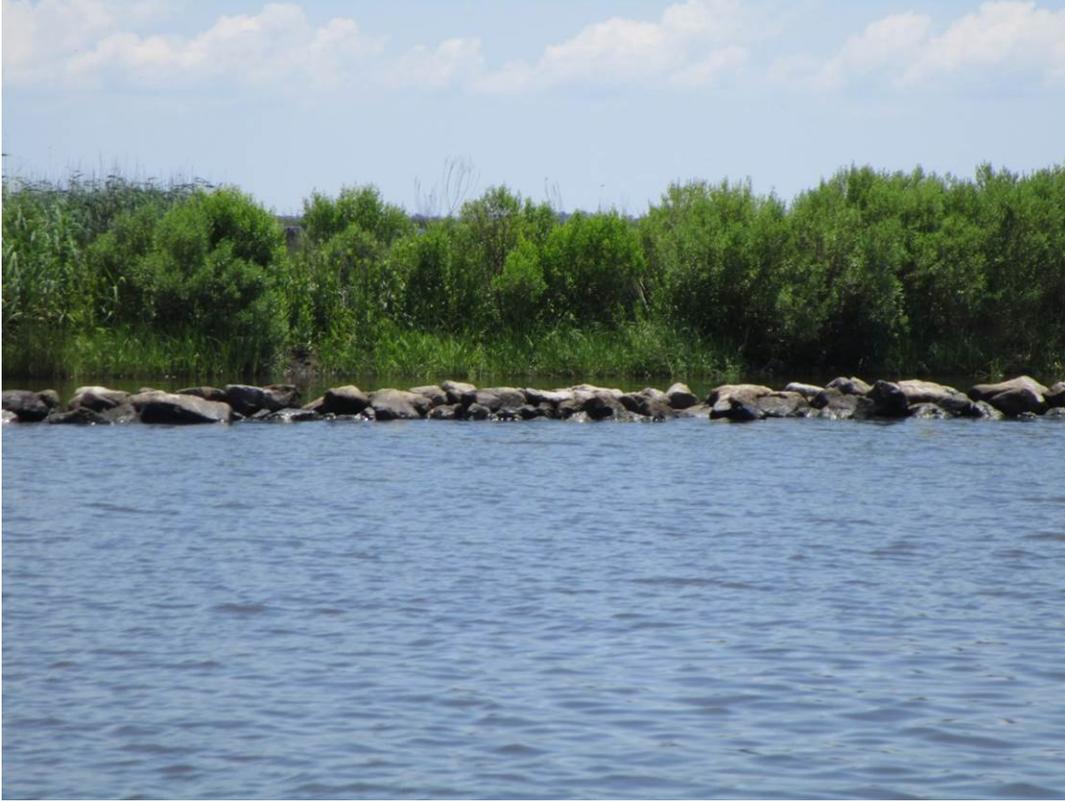
Inspection of this feature was performed visually from the Barataria Bay Waterway due to lack of access over the rock shoreline protection structure and shallow depths encountered outside of established waterways. The marsh creation area appeared well-vegetated with healthy marsh grass and Roseau cane (Photos #5 & #6). No maintenance needs were identified for this area.

Photo #5 – Marsh Creation Area Viewed from Barataria Waterway

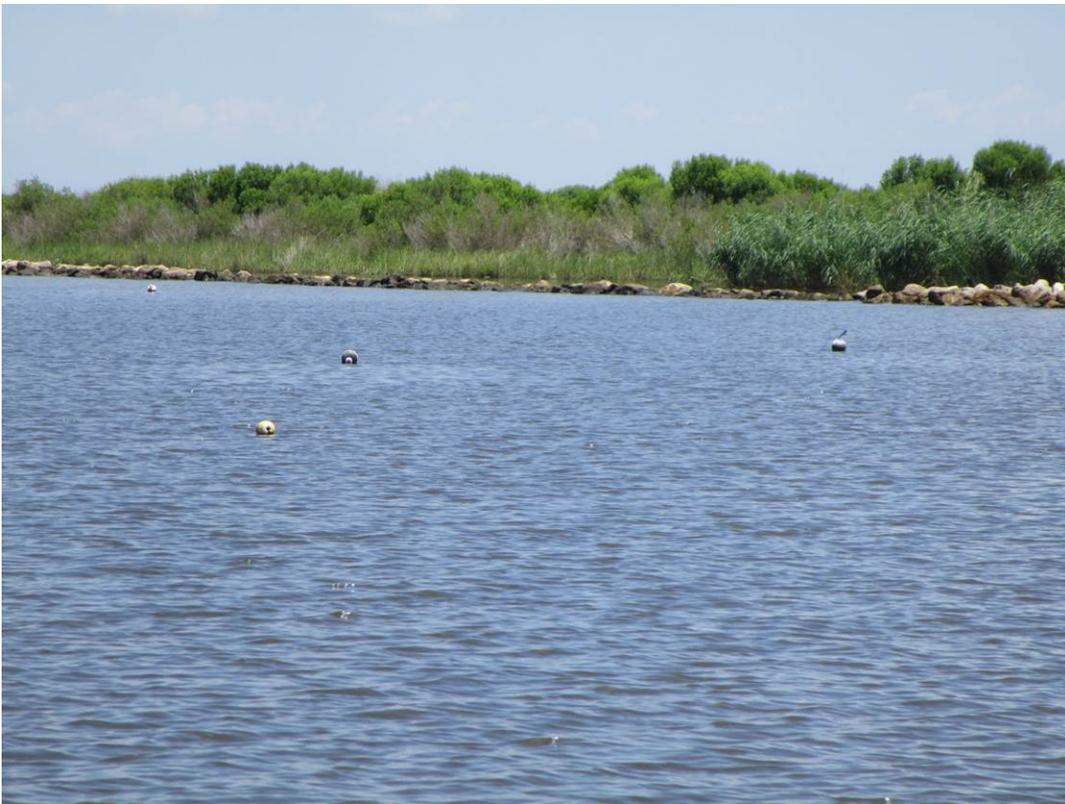
Photo #6 – Marsh Creation Area Viewed from Barataria Waterway
