**State of Louisiana
Coastal Protection and Restoration Authority**

2015 Annual Inspection Report

**DELTA MANAGEMENT AT
FORT ST. PHILIP (BS-11)**

State Project Number BS-11
Priority Project List PPL-10

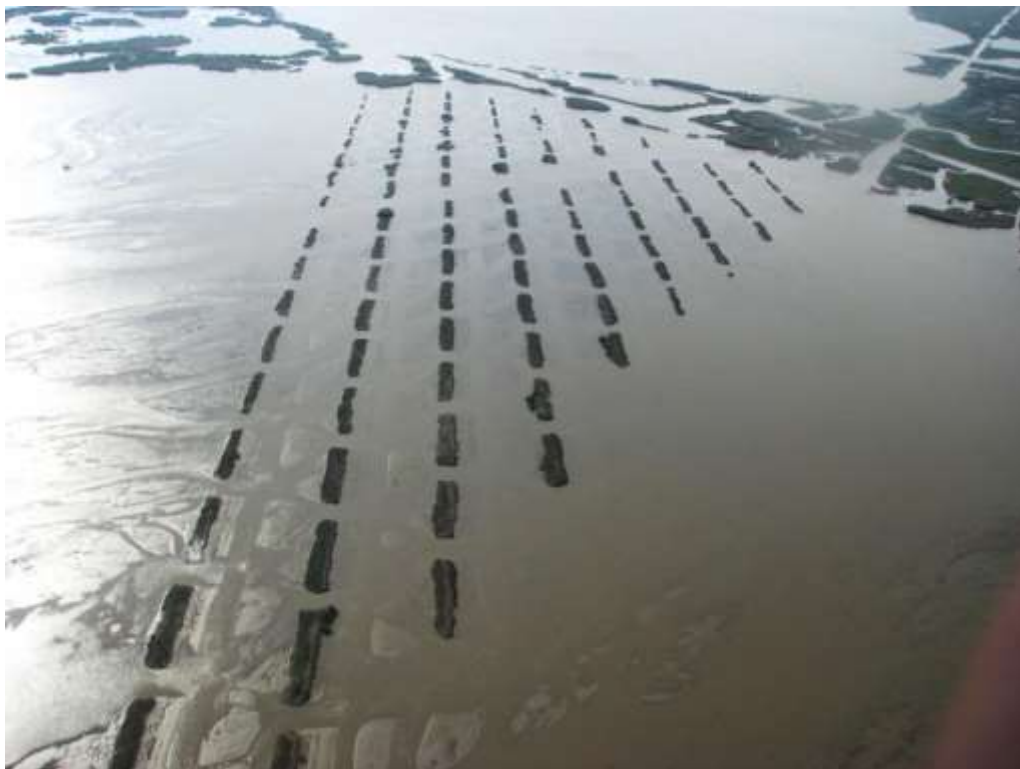
- A. Terraces: Due to a combination of a high river stage and post-construction settlement, most of the terraces were submerged to a shallow depth at the time of inspection. However, emergent vegetation was noted growing on all terraces within the project area. Dense stands of Roseau cane were observed in several locations. Many of the terrace borrow areas appear to be infilling, which indicates that sediment is being trapped as intended.

Terrace Field (12/08/2011 Stock Photo included for reference)

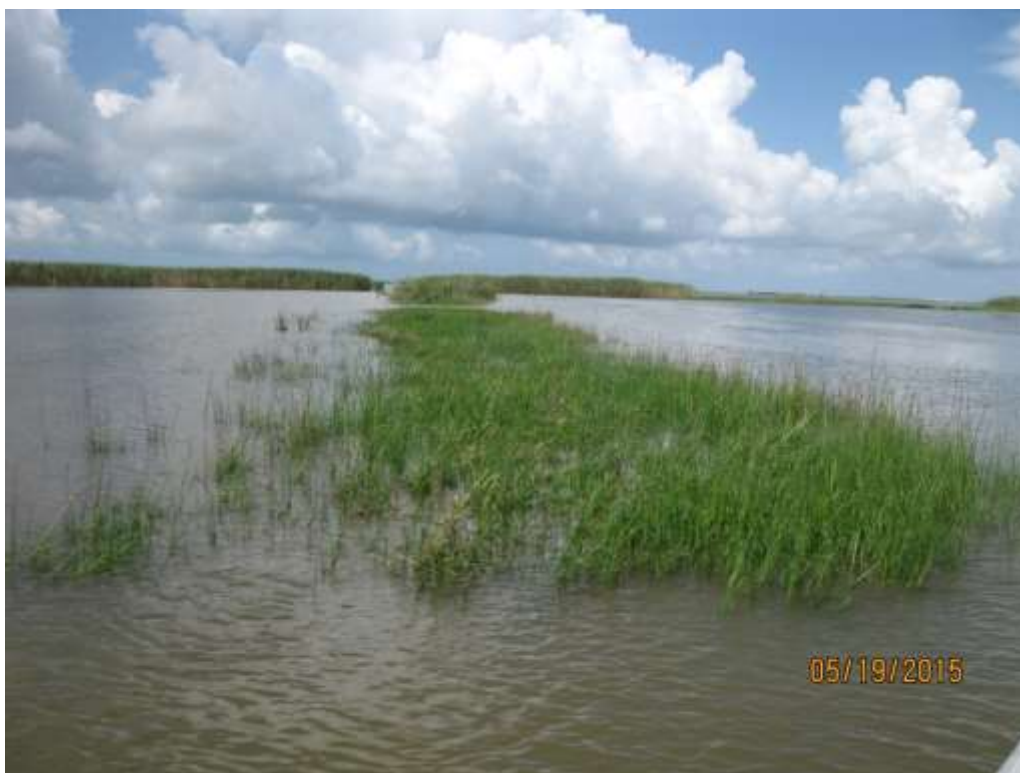
Marsh grass growing on terrace in Bay Denesse

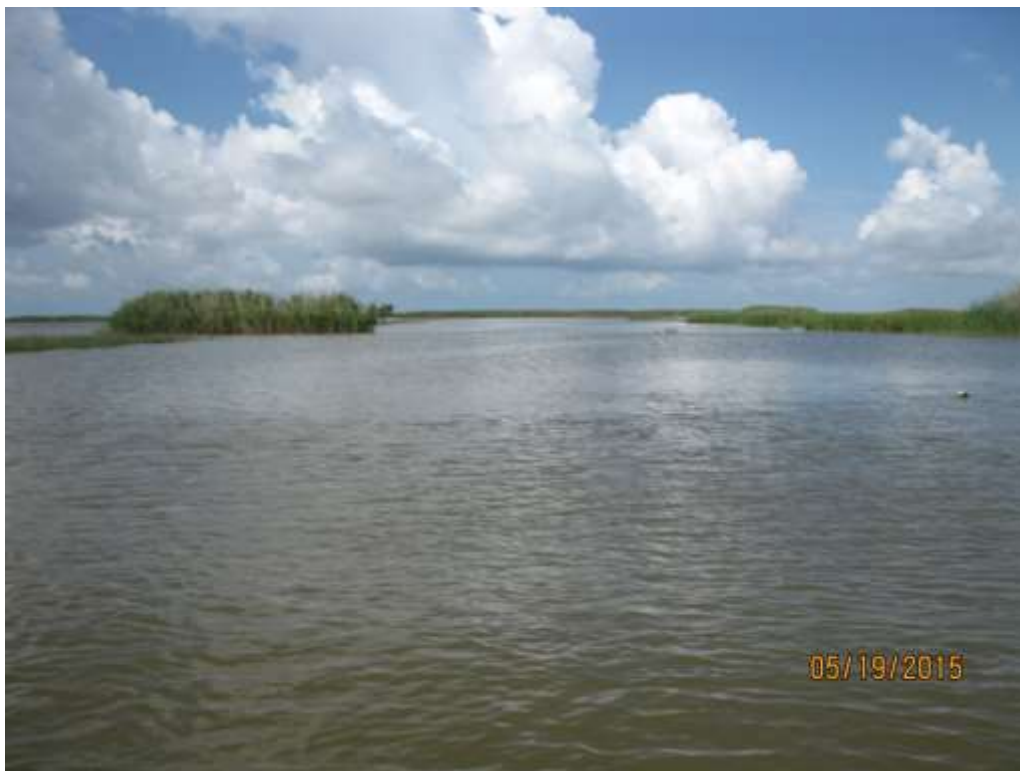
Roseau cane observed growing in terrace field

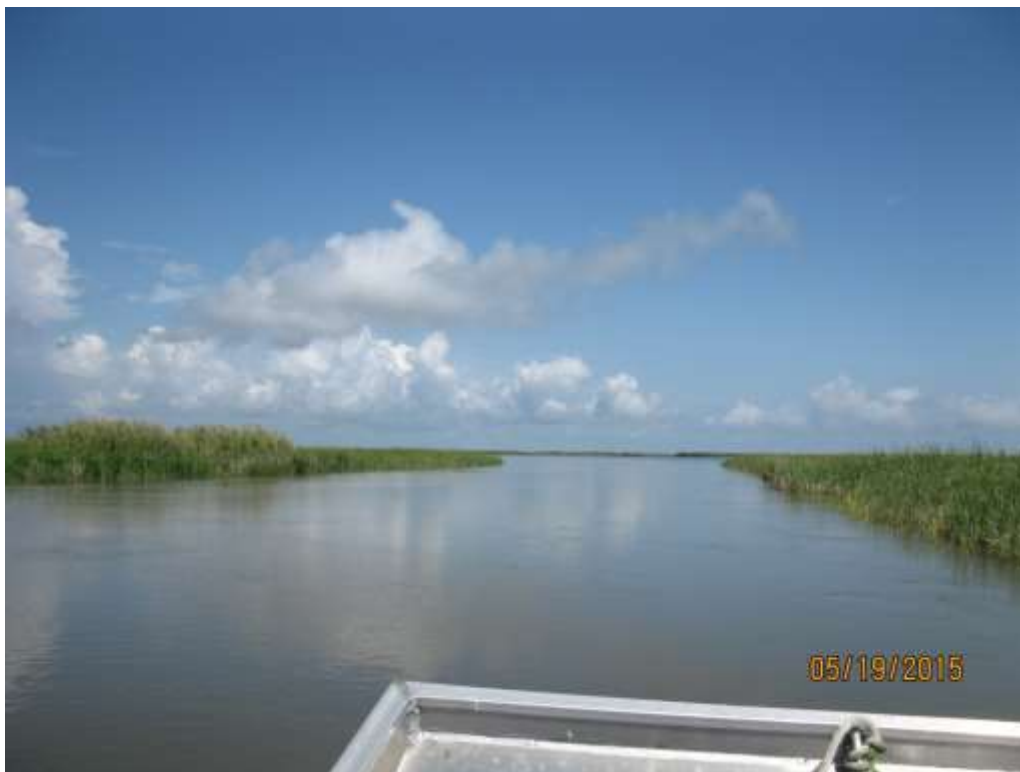
- B. Crevasse No. 1A: This crevasse is the longest of all, and funnels river water directly into the Bay Denesse terrace field. Currents through this crevasse were moving swiftly and appeared to be carrying a significant sediment load.

Crevasse 1A with terrace field beyond

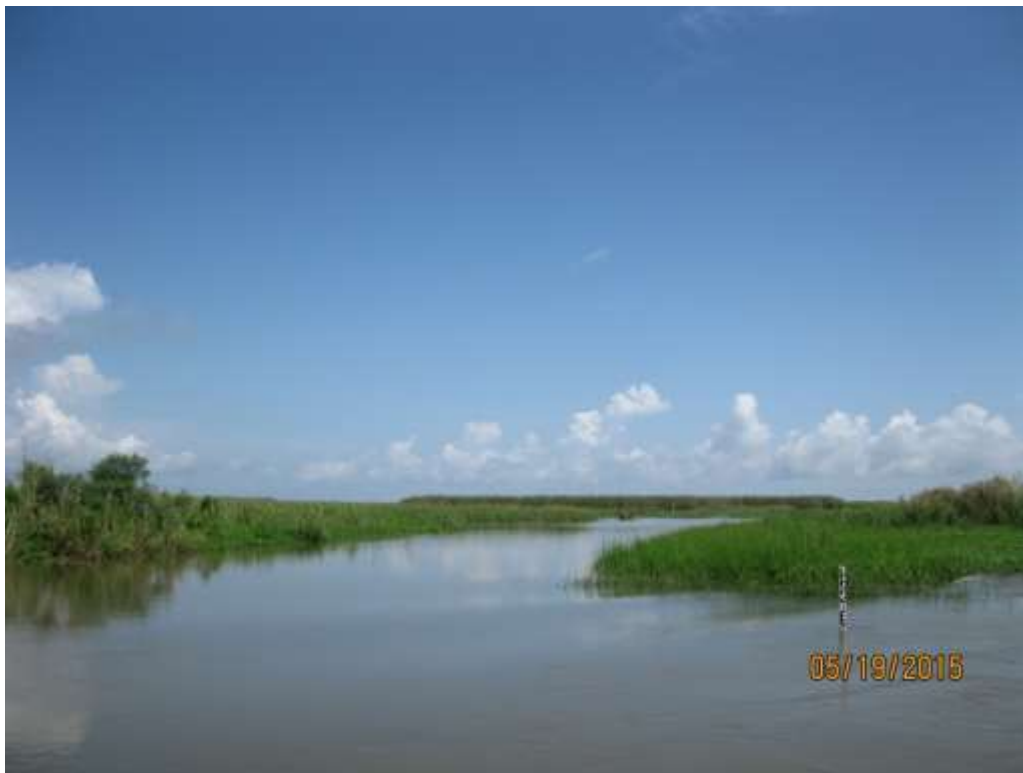
Crevasse 1B

- C. Crevasse No. 1B: This crevasse, which is the shortest of all, feeds a small area of marsh. Strong flow was observed in this channel. Thick growths of marsh grass were observed on the channel banks and a large stand of Roseau cane is growing within the receiving area.

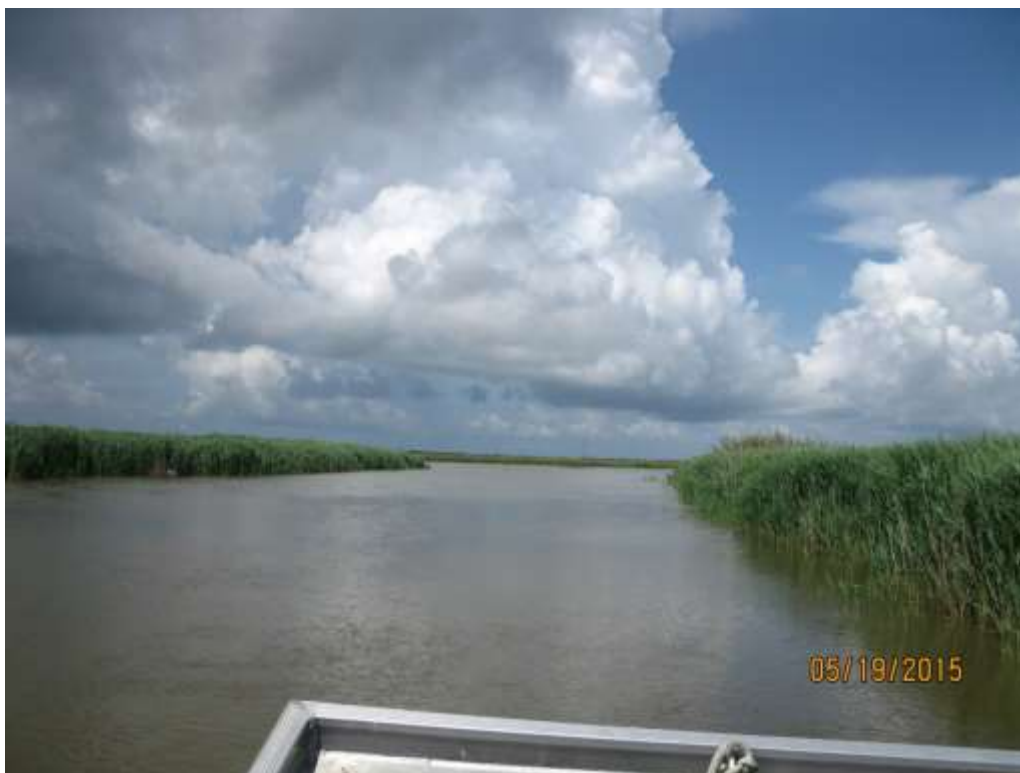
Crevasse 1C

- D. Crevasse No. 1C: A large volume of sediment-laden water was flowing through the channel into the receiving area. Several small patches of emergent vegetation were observed just beyond the outfall, and healthy marsh grass rings the entire perimeter of this site.

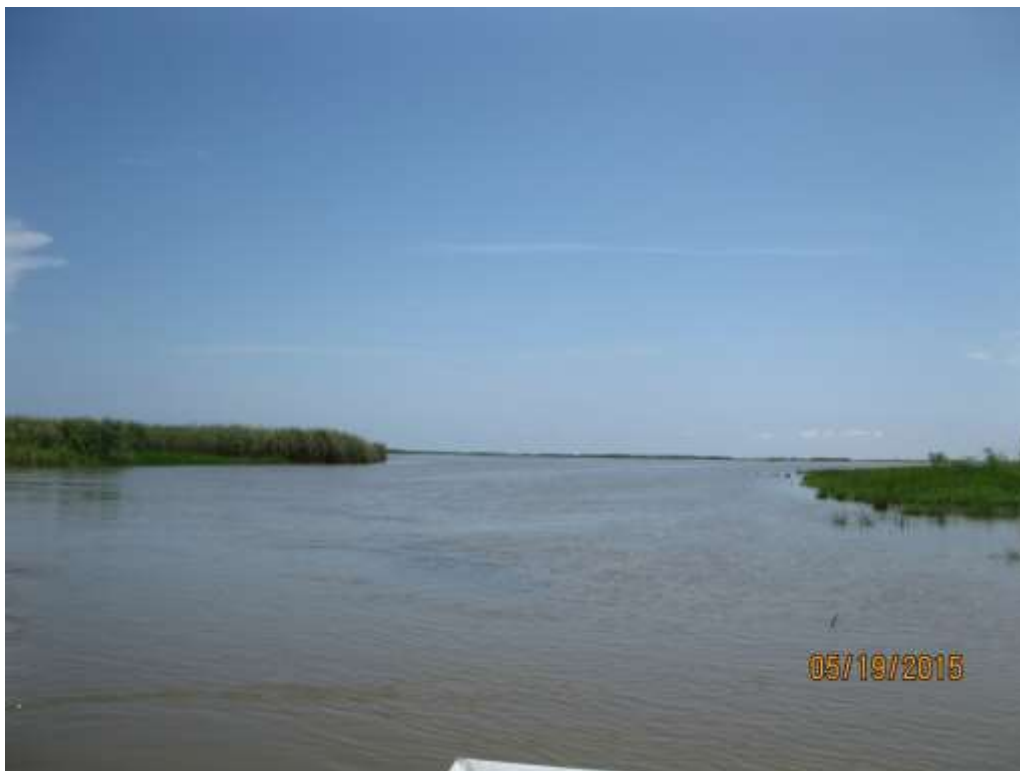
- E. Crevasse No. Alt. 2A: Channel banks are well-vegetated, and flow is maintained within the channel. While little emergent vegetation was present within the open water of the receiving area, the current flowing into this site was very turbid. This indicates that sediment is being carried in through the crevasse as designed.

Crevasse Alt 2A with receiving area beyond

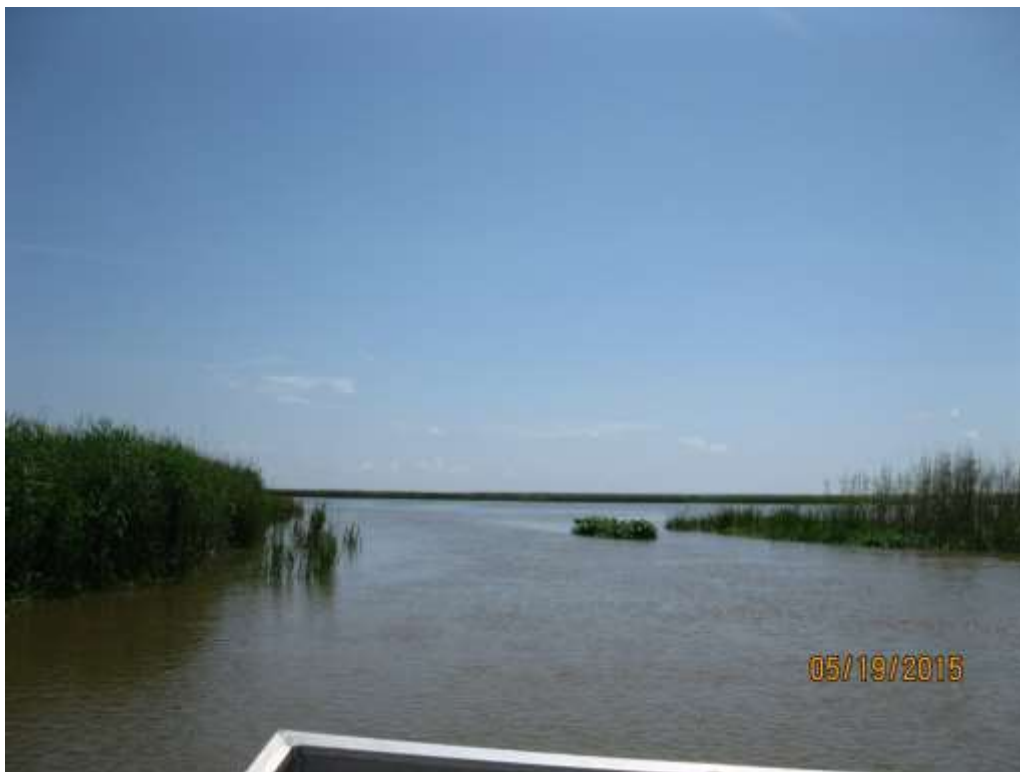
- F. Crevasse No. 2B: Strong flow was present within the channel. Roseau cane and dense, healthy marsh grass surround the entire receiving area. Very little emergent vegetation was observed within the shallow water of the outfall area; however, a significant SAV presence was noted.

Crevasse 2B with receiving area beyond

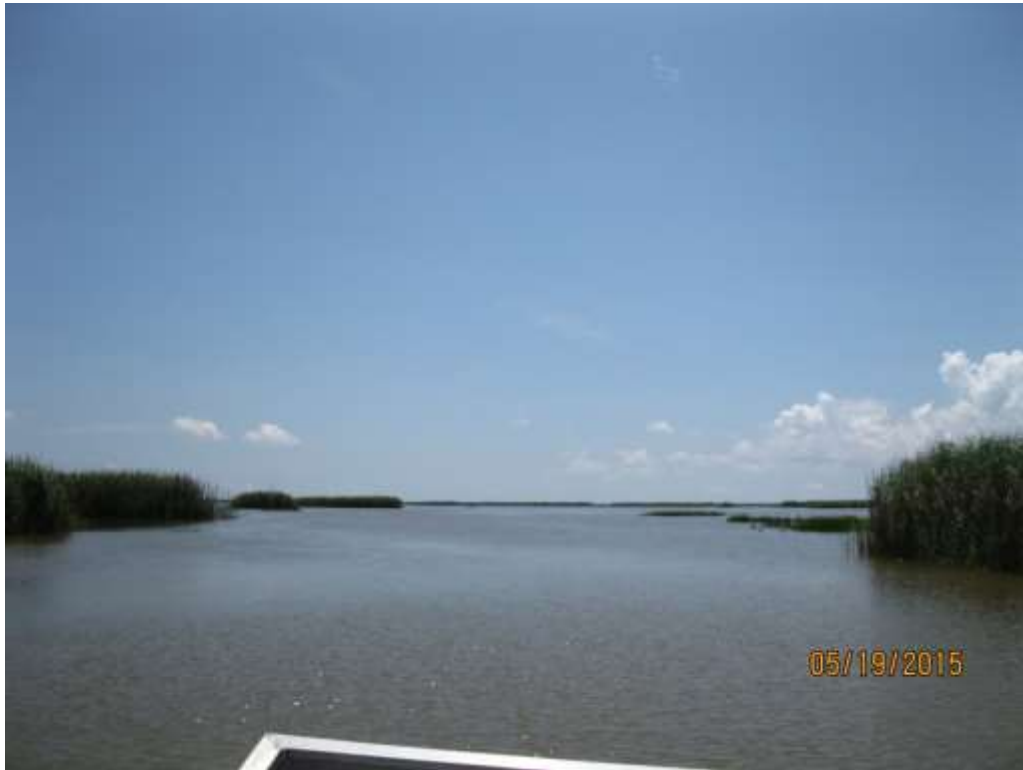
Crevasse 2C

- G. Crevasse No. 2C: Water was flowing well in the channel, and both banks exhibited healthy growths of marsh grass and Roseau cane. Most of the receiving area is shallow open water, but some patches of emergent vegetation were present.
