**State of Louisiana
Coastal Protection and Restoration Authority**

2016 Annual Inspection Report

**DELTA MANAGEMENT AT
FORT ST. PHILIP (BS-11)**

State Project Number BS-11
Priority Project List PPL-10

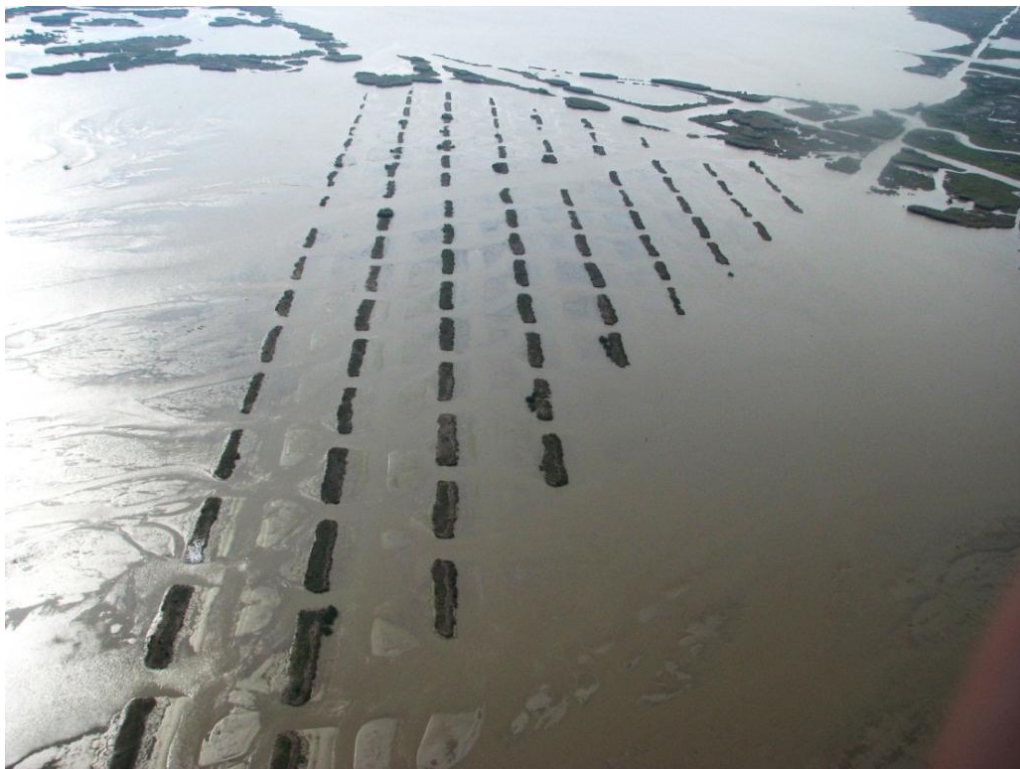
Terrace Field (12/08/2011 Stock Photo included for reference)

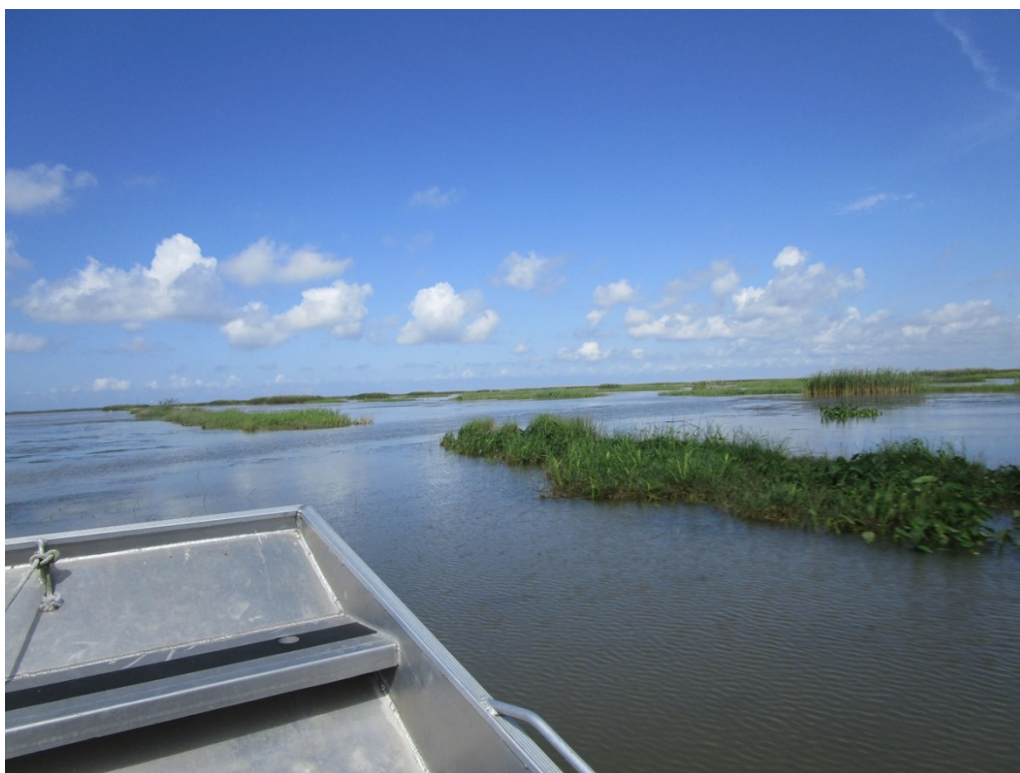
- A. Terraces: River stage was high; however, emergent vegetation was noted growing on all terraces within the project area. Despite the high river, water depth between terrace rows was shallow, which may indicate desirable sediment deposition is occurring in the receiving bay.

Emergent vegetation on Bay Denesse terraces

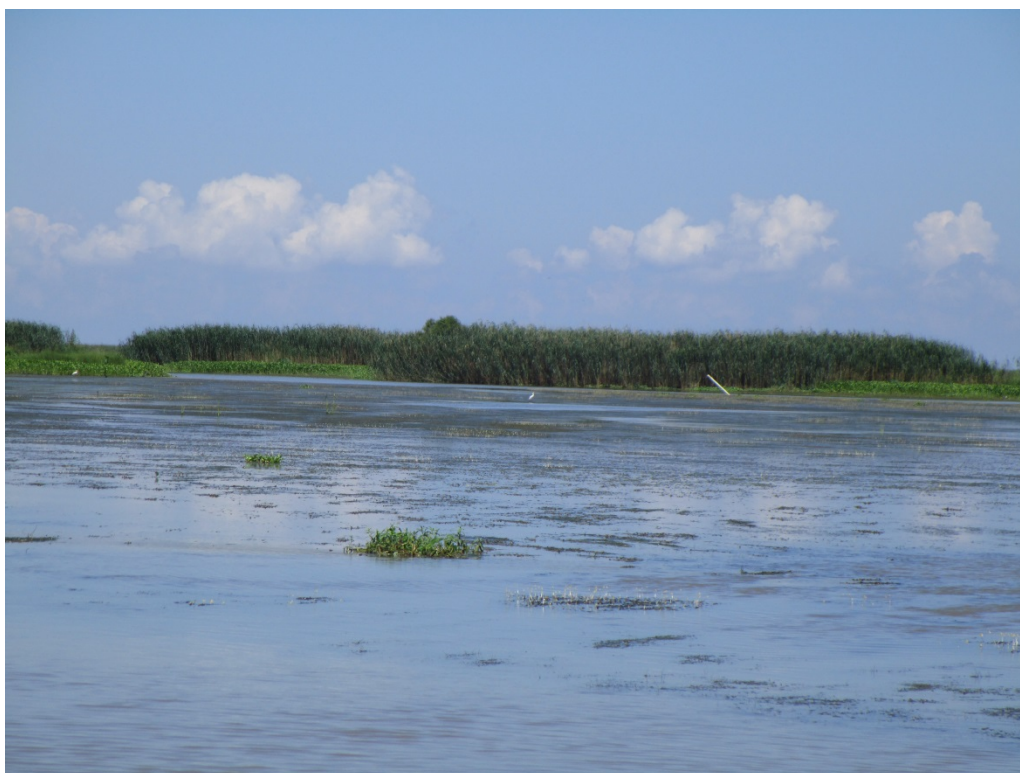
Receiving Area 1A

- B. Crevasse No. 1A: Strong flow was observed carrying sediment-laden water into the Bay Denesse terrace field.
- C. Crevasse No. 1B: Flow was observed in the channel. Large amounts of emergent vegetation were growing adjacent to the crevasse and within the receiving area.

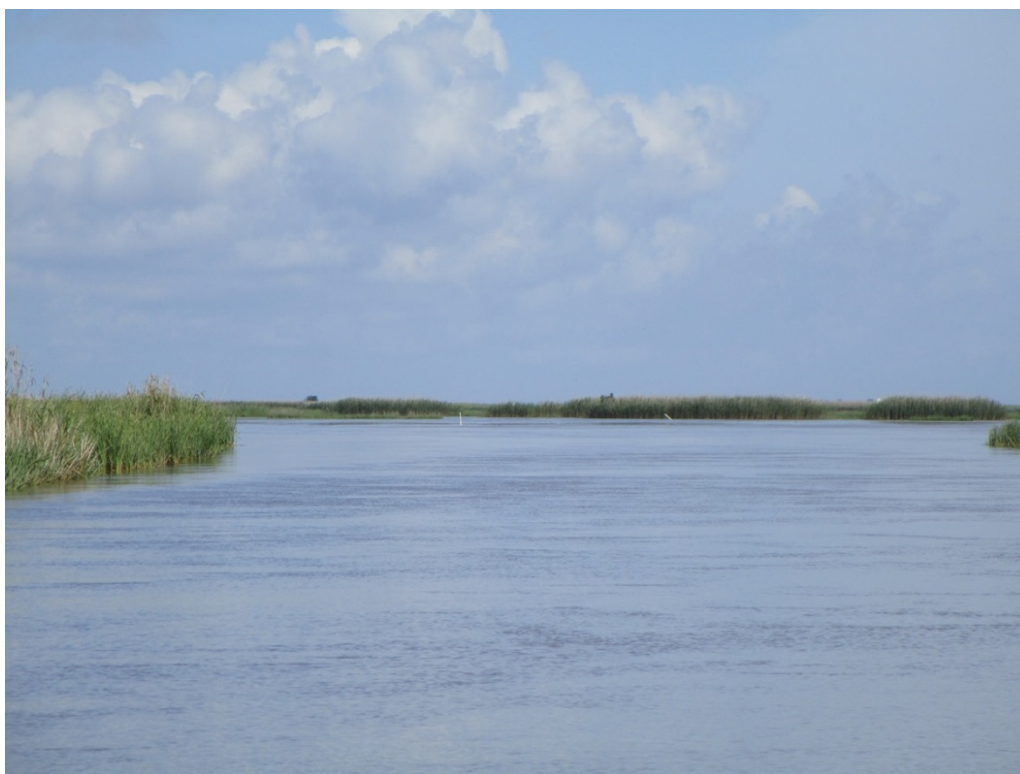
Crevasse 1A with terrace field beyond

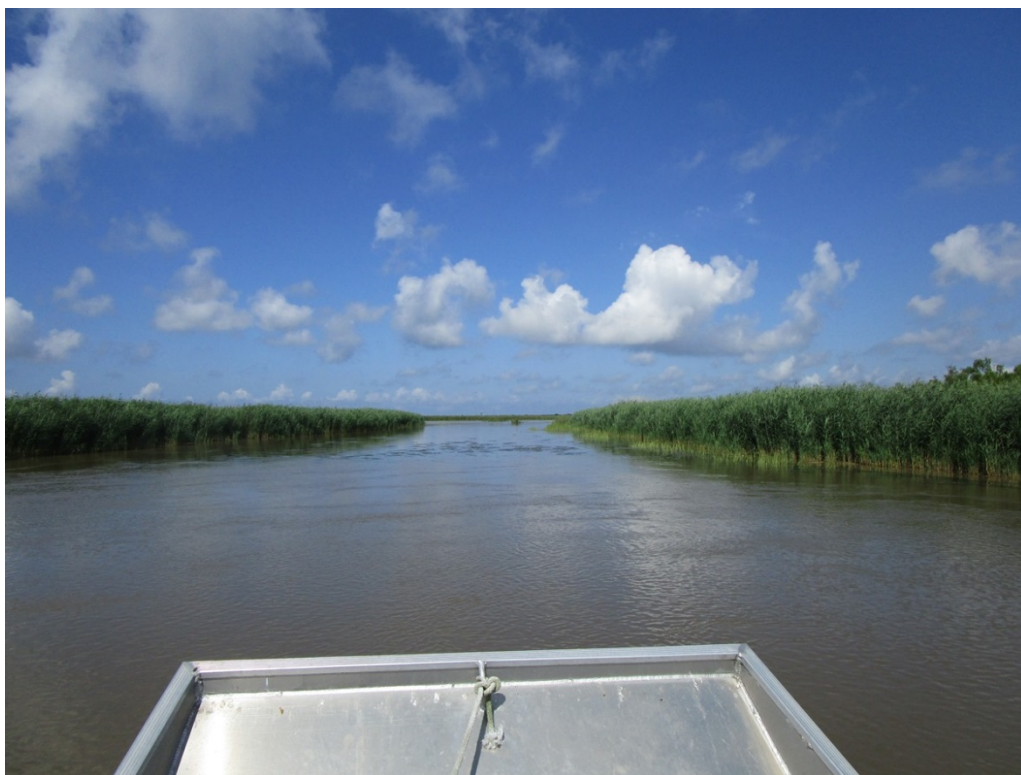
Crevasse 1C

- D. Crevasse No. 1C: Water flow was maintained in the channel. Depth in the receiving bay was shallow, and isolated patches of emergent vegetation were present.

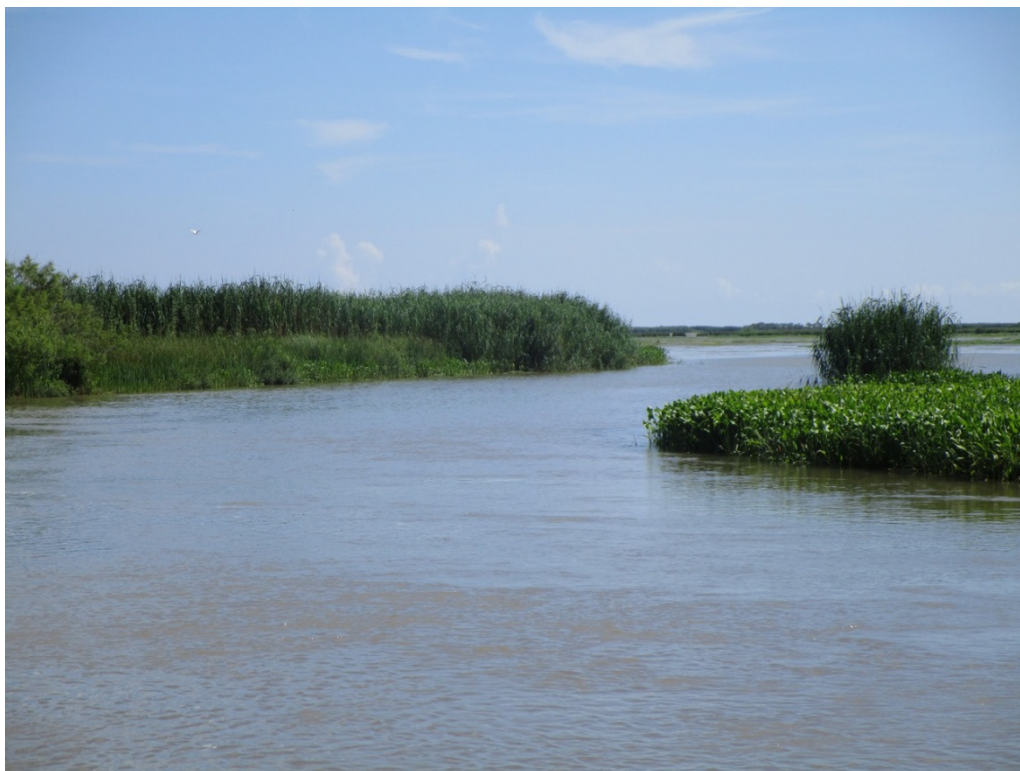
Crevasse Alt 2A

- E. Crevasse No. Alt. 2A: The channel was flowing freely, and significant emergent vegetation was observed in the receiving area.
- F. Crevasse No. 2B: Flow was observed in the channel. Dense growth of emergent vegetation was noted in the receiving bay.

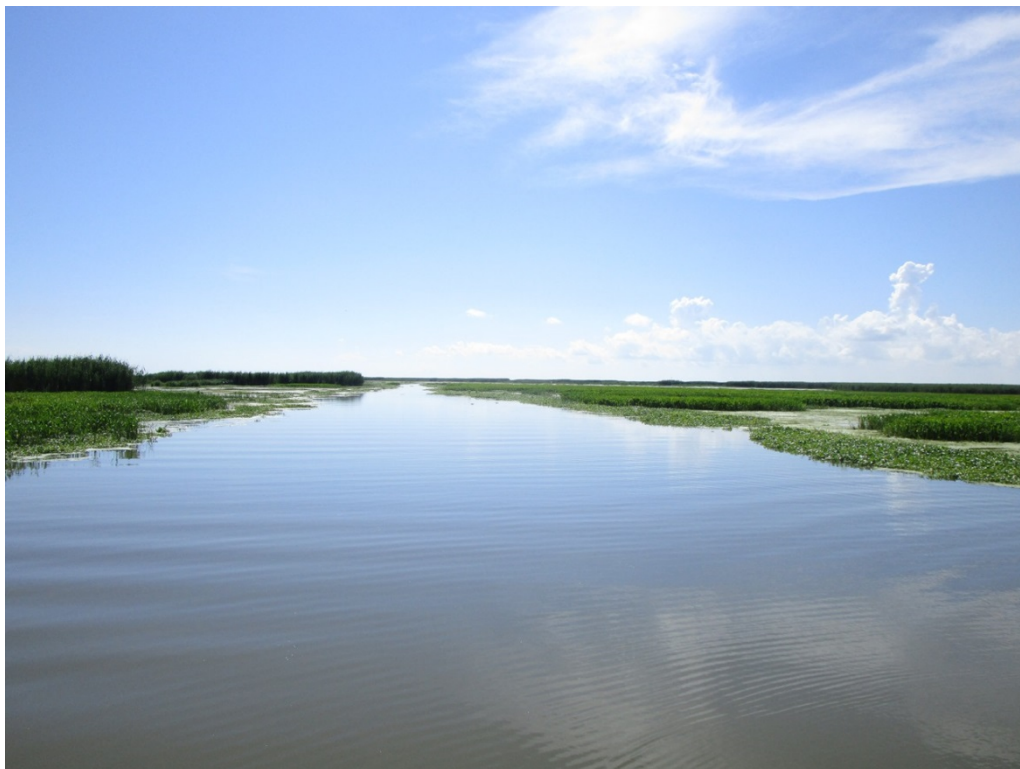
Crevasse 2C

- G. Crevasse No. 2C: Water was flowing well in the channel. The receiving area exhibited large areas of emergent vegetation near the crevasse outfall.
