**Coastal Protection and Restoration
Authority of Louisiana (CPRA)**

2014 Operations, Maintenance, and Monitoring and Final Close Out Report

Sabine Refuge Protection (CS-18)

State Project Number CS-18
Priority Project List 1

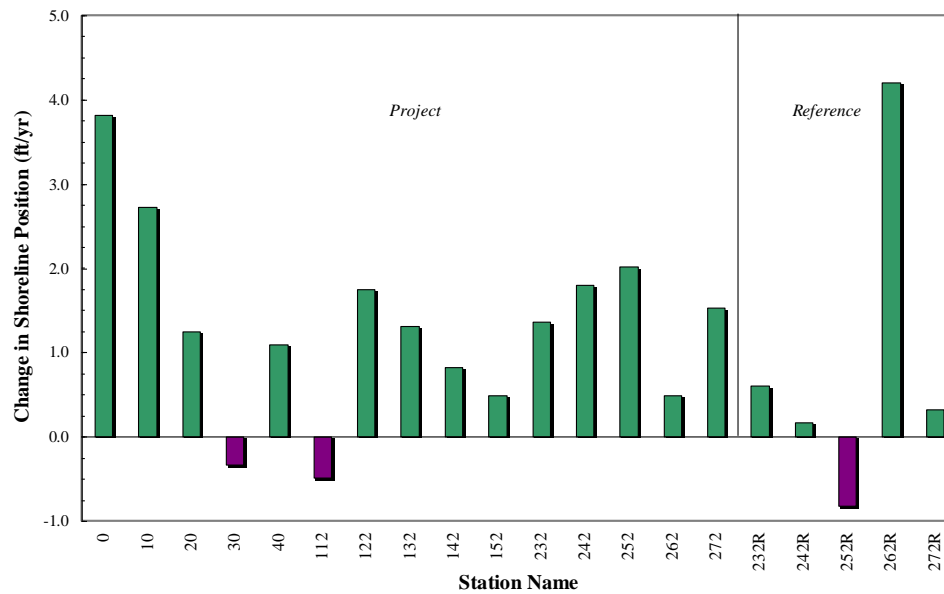
Shoreline survey results, presented in Figures 4, shows shoreline position change during the study period differing by less than 8.5 ft (2.6 m) at any one station for both the project and reference areas. Shoreline advance was detected at all project stations except stations 30 and 112 and for all reference stations except 252R during the period between 1995 and 2000 (Figure 5). Mean shoreline advance rates were calculated to be 1.3 +/- 1.1 ft/yr (0.4 + 0.3 m/yr) and 0.9 +/-1.9 ft/yr (0.3 + 0.6 m/yr) for the project and reference areas, respectively. The results of the two-sample t-test indicated that there was no significant difference in shoreline change rate detected between the project and reference areas ($P = 0.90$).

Figure 4. Sabine Refuge Protection (CS-18) shoreline change for the project and reference area from 1995 to 2000. Rates are calculated in ft/yr.

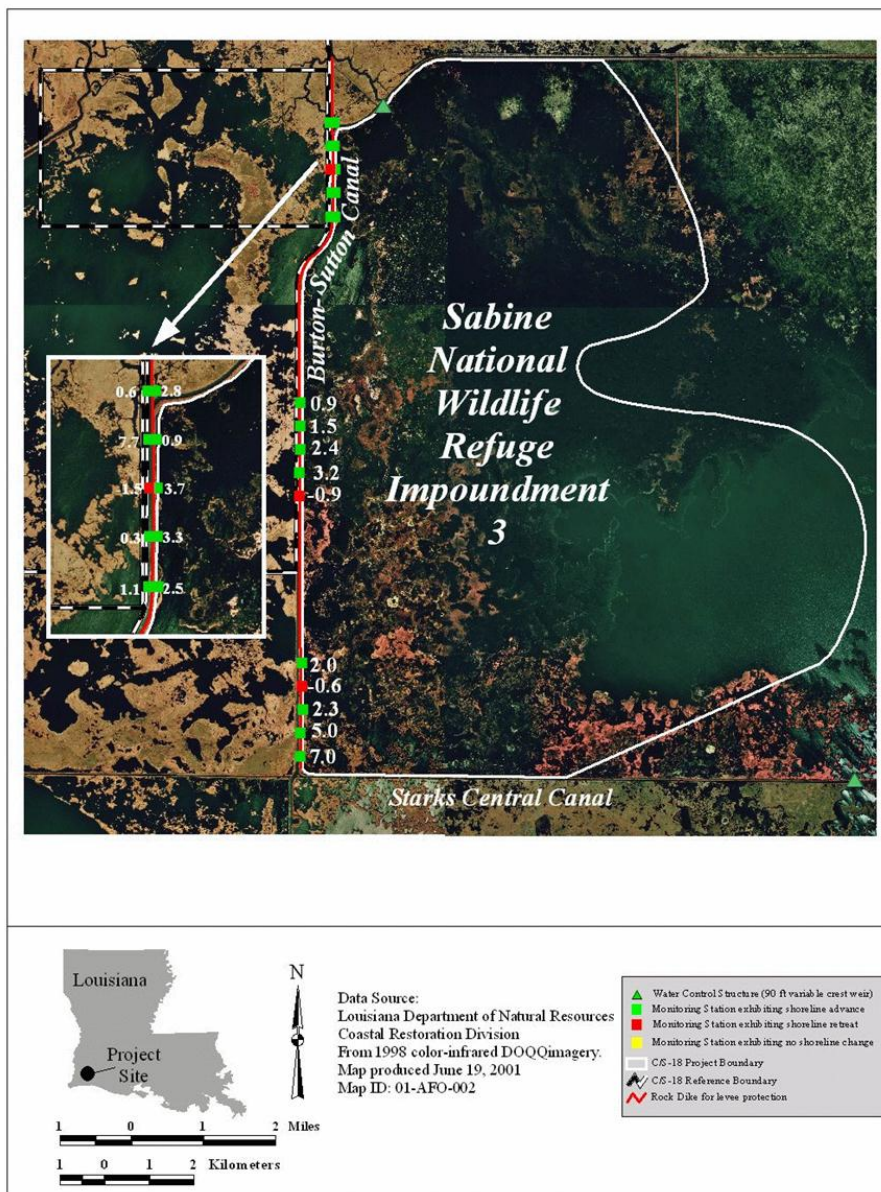
Figure 5. Sabine Refuge Protection (CS-18) shoreline change (ft) at project and reference area monitoring station locations between October 1995 and August 2000.

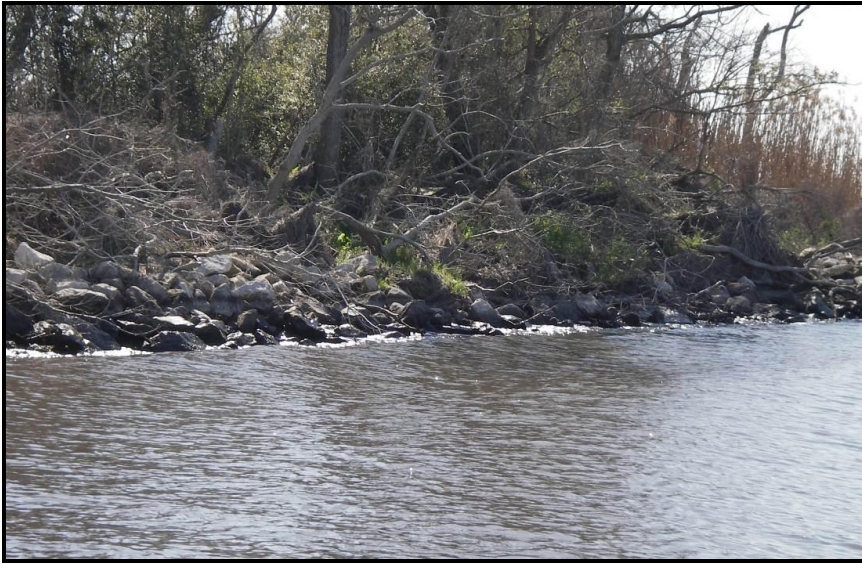
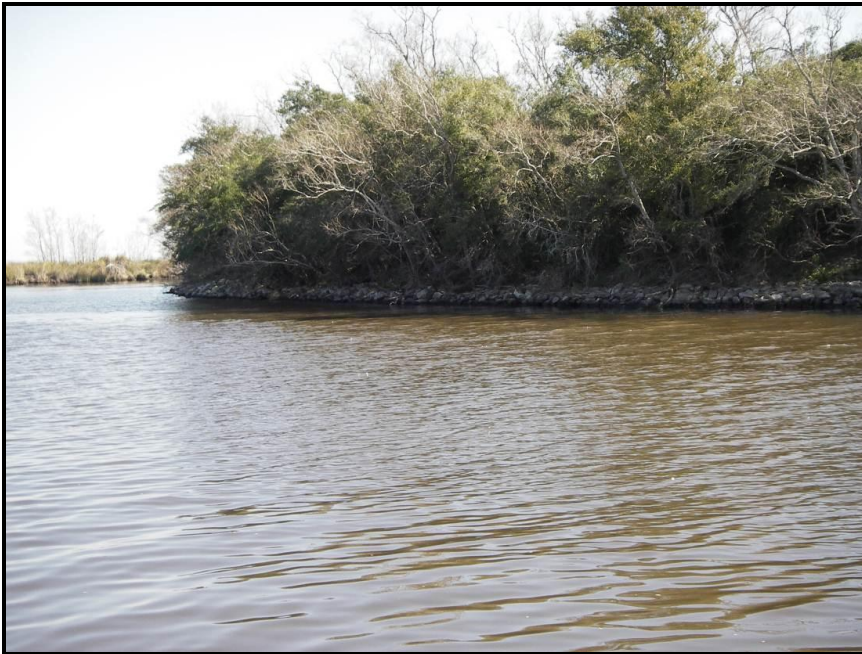
The rock breakwater along the Burton Sutton Canal was inspected along its entire reach. The water level in the Burton Sutton Canal was estimated to be +0.75 NAVD88. The dike is in excellent post construction condition. No need for any maintenance in the foreseeable future. (Photos 1 – 2; March 2010)

Photo 1—southern tie-in on Burton Sutton Canal (2010)

Photo 2—northern tie-in on Burton Sutton Canal (2010)

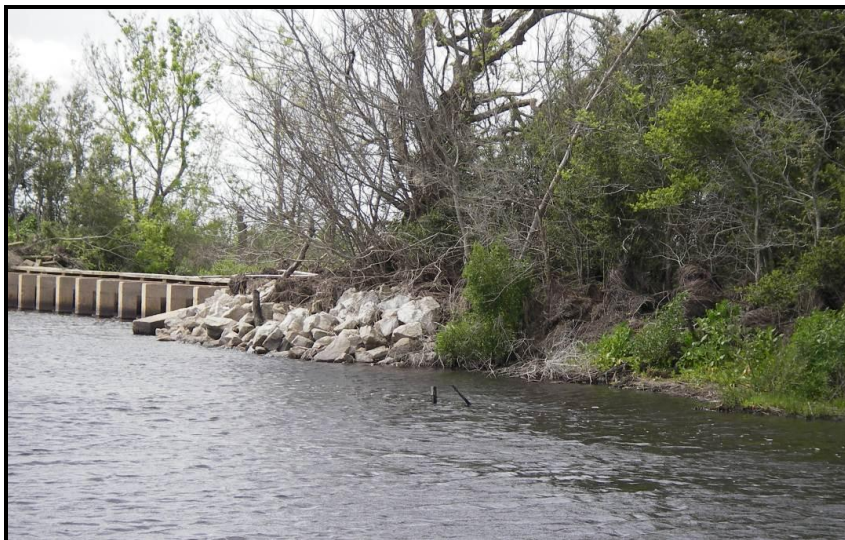
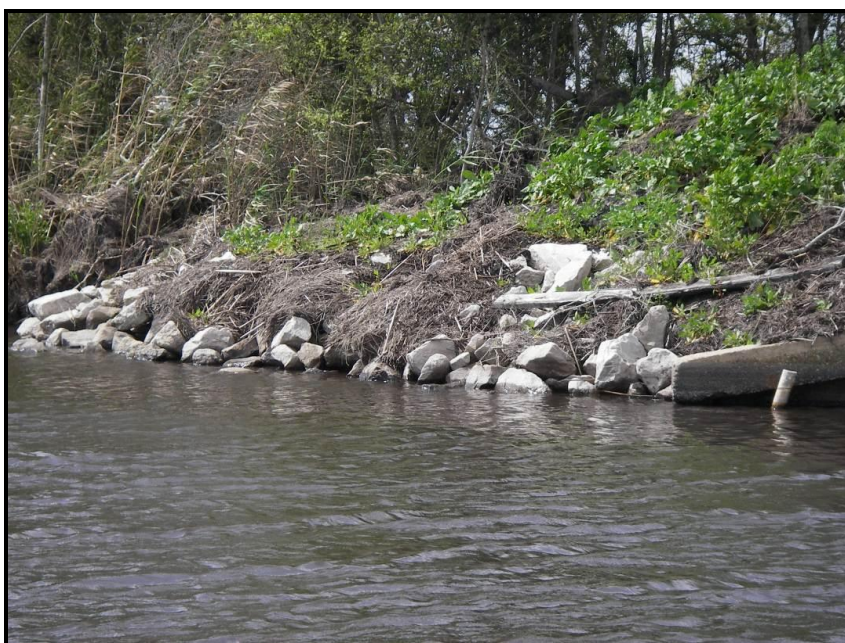
The weirs at Beach Canal Structure No. 2, Northline Canal Structure No. 3, and Stark's Central Canal Structure No. 4 were inspected for rock reinforcement at each wingwall. No maintenance was required at that time. (Photos 3-8; December 2007)

Photo 3—northern wingwall rock on Beach Canal Structure No. 2 (December 6, 2007)

Photo 4—southern wingwall rock on Beach Canal Structure No. 2 (December 6, 2007)

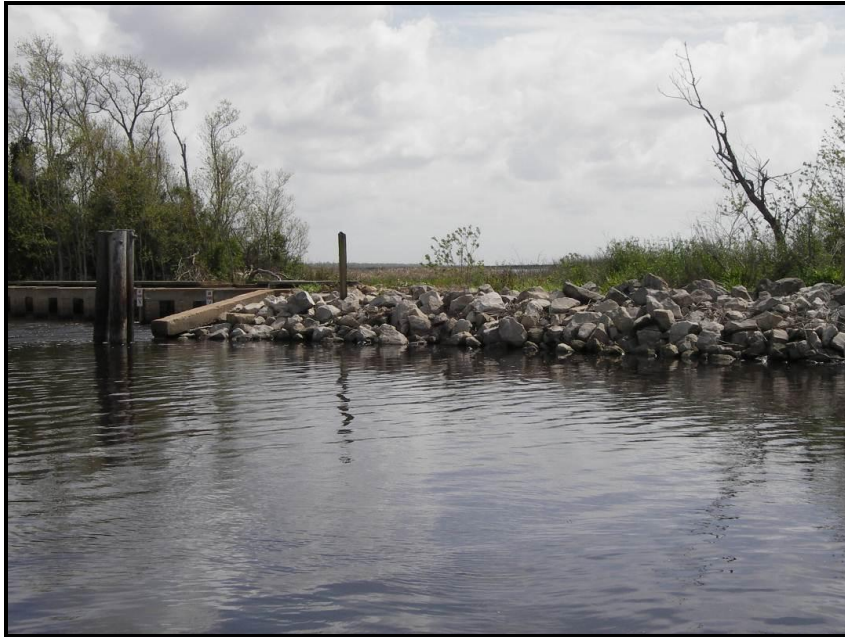
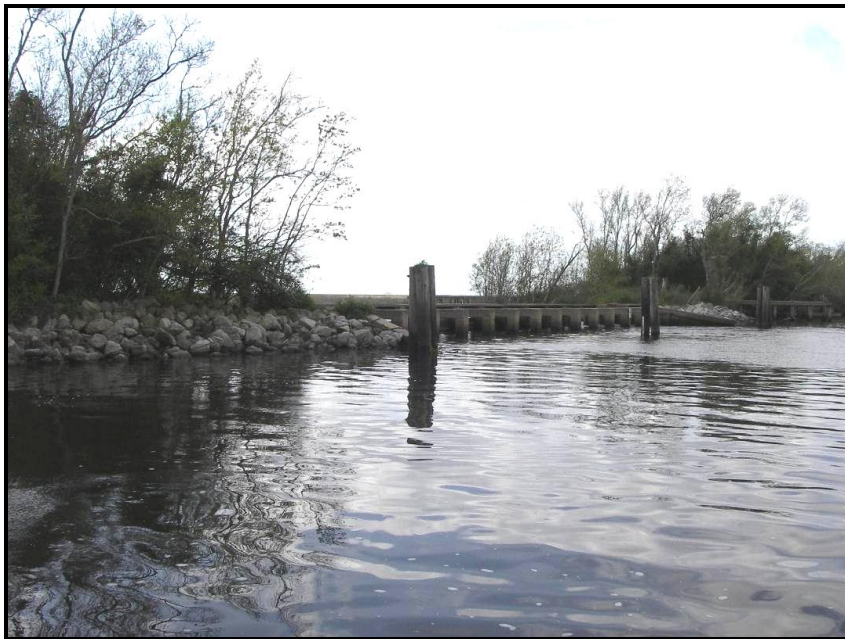
Photo 5 – southwest wingwall rock on Northline Canal Structure No. 3 (Dec. 6, 2007)

Photo 6 – northeast wingwall rock on Northline Canal Structure No. 3 (Dec. 6, 2007)

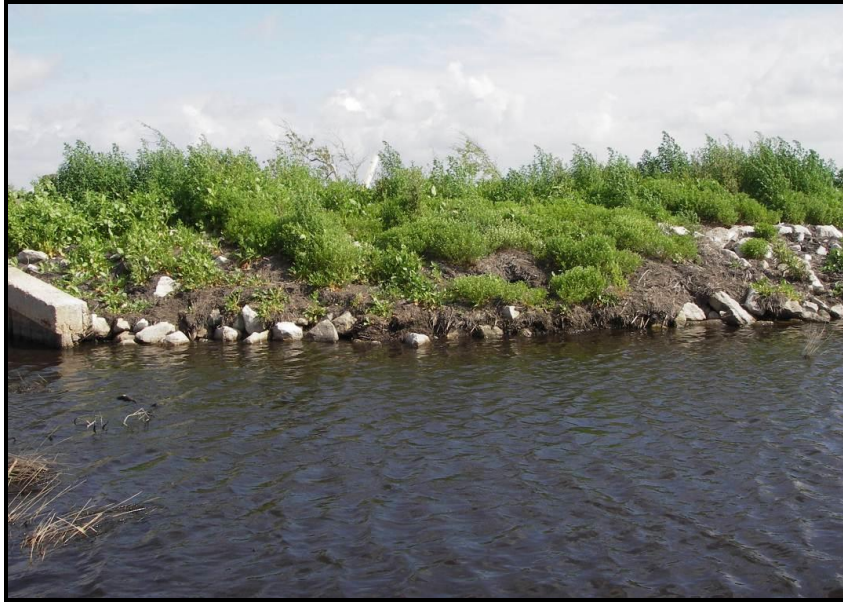
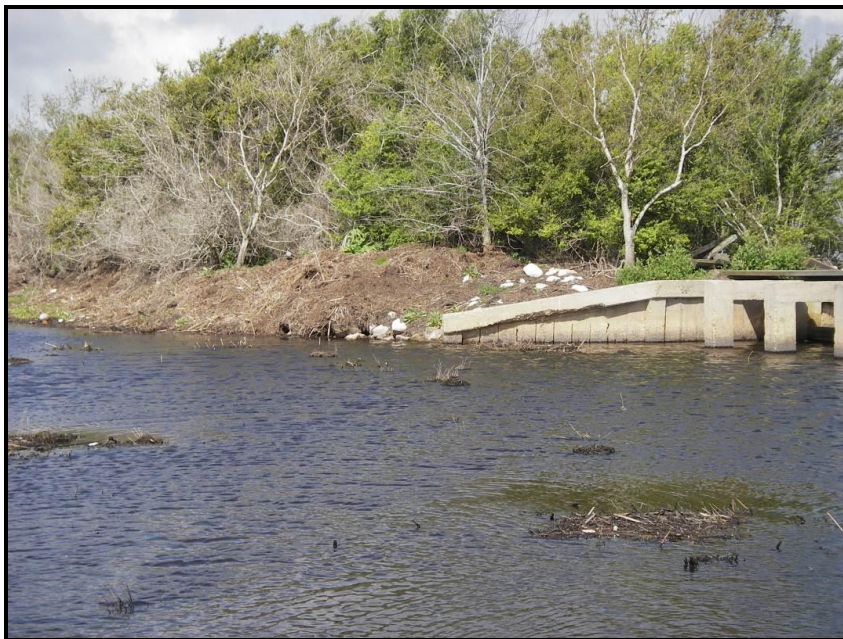
Photo 7 – eastern wingwall rock on Stark's Central Canal Structure No. 4 (Dec. 6 2007)

Photo 8 – western wingwall rock on Stark's Central Canal Structure No. 4 (Dec. 6, 2007)

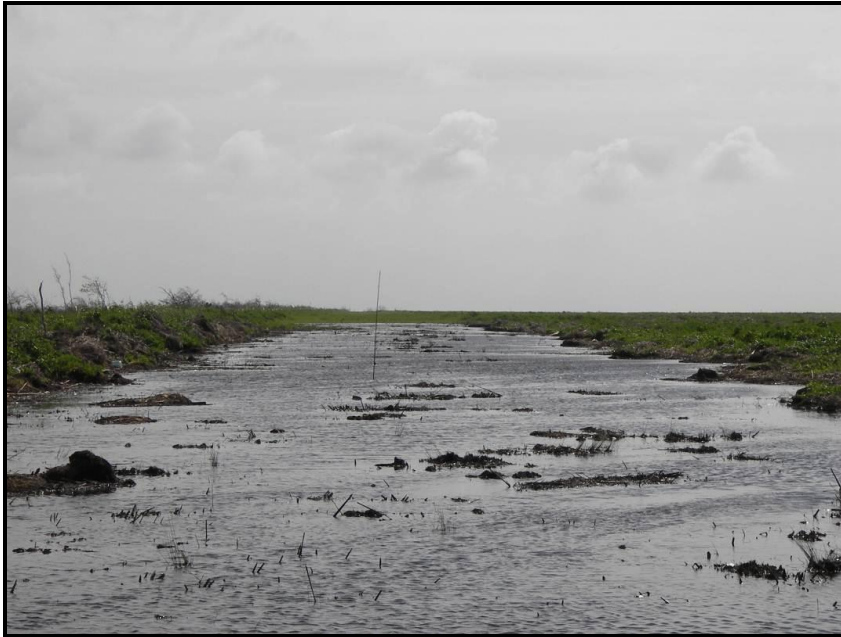
During the 2007 inspection, the Stark's Canal was found to be clogged with wrack and debris resulting from Hurricane Rita. USFWS chose at that time to leave the material in place to help control water flow in the refuge. (Photo 9; December 2007)

Photo 9 – Central Canal, view looking east, showing canal clogged with wrack and debris from Hurricane RITA which will remain in place. (Dec. 6, 2007)
