**2014/2015 Annual Inspection
Report**

**HWY 384 HYDROLOGIC
RESTORATION PROJECT
(CS-21)**

State Project Number CS-21
Priority Project List 2

May 11, 2015
Cameron Parish

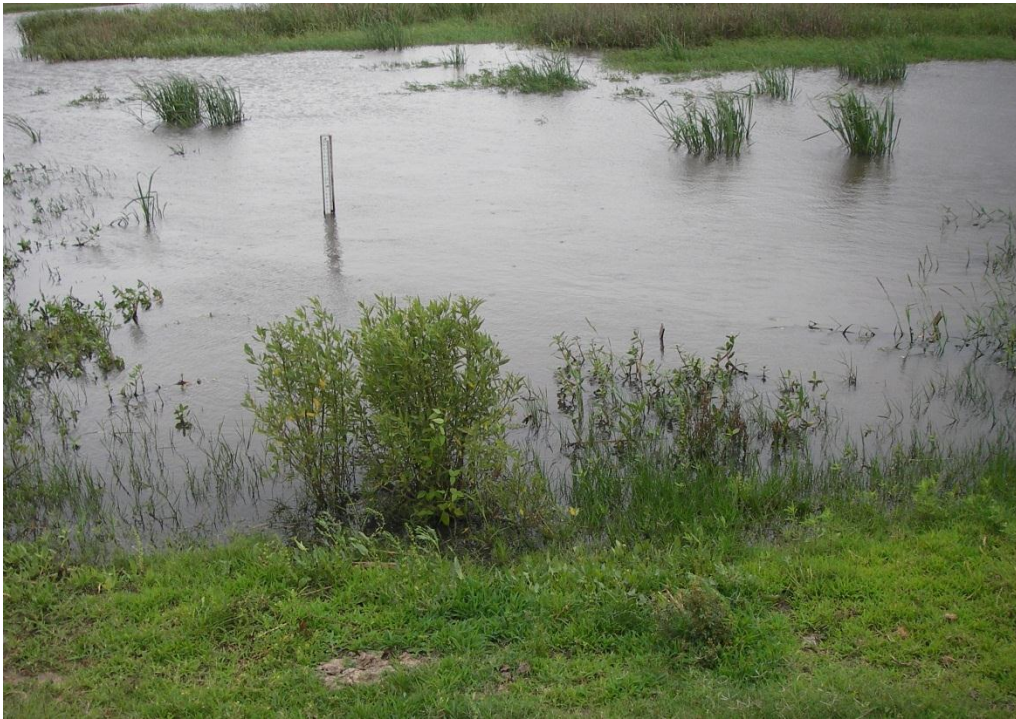
Photo No. 1, Structure No.1, Outlet Side

Item	Condition	Physical Damage	Corrosion	Photo #	Observations and Remarks
Steel Bulkhead / Caps	N/A				
Flapgates/Outlet Pipe	Good			1	Water was flowing into the structure from the GIWW. Flaps were below water.
Inlet Channel	Poor			2-4	Then inlet channel and area near the hyacinth fence have silted in significantly and require cleaning.
Hardware/Sluiceways	Good			2	Two gates were open and flowing water. Flow is being restricted by sedimentation, vegetation and debris.
Hyacinth Fence	Fair			2 & 4	Debris, sediment, and vegetation have accumulated significantly since the last cleaning in November 2013.
Timber Piles	Good			2 & 4	
Timber Wales	N/A				
Plastic Pile Caps	Good			2 & 4	Plastic pile caps are present.
Cables	N/A				
Signage /Supports				1 & 2	Staff Gauges have been replaced on the inlet and outlet side with reference to NAVD88 Geoid12A
Staff Gauges	Poor				
Rip Rap embankment	Good				
InSitu AquaTroll 200 - 29r	Good			2	Sonde was operational.

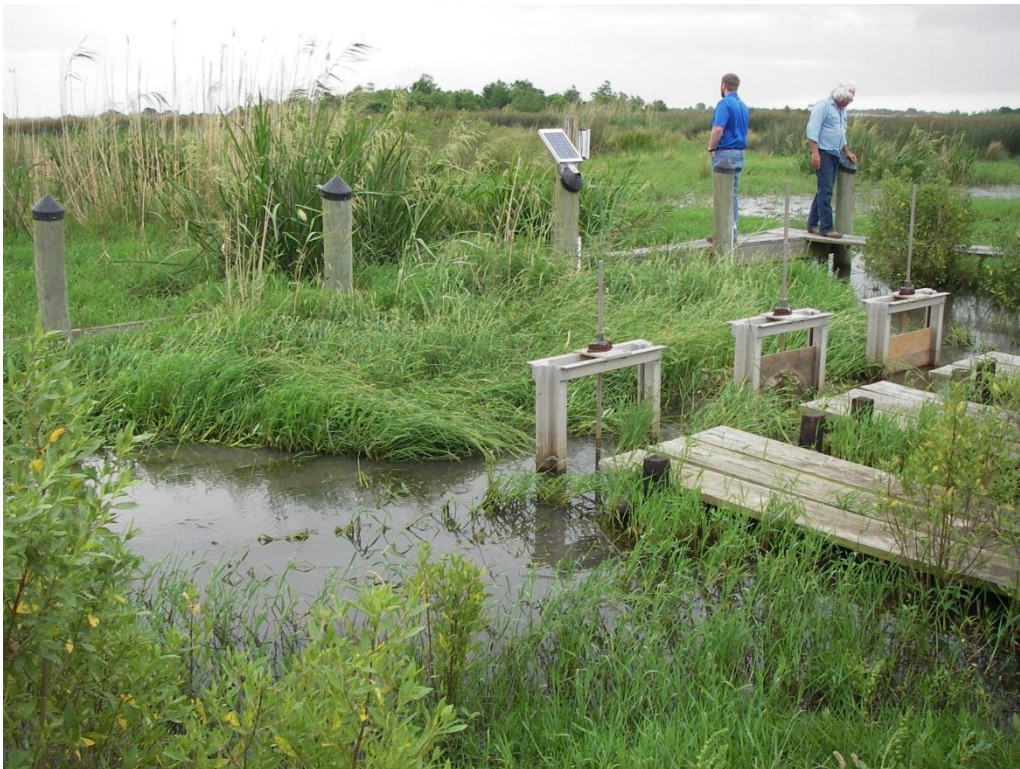
The structure is in good condition; however, the inlet channel has silted in. The outline of the channel is no longer visibly distinguishable through the vegetation. There is still freshwater entering the structure from the GIWW at higher water elevations. The water level on the inside of the project at Structure No. 1 was at 1.1ft elevation.

The plastic pile caps are present and working as intended. The two of the three sluice gates were open. The area in the vicinity of the hyacinth fence and culverts again has an accumulation of sediment and vegetation after being cleaned up on November 14, 2013. A contract has been awarded to Patriot Construction to perform the upcoming maintenance work including cleaning out the inlet channel and the culverts, replacing the wood walkways and hyacinth fence, and repairing the levee northwest of the structure. (See Appendix B, Photos 1-4)

Photo No. 2, Structure No.1, Inlet Side- Inlet Channel, Hyacinth Fence and Operations Equipment

- Remove sediment in the inlet channel from the GIWW to the structure.
- Remove sediment and debris adjacent to the hyacinth fence.
- Flush the three 24" culverts to clear away any sediment present.
- Clear any obstructions preventing the flap gates from closing properly.
- Replace any missing wire on the hyacinth fence.
- Replace or repair any loose or deteriorating boards on the walkway to the sonde.
- Repair the levee north of the structure to elevation +3.5.

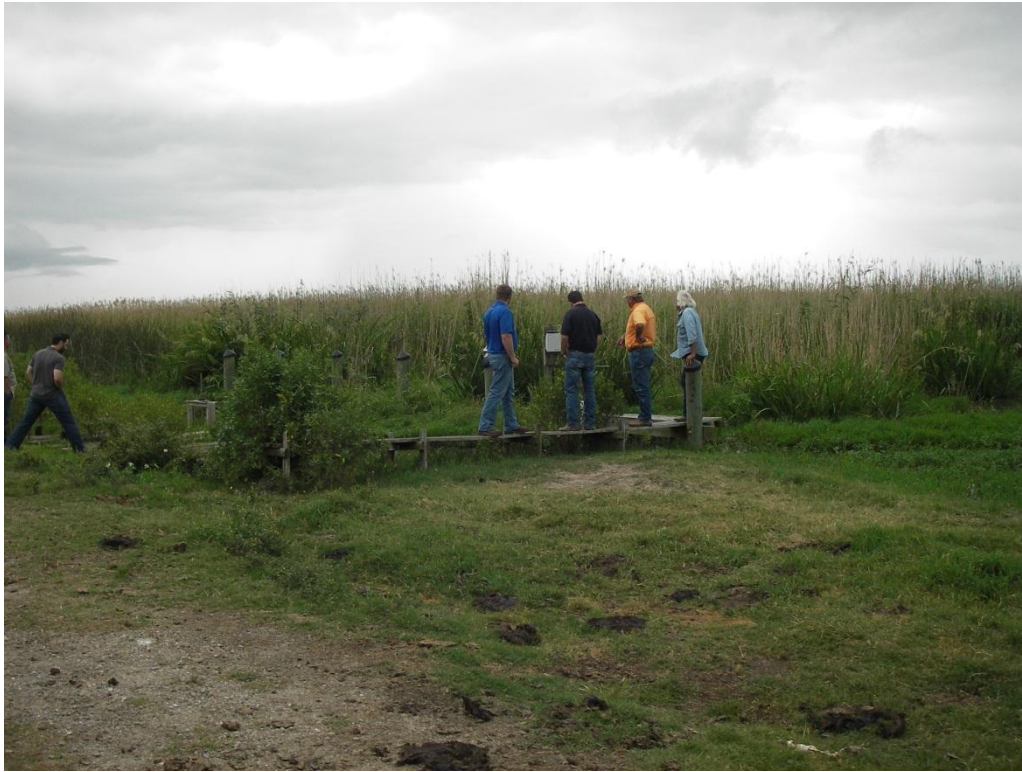
Photo No.3, Structure No.1, Walkway Looking Northwest – Vegetation in Channel

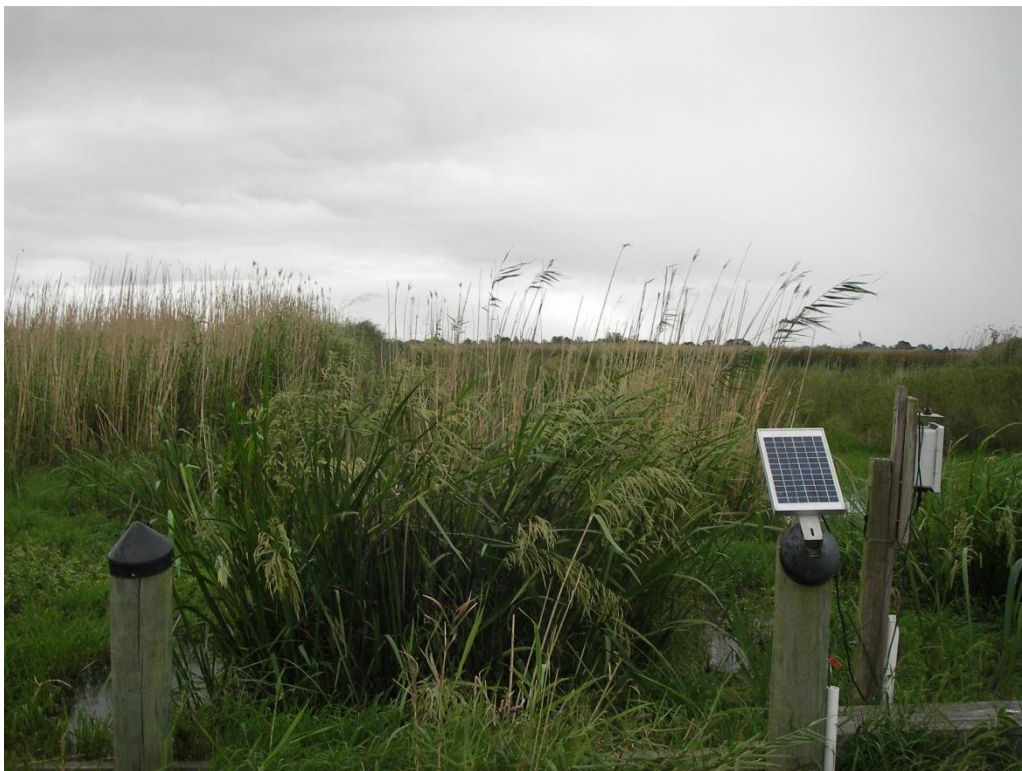
Photo No. 4, Vegetation in Inlet Channel to Structure No.1

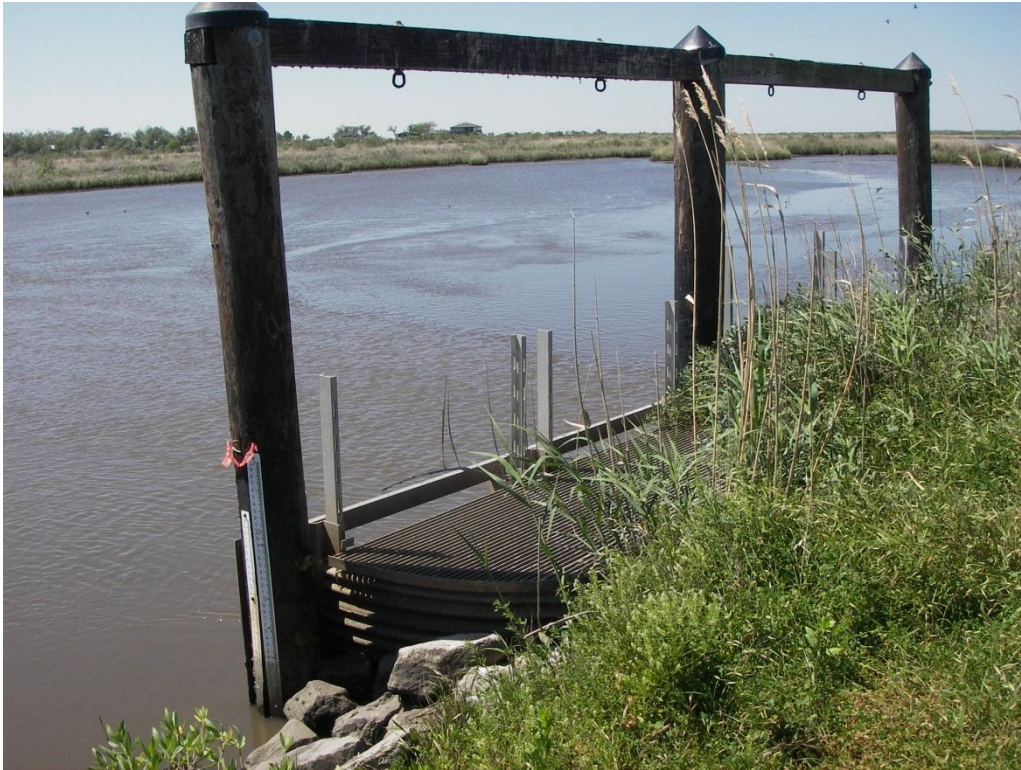
This structure was not visited during the inspection; however, the operations contractor has not reported any problems. (Appendix B, Photos 5&6)

Photo No. 5, Structure No. 12, Inlet Side- New Staff Gauge (April 2014)

Item	Condition	Physical Damage	Corrosion	Photo #	Observations and Remarks
Steel Bulkhead / Caps	N/A				
Steel Grating	Good			5	
Stop Logs	Good			5	Water was flowing from within the project area to the lakeside.
Hardware/Flapgates	Good			6	Flap gates were open.
Timber Piles	Good			5	
Timber Wales	N/A				
Plastic Pile Caps	Good			5 & 6	Plastic pile caps were in place.
Cables	N/A				
Staff Gages	Fair			5 & 6	Staff gauges on the inlet and outlet side need cleaning or replacement. They are encrusted and/or covered in scum.
Rip Rap embankment	Good			5 & 6	Embankment was in good condition.
InSitu AquaTroll 200 - 15r	Good				The sonde was operational.
Access Roadway	Good				The access road was in good condition. New limestone was placed in sections on the road by others, possibly due to monitoring well work in the project area and use of the road for access.

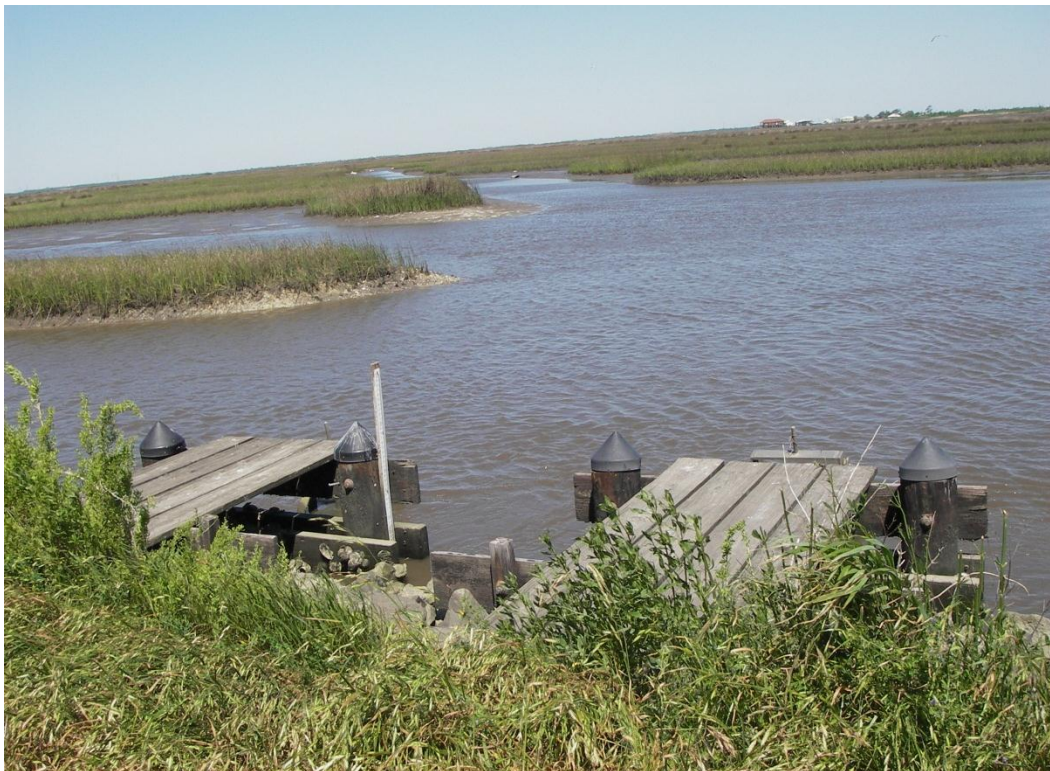
Photo No. 6, Structure No. 12, Outlet Side- Water Flowing Out to Lakeside (April 2014)

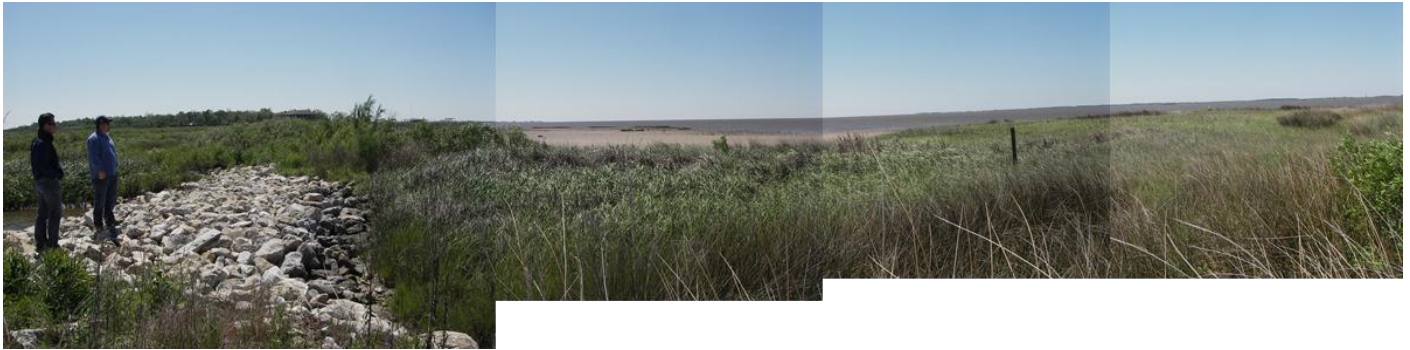
The rock plug was not visited during this inspection. (Appendix B, Photos 7&8)

Photo No. 7, Structure No. 8, Rock Plug Looking South (April 2014)

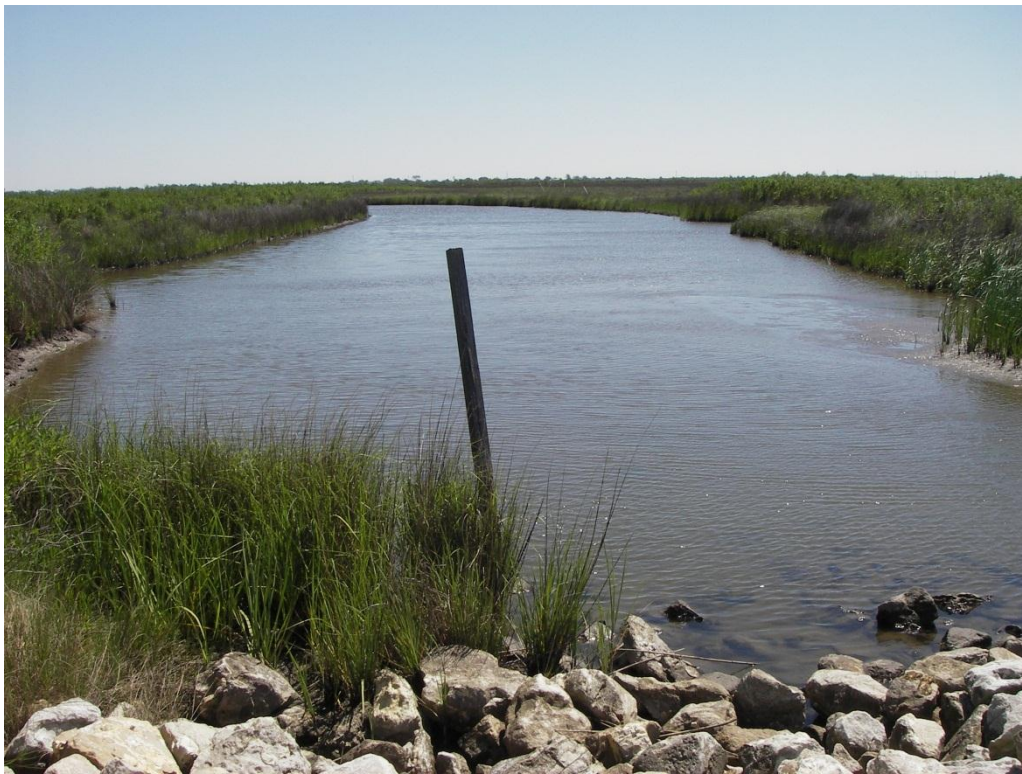
Photo No. 8, Structure No. 8, Rock Plug - Vegetation on Project Interior (April 2014)

Item	Condition	Physical Damage	Corrosion	Photo #	Observations and Remarks
Steel Bulkhead / Caps	N/A				
Steel Grating	N/A				
Stop Logs	N/A				
Hardware	N/A				
Timber Piles	N/A				
Timber Wales	N/A				
Galv. Pile Caps	N/A				
Cables	N/A				
Signage /Supports Staff Gages	N/A				Both staff gages missing, it was decided not to replace either one due to no flow through plug.
Rip Rap (plug)	Good			7 & 8	The rock plug is in tact and vegetation has started rooting into the crevices of the rock. Interior project area also has new growth where there was previously open water. Lakeside area is continuing to silt in and is vegetating.
Earthen Embankment
