**2019 Operations, Maintenance, and
Monitoring Report**

**Highway 384 Hydrologic
Restoration (CS-21)**

State Project Number CS-21
Priority Project List 2

November 2019
Cameron Parish

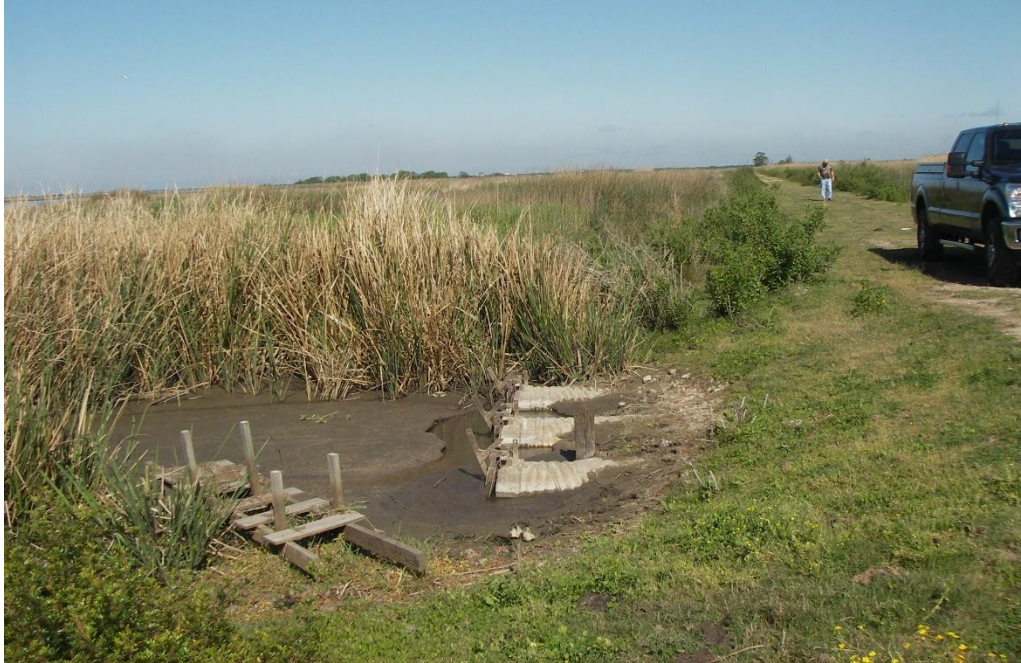
The board walkways are in good conditions since being replaced. An ever increasing amount of vegetation has established itself on the inside of the project area near Structure No. 1. There is evident submerged vegetation in the cove north of the structure. (See Appendix B, Photos 1-4)

Photo No. 1, Structure No.1, Project Interior

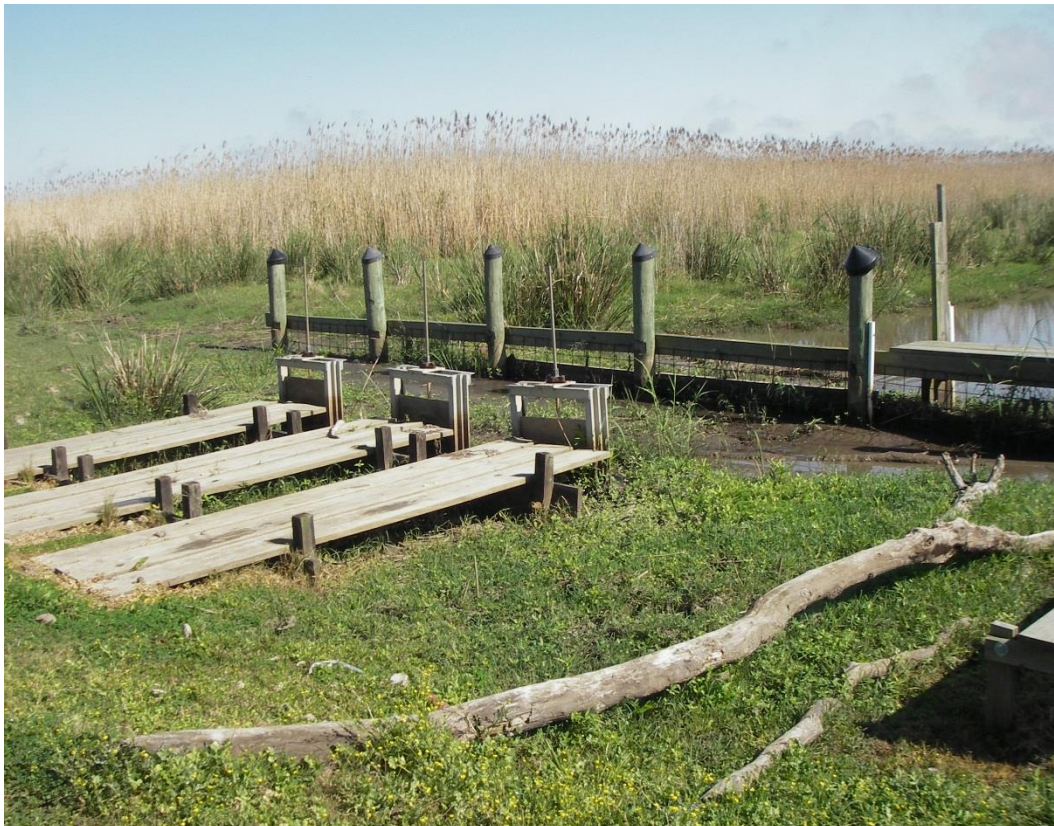
The structure and inlet channel are in good condition. The inlet channel which was dredged in 2015 is still supplying freshwater to the structure; however, sediment has deposited around the hyacinth fence, the culvert inlets and on the project interior adjacent to the structure. The collection of sediment has restricted the flow through the culverts and prevents the flaps from opening properly. Currently limited flow is passing through two of the three culverts. Flow can be restored by cleaning out adjacent to the structure to allow the flaps to operate as intended.

Photo No. 2, Structure No.1, Inlet Channel, Hyacinth Fence and Operations Equipment

Item	Condition	Physical Damage	Corrosion	Photo #	Observations and Remarks
Steel Bulkhead / Caps	N/A				
Flapgates/Outlet Pipe	Fair			1	Sediment has restricted the flapgates from opening all the way.
Inlet Channel	Good			2&4	Inlet channel is in good condition after the 2015 dredging project; however, sediment has collected adjacent to the hyacinth fence, and culverts
Hardware/Sluiceways	Good			2	All gates are open but only two are partially flowing water due to sediment against the structure
Hyacinth Fence	Good			2-4	Sediment, debris and vegetation is accumulating since the 2015 maintenance event.
Timber Piles	Good			2-4	
Timber Wales	N/A				
Plastic Pile Caps	Good			2 & 4	pile caps are in place
Cables	N/A				
Signage /Supports				1 & 2	Staff Gauges were replaced on the inlet and outlet side in 2014 with reference to NAVD88 Geoid12A
Staff Gauges	Good				
Rip Rap embankment	Good				
InSitu AquaTroll 200 - 29r	Good			2	Telemetry has been replaced with a 300R tube unit and ATT 3G services. Sonde was not operational due to sediment around it.

Clearing of sediment and debris around Structure No. 1 would restore freshwater into the project interior. This work would be necessary ever two to three years to ensure continued flow into the project.

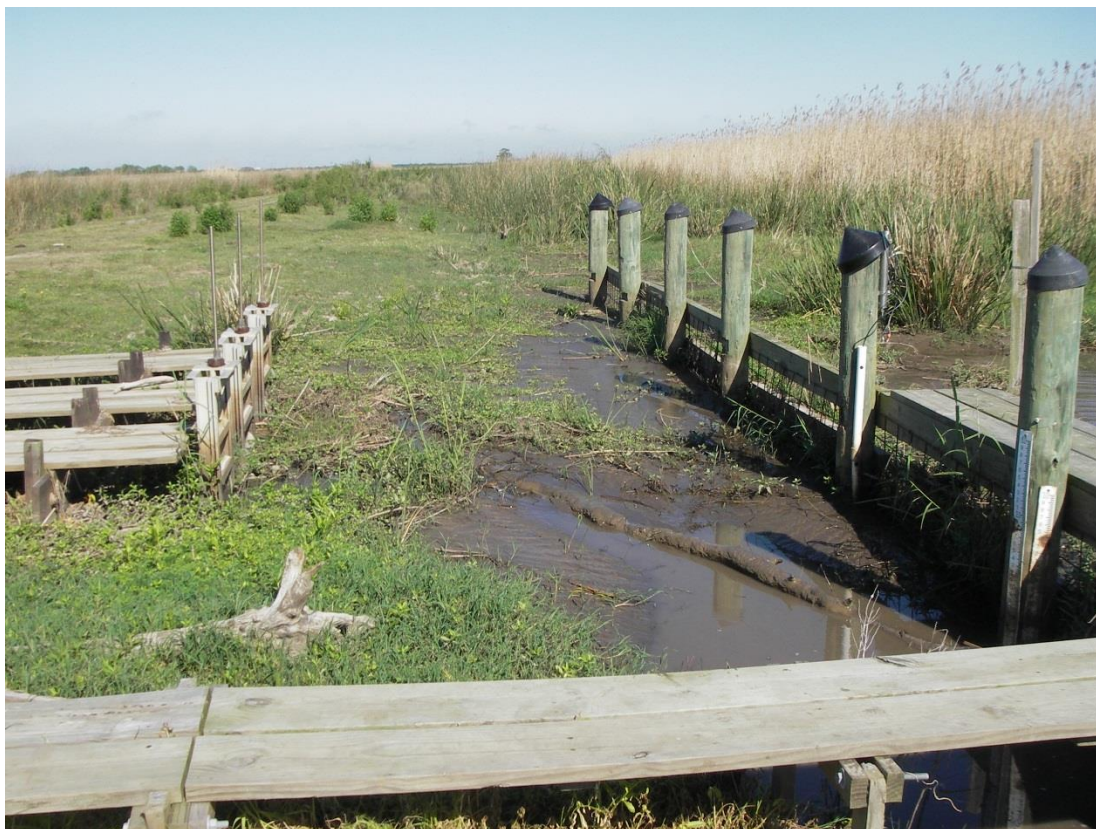
Photo No.3, Structure No.1, Culverts - Sediment

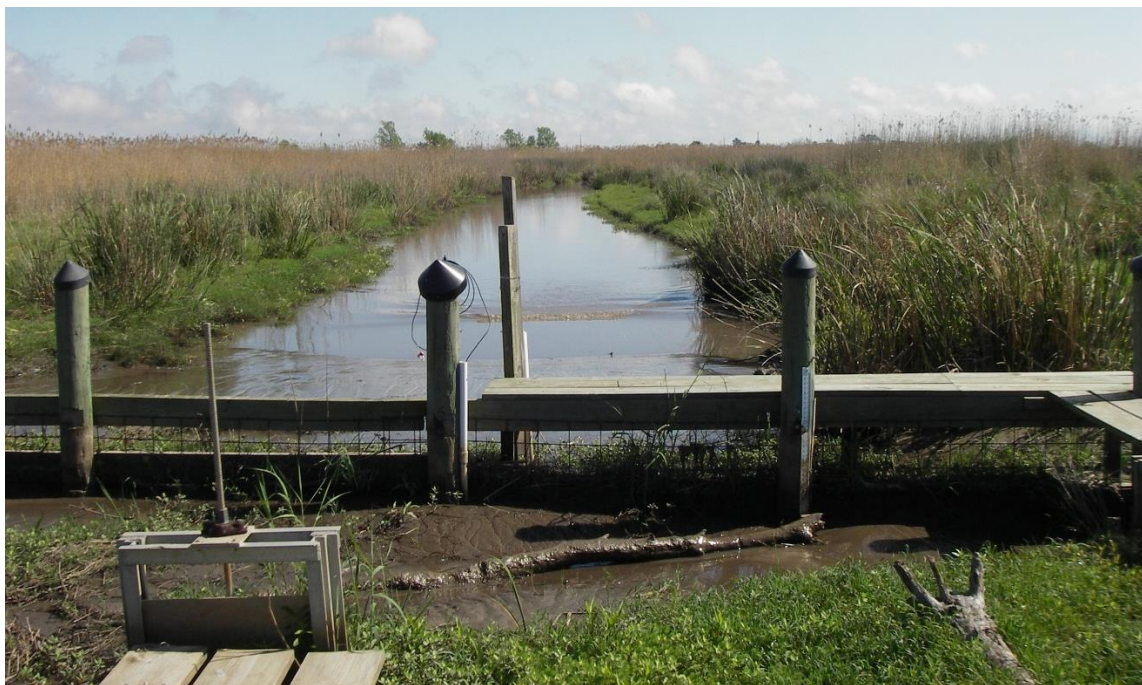
Photo No. 4, Inlet Channel to Structure No.1, Last Dredged in 2015

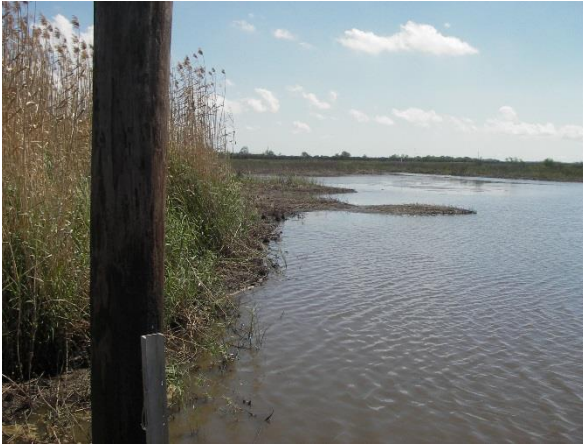
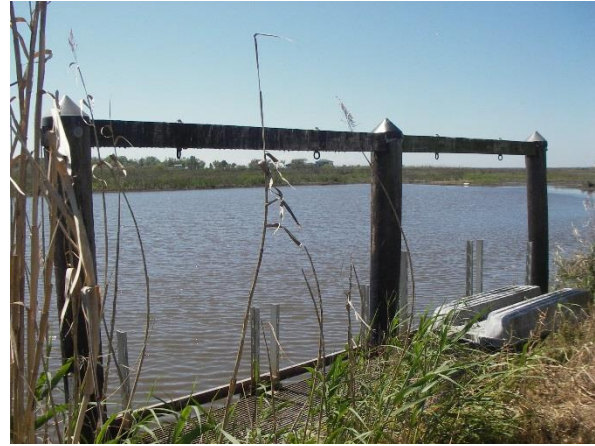
Photo No. 5, Structure No. 12, Inlet Side

The structure is in good condition. The water level was very low. The staff gauge read -0.6ft on the inside and -0.7ft on the inside. The vegetation on the terraces was plentiful and expanding. The board walkways were in good condition. (Appendix B, Photos 5&6)

Item	Condition	Physical Damage	Corrosion	Photo #	Observations and Remarks
Steel Bulkhead / Caps	N/A				
Steel Grating	Good			5	
Stop Logs	Good			5	
Hardware/Flapgates	Good			6	
Timber Piles	Good			5	
Timber Wales	N/A				
Plastic Pile Caps	Good			5 & 6	Plastic pile caps were in place.
Cables	N/A				
Staff Gages	Fair			5 & 6	Staff gauges on the inlet and outlet side were replaced in 2014 to the GEOID 12A datum.
Rip Rap embankment	Good			5 & 6	Embankment was in good condition.
InSitu AquaTroll 200 - 15r	Good				The telemery equipment has been upgraded to a 300R tube unit with ATT 3G service.
Access Roadway	Good				The access road was in good condition. New limestone was placed in sections on the road by others, possibly due to monitoring well work in the project area and use of the road for access.

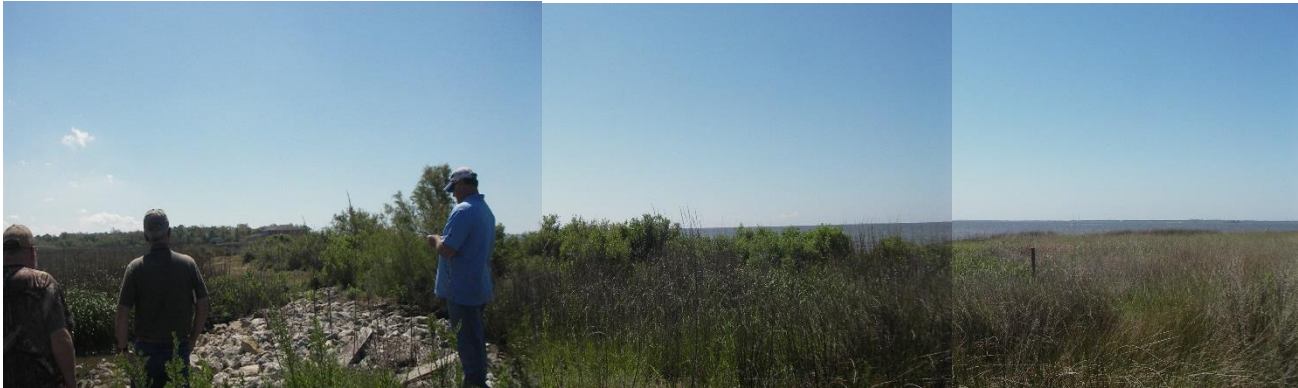
Photo No. 7, Structure No. 8, Rock Plug Looking South towards lake

The rock plug was in excellent condition. Vegetation has expanded along the rock plug on the lake side and on the interior. Open water in the marsh interior can no longer be seen from the rock plug. (Appendix B, Photos 7&8)

Item	Condition	Physical Damage	Corrosion	Photo #	Observations and Remarks
Steel Bulkhead / Caps	N/A				
Steel Grating	N/A				
Stop Logs	N/A				
Hardware	N/A				
Timber Piles	N/A				
Timber Wales	N/A				
Galv. Pile Caps	N/A				
Cables	N/A				
Signage /Supports Staff Gages	N/A				no longer necessary
Rip Rap (plug)	Good			7 & 8	The rock plug is in tact and vegetation has expanded along the plug on the lake side. Besides the small channel there is no longer any open water visible from the plug in the project interior.
Earthen Embankment

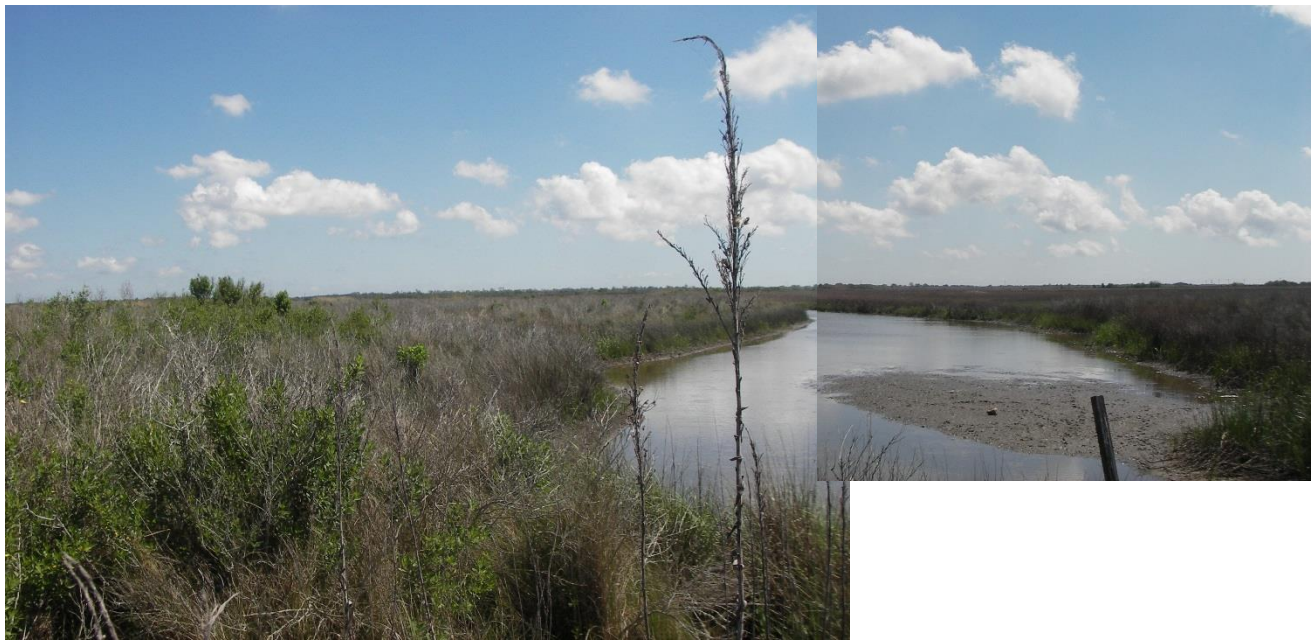
Photo No. 8, Structure No. 8, Rock Plug - Vegetation on Project Interior

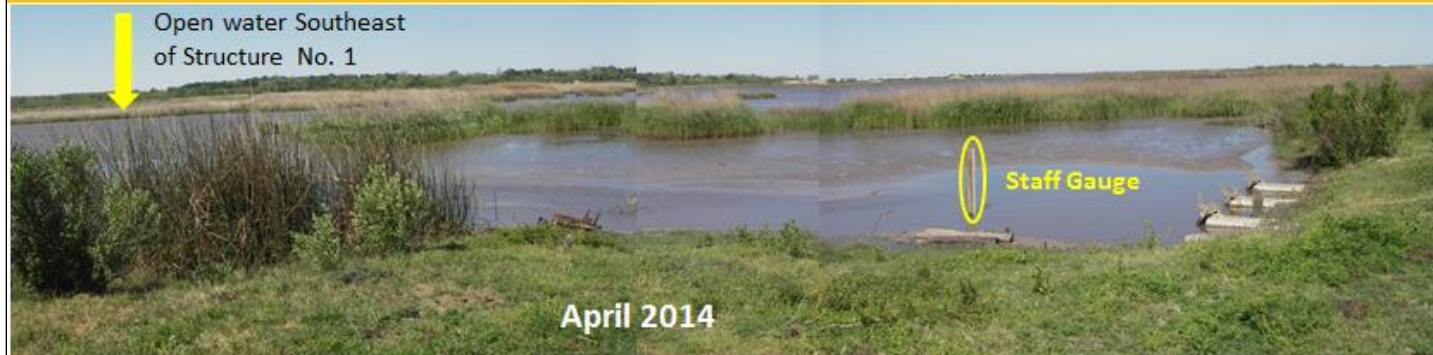
September 2015
 Maintenance Project to
 Restore Flow through
 Structure No. 1—
 Dredging inlet channel
 and road repair

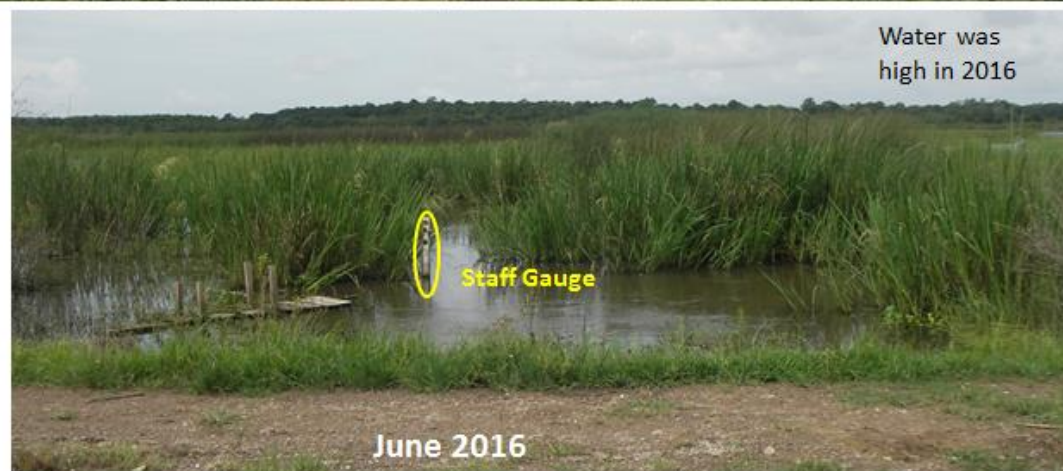
Photo No. 9, Vegetation Changes Over Time (2014- 2016): Project Interior –Structure No.1

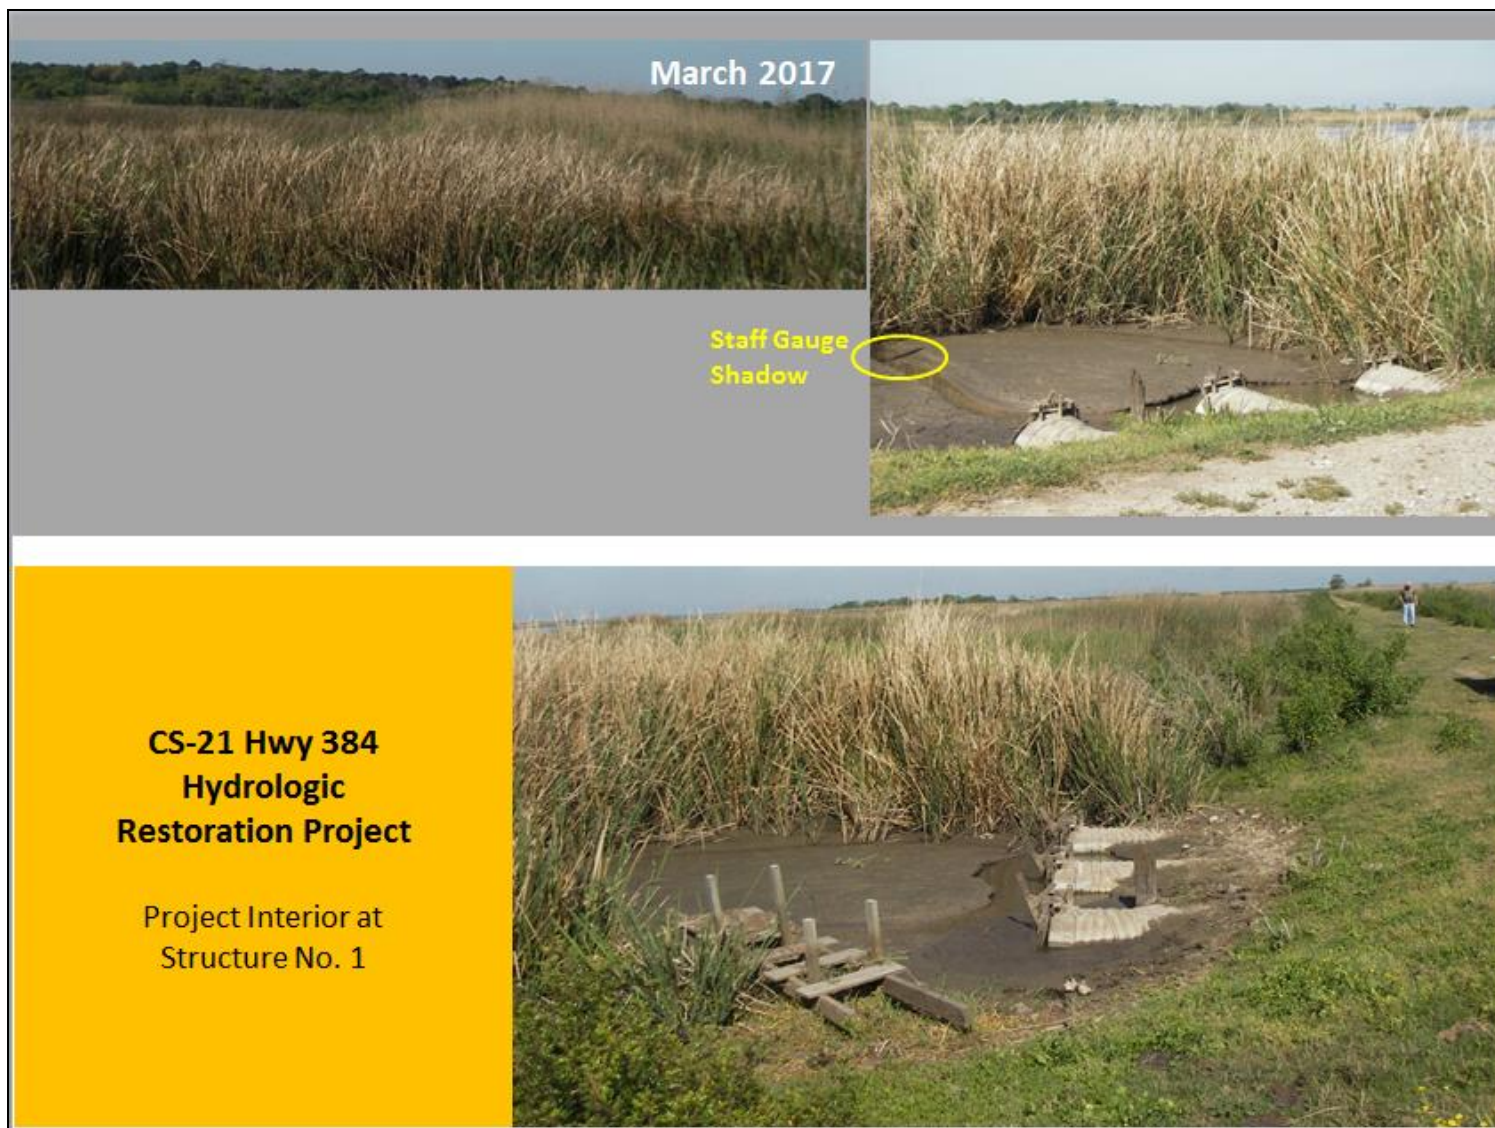
Photo No. 10, Vegetation Changes Over Time (2017): Project Interior –Structure No. 1

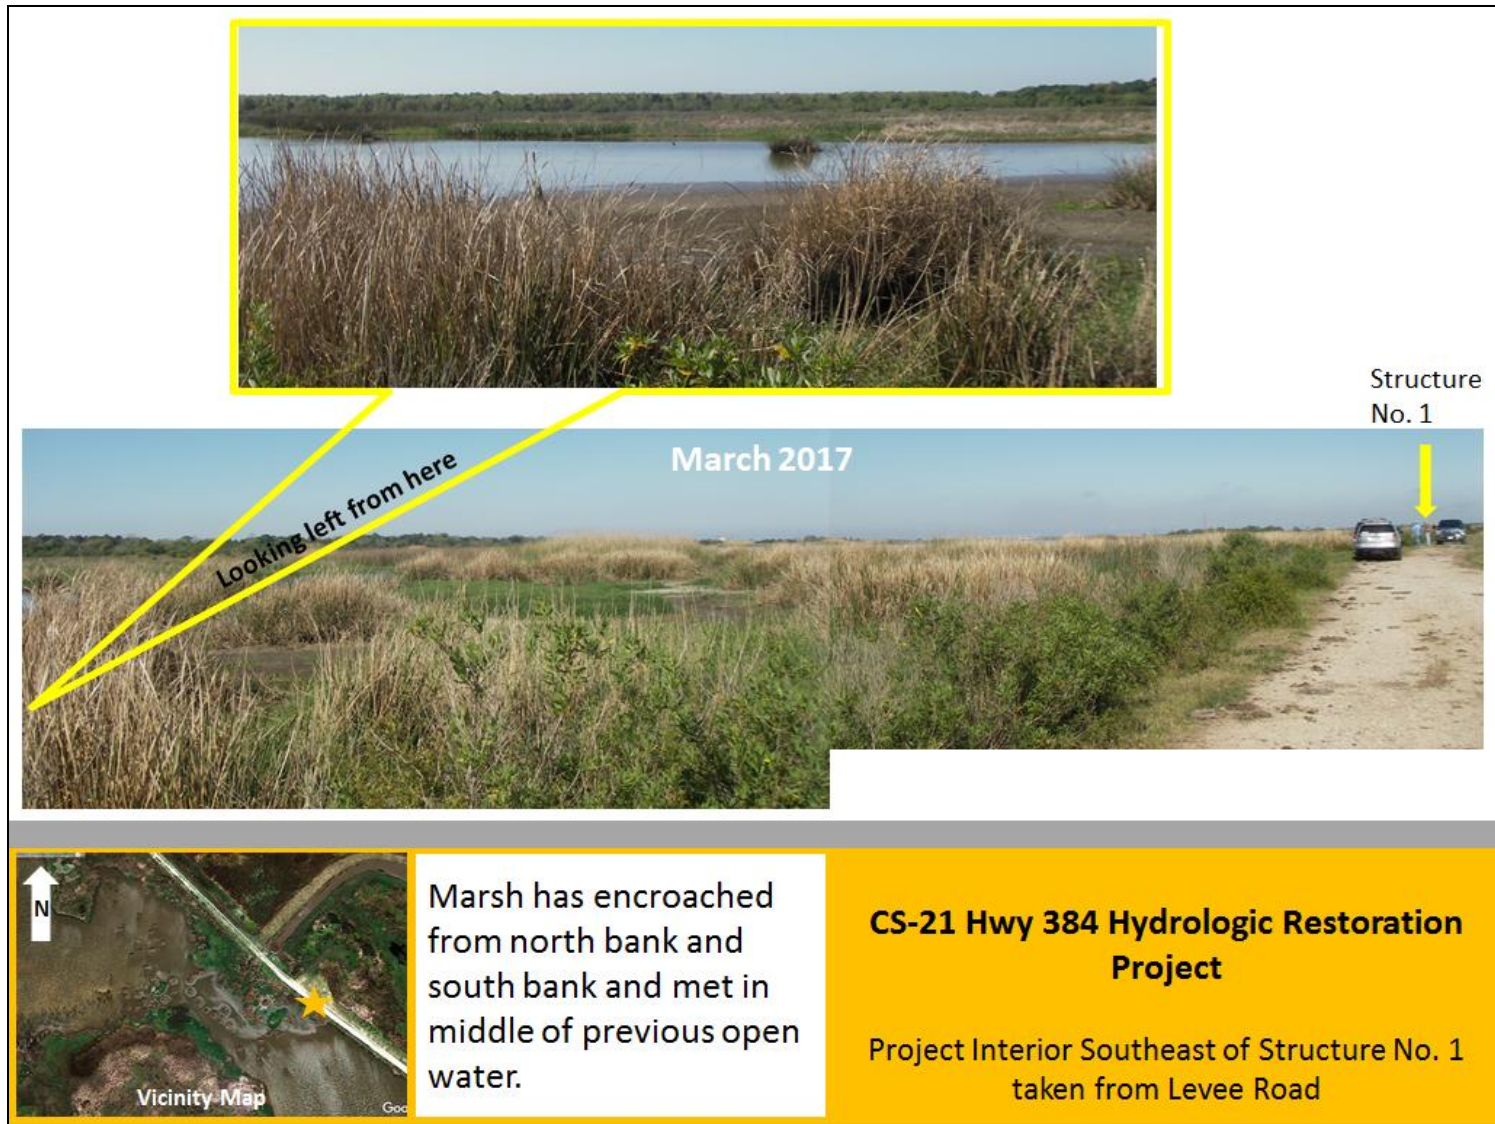
Photo No. 11, Vegetation Changes Over Time (2017): Project Interior – Southeast of Structure No. 1

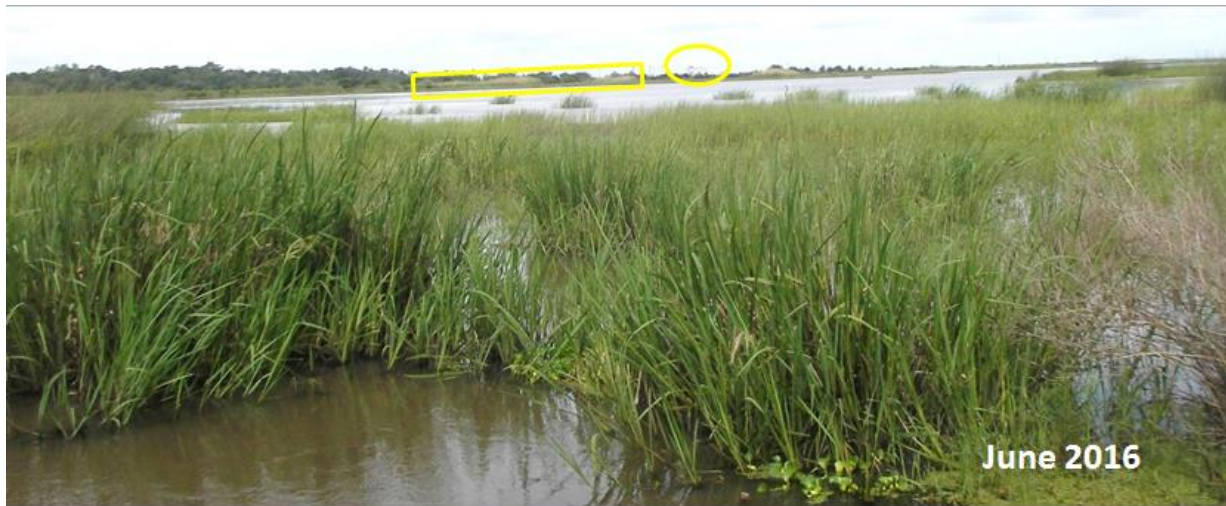
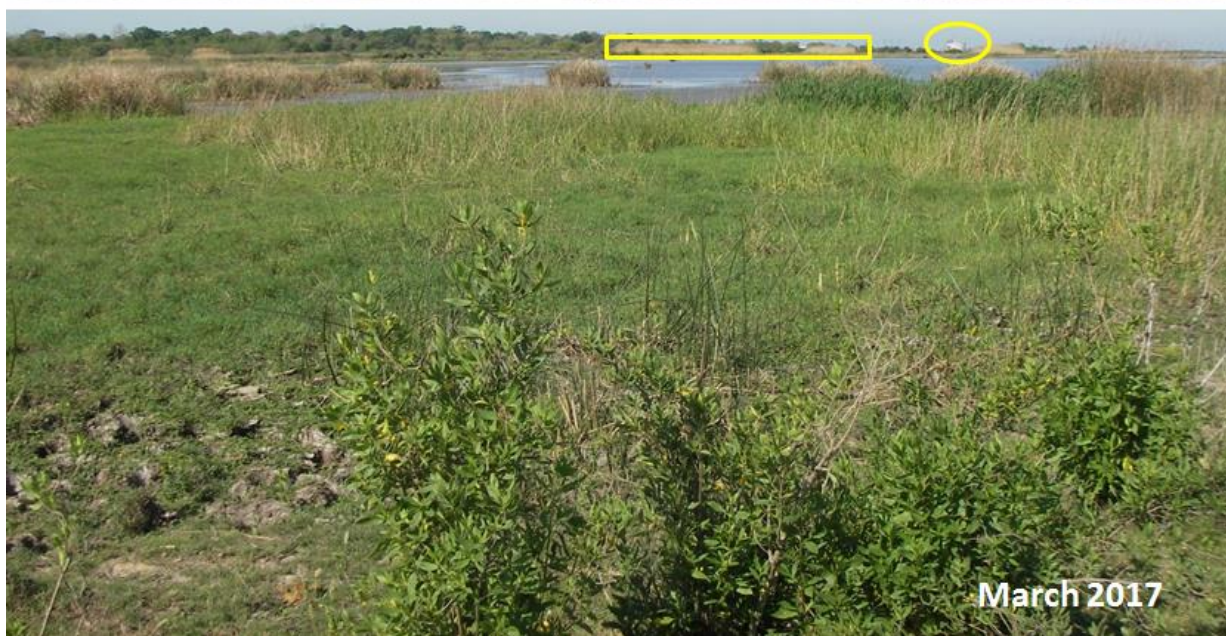
Project Interior
taken Northwest
of Structure No.
1 on levee road.

Water was high in
2016 and low in
2017 but the
changes in the
marsh elevation
are still evident.
