**Coastal Protection and Restoration
Authority (CPRA)**

2017 Operations, Maintenance, and Monitoring Report

Perry Ridge Shore Protection

State Project Number CS-24
Priority Project List 14

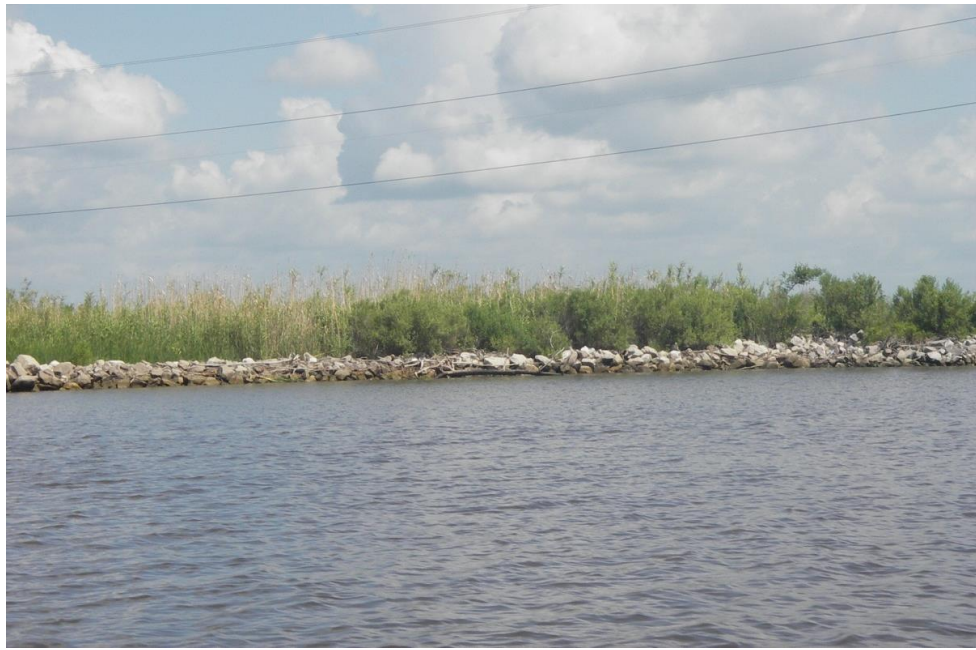
The dike is in good condition with a few low areas below constructed elevation. One 50 foot gap was noted where the dike was disturbed by a barge. Visible signs of accretion are occurring behind the rock dike. No maintenance is recommended at this time. (Photos: Appendix A, Photo 1-2)

Photo No.1, Typical Rock Dike

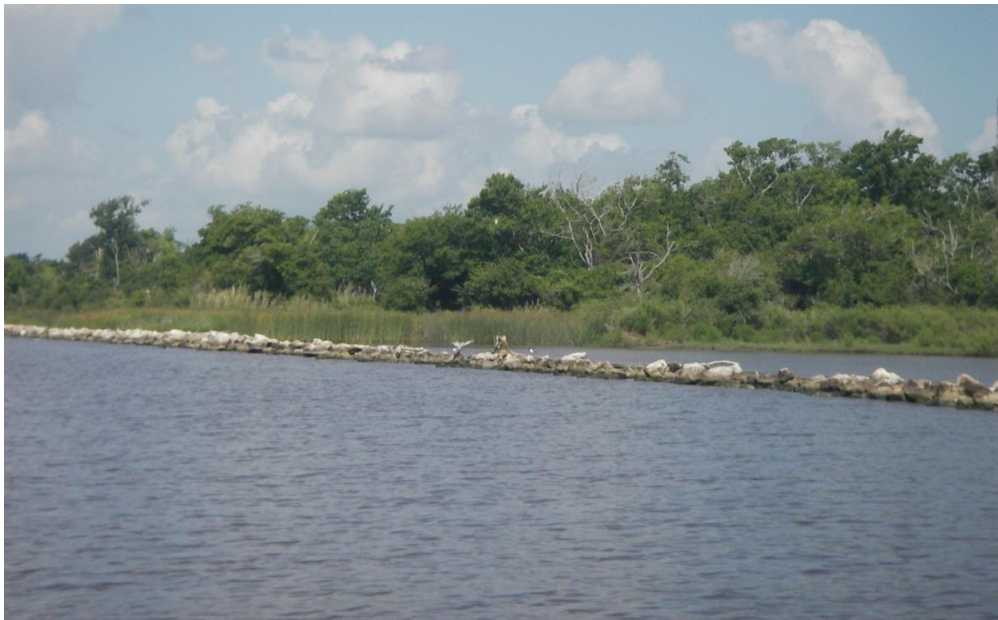
Photo No.2, Accretion behind Rock Dike
