## 2018 Operations, Maintenance, and Monitoring Report

### Black Bayou Hydrologic Restoration

State Project Number CS-27  
Priority Project List 6

November 2018  
Calcasieu and Cameron Parishes

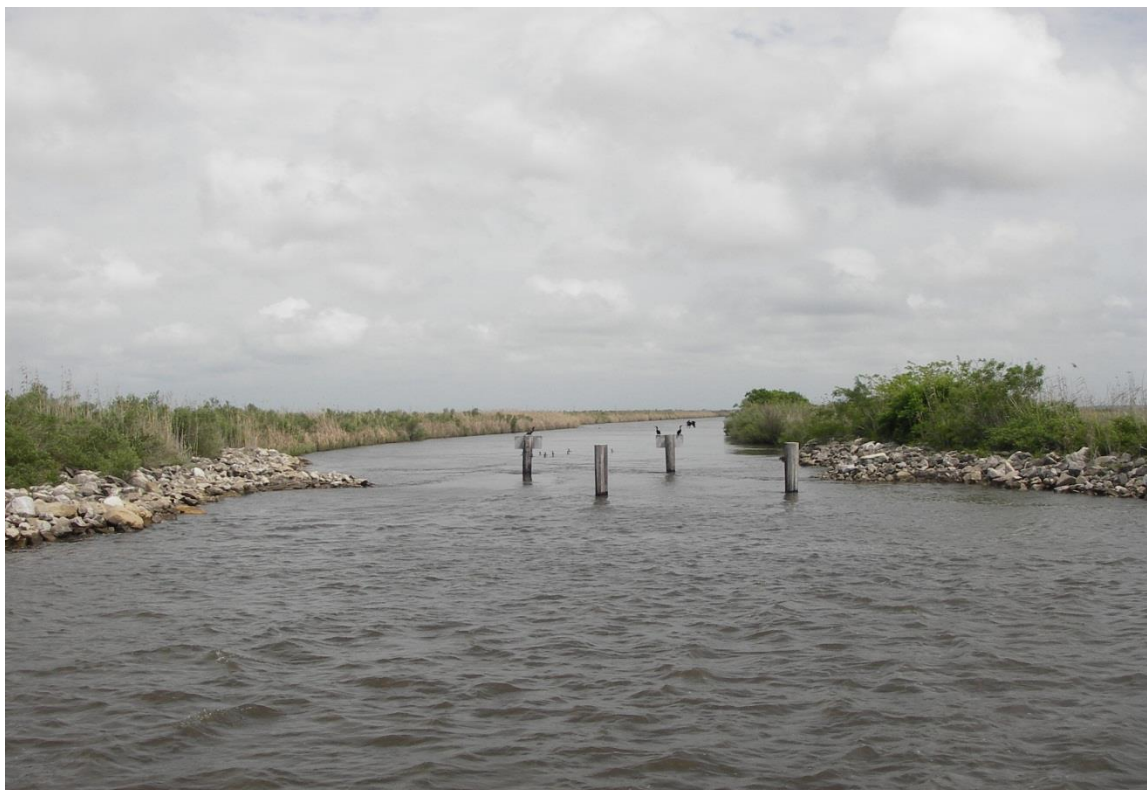
The rock weir seems to be in excellent condition, however landowners indicated that there was some scouring on the inlet and outlet sides of the weir. Upon further investigation, it was found that water was approximately 20 feet deep on the Black Bayou side and approximately 14 feet deep on the inside of the structure. Water depth at the sill is approximately 4.5 feet deep. The two arrow signs on the Black Bayou side of the structure are still missing and will need to be replaced. The erosion on the SE will continue to be monitored, but has stabilized. Navigational lights and signs are inspected quarterly by contractor. (Photos: Appendix A, Photo 1)

**Photo 1**—Navigational Aids and signage at Block's Creek

Item	Condition	Physical Damage	Corrosion	Photo #	Observations and Remarks
Block's Creek Weir	Good			1	Scouring taking place on each side of the structure. 20 ft deep on Black Bayou side and 14ft deep on interior. Sill is at 4.5ft. Two arrow signs are missing. No other maintenance required at this time.
Burton Canal Weir	Good			2	Scouring taking place on each side of the of the wier. 29.5ft on Sabine river side and 33.7ft deep on interior. Sill is at 6.5ft
Black Bayou Cut-Off Canal Weir	Good			3	Scouring is taking place on each side of the weir. 33.5ft deep on the GIWW side and 23ft deep on interior. Sill is at 10.5ft deep.
Culvert1/Culvert2	good			13-16	Good condition
Timber Piles	N/A				
Timber Wales	N/A				
Galv. Pile Caps	N/A				
Navigational Aid Lights	Good				Inspected quarterly.
Signage /Supports	Good				See note on Block's creek
Rip Rap	Good

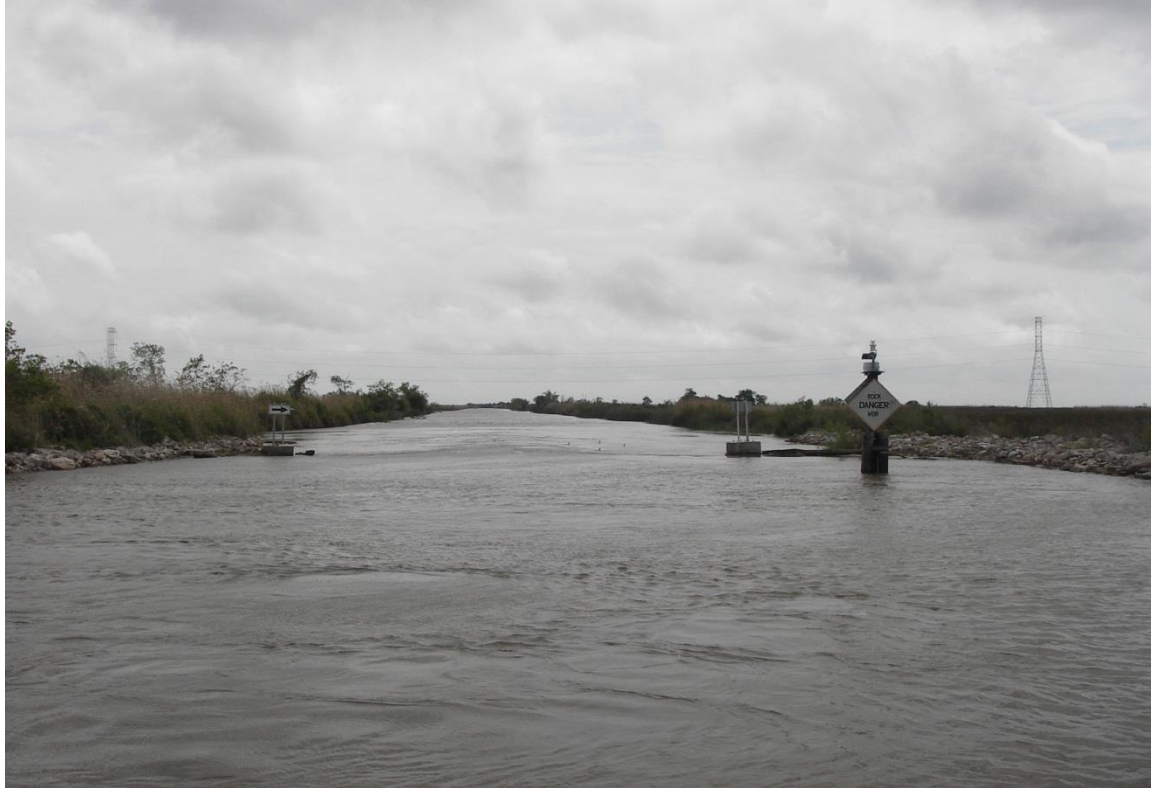
The situation at this weir is the same as at Block's Creek. Water levels on the Sabine River side are approximately 29.5 feet deep and on the inside of the structure, 33.7 feet deep. The sill is at 6.5 feet deep. The scouring along the canal banks inside of the weir at the end of the dike has stabilized. The arrow sign on the SW side of the structure is missing and will need to be replaced. Navigational lights and signs are inspected quarterly by contractor. (Photos: Appendix A, Photo 2)

**Photo 2**—Burton Canal Structure w/ missing SW arrow sign

1. Replace stolen warning signs at both the Vinton and Black Bayou closures.
2. Task an engineering firm to evaluate the extent of scouring around the three weir structures and estimate a repair cost.

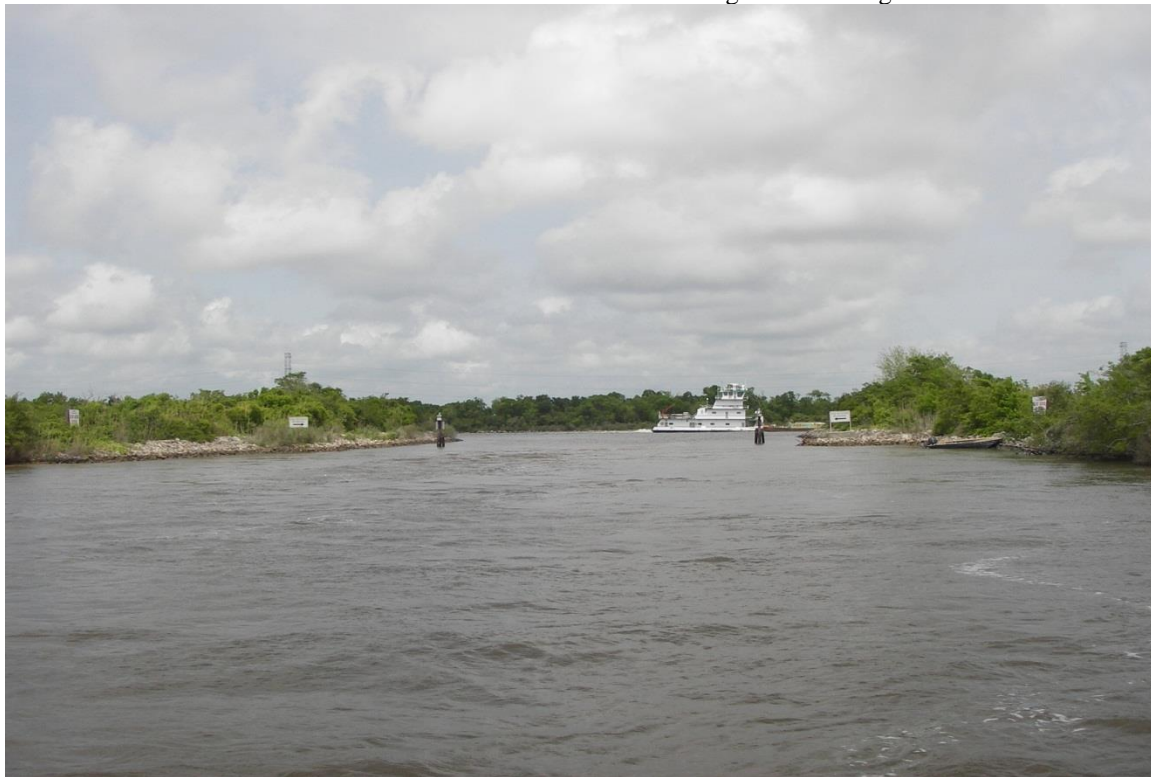
Scouring around the structure has occurred here as well. Water depths were 33.5 feet deep on the GIWW side and 23 feet deep on the inside. Sill depth is 10.5 feet. Navigational lights and signs are inspected quarterly by contractor. Coast Guard signs on the inside of the structure were missing at the time of this inspection. (Photos: Appendix A, Photo 3)

**Photo 3**—Black Bayou Cut Off Canal structure

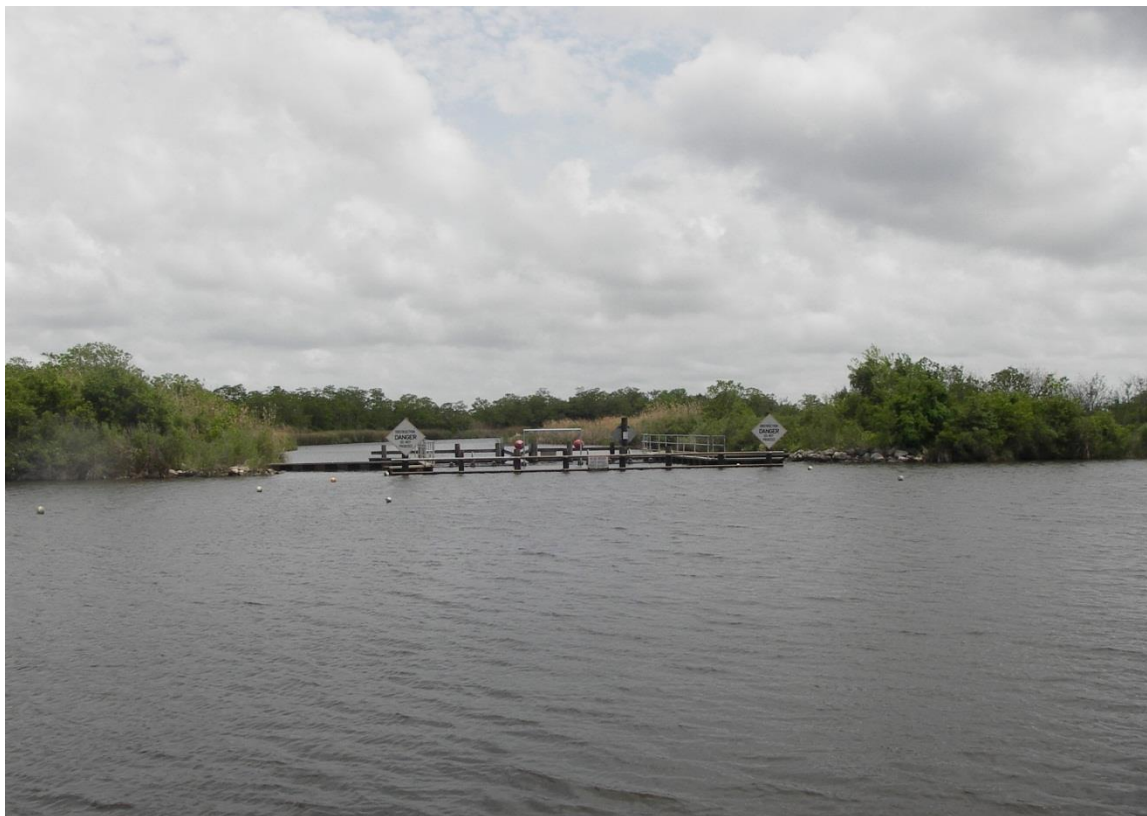
**Photo 4—SRT Gate**

The structure is in very good condition. Pillow blocks, signage, railings, wingwalls, etc. remain in excellent condition. The railing along the top of the gate continues to rust and will have to be monitored. The seams at the sheet piles are rusting also, however there is no need for maintenance at this time. Colonies of oysters were noticed on the rocks on the outside of the structure and none on the inside. (Photos: Appendix A, Photos 4-6)

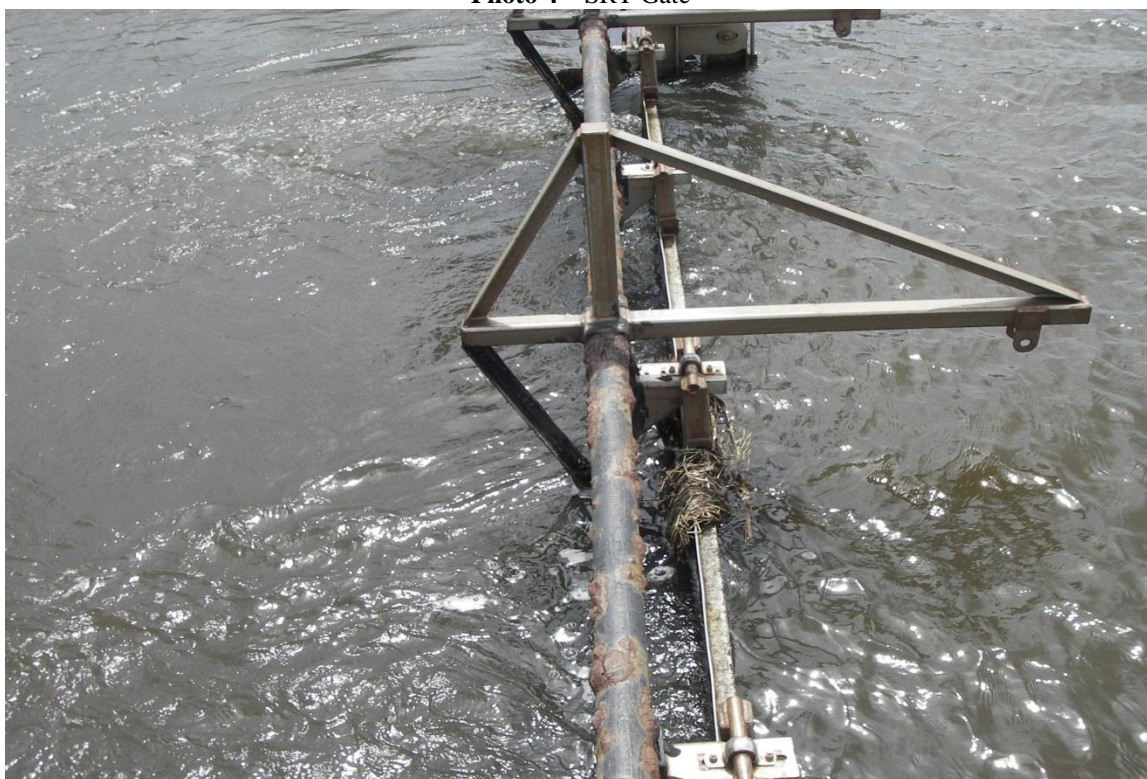
**Photo 5—pillow block on SRT Gate flap & railing rust**

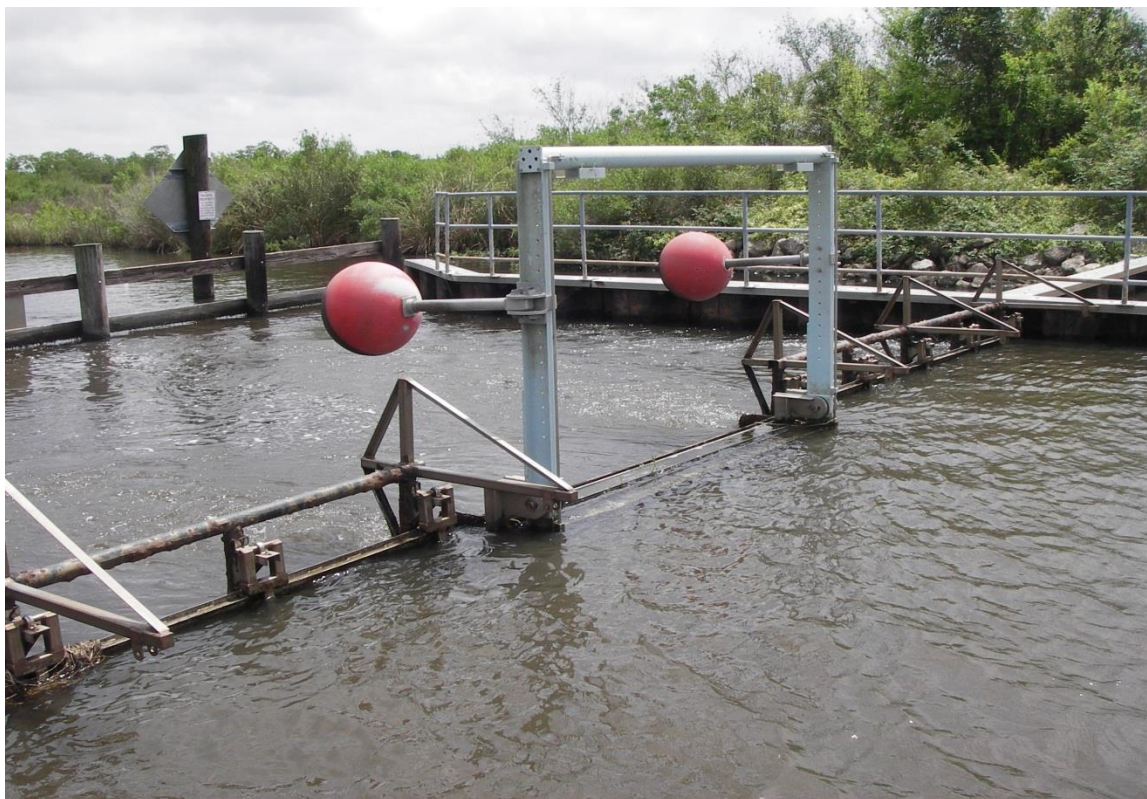
**Photo 6—SRT Gate**

Item	Condition	Physical Damage	Corrosion	Photo #	Observations and Remarks
Steel Bulkhead / Caps	Good			6	Rusting at sheet pile seams. Will continue to monitor.
Steel Grating	N/A				
Stop Logs	N/A				
Hardware	Good				
Timber Piles	Good				
Timber Wales	Good				
Galv. Pile Caps	Good				
SRT Gate	Good		Moderate	4-6	Pillow blocks were replaced during last inspection. Gate is in good condition. The railing above the gate is showing signs of corrosion. No maintenance required at this time.
Signage / Supports Vinton Canal	Good			4	Good condition.
Rip Rap (fill)	Good				
Rock Plug (Concrete sack repair)	Good			7	Good condition

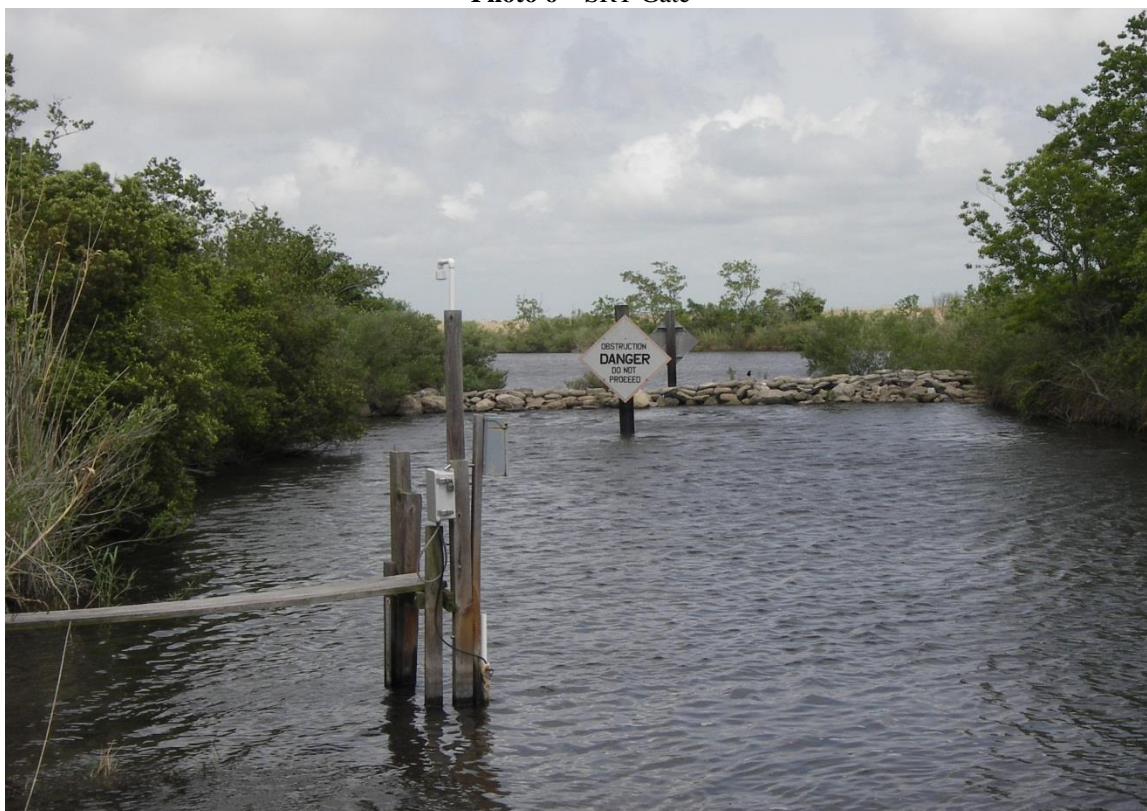
**Photo 7—Rock plug near SRT Gate**

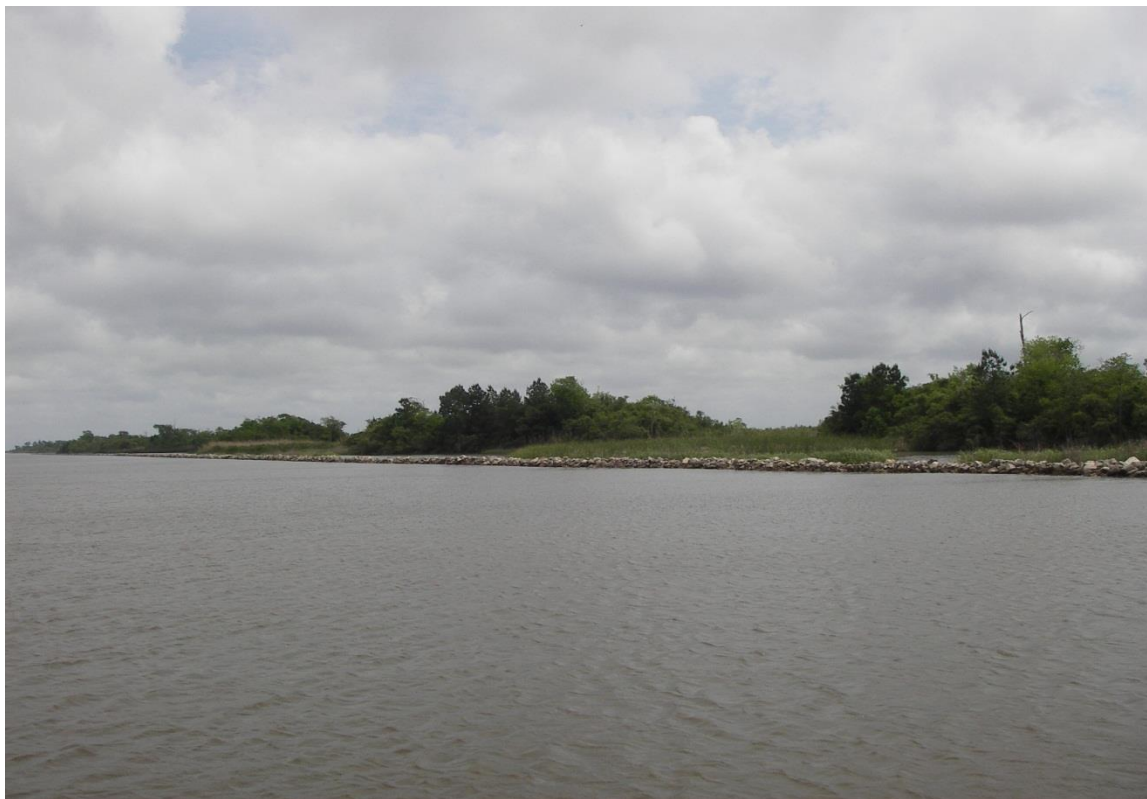
**Photo 8**—Typical section of rock dike

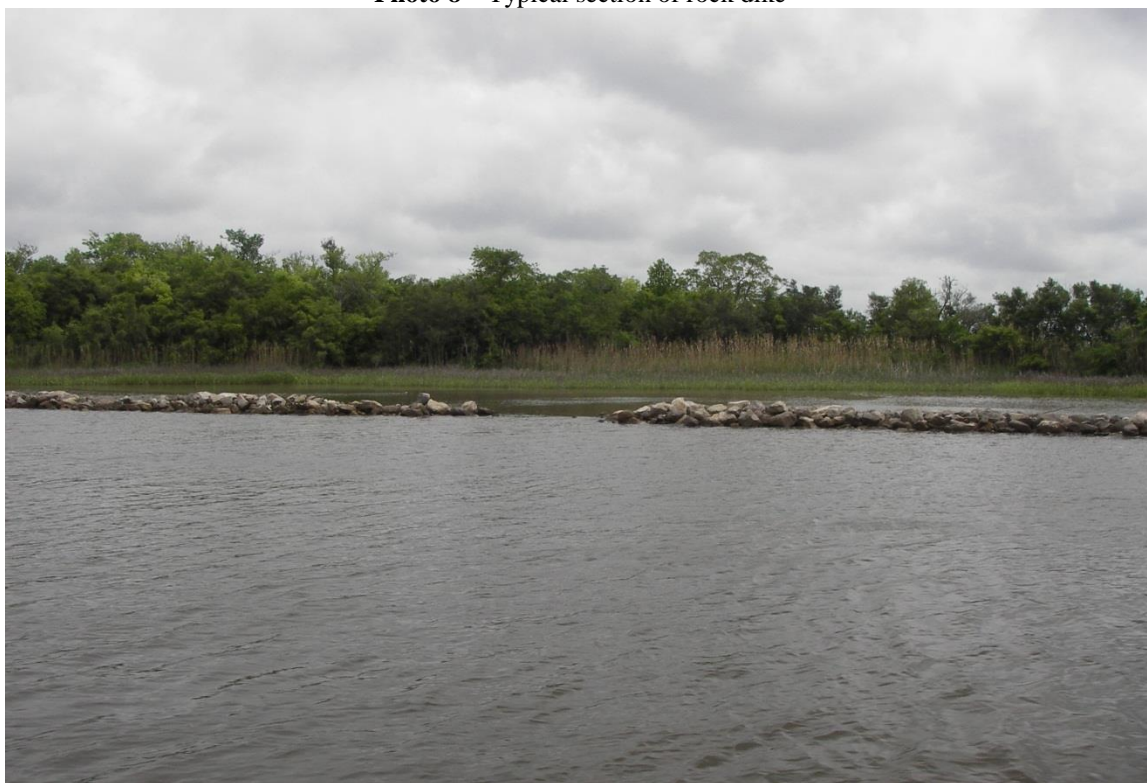
**Photo 9**—gap in dike with new vegetation between dike & shoreline

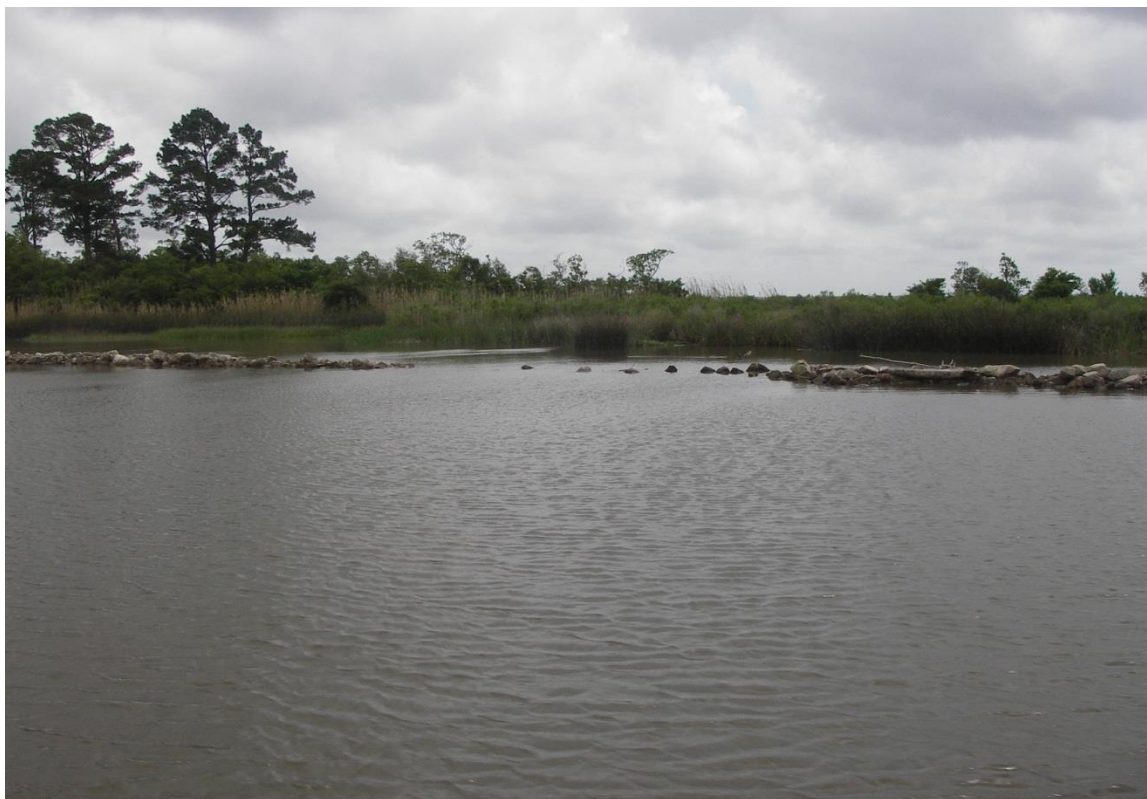
**Photo 10**—gap in dike

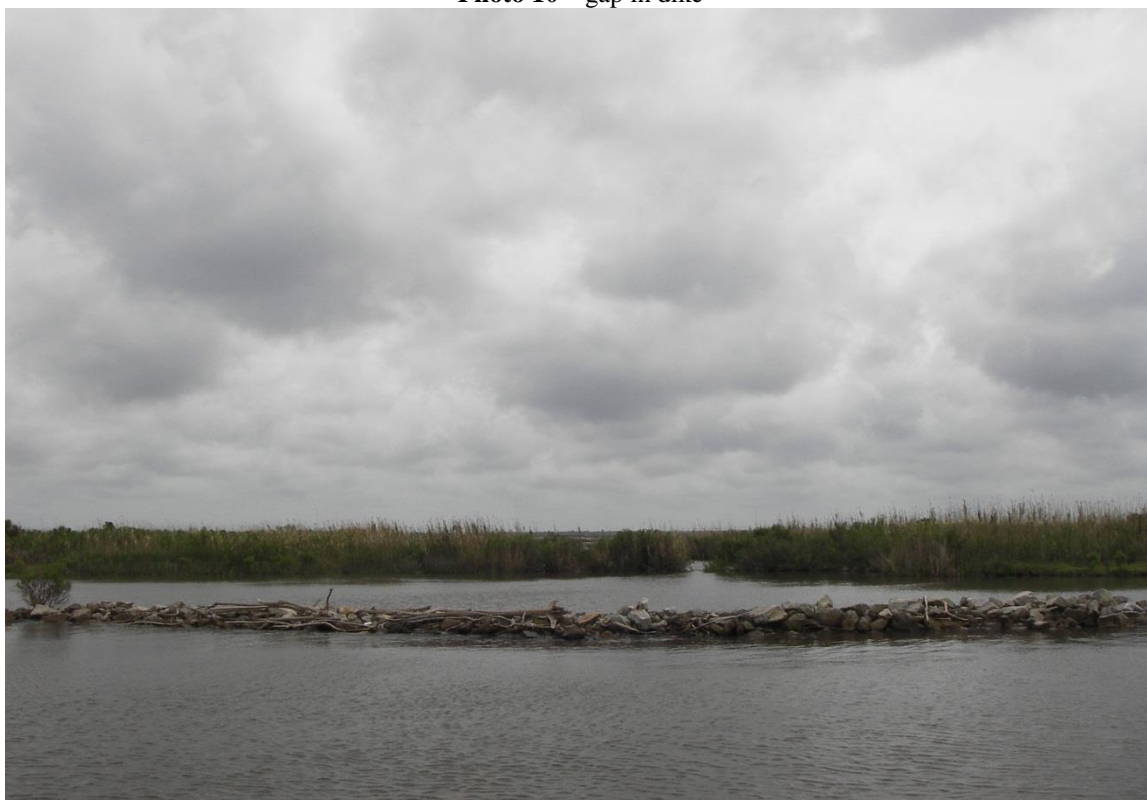
**Photo 11**—break near closure behind dike

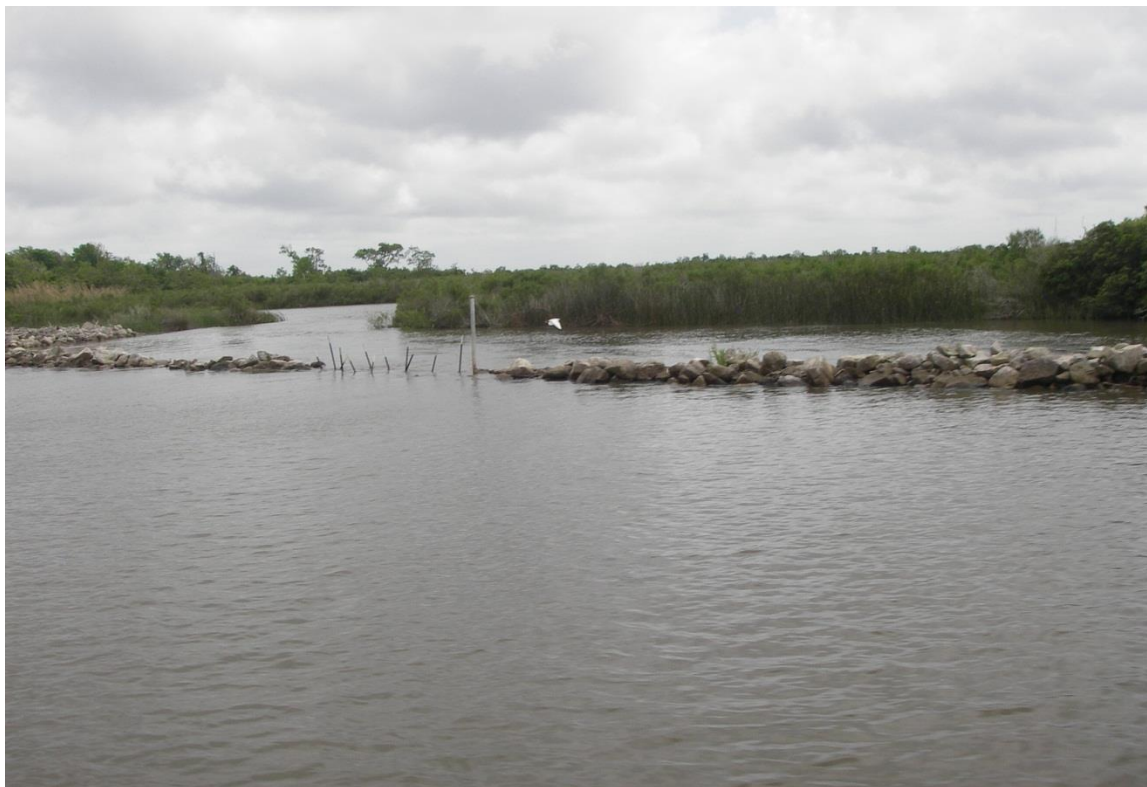
**Photo 12**—gap in dike and break near closure behind dike

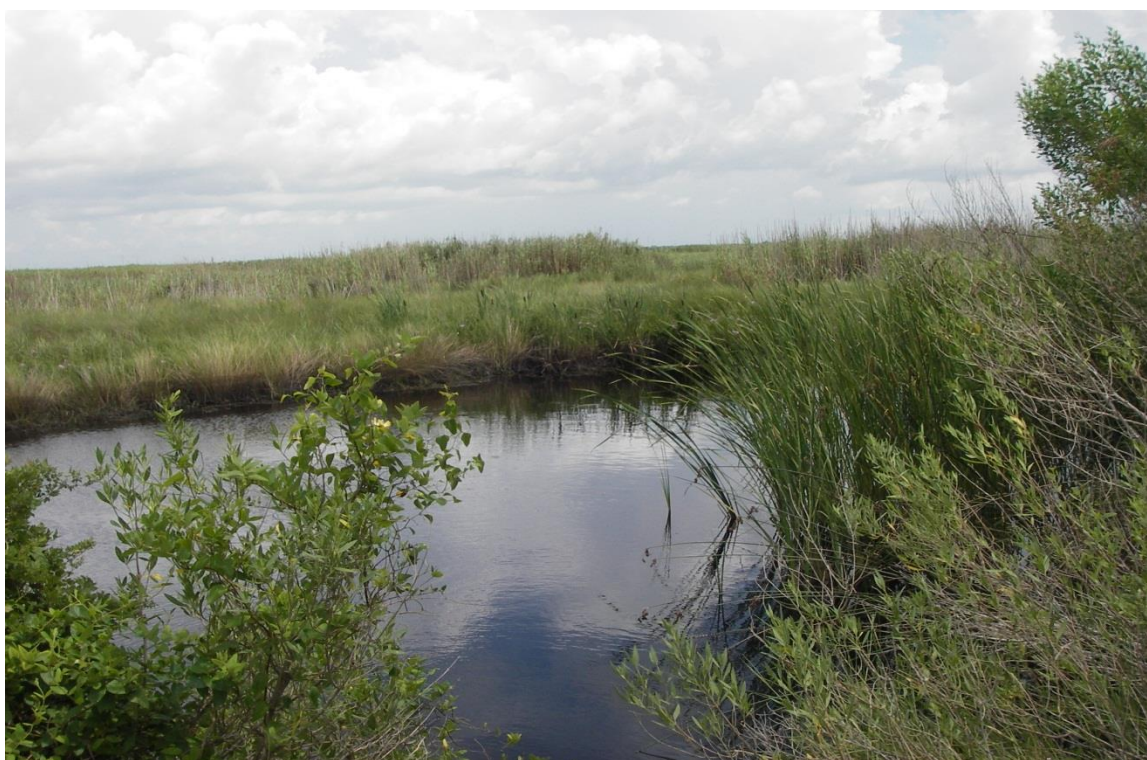
These culverts were inspected on June 26, 2015. They appear to be in very good, post construction condition and in no need of repair. No concerns have been expressed by the landowners. (Photos: Appendix A, Photos 13-16)

**Photo 13**—inlet side of eastern culvert

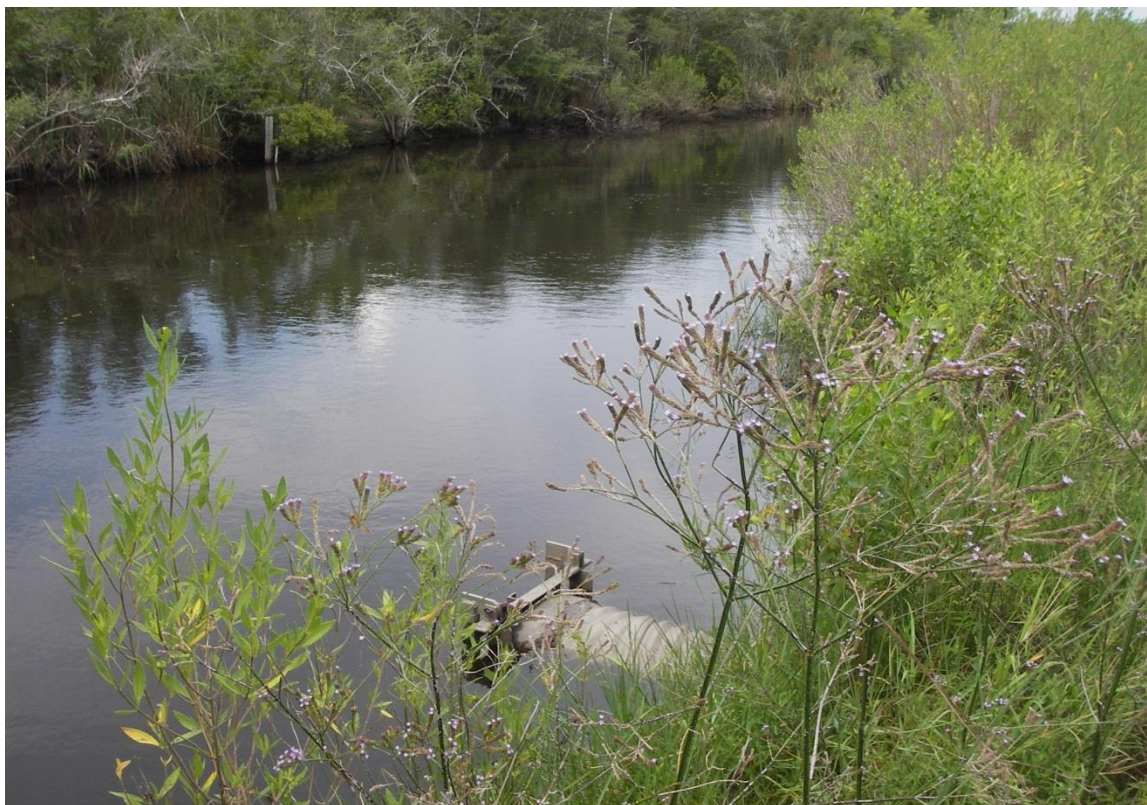
**Photo 14**—flapgate side of eastern culvert

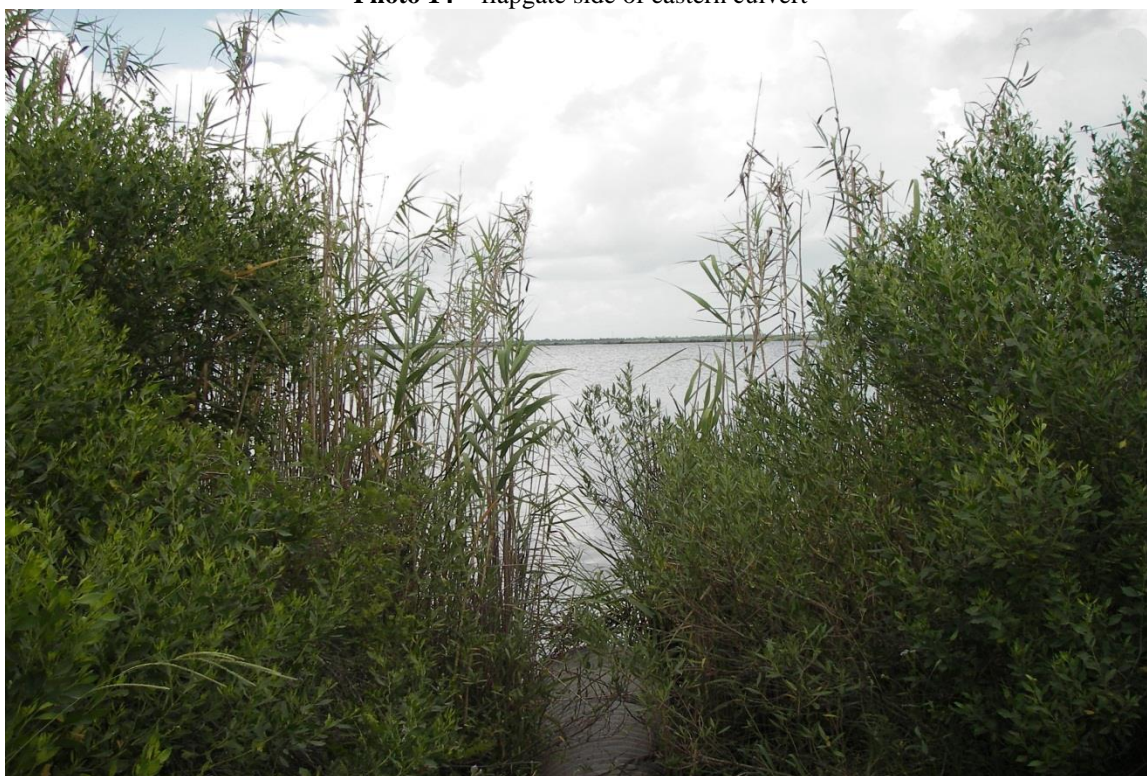
**Photo 15**—inlet side of western culvert

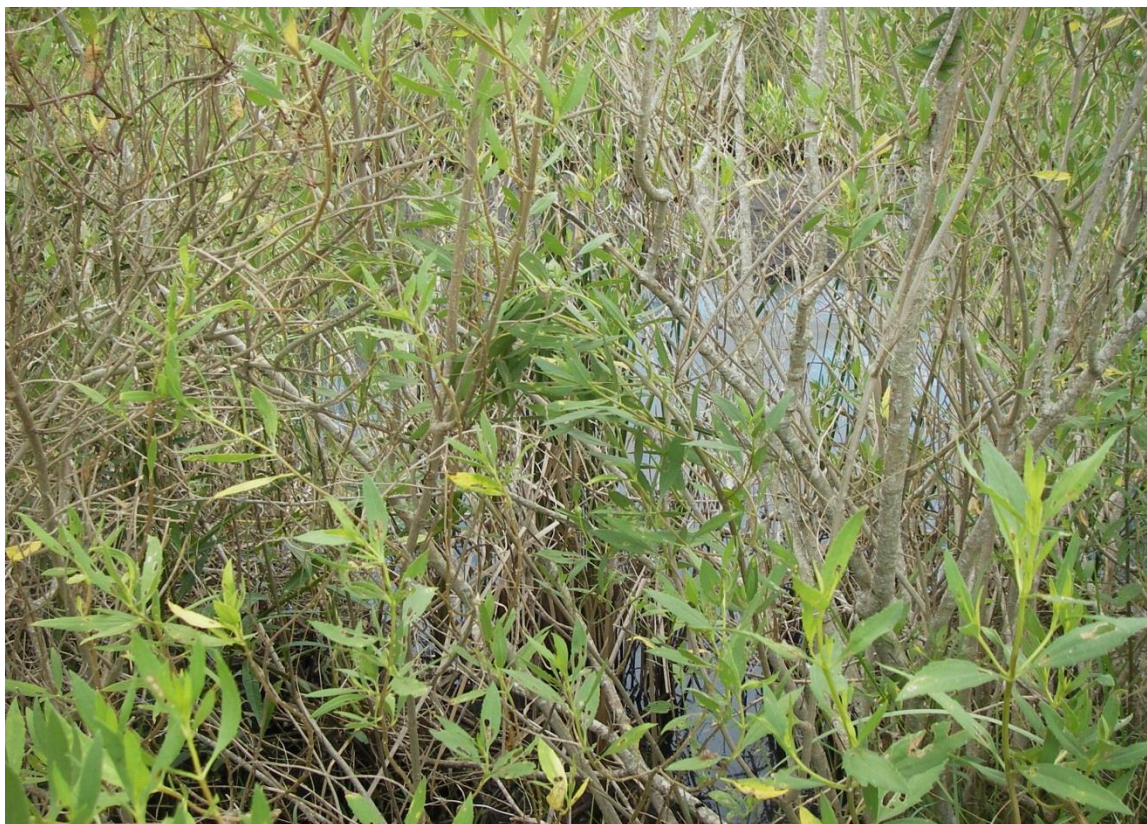
**Photo 16**—flapgate side of western culvert
