## **2016/2017 Annual Inspection Report**

### **SABINE REFUGE MARSH CREATION PROJECT (CS-28-4&5)**

State Project Number CS-28-4&5  
Priority Project List 8

June 15, 2017  
Cameron Parish

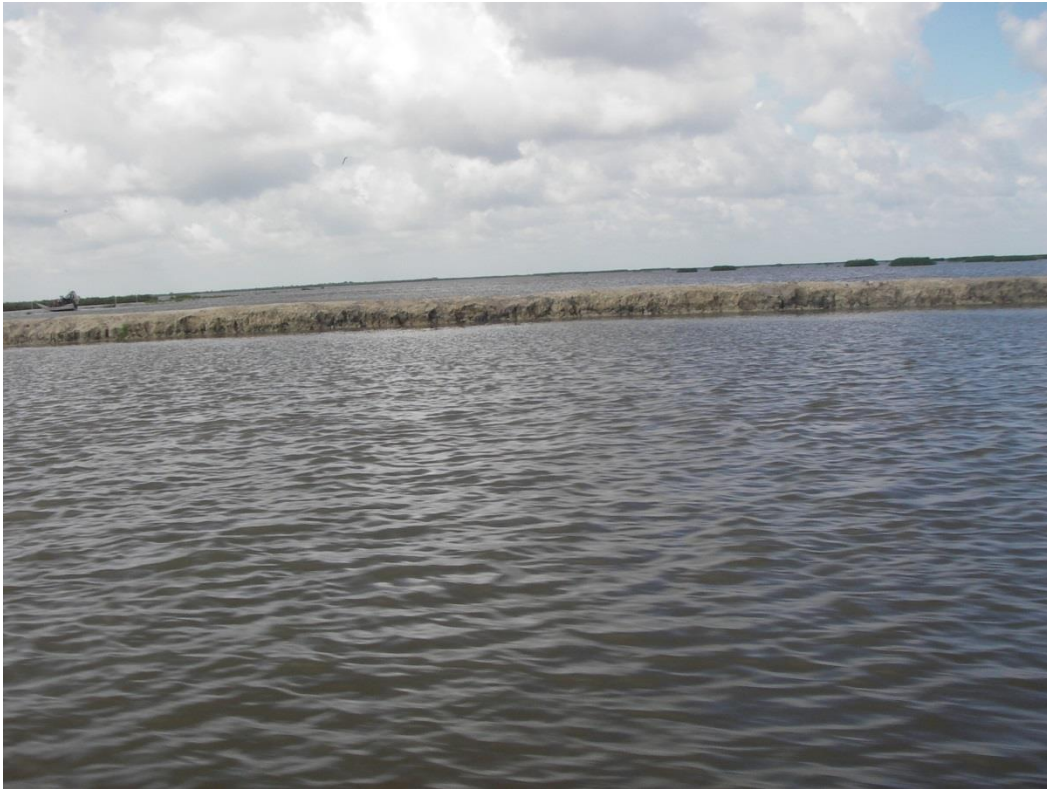
No need for maintenance at this time. The cell has some vegetation starting to take hold. The containment dikes appear to have gaps forming or remaining from original construction. (Photos: Appendix B, Photos 1 - 6)

**Photo No. 1,** Cycle No. 4, East Containment Dike, Looking Southwest

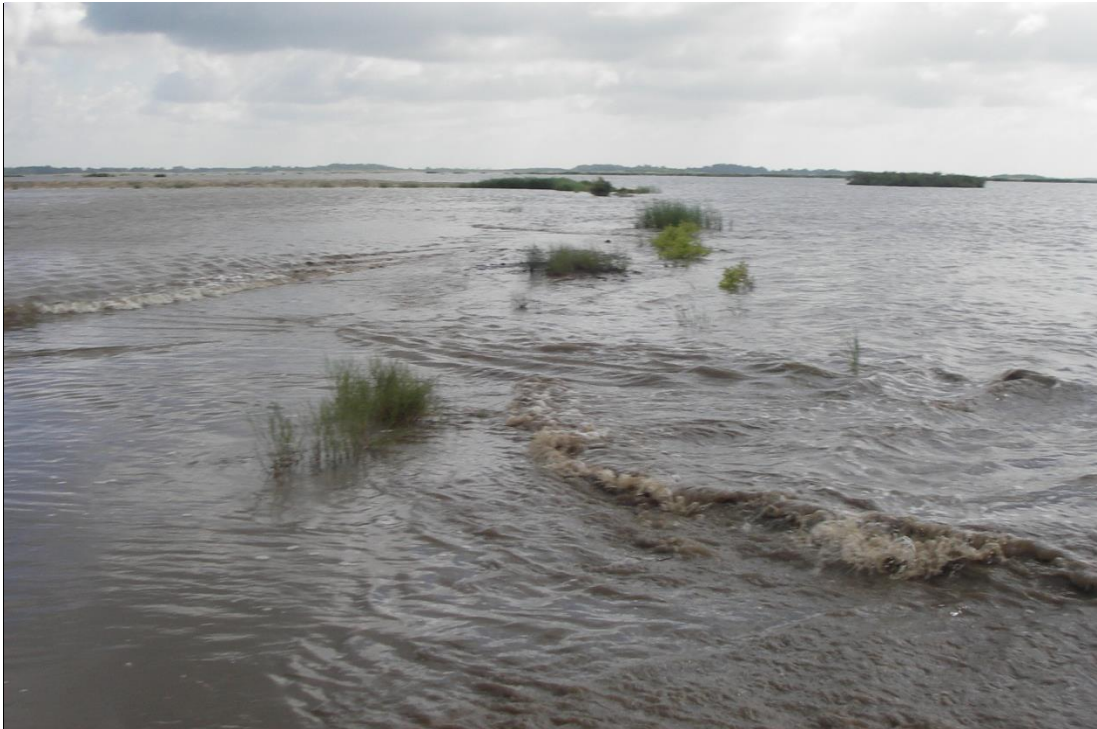
**Photo No. 2,** Cycle No. 4, East Containment Dike, Looking East

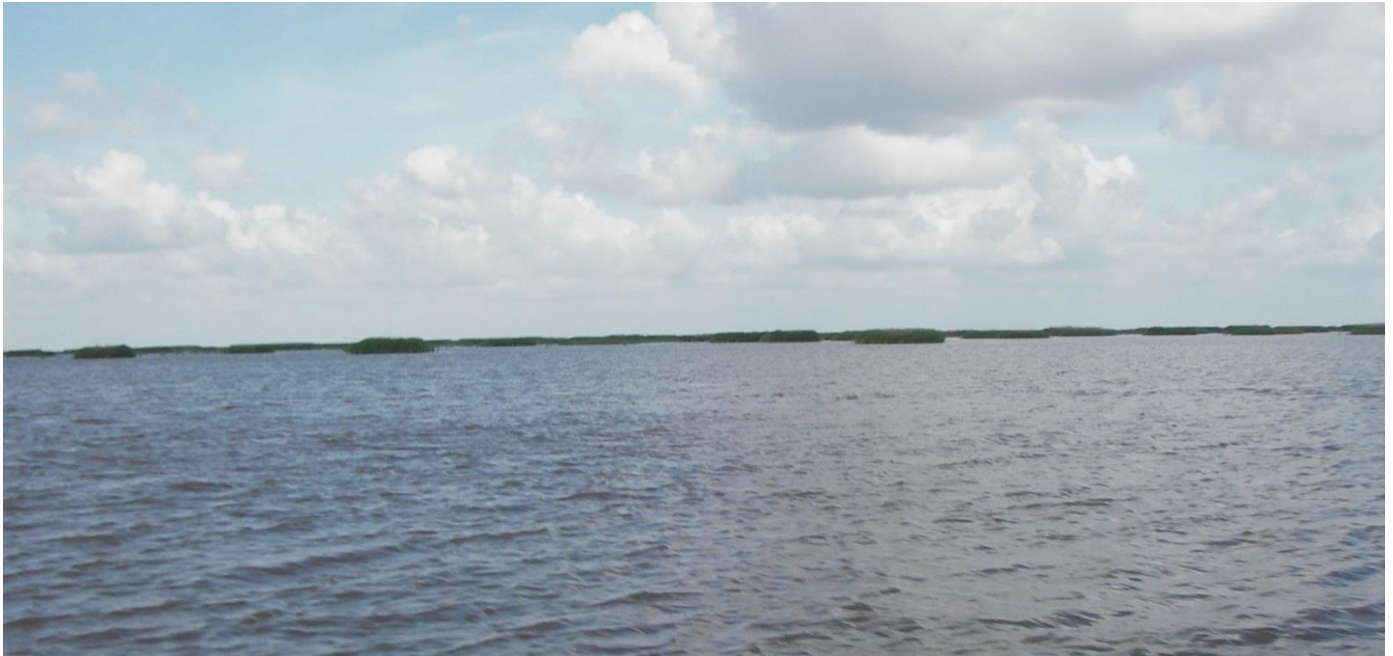
**Photo No. 2,** Interior of Marsh Creation Cycle No. 4

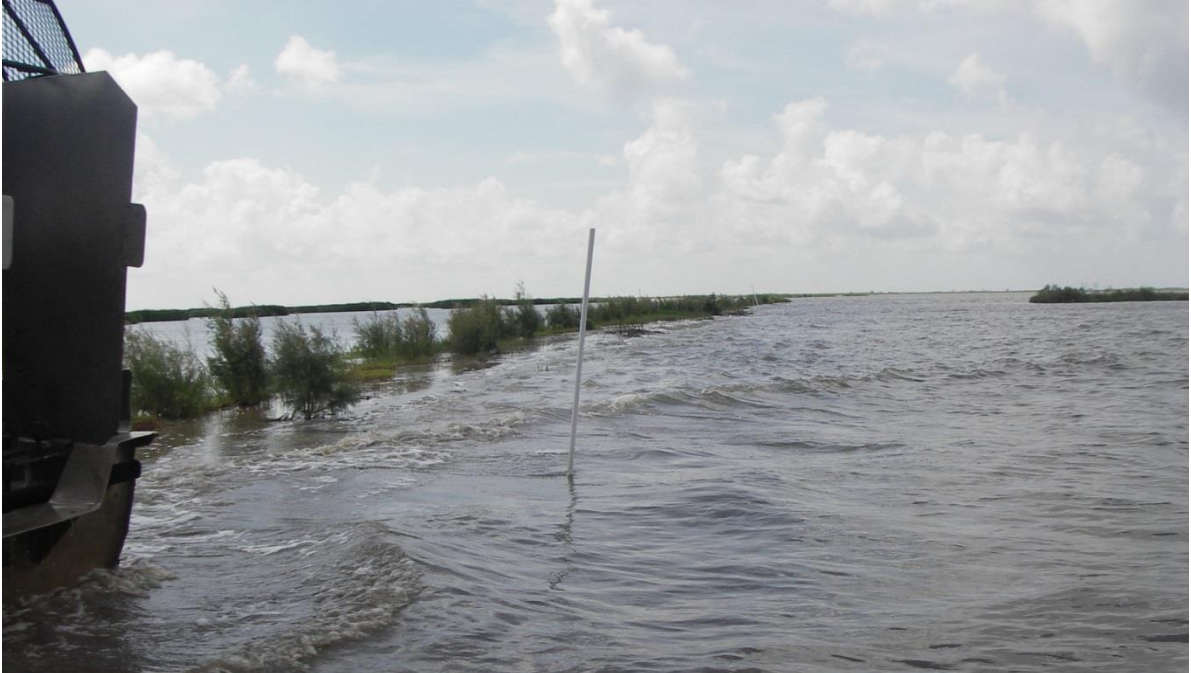
No need for maintenance at this time. The cell has thick stands of vegetation starting to take hold, more so than Cycle No. 4. The containment dikes appear to have gaps forming or remaining from original construction. (Photos: Appendix B, Photos 1 - 6)

**Photo No. 3,** West Containment Dike of Cycle No. 5 – Looking South

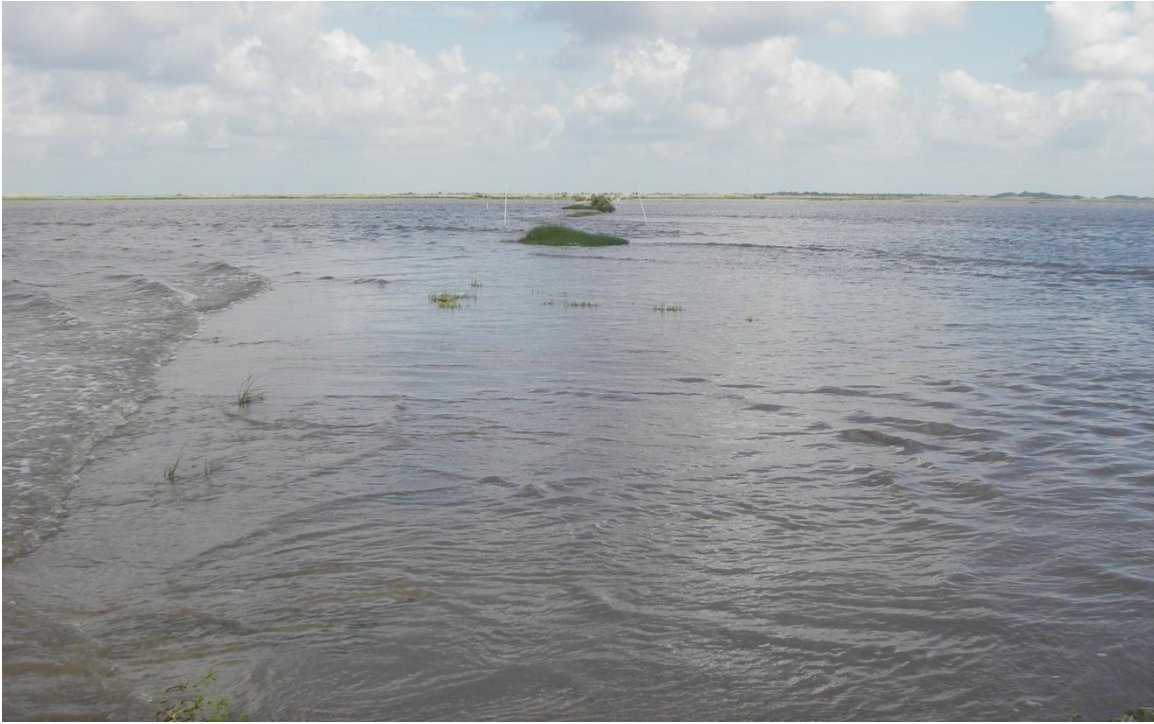
**Photo No. 4,** West Containment Dike of Cycle No. 5 – Looking North

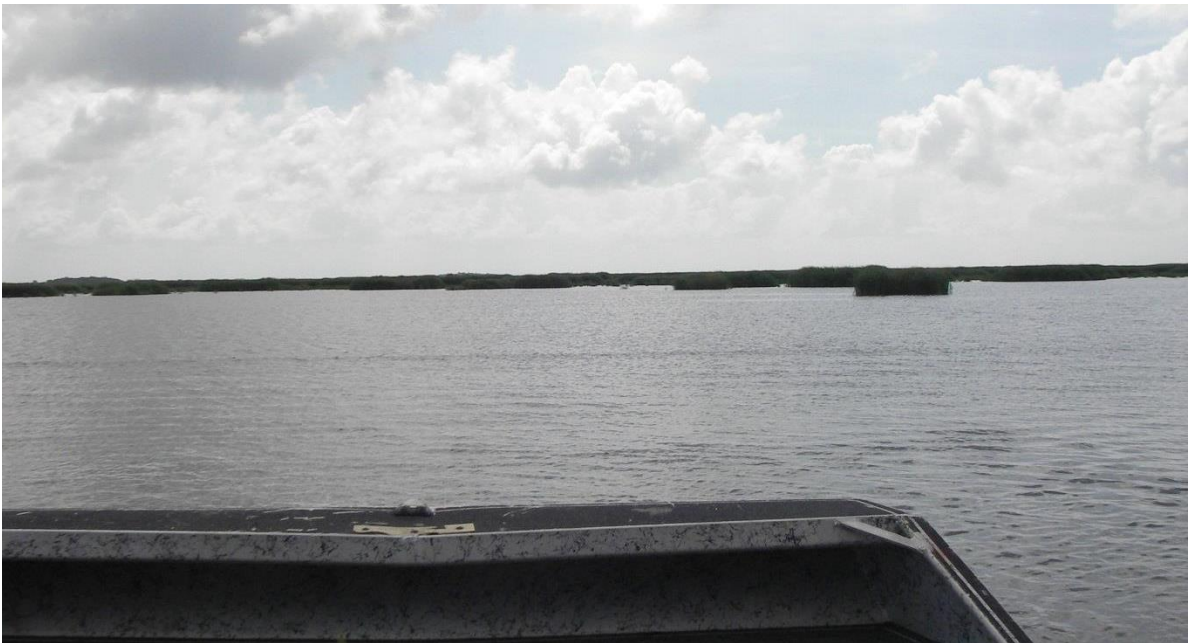
**Photo No. 5,** Interior of Marsh Creation Cycle No. 5

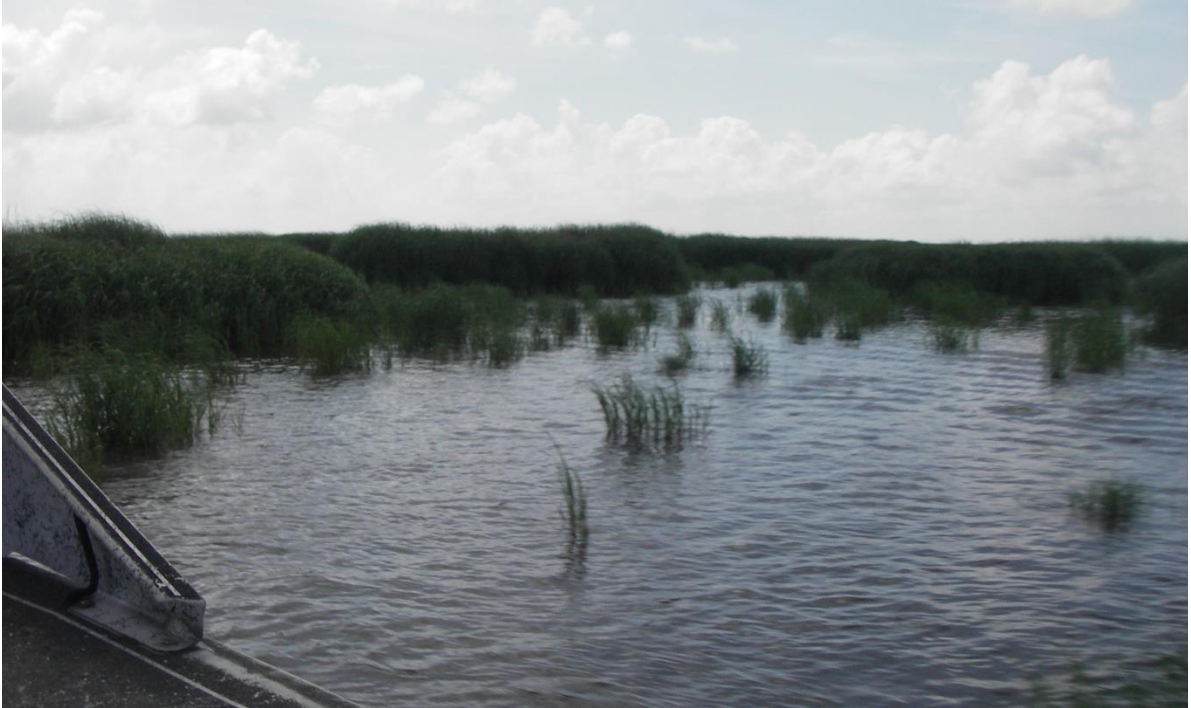
**Photo No. 6,** Vegetation within Cycle No. 5

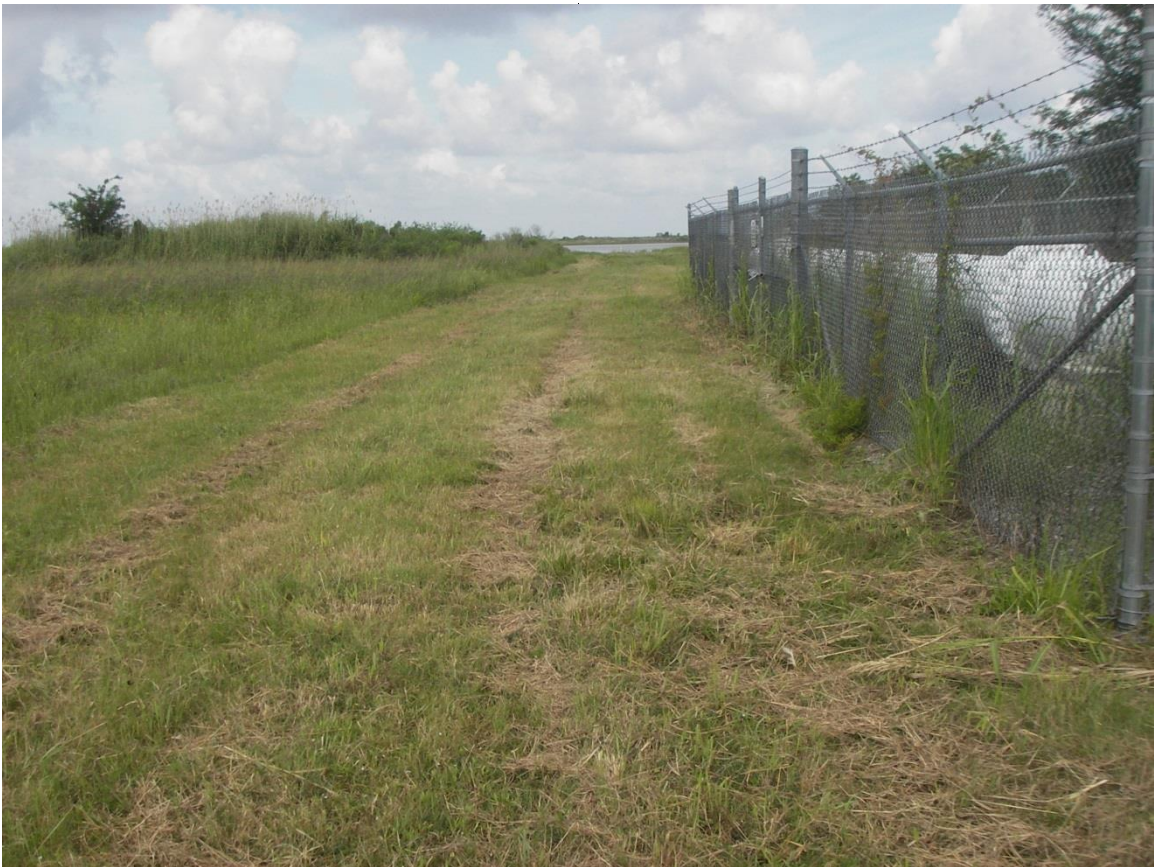
**Photo No. 7,** Access from Permanent Pipeline Corridor, Looking West

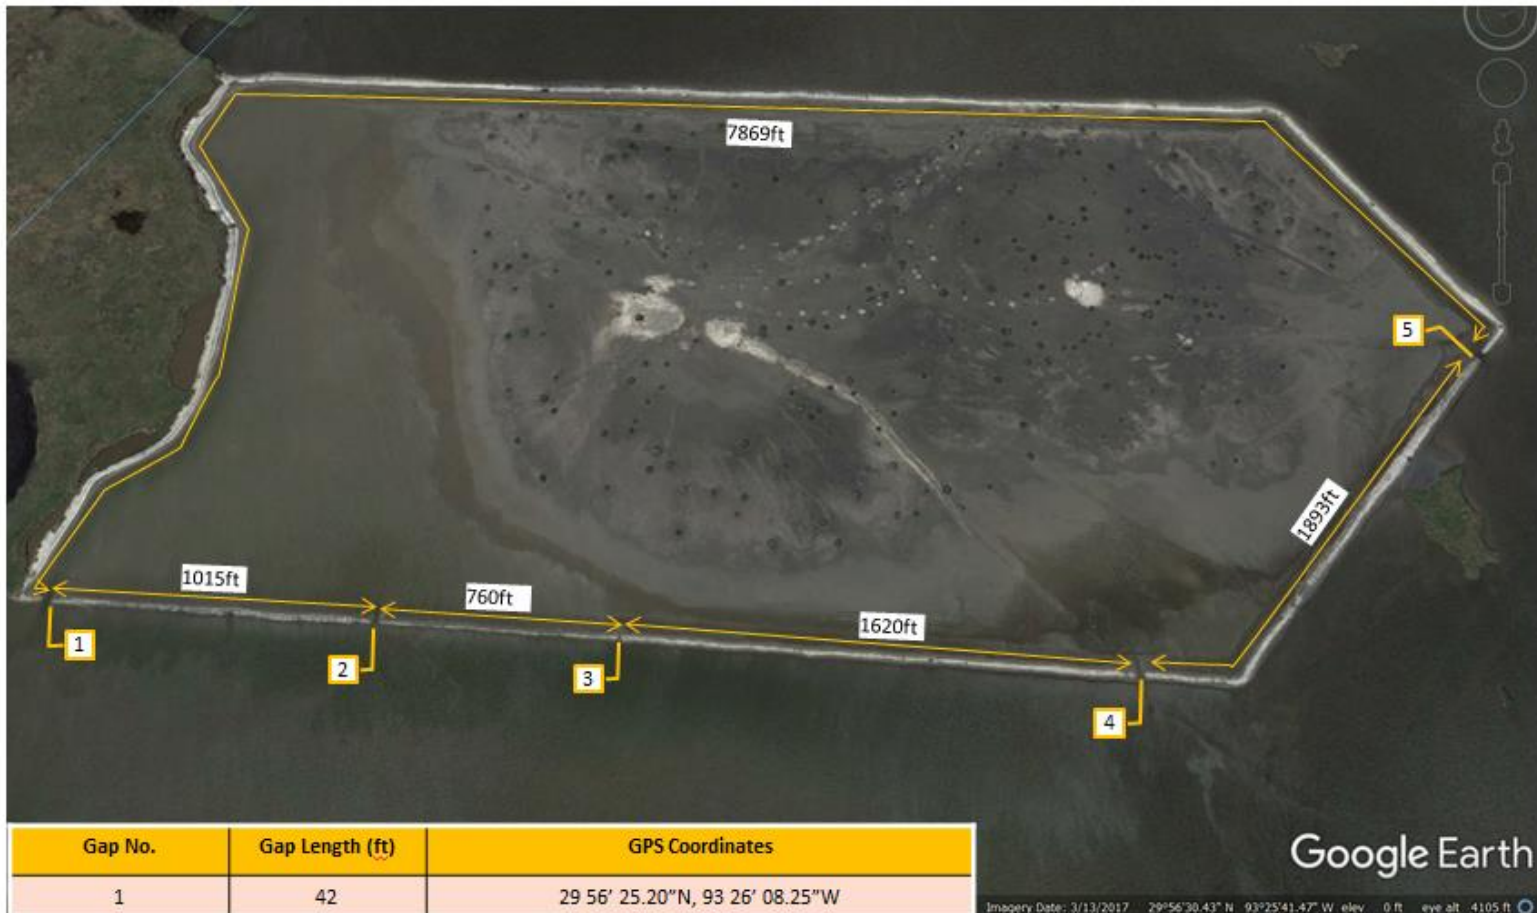
### CS-28 Sabine Refuge Marsh Creation, Cycle 4 Gap Locations – March 2017 – Identified from Google Earth

Gap No.	Gap Length (ft)	GPS Coordinates
1	42	29 56' 25.20"N, 93 26' 08.25"W
2	35	29 56' 24.26"N, 93 25' 56.06"W
3	9	29 56' 23.62"N, 93 25' 47.16"W
4	30	29 56' 22.21"N, 93 25' 28.45"W
5	34	29 56' 33.24"N, 93 25' 12.91"W

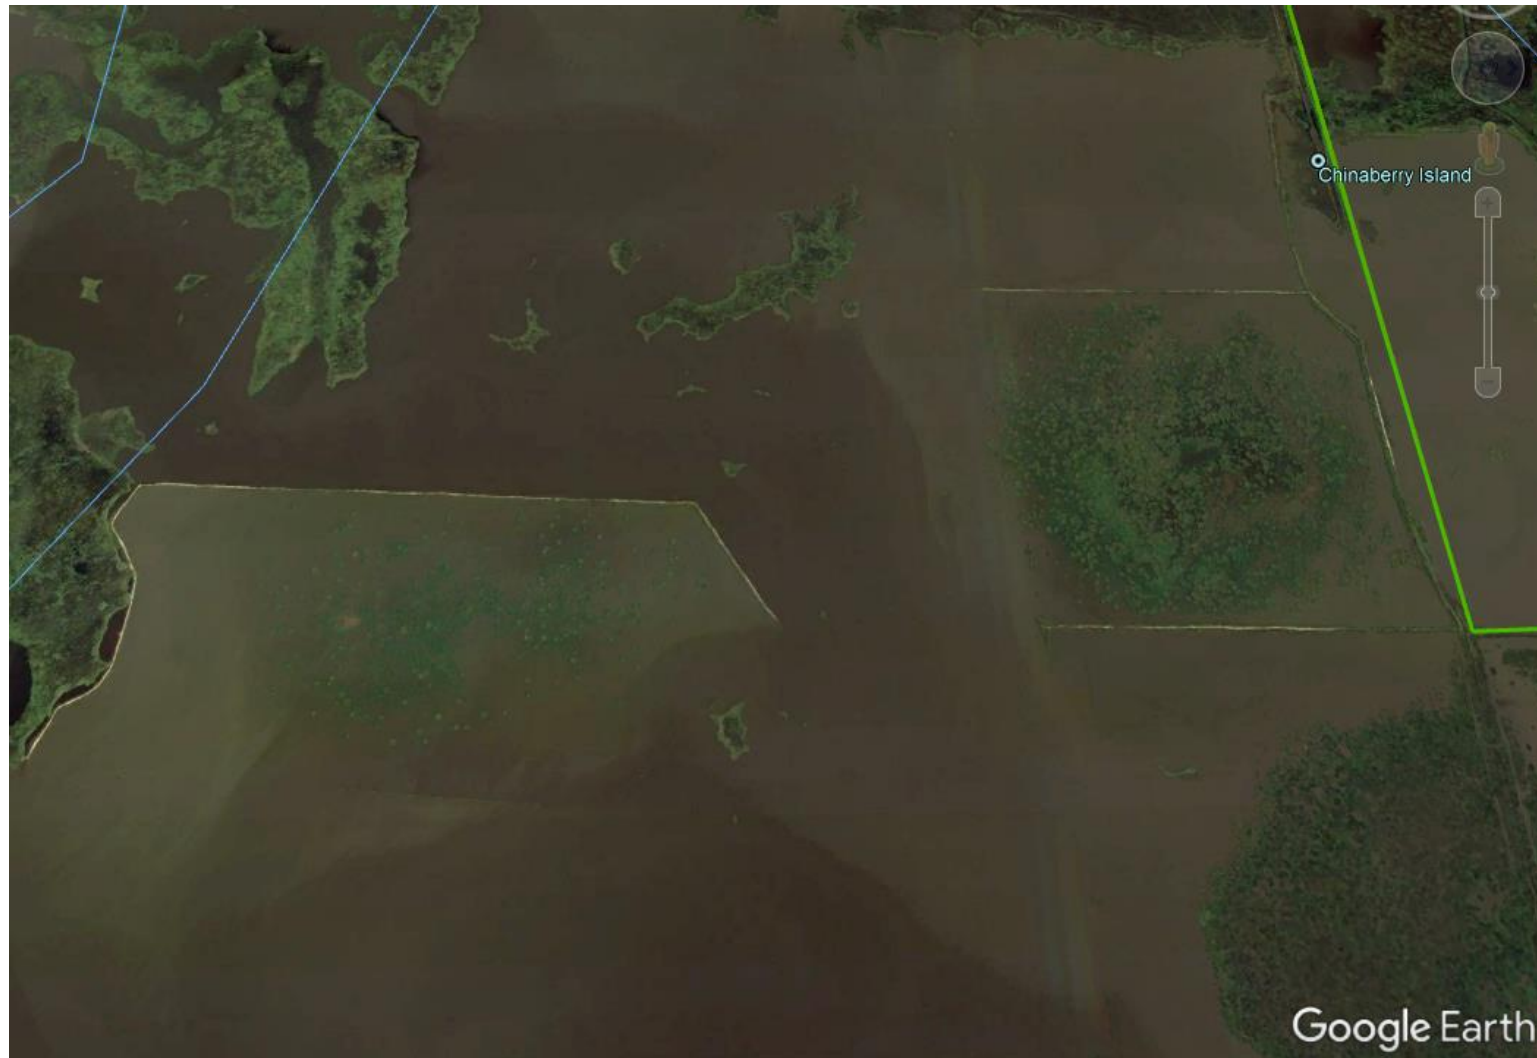
**September 1, 2017 Google Earth Image – High Water Post Hurricane Harvey**
