2014/2015 Annual Inspection Report

SABINE REFUGE MARSH CREATION PROJECT (CS-28-2)

State Project Number CS-28-2
Priority Project List 8

June 8, 2015
Cameron Parish

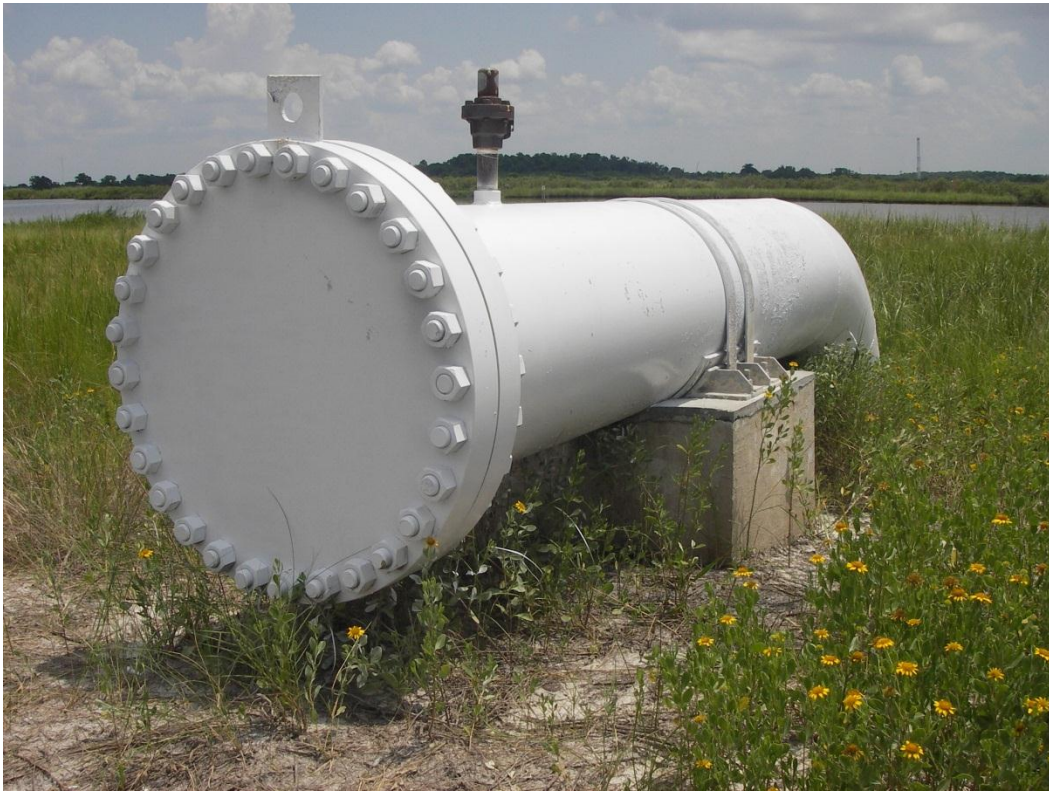
Mike Hooks Dredging recently used the pipeline (winter of 2015) to pump into CS-28 Cycles 4 and 5. There were no issues with the pipeline during this period of usage. The blind flange risers on each end of the pipeline are in good condition and have been recently painted after the pumping of cycles 4 and 5 on the Sabine Refuge. The above ground booster locations (east and west) are in good condition as well and the grass and vegetation are maintained within the fenced areas. The remainder of the pipeline below ground was inspected via airboat/ATV and no visible signs of erosion or leakage were apparent. No need for any maintenance in the foreseeable future. (Photos: Appendix B, Photos 1 - 6)

Photo No. 1, West end blind flange and riser

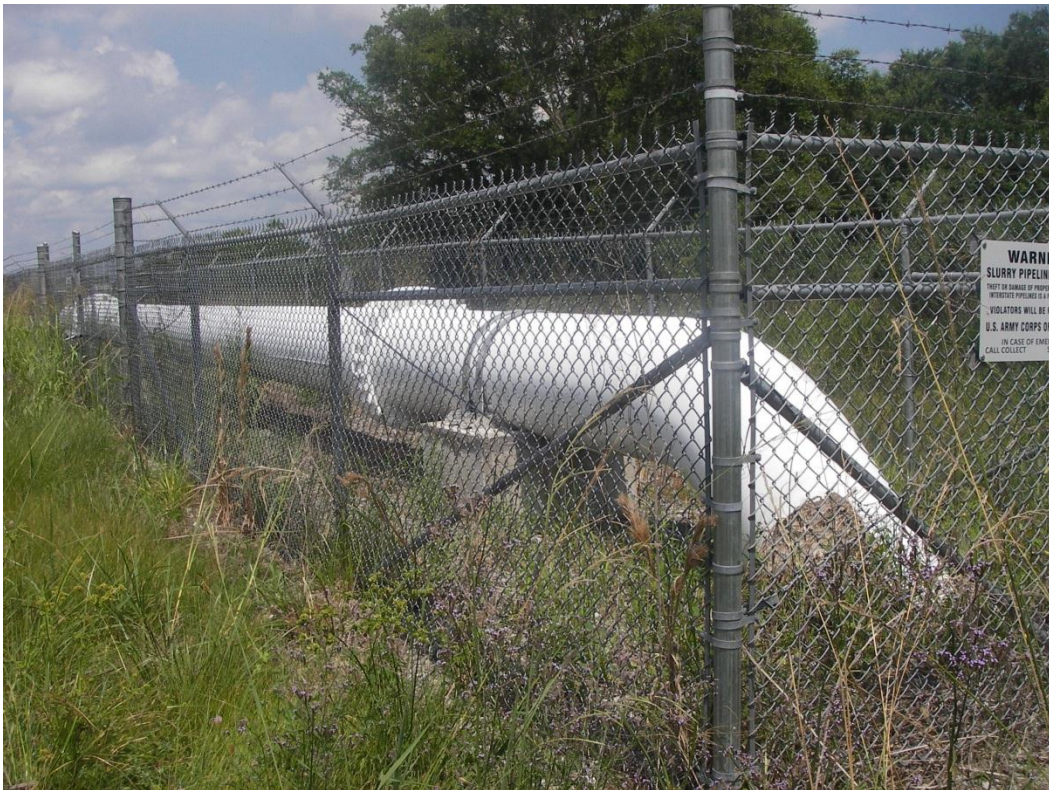
Photo No. 2, West end above ground booster station

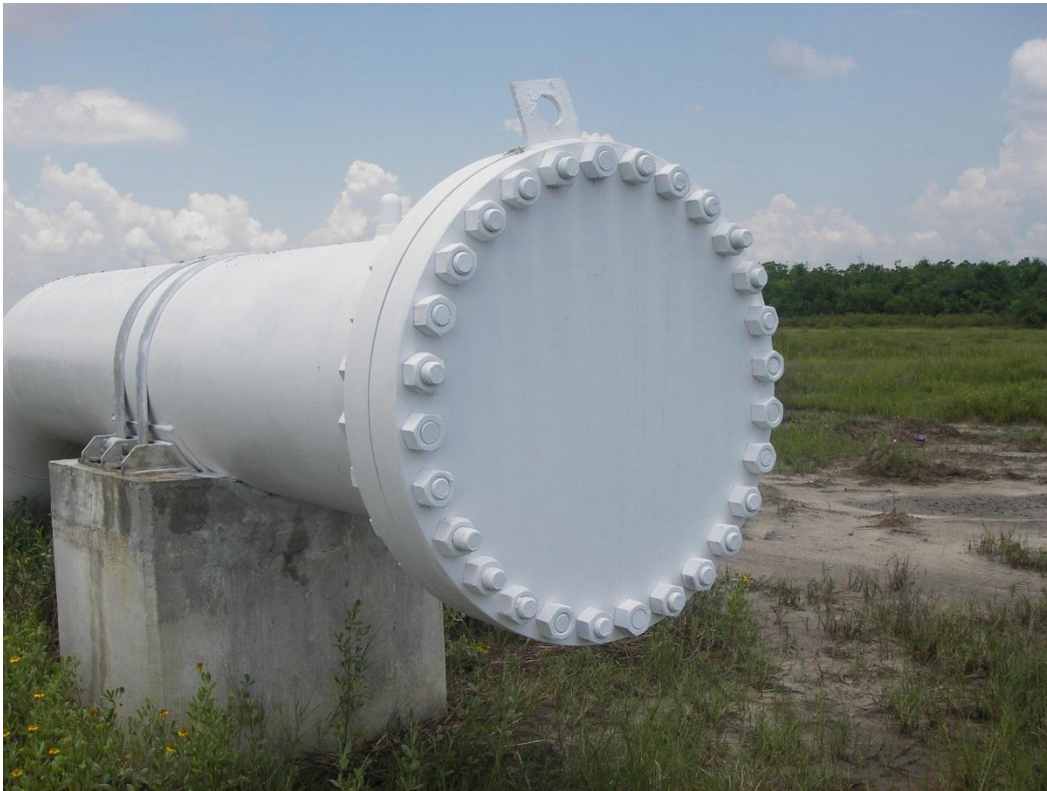
Photo No. 3, East end blind flange and riser

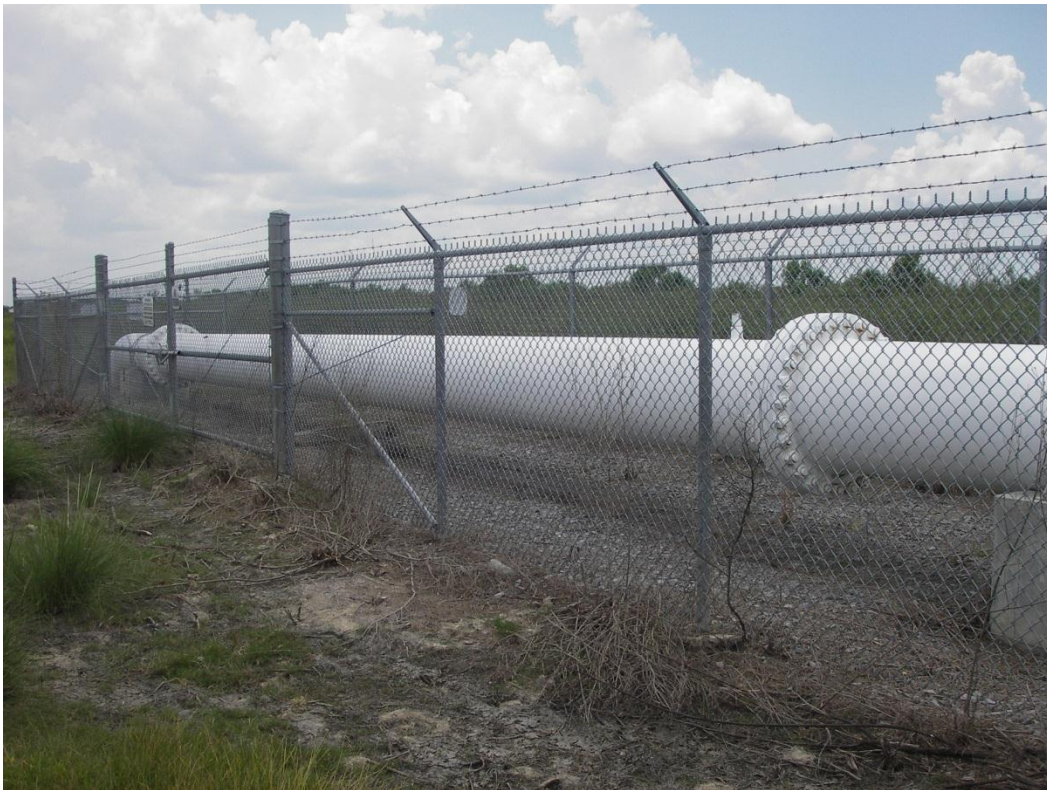
Photo No. 4, East end above ground booster station

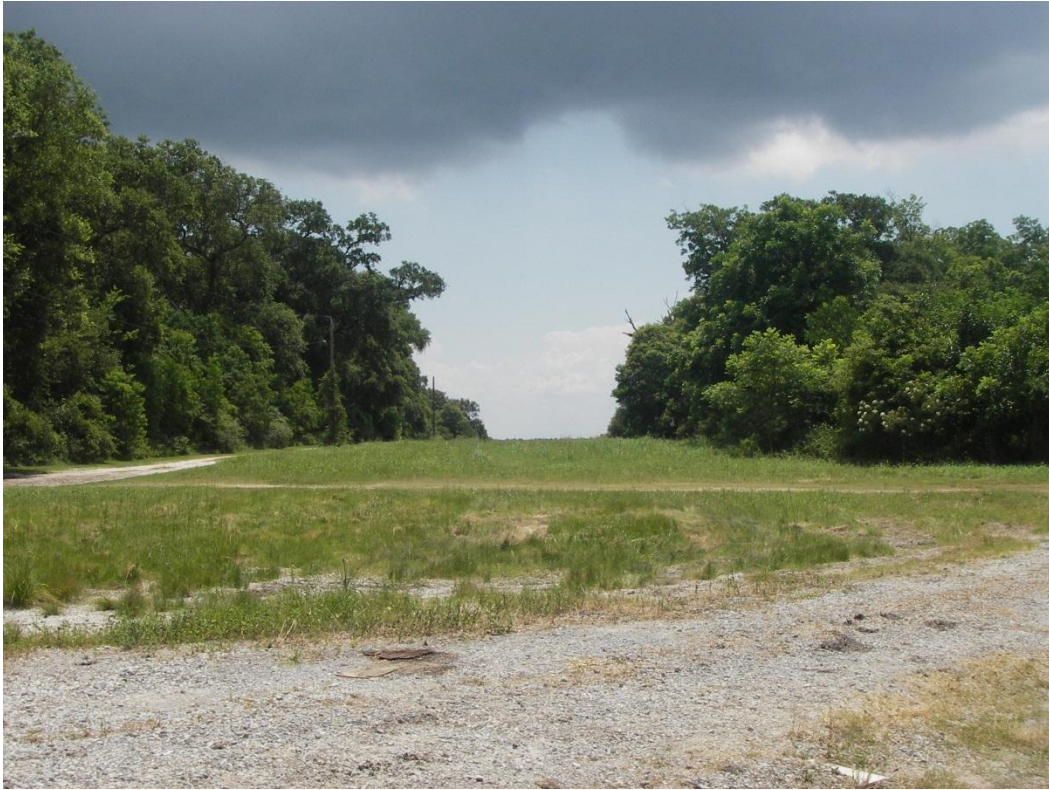
Photo No. 5, View of ROW, west end, looking east

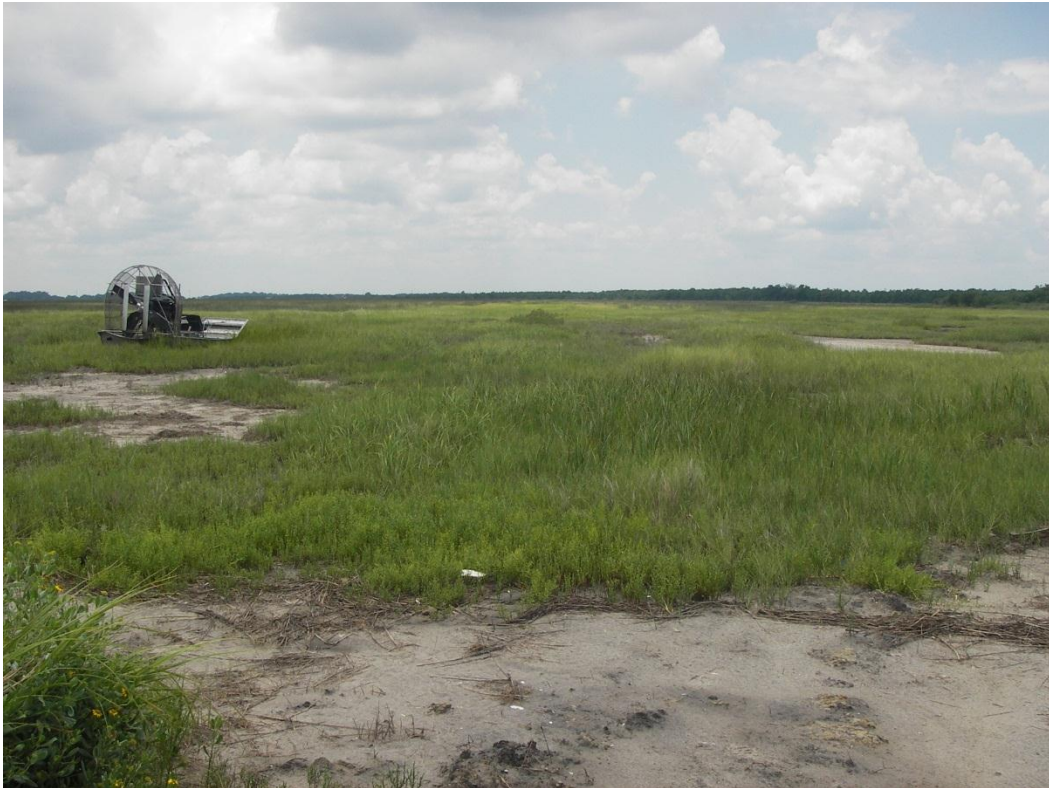
Photo No. 6, View of ROW, east end, looking west
