### 2016/2017 Annual Inspection Report

### BLACK BAYOU CULVERTS HYDROLOGIC RESTORATION PROJECT (CS-29)

State Project Number CS-29  
Priority Project List 9

March 7, 2017  
Calcasieu and Cameron Parishes

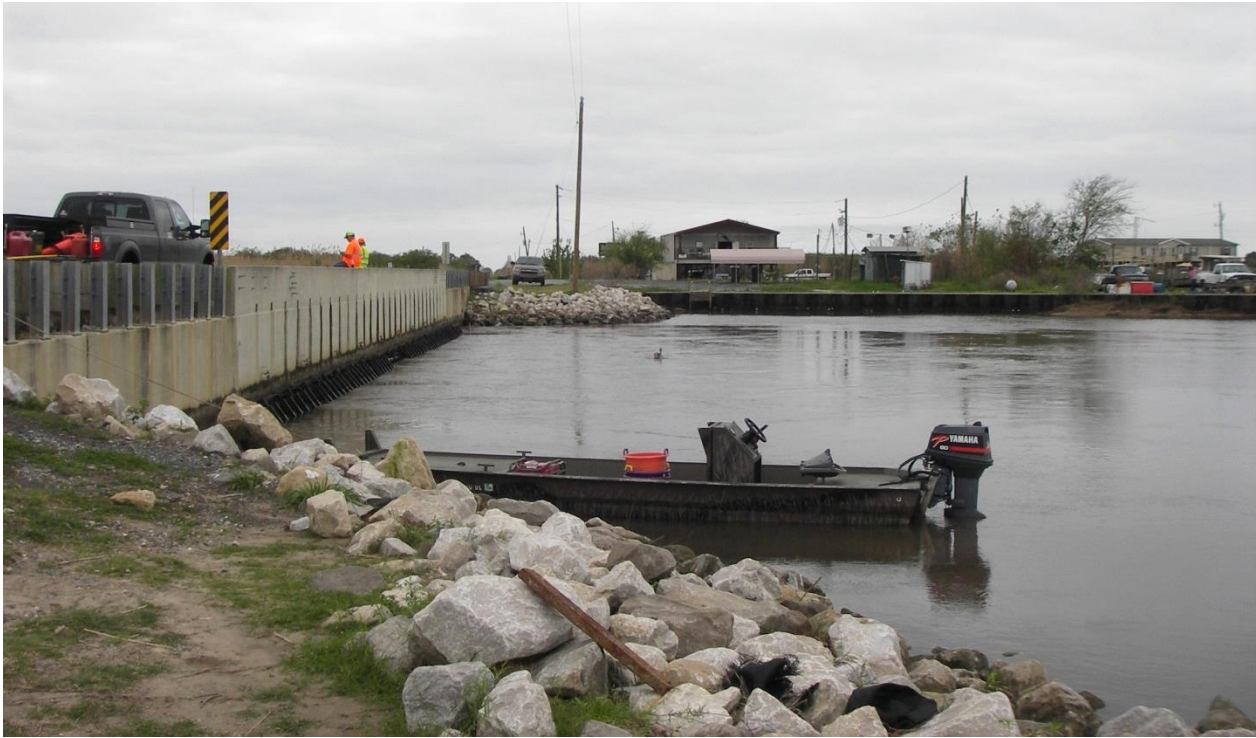
The visible rock rip rap was in good condition. (Photos: Appendix B, Photos 1&2)

**Photo No. 1, West Side of Box Culvert Structure (Looking South) – Low Tide**

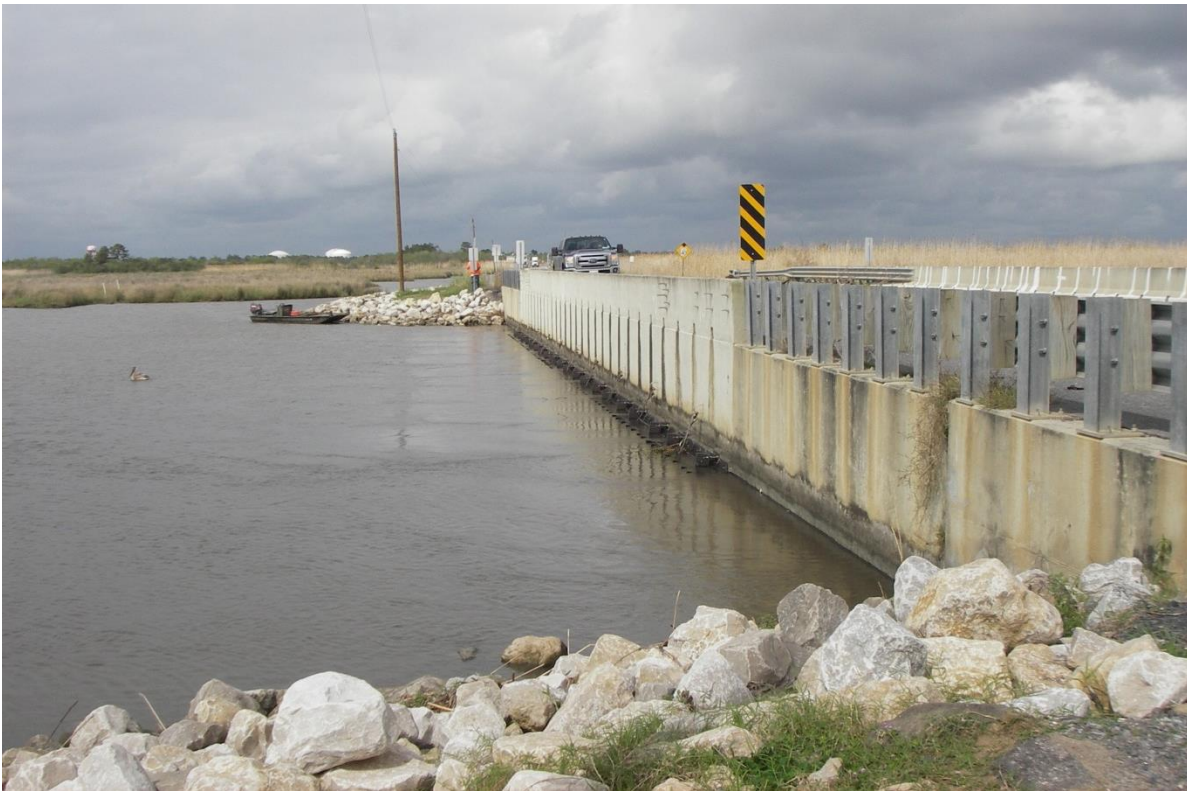
**Photo No. 2, West Side of Box Culvert Structure (Looking North) – High Tide**

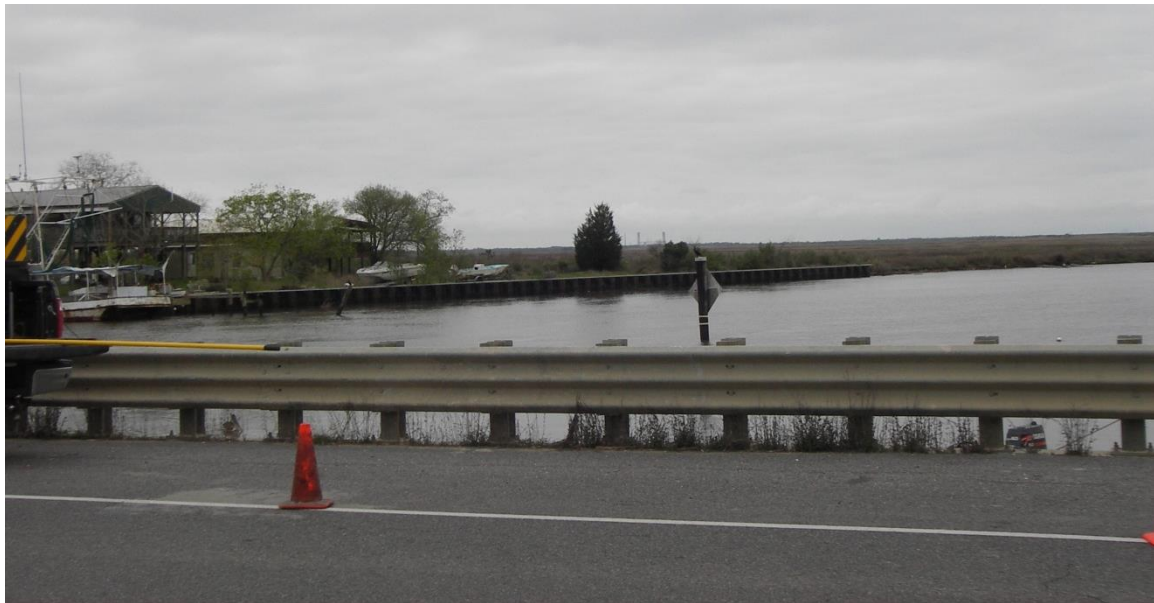
The steel sheet pile bulkhead was in good condition. (Photos: Appendix B, Photos 3&5)

**Photo No.3,** West Side of Box Culvert Structure, Steel Bulkhead & Warning Sign

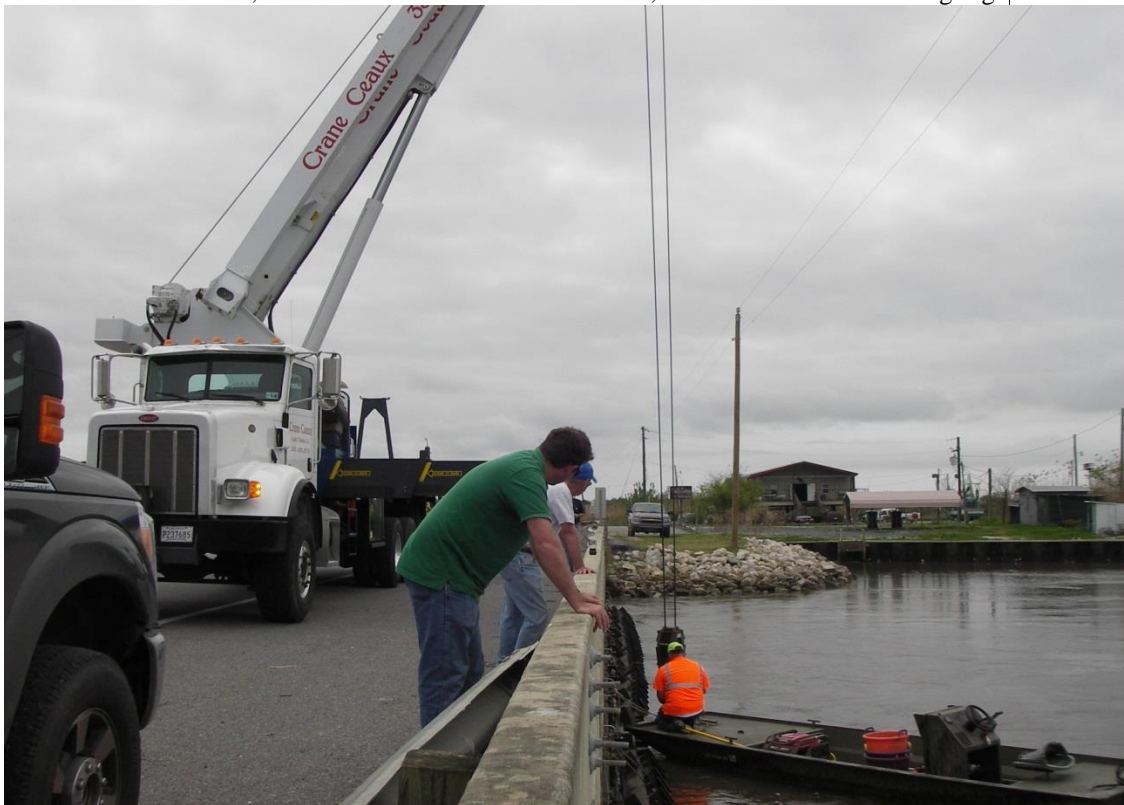
The flapgates were performing as intended with the exception of Gates No. 4 & 5. The operations contractor assisted with an inspection of the two gates. The gates were lifted with a crane truck. A 2"x12"x12' board was removed from the support bracing of Gate No. 5. The board was wedged in the supports and extending out the north side where it was caught between gate no. 4 and the culvert facing. The south center guide ring on gate no. 4 was broken and removed. Both gates opened and closed properly after this operation.

**Photo No.4,** West Side of Box Culvert Structure, Crane Lifting Gate

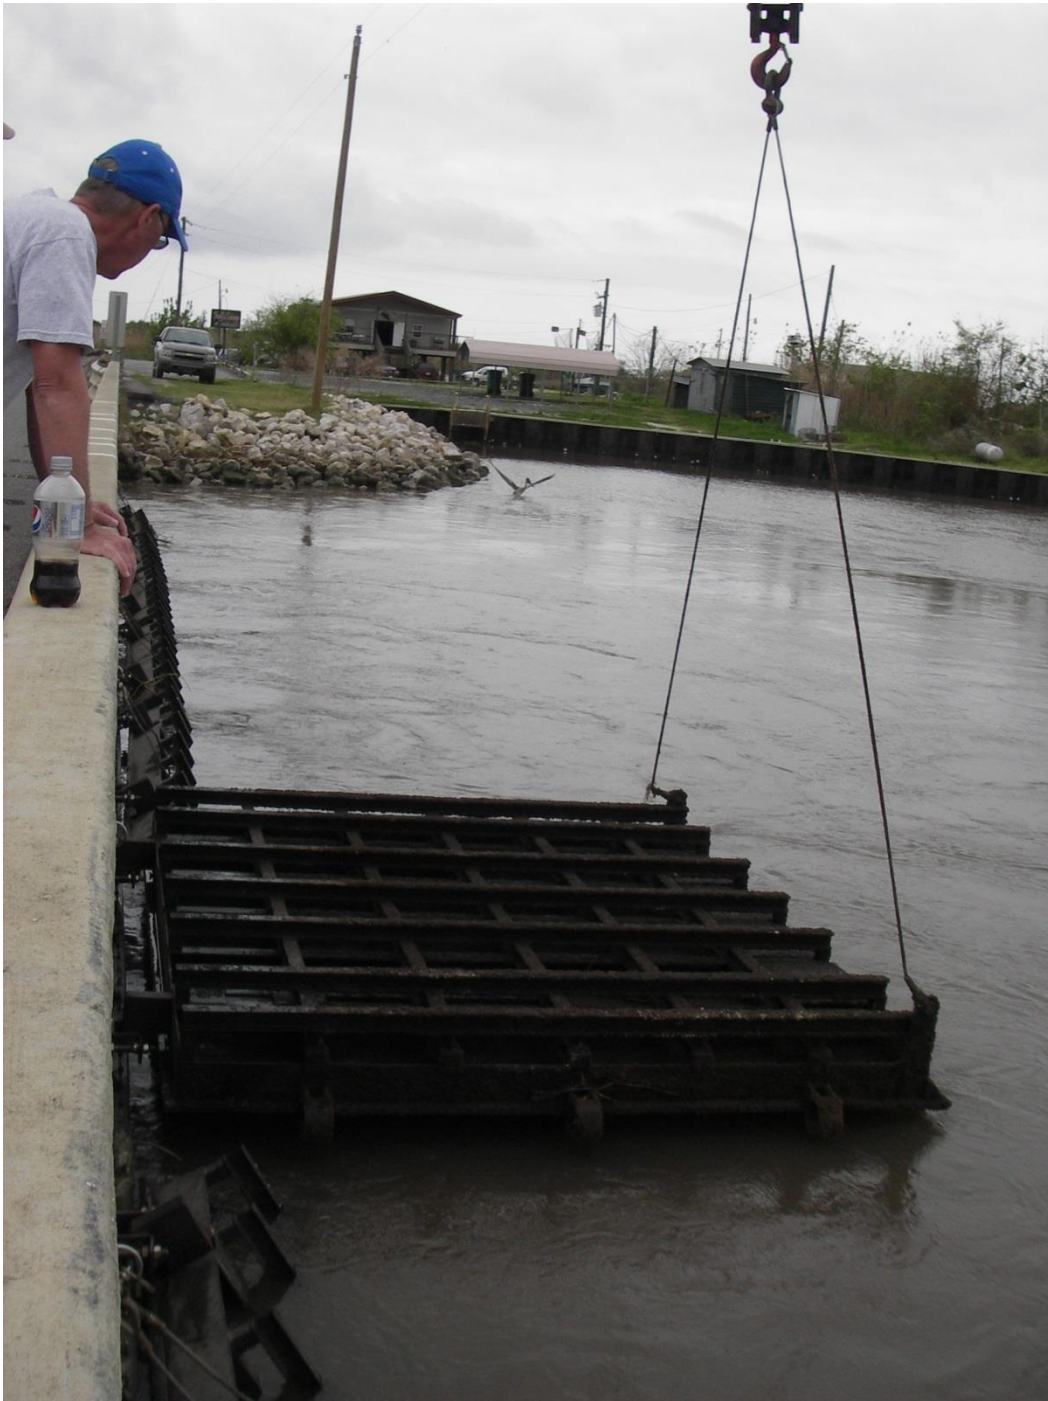
**Photo No. 5,** West Side of Box Culvert Structure, Flap Gate, Rock Armoring, & Steel Bulkhead

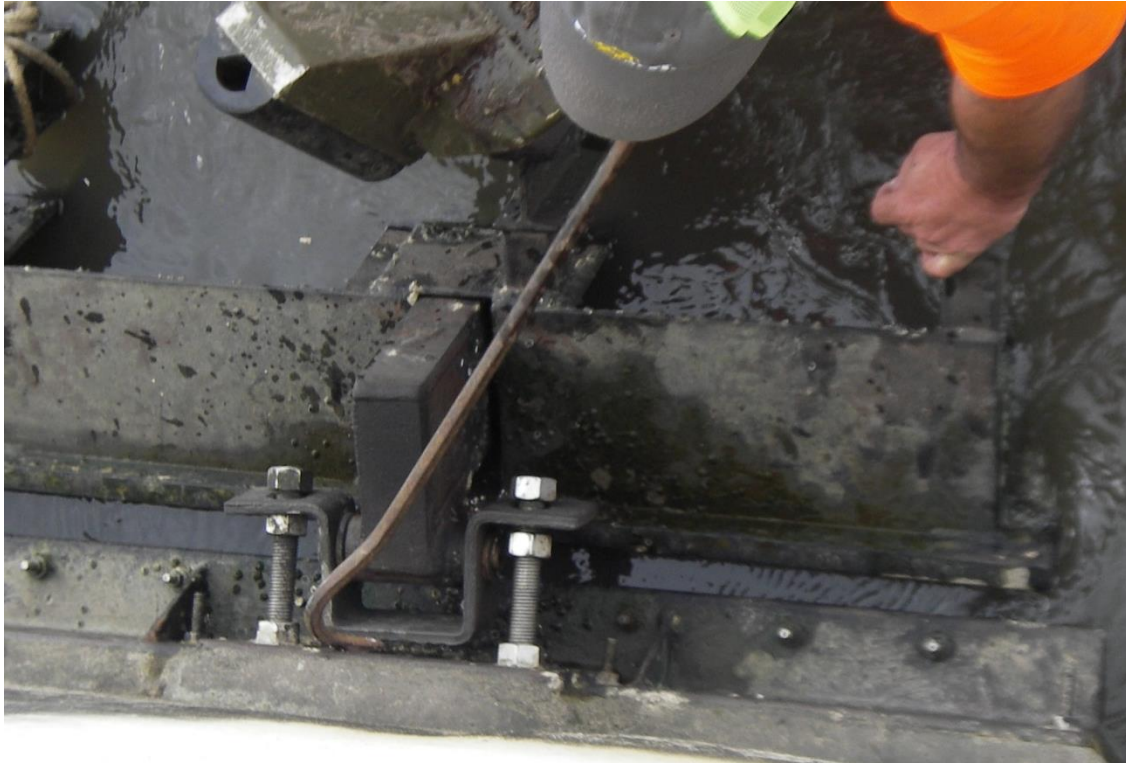
It was noted that the nuts on the flapgate hinge anchor rods were loose and backing off of the threads. Each were inspected and tightened. The nuts will need to be replaced with lock nuts with a Teflon insert.

**Photo No. 6,** Anchor Rods on Flapgates, Nuts Loosening and Backing Off of Anchor Rod

**April 2017 Simon and Delany:** This maintenance event included parts and labor to replace the stainless steel nuts on the flapgate anchor rods with Teflon stop nuts to prevent the nuts from loosening and backing off the anchor rod.

Use locking nuts on gates such as these where the continuous opening and closing of the gate can jar the nuts loose from their anchor rods.

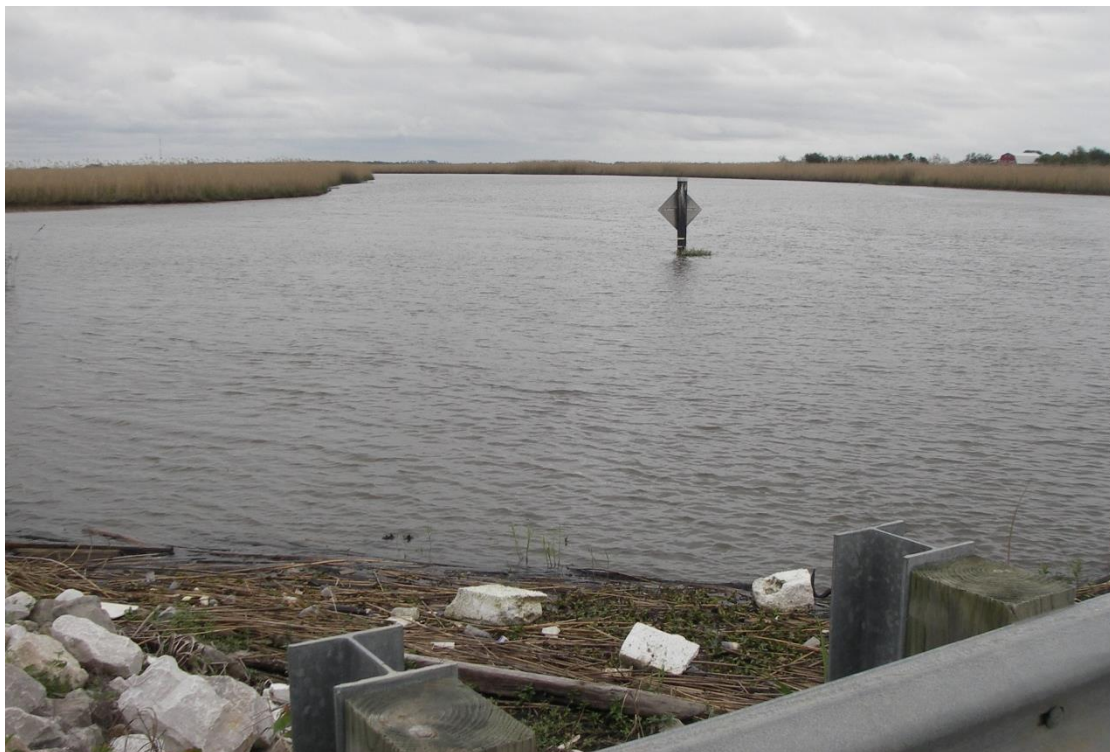
**Photo No.7,** East Side of Box Culvert Structure, Warning Sign

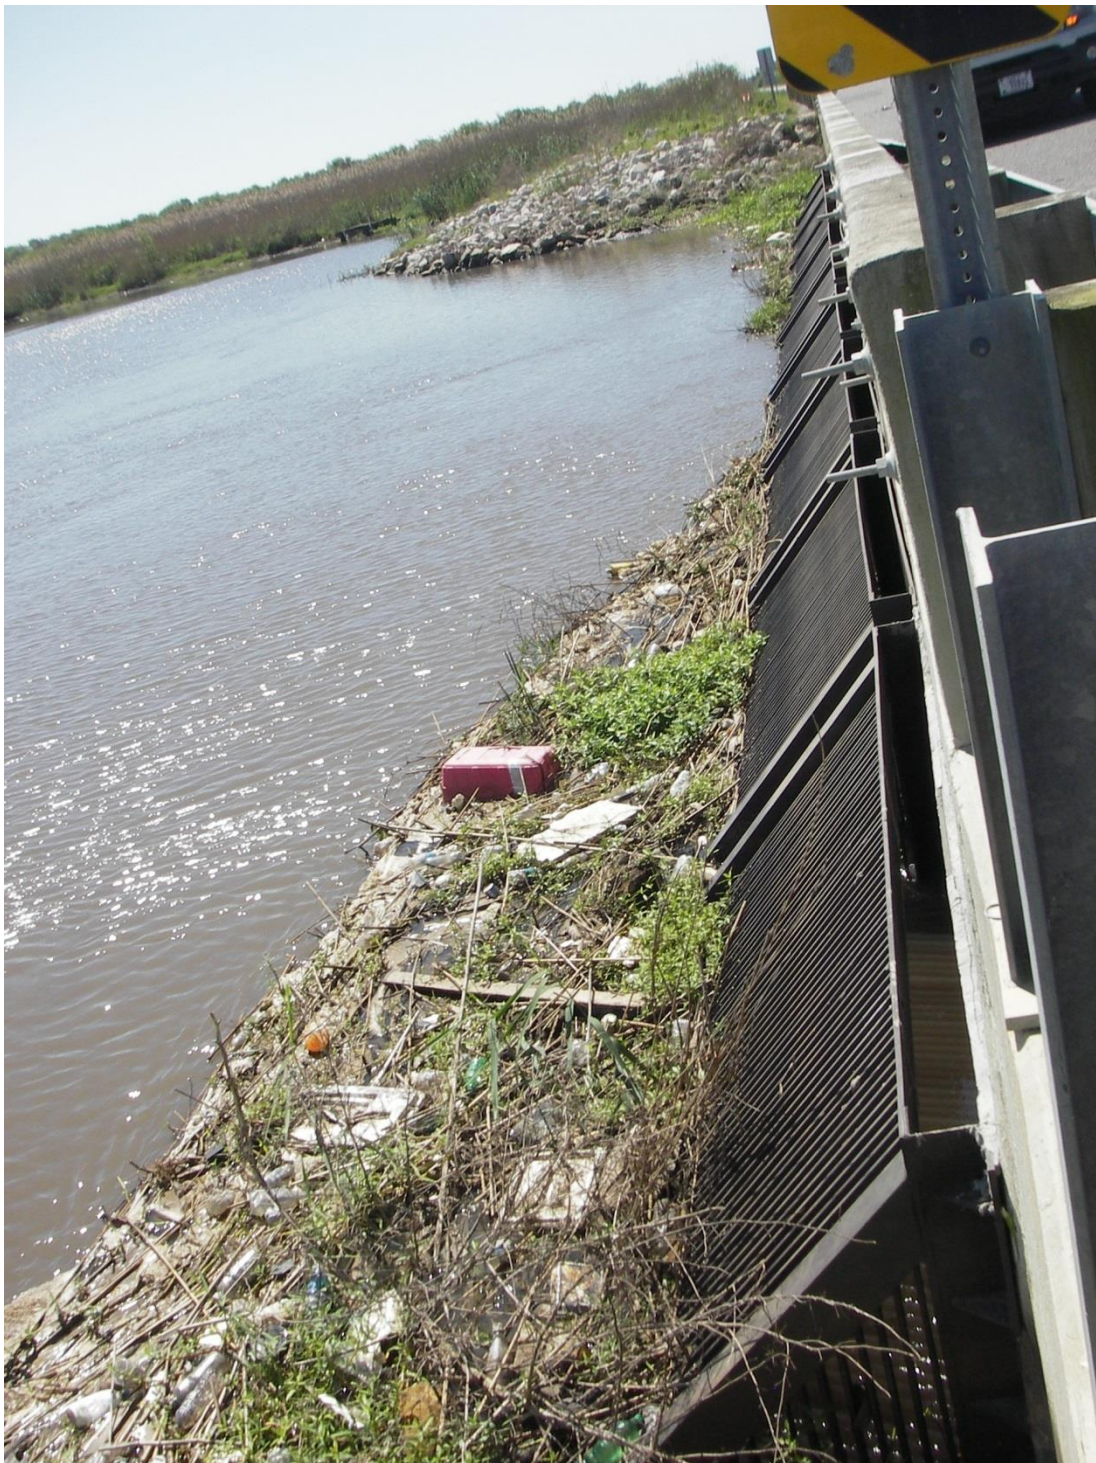
The trash screens on the east side of the structure were working as intended. There was floating vegetation and debris collecting at the trash screens.

Floating debris may prove to be a maintenance issue during wet years.

**Photo No. 8,** East Side of Box Culvert Structure (Looking South), Floating Debris
