2014/2015 Annual Inspection Report

HOLLY BEACH SAND MANAGEMENT PROJECT (CS-31)

State Project Number CS-31 Priority Project List 11

November 12, 2014 Cameron Parish

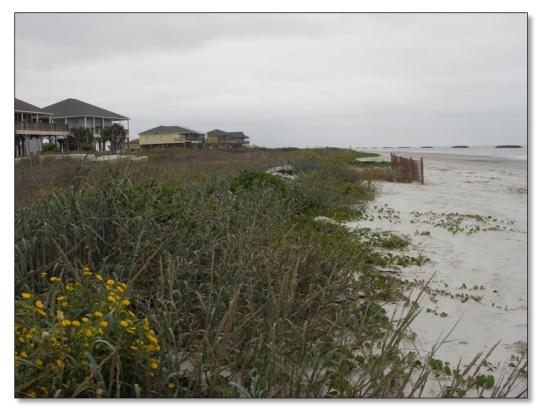
Photo No. 1, Typical sand fence section on westernmost end of project

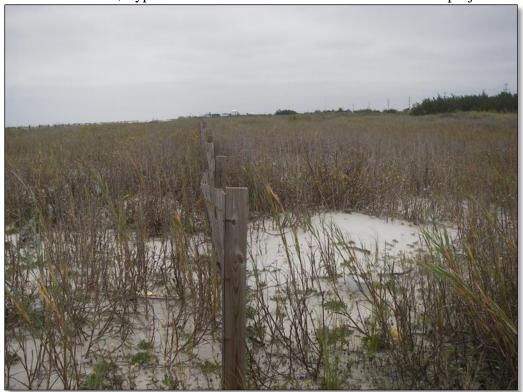
Photo No. 2, Double fence section with plantings thriving

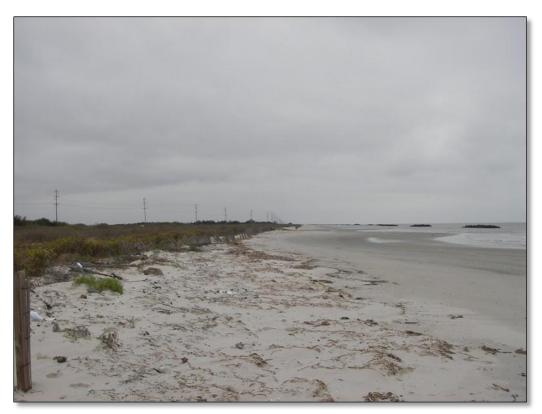
The sand fence has suffered extensive damage due to tidal action. There were many sections of considerable length where the fence fabric was completely removed from the posts. We did not generally see many broken sections of fence material lying on the beach. There are many bare posts remaining.

Photo No. 3, Long section of damaged fence

Overall, the Holly Beach Sand Management Project is in fair condition and functioning as designed with problems as noted above. Beach nourishment should be considered in the near future as wind and wave action are scouring the beach and encroaching on LA Highway 82. We will monitor the project and may task a contractor to remove some of the damaged fencing and posts. Making repairs to damaged fence sections would most likely not be a wise decision at this time.

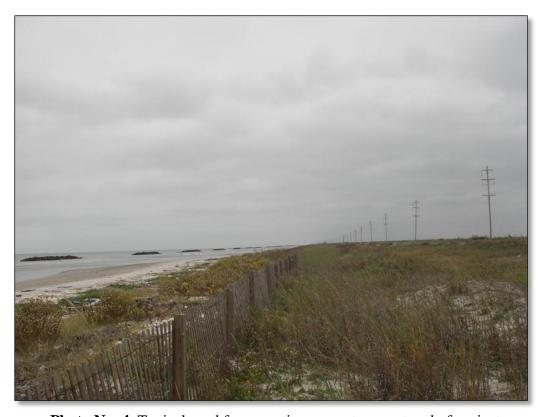
Photo No. 4, Typical sand fence section on easternmost end of project
