**Coastal Protection and Restoration
Authority of Louisiana (CPRA)**

2016/2017 Annual Inspection Report

EAST SABINE LAKE HYDROLOGIC RESTORATION PROJECT (CS-32)

State Project Number CS-32
Priority Project List 10

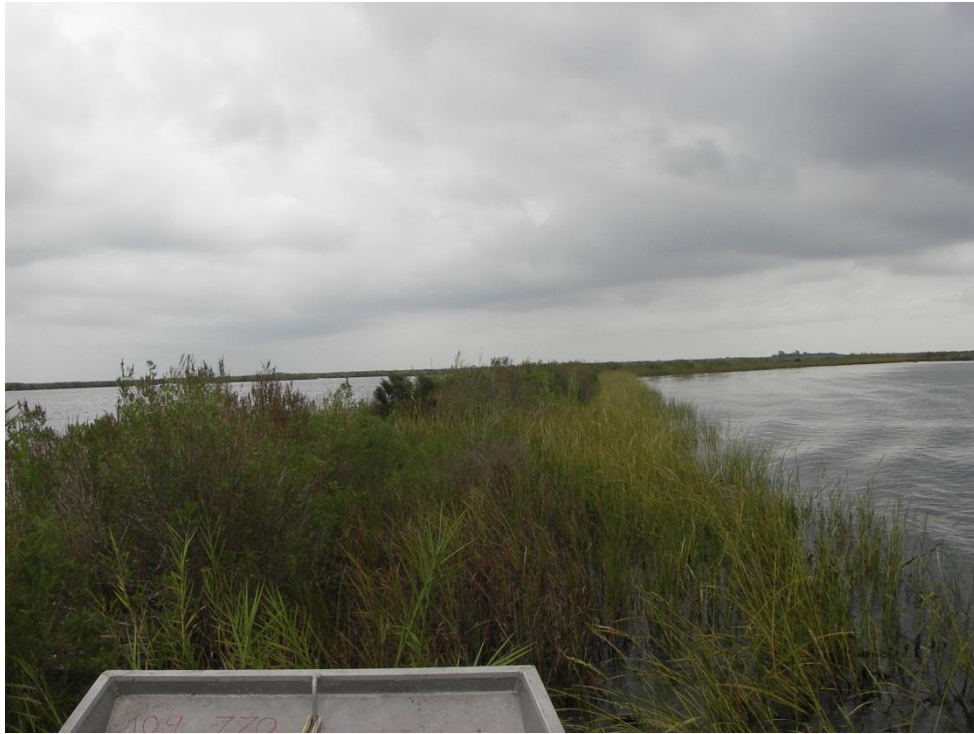
The inspection began on the north end of the terrace field and proceeded south. Each air boat took a row of terraces meeting up along the way to discuss what was seen. The northern section of terraces (CU1) had a variety of vegetation, i.e. smooth cordgrass, roseau cane, baccharis, iva, and a few cattails. The terraces narrowed heading south (CU1A), but there was still good cordgrass spread beyond the terrace width. There were skips in vegetation coverage noted, averaging 5%-7% bare areas. (See Appendix B, Photos 1-5)

Photo No.1 –Northern Section of Terraces – Variety of Vegetation (2014)

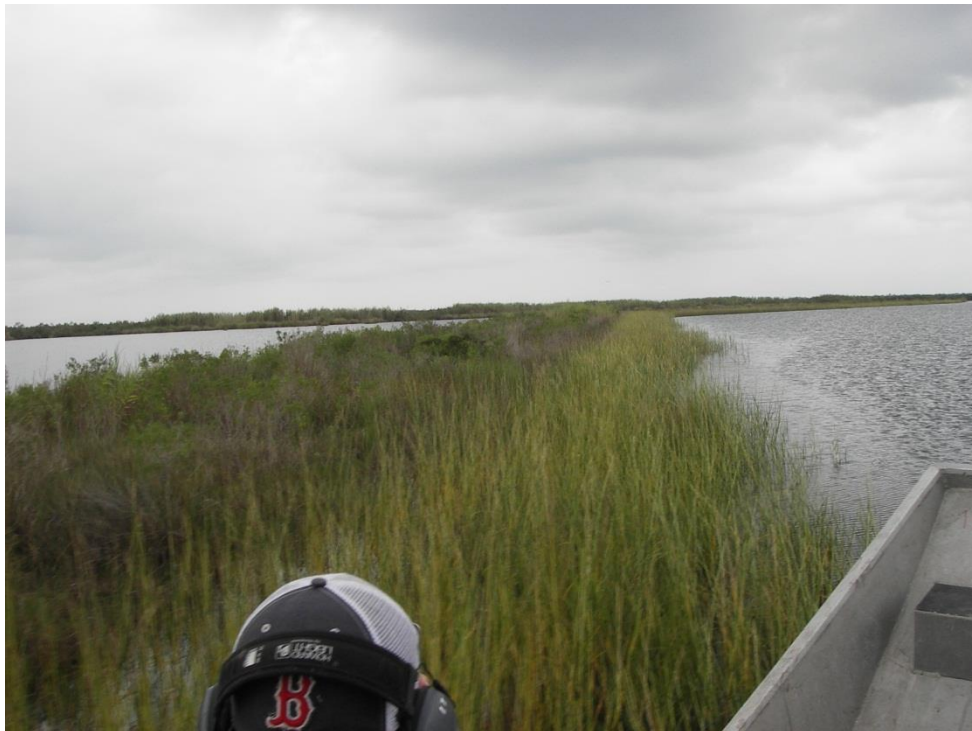
Photo No. 2 –Northern Section of Terraces – Expansion (2014)

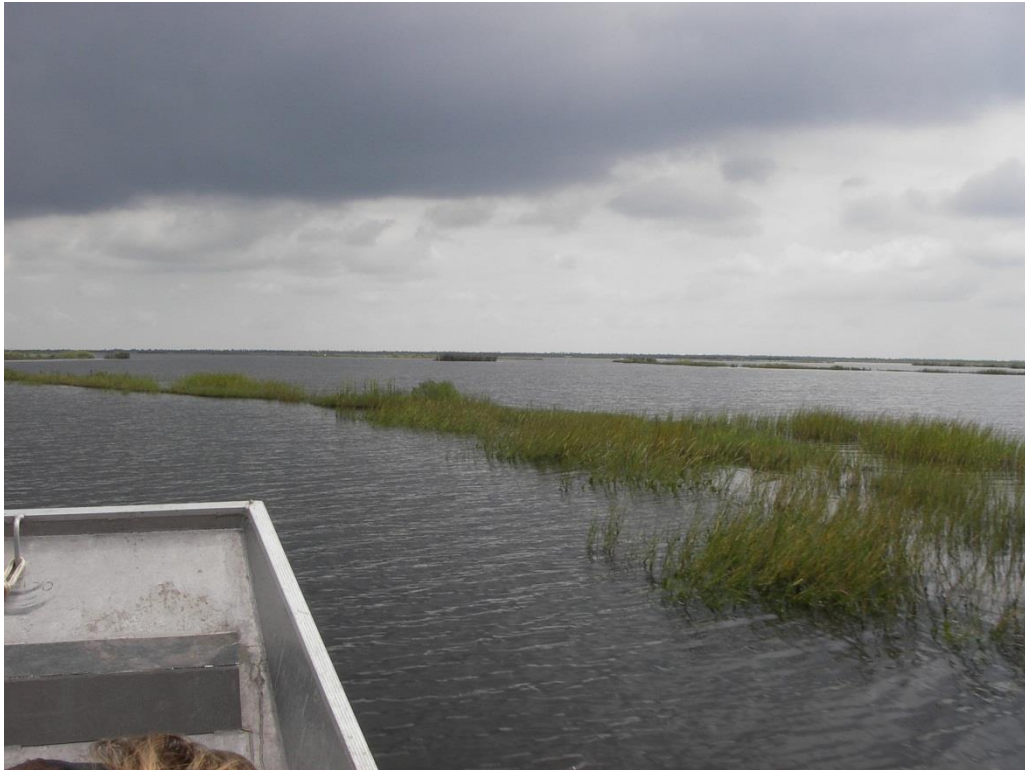
Photo No. 3 – Some Narrowing of Terraces Going South (2014)

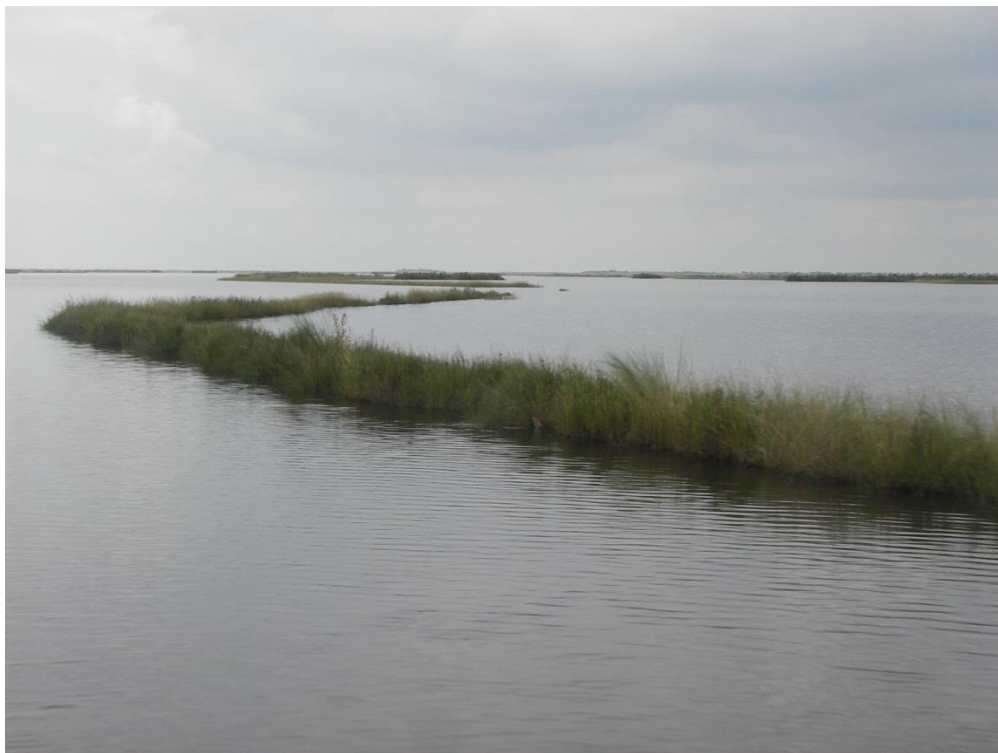
Photo No. 4 – Southern Terraces (2014)

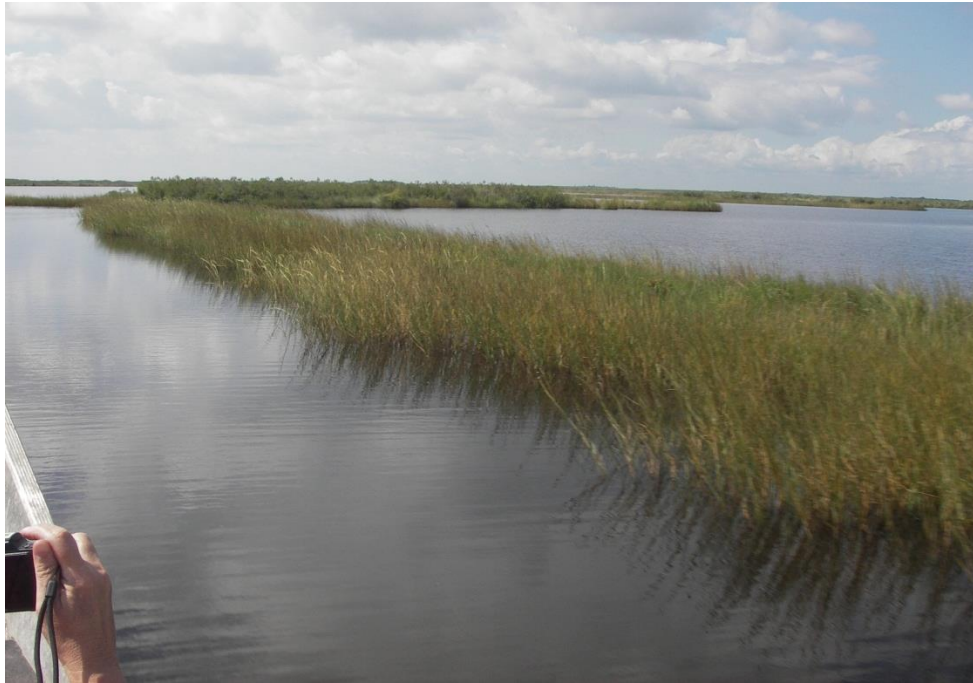
Photo No. 5 – Southern Terraces

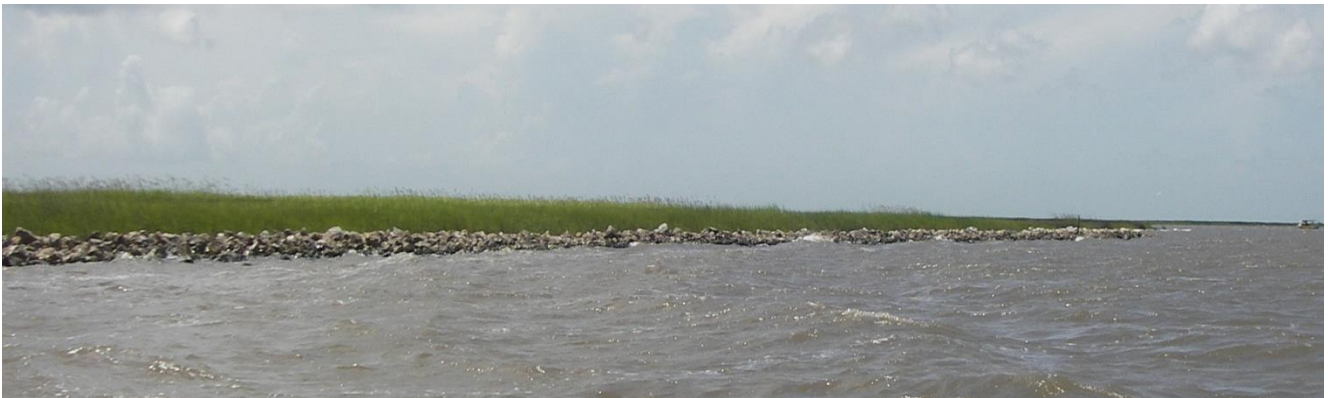
The water level was approximately a foot higher than normal. Although there were low areas of the rock dike noted between the south warning sign up to just south of the bend in Willow Bayou, the foreshore rock dike was in good condition and performing as intended. The higher water level contributed to the low appearance of the rock dike and there were no signs of damage to the original marsh behind the rock dike. This area will continue to be monitored.

Photo No. 6 – South End of Sabine Lake Foreshore Rock Dike

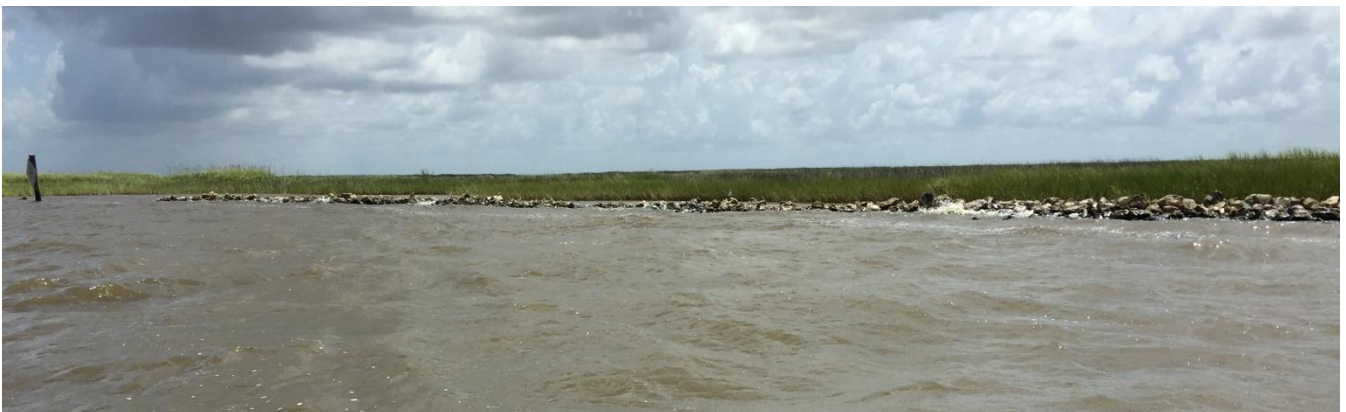
Photo No. 7 – Sabine Lake Foreshore Rock Dike, South of Southern Warning Sign

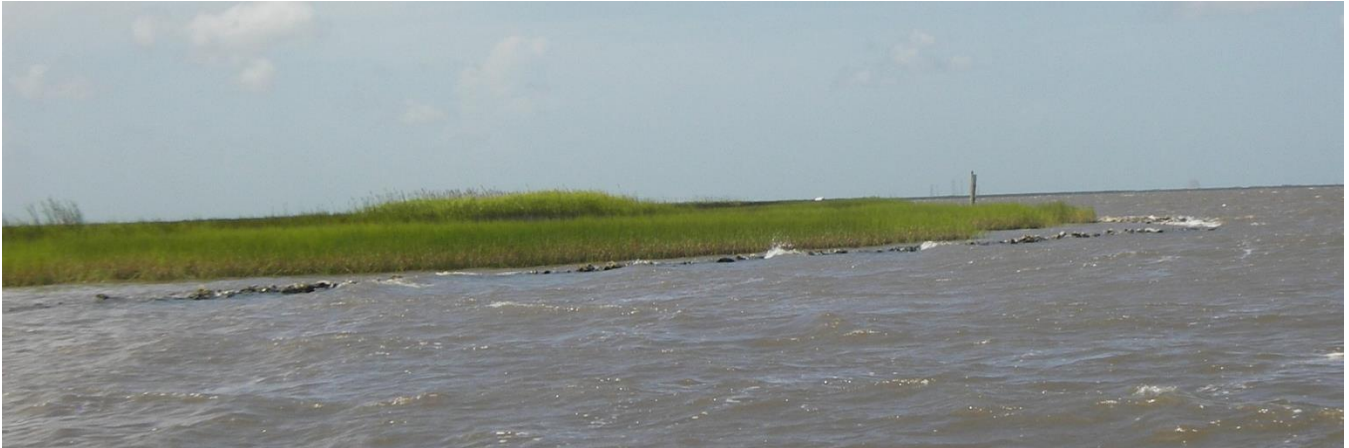
Photo No. 8– Sabine Lake Foreshore Rock Dike, Low area of Rock

Overall, the project is in good condition. The vegetation has filled in very well behind the foreshore rock dike. Although there appears to be low areas of foreshore rock dike at the southern end, the dike is still providing protection to the east shoreline of Sabine Lake. The lower segments of rock will be monitored for a potential maintenance event in the future.

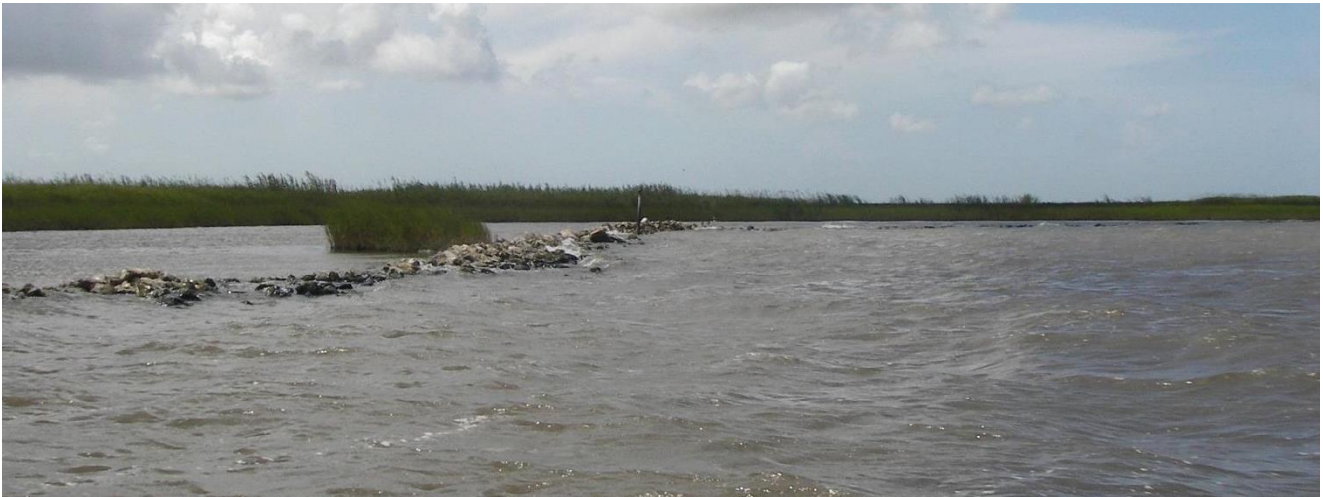
Photo No. 9– Sabine Lake Foreshore Rock Dike, Low area of Rock

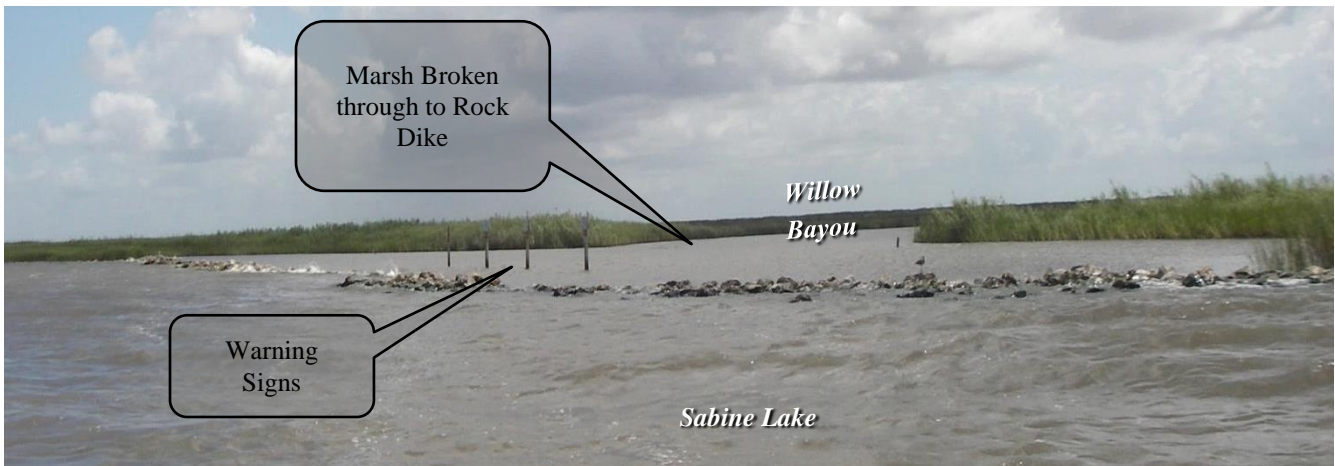
Smooth cordgrass has filled in nicely behind several segments of the rock dike. Willow Bayou however has broken through the marsh to the rock dike. At high water levels a section of rock dike in this area is submerged and can be mistaken by boaters as a route out of the Willow Bayou. Four signs were installed in August 2015 to mark the submerged rock. The existing warning signs along the rock dike were in place and intact. (See Appendix B, Photos No. 6-13)

Photo No. 10– Sabine Lake Foreshore Rock Dike,
Low area at Willow Bayou bend (looking northeast) - Warning Signs

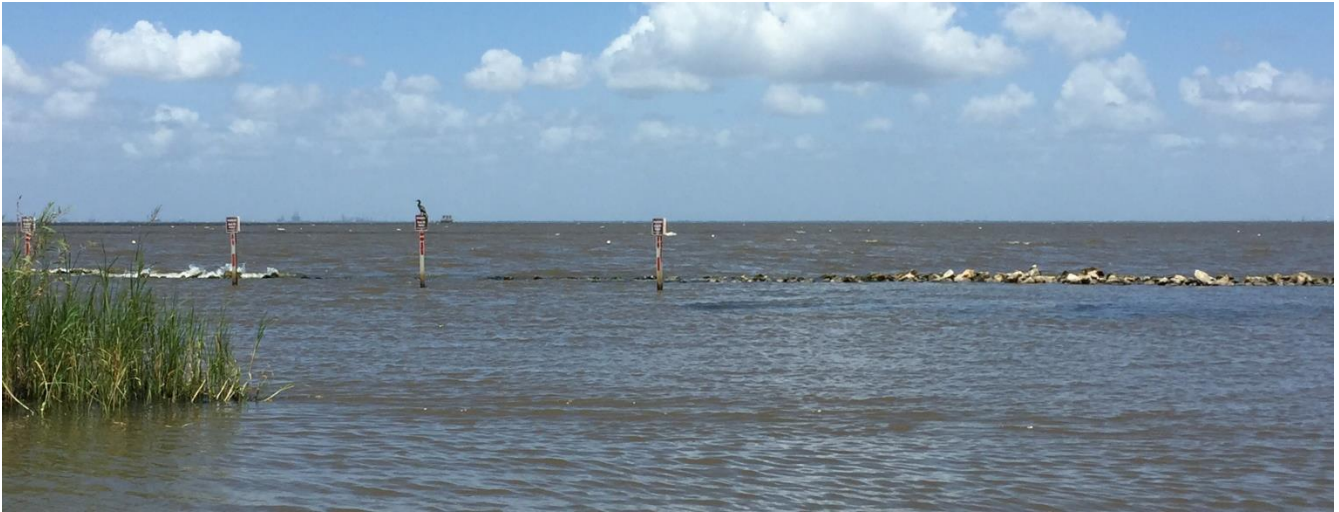
Photo No. 11– Sabine Lake Foreshore Rock Dike,
Low area at Willow Bayou bend (Same Location as Photo 10, looking west) - Warning Signs

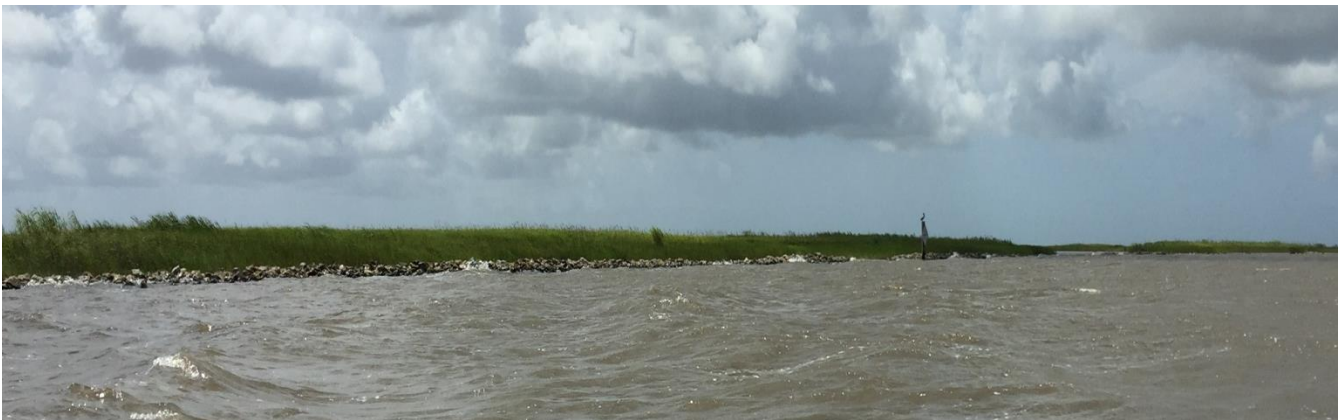
Photo No. 12– Sabine Lake Foreshore Rock Dike, near North Warning Sign

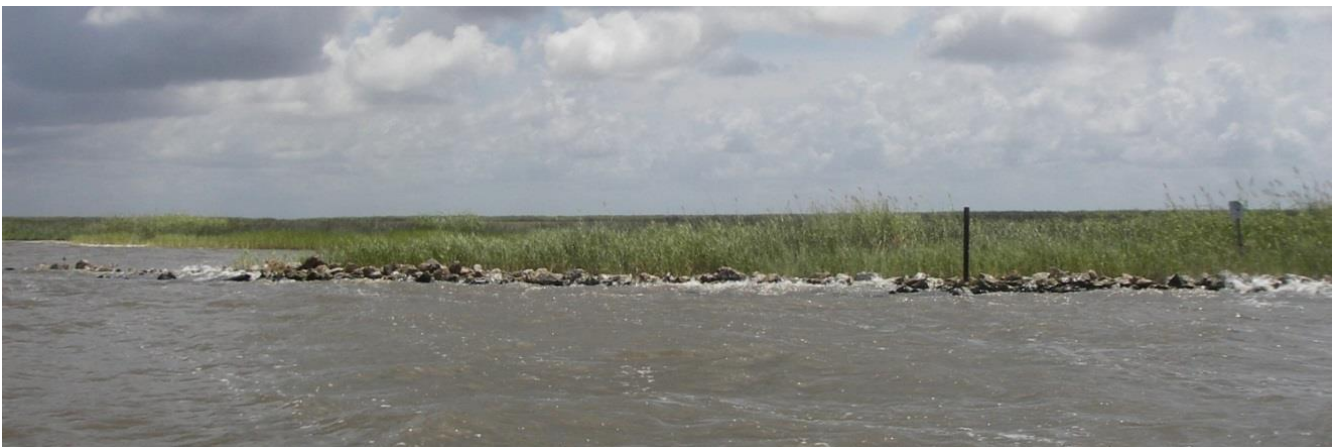
Photo No. 13– Sabine Lake Foreshore Rock Dike, North End

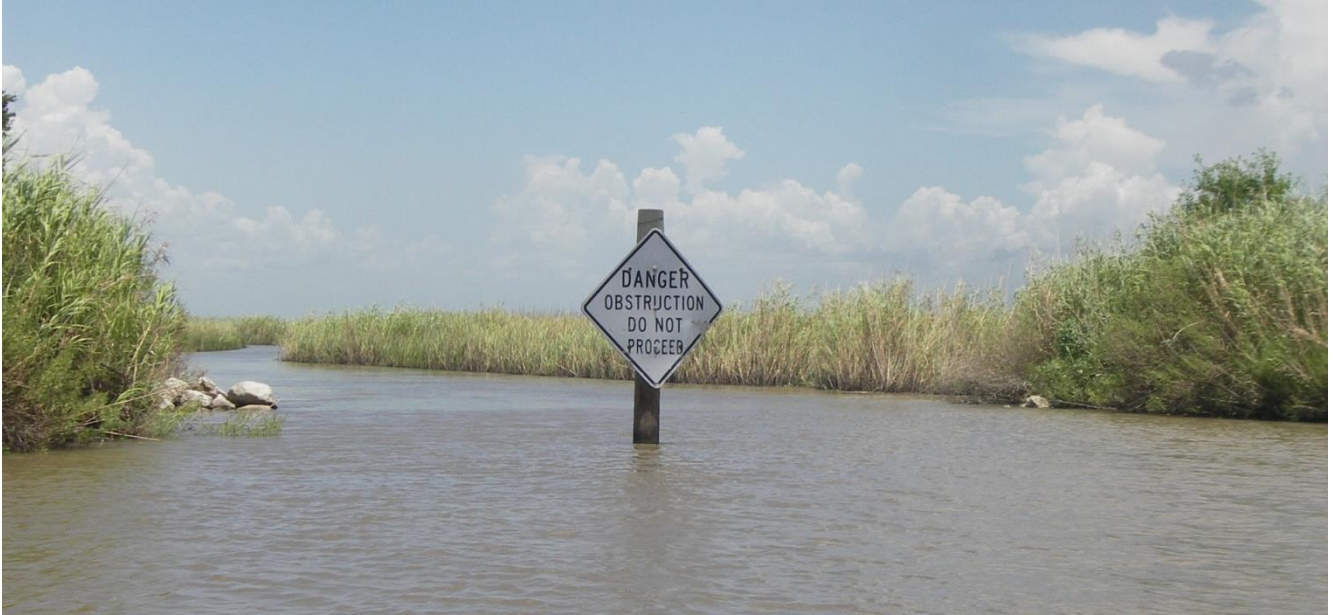
The Pines Ridge Weir is still functioning as intended. The water level on the staff gauge adjacent to the outside of the weir was at 2ft. 1.5 in. Normal water levels average 1.2ft. Due to the higher than normal water levels, there was little rock visible above the water. Probing the area revealed rock approximately 3.5 ft. below the water at center and the weir appeared to be intact. The warning sign was struck by something but was still intact. (See Appendix B, Photos No. 14)

Photo No. 14– Pines Ridge Weir, from Project Exterior

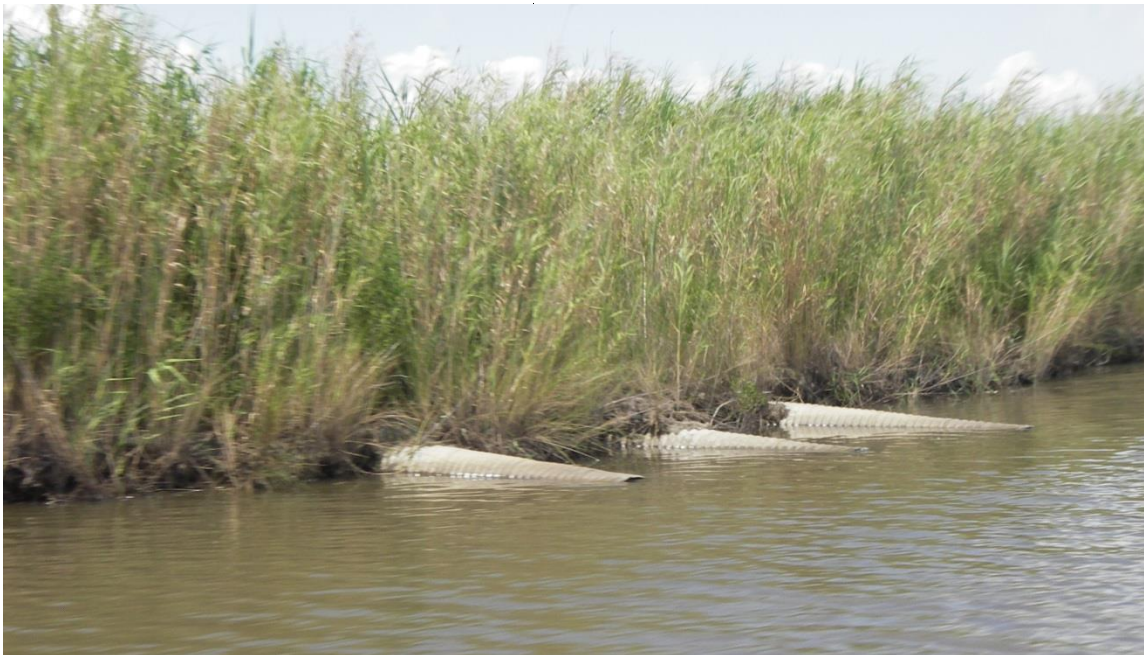
The culverts were intact and appeared to be functioning.

Photo No. 15– Bridge Bayou Culverts in Grey's Ditch

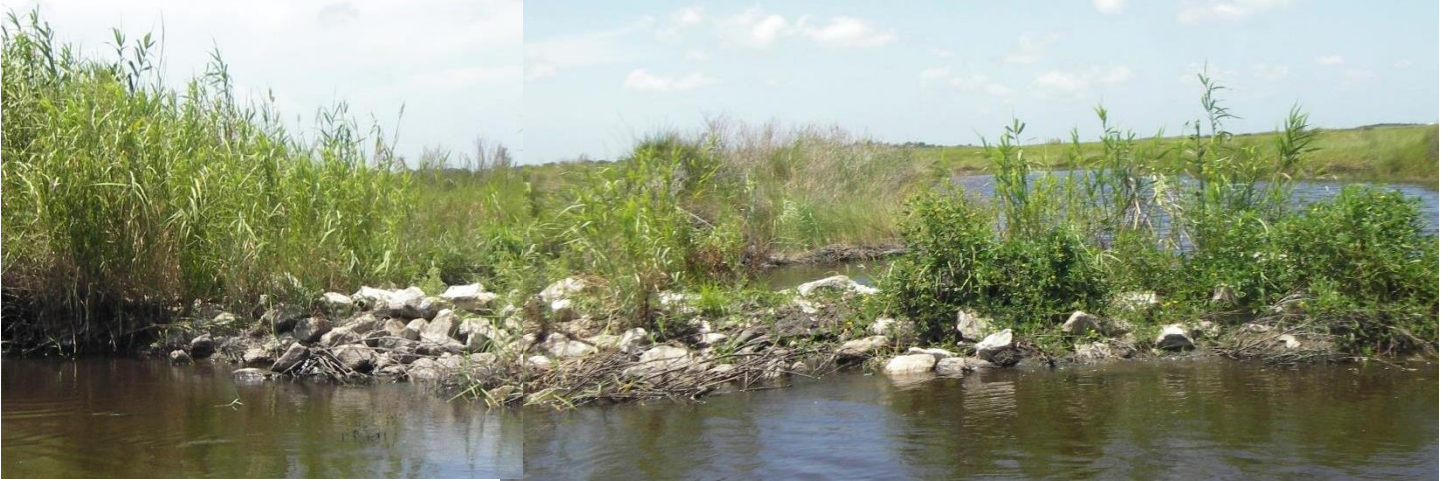
The Cameron Parish Gravity Drainage District No. 7 replaced the rock plug located on the Southline Canal that they had previously removed to facilitate drainage after Hurricane Ike.

The Double Island Gully Plug is again functioning as a plug as originally intended.

Photo No. 16– Double Island Gully Plug
