**State of Louisiana
Coastal Protection and Restoration Authority**

2015 Operations, Maintenance, and Monitoring Report

East Sabine Lake Hydrologic Restoration (CS-32)

State Project Number CS-32
Priority Project List 10

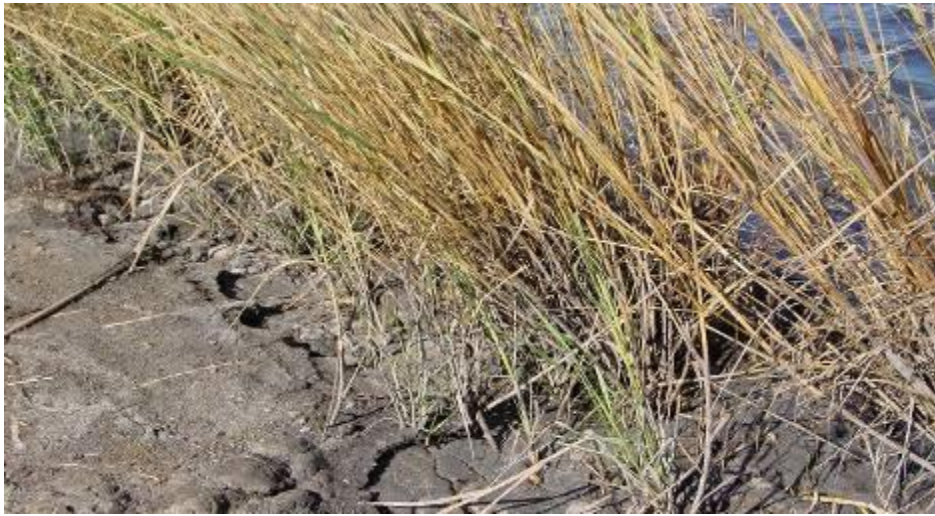
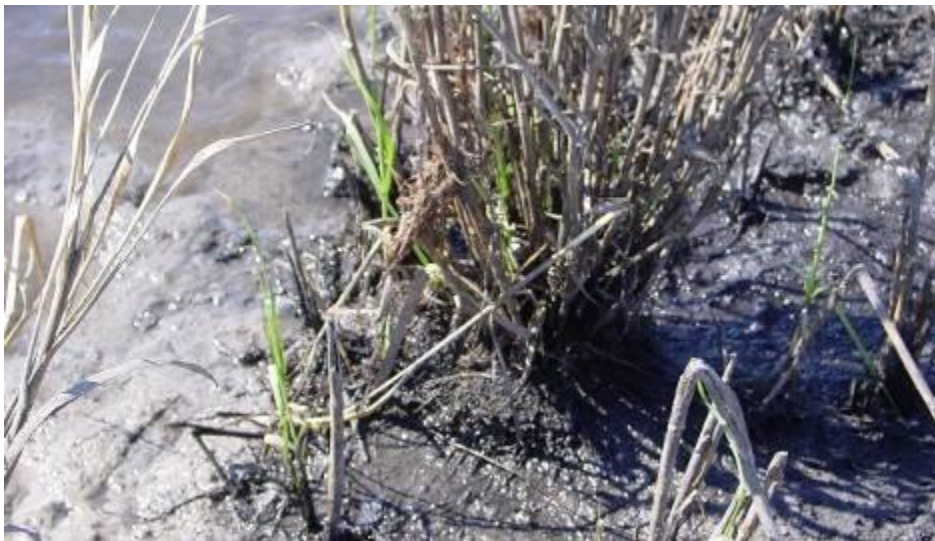
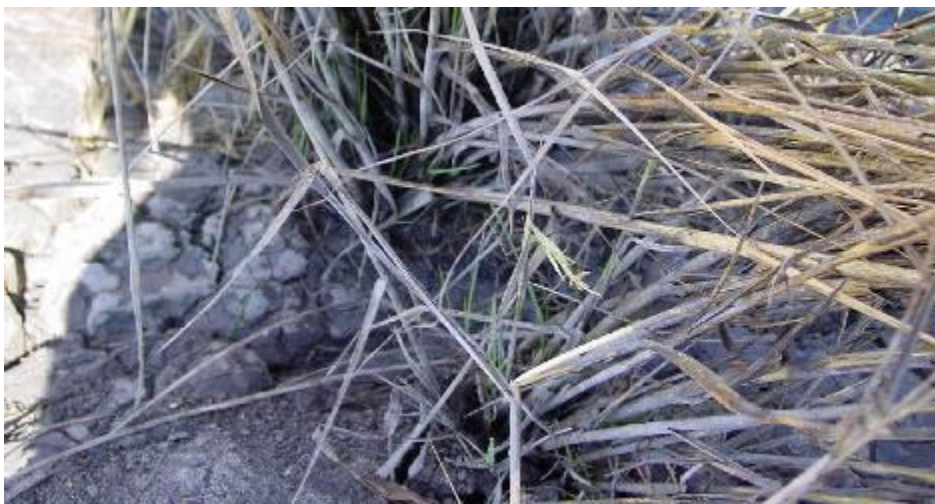
On the southern terraces, a few very young green stems were found emerging from the roots or stem tips of the plants, with the oldest transplants showing the most new growth.

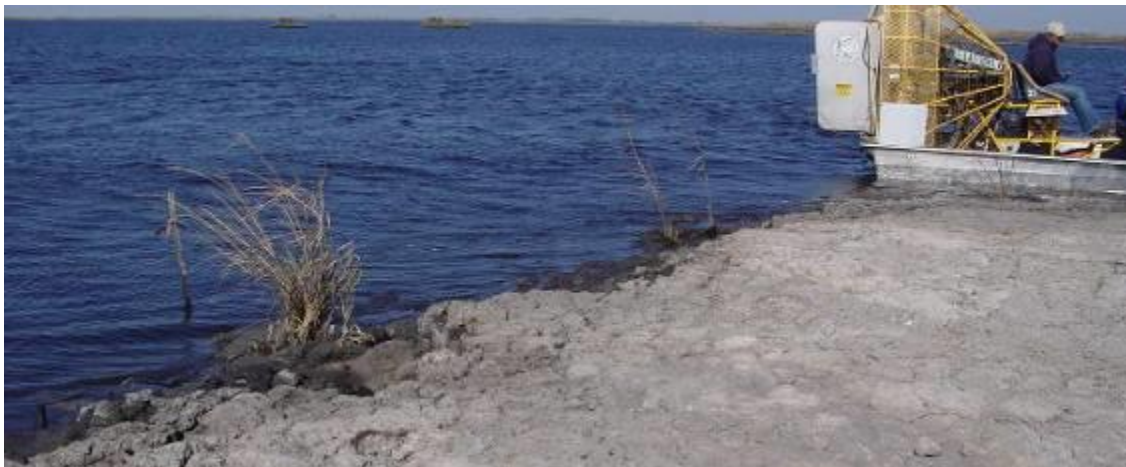
Proceeding northward, we began to note gaps in the planted rows and the number of plants missing on each terrace segment progressively increased.

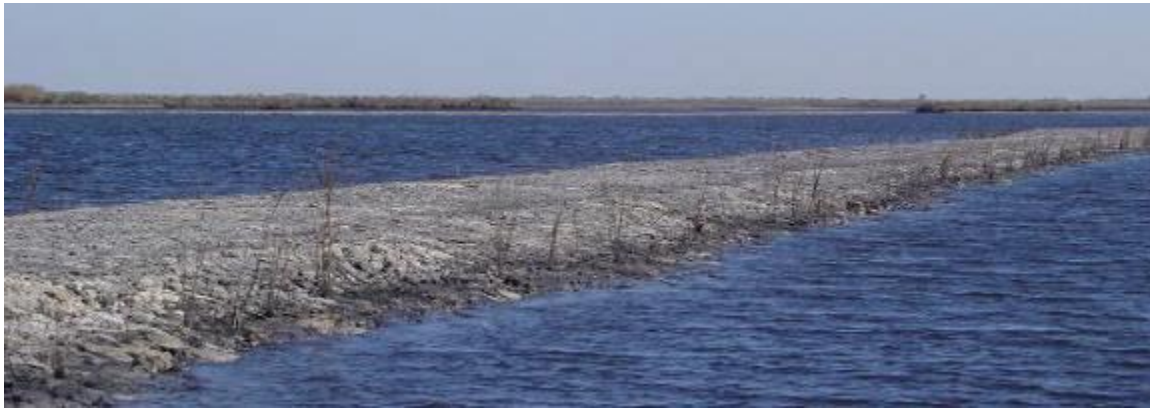
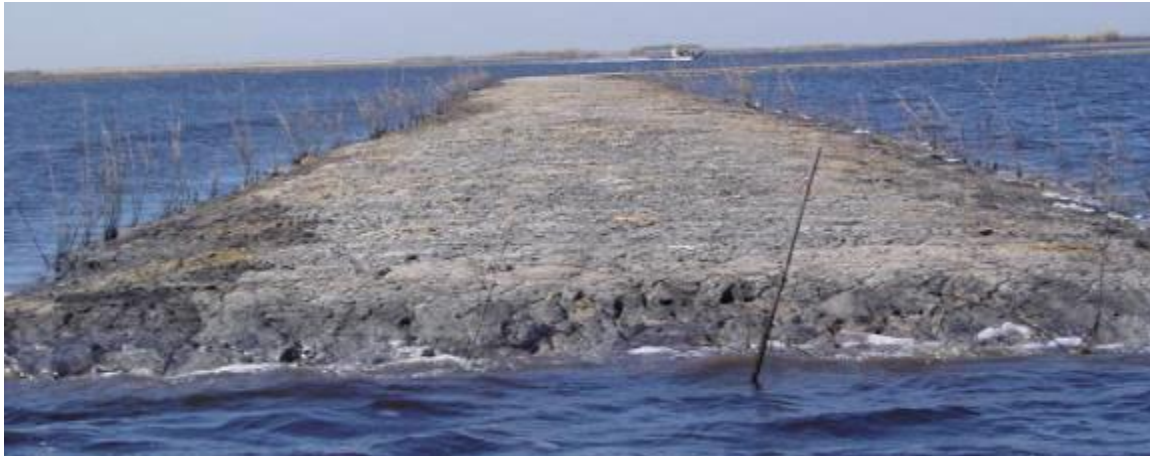
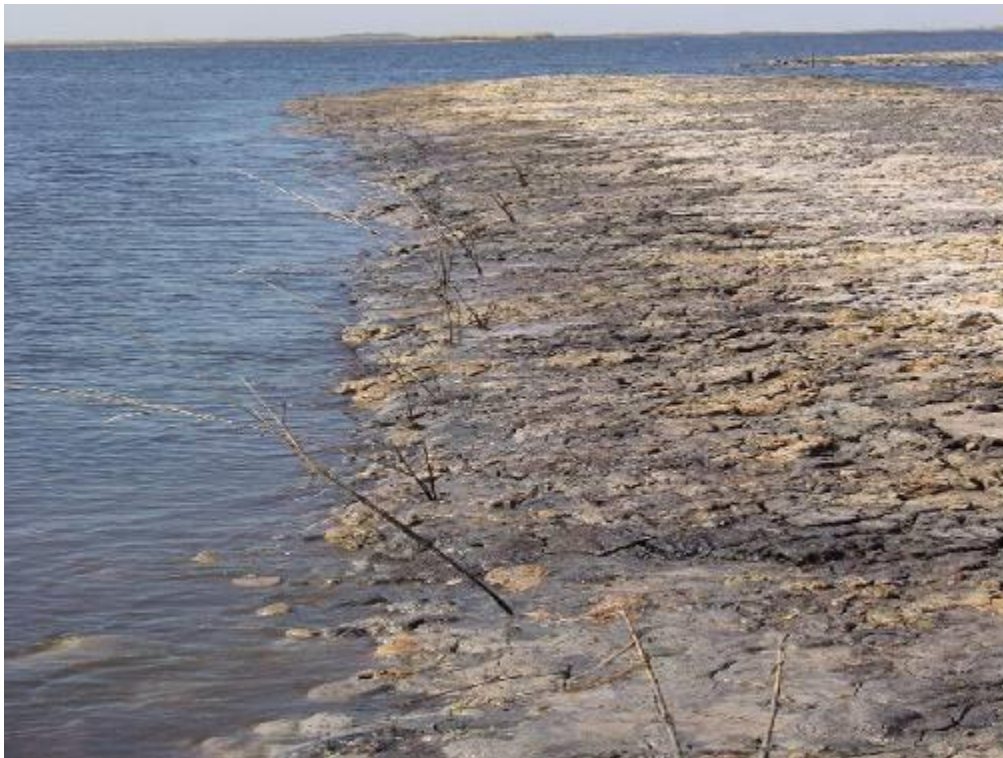
In addition, the younger a transplant was, the less old and new growth was present. From oldest to youngest, mortality increased, and the base of the plant stems ranged in color from pale yellow/green to brown/black and rotten at the base.

It is recommended that the destroyed plantings be replaced as soon as possible, in order to achieve the necessary stabilizing vegetative cover on the exposed tops and edges of the earthen terraces, particularly now that the start of hurricane season is days away. Please contact me and the LDNR and USFWS project and O&M managers to discuss how, and how soon, this can be accomplished.

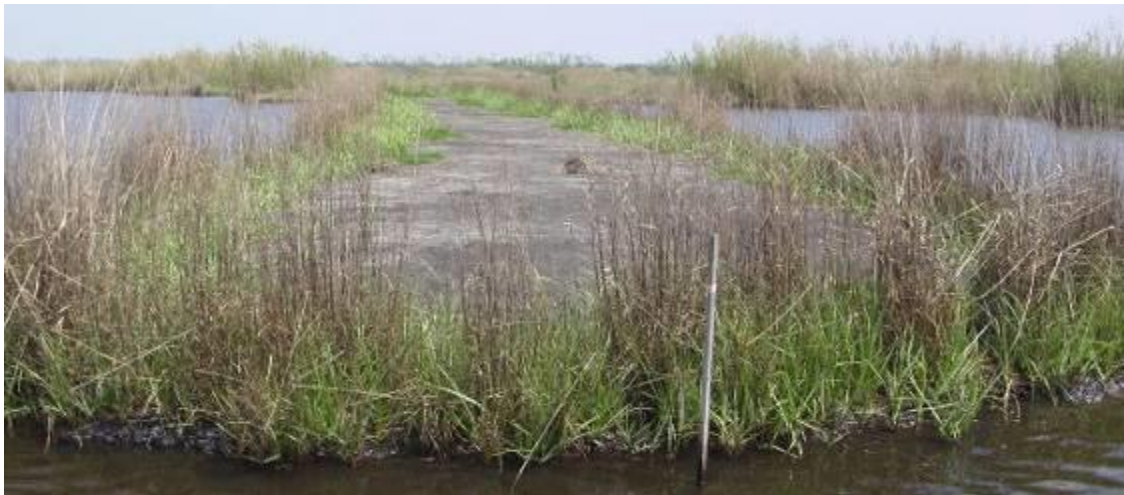
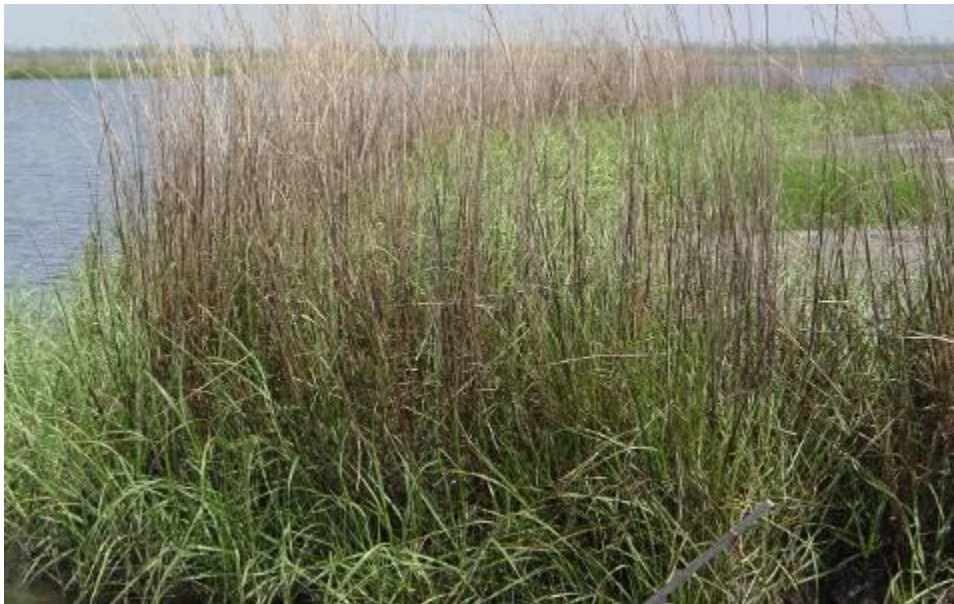
The oldest vegetative plantings on the southern terraces appeared to have recovered very well, having produced significant new growth and lateral spread (below).

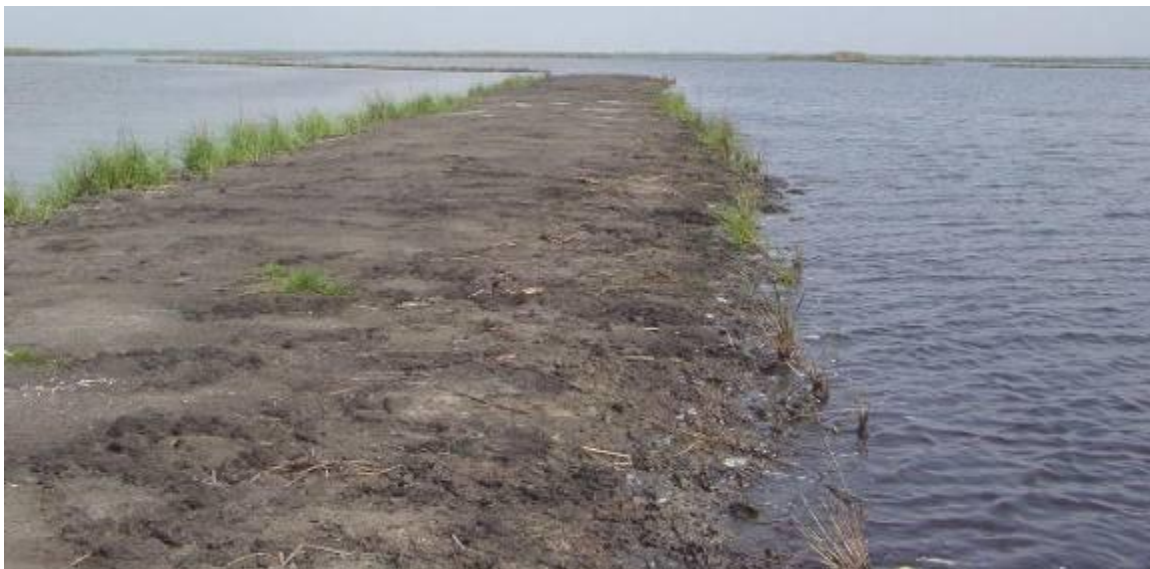
However, moving northward, we found that as age of the plantings decreased, mortality increased, until the plantings no longer formed a continuous vegetative hedge at the toe of the terrace segments. On the newest terrace segments, remaining plants formed very sparsely

distributed live clumps, or single plants with a couple of stems each. There was no longer difficulty in calculating the plant mortality.

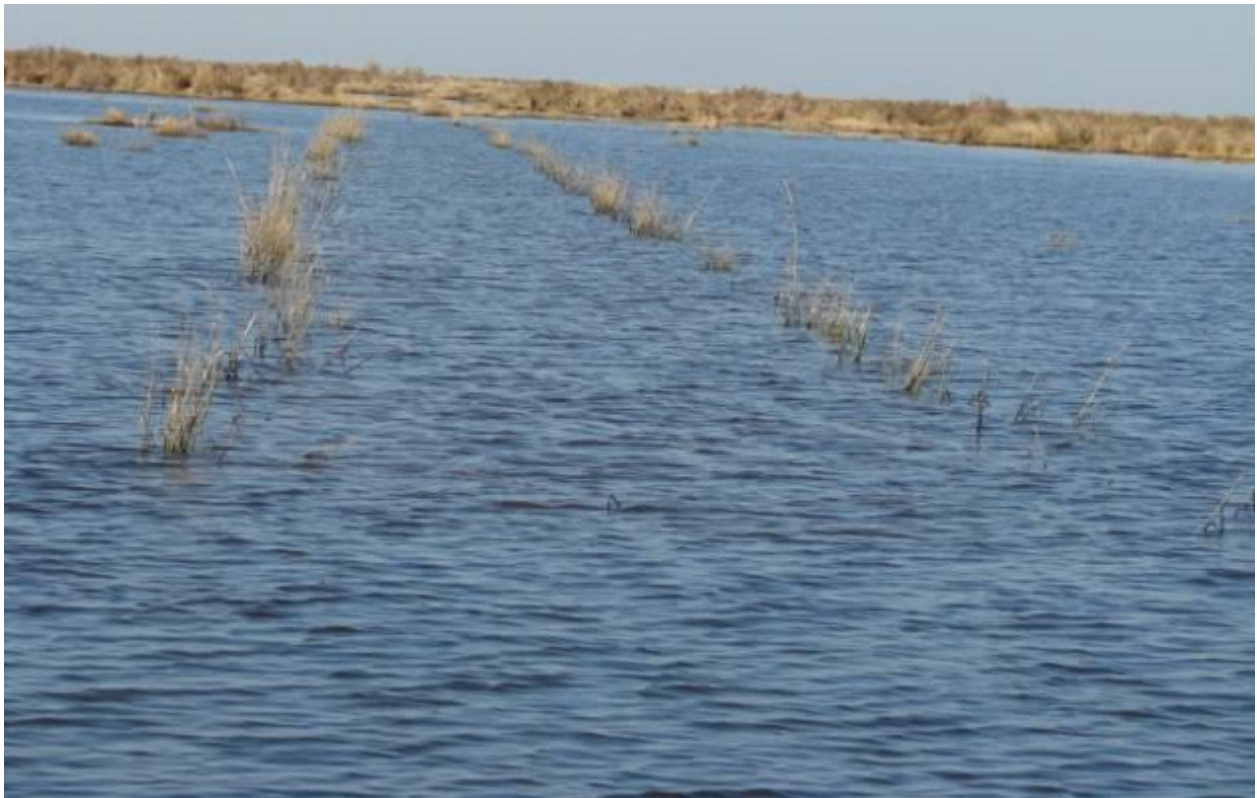
Figure 4. Project terraces remained flooded one month following Hurricane Ike landfall.

Figure 5. Project terraces remained flooded one month following Hurricane Ike landfall.

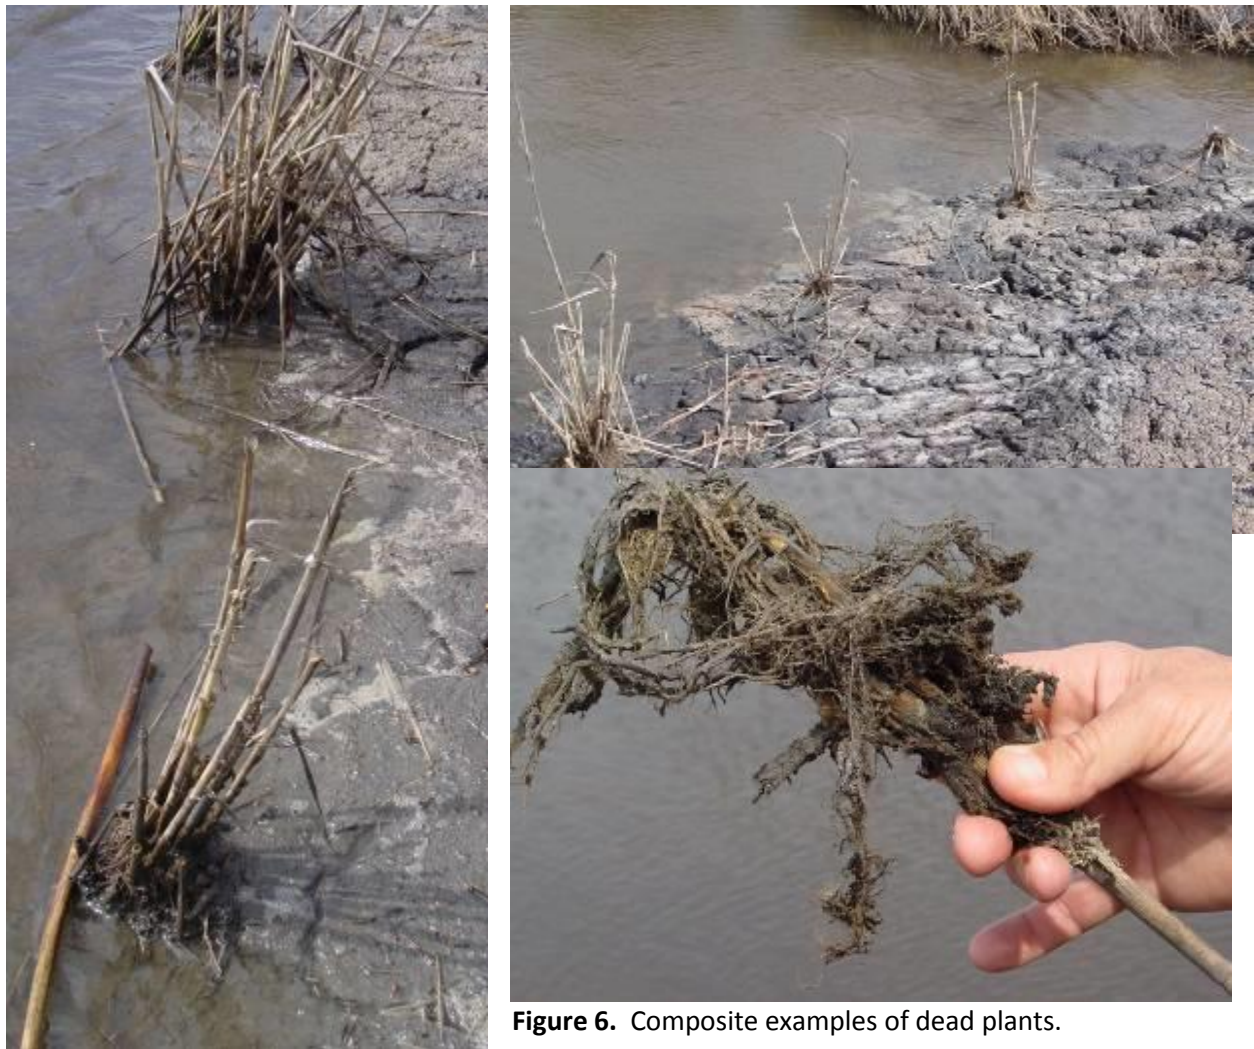
Figure 6. Composite examples of dead plants.

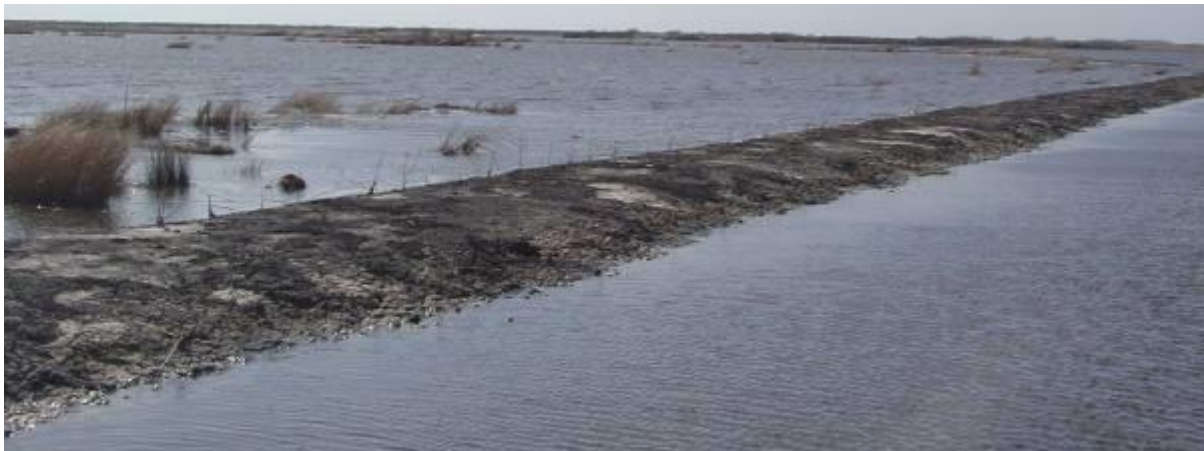
Figure 11. Less evidence of recovery was seen from the most recently planted transplants.

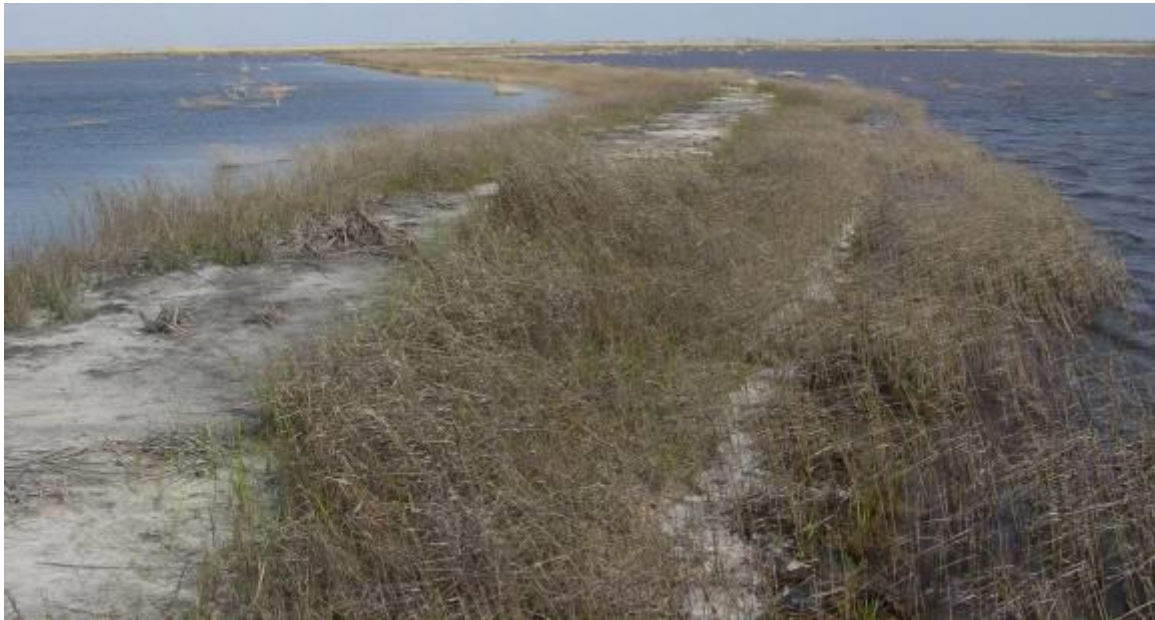
The plants on the Construction Unit 1 terraces that were completed in 2007 were also significantly impacted. The vegetation had obviously spread and was forming fairly dense cover on those terrace segments prior to the storm, but all emergent stems that remained post storm were completely browned. Nevertheless, new plant growth emerging at sufficient density was observed on all the CU-1 terrace segments (Figures 12 through 14).

Figure 12. Post hurricane condition of vegetation on CU 1 terraces.

Recommendations: I do not recommend that any CU-1 terrace segments be replanted, since the density of the new growth we found there indicates that sufficient cover will likely be achieved from the remaining plant material. I do recommend that the dead and missing CU-1A plants be replaced as soon as possible, in order to achieve the necessary stabilizing vegetative cover on the exposed tops and edges of the earthen terraces. I also recommend that all Row 1 terrace segments that were built (segments 1 through 7) be planted, whether or not the construction work on this row was completed.

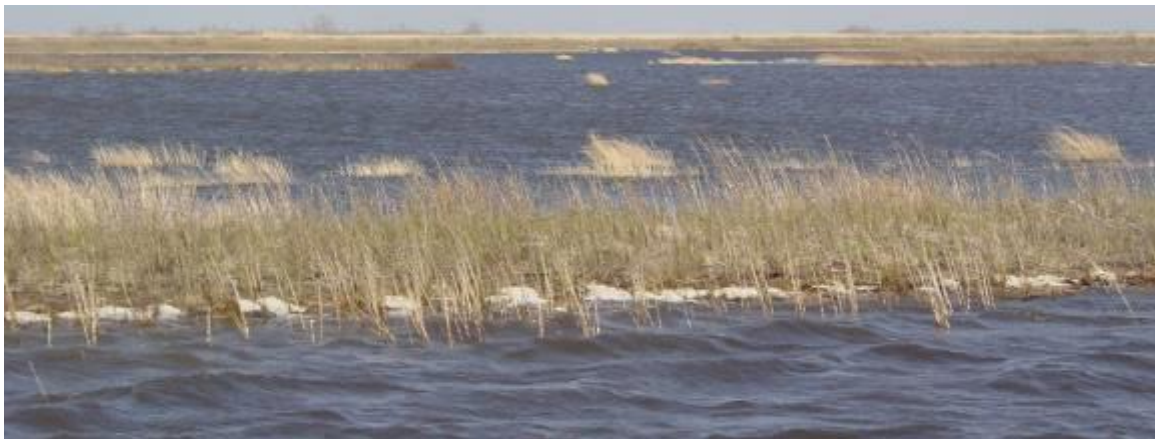
Figure 13. Post hurricane condition of vegetation on CU 1 terraces.

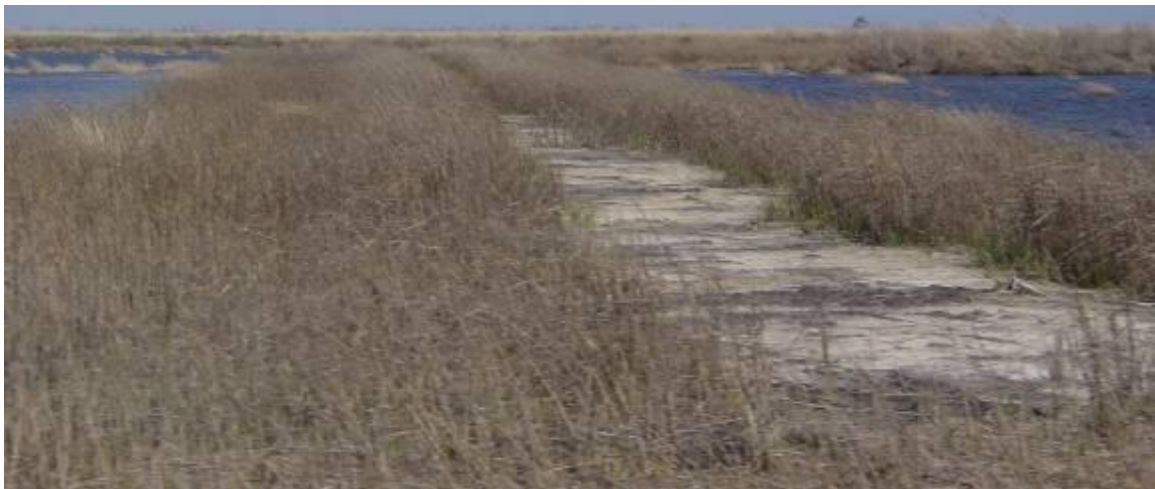
Figure 14. Post hurricane condition of vegetation on CU 1 terraces.

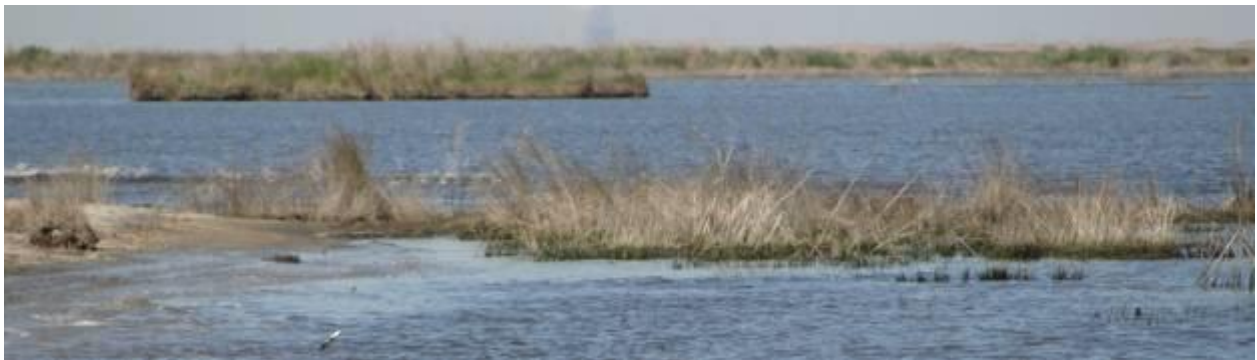
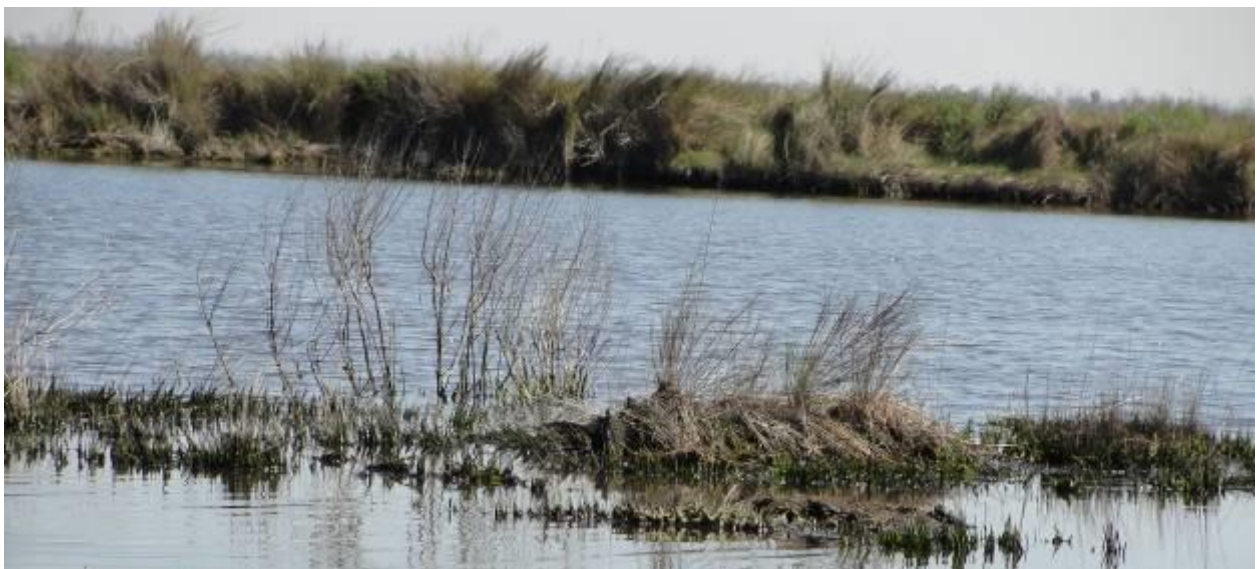
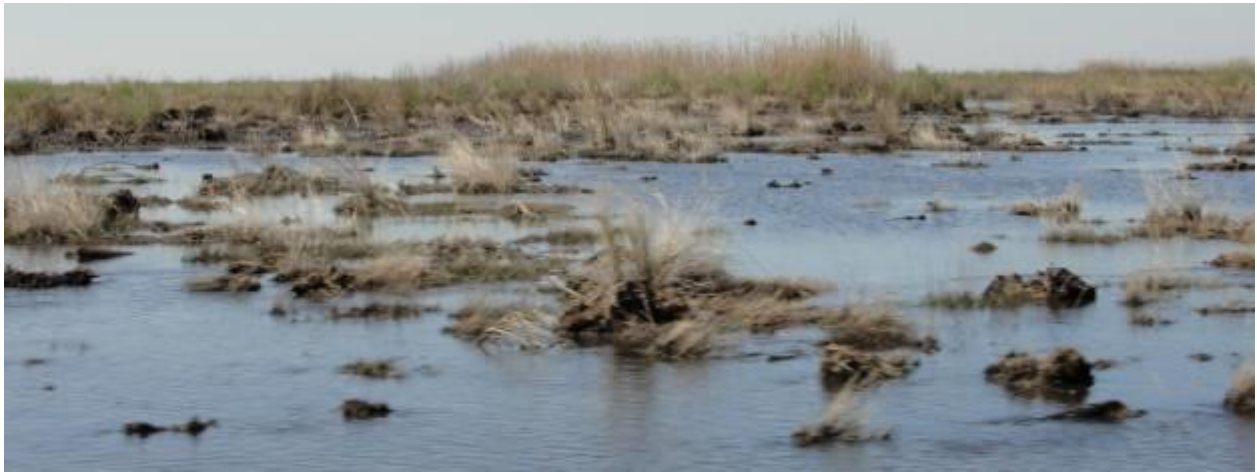
Condition of existing natural emergent marsh next to terraces:

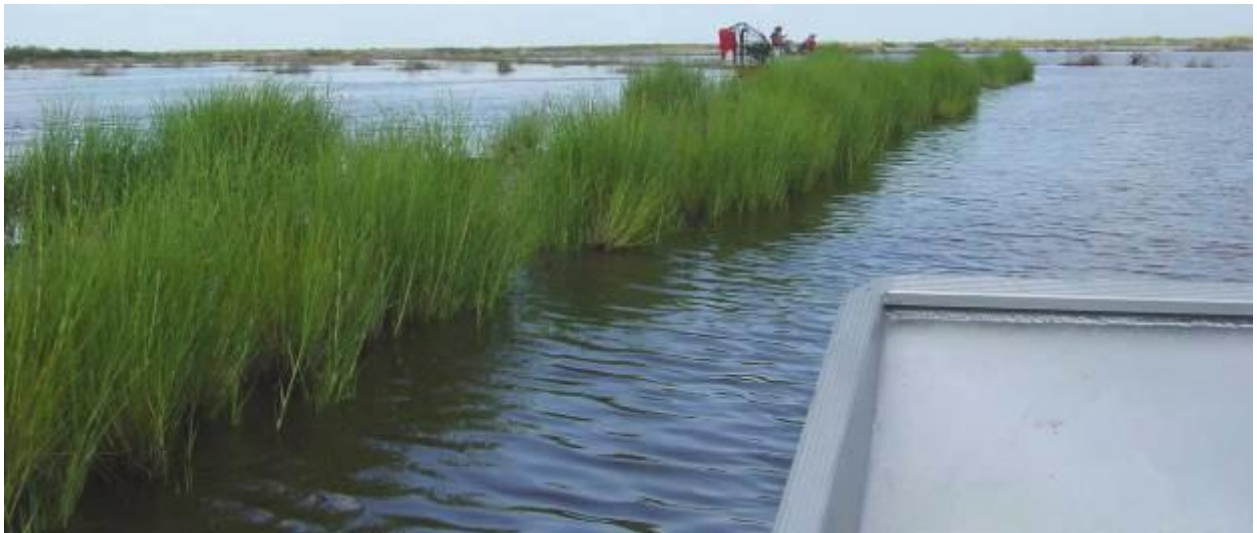
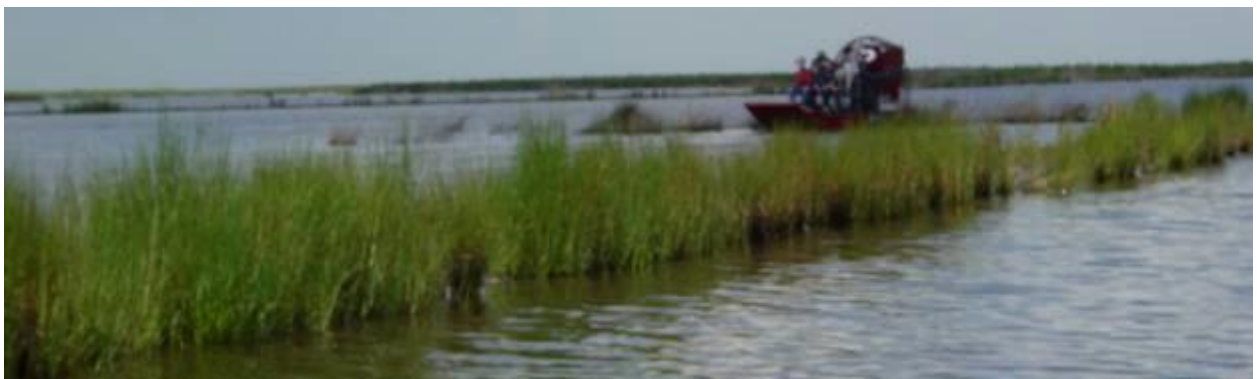
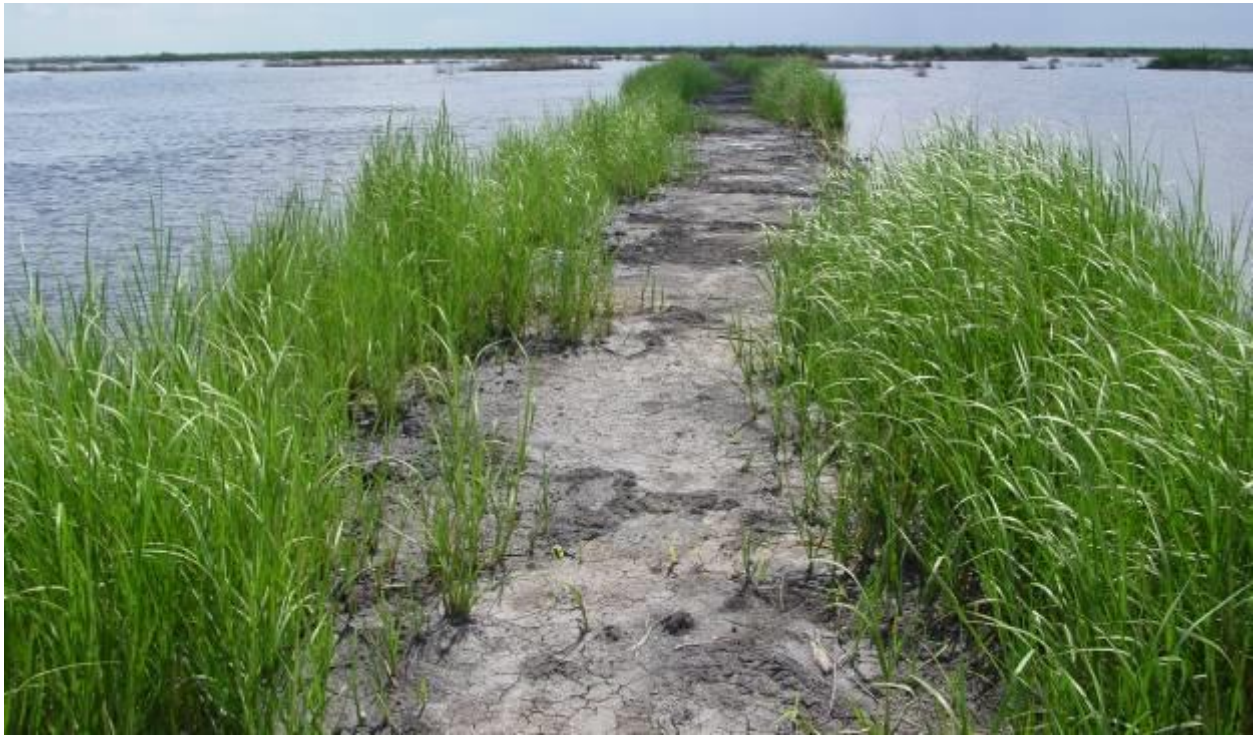
Examples of condition of older plantings when appeared to be recovering well in August 2009:

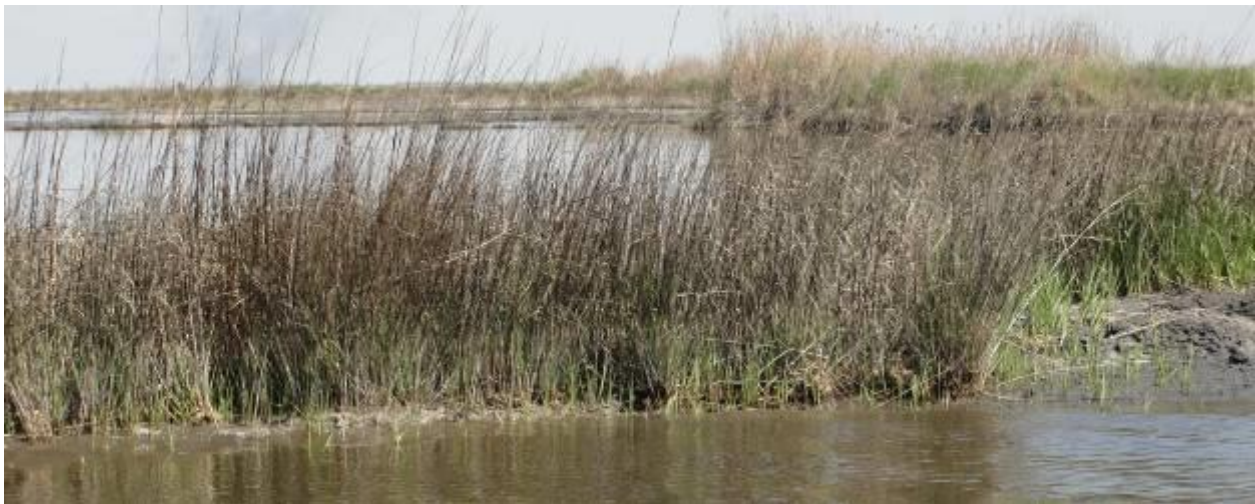
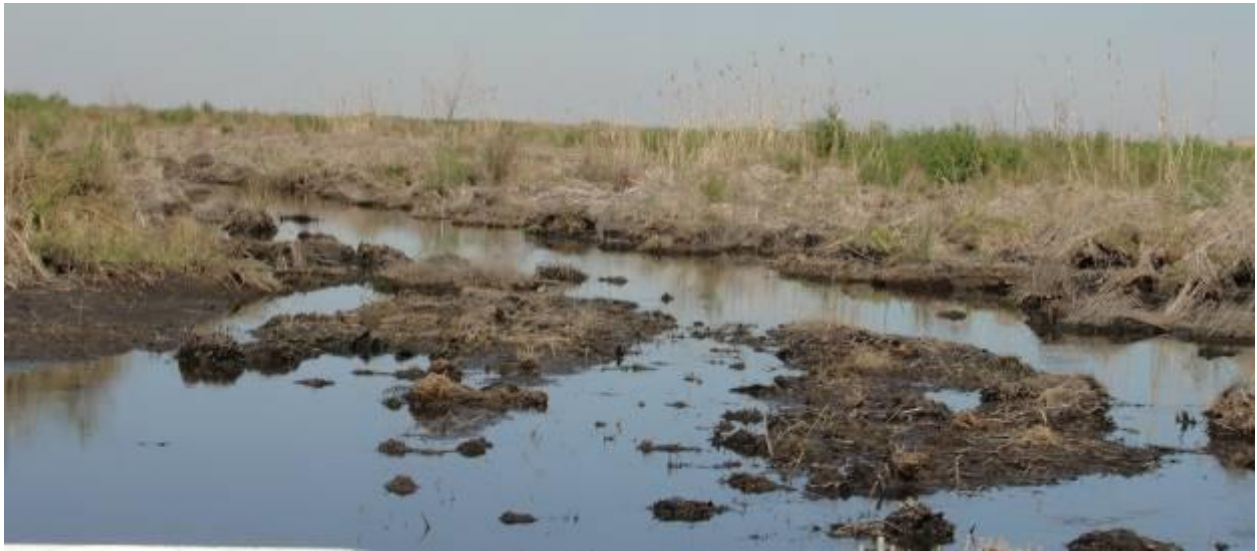
Contrast above with the appearance of the condition of those older plantings in March 2010:

Because of the high uncertainty at this date of what below-ground tissue remains viable, a mortality rate or pattern cannot reasonably be determined for any of the plantings, regardless of age. I recommend returning to the project site in September near the end of this year's growing season when a much more accurate assessment of the extent of plant survival can be made. Collection and analysis of soil samples may also provide additional insight in discerning actual causes of the apparent poor performance of all the plants.

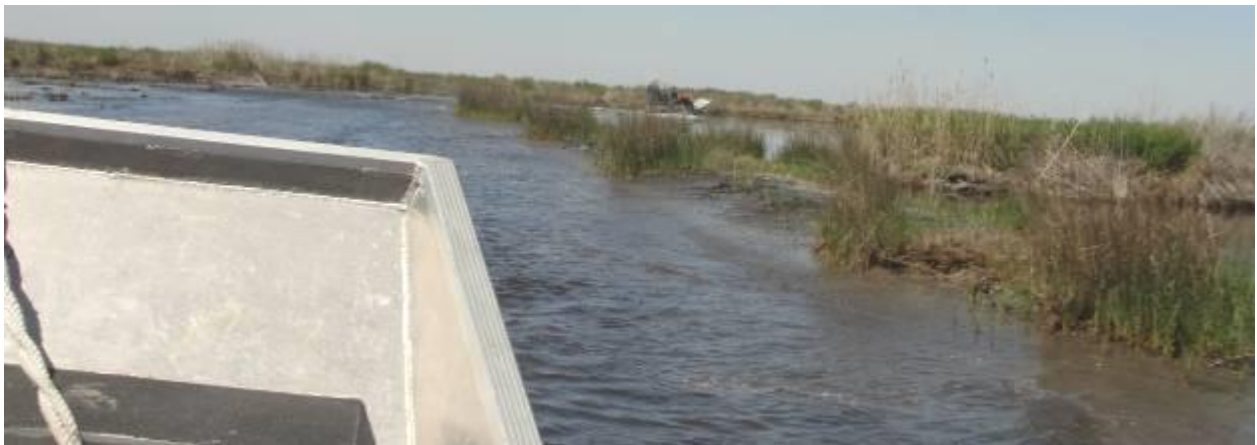
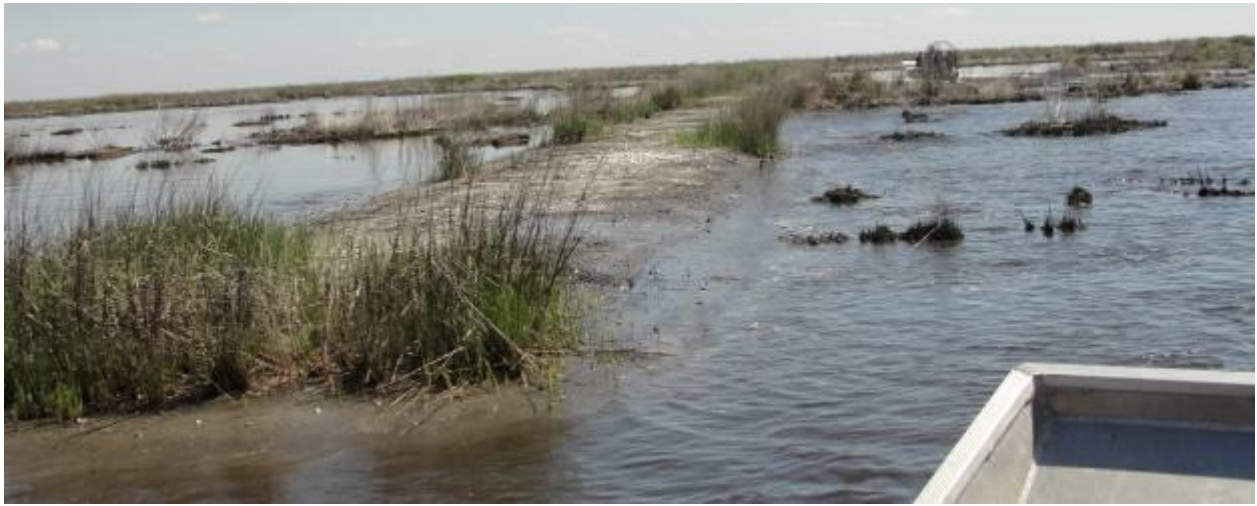
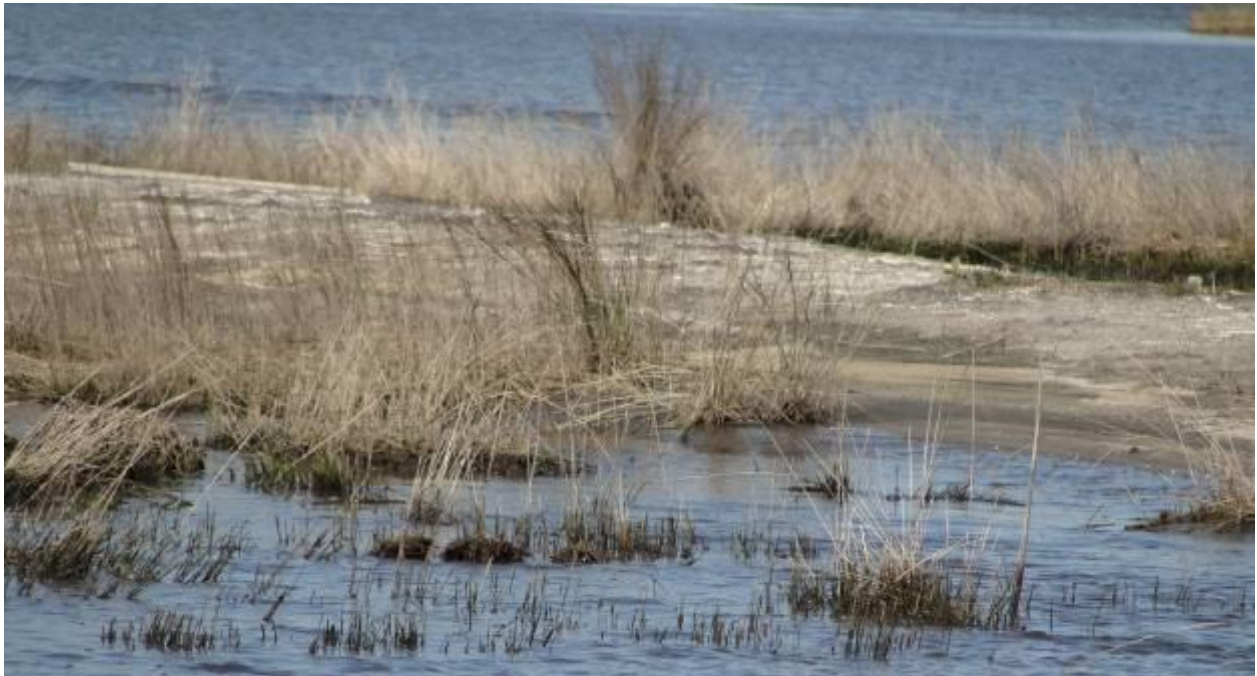
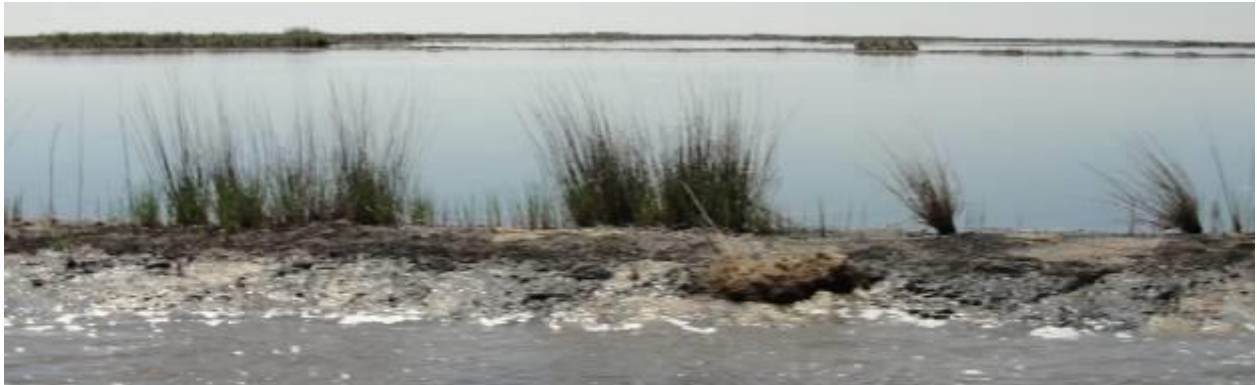
March 2010 condition of terrace segments with combination of older and recent plantings:
