**State of Louisiana
Coastal Protection and Restoration Authority**

2015 Operations, Maintenance, and Monitoring Report

East Sabine Lake Hydrologic Restoration (CS-32)

State Project Number CS-32
Priority Project List 10

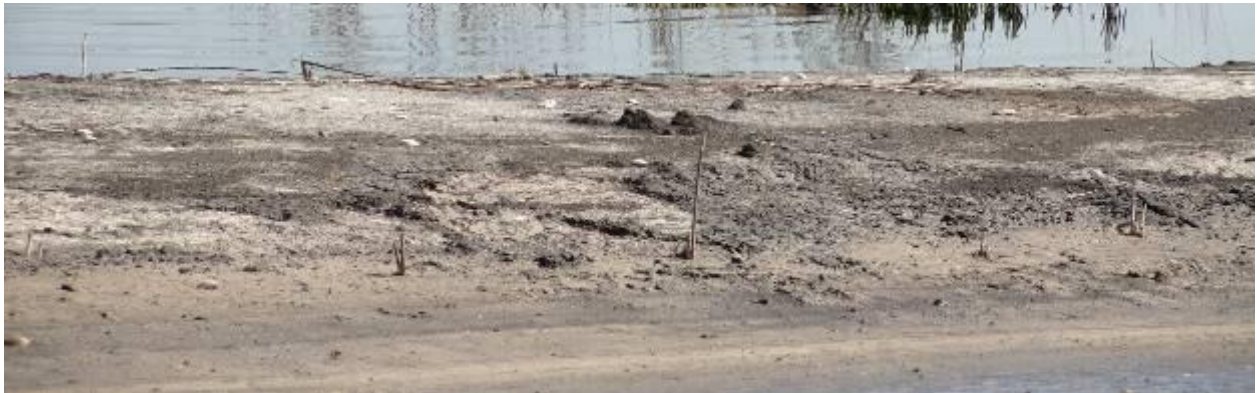
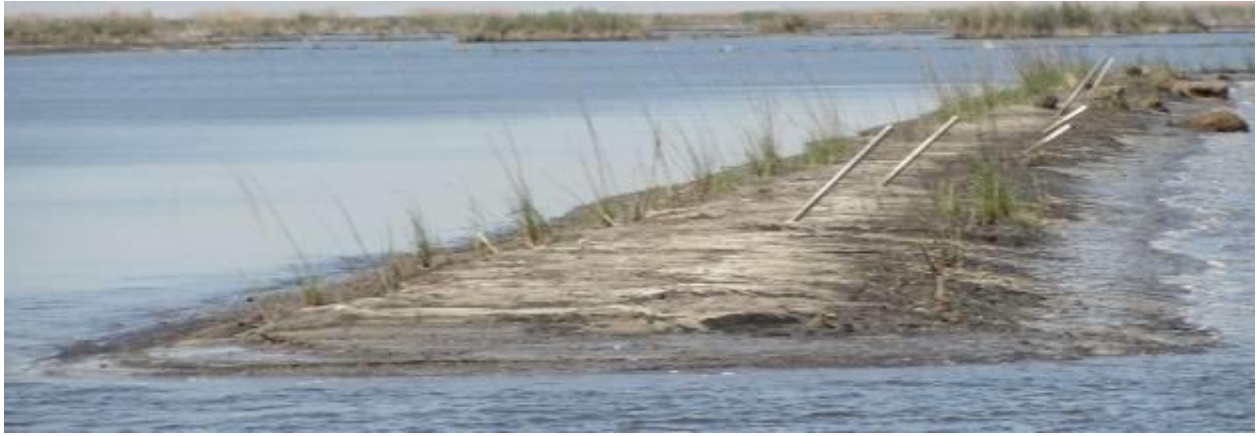
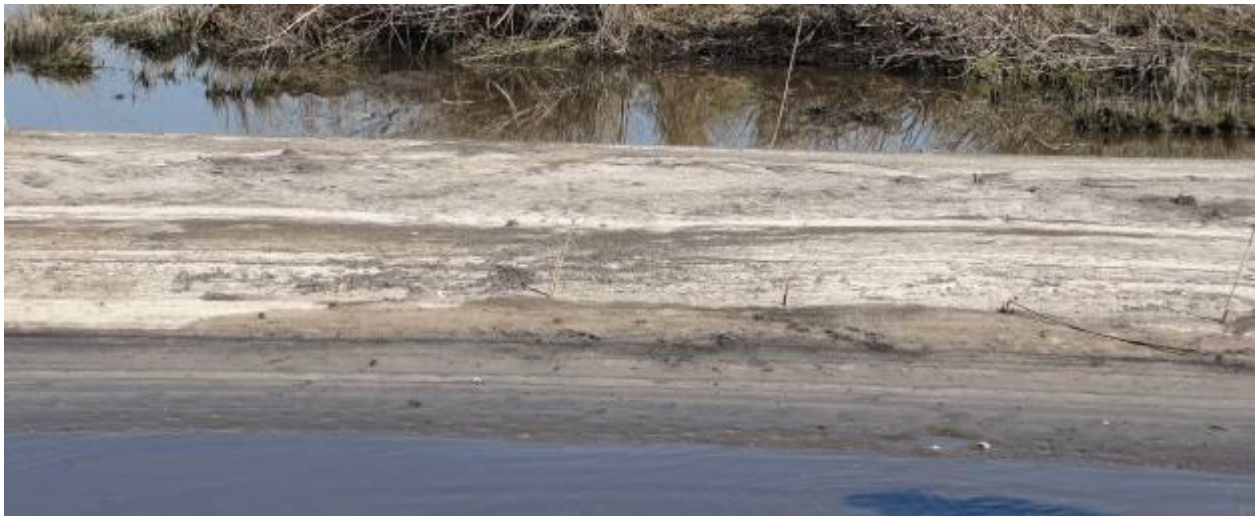
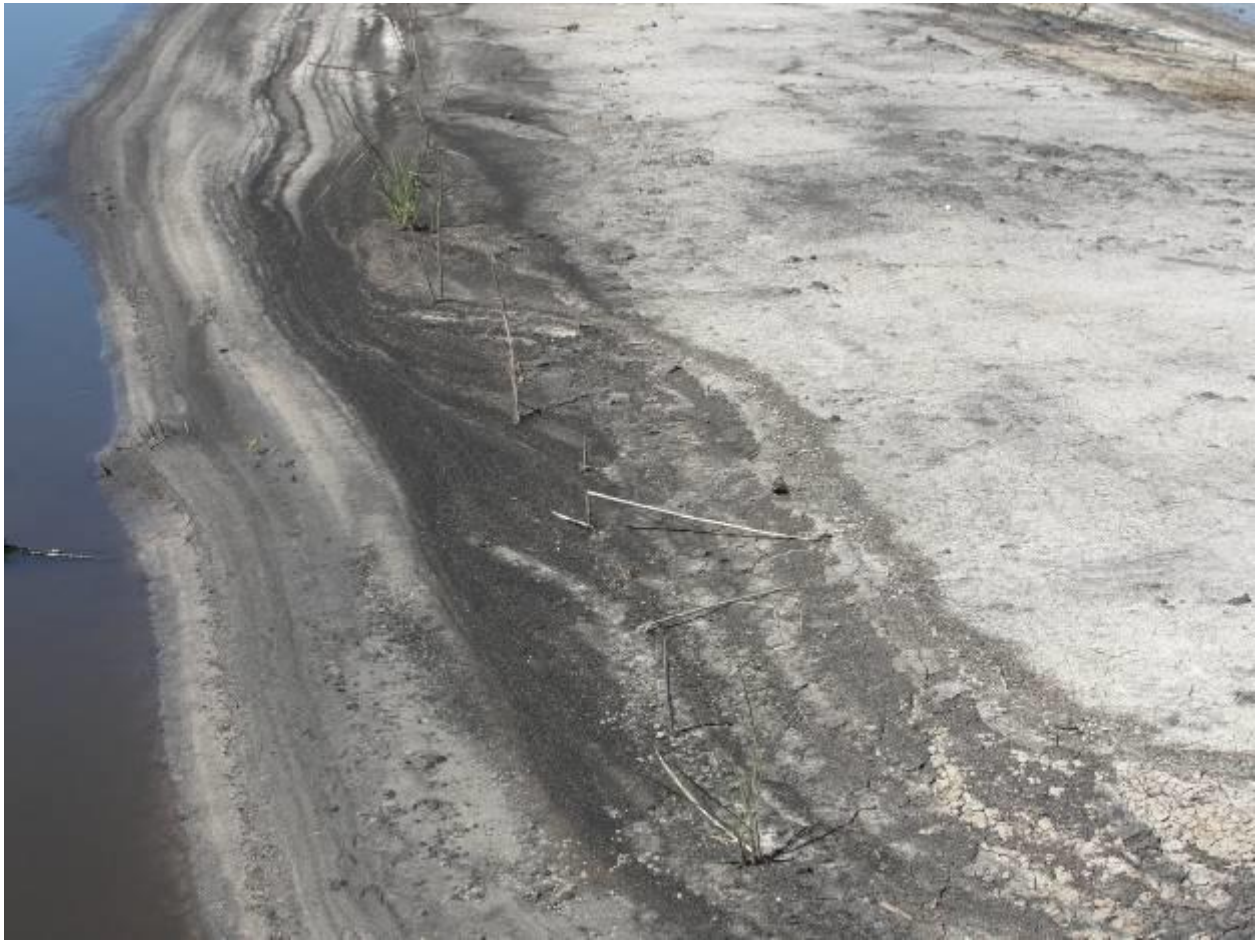
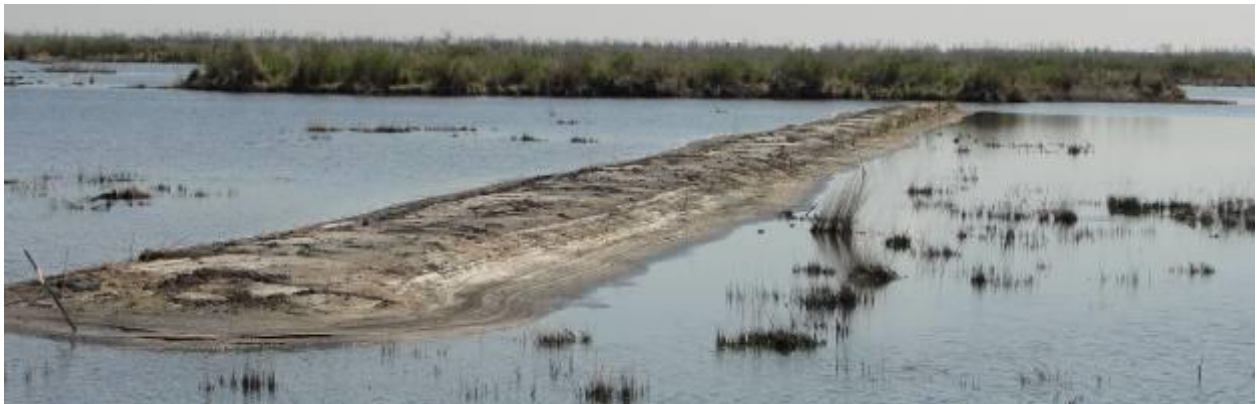
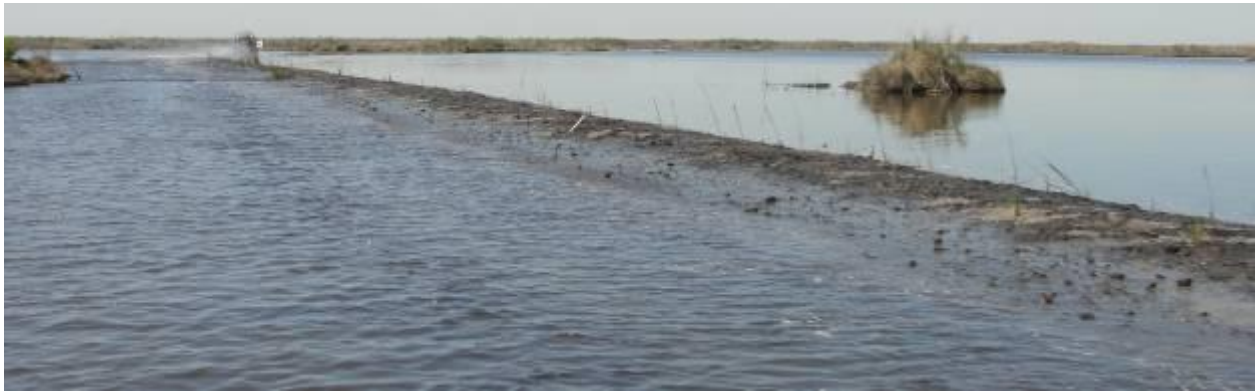
March 2010 condition of newest plantings:

For the newest CU-1B plantings, it is not likely that the source of the plants is a factor contributing to their current state, as the contract plants came from two different nurseries, one in Cameron Parish and one in Lafourche Parish, and all of the remaining plants from the other CU's generally appeared to be in the same condition on the date of this field trip.

Although mainly conjecture, weather could have played a causative role in the overall plant condition we observed. Installation of the CU-1B plantings was completed in July 2009 which turned out to be less than an ideal time for bare-root plant establishment. Following the extreme and prolonged saltwater inundation from hurricane Ike surge in September 2008, southwest LA experienced severe drought conditions in the first half of 2009, with a precipitation deficit persisting until October. In addition, discreet and continuous measurements during the summer revealed that salinities in the project area were significantly higher than normal - greater than 12ppt, and with water temperatures remaining around 85°F until September (CRMS). This may have led to stagnant or phytotoxic soil conditions until precipitation levels returned to normal in October, but by that time it was already at the end of the growing season when plants are beginning to senesce. This period was then followed by an unusually cold winter pattern that began in late November and persisted throughout south Louisiana. Minimum temperatures frequently dropped into the 30's or below for at least half of Jan and Feb 2010 dates (NWS monthly summaries for the Lake Charles/Port Arthur area). It is possible that the newest plantings experienced higher mortality or dieback of aboveground tissue from the combination of elevated stress during initial acclimation and then additional impact by the ensuing cold temperatures to any new shoot growth that did occur. Further, following a typical winter season, robust new growth is not usually seen in smooth cordgrass until March when warmer spring temperatures become entrenched. So it is also possible that this year's new growth expected for all plants in the area may still be absent because it's been retarded by the persistent winter weather pattern and the late freeze in early March.

Because of the high uncertainty at this date of what below-ground tissue remains viable, a mortality rate or pattern cannot reasonably be determined for any of the plantings, regardless of age. I recommend returning to the project site in September near the end of this year's growing season when a much more accurate assessment of the extent of plant survival can be made. Collection and analysis of soil samples may also provide additional insight in discerning actual causes of the apparent poor performance of all the plants.

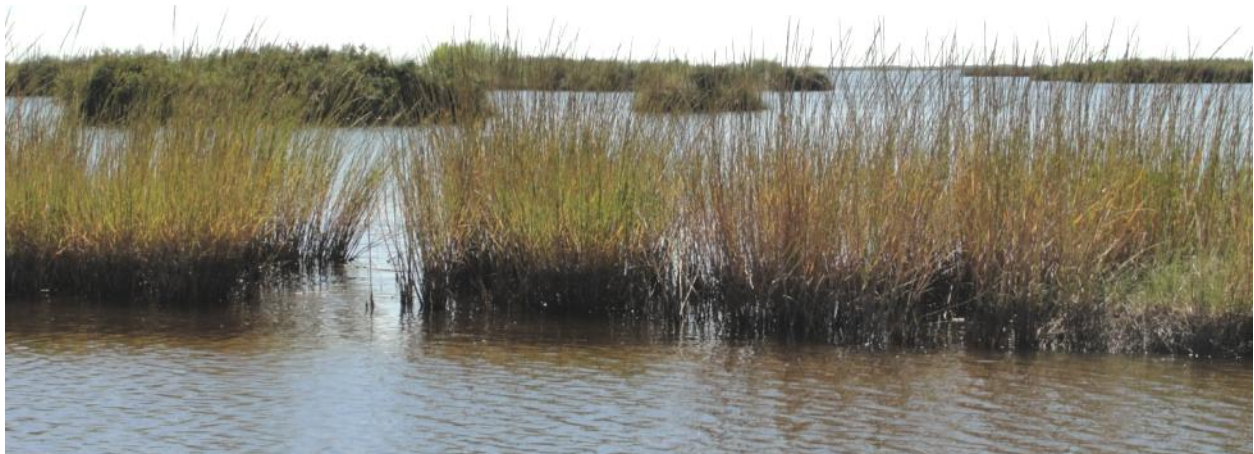
The vegetative growth of smooth cordgrass on the oldest and southeasternmost CU-1 Rows 16 to 25 looked excellent, as did that on newer CU-1A/B Rows 11 to 8, and the coverage was nearly 100%. The few gaps that were occasionally present on a few segments were minor and some gaps were occupied by other species such as seashore paspalum (*Paspalum vaginatum*) where the terrace crown was above the water elevation on this date.

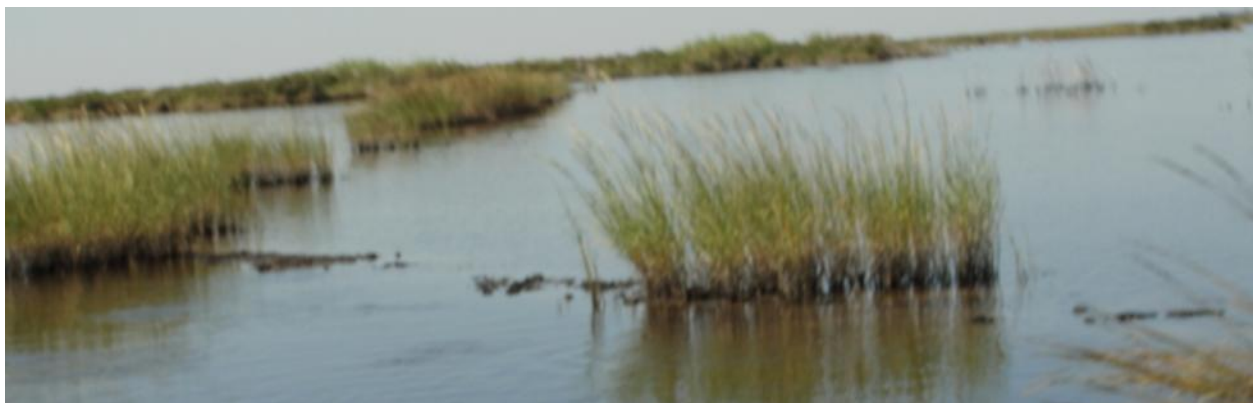
As the party continued north, the survival estimates for the rows dropped dramatically and ranged from fair to poor (5% to 50%) on the CU-1A/B Rows 4 to 2, but the vegetation that did remain appeared to be recovering well and for the most part looked very healthy.

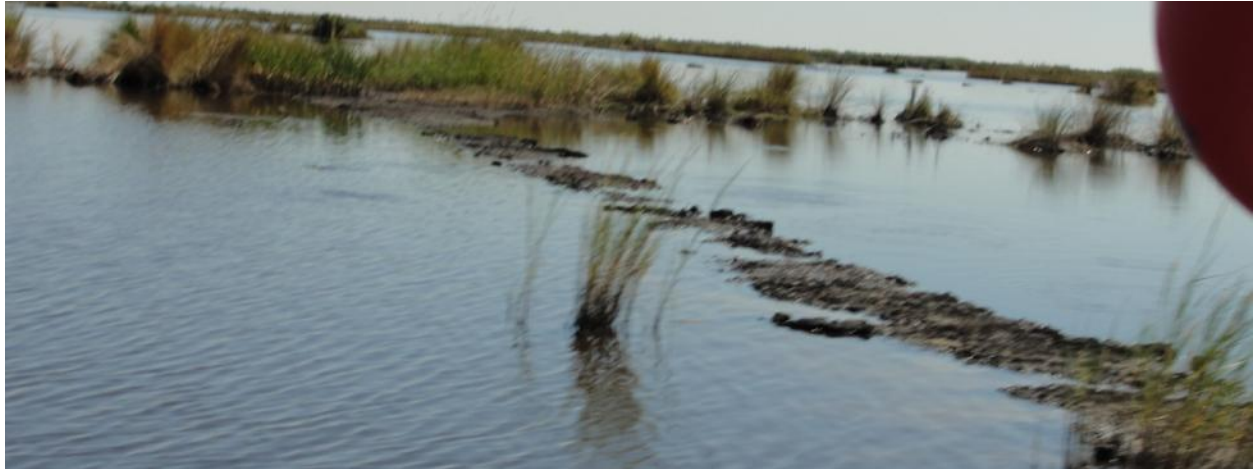
There were a few exceptions however where some plants appeared to be struggling, but those were generally found where the terrace segments were severely impacted and were obviously narrowed with lower crown elevation.

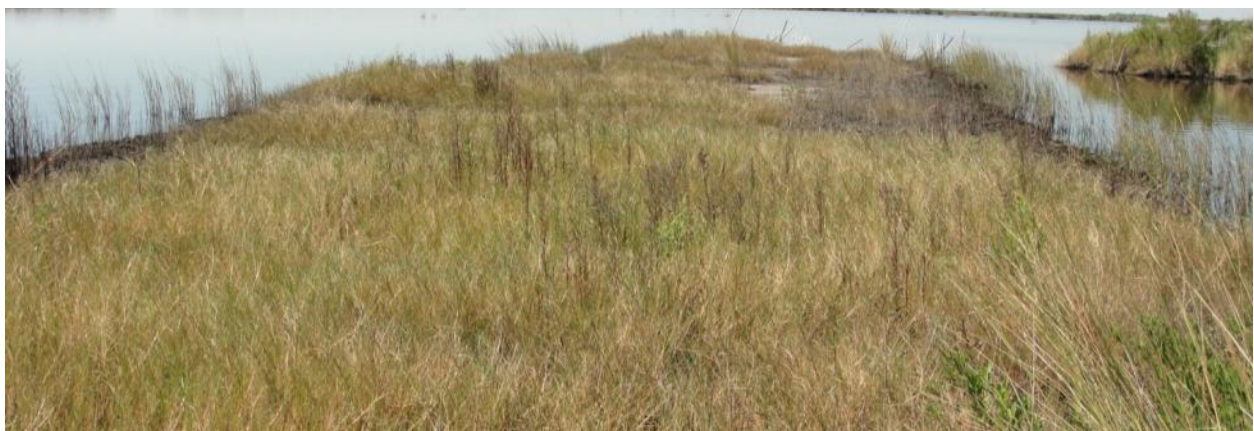
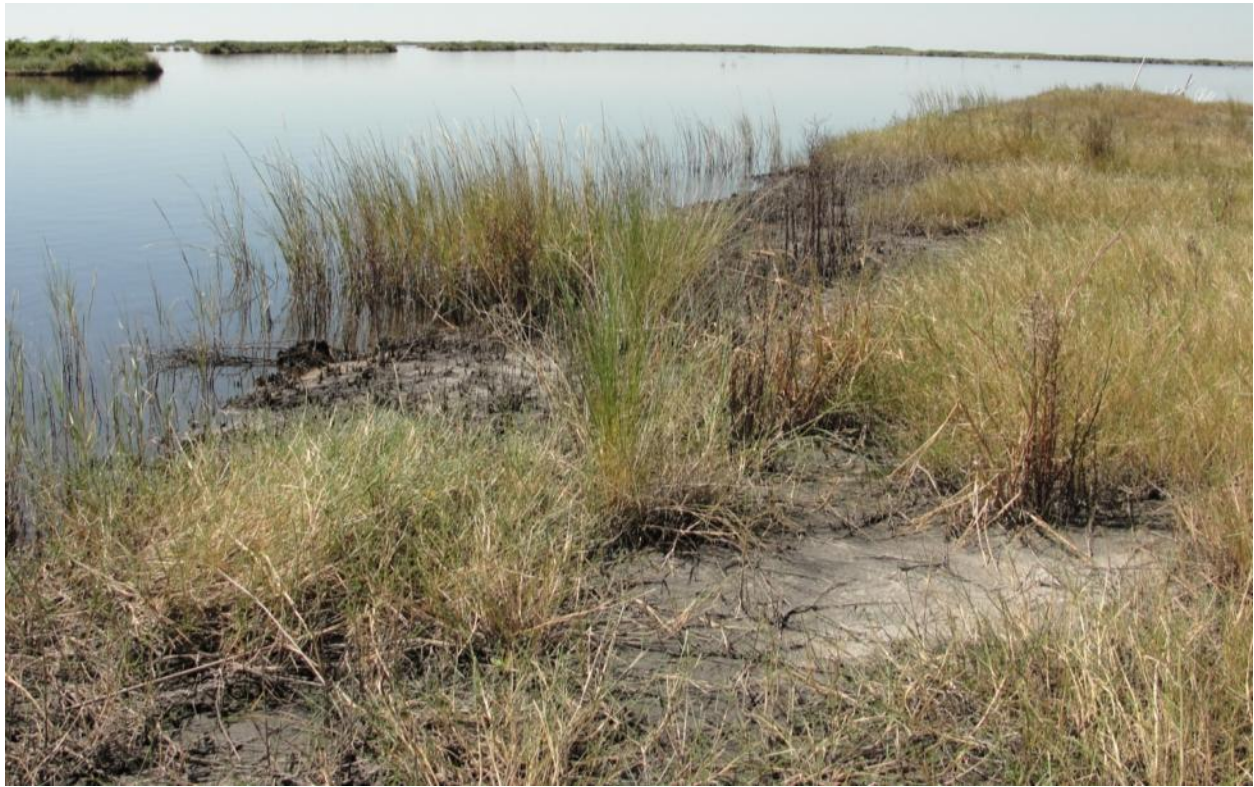
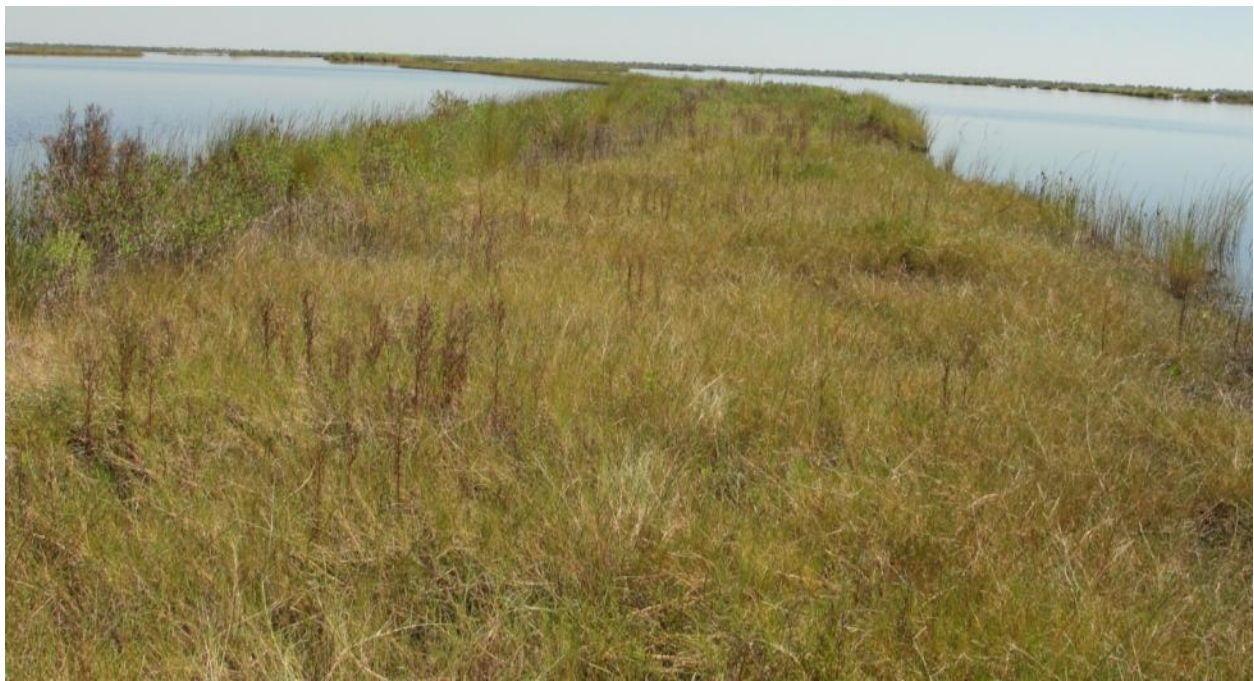
The older CU-1 Row 14A terraces continue to be in very good shape, and well covered with vegetation (below). Most of the crown cover however was from a variety of other pioneering species, mainly seashore paspalum and marshhay cordgrass (*Spartina patens*), but seashore elder (*Iva imbricata*), leafy three-square (*Schoenoplectus maritimus*), goldenrod (*Solidago* sp.) and sedges (*Cyperus* spp.) were also present, as well as saltmarsh aster (*aster tenuifolius*), cattail (*Typha* spp.), camphorweed (*Pluchea camphorata*) and marsh morningglory (*Ipomoea sagittata*), and walter's millet (*Echinochloa walteri*). The smooth cordgrass at the toe of this row's segments actually looked in poor shape, and the cover it provided was sparse along some edges.

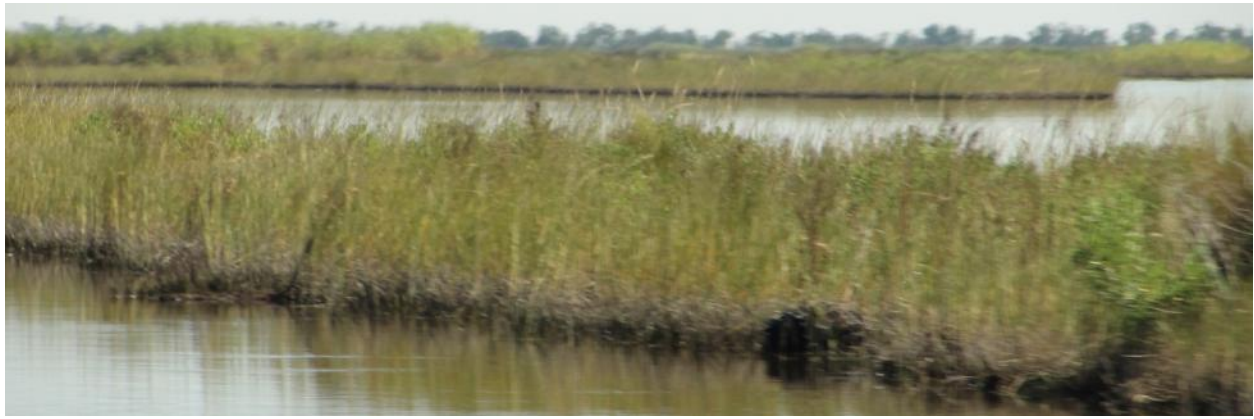
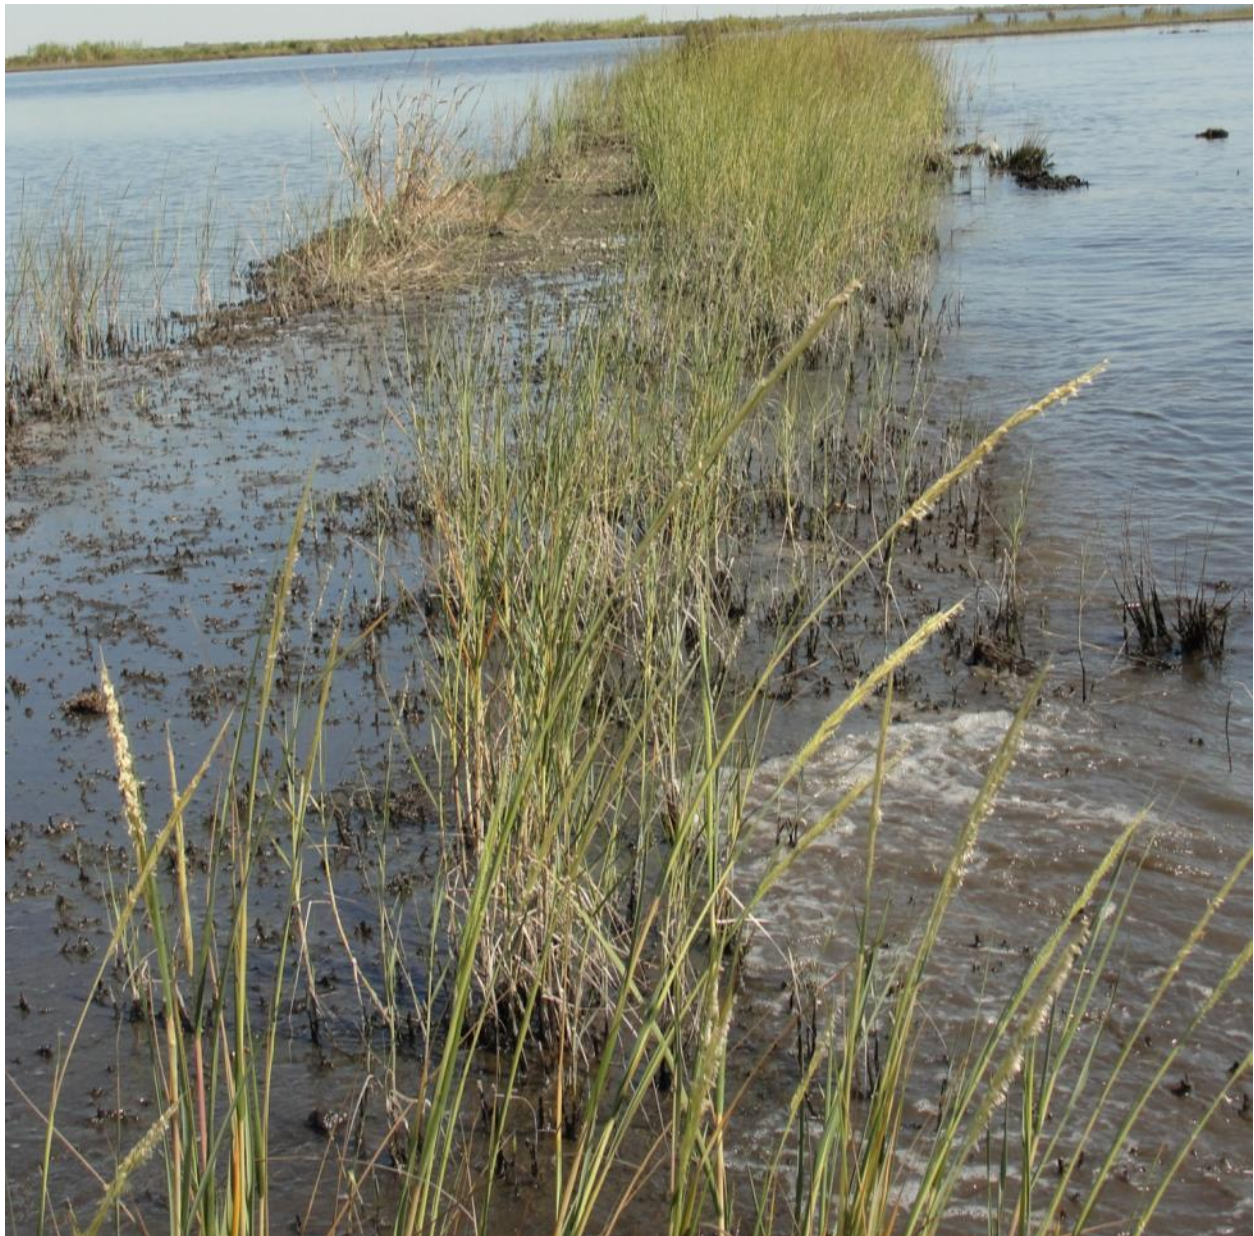
Overall, the southern rows of CU-1 group looked stable though some had obviously narrowed. There were some areas of loss observed, but there was no discernable pattern that might explain the loss, or why the smooth cordgrass was not recovering well on some segments or in spots, but on others, though providing thin cover, the individual plants looked fairly robust.

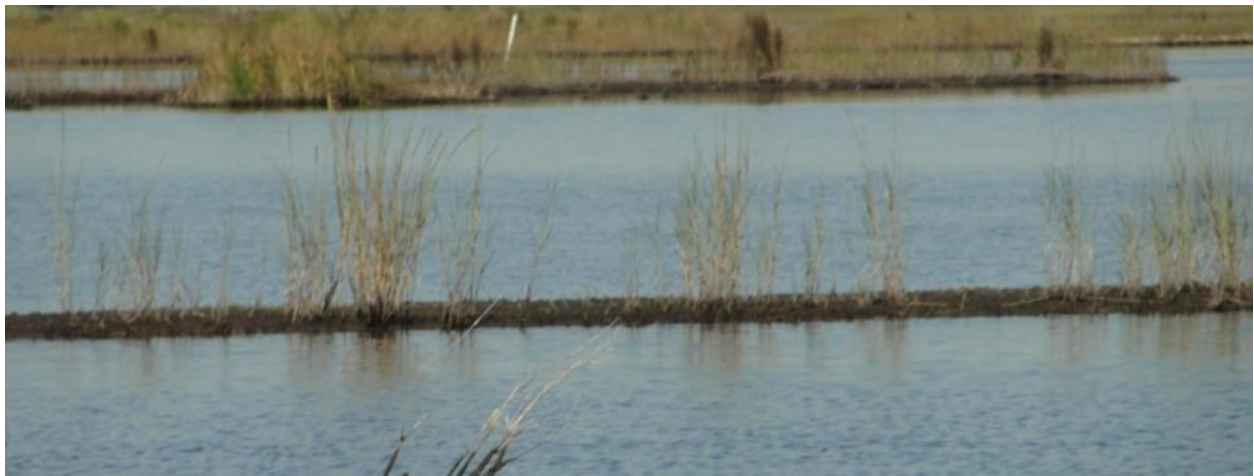
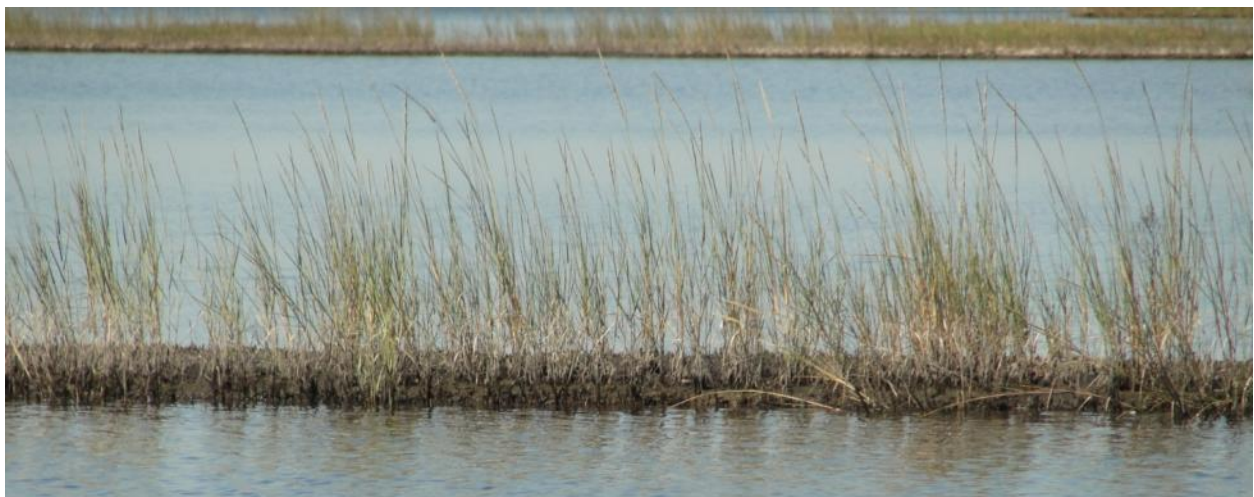
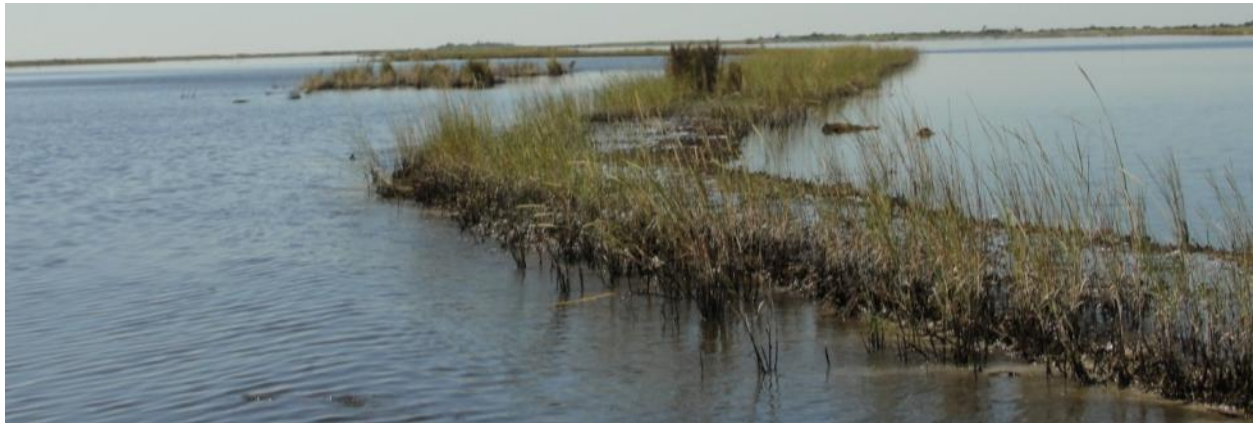
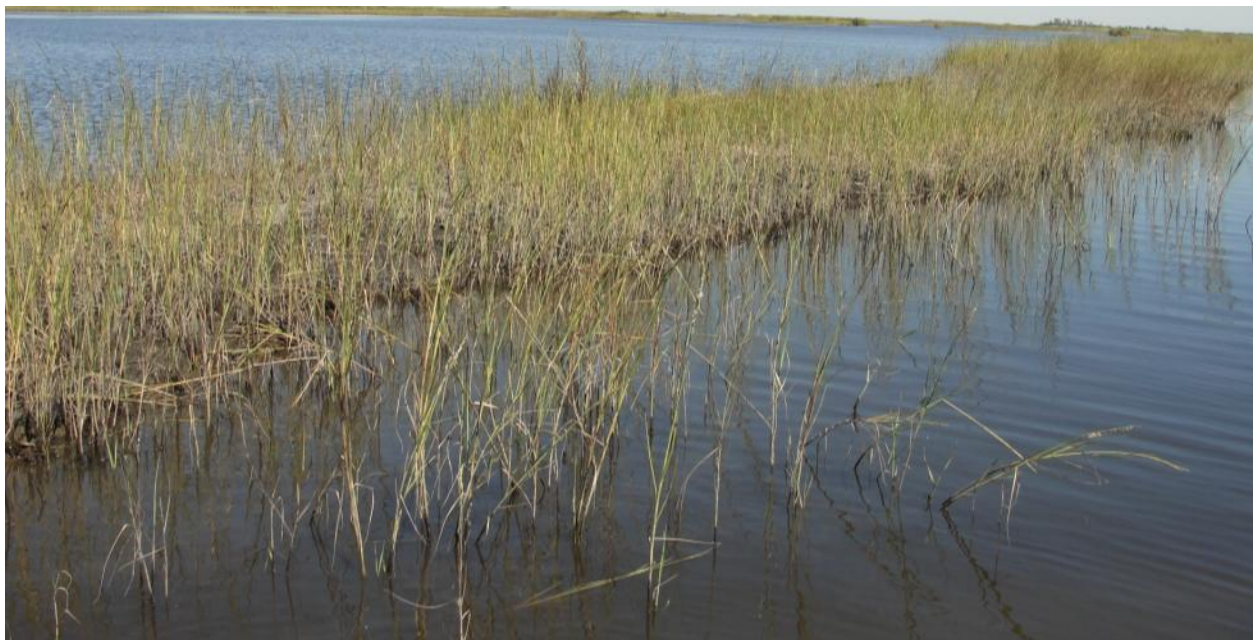
Continuing north, the survival and cover on the CU-1 terraces was found to vary quite a lot. Many terrace segments were much narrower and had poor to no cover, but there were other segments where the cover was good and the terraces retained their width. Overall though, there were only a few sites found where individual smooth cordgrass plants looked as robust as those seen to the south. It almost appeared that some plantings were just beginning to re-emerge and expand the cover.

Recommendation: The project team discussed options and it is recommended that the construction phase of this project be closed out. The remaining plantings are expected to continue to recover and expand but where there are large stretches of missing plants, it is advisable to re-vegetate with additional plantings that can be conducted through O&M. I recommend that an O&M planting to target areas with poor to no cover be planned for TY1 or 2, and could probably be accomplished for less than \$100,000 (not amortized \$). To provide for adequate cover to be maintained throughout the 20-year project life, O&M funds should also be available for an additional O&M planting event if it becomes necessary later in the project life. Darryl Clark has confirmed that there currently is \$254,428.04 in the project O&M budget, which is sufficient to fund a TY1 or 2 planting. OCPR typically implements the O&M activities, but if USFWS & OCPR agree, NRCS can design and implement the planting.
