**Coastal Protection and Restoration
Authority (CPRA)**

2023 Operations, Maintenance, and Monitoring Report

Oyster Bayou Marsh Restoration

State Project Number CS-0059
Priority Project List #21

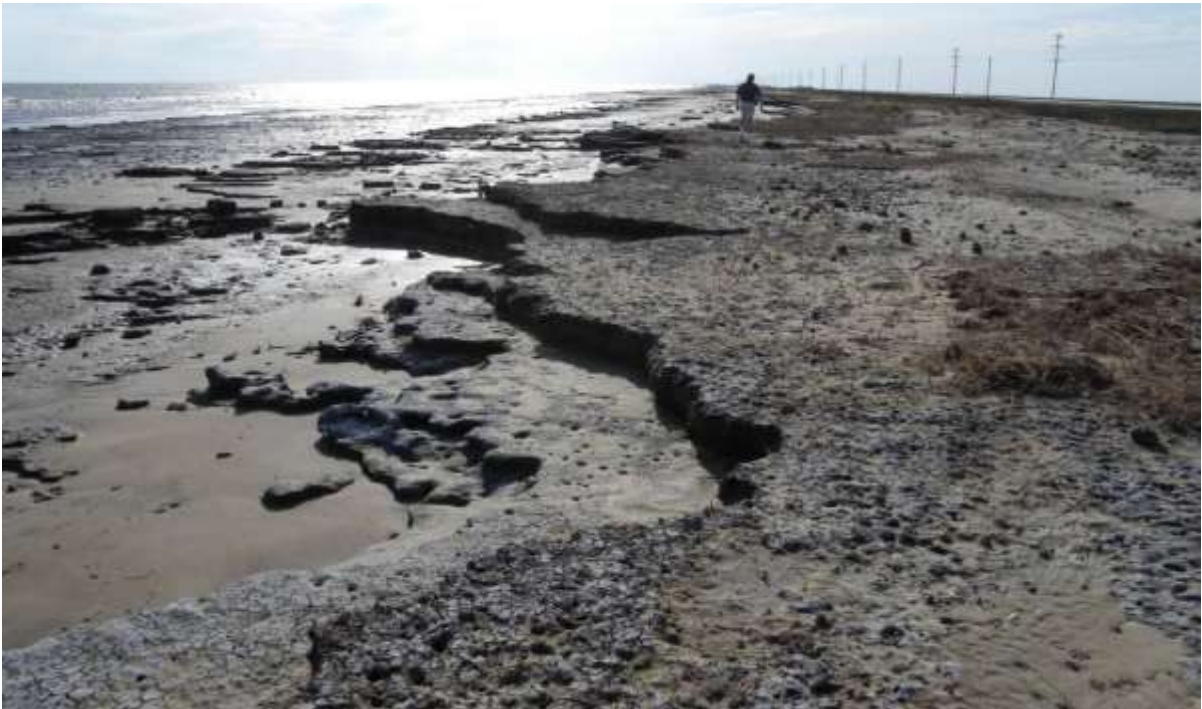
Figure 2A. Gulf of Mexico shoreline before construction of the Cameron Parish Shoreline Restoration Project (CS-0033); beach erosion had reached HW 82 at the southern margin of the Oyster Bayou project area.

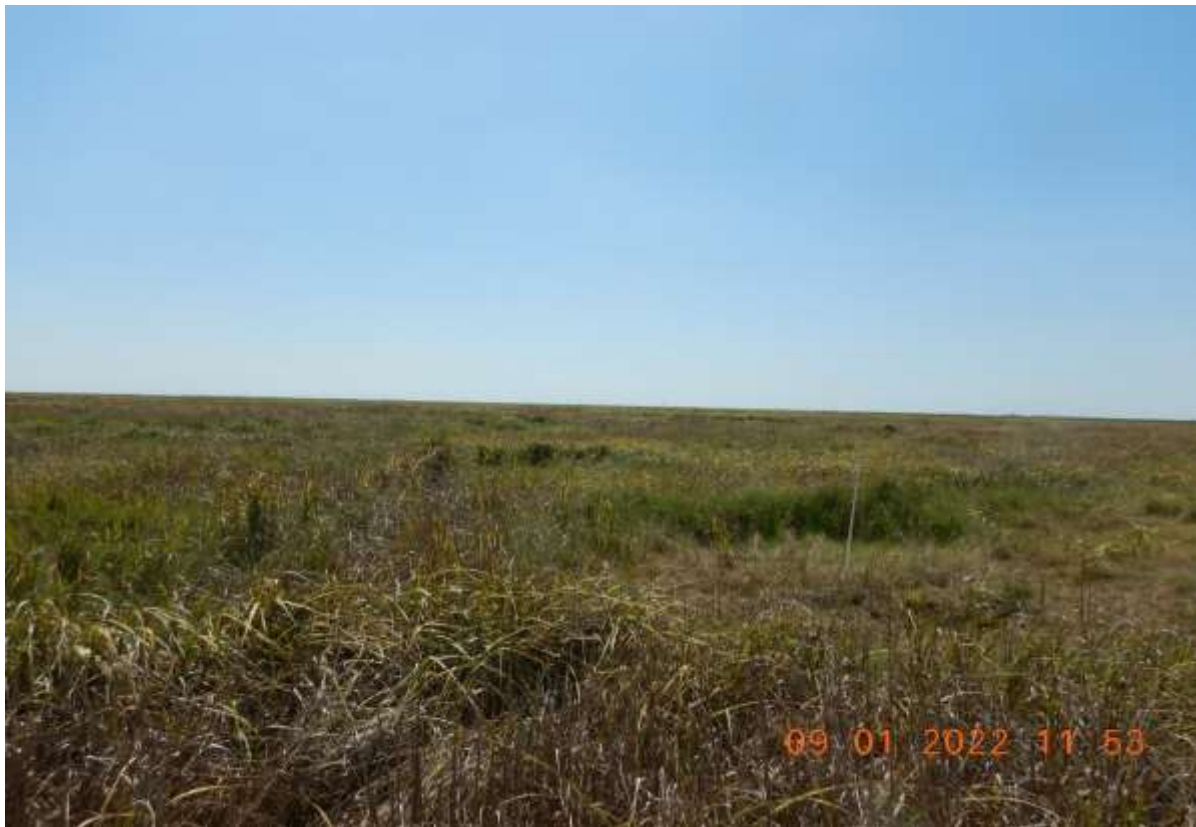
Figure 20. View of vegetation station V08 in MCA 5 on September 2022 with some drought stressed vegetation.

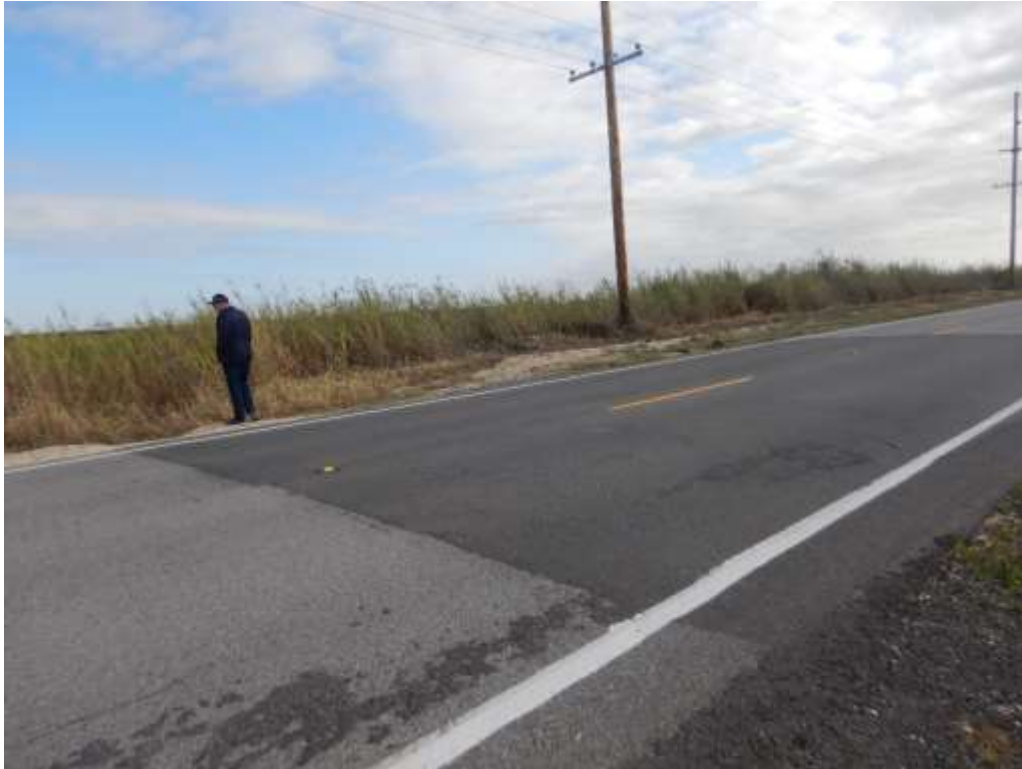
Photo 1: LA 27/82 near Entrance to CS-0059 Project Site, Highway Rehabilitation Patch Pictured (looking Southwest), 11/3/2023

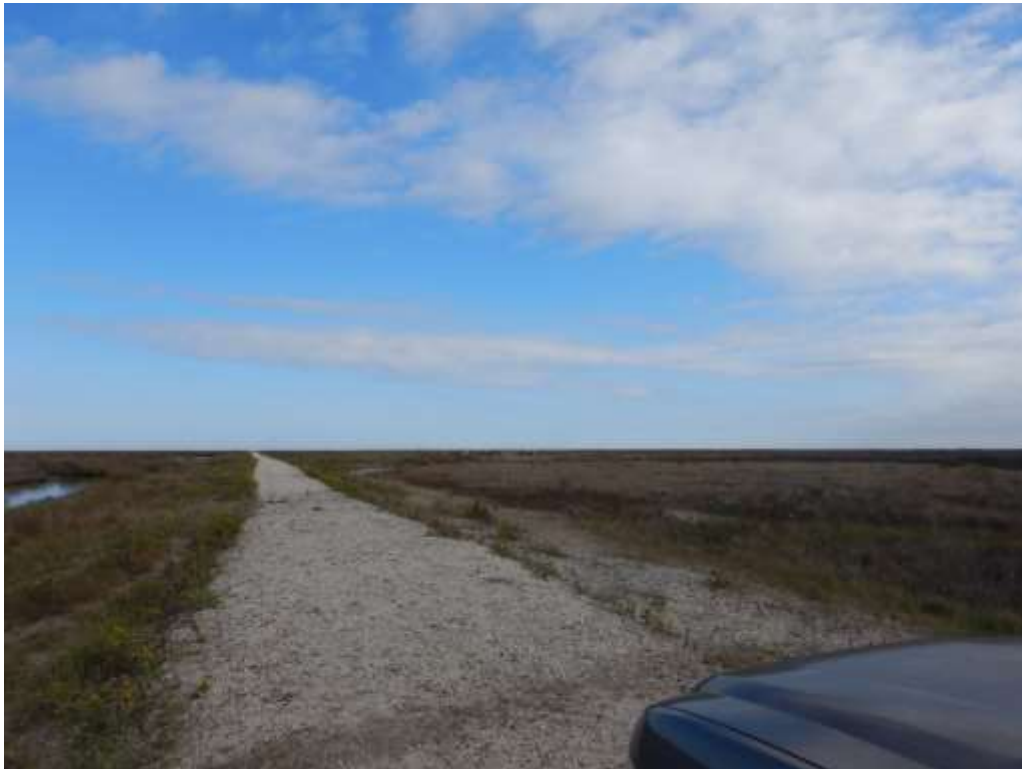
The condition of Oil Field Road was observed during the site visit and inspection, and observed to be in proper working order. Several dike gapping locations were visited, and in particular the ones observed on the eastern side of the project appeared to be promoting proper hydrologic exchange. See photos in **Appendix B**.

Photo 4: Photo of Oil Field Road with MCA3 Shown to the Right, MCA1 Pictured to the Left (looking North), 11/3/2023

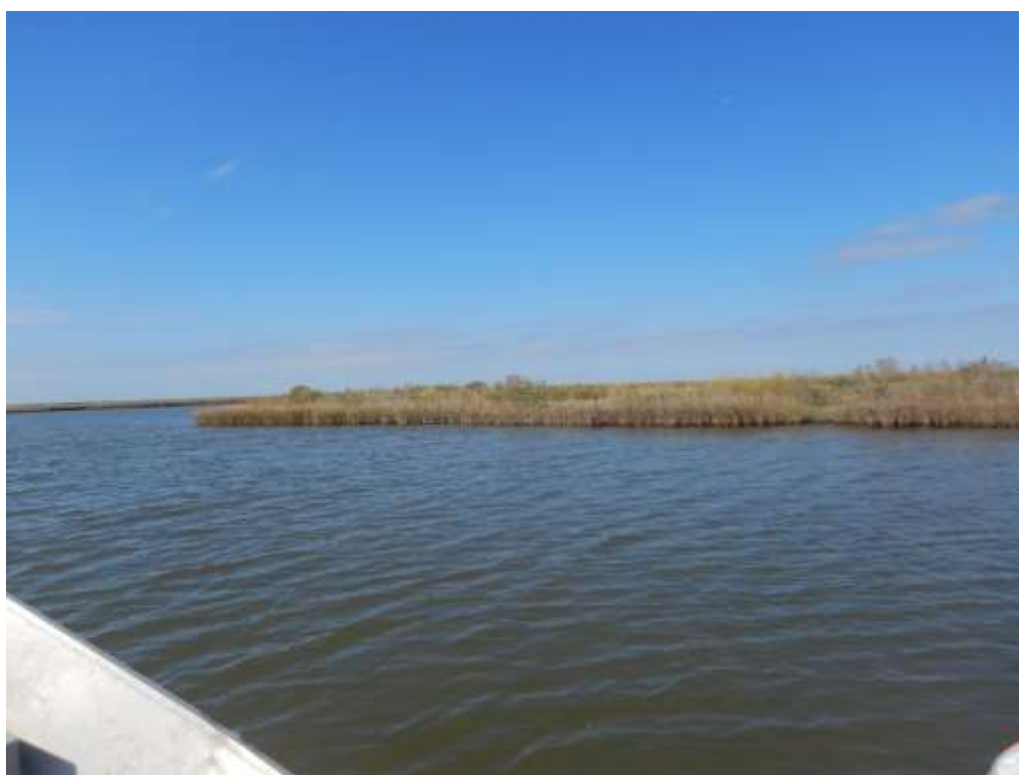
The terrace field north of MCA5 and the unconfined area appears to be functioning properly. Large expanses of marsh vegetation were seen to exist here, making the terraces themselves difficult to distinguish within the immediate vicinity—a sign of properly functioning terrace features and validating the terracing/nourishment approach used near this area during construction. No additional action is required here at this time. The CS-0059 team intends to recommend survey data is collected here during future data collection efforts supporting upcoming maintenance activity, though not the priority for the survey data collection event. See photos in **Appendix A**.

Photo 12: Photo of Constructed Terraces near unconfined nourishment area (looking North), 11/3/2023

Similar to above, CPRA recommends some survey data be collected in the terrace field, to better understand the post-construction elevations in the terrace field, which appear to be functioning very well. This surveying should only be done in tandem with the more critical survey in the marsh creation areas, and since no maintenance activity is anticipated here, survey data collection here is not a priority. Survey data collected at the terrace field can be shared with monitoring staff in order to efficiently utilize budget.

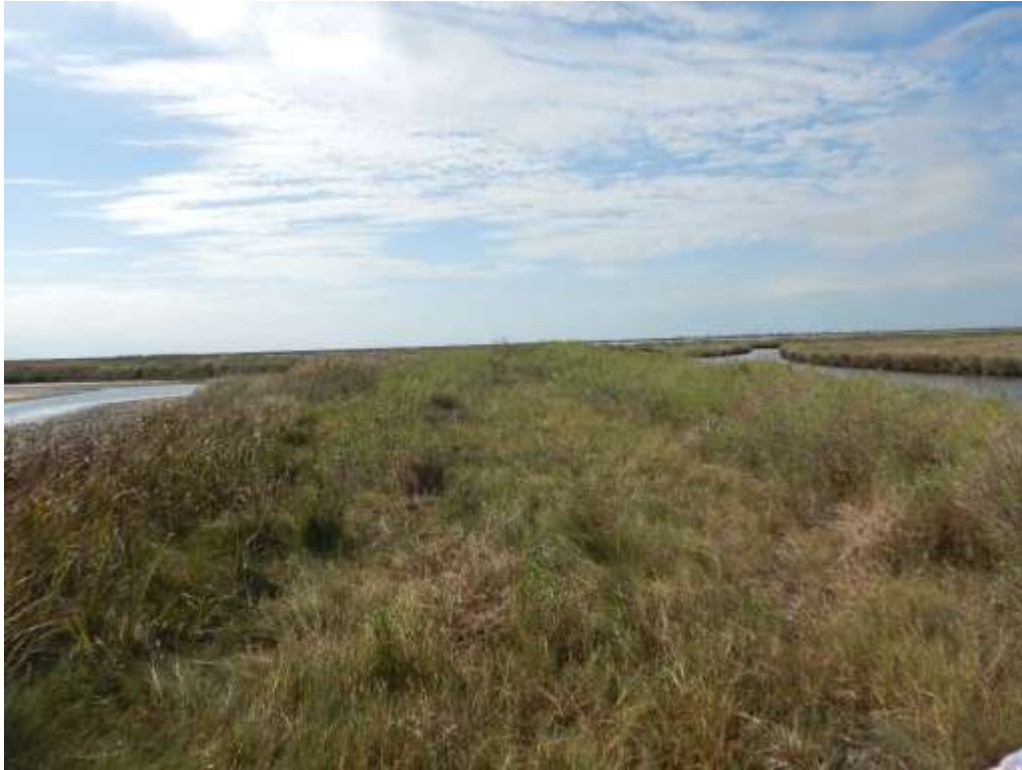
recommend for additional dike gapping, which is located between MCA1 and MCA5, as the CS-0059 team recommends surveying to more accurately identify locations to be considered for additional dike gapping via future maintenance events. See photos in **Appendix A**.

Photo 15: Photo of Remnant Earthen Containment Dike Between MCA1 and MCA5, MCA5 Pictured to the Right, MCA1 Pictured to the Left (looking East), 11/3/2023

As stated in Aucoin 2020, 48 gaps; the locations of which were chosen to be adjacent to nearby tidal creeks, waterbodies, or prior weir box locations of the containment dikes was done by the construction contractor at the end of construction. It is possible that additional gapping in the future may be necessary and will continue to be evaluated. In order to more fully promote hydrologic exchange at the project site, CPRA recommends to prepare for a dike gapping project in an upcoming O&M event, by first collecting survey data throughout the project site to best identify prospective gap locations. CPRA believes that this survey data could be timed a bit later in the post-construction lifespan of the project, to capture elevations at a later point in the settlement curve, when settled elevations across the project begin to approach an intersection with eustatic sea level rise rates.

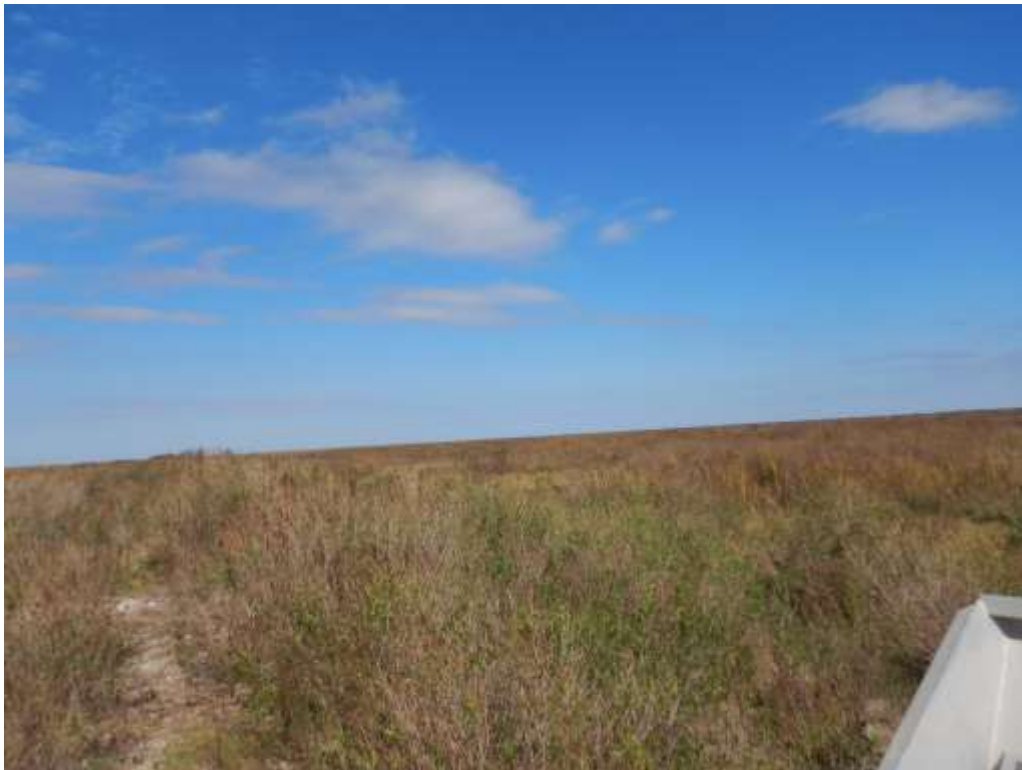
Photo 16: Photo Emphasizing High Containment Dike Area Near MCA1/MCA5 Boundary, This Location Likely to Receive Gapping via Future O&M Event, 11/3/2023
