2021 Operations, Maintenance, and Monitoring Report

Cameron Creole Maintenance

State Project Number CS-04a
Priority Project List 3

September 2021
Cameron Parish

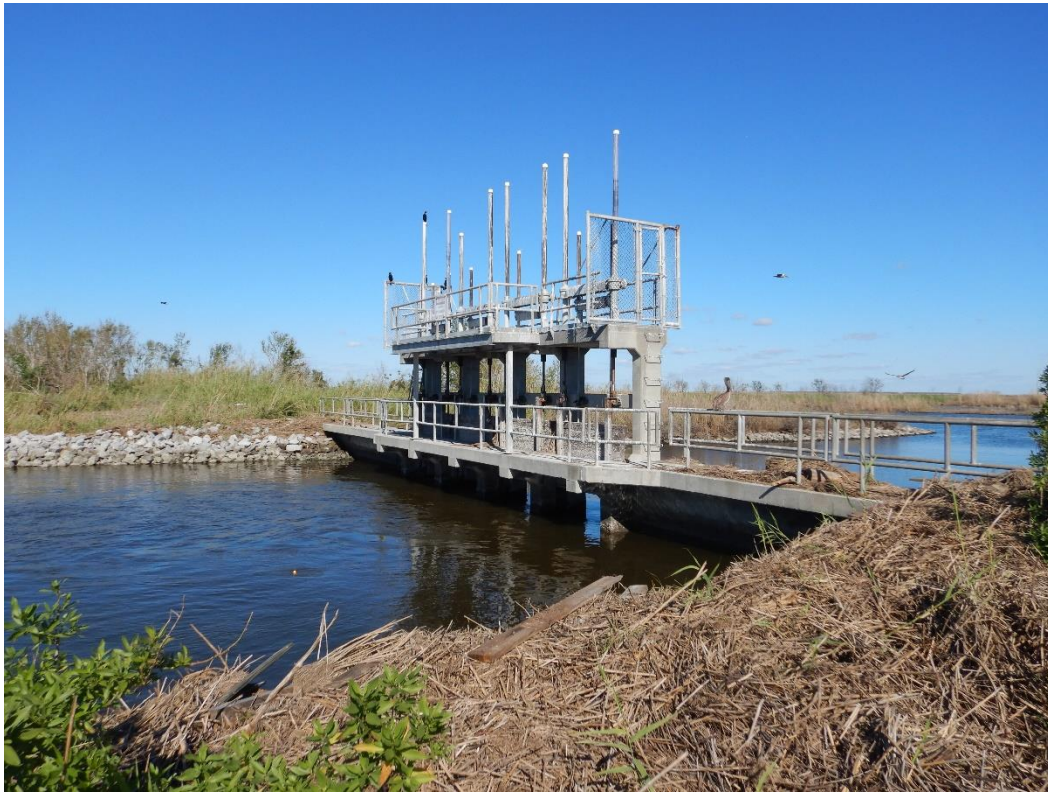
Peconi Bayou Structure –	Storm debris on structure. No physical damage to structure.
Mangrove Bayou Structure –	Storm debris on structure. Southernmost gate not operating properly. The outlet (lakeside) is silted in following Hurricane Delta.
Grand Bayou Structure –	Storm debris on structure. Two (2) gate boards on one of the gates were detached from the gate. There was damage to the walkway. Boat bay guides were detached from anchors.
Lambert Bayou Structure -	Storm debris on structure. The handrails and fencing are detached from the structure. Stairs to the upper platform are damaged.

Photo No. 1, Peconi Bayou Water Control Structure – No damage to structure.

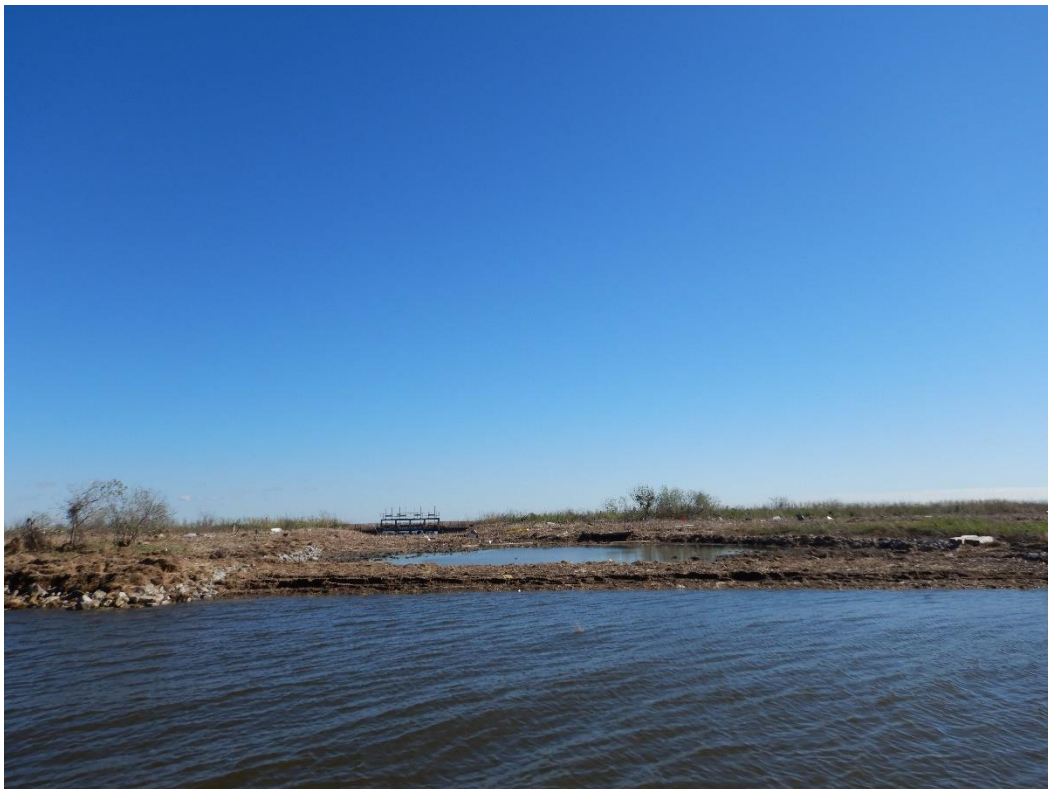
Photo No. 2, Mangrove Bayou Water Control Structure – Siltation on outlet (lakeside) of the structure.

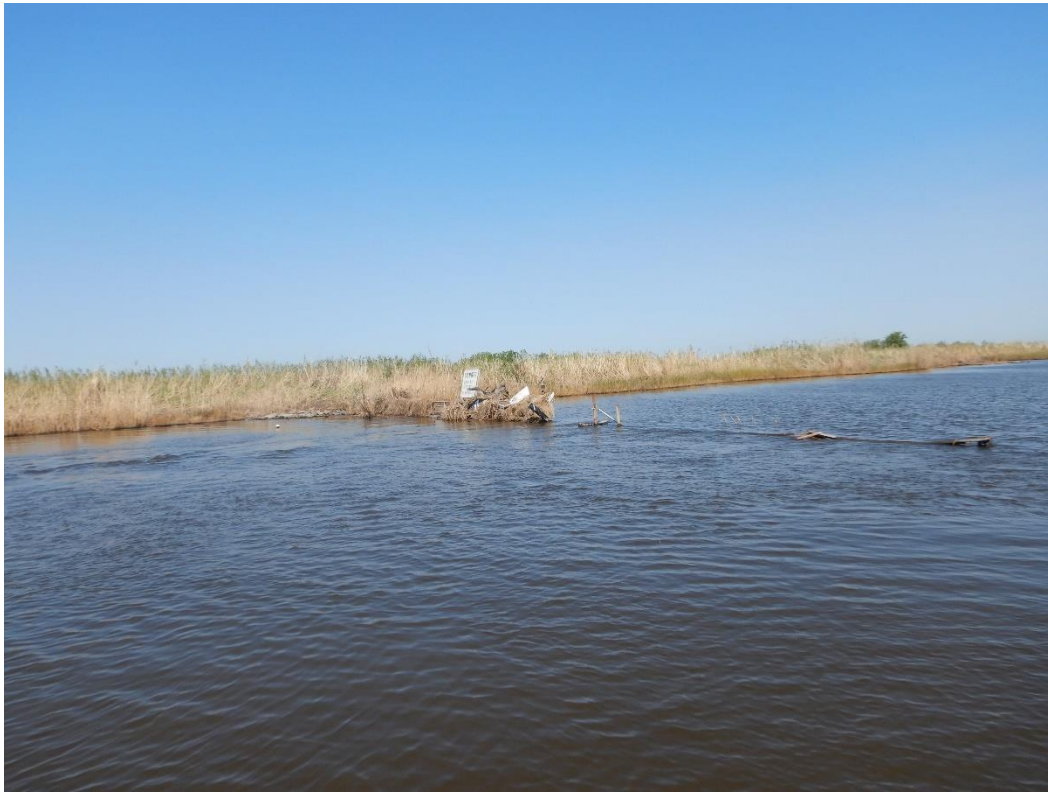
Photo No. 3. Mangrove Bayou Canal Plug – Failing railing and signage.

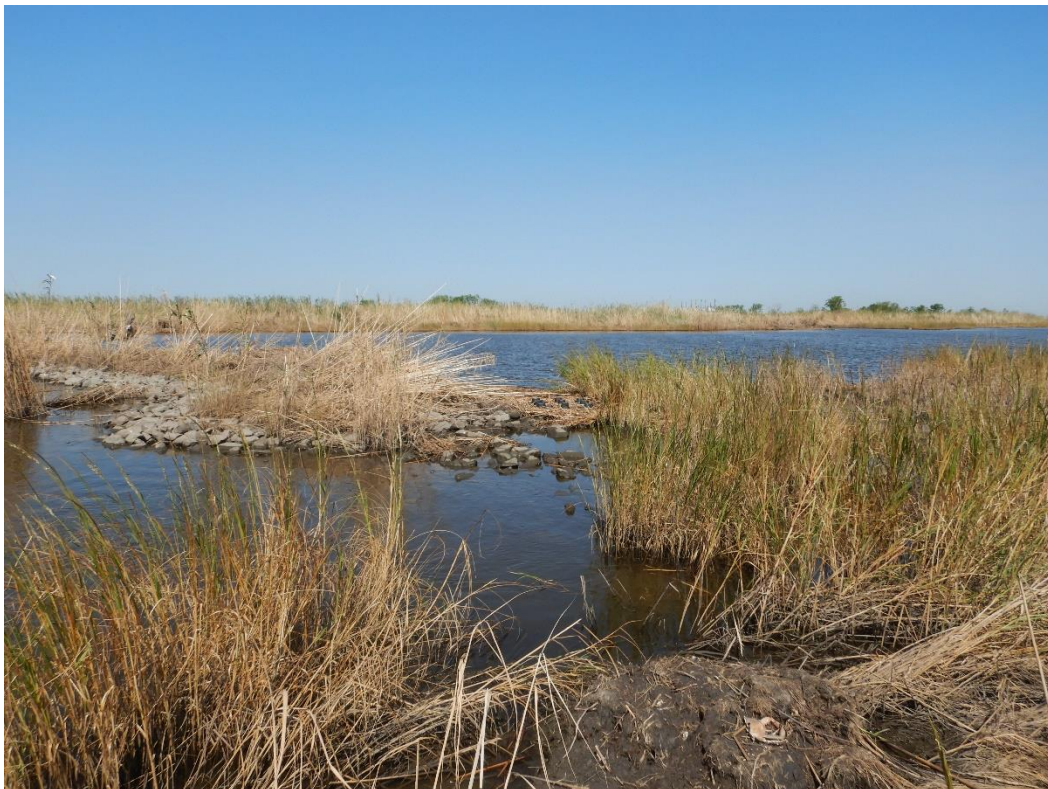
Photo No. 4. Mangrove Bayou Canal Plug – Erosion and scour on east side of structure.

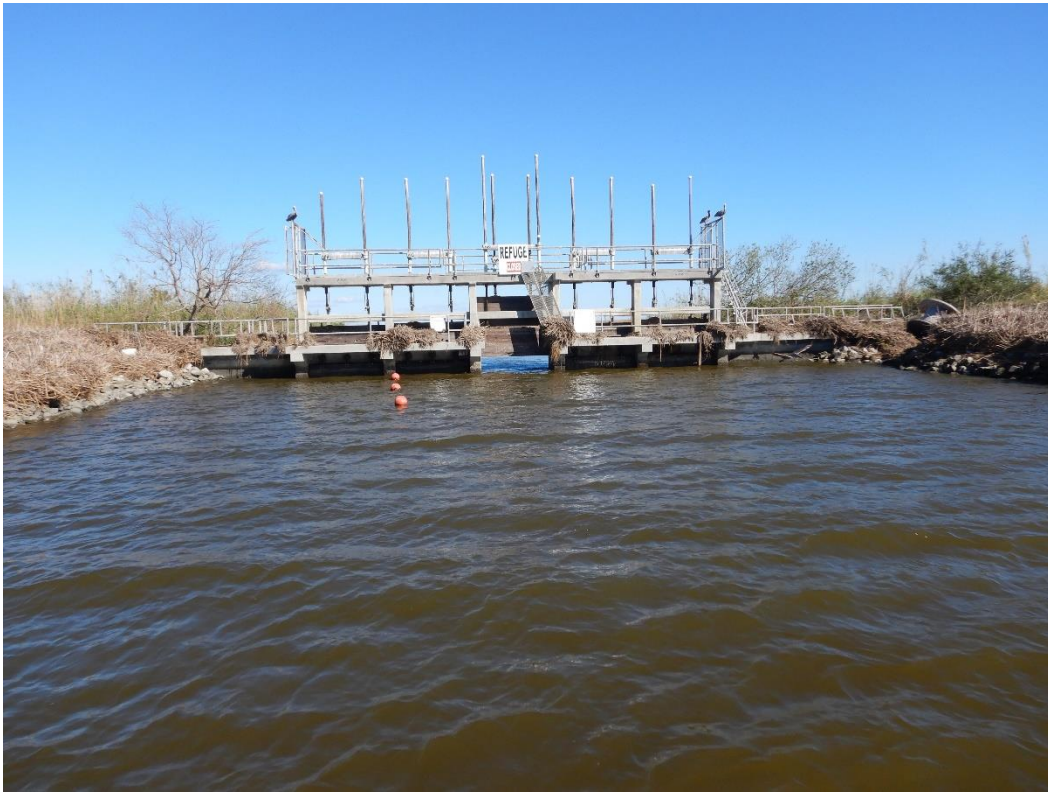
Photo No. 5, Grand Bayou Water Control Structure – Minor erosion and scour around end of structure.

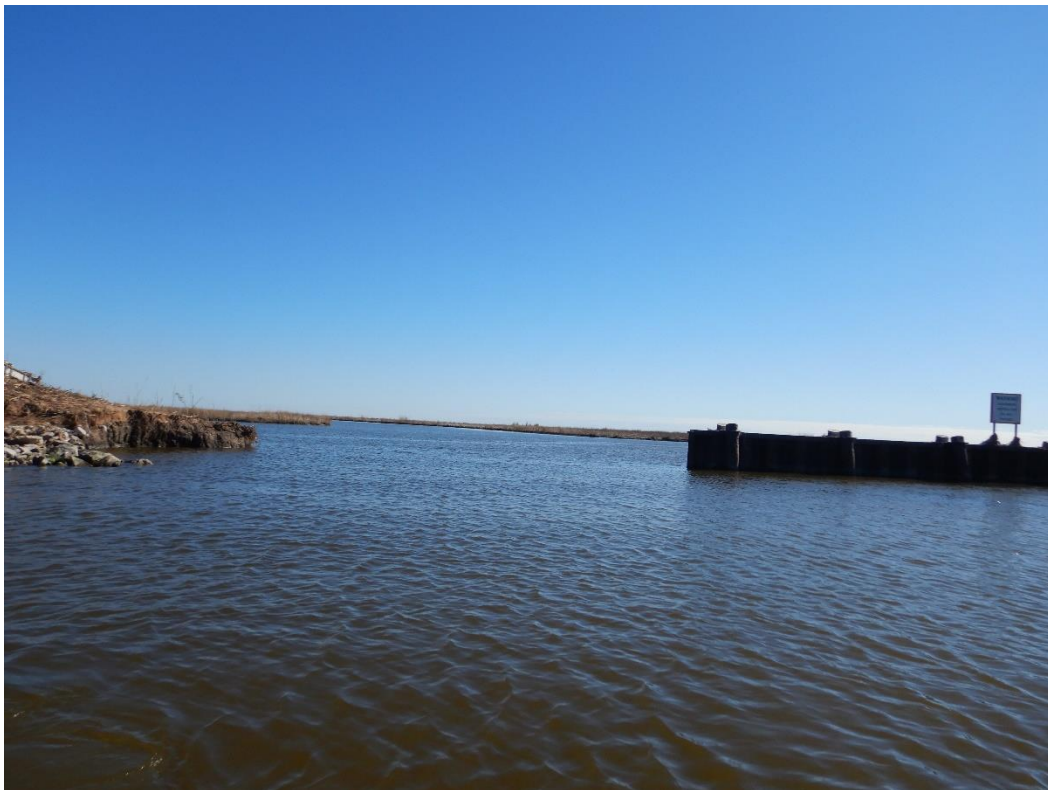
Photo No. 6, Grand Bayou Breach – Breach in levee at 2006 Rita repair.

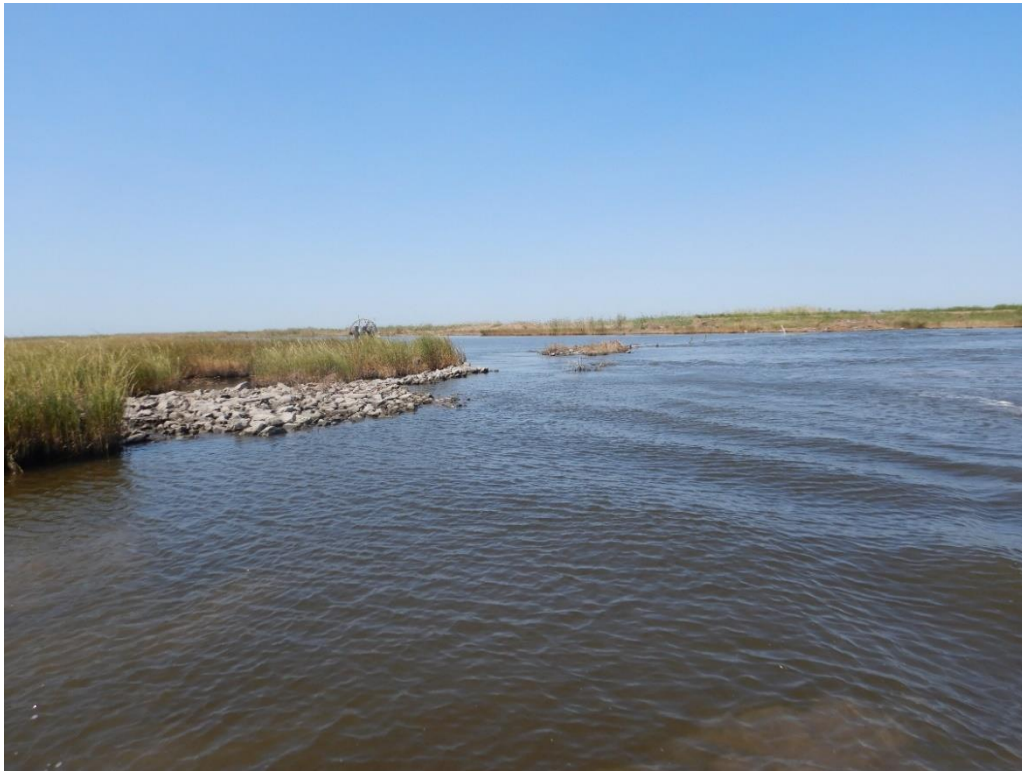
Photo No. 7, Grand Bayou Canal Plug – Railings in need of repair. Erosion and scour on east side of plug.

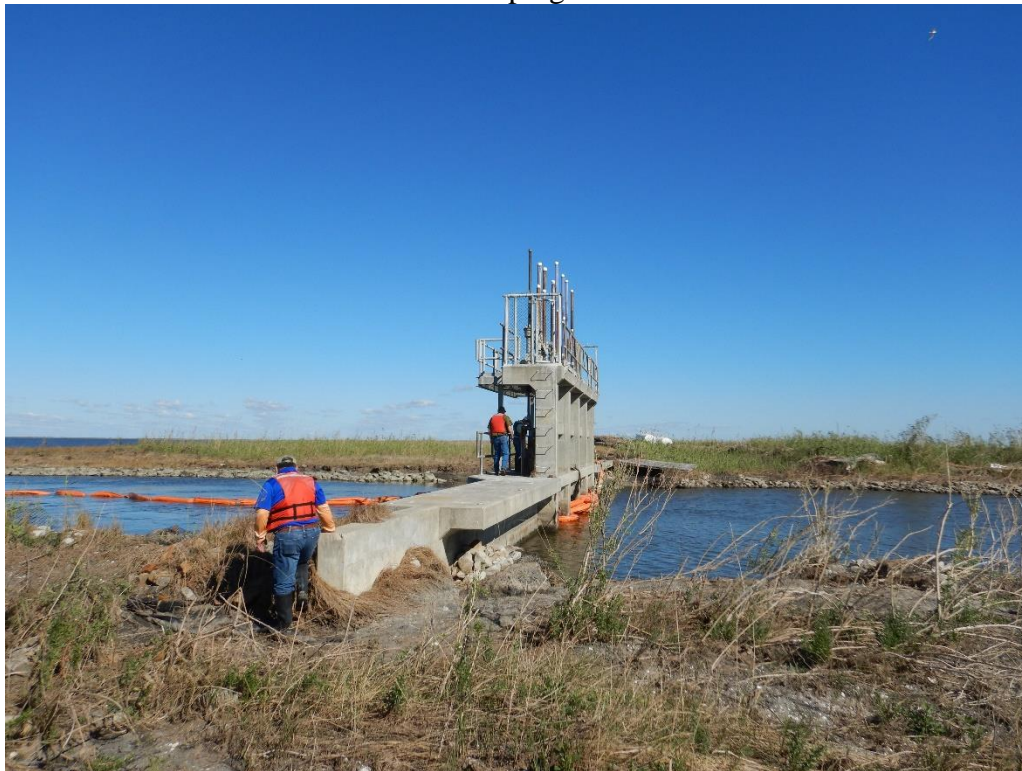
Photo No. 8. Lambert Bayou Water Control Structure – some scour and erosion on the land bridge connecting the water control structure to the sheet pile breach.

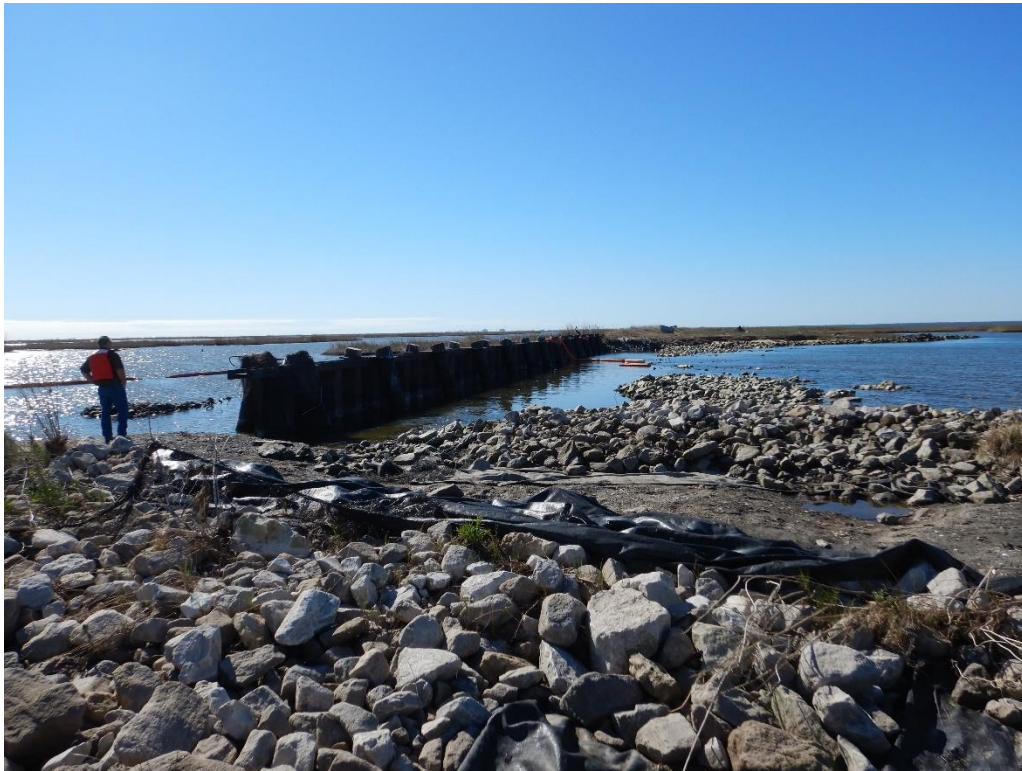
Lambert Bayou breach repair – approximately 15-20 feet of levee has scoured at the northern end of the sheet pile structure. Pending further investigation, the depth of scour is unknown. It is also believed the levee connecting the breach repair and the water control structure has been reduced in elevation from the storm surge passing over it.

Photo No. 9. Lambert Bayou Breach – Scour on northern end and along sheet pile structure.

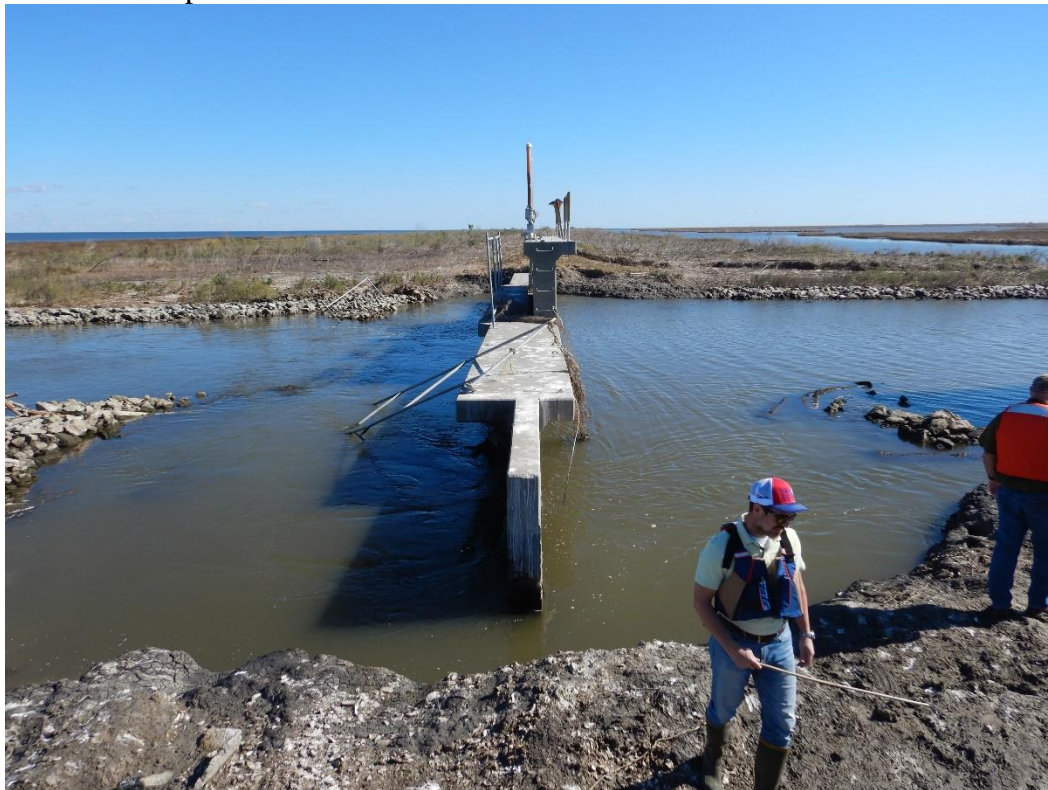
Storm debris on structure. The handrails and fencing are detached from the structure. There is scour on both ends of structure.

Photo No. 10. No Name Bayou Water Control Structure – Significant scour on each end of the structure.

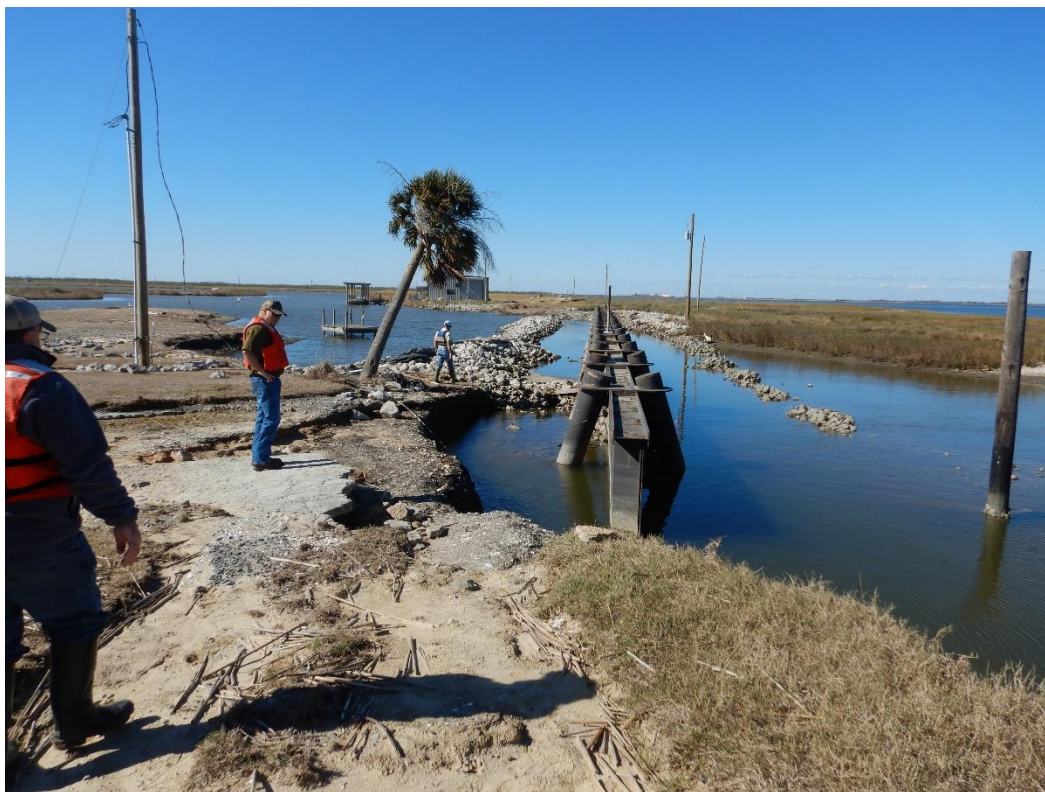
No Name Bayou breach repair – there is some significant scour on the eastern end of the sheet pile structure and minor scour on the western end. Rock along the entire length and ends of the structure has been displaced or washed away from storm surge. A landowner access road has been washed out along the entire length (350 feet) of the south side of the sheet pile structure.

Photo No. 11. No Name Bayou Breach – Scour along and on ends of post Rita sheet pile repair.
