**Coastal Protection and Restoration
Authority of Louisiana (CPRA)**

**2022 Operations, Maintenance,
and Monitoring Closeout Report.**

**SWEET LAKE/WILLOW LAKE
HYDROLOGIC RESTORATION**

State Project Number CS-11B
Priority Project List 5

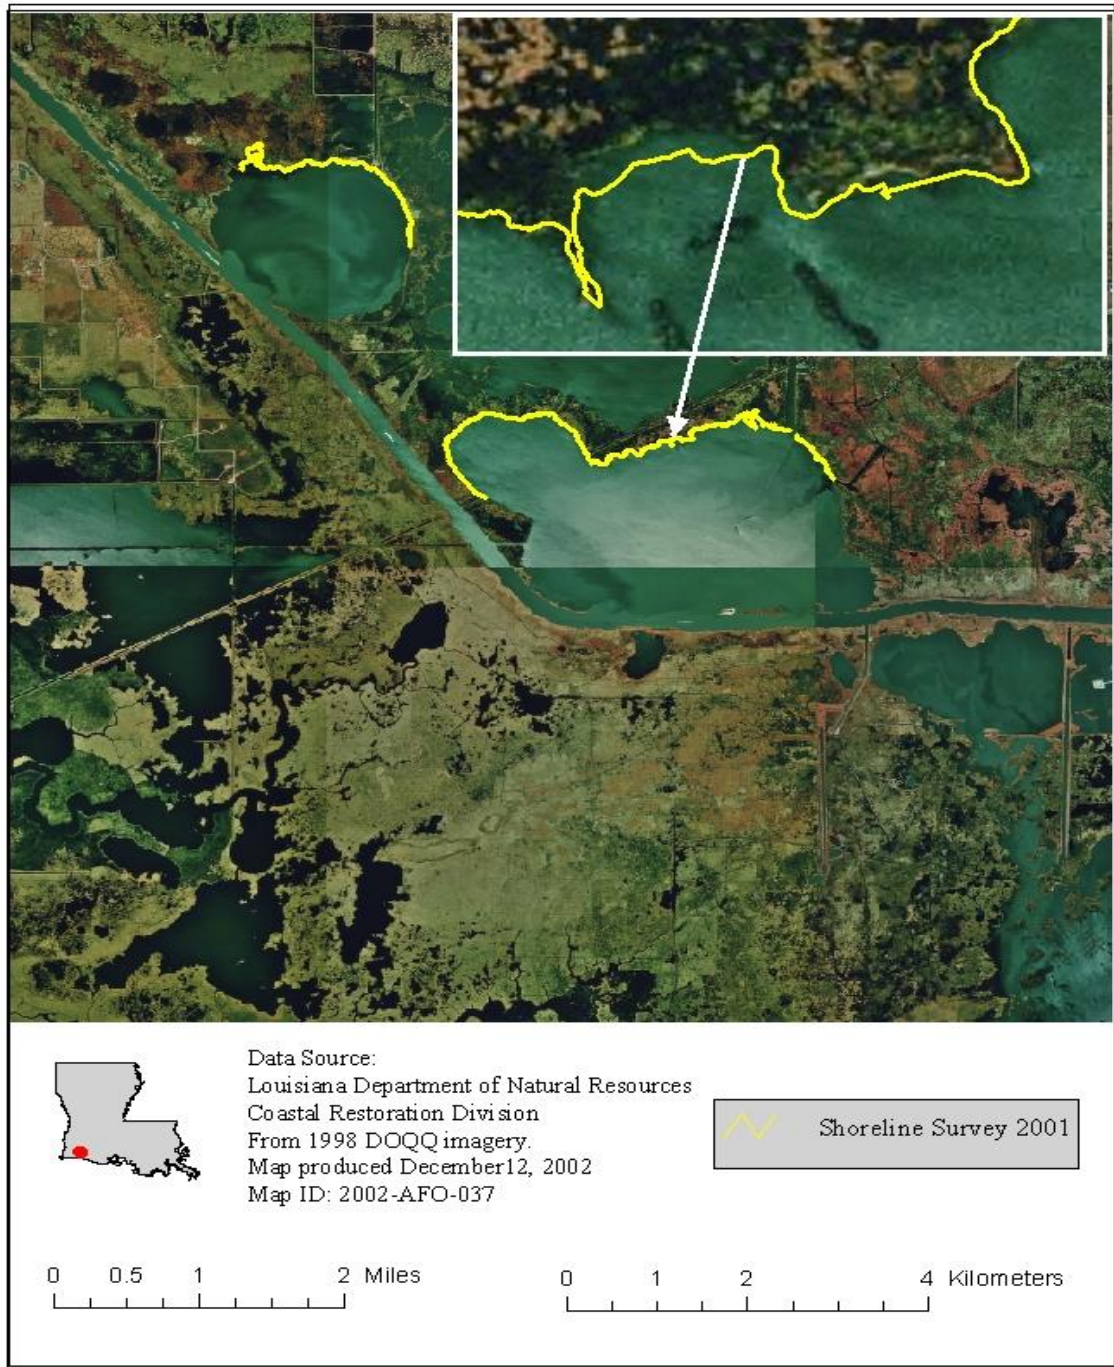
DGPS readings to document shoreline position were collected in August 2001 (pre-construction) as baseline data (Figure 5). Due to elevated water levels and constant wave poundings, a rapid deterioration of the terraces occurred within the first year. The shoreline terraces were deemed ineffective and the 2004, 2009 & 2016 post construction shoreline

Figure 5. Baseline shoreline position survey of the Sweet Lake/Willow Lake Hydrologic Restoration (CS-11b) project area from data obtained August 2001.

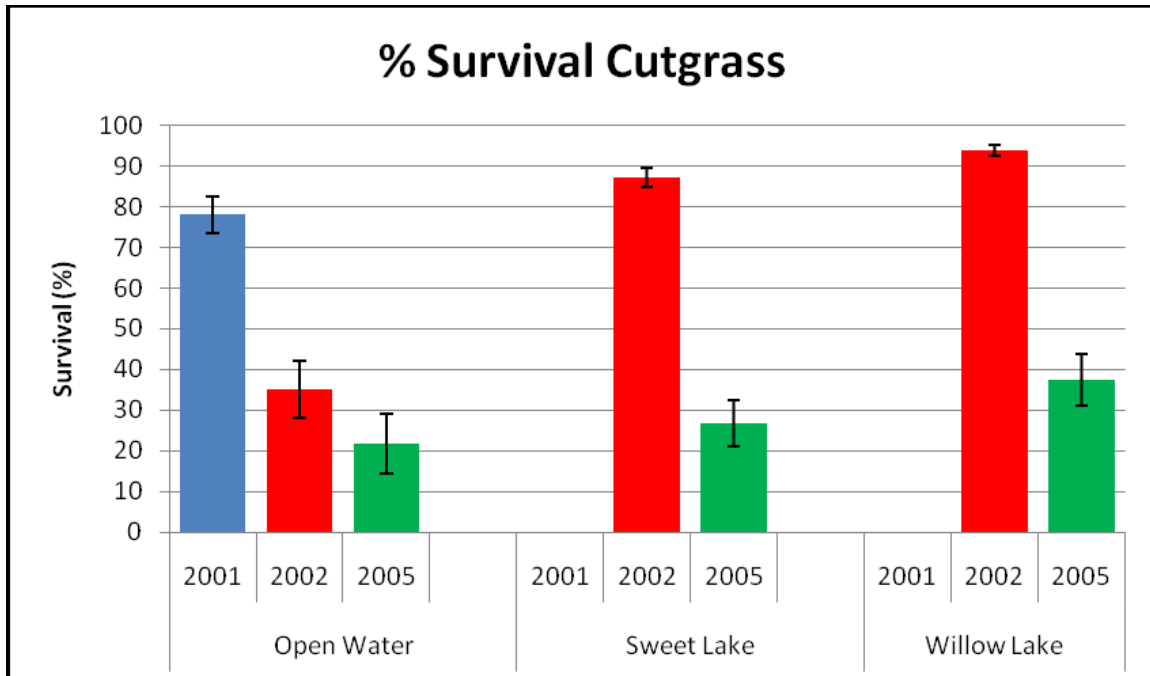
Zizaniopsis miliacea (giant cutgrass) plantings installed in 2001 and 2002 did not survive beyond the first few years. Generally, % survival of plantings on the terraces in all three areas planted reduced from about 80% to about 30% between 2001/2002 and 2005 (Figure 6).

The failure of the *Z. miliacea* was due to elevated water levels, wind driven fetch, and resulting erosion of the terraces. Most of the plantings washed away within the first year. The goal of reducing shoreline erosion with terraces was not achieved.

Figure 6. Mean percent survival of cutgrass (*Zizaniopsis miliacea*) plantings on the Open Water, Sweet Lake and Willow Lake terraces for 2001, 2002 and 2005 sampling periods.

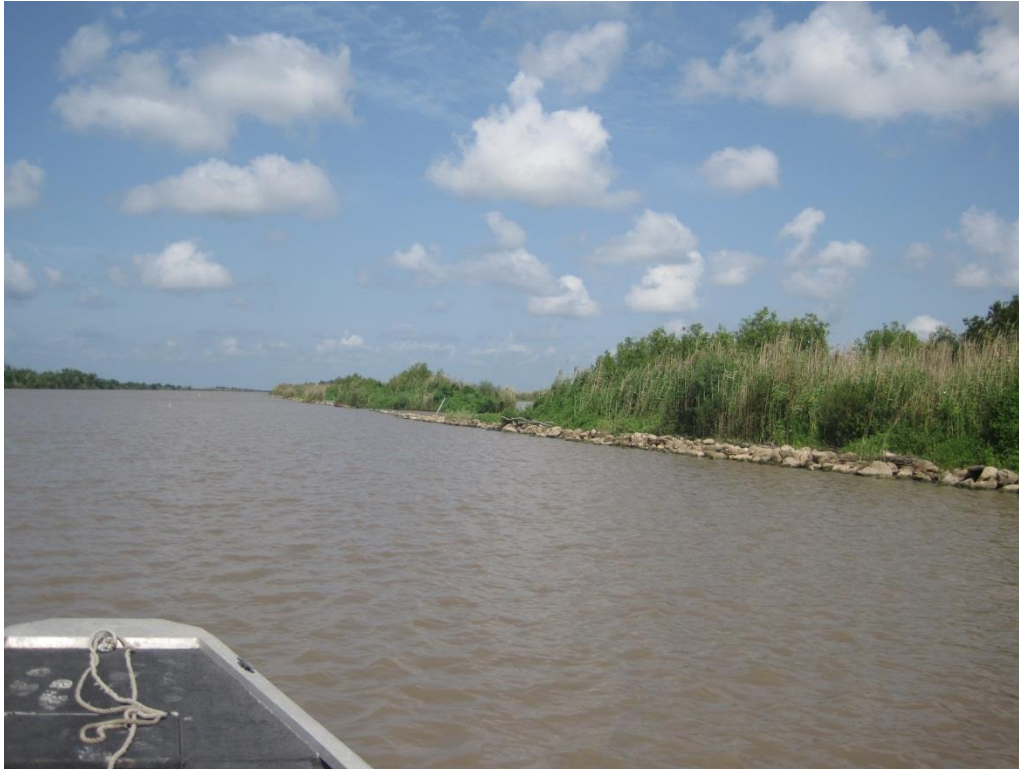
Photo No. 1, (Sweet Lake) Typical rock dike

| Item | Condition | Physical Damage | Corrosion | Photo # | Observations and Remarks |
|---|---|---|---|---|---|
| Foreshore Dike | Good | | | 1 | 300 Linear feet of dike on eastern edge of Willow is low,. Also, there is a 50 foot section of rock dike that has apparently been pushed back. Another 4 foot section is missing in another area. |

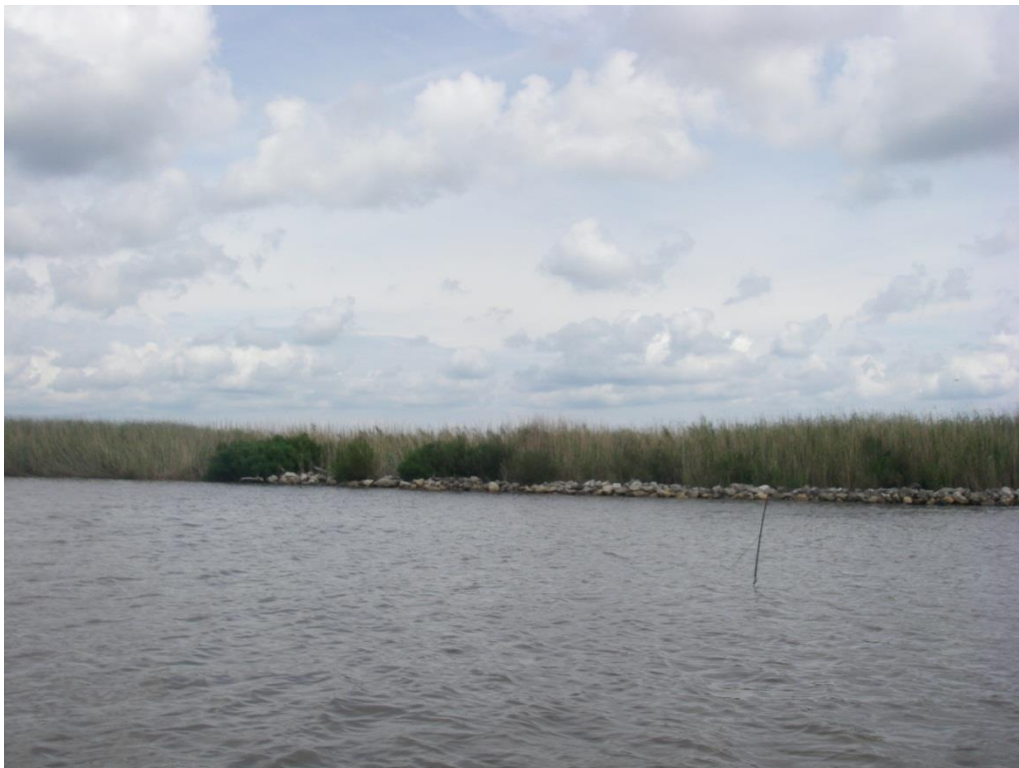
The dikes were in reasonably good condition. There were a few low places along the length of the rock dike. The most significant low stretches were along the open water areas adjacent to Sweet Lake. There was an additional low area approximately 50 feet length along the very eastern end of the project area where the dike appears to have been “pushed back” 10-12 feet apparently by a barge. There is another area approximately 4 feet long in which the dike appears to have been removed by hunters or fishermen. Several settlement plates are either broken or leaning and are of no use. No gauges were available in the vicinity to determine water levels. The shallow water terraces of the project were not visible because their condition had deteriorated earlier in the project and due to high water conditions in Sweet Lake and Willow Lake. (Photos: Appendix A, Photos).

Photo No. 2, Western End of Sweet Lake Rock Dike

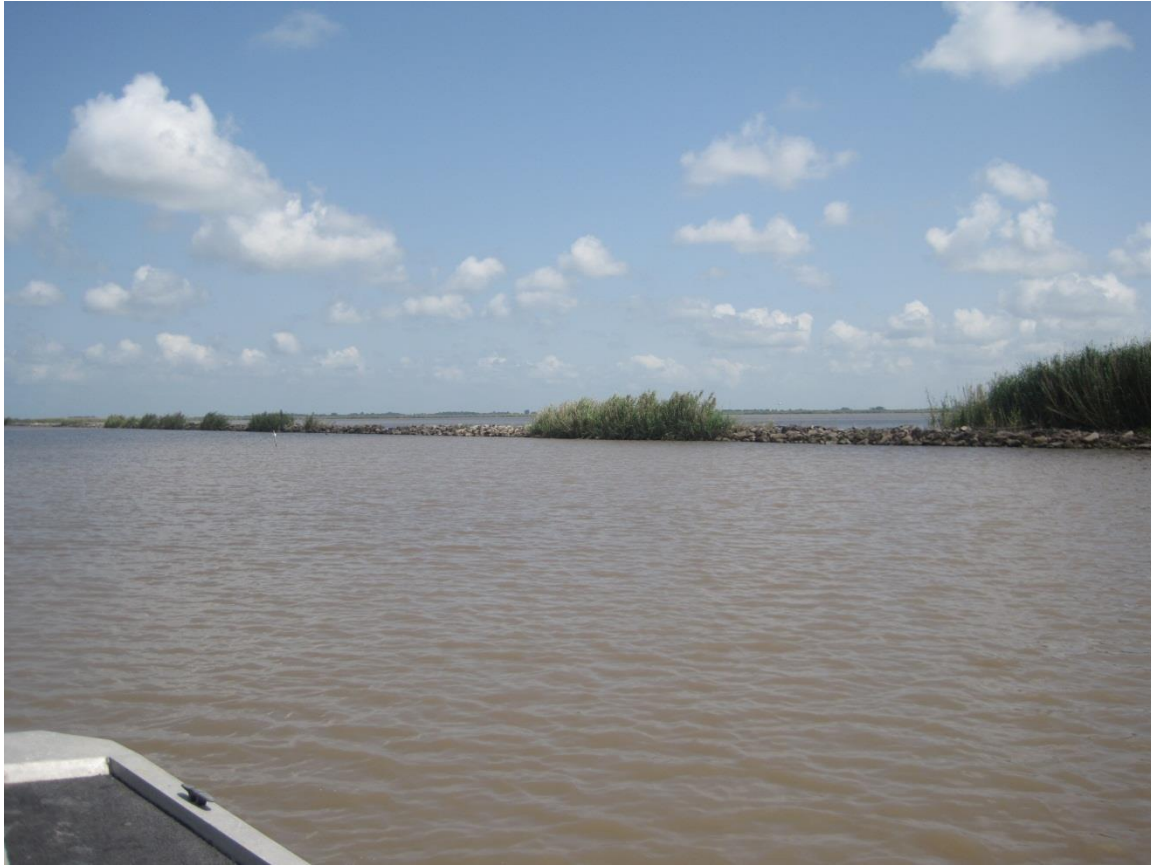
Photo No. 3, Willow Lake Rock Dike (Southeastern End)
