## **2020 Operations, Maintenance, and Monitoring Report**

### **Black Bayou Culverts Hydrologic Restoration**

State Project Number CS-29  
Priority Project List 9

DEC 2020  
Calcasieu and Cameron Parishes

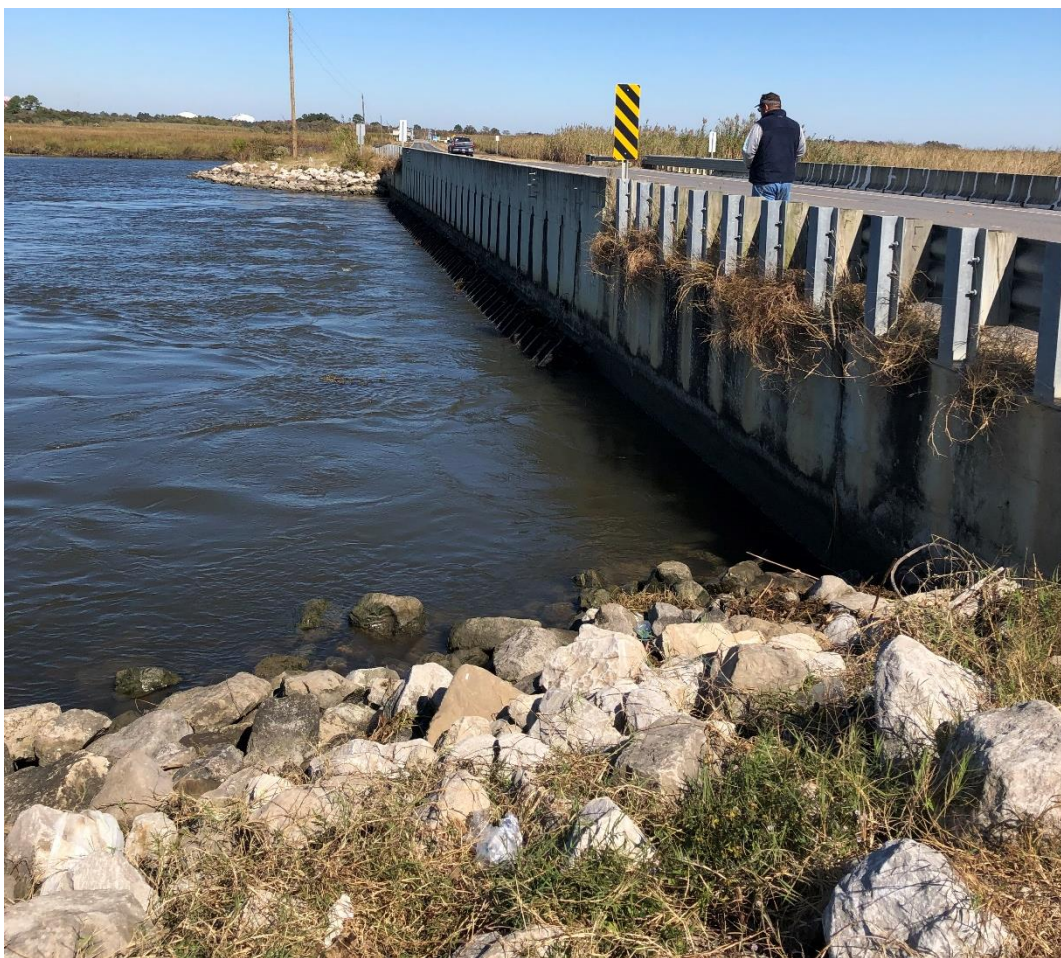
The visible rock rip rap was in good condition. (Photos: Appendix A, Photos 1, 2, 5, 6 & 7)

**Photo No. 1, West Side of Box Culvert Structure (Looking North) -November 2019**

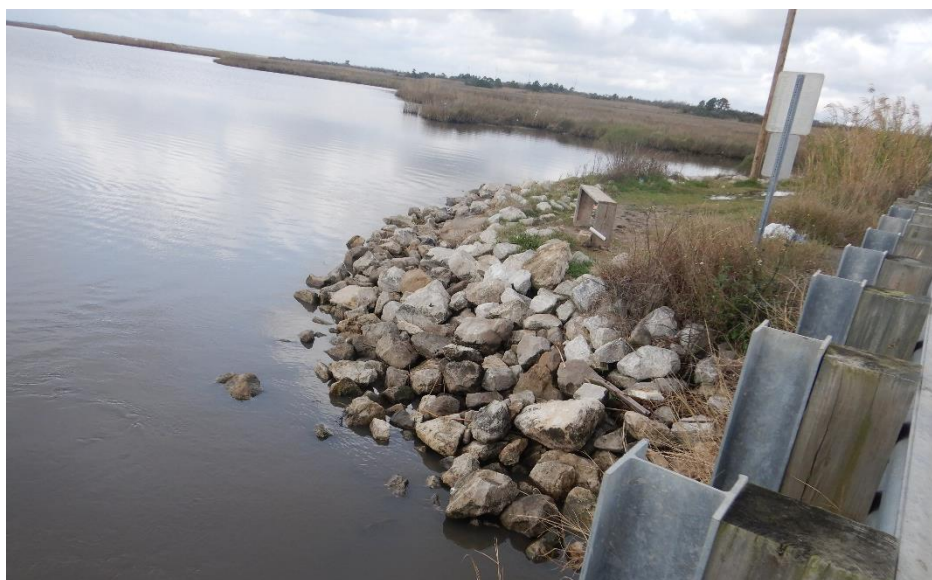
**Photo No. 2, West Side (Looking North) – Rip Rap on North Bank of the Channel- January 2020**

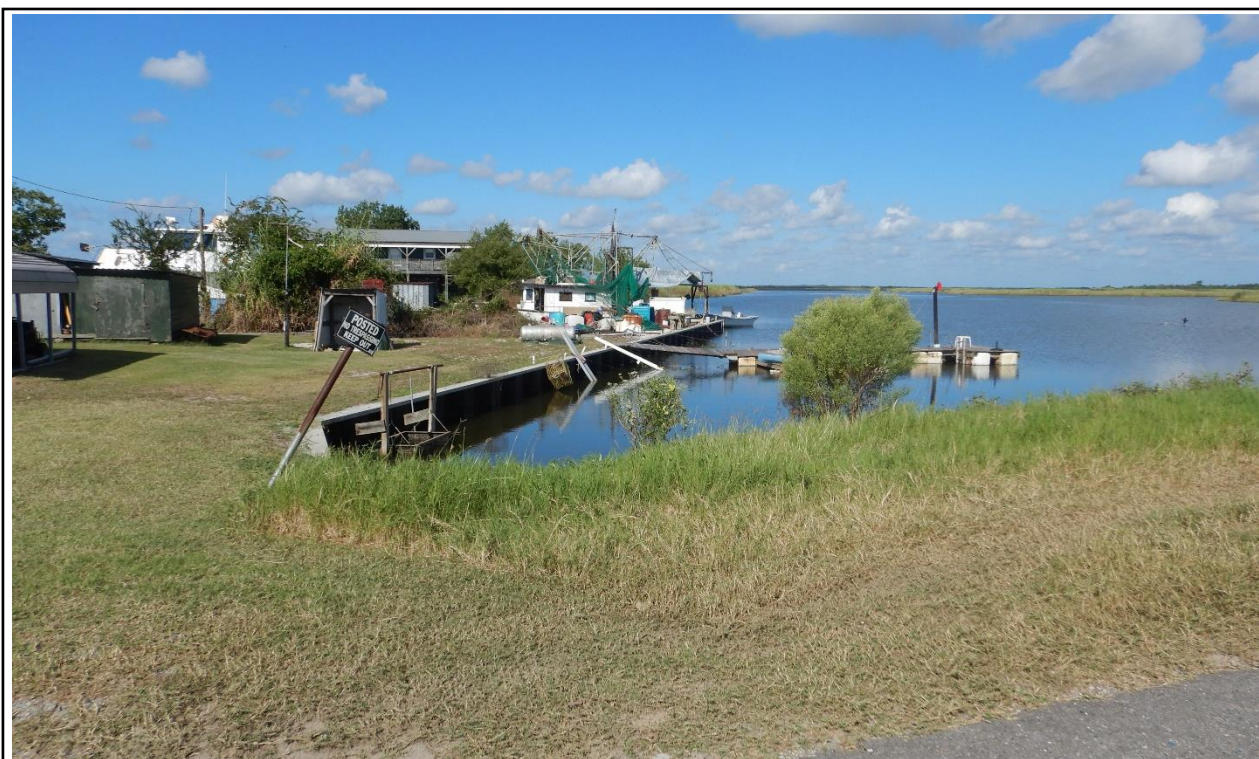
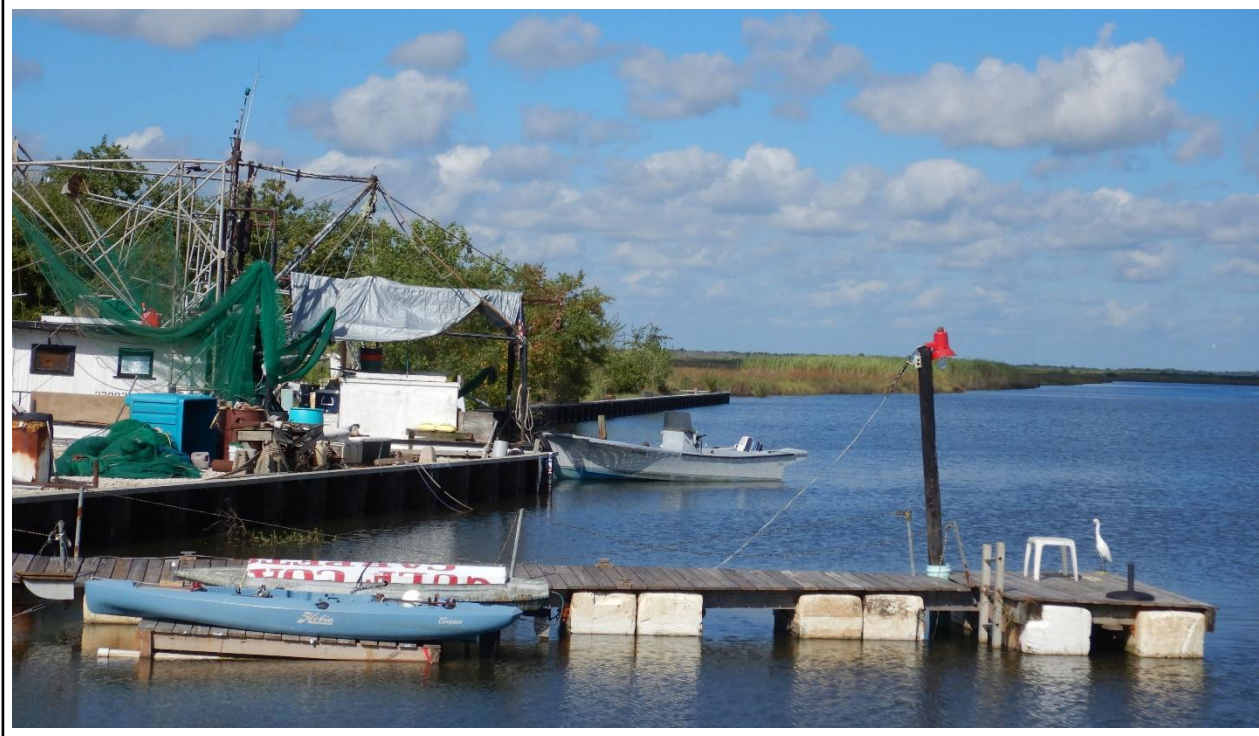
The steel sheet pile bulkhead was in good condition. (Photos: Appendix A, Photo 3)

**Photo No.3,** West Side of Box Culvert Structure, Steel Bulkhead - October 2019

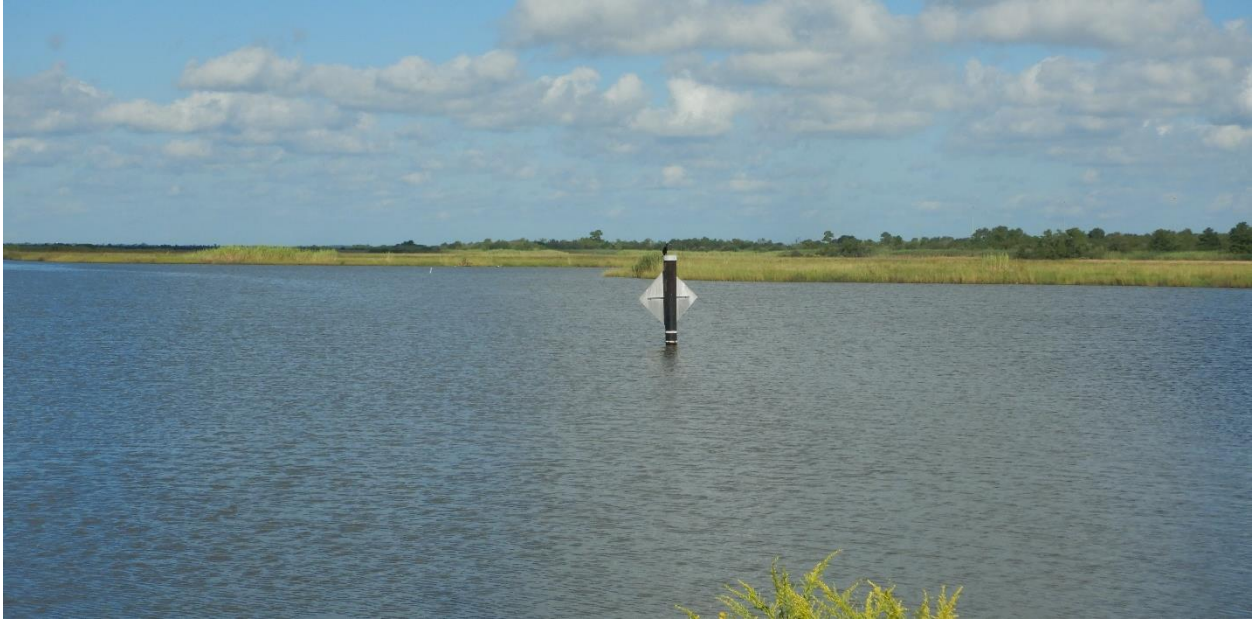
**Photo No.4,** West Side of Box Culvert Structure, Warning Sign- October 2019

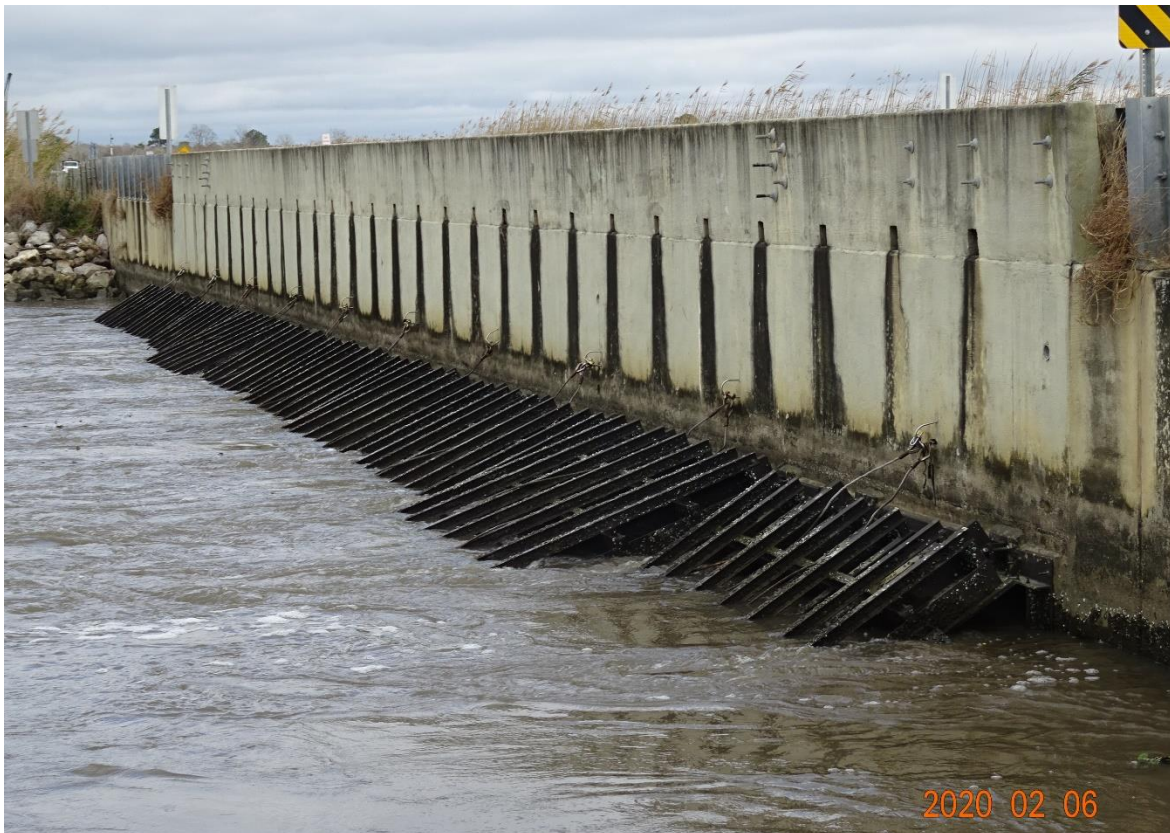
**Photo No. 5,** West Side of Box Culvert Structure, Flapgates & Headwall- February 2020

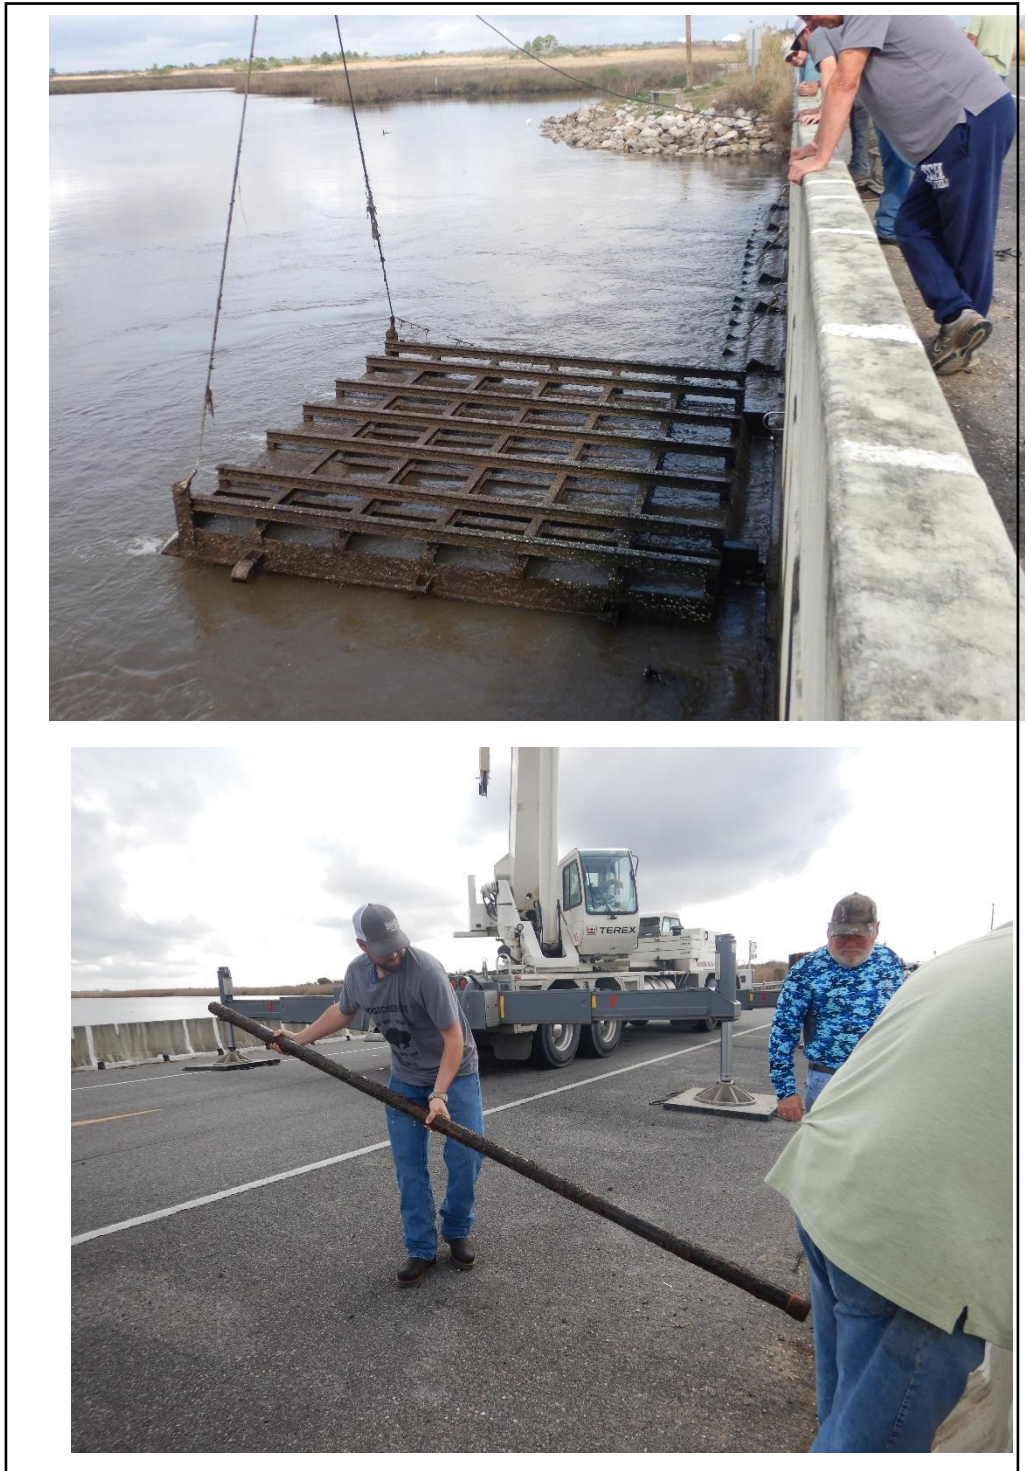
The flapgates were free flapping as intended; however, seven gates have broken locking rings and/or stop plates which require repair. See attached Inspection Report in Appendix C. All but Gate No. 4 can be locked down when necessary with the remaining intact rings. A 10ft piece of steel drill pipe was found in the headwall locking rings in an attempt to prevent the gate from closing. However, the pressure of the water on the gate at high tide crushed the aluminum rings. There are stop plate welds that are broken which could be the result of a pipe

**Photo No. 6,** West Side of Box Culvert Structure,  
Flap Gate No. 4 – Broken Locking Rings & Steel Drill Pipe - January 2020

Estimates are being obtained to repair Gate No. 4 and any additional locking rings permissible within the project budget. Repairs are required to be sequenced in groups of three gates per one event in order to use the sluice gates to isolate the culverts while the flapgates are removed from the structure.

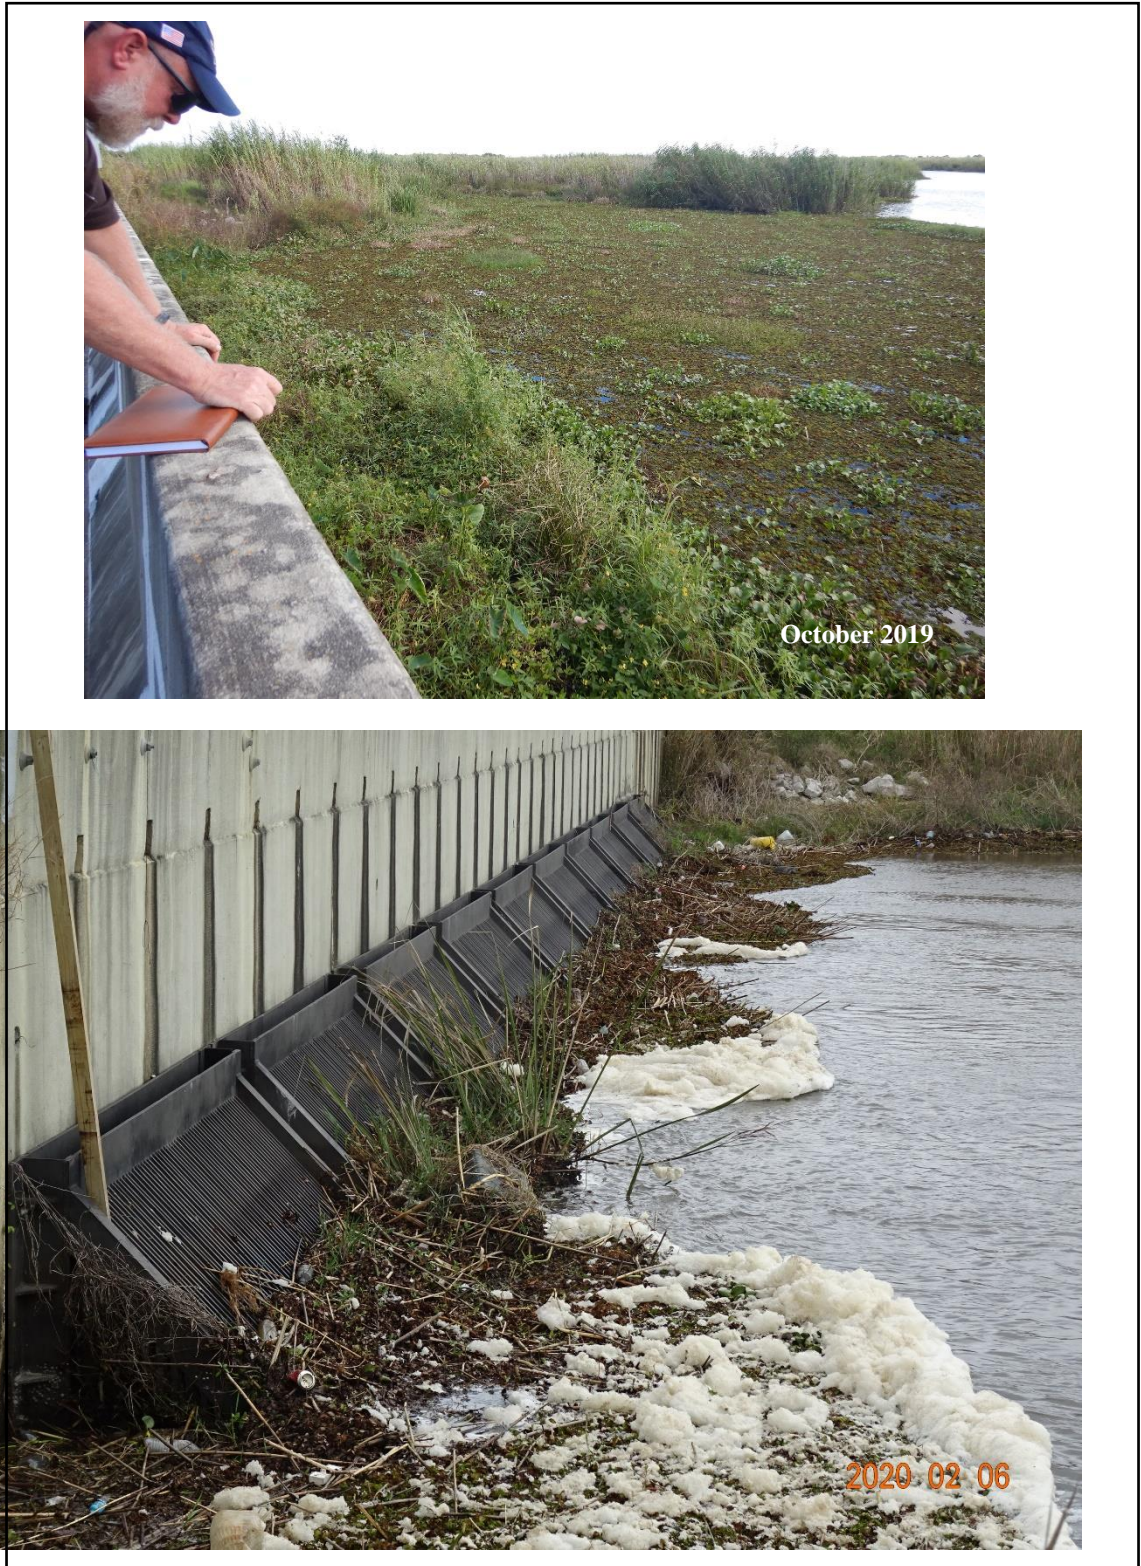
The trash screens on the east side of the structure were working as intended. There was floating vegetation and debris collecting at the trash screens. During additional visits, it was found the debris does migrate back into the GIWW or pass through the structure as the hydraulic conditions fluctuate. (Photos: Appendix A, Photo 7)

**Photo No. 7,** East Side of Box Culvert Structure (looking North), Trash Screens, Vegetation & Debris (October 2019 & February 2020)

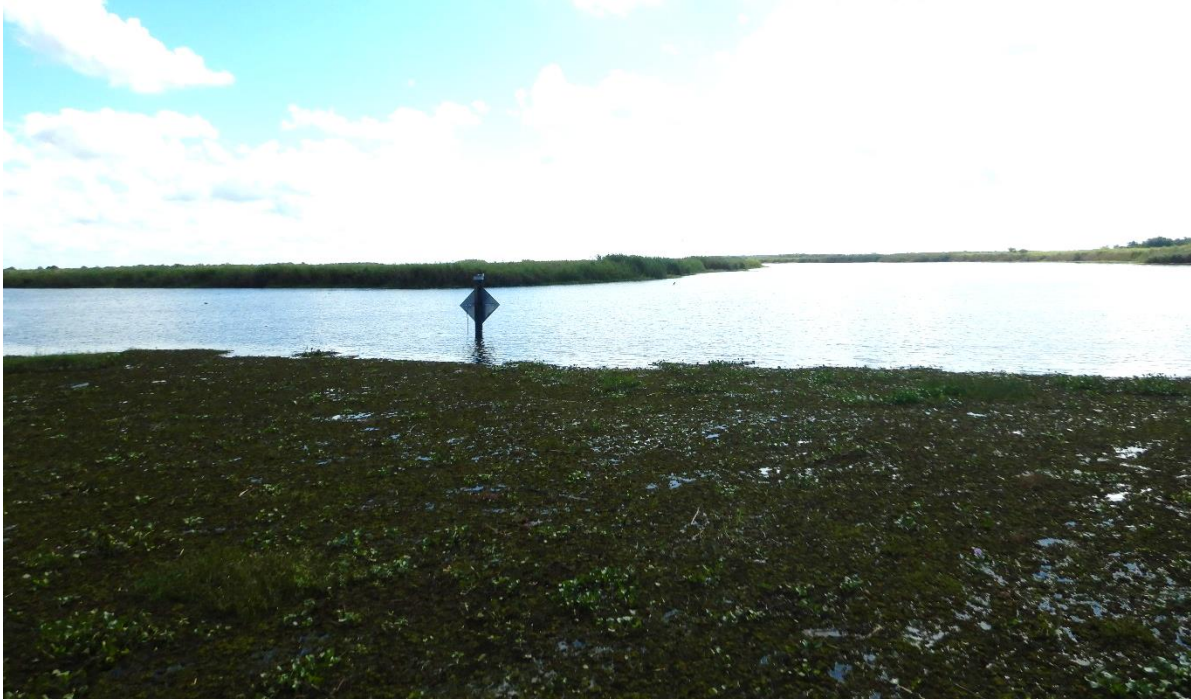
**Photo No.8,** East Side of Box Culvert Structure, Warning Sign - October 2019

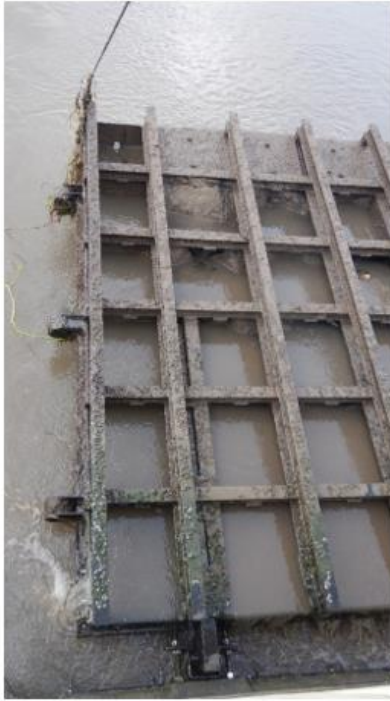
## Gate No. 1:

- Broken North Center Locking Ring
- Reshaped South Center Locking Ring

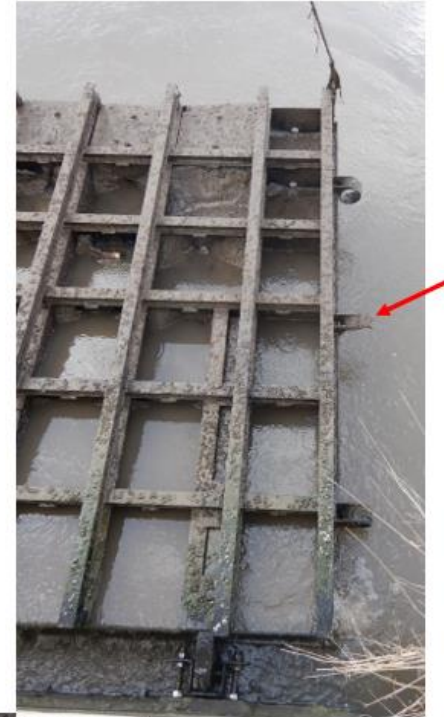
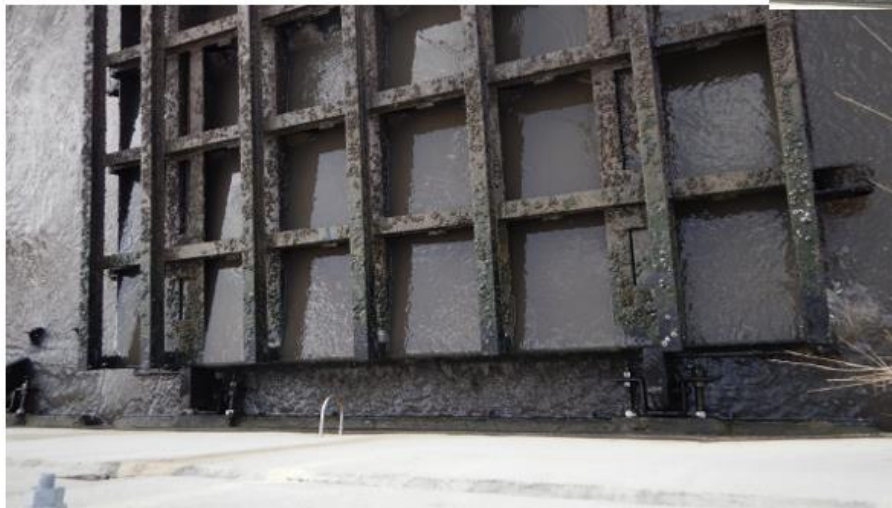
## Gate No. 2:

No damage noted

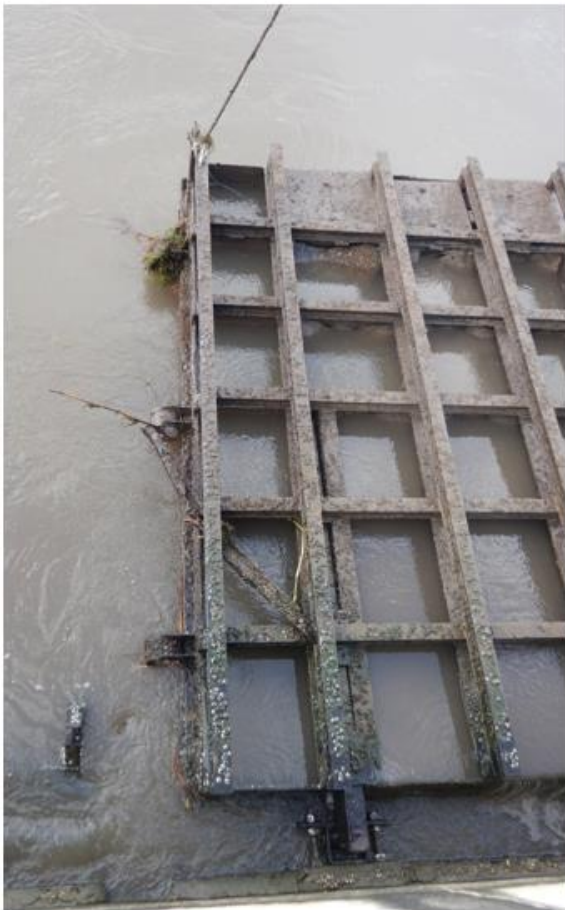
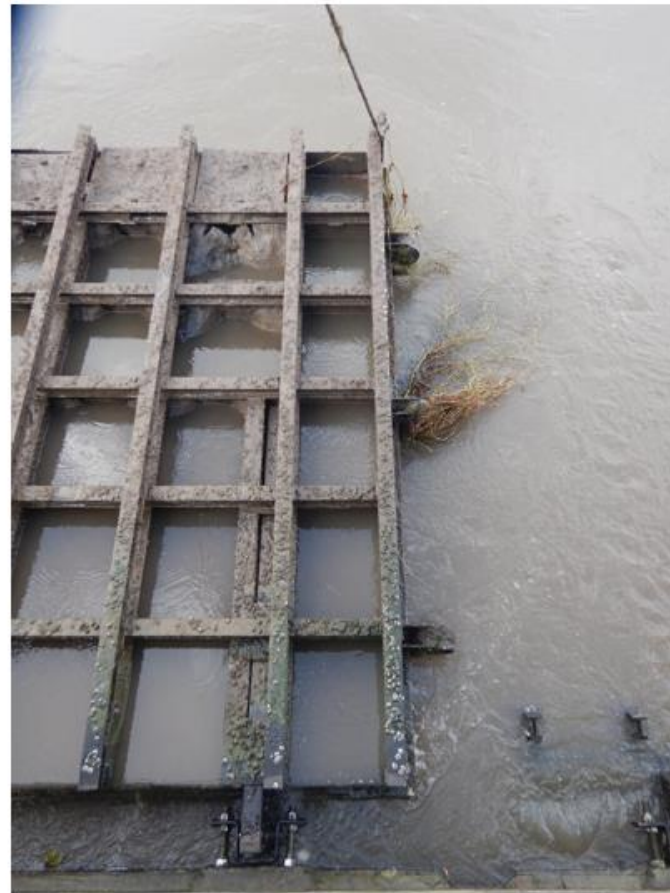
## Gate No. 3:

-Broken North and South Top Locking Ring

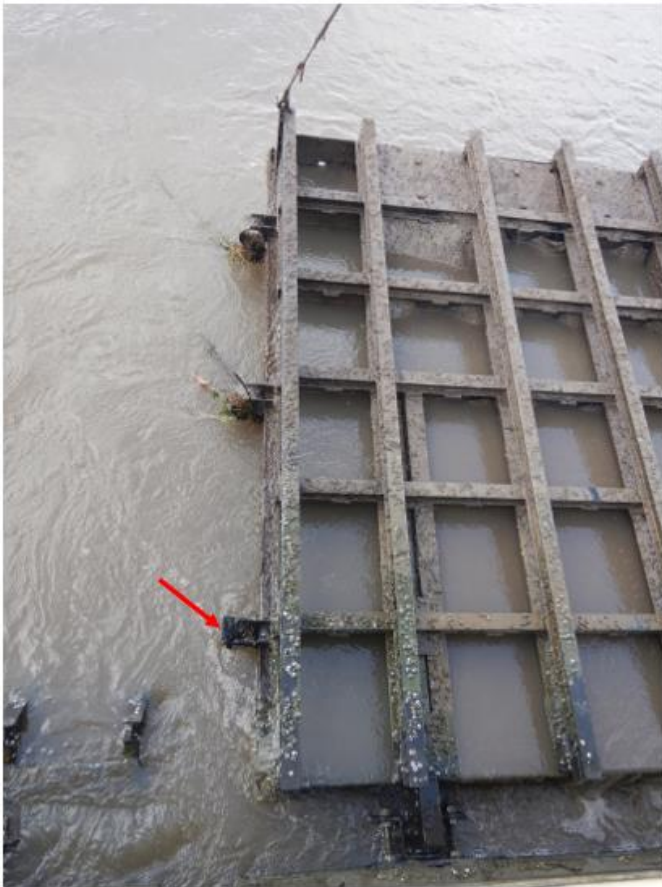
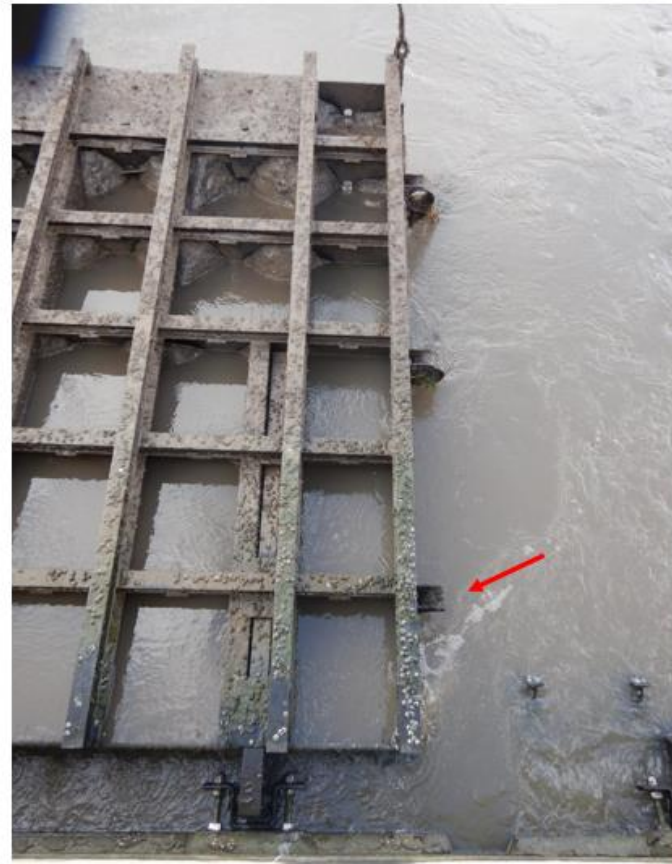
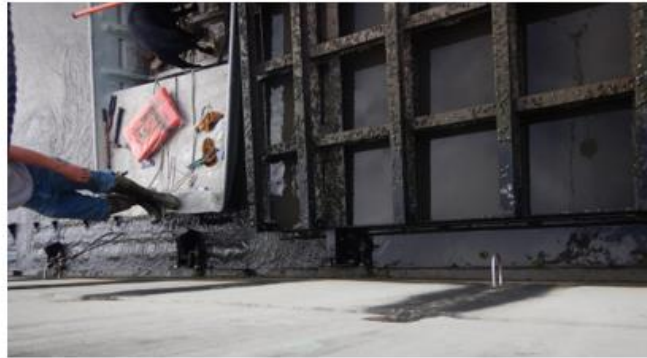
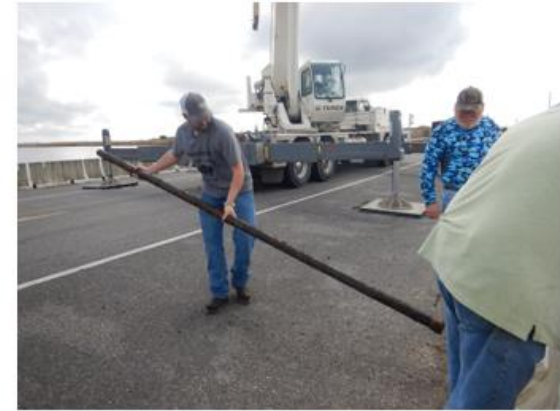
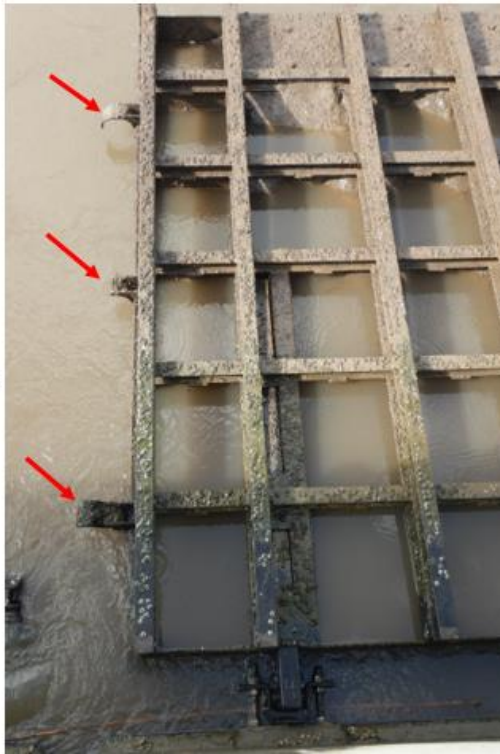
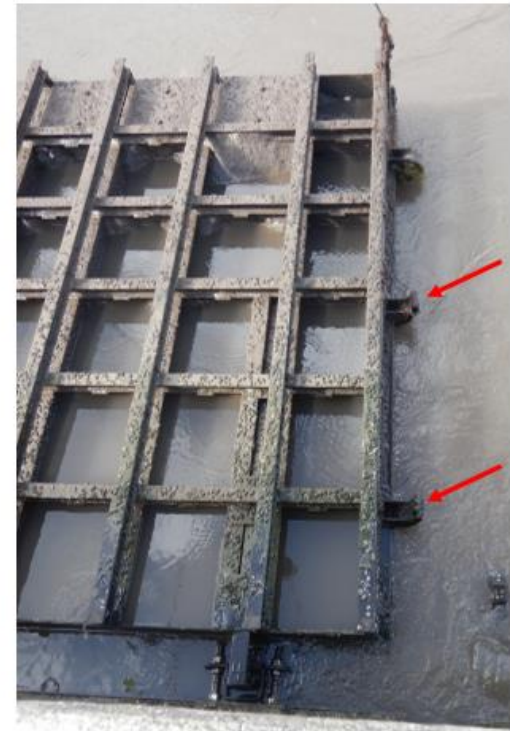
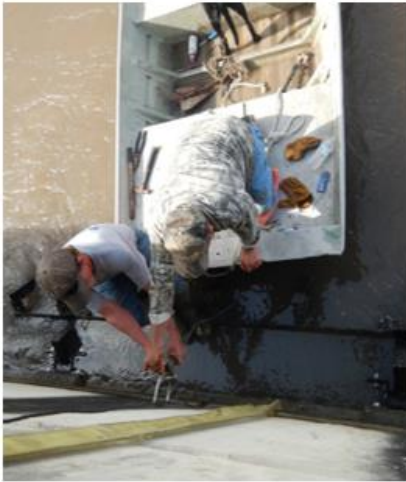
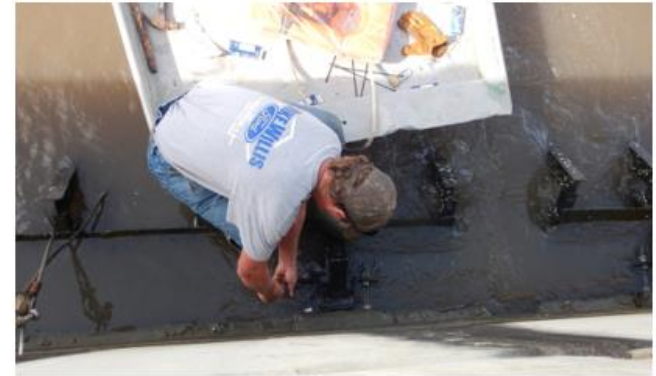
## Gate No. 4:

- Broken North and South Top Locking Ring
- Broken North and South Center Locking Ring
- Broken South Bottom Locking Ring
- Pulled steel drill pipe from the headwall locking rings on South side

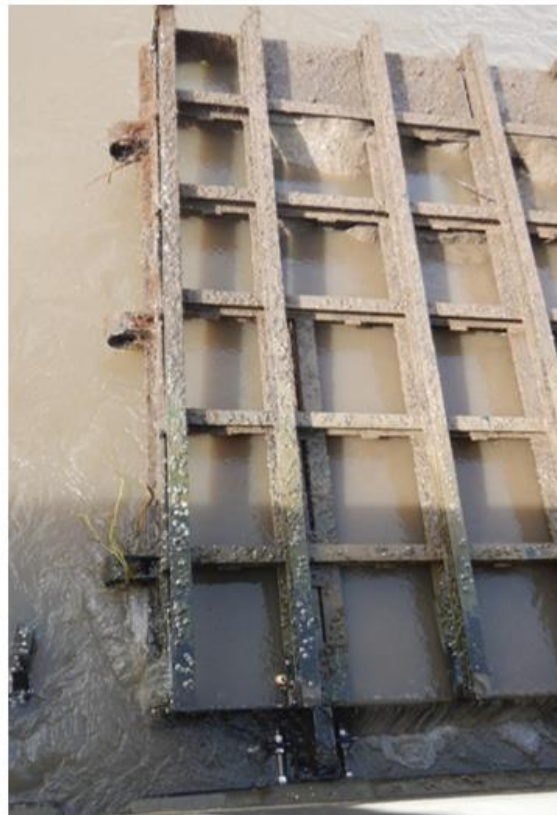
## Gate No. 5:

-All rings are intact. Tightened backing nuts on the hinge bolts.

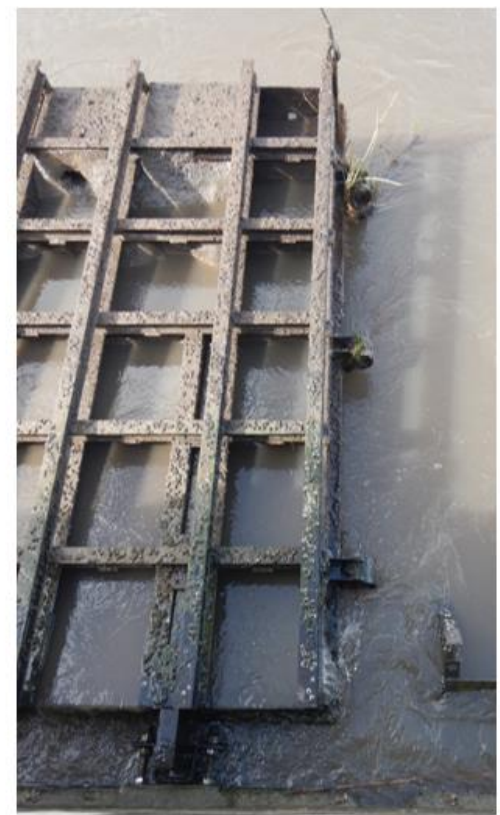
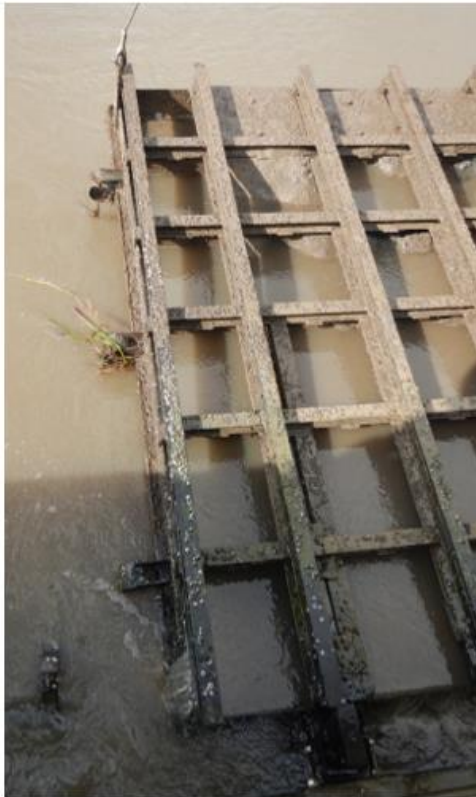
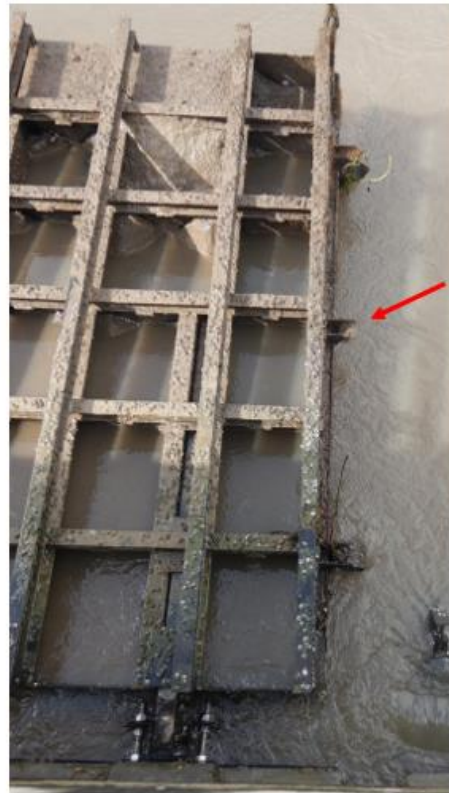
## Gate No. 6:

- Broken North Center Locking Ring
- Tightened backing nut on hinge bolts

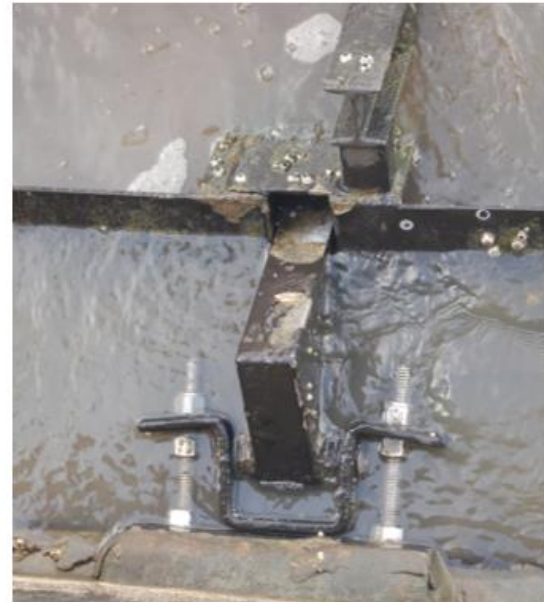
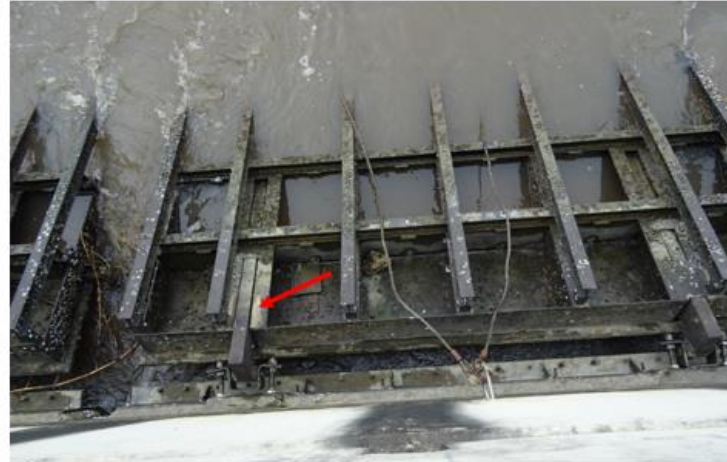
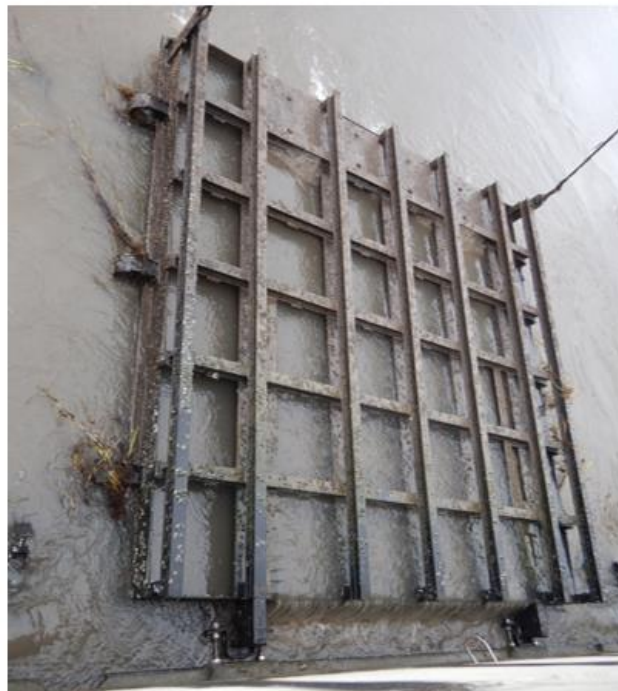
## Gate No. 7:

-All locking rings intact. Stop plate broken off, still on gate.

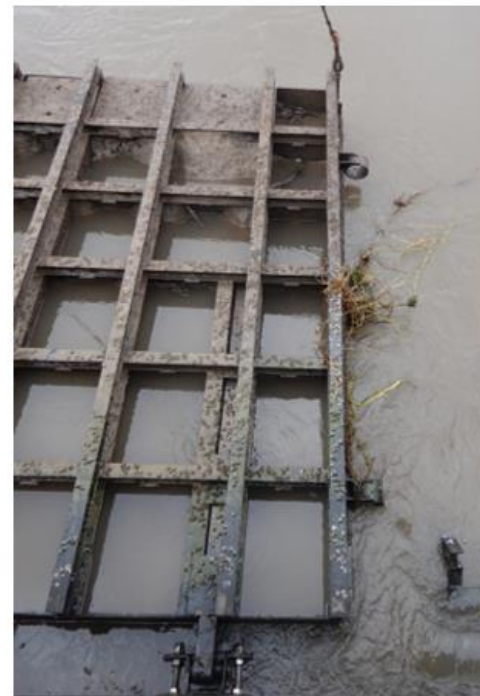
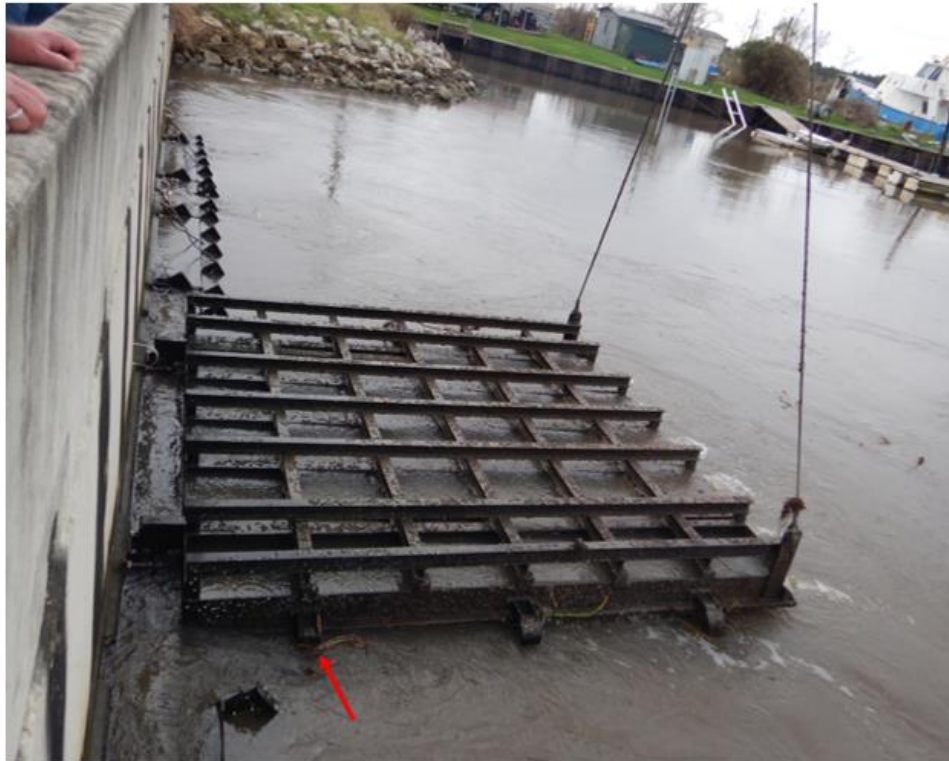
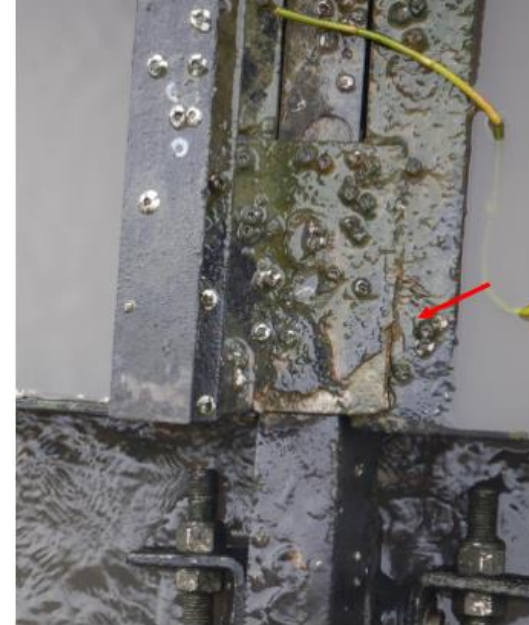
## Gate No. 8:

- Broken North Top Locking ring
- Crack in North & South top Stop plate welds
- Tightened backing nut on hinge bolts

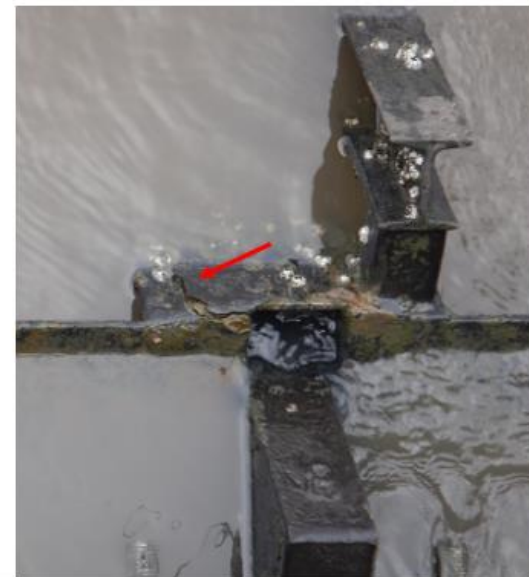
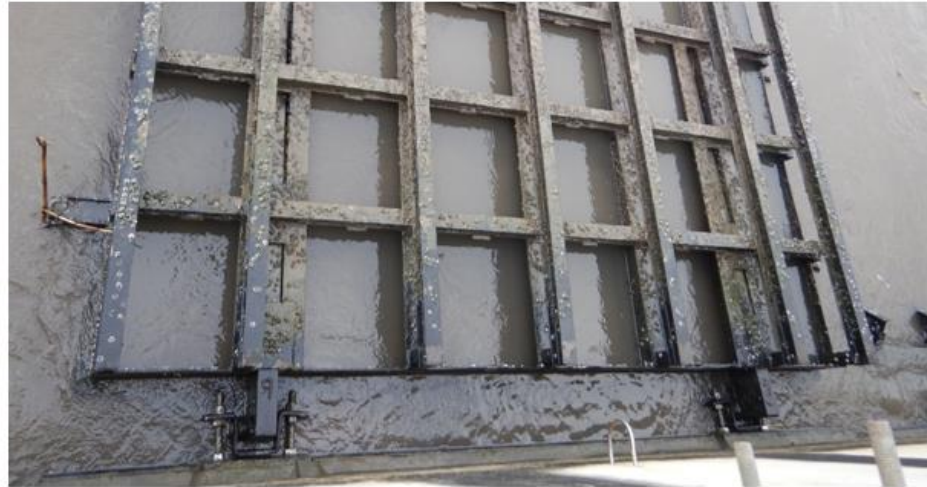
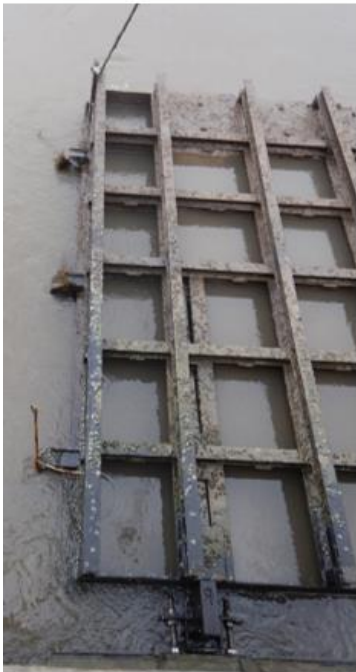
## Gate No. 9:

-Broken North Bottom Locking ring

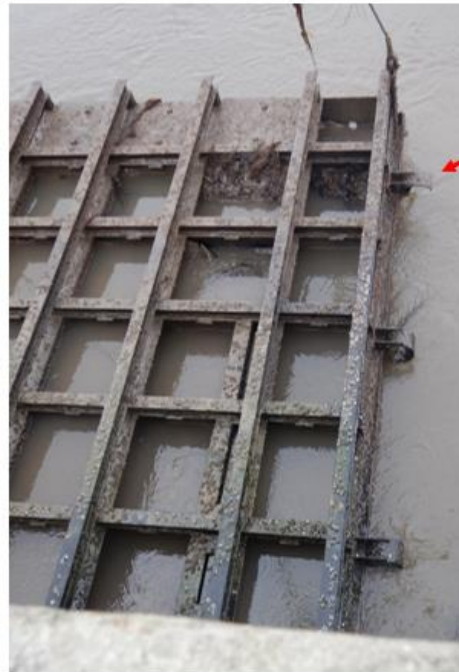
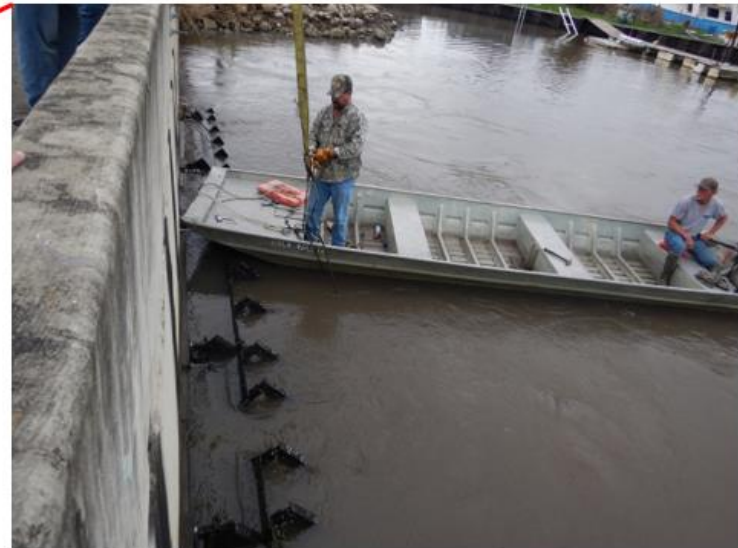
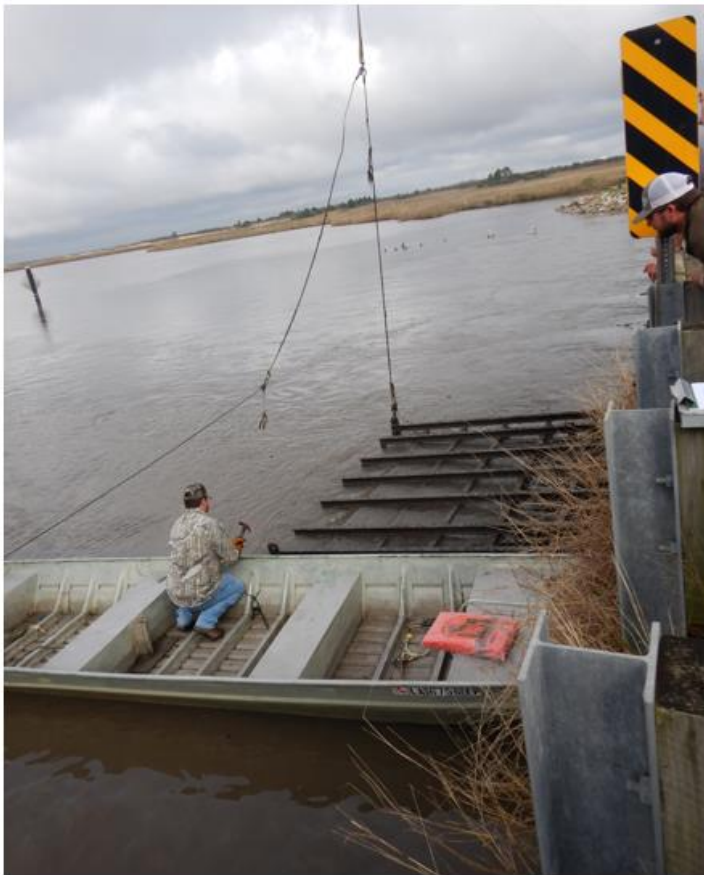
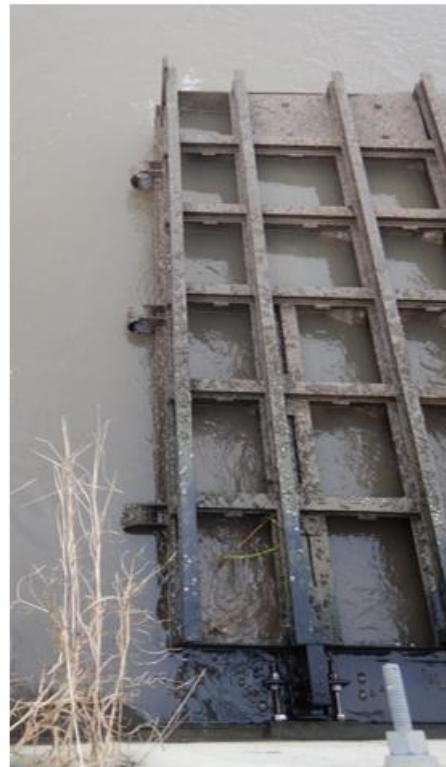
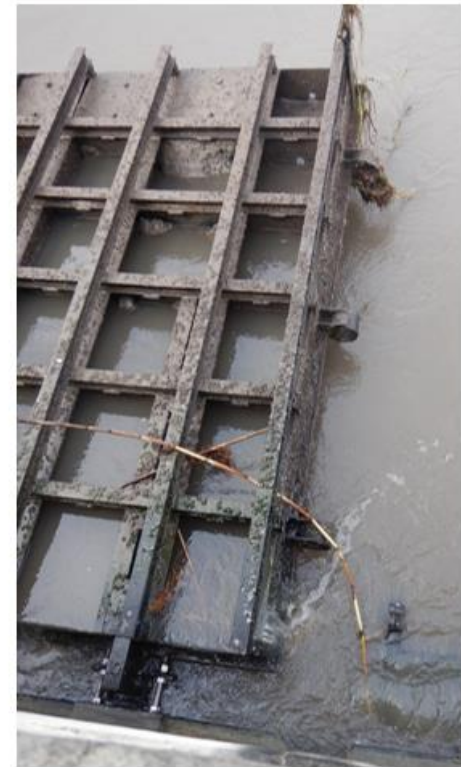
## Gate No. 10:

- Replaced Missing pin on South Lifting Eye/Cable
- All locking rings are intact.
