**Coastal Protection and Restoration
Authority of Louisiana (CPRA)**

2023 Operations, Maintenance, and Monitoring Report

Black Bayou Culverts Hydrologic Restoration

State Project Number CS-29
Priority Project List 9

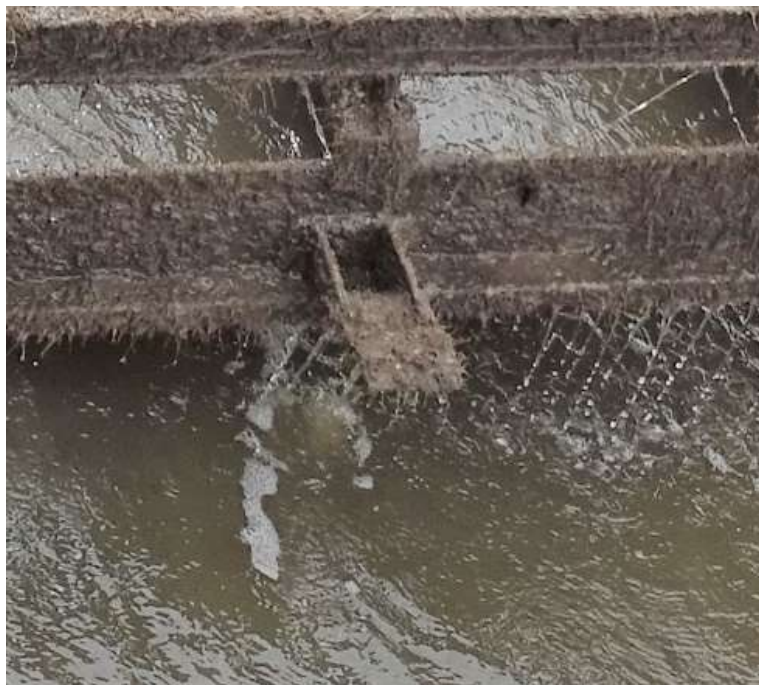
The flap gates were free flapping as intended; however, six gates have broken locking rings and/or stop plates which will require eventual repair. The stop plate welds that are broken may be the result of board/pipes or other objects inserted behind the gate arms where they connect to the hinges in an effort to keep the gates open. See photos: Appendix A, Gates 1, 3, 6, 7, 8 and 9 and Appendix D, Inspection Report and Notes.

1b. Gate No. 1 – Damaged Locking Ring, Feature No. 7 - North side of Gate

Estimates are being obtained to repair Gates No. 5 and 9. Sluice gates will be installed during this operations to isolate the culverts while the flapgates are removed from the structure.

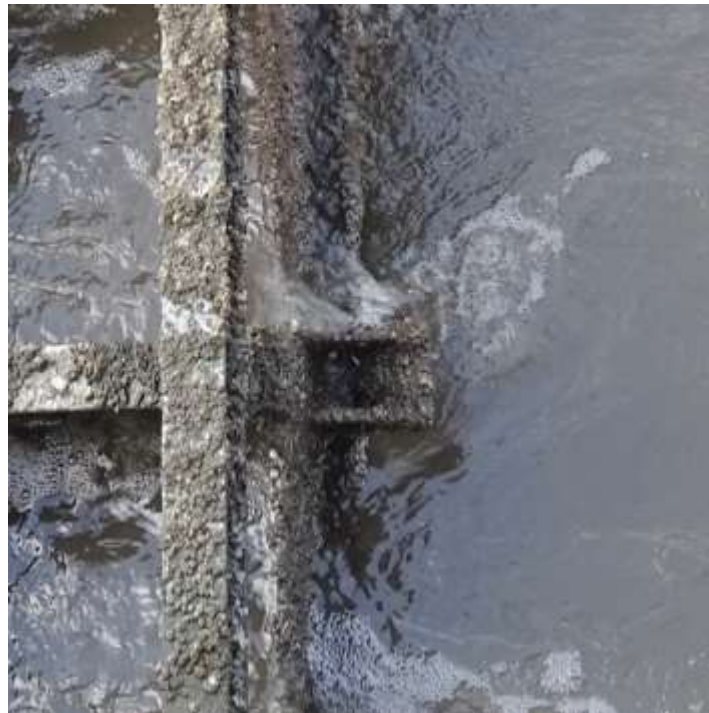
Damaged Locking Ring, See Photo 3b

3b. Gate No. 3 – Damaged Locking Ring, Feature No. 8 - North side of Gate

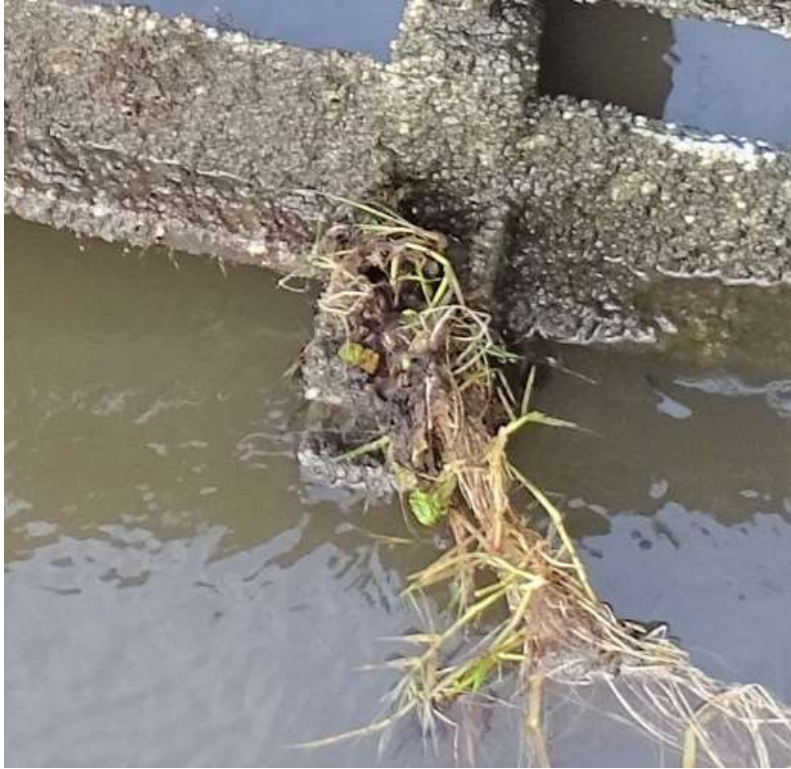
3e. Gate No. 3 – Damaged Locking Ring, Feature No. 3 - South side of Gate

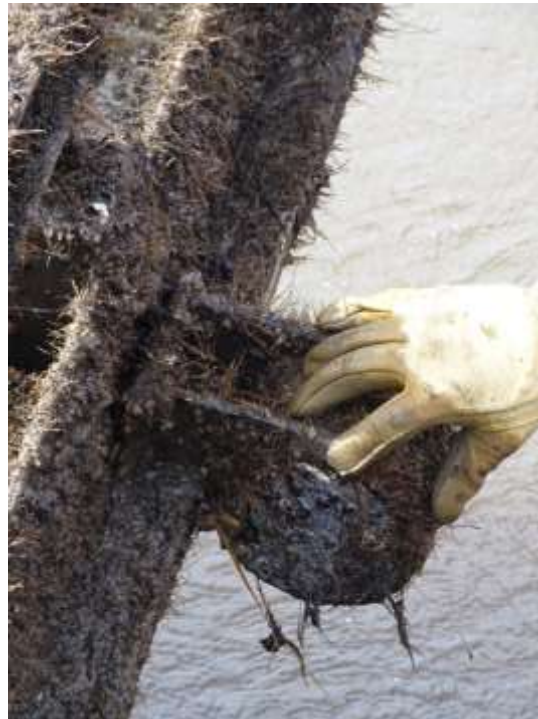
Two of the gates, 5 & 9 have missing locking rings which will make it difficult to lock these gates closed should the need arise. Repairs to these gates will need to be considered in the near future. All other gates can be locked closed if need be.

5b. Gate No. 5 – Damaged Locking Ring, Feature No. 6 - North side of Gate

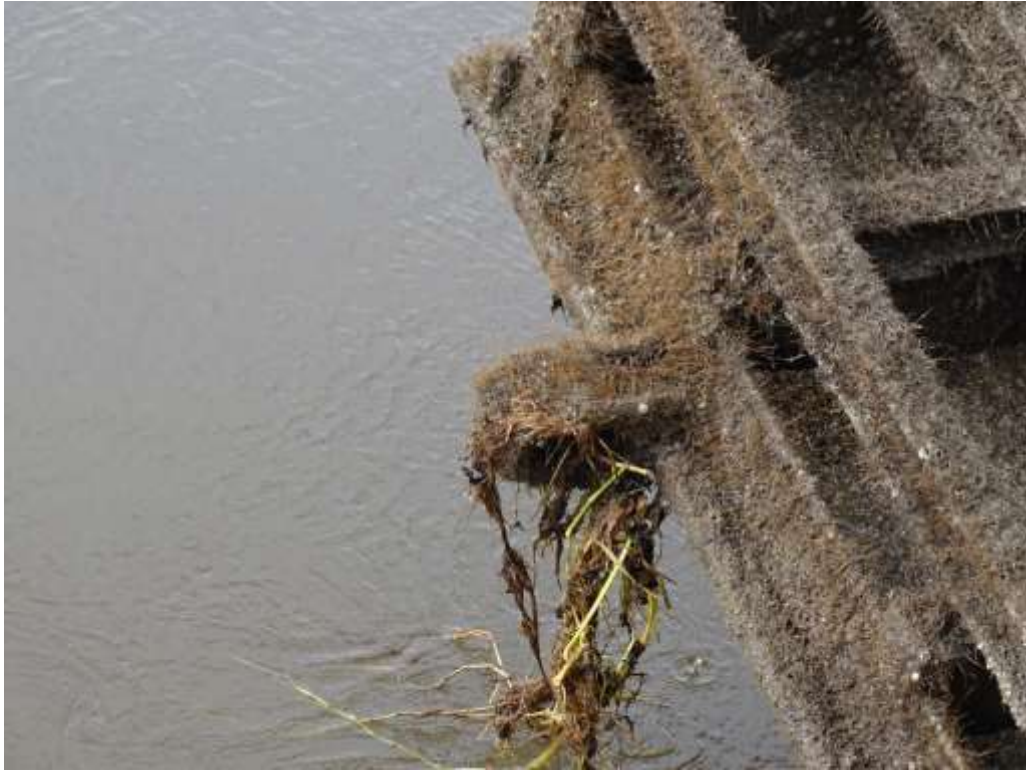
5e. Gate 5 – Damaged Locking Ring – Feature No. 5 - South side of Gate

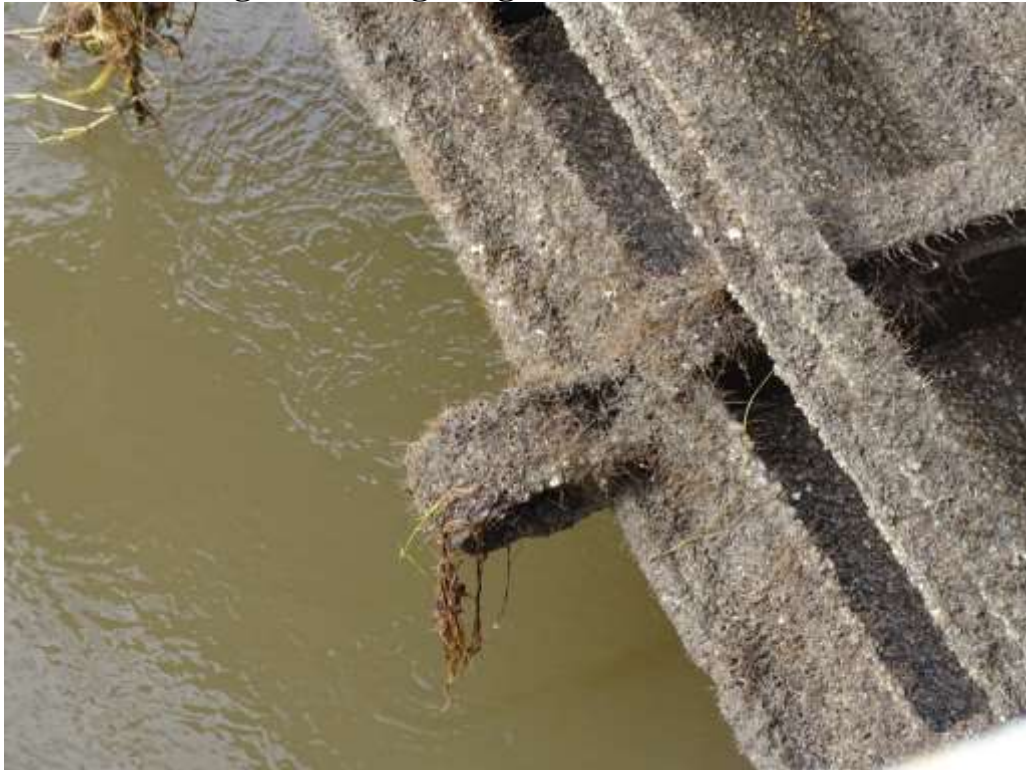
5f. Gate 5 – Damaged Locking Ring – Feature No. 4 - South side of Gate

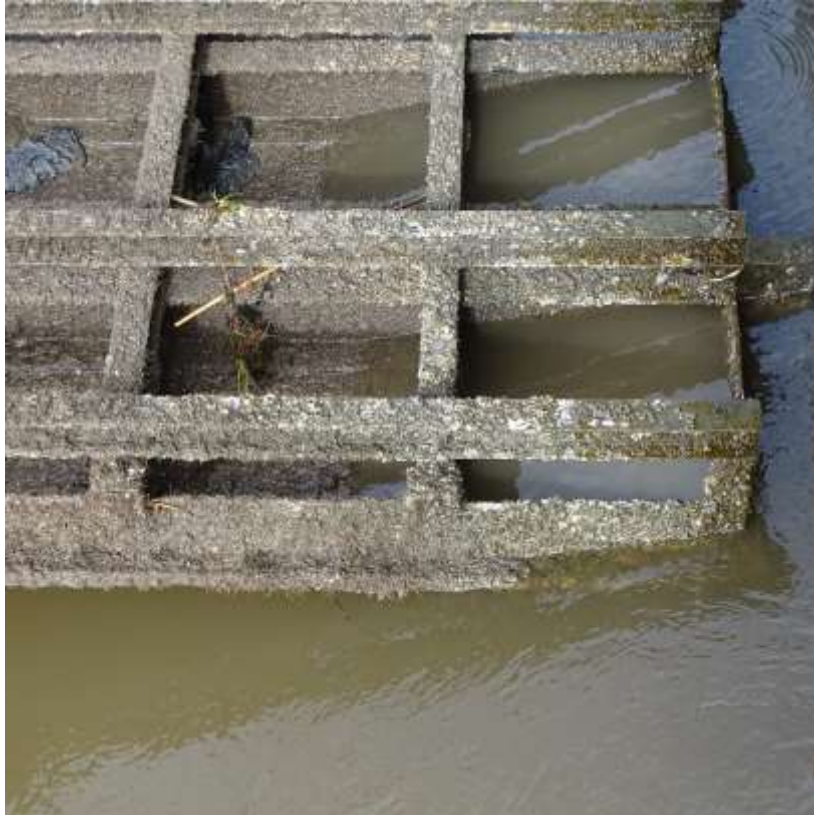
5g. Gate 5 – Missing Locking Ring – Feature No. 3 - South side of Gate

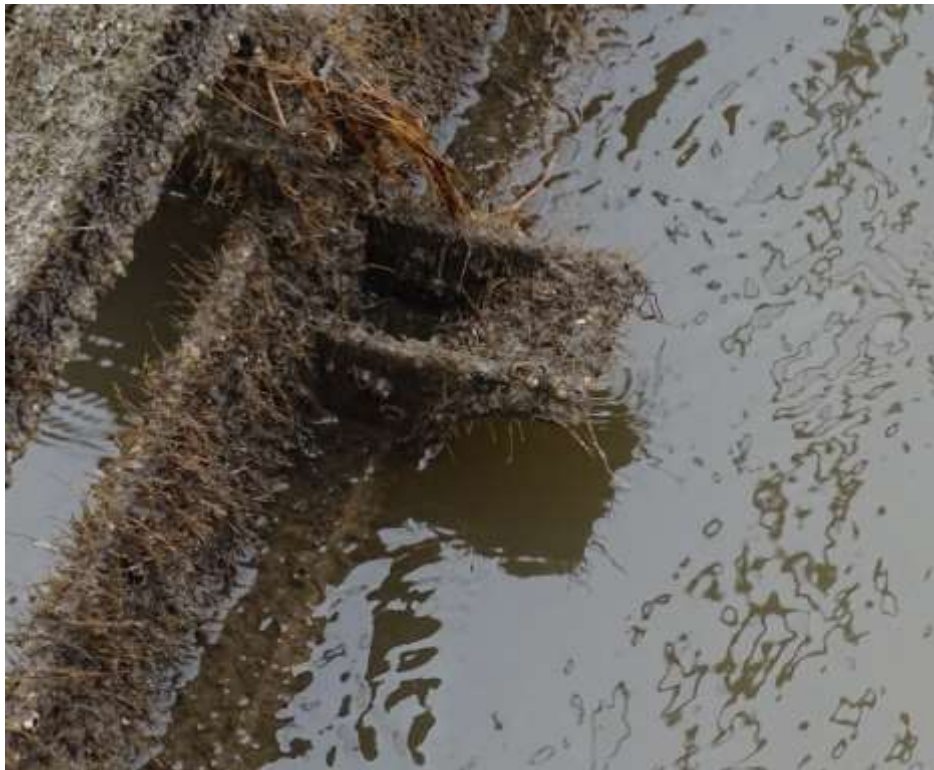
6b. Gate No. 6 – Damaged Locking Ring, Feature No. 7 - North side of Gate

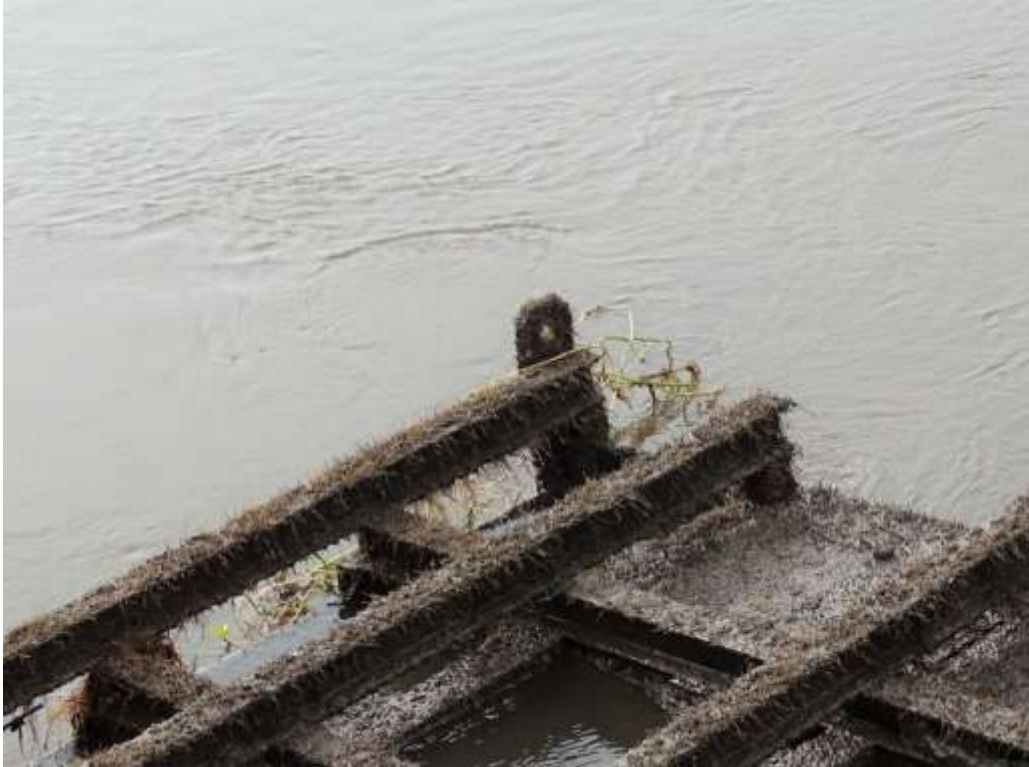
6e. Gate 6 – Lifting Eye – Shackle Pin Missing – South side of Gate

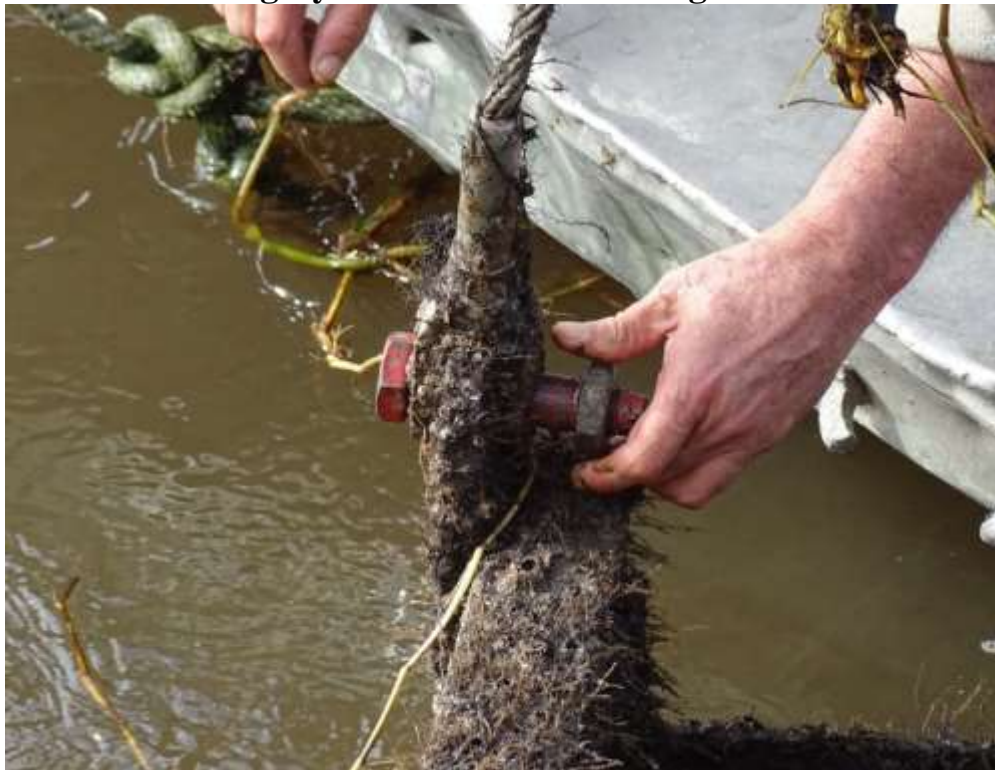
6f. Gate 6 – Lifting Eye – Shackle Pin Replaced – South side of Gate

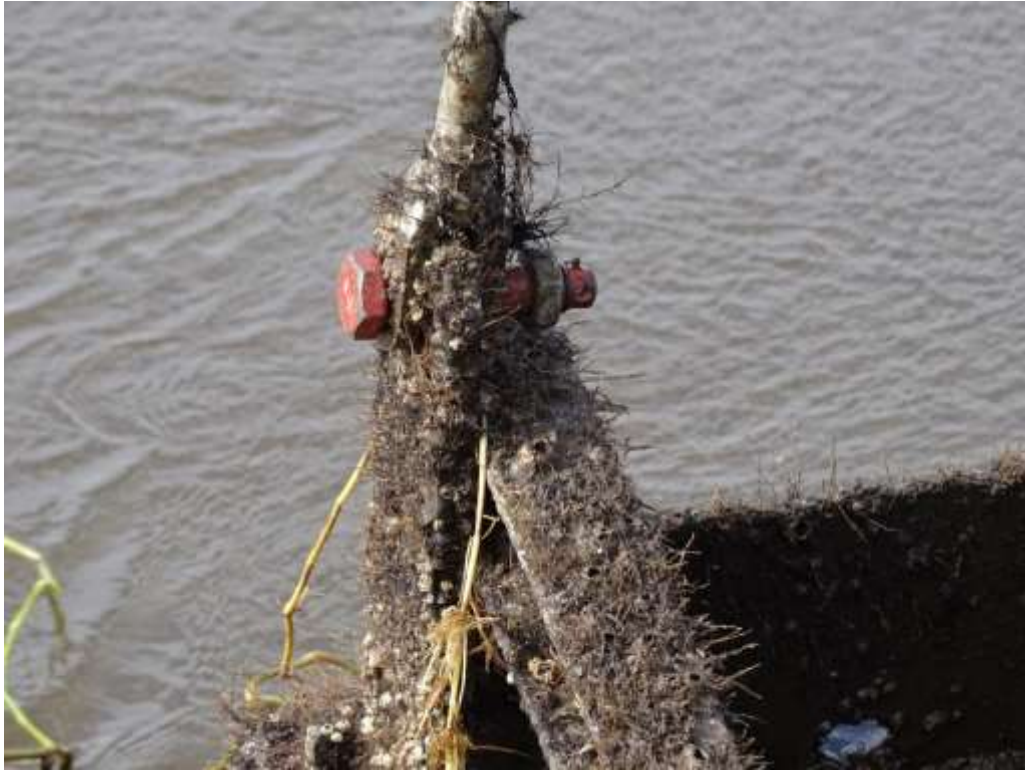
6g. Gate 6 – Lifting Eye – Shackle Pin Replacement in Place – South side of Gate
(Replacement shackle pin supplied by Crane Operator)

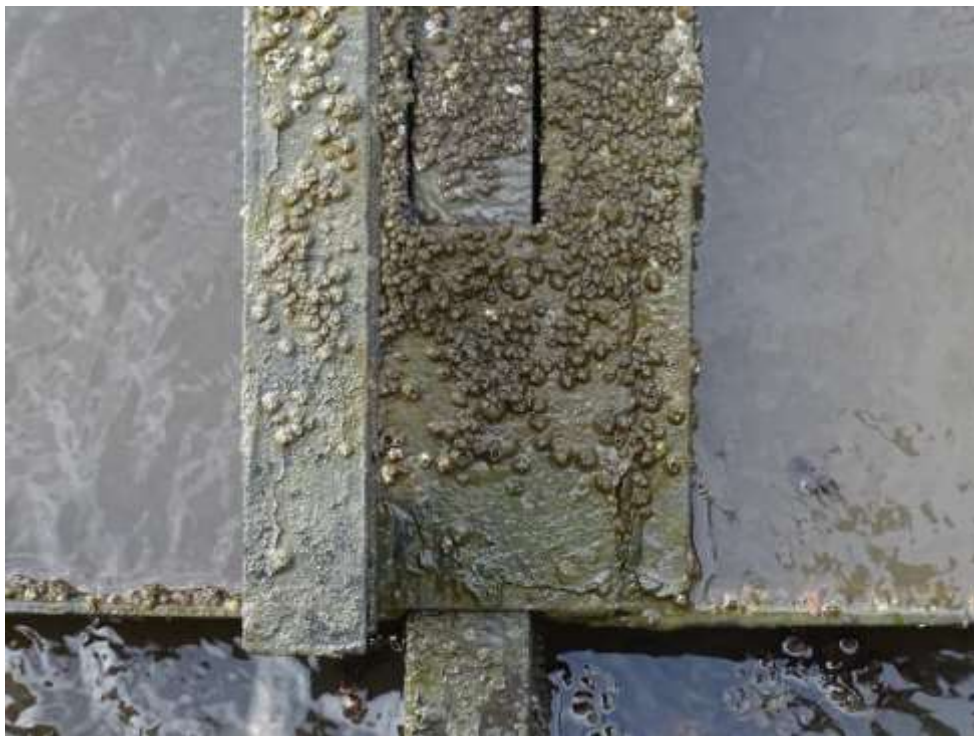
6h. Gate 6 – Cracked Weld – Stop Plate, Feature No. 16 - South side of Gate

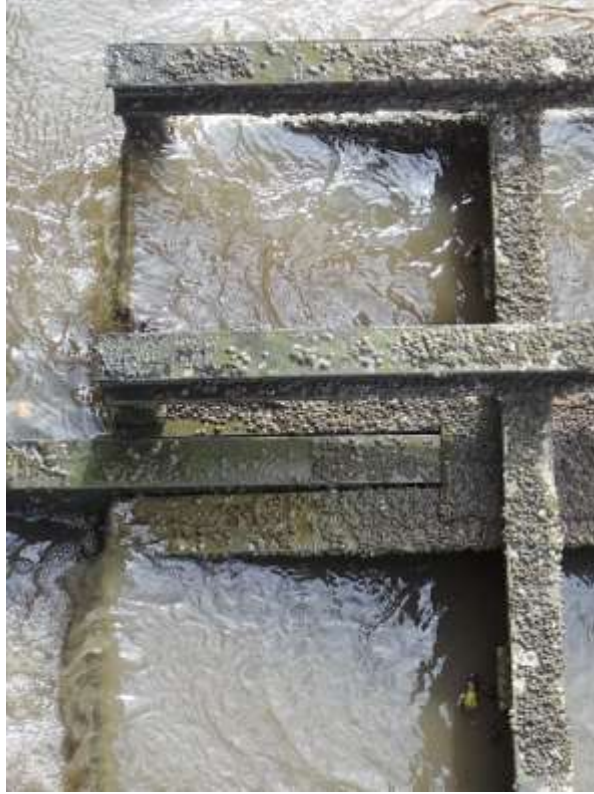
7e. Gate 7 – Missing Stop Plate, Feature No. 16 – South side of Gate

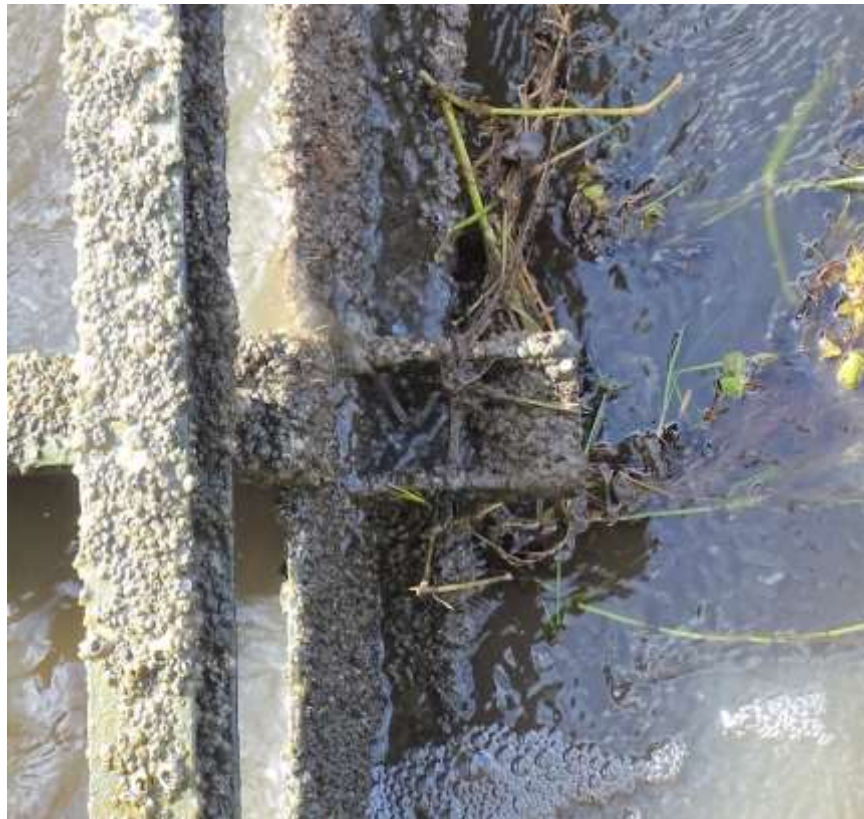
8b. Gate No. 8 – Damaged Locking Ring, Feature No. 8 - North side of Gate

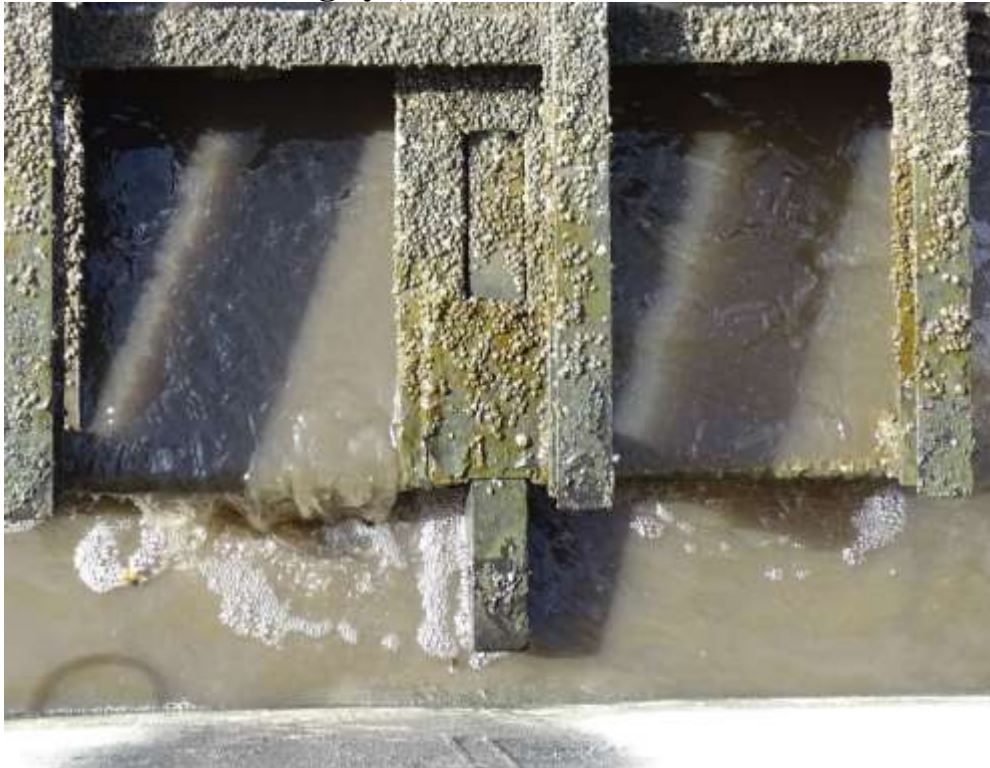
8d. Gate 8 – Cracked Weld, Stop Plate, Feature No. 15 – North Side of Gate

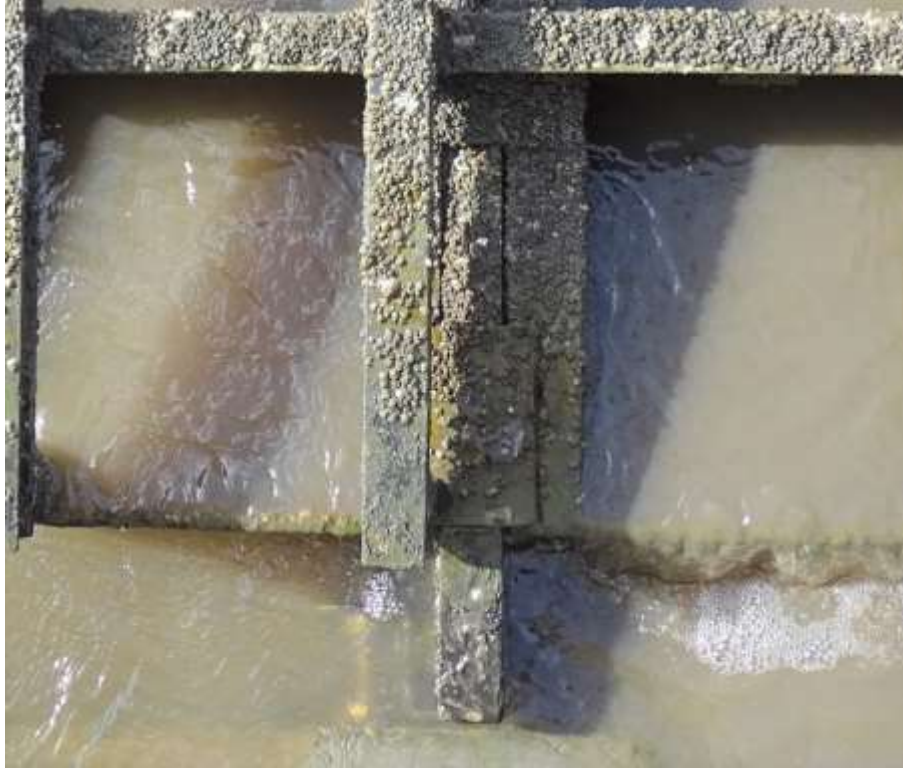
8g. Gate 8 – Cracked Weld, Stop Plate, Feature No. 16 – South Side of Gate

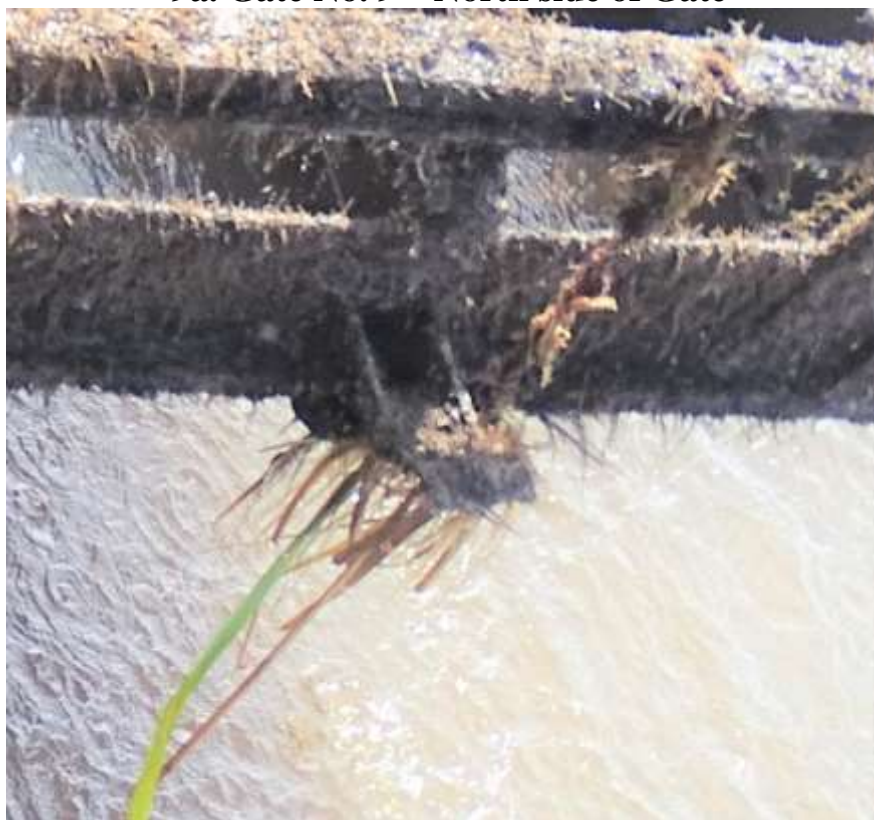
9b. Gate No. 9 – Damaged Locking Ring, Feature No. 6 - North side of Gate

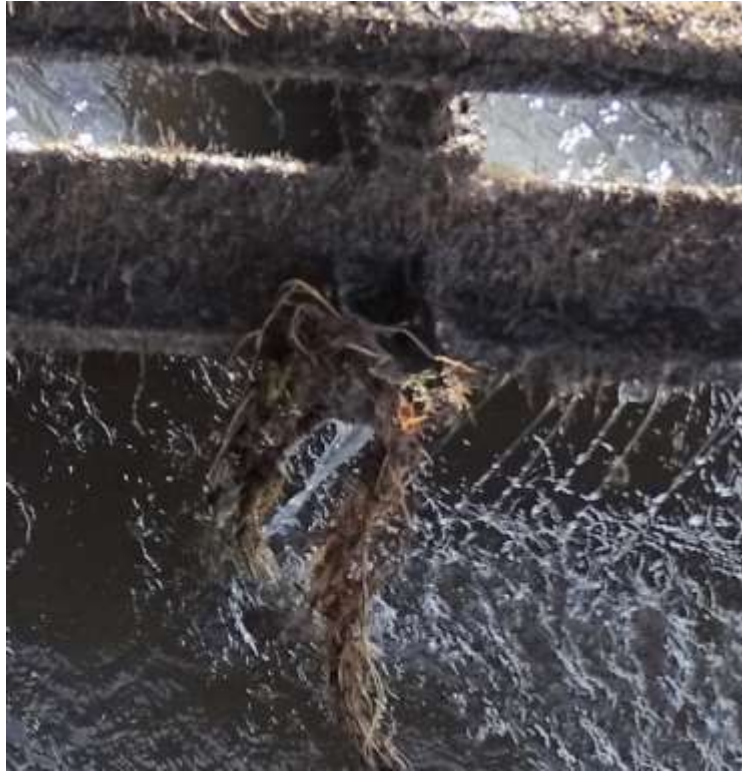
9c. Gate No. 9 – Damaged Locking Ring, Feature No. 7 - North side of Gate

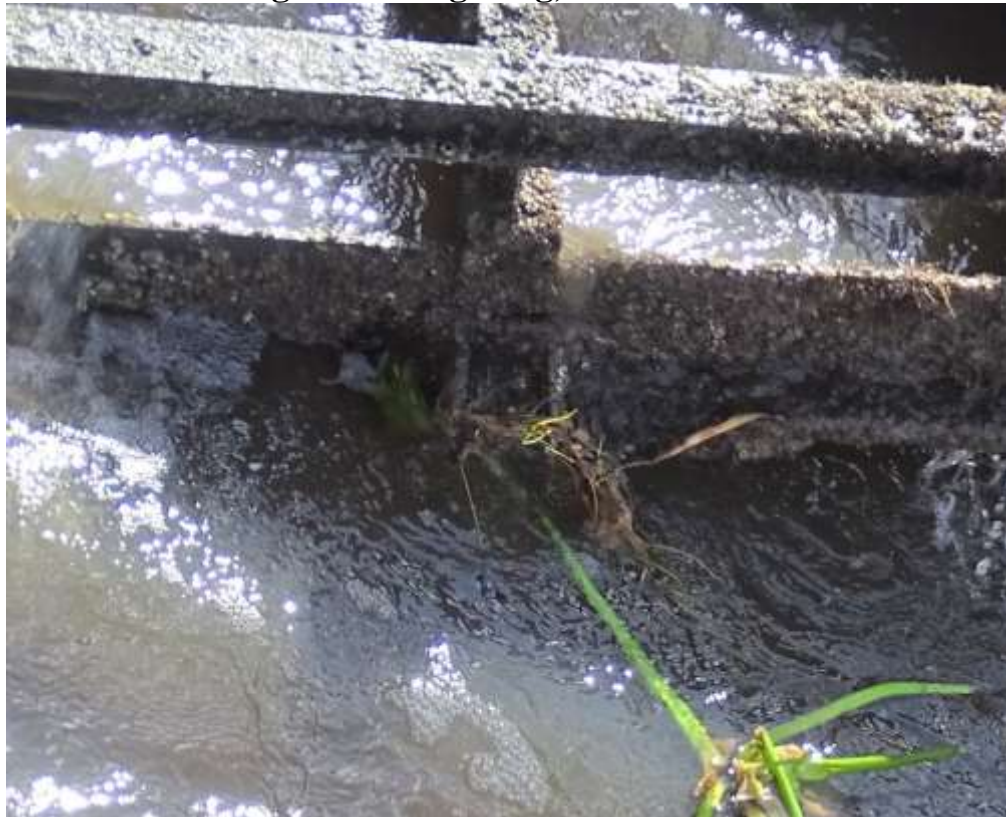
9d. Gate 9 – Damaged Locking Ring, Feature No. 8 - North side of Gate

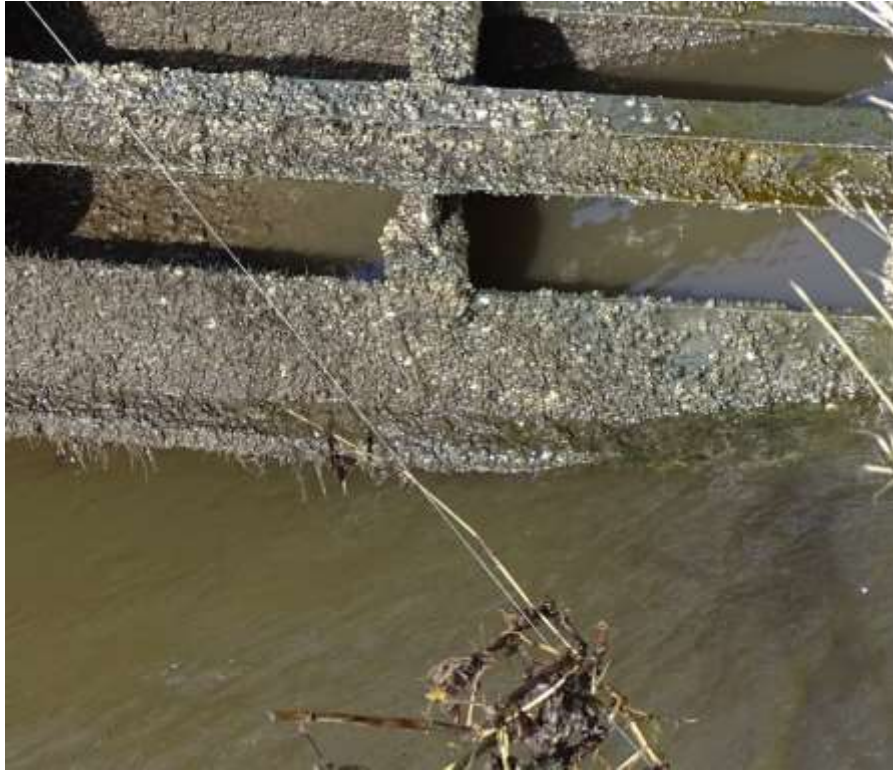
9g. Gate 9 – Missing Lock Ring, Feature No. 3 – South Side of Gate
