**2017/2018 Annual Inspection
Report**

**EAST SABINE LAKE
HYDROLOGIC RESTORATION
PROJECT (CS-32)**

State Project Number CS-32
Priority Project List 10

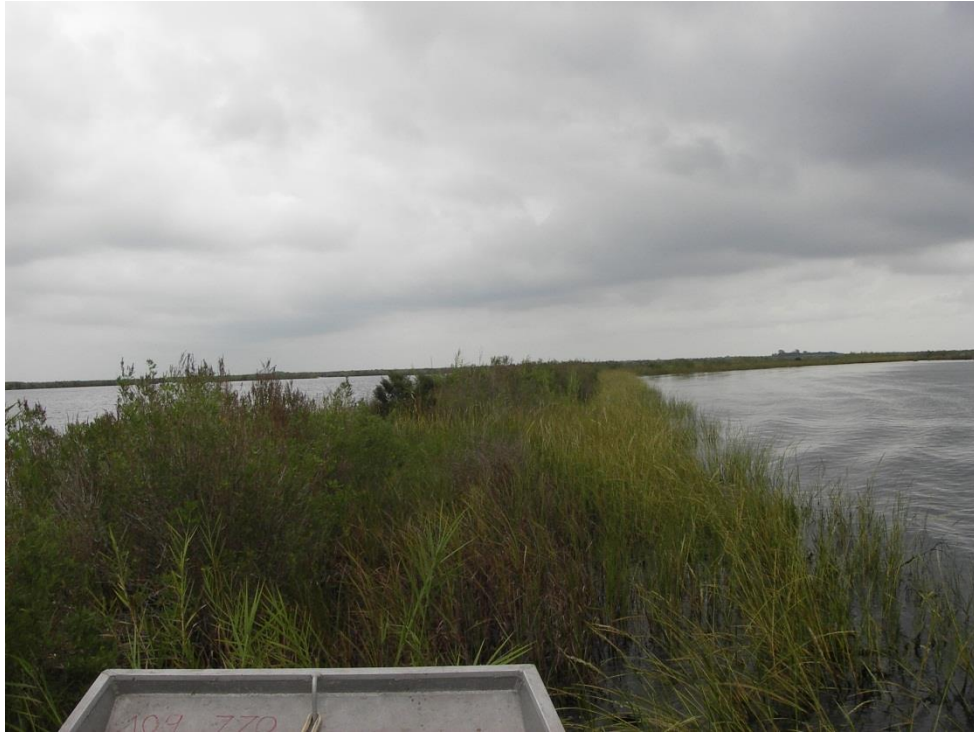
The inspection began on the north end of the terrace field and proceeded south. Each air boat took a row of terraces meeting up along the way to discuss what was seen. The northern section of terraces (CU1) had a variety of vegetation, i.e. smooth cordgrass, roseau cane, baccharis, iva, and a few cattails. The terraces narrowed heading south (CU1A), but there was still good cordgrass spread beyond the terrace width. There were skips in vegetation coverage noted, averaging 5%-7% bare areas. (See Appendix B, Photos 1-5)

Photo No.1 –Northern Section of Terraces – Variety of Vegetation (2014)

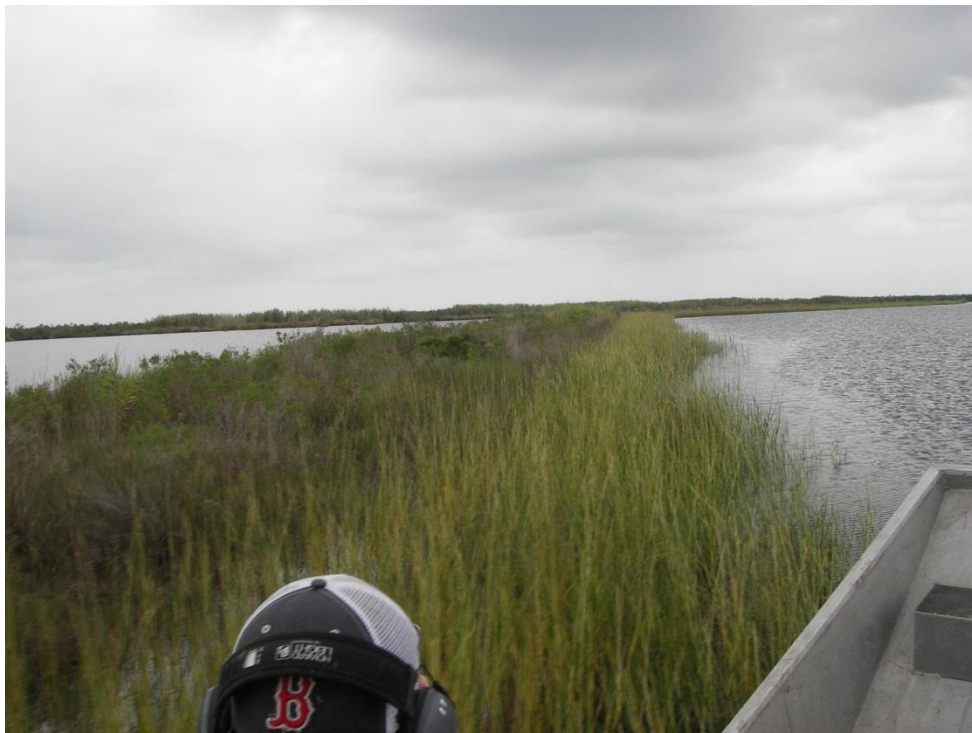
Photo No. 2 –Northern Section of Terraces – Expansion (2014)

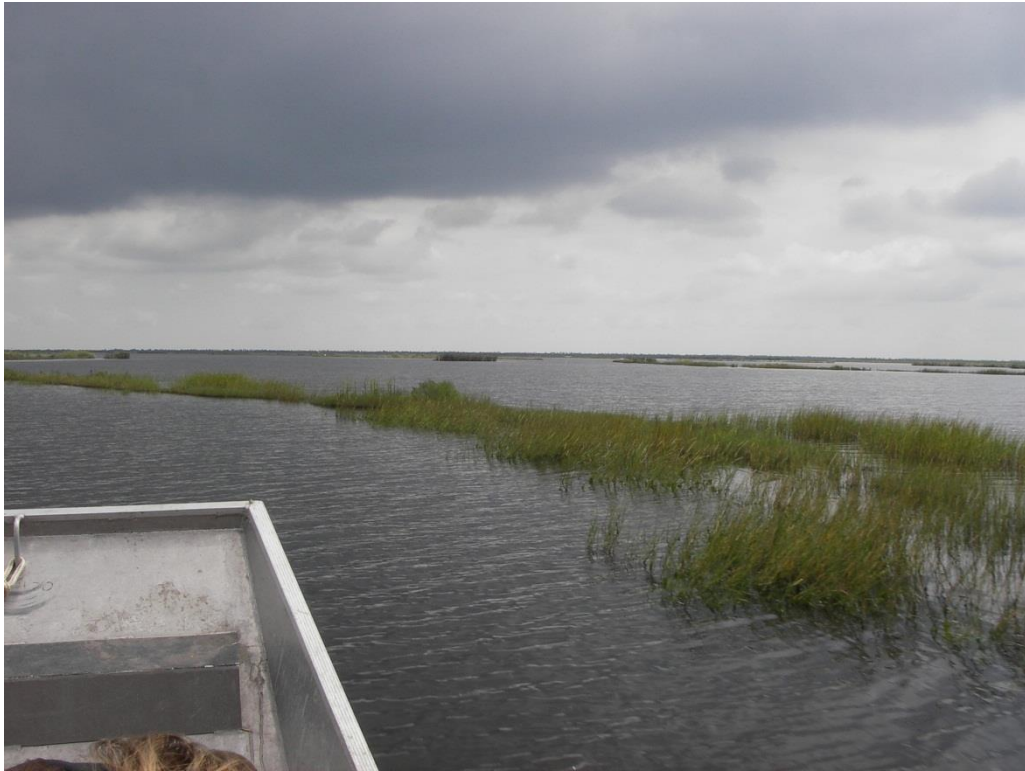
Photo No. 3 – Some Narrowing of Terraces Going South (2014)

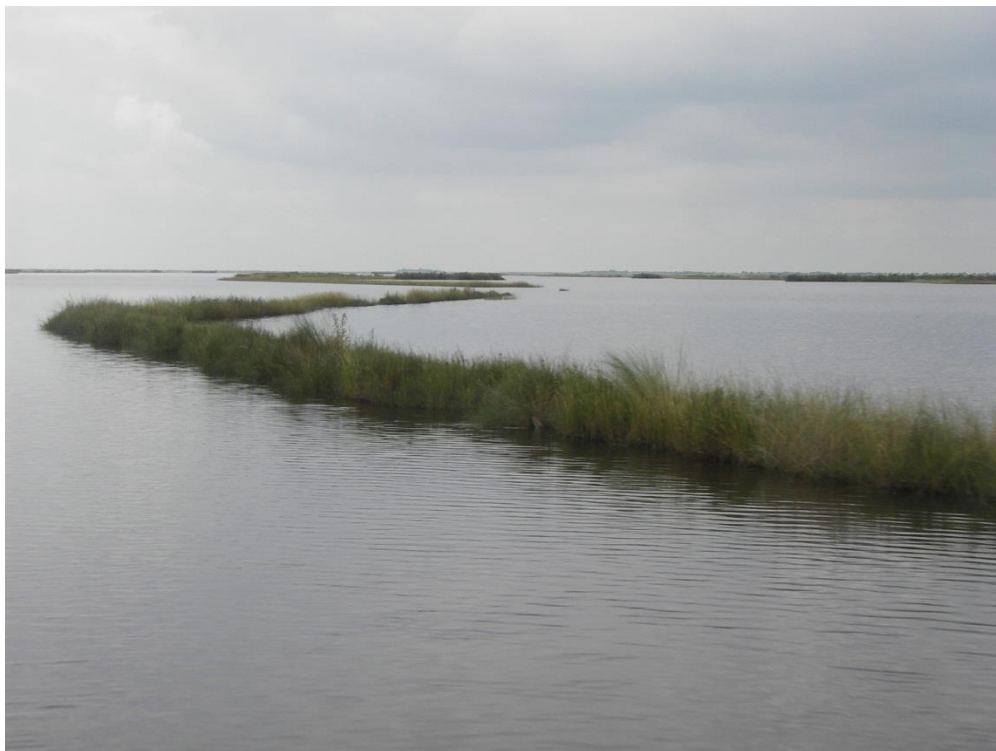
Photo No. 4 – Southern Terraces (2014)

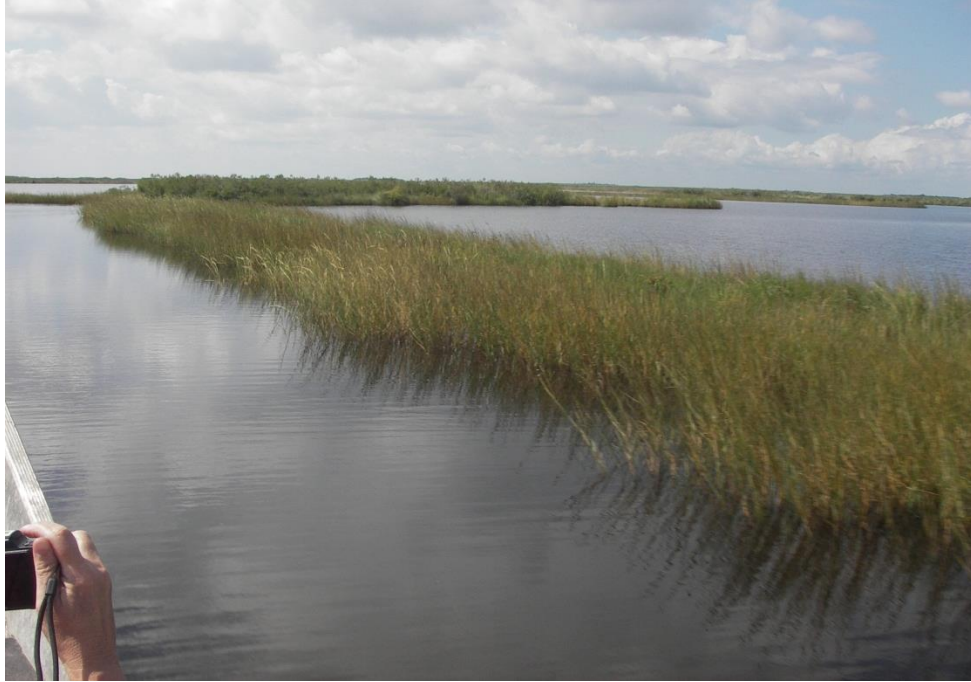
Photo No. 5 – Southern Terraces (2014)

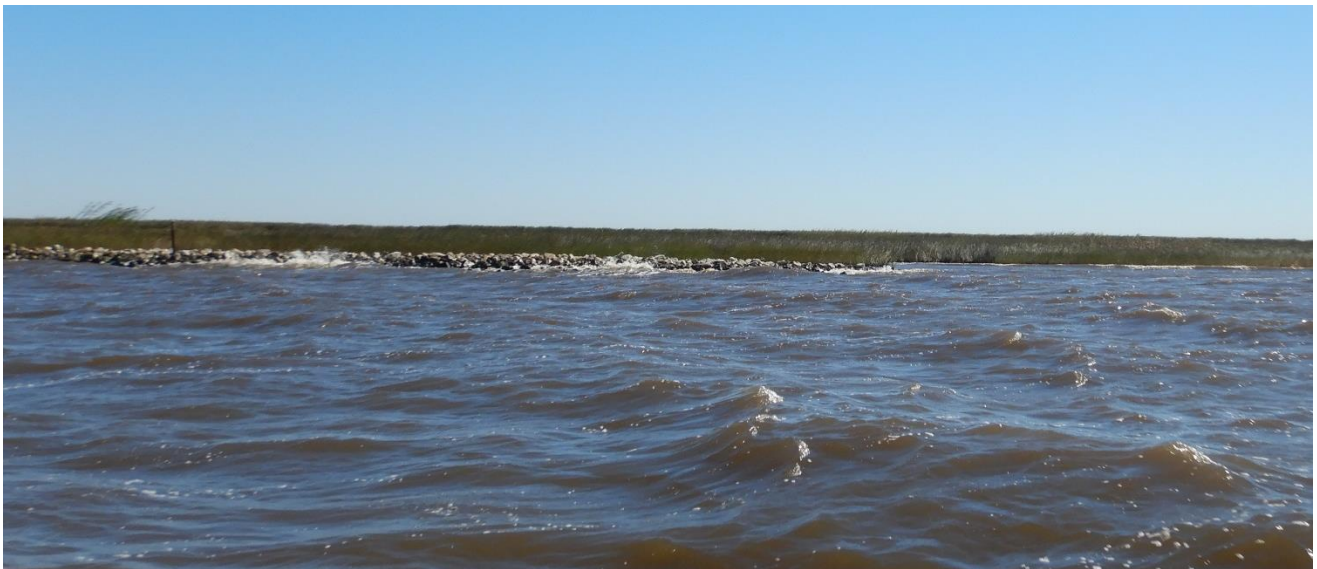
The water level was higher than normal. Although there were low areas of the rock dike noted between the south warning sign up to just south of the bend in Willow Bayou, the foreshore rock dike was in good condition and performing as intended. Approximately two feet of rock extended above the water level over 80% of the dike length and there were no signs of damage to the original marsh behind the rock dike. This area will continue to be monitored.

Photo No. 6 – South End of Sabine Lake Foreshore Rock Dike

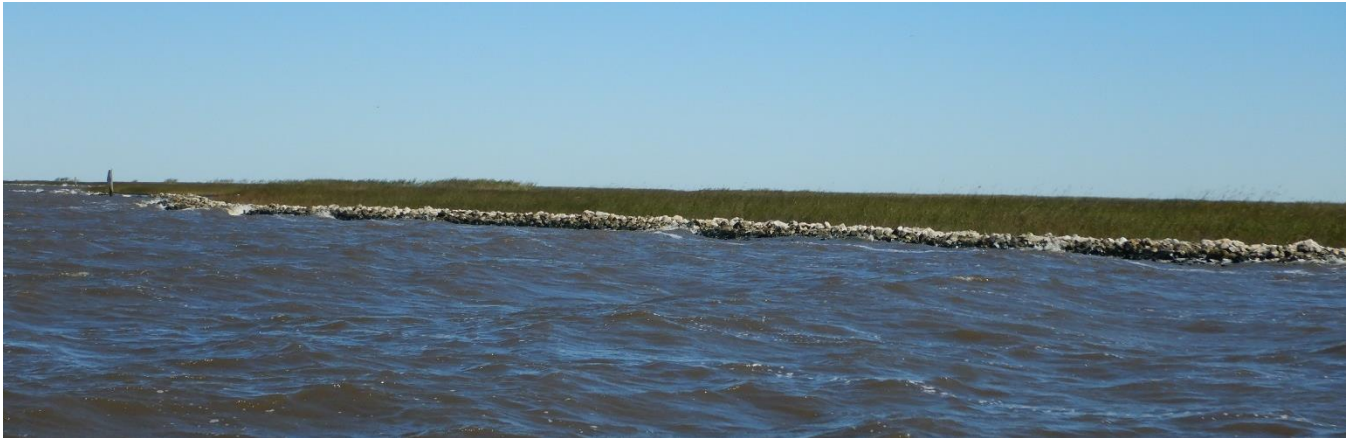
Photo No. 7 – Sabine Lake Foreshore Rock Dike, South of Southern Warning Sign

Overall, the project is in good condition. The vegetation has filled in very well behind the foreshore rock dike. Although there appears to be low areas of foreshore rock dike at the southern end, the dike is still providing protection to the east shoreline of Sabine Lake. The lower segments of rock will be monitored for a potential maintenance event in the future.

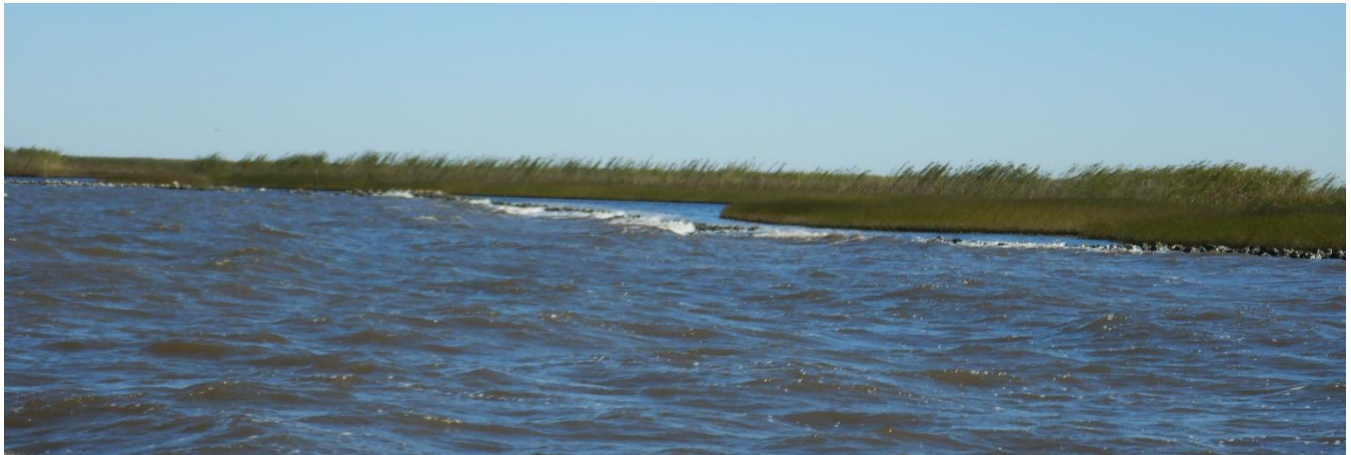
Photo No. 8– Sabine Lake Foreshore Rock Dike, Low area of Rock

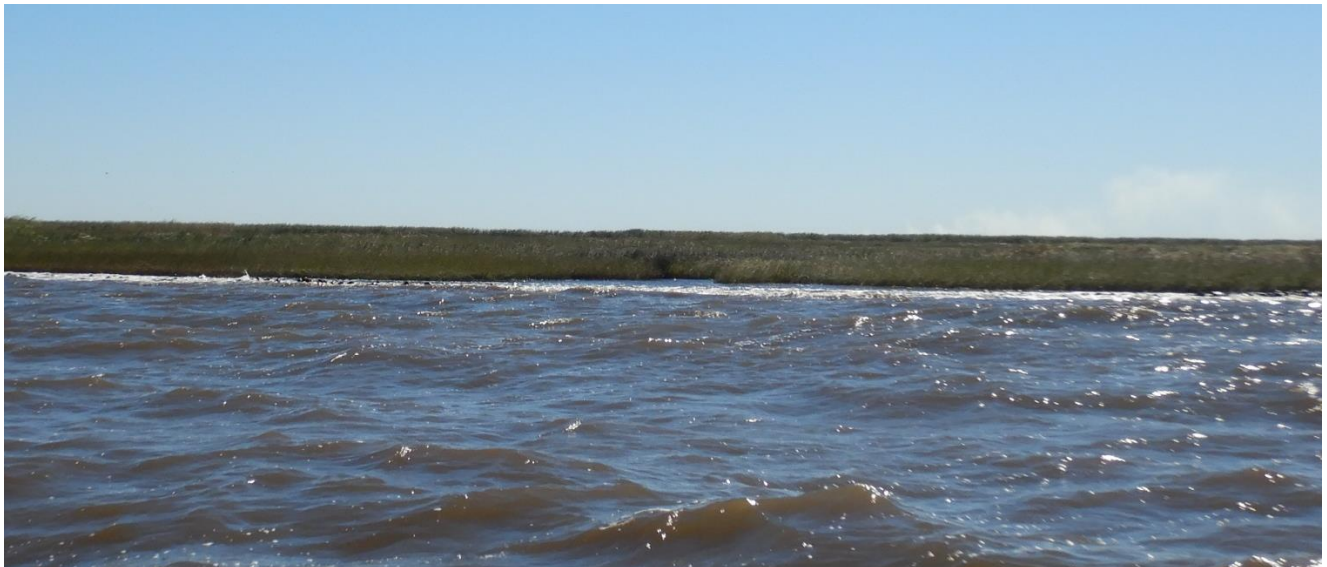
Photo No. 9– Sabine Lake Foreshore Rock Dike, Low area of Rock

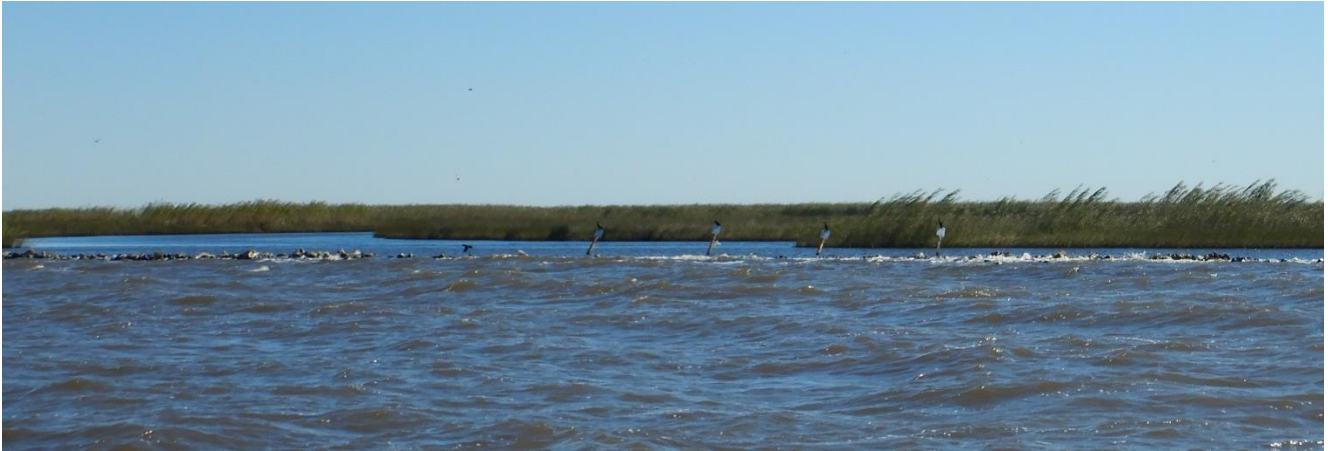
The four signs installed in August 2015 to mark the submerged rock near Willow Bayou are leaning likely due to the high water from Hurricane Harvey earlier in the year. They are still functional at this time, but may need to be repaired in the future. (See Appendix B, Photos No. 6-12)

Photo No. 10– Sabine Lake Foreshore Rock Dike,
Low area at Willow Bayou bend (East) - Warning Signs

The warning signs marking Willow Bayou will be monitored in the future for repair.

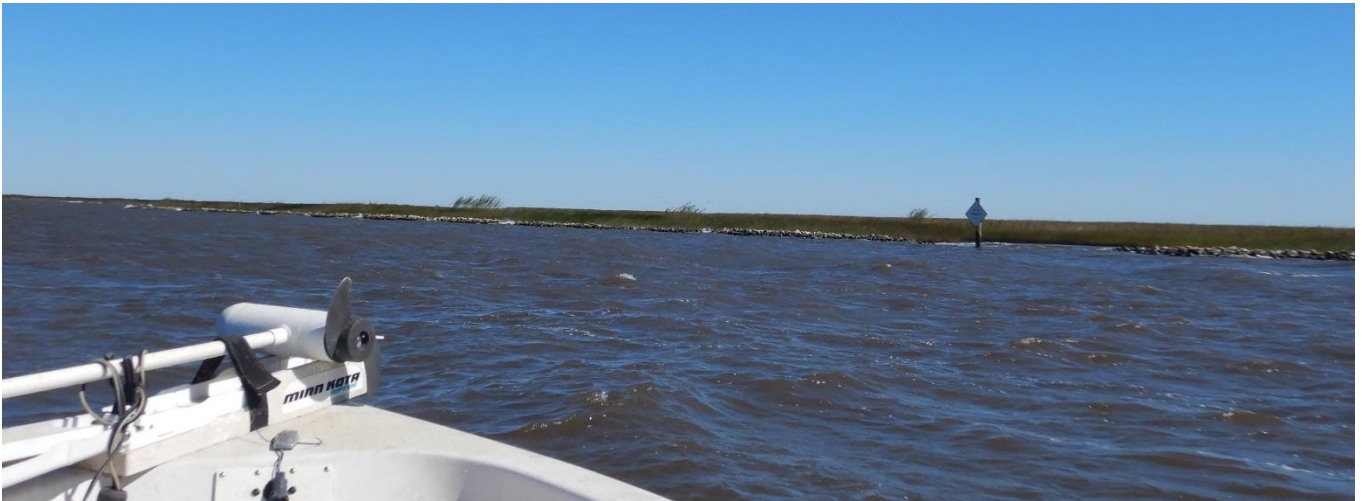
Photo No. 11– Sabine Lake Foreshore Rock Dike, near North Warning Sign

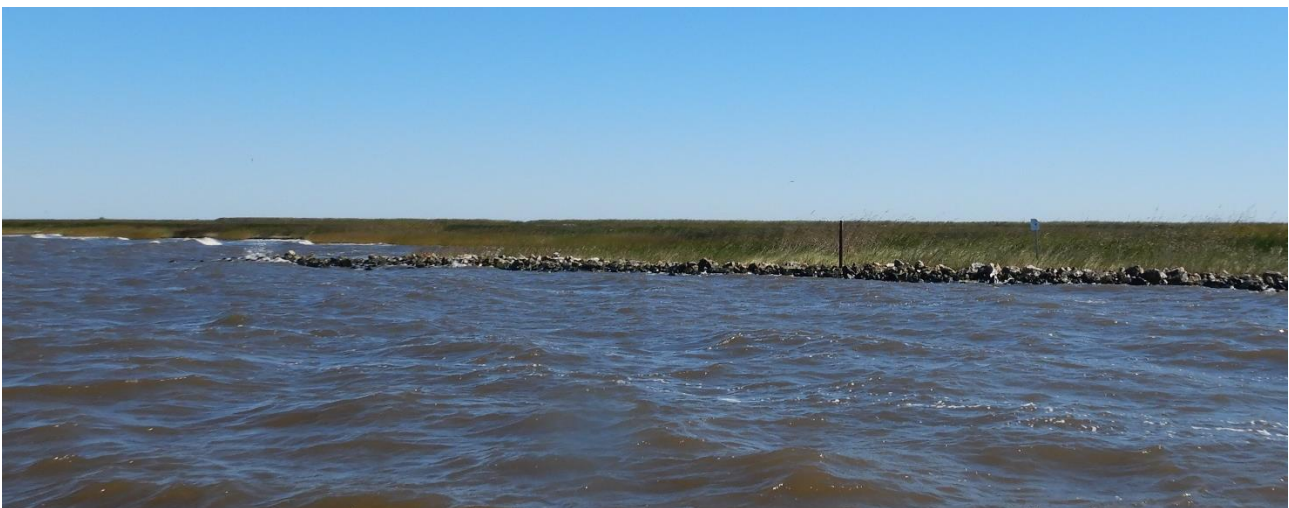
Photo No. 12– Sabine Lake Foreshore Rock Dike, North End

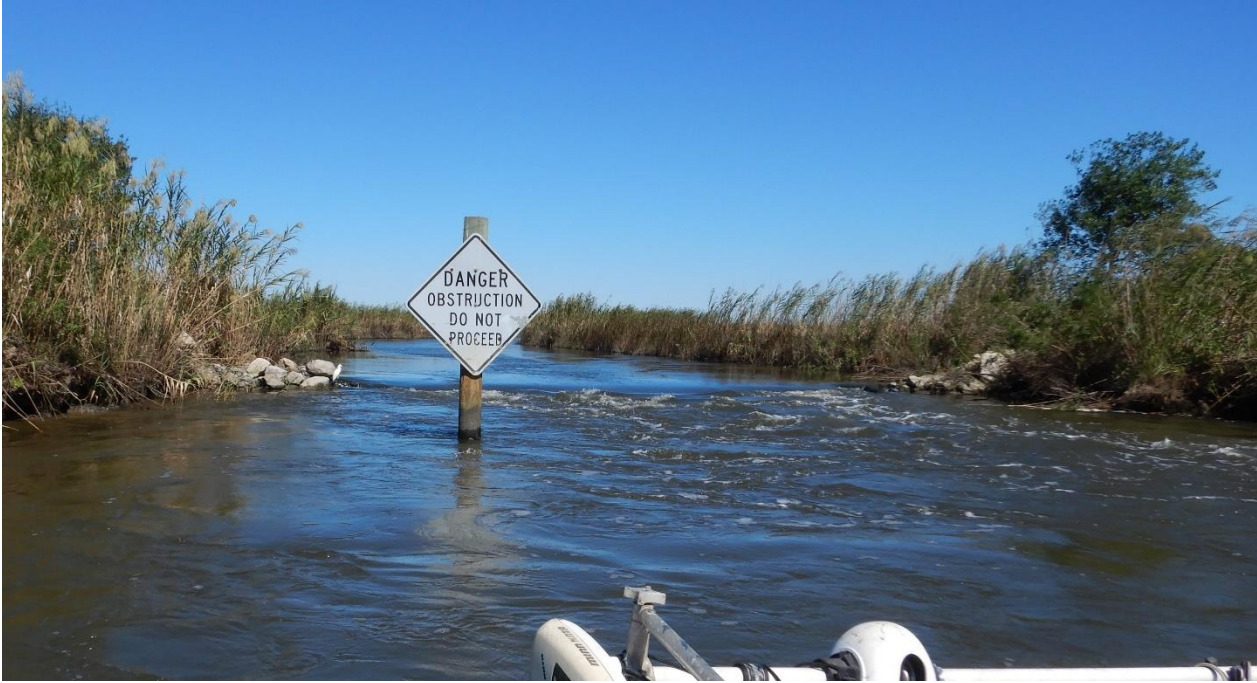
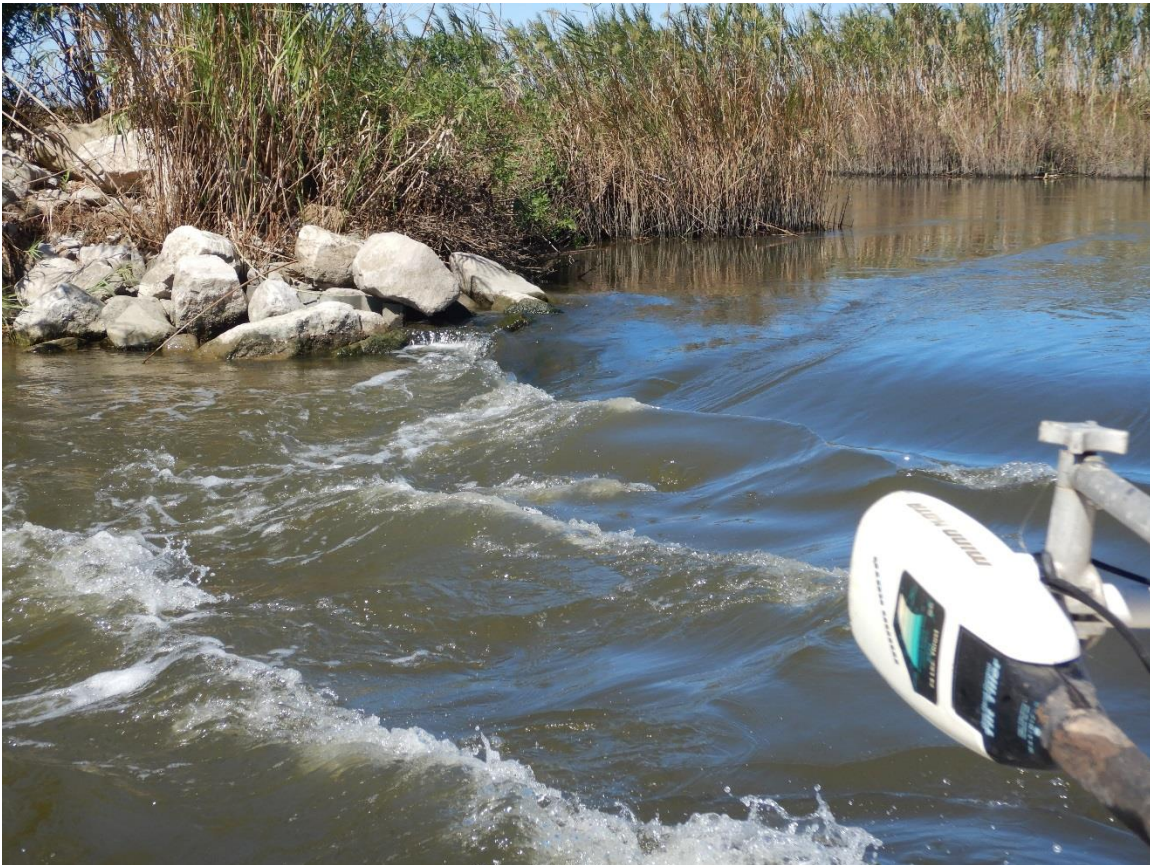
The Pines Ridge Weir is still functioning as intended. Water was flowing rapidly out of the northern marsh into the Pines Ridge Canal. The head differential appeared to be 1.5ft across the weir. The flow was too swift to obtain probe the rock weir and obtain depth measurements. The warning sign was still intact. (See Appendix B, Photos No. 13)

Photo No. 13– Pines Ridge Weir, from Project Exterior

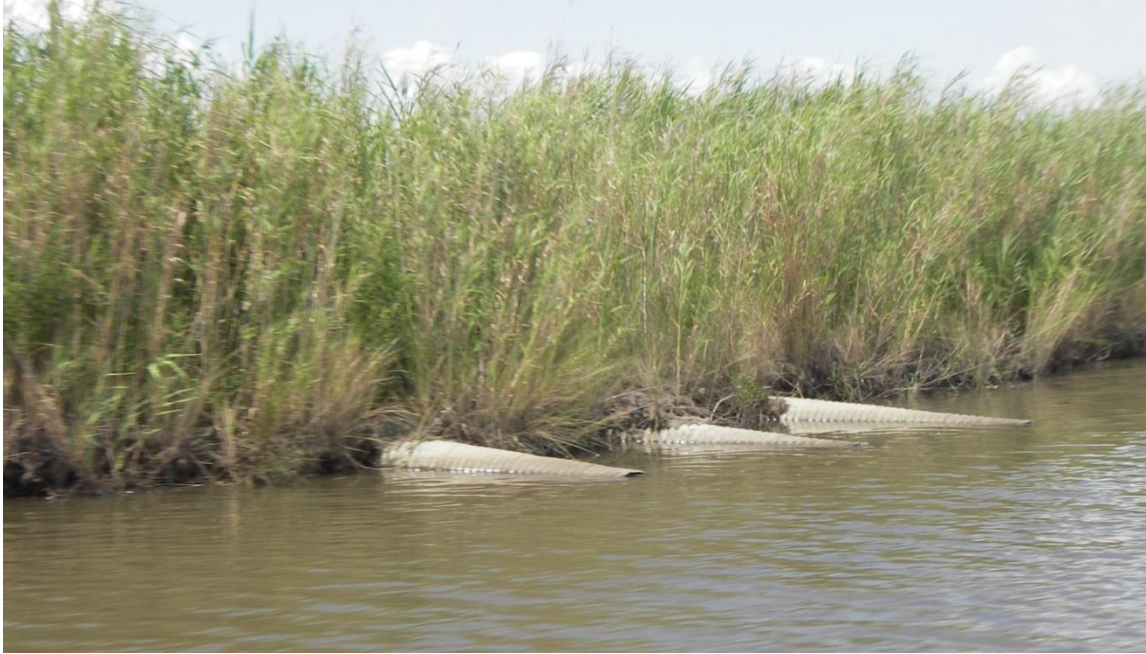
Photo No. 14– Bridge Bayou Culverts in Grey’s Ditch (2016)

Bridge Bayou Culverts	N/A				The culverts were intact during the last inspection in 2016.

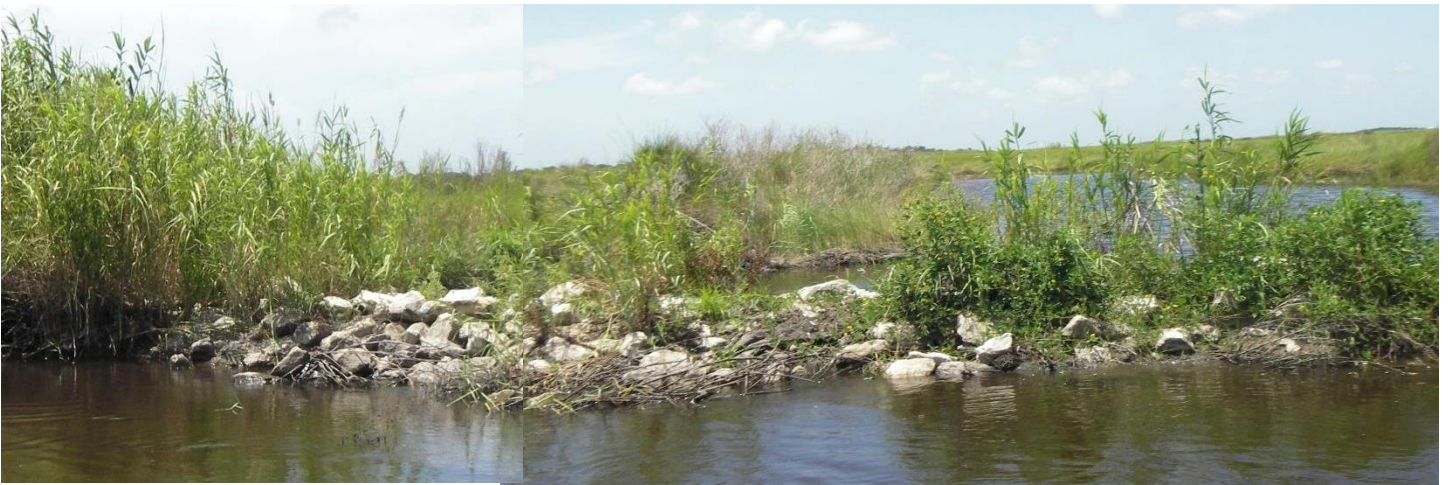
Photo No. 15– Double Island Gully Plug (2016)

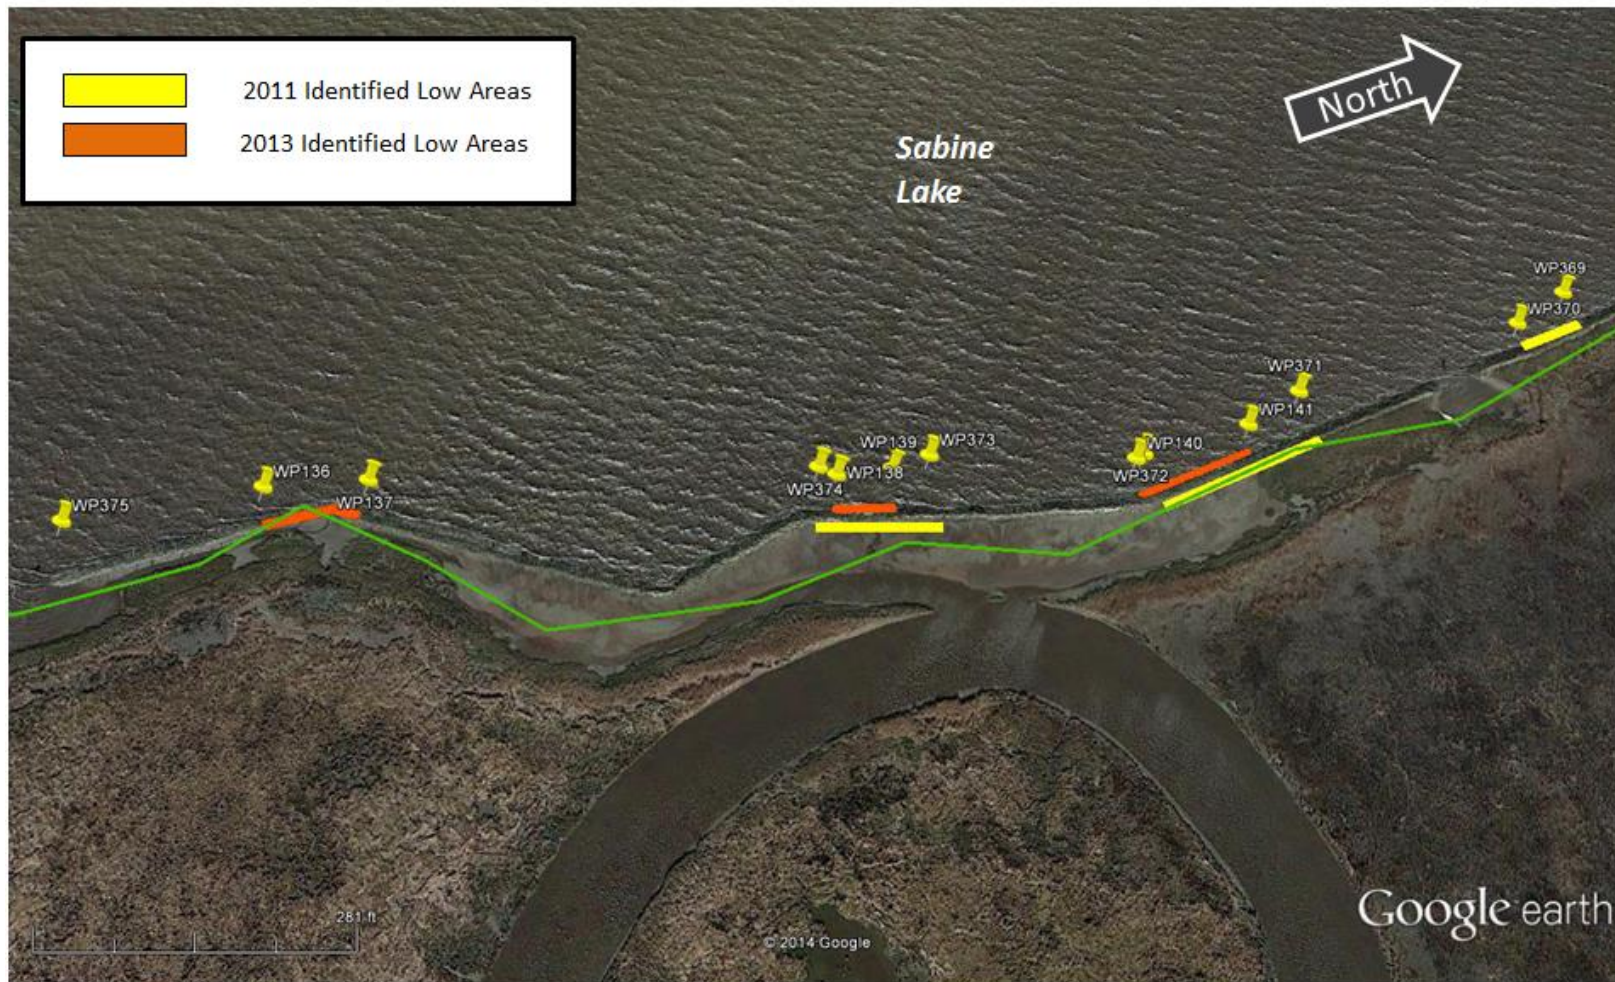
CS-32 East Sabine Lake Hydrologic Restoration Foreshore Rock Dike – Low Areas

Item	Condition	Physical Damage	Corrosion	Photo #	Observations and Remarks
Foreshore Rock Dike	Good			6-13	The rock dike is functioning as intended. There are low areas identified along the dike between the south warning sign and the Willow Bayou Bend which will continue to be monitored. The temporary refuge signs installed along the rock dike in the vicinity of Willow Bayou have been pushed over to a 45 deg angle.
Pines Ridge Weir/ Warning Sign	Good			14	The weir is in tact. The water elevation was approximately above normal at the time of the inspection. Water was rushing out of the marsh. During a prior inspection probing showed the center of the weir to be at approximately 3.5ft depth. The warning sign is still in place.
Hardware					
Staff Gauge at Pine Ridge	Good				Still legible
Double Island Gully Plug	N/A				Last inspected in 2016.
Signage /Supports	Good				The warning signs along the foreshore rock dike in Sabine Lake were intact.
