# PROJECT COMPLETION REPORT

CAMERON-CREOLE MAINTENANCE & REPAIRS PROJECT (CS-004-A)  
STORM DAMAGE REPAIRS  
CAMERON PARISH, LOUISIANA

ROYAL PROJECT NO. 2022-038-002

**DATE: OCTOBER 30<sup>TH</sup>, 2024**

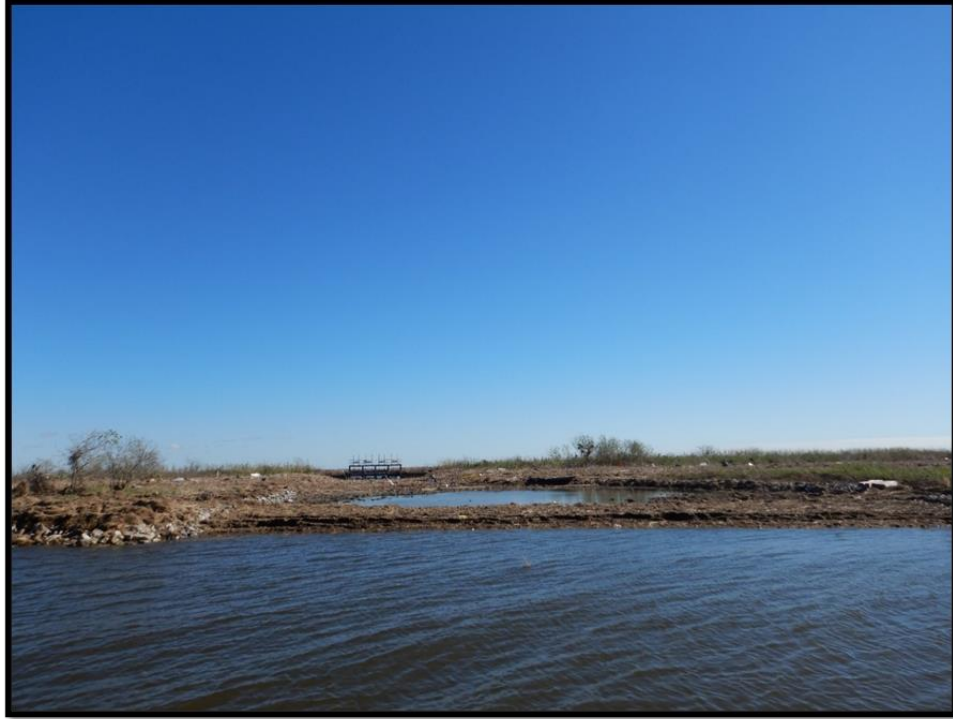
*Figure 10. Mangrove Bayou Outlet Channel- Siltation & Debris, Post-Hurricane Laura*

Beginning at the outlet channel's transition to Lake Calcasieu (also referred to as the mouth of the outlet), the dredged footprint begins with a width of approximately 104-ft which gradually tapers down as it traverses east, nearing the WCS, to a width of approximately 77-ft. The dredged channel bottom elevation is -4.5' (NAVD88) and the dredged side slopes are 3:1 (H:V). In total, approximately 4,000 cubic yards of materials were mechanically excavated and removed from the channel over an extent of 500 linear feet. In addition to siltation and sediments deposited within the channel during Hurricane Laura, other materials excavated and removed from the channel included vegetation, driftwood, and old timber board mats. Materials were removed from the channel via bucket dredging utilizing a combination of barged excavators and an amphibious excavator or marsh buggy. Once excavated, materials were stockpiled on barges then barged offsite to an approved disposal site. No items were encountered that required special handling during the dredging of the Mangrove Bayou Outlet Channel. Figure 18 depicts the completed work at Mangrove Bayou outlet channel.

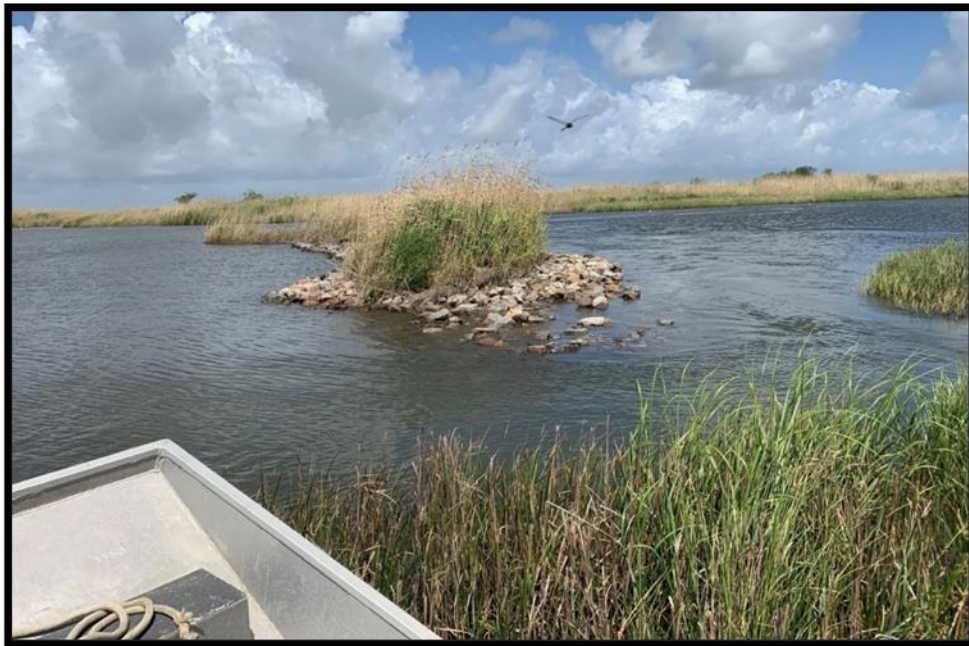
*Figure 11. Mangrove Bayou Interior Canal Plug - Scouring of Eastern Tie-in, Post-Hurricane Laura*

Beginning at each end of the existing weir structure, 55-lb rip rap was used to fill in scoured areas as well as cap and protect what is left of the existing tie-in embankment. The finished repair entails a rip rap berm, built up to an elevation of +2.0' (NAVD88) with varying crown width and side slope. Figure 19 depicts the completed work at Mangrove Bayou interior canal plug.

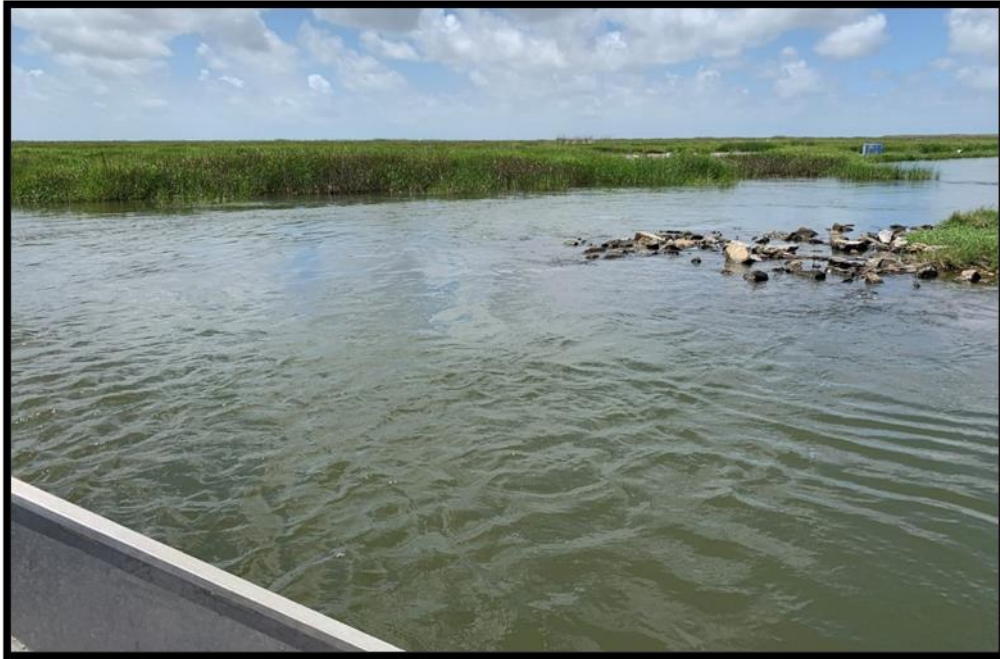
*Figure 12. Grand Bayou Interior Canal Plug - Scouring of Eastern Tie-In, Post-Hurricane Laura*

Beginning at each end of the existing weir structure, 55-lb rip rap was used to fill in scoured areas as well as cap and protect what is left of the existing tie-in embankment. The finished repair entails a rip rap berm, built up to an elevation ranging between +1.5' and +2.0' (NAVD88) with varying crown width and side slope. Figure 20 depicts the completed work at Grand Bayou interior canal plug.

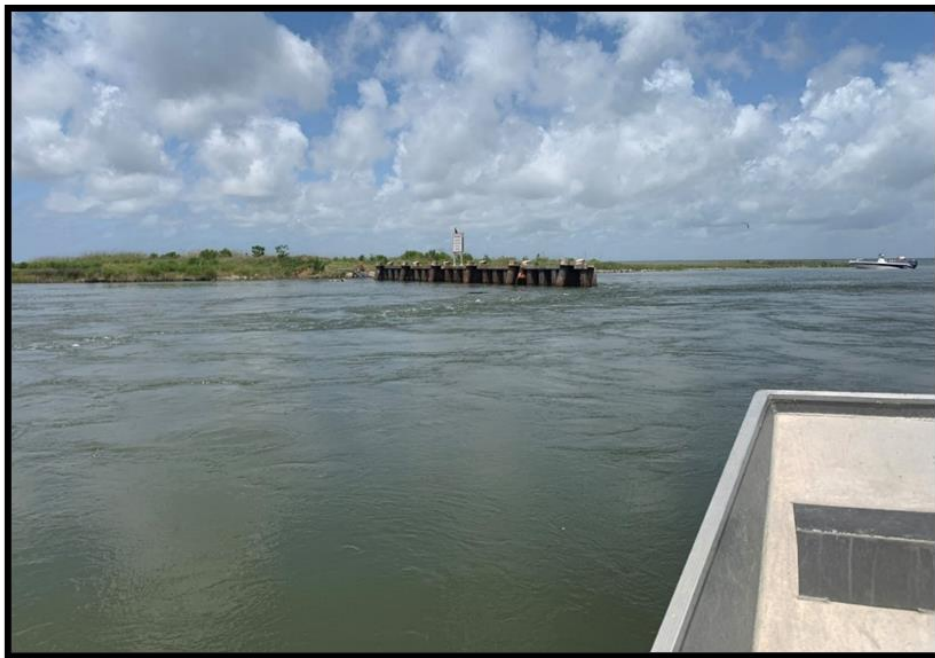
*Figure 13. Grand Bayou Levee Breach Structure - Overview of Scouring on North End, Post-Hurricane Laura*

The levee breach repair at Grand Bayou is an extension on the north side of an existing Hurricane Rita sheet pile repair to address the new scour area in the Cameron-Creole levee. The sheet pile extension consisted of 90LF of PZ-35 sheet pile wall, having a section length (vertical length) of 60-ft long, anchored with 70-ft batter piles, and encased by approximately 2,600 tons of 55-lb rip rap. The PZ-35 steel sheet piles are anchored by five sets of 18” steel batter piles. The batter piles are connected to the sheet pile wall with gusset plates, which are welded to a W18 x 55 steel whaler beam acting as the top cap of the sheet pile wall. Figure 22 depicts the completed work at Grand Bayou levee breach.

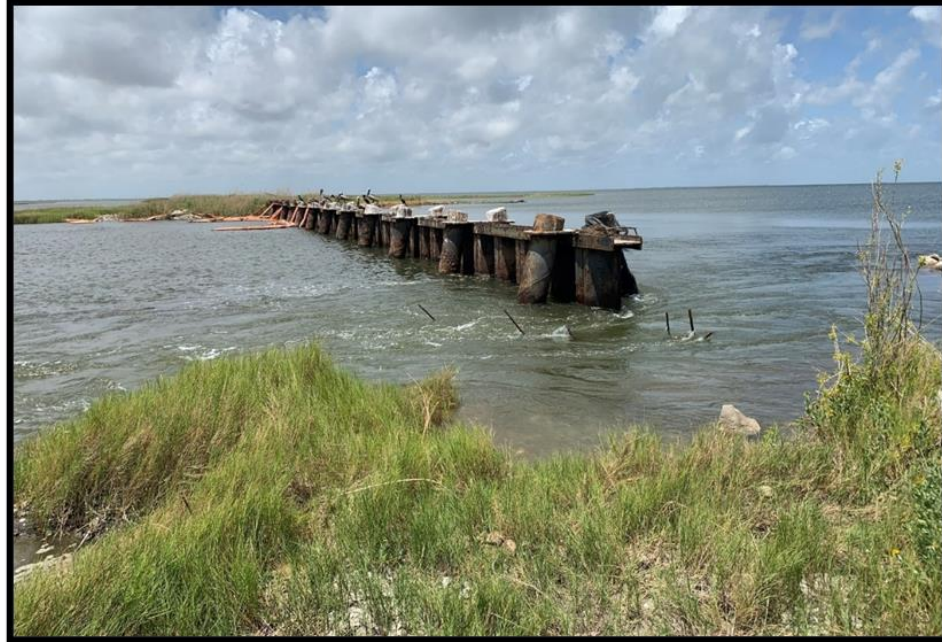
*Figure 14. Lambert Bayou Levee Breach Structure - Overview of Scouring on North East End, Post-Hurricane Laura*

The levee breach repair at Lambert Bayou is an extension on the northeast side of an existing Hurricane Rita sheet pile repair. The sheet pile wall was extended to the southwestern end of the existing Lambert water control structure. This sheet pile extension consisted of 75-LF of PZ-35 sheet pile wall, having a section length (vertical length) of 45-ft long, anchored with 60-ft batter piles, and encased by approximately 2,950 tons of 55-lb rip rap. The PZ-35 steel sheet piles are anchored by four sets of 18” steel batter piles. The batter piles are connected to the sheet pile wall with gusset plates, which are welded to a W18 x 55 steel whaler beam acting as the top cap of the sheet pile wall. The extension ties in and connects to the Lambert Bayou Water Control Structure with an HP16x141 (H-pile) that is interlocked with the sheet pile on one side of its web and sized for a snug acceptance of the water control structure’s wingwall between the H-pile flanges. Figure 23 depicts the completed work at Lambert Bayou levee breach.

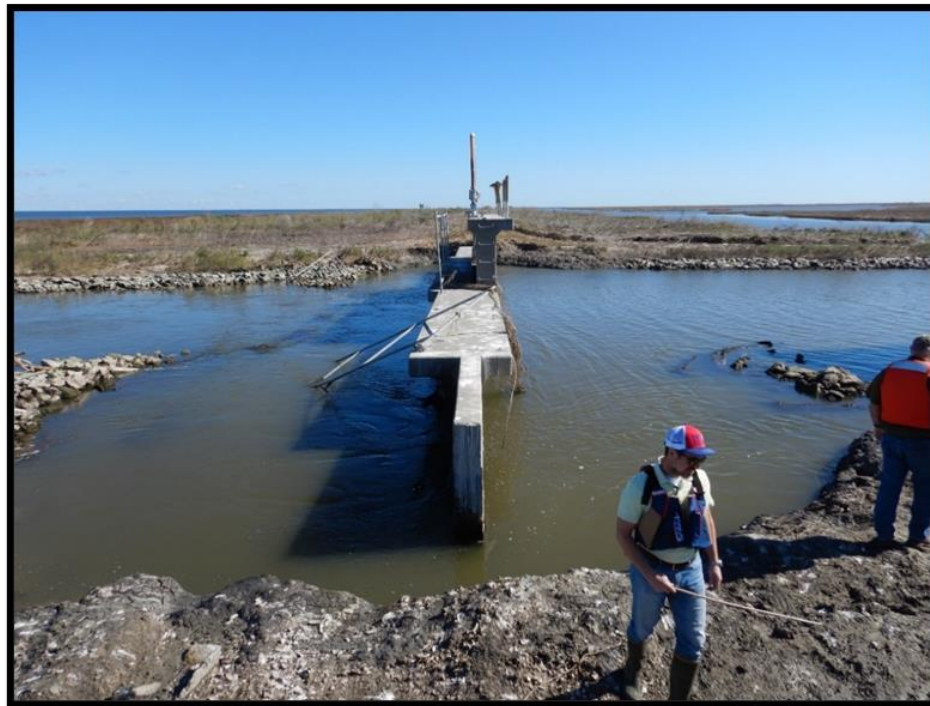
*Figure 15. No Name Bayou Water Control Structure - Scouring of Tie-Ins, Post-Hurricane Laura*

At the No Name Bayou Water Control Structure, 55-lb rip rap was used to fill in and build up the scoured areas around each end of the structure. In addition to the scour repairs, several mechanical repair activities took place in order to regain full functionality of the structure. Details regarding the mechanical repairs are provided in Table 7, below.

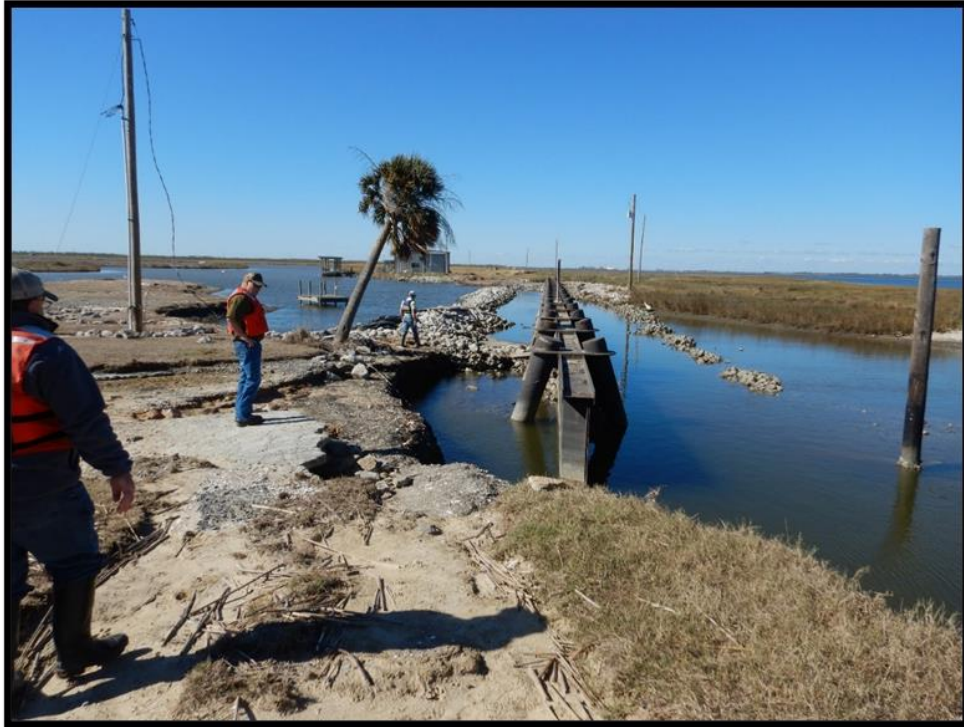
Figure 16. No Name Bayou Levee Breach Structure - Scouring Around Structure, Post-Hurricane Laura

At the No Name Bayou Levee Breach, 55-lb rip rap was used to fill in and build up the scoured areas around the Eastern end of the existing Hurricane Rita Sheet pile Repair. Figure 24 depicts the completed work at No Name Bayou levee breach.

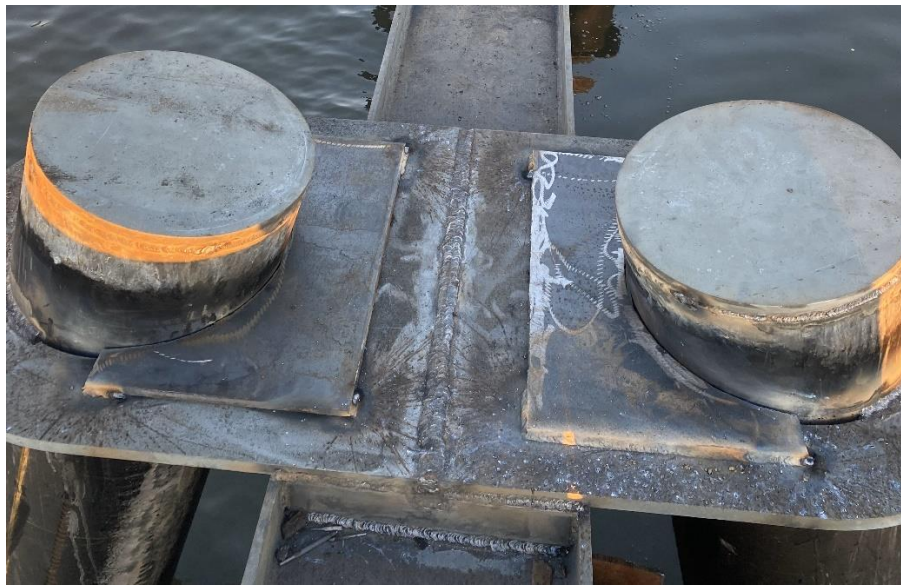
*Grand Bayou/Lambert Bayou Levee Breach – Gusset Plates:* Original gusset plate (batter pile attachment plate) design for the adjacent existing levee breach structures, which were constructed in 2006, was referenced during design and implemented during construction of the Cameron-Creole Maintenance and Repairs Project. It was understood that due to the required 15-degree batter angle of the piles and the intended horizontal orientation of the gusset plate, the hole needed to be larger than the 18" pipe diameter in order to account for the pile angle. Although the gusset

plate parameters and dimensions were originally the same for both the Lambert and Grand Bayou locations, GIC made two separate orders with the Lambert Bayou plates as the initial order. After the first set of batter piles had been driven to the required depth at Lambert Bayou, GIC attempted to install the first gusset plate. The hole dimensions specified in the construction plans (and as-builts) for the adjacent existing structures constructed in 2006, and referenced for this project, were discovered to be too large to obtain sufficient contact length for the weld between the pipe pile and the plate hole perimeter. GIC notified Royal of the issue at hand, and field changes were implemented to achieve a resolution. The first field change included removing an interior slice from the center of the two-hole plate to create two separate one-hole plates which could be sucked in towards the sheet pile wall. This allowed GIC to obtain sufficient contact length for establishing a weld along the back side of the gusset plates and the battered pipe piles, and left only the inward facing side with a gap between the pipe pile and gusset plate. These gaps were addressed by welding an additional cover plate of ½” thickness over them, to establish a minimum of 28 ¼” of contact length with the perimeter of the pipe on the inward facing side. An image depicting the cover plates set in-place prior to being welded is shown below.

*Figure 17. Lambert Bayou Batter Pile Attachment Plates - Cover Plates*

The cover plate was then welded to both the gusset plate and the pipe pile to effectively tie the system in. As-built details drafted for this field change can be seen under Appendix E.4.

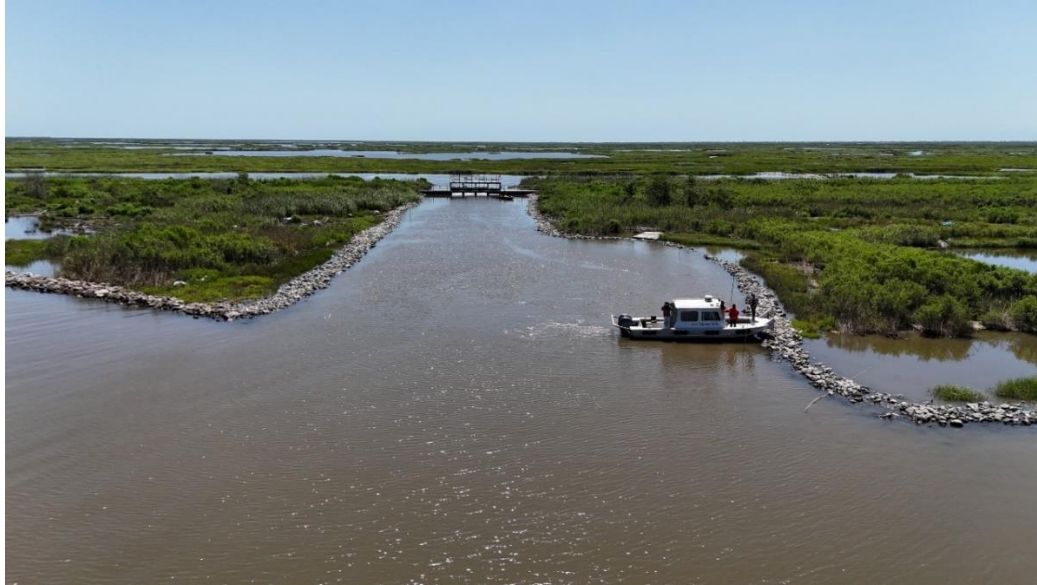
*Figure 18. Mangrove Bayou Outlet Channel, Post-Construction*

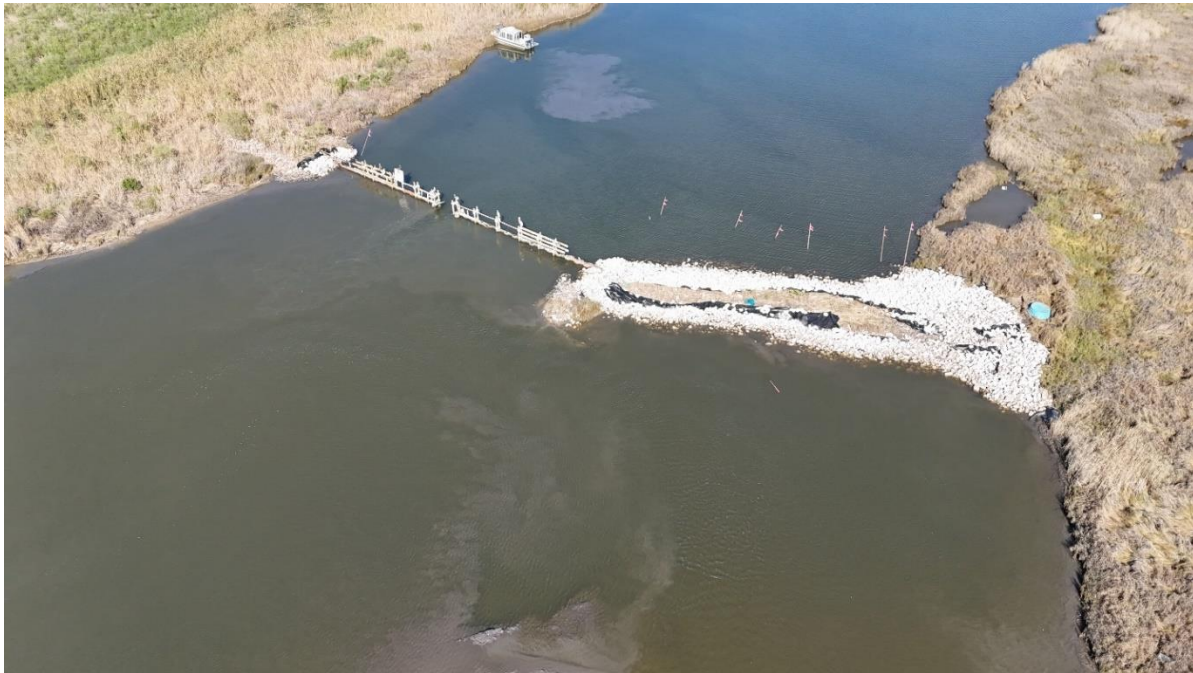
*Figure 19. Mangrove Bayou Interior Canal Plug, Post-Construction*

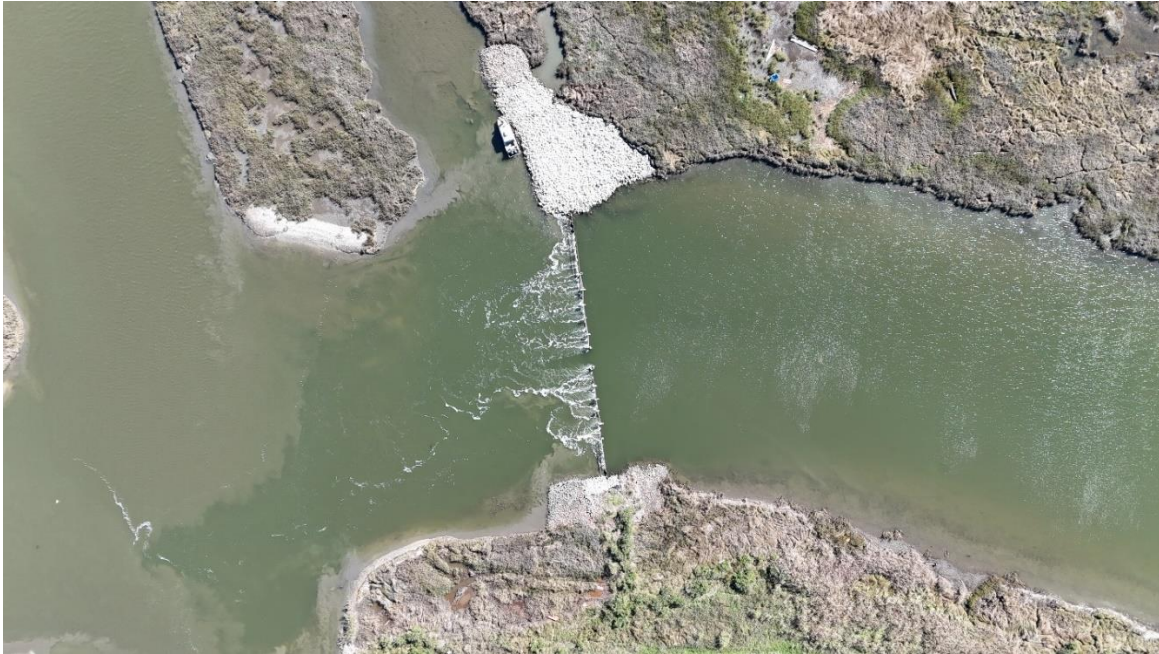
*Figure 20. Grand Bayou Interior Canal Plug, Post-Construction*

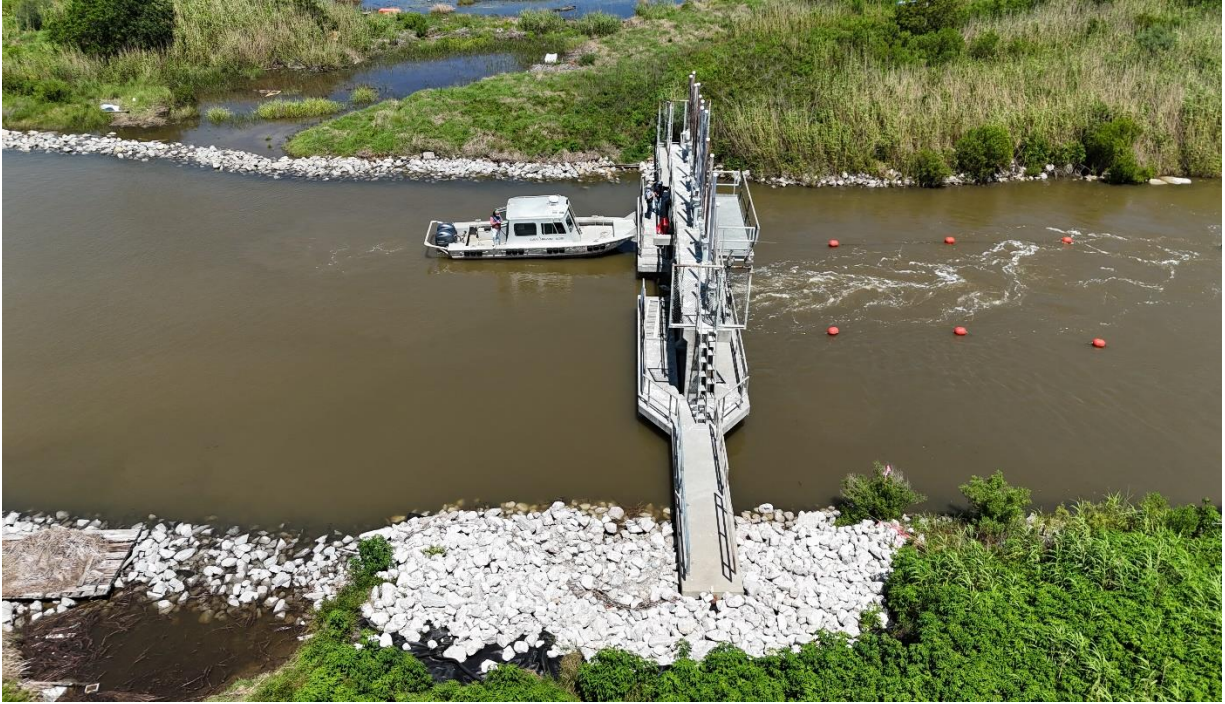
*Figure 21. Grand Bayou Water Control Structure, Post-Construction*

At the Grand Bayou Water Control Structure, 55-lb rip rap was used to fill in and build up the scoured area around the southern end of the structure to an elevation of +5.0' (NAVD88). In addition to the scour repair, several mechanical repair activities took place to regain full functionality of the structure. Details regarding the mechanical repairs are provided in Table 5, below.

For the flap gate replacement listed under Item 2 in the above table, GIC opted to self-fabricate the gate after the original gate manufacturer, Rodney Hunt, informed them that although they are still able to supply replacement parts and components, they no longer offer the whole timber flap gate as a product. With this information, GIC procured the required timber boards from Coastal Timbers, Inc. (New Iberia, LA) and the required connection hardware from STS Industrial, Inc. (Sulphur, LA) in order to fabricate the gate themselves, in-house. All gate components were obtained and assembled by GIC in accordance with the dimensions shown in the Final As-Built drawings under Appendix E.

During installation, GIC encountered issues with seating the flap gate due to the build-up of corrosion around the interior edges of the thimble/frame. To solve this issue, GIC had to slightly decrease the overall width of the 118-in. wide flap gate. The crew brought the flap gate back to their shop, where they disassembled the seal and retainer strip from the gate, then shaved approximately 1-in. off each side of the gate. After decreasing the width down by a total of two inches, the seals and retainer strips were reattached to the flap gate system, and crews returned to the site for a successful installation.

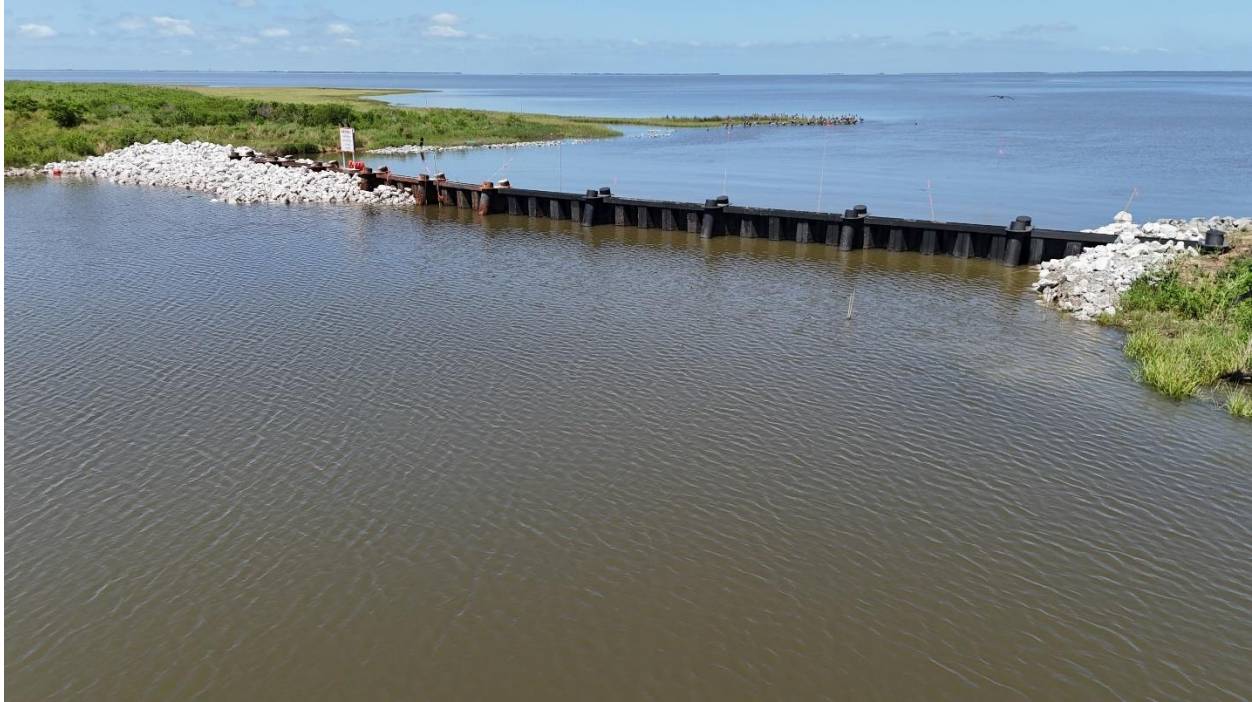
*Figure 22. Grand Bayou Levee Breach Structure, Post-Construction*

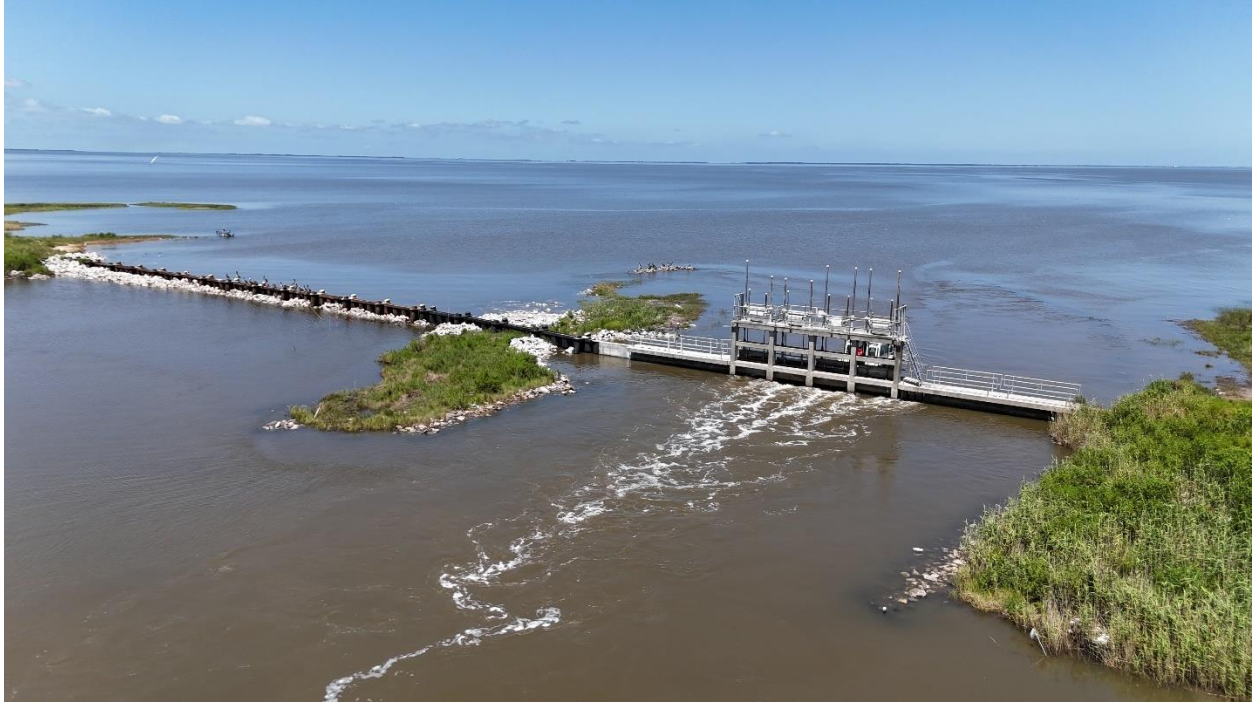
Figure 23. Lambert Bayou Breach and Water Control Structure, Post-Construction

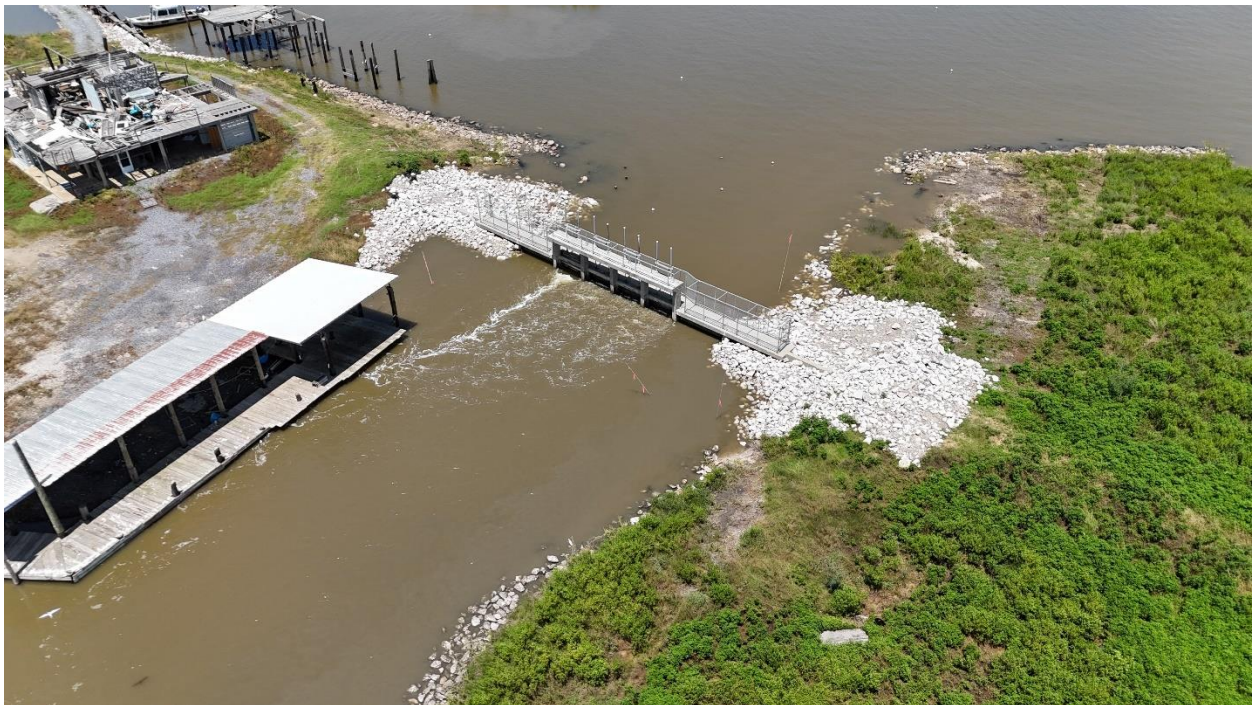
Figure 24. No Name Bayou Water Control Structure, Post-Construction

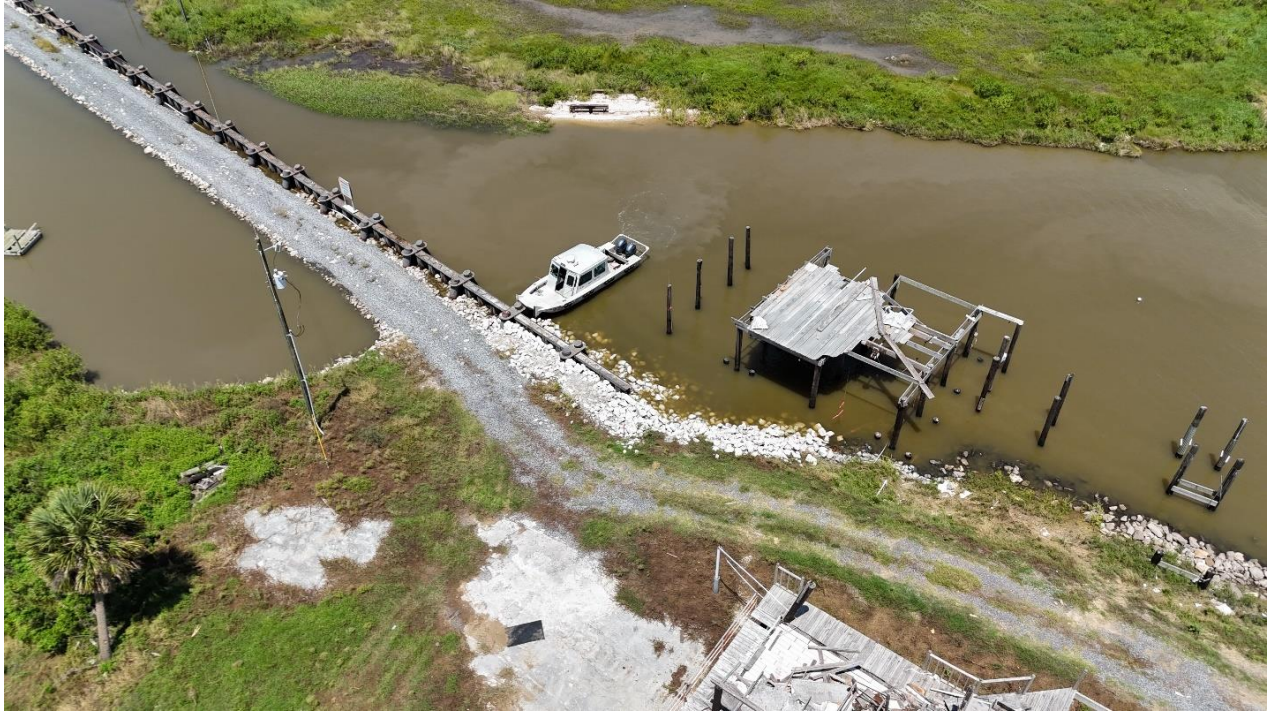
*Figure 25. No Name Bayou Levee Breach Structure, Post-Construction*
