**State of Louisiana  
Coastal Protection and Restoration Authority**

**2019 Annual Inspection Report**

**Lake Borgne Shoreline Protection  
Project**

State Project Number PO-30  
Priority Project List 10

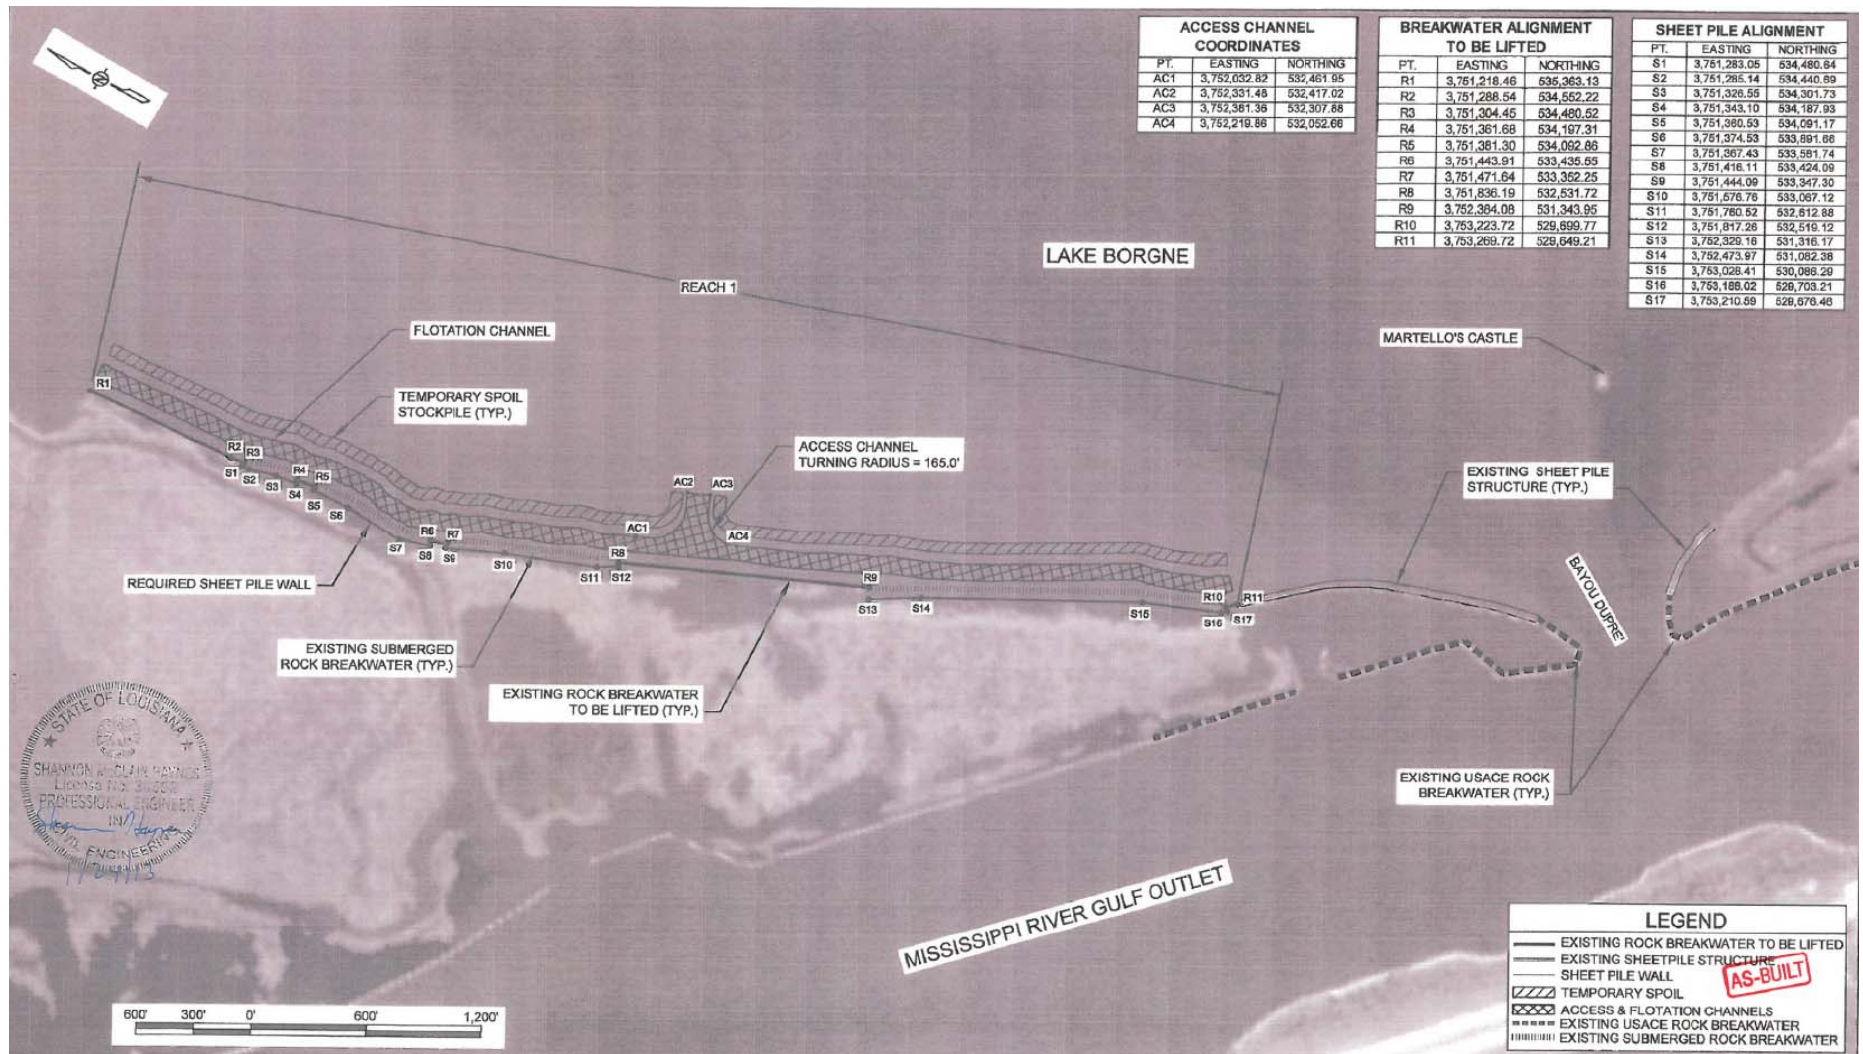
Figure 1: 2013 Maintenance Event As Built for Reach 1

- A. Breakwater Reach 1 (North of Bayou Dupre)** – There is significant deterioration of this feature, as described below from north to south. See Figure 1 for point coordinates.

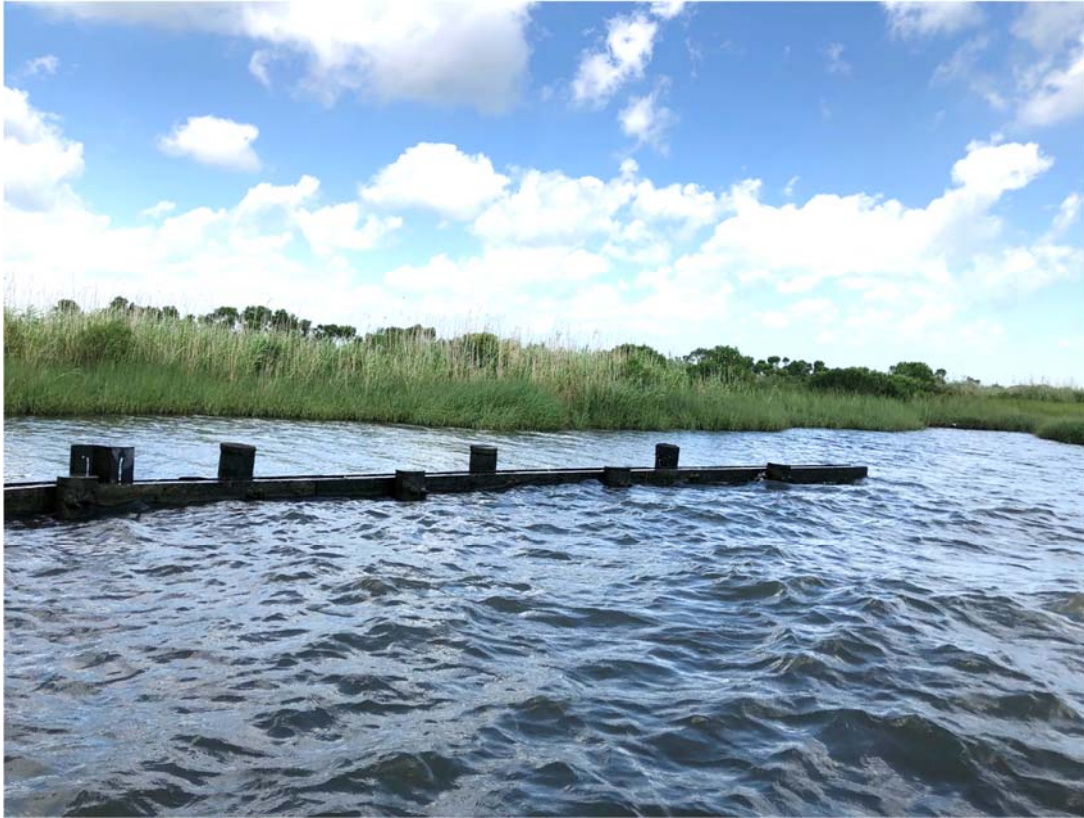
**Photo 1: Reach 1 (5/29/2019)**

Beginning of sheetpile wall- No repairs required on this stretch: 29°57'40.45", -89°50'51.04"

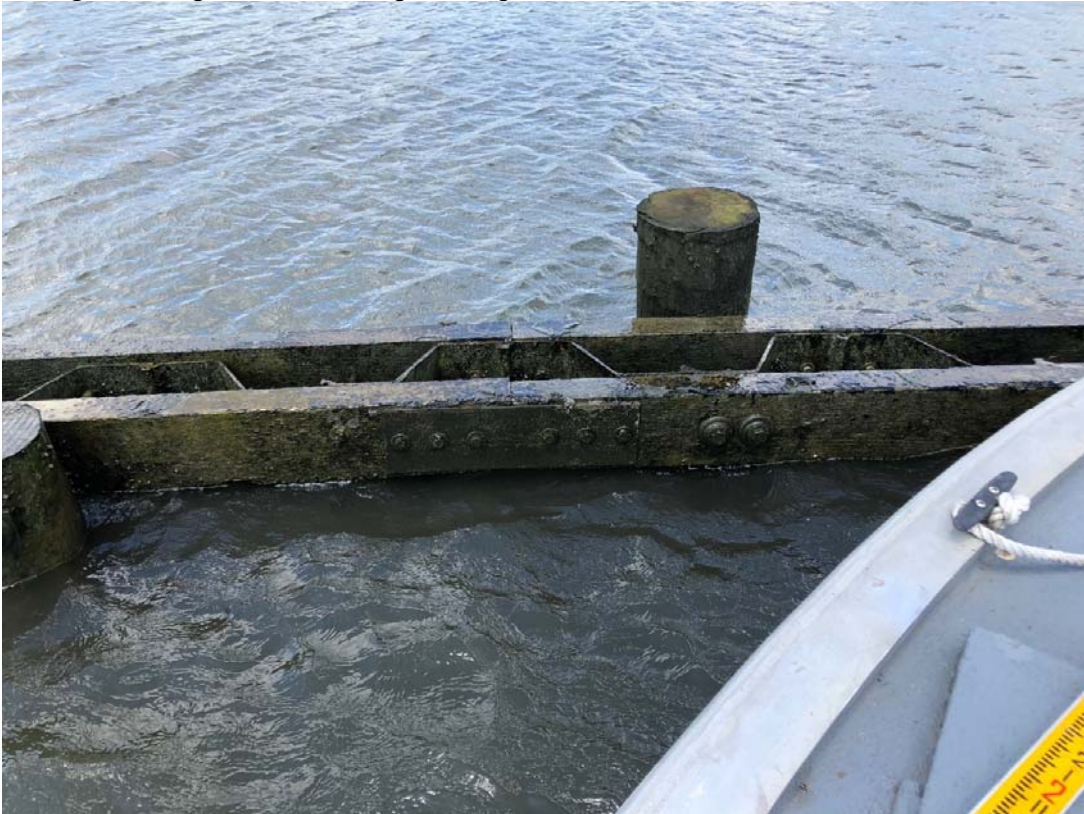
**Photo 2: Reach 1 (5/29/2019)**

No repairs required on this stretch: 29°57'39.24", -89°50'50.90"

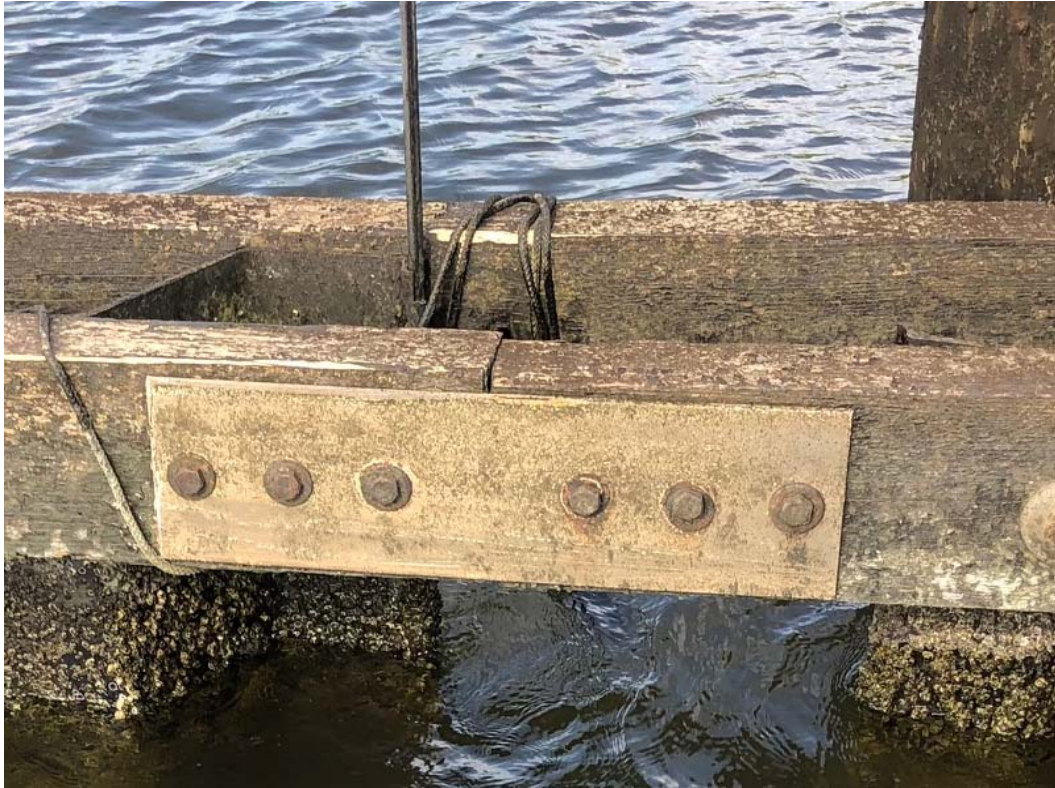
**Photo 3: Reach 1**

No repairs required on this stretch, but missing & deteriorated washers visible, and one sheet is missing:  
29°57'39.59", -89°50'51.10"

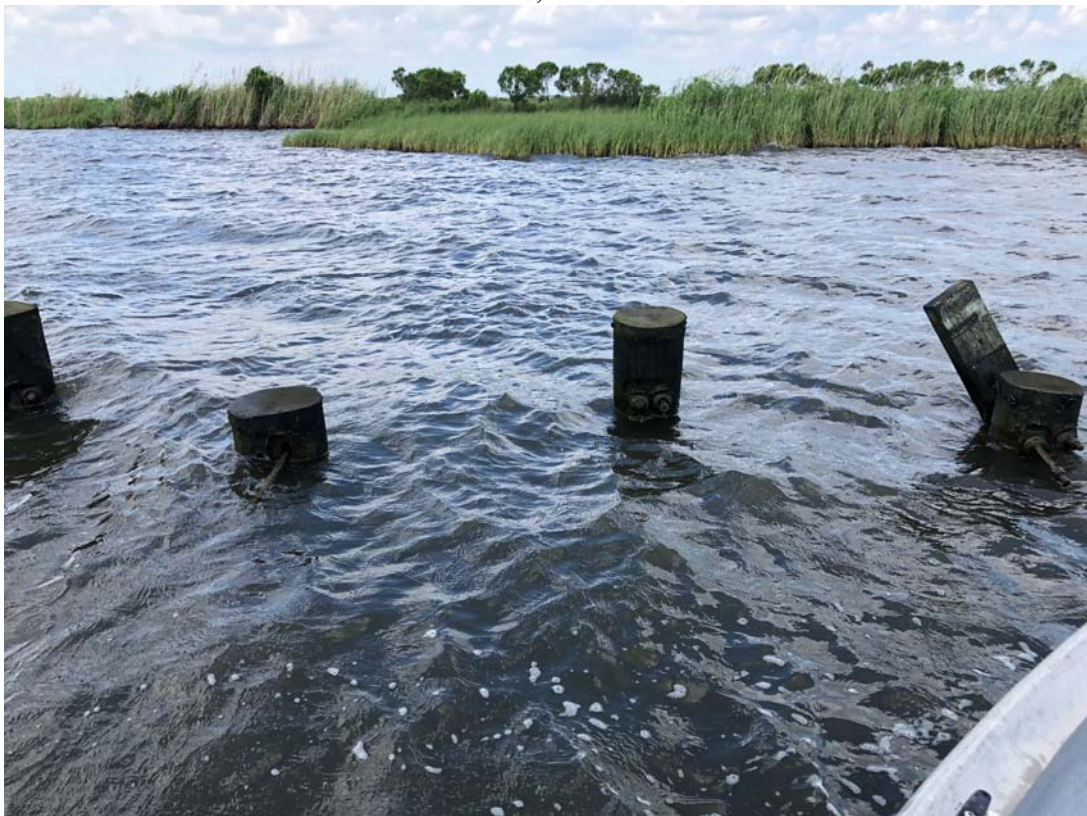
**Photo 4: Reach 1 (5/29/2019)**

| Start Point | End Point | Length (LF) | Type | Condition |
|---|---|---|---|---|
| R5 | R6 | 660 | Sheetpile | This entire section is badly deteriorated. None of this section appears to be salvageable aside from the piles. A maintenance event is being planned to rehabilitate this segment. |

Entire stretch to be rehabilitated (aside from piles): 29°57'35.98", -89°50'49.97

CPRA is currently planning a maintenance event to rehabilitate segments along the sheetpile wall in Reach 1, replace the failed tie rod on the double sheetpile wall breakwater, and enhance intact waler splices by replacing hardware with more durable alternatives.

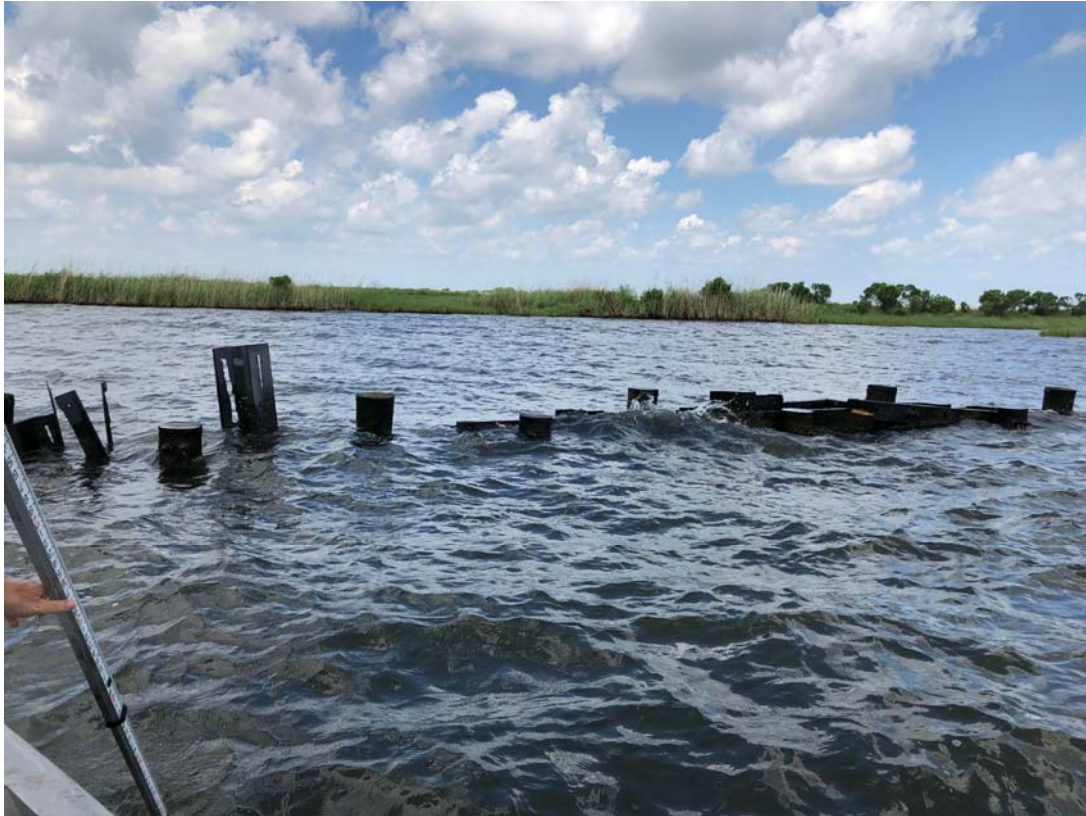
**Photo 5: Reach 1 (5/29/2019)**

Entire stretch to be rehabilitated (aside from piles): 29°57'34.34", -89°50'50.13"

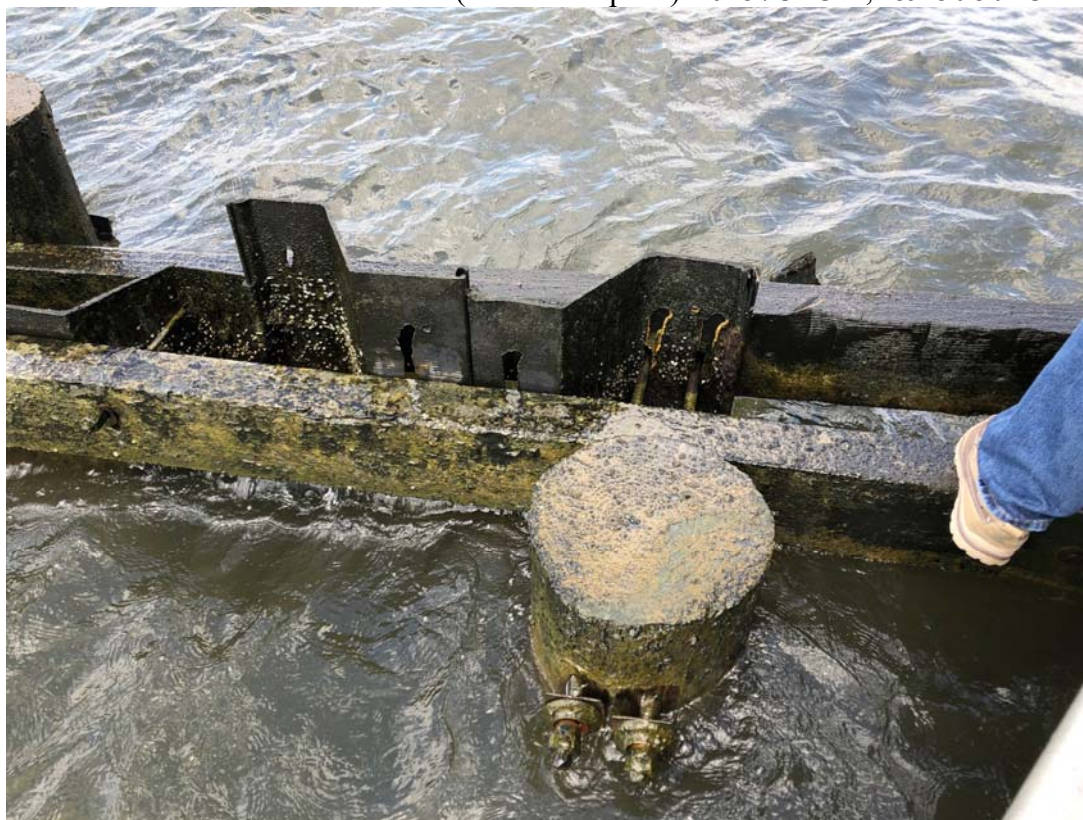
**Photo 6: Reach 1 (5/29/2019)**

Entire stretch to be rehabilitated (aside from piles)

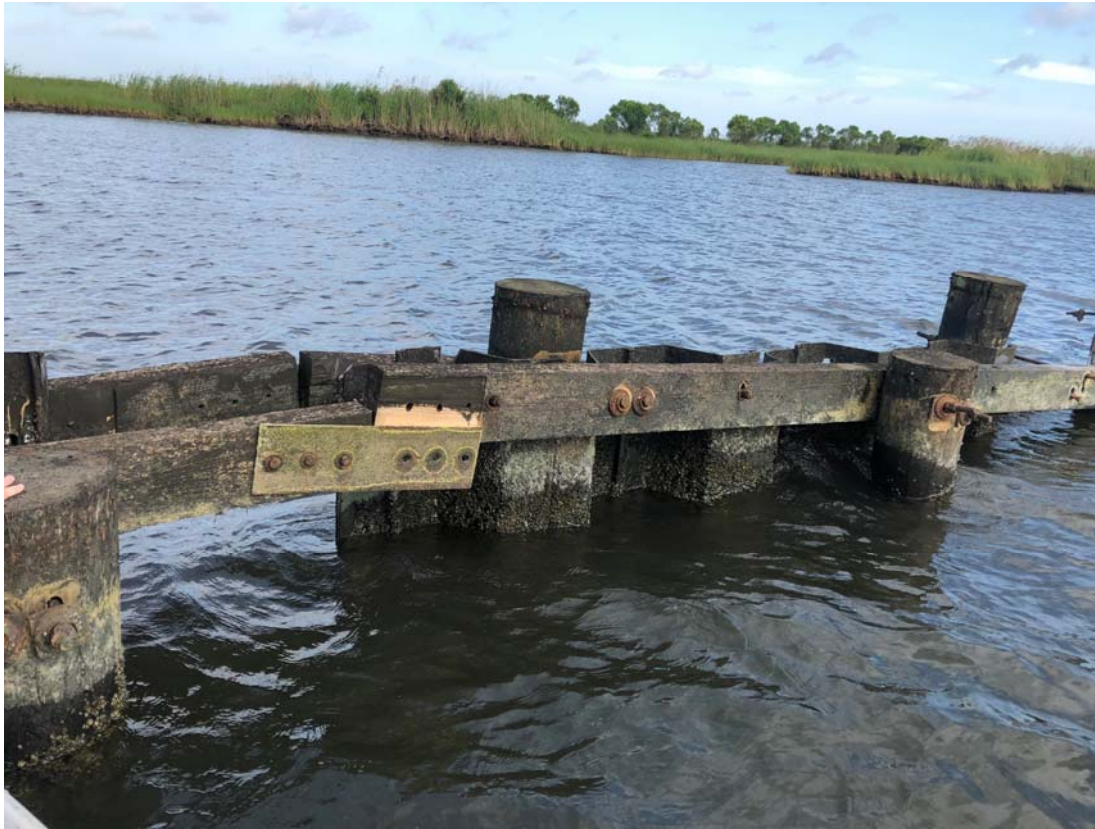
**Photo 7: Reach 1**

Entire stretch to be rehabilitated (aside from piles): 29°57'34.60", -89°50'50.52"

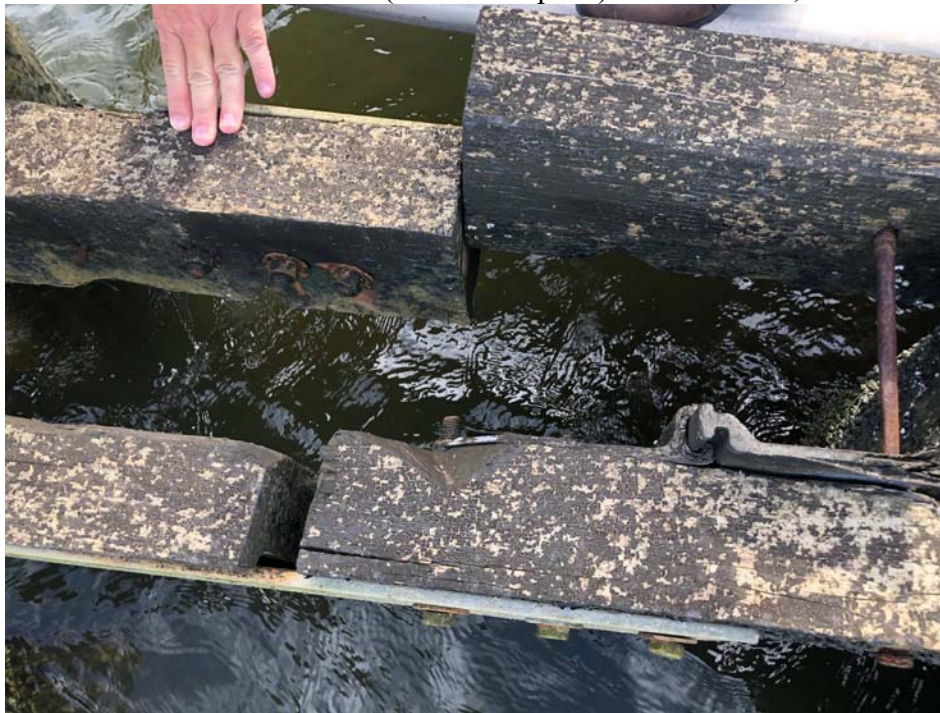
**Photo 8: Reach 1**

Entire stretch to be rehabilitated (aside from piles) – Note that the side of the splice that failed utilized lag bolts. The side of the splice that remained intact utilized through bolts: 29°57'34.60", -89°50'50.57"

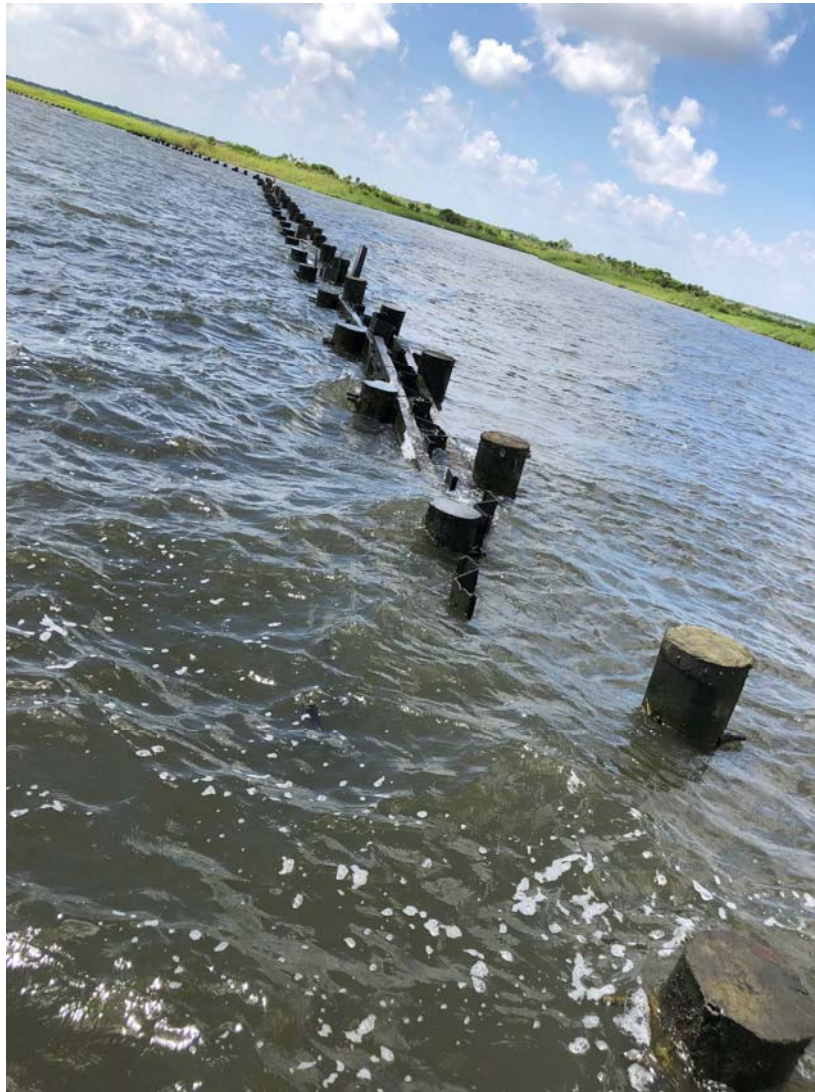
**Photo 9: Reach 1 (5/29/2019)**

Entire stretch to be rehabilitated (aside from piles): 29°57'34.75", -89°50'50.46"

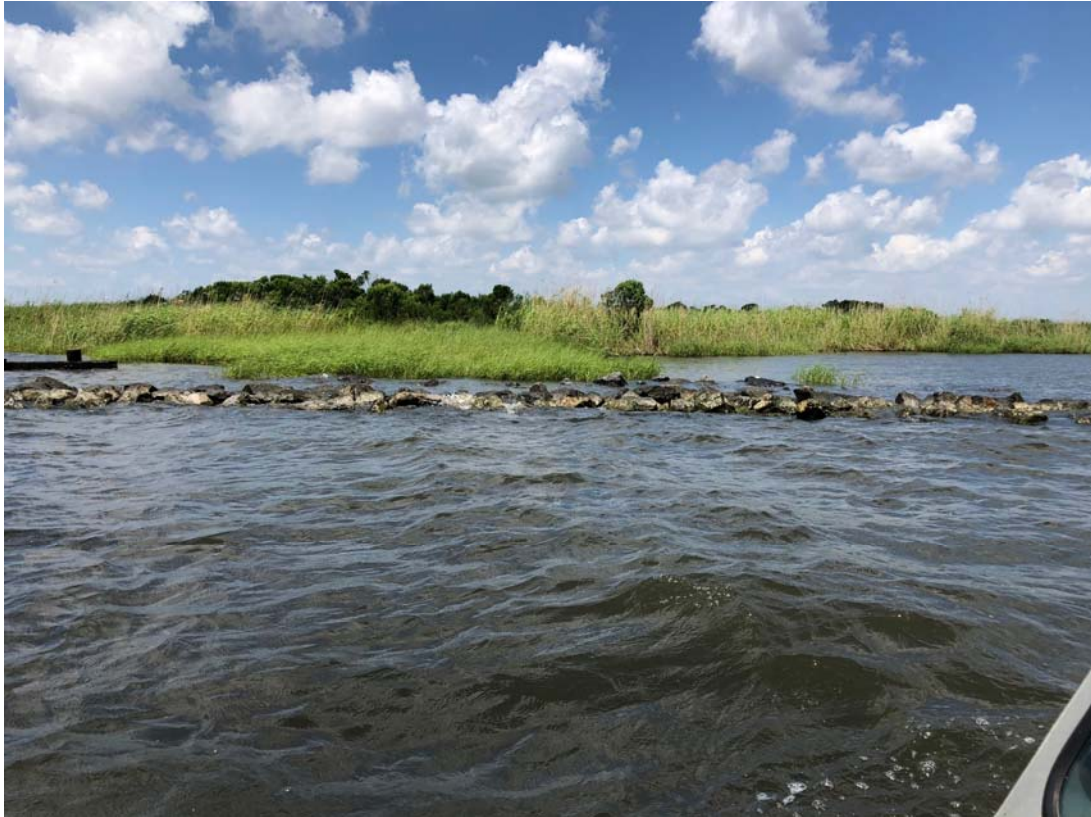
**Photo 10: Reach 1 (5/29/2019)**

Short rock breakwater segment in good condition: 29°57'30.31", -89°50'49.06"

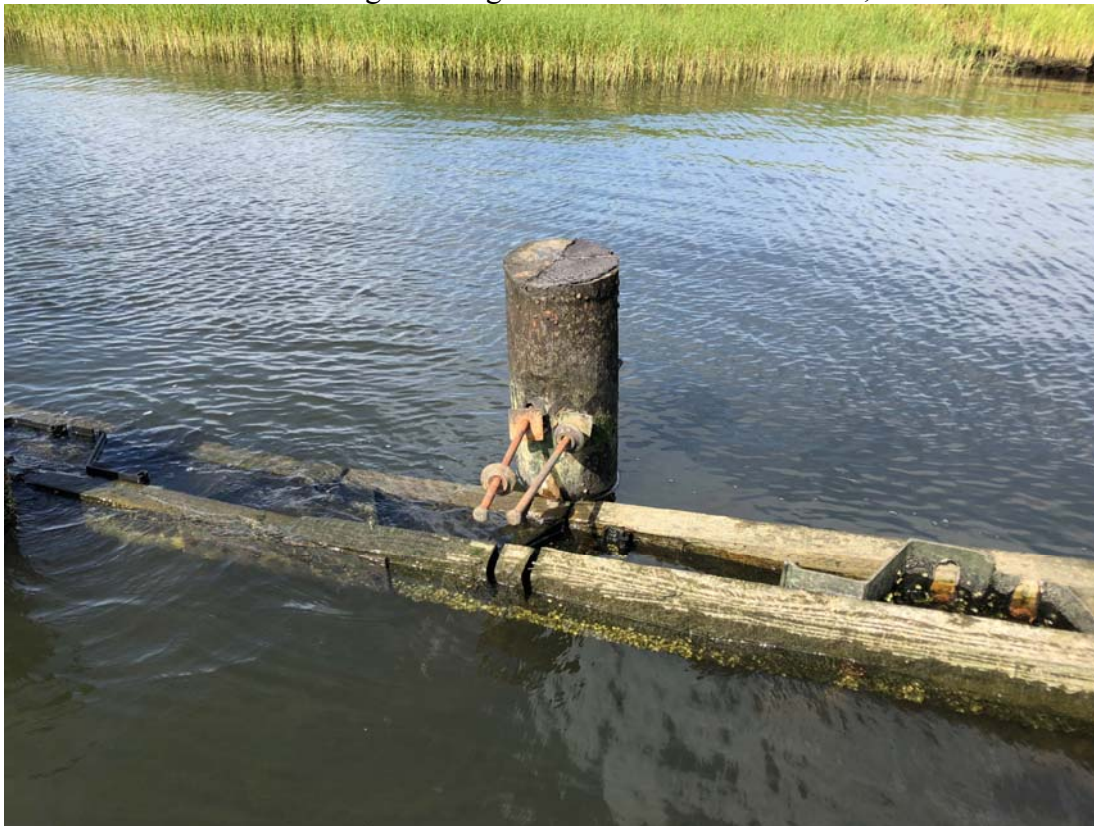
**Photo 11 – Reach 1**

| Start Point | End Point | Length (LF) | Type | Condition |
|---|---|---|---|---|
| R7 | R8 | 905 | Sheetpile | Approximately 35% of the length of this segment will be able to remain, and approximately 65% of the length of this segment will need to be rehabilitated, with only the piles to remain. From north to south, the first 150 feet will need to be rehabilitated, followed by 325 feet that can remain, and the remainder of approximately 430 feet will need to be rehabilitated. A maintenance event is being planned to repair this segment. |

Approximately 65% of this segment to be rehabilitated (aside from piles): 29°57'28.68", -89°50'49.28"

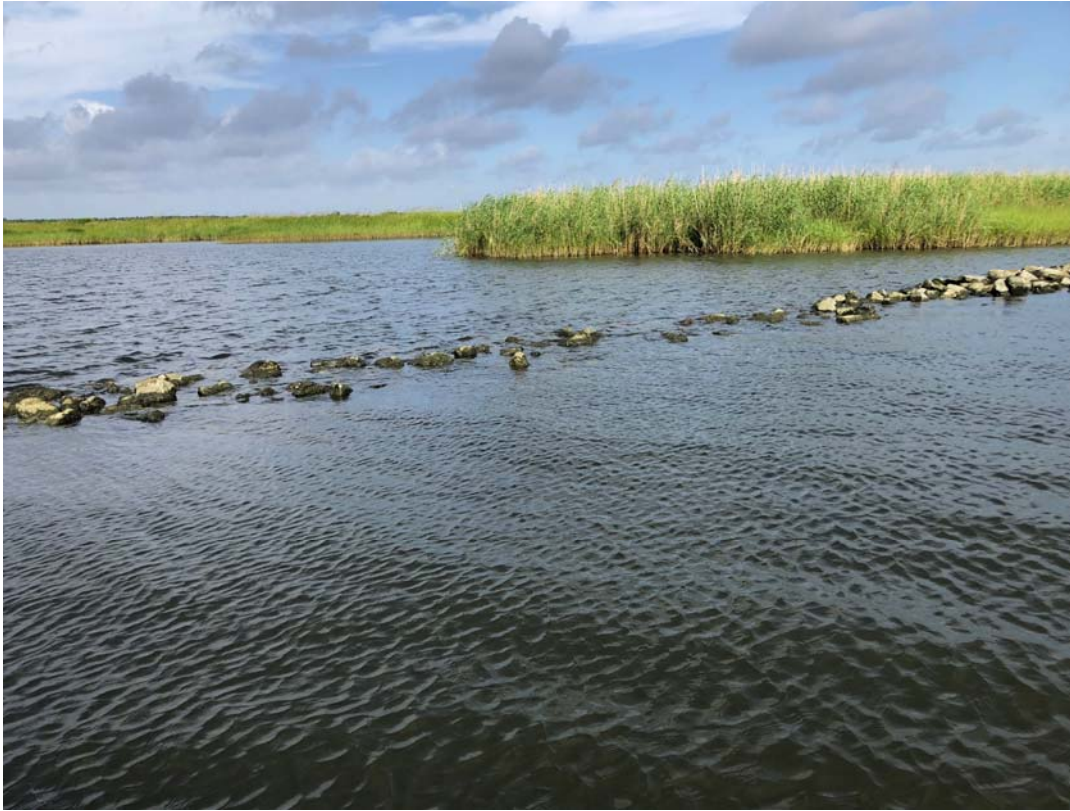
**Photo 12: Reach 1**

| Start Point | End Point | Length (LF) | Type | Condition |
|---|---|---|---|---|
| R8 | R9 | 1310 | Rock | This segment has experienced some settlement. There is one area (about 150 to 200 feet long) that has settled to approximately +0.75' NAVD 88. This occurs at roughly 29°57'20.14", -89°50'43.84". |

Low spot: 29°57'18.18", -89°50'43.57"

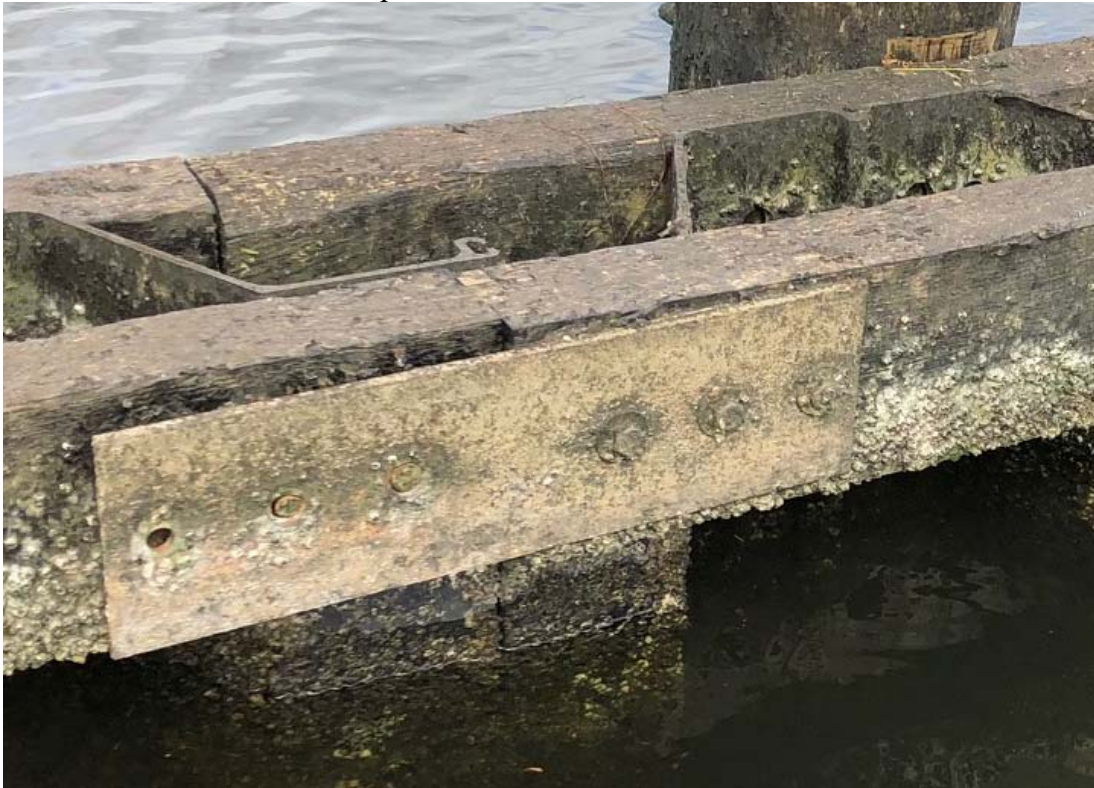
**Photo 13: Reach 1**

| Start Point | End Point | Length (LF) | Type | Condition |
|---|---|---|---|---|
| R9 | R10 | 1850 | Sheetpile | Approximately 65% of the length of this segment will be able to remain, and approximately 35% of the length of this segment will need to be rehabilitated, with only the piles to remain. From north to south, the first 725 feet can remain, followed by 175 feet that will need to be rehabilitated, followed by 270 feet that can remain, followed by 105 feet that will need to be rehabilitated, followed by 215 feet that can remain, and the remainder of the approximately 360 feet will need to be rehabilitated. A maintenance event is being planned to rehabilitate this segment. |

Approximately 35% of this segment to be rehabilitated (aside from piles) – Note that heads of bolts are deteriorated/missing: 29°57'7.19", -89°50'38.35"

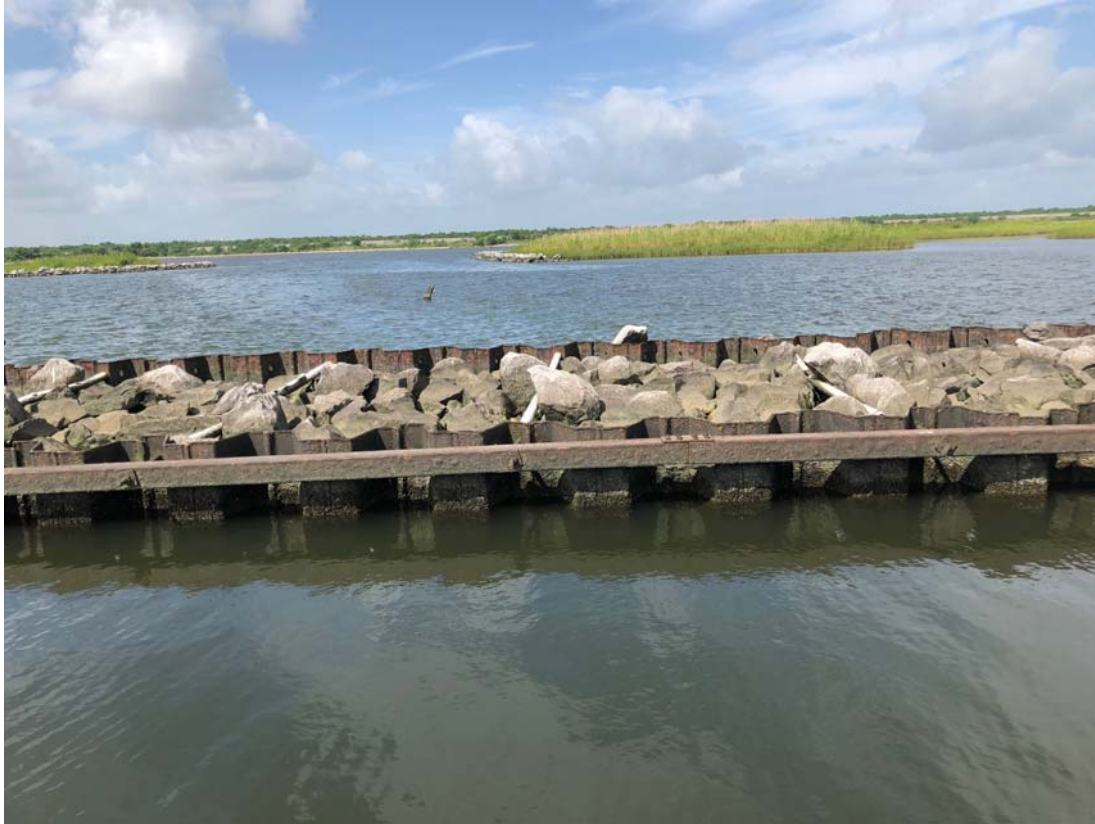
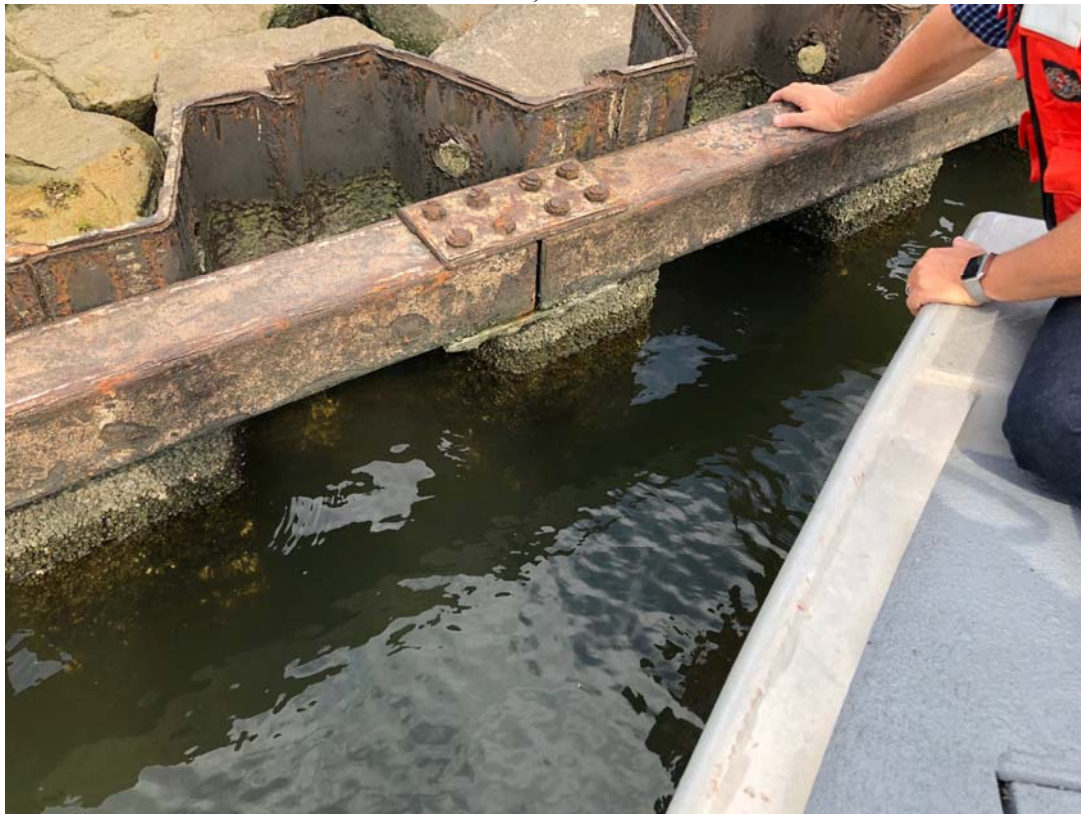
- F. Double Sheetpile Wall Breakwater at the mouth of Bayou Dupre** – The double sheetpile wall breakwater appears to be in good condition. One tie rod has failed. A maintenance event is being planned to replace the tie rod. The rock has experienced minor settlement to roughly +2.0' NAVD 88. The performance of the feature does not appear to be affected.

| MAINTENANCE INSPECTION REPORT CHECK SHEET | | | | | |
|---|---|---|---|--|--|
| Reaches 1 & 2<br>Double Sheet-pile | Good | Minor | light | 14-15 | One tie rod has failed. Rock has experienced minor settlement - to roughly +2.0' NAVD 88. |

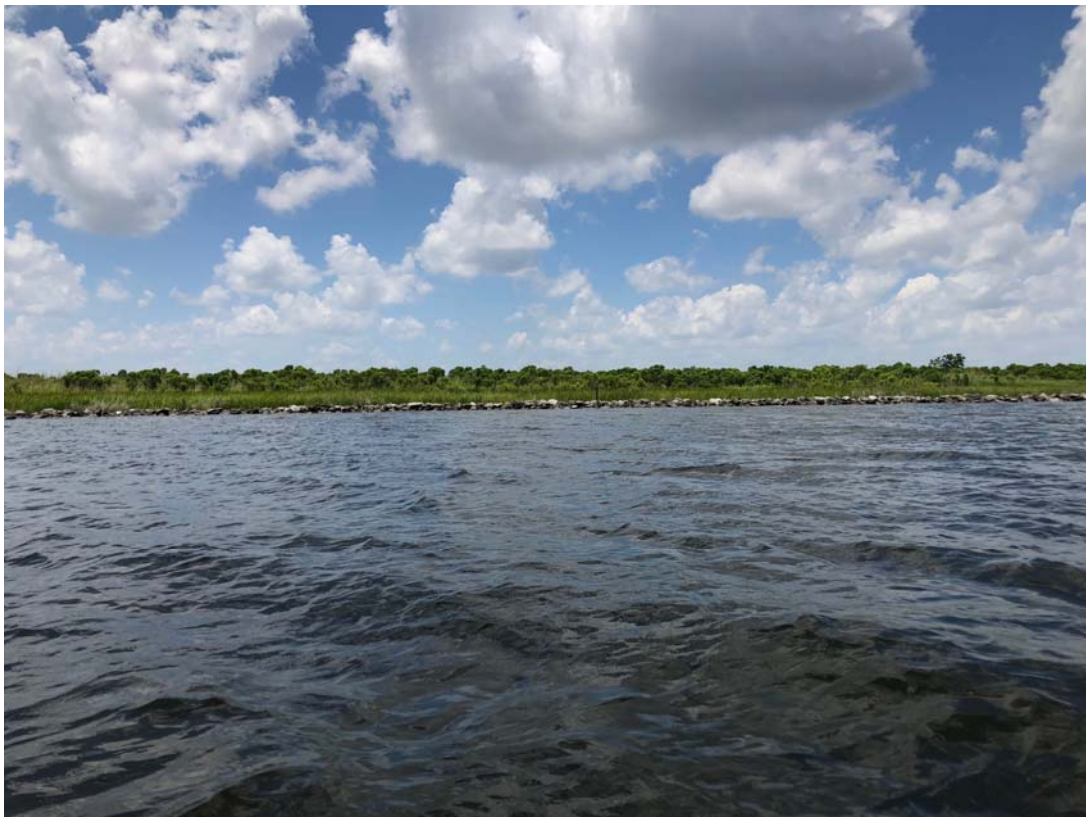
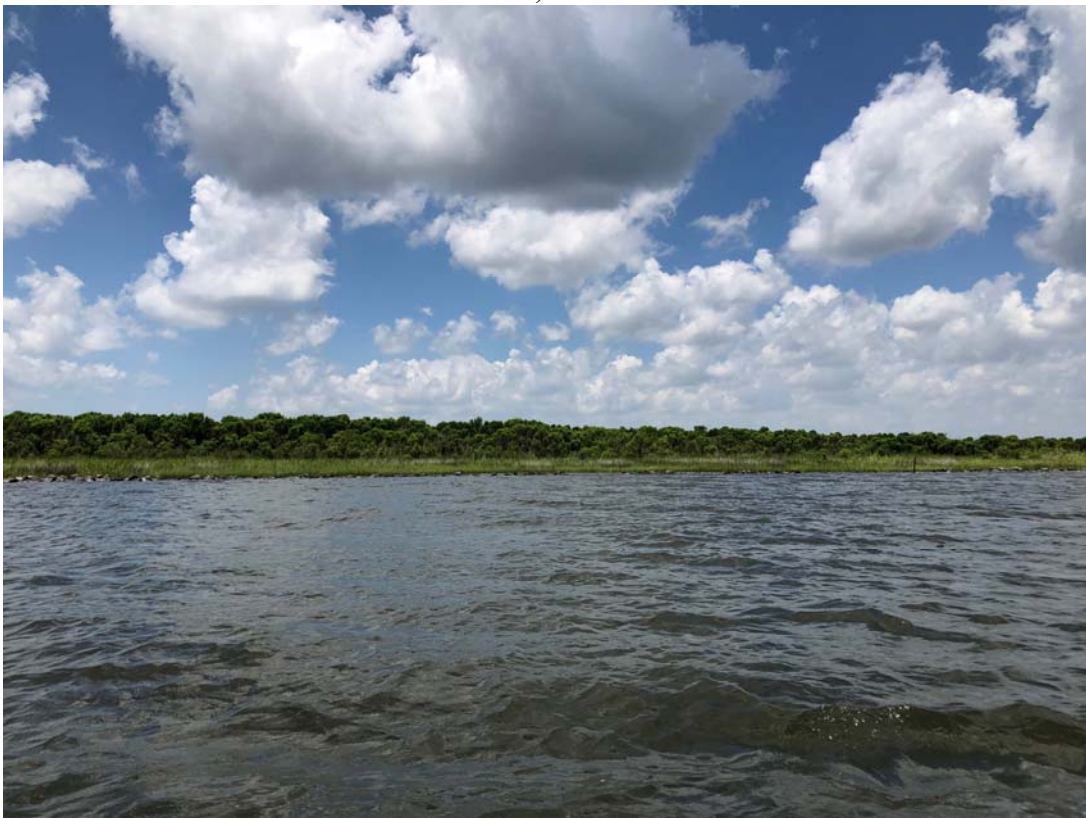
- B. Breakwater Reach 2 (South of Bayou Dupre)** – The rock breakwater appears to be mostly in good condition. There is a section approximately 100 feet long at 29°56'30.55", -89°49'59.21" that appears to be approximately 0.5 feet lower than the adjacent rock.

| MAINTENANCE INSPECTION REPORT CHECK SHEET | | | | | |
|---|---|---|---|--|--|
| Reach 2<br>Rock Breakwater | Good | Some settlement | N/A | 16-17 | There is one area roughly 100 feet long at 29°56'30.55", -89°49'59.21" that appears to be approximately 0.5 feet lower than the adjacent rock. |

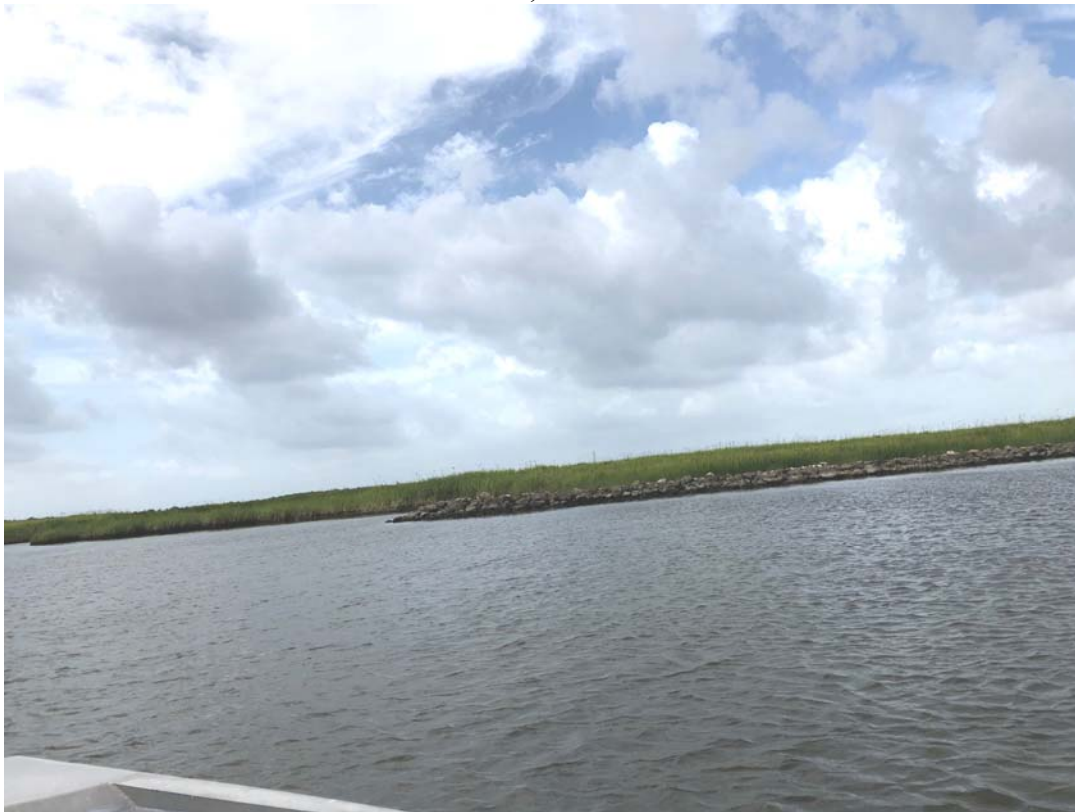
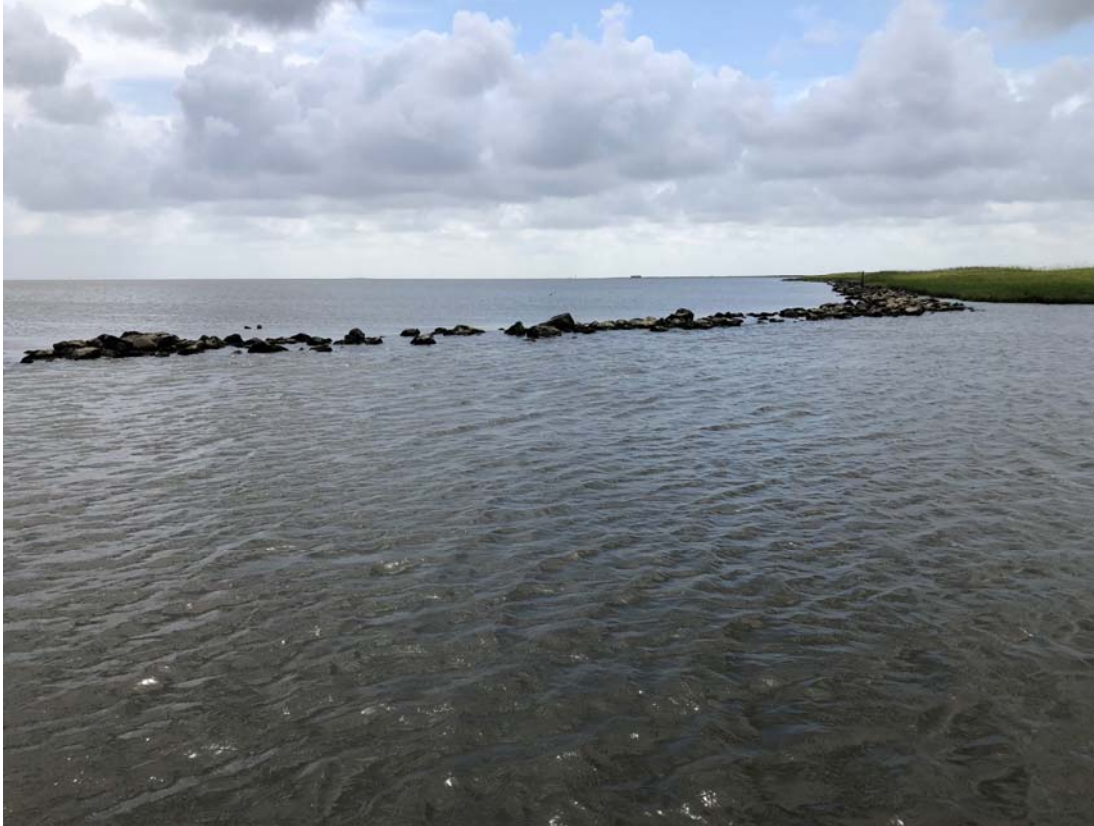
- C. Breakwater Reach 3 Strong (West of Tennessee Gas Pipeline)** – The rock breakwater has some areas of settlement to below +1.5' NAVD 88 at the following locations: about 100' long at 29°52'14.76", -89°41'48.65" and about 200' long at 29°52'10.36", -89°41'31.07". The marsh is very healthy. There is some rock settlement and marsh retreat at the mouth of Fort Bayou.

| MAINTENANCE INSPECTION REPORT CHECK SHEET | | | | | |
|---|---|---|---|--|--|
| Reach 3<br>Rock Breakwater | Good | Some settlement | N/A | 19-20, 22 | The rock breakwater has some areas of settlement to below +1.5' NAVD 88 at the following locations: about 100' long at 29°52'14.76", -89°41'48.65" and about 200' long at 29°52'10.36", -89°41'31.07". The marsh is very healthy. There is some rock settlement and marsh retreat at the mouth of Fort Bayou. |

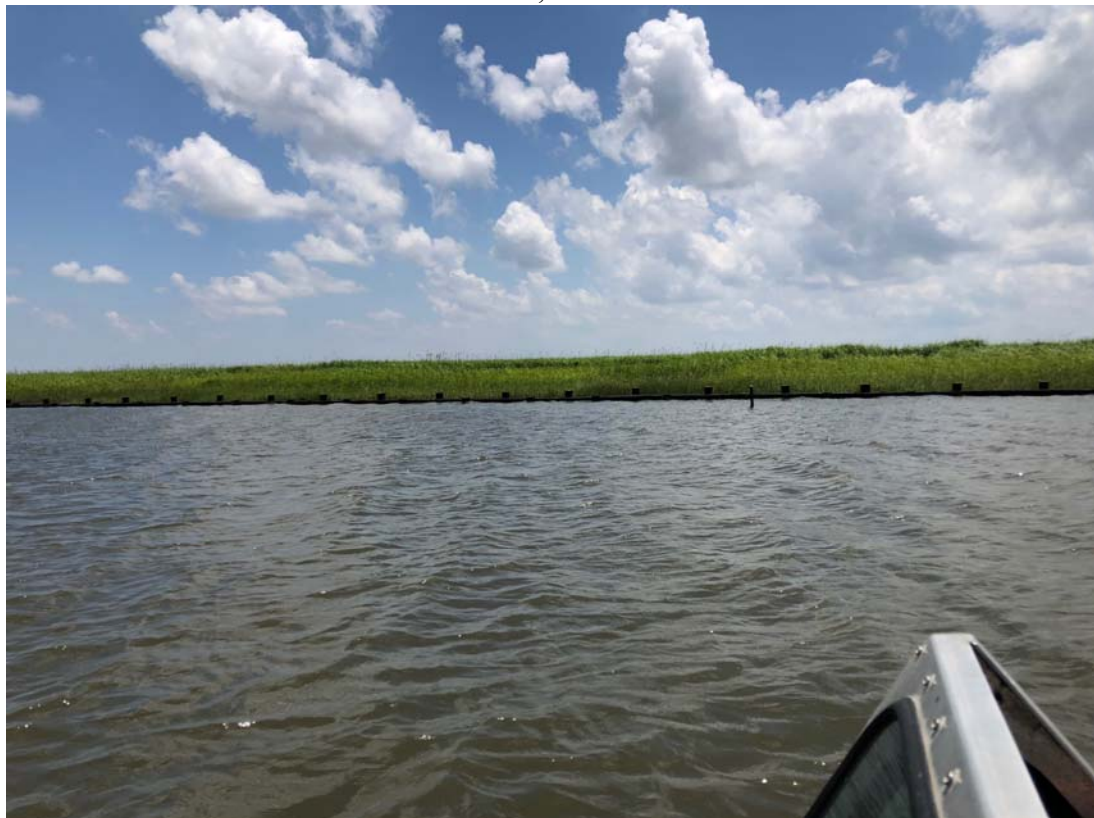
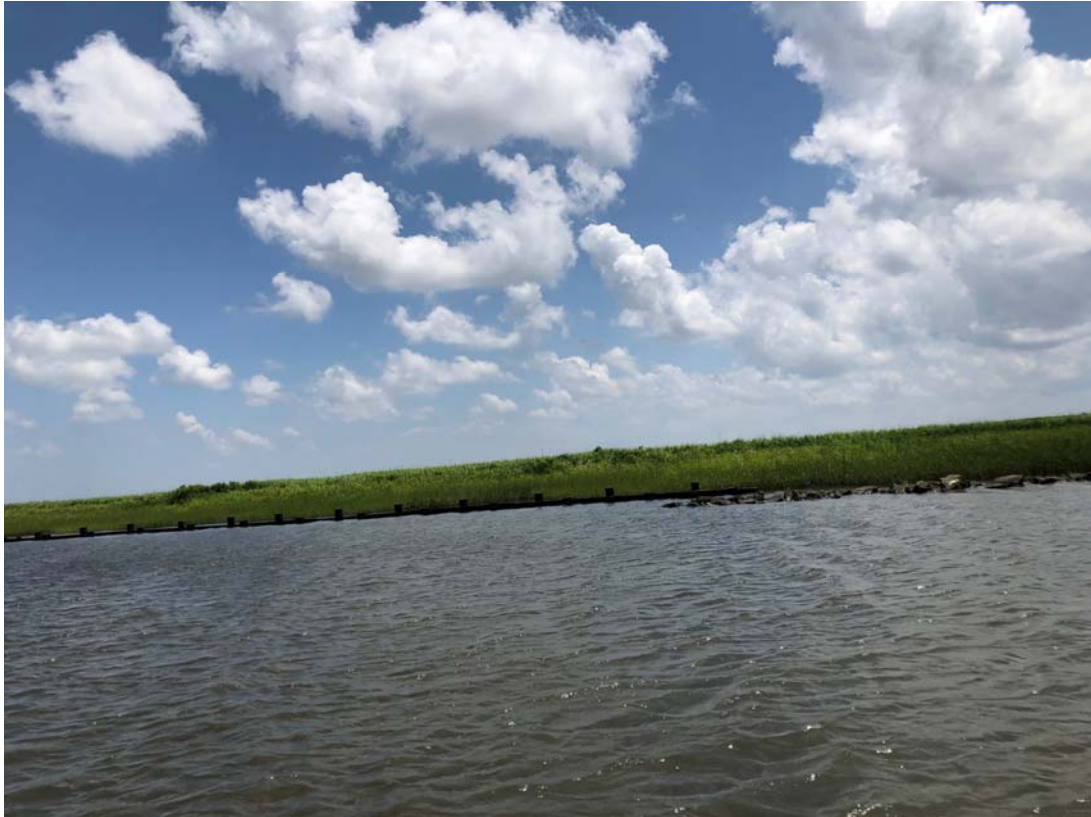
- D. Breakwater Reach 3 Weak (Between Tennessee Gas Pipeline and Bayou Yscloskey)** – The rock breakwater and composite sheetpile walls were in good condition. Some washers and one bolt are missing. One sheet is missing.

| MAINTENANCE INSPECTION REPORT CHECK SHEET | | | | | |
|---|---|---|---|--|--|
| Reach 3<br>Composite Sheetpile<br>Const. 2013 | Good | None | N/A | 21-22 | Some washers and one bolt are missing. One sheet is missing. |

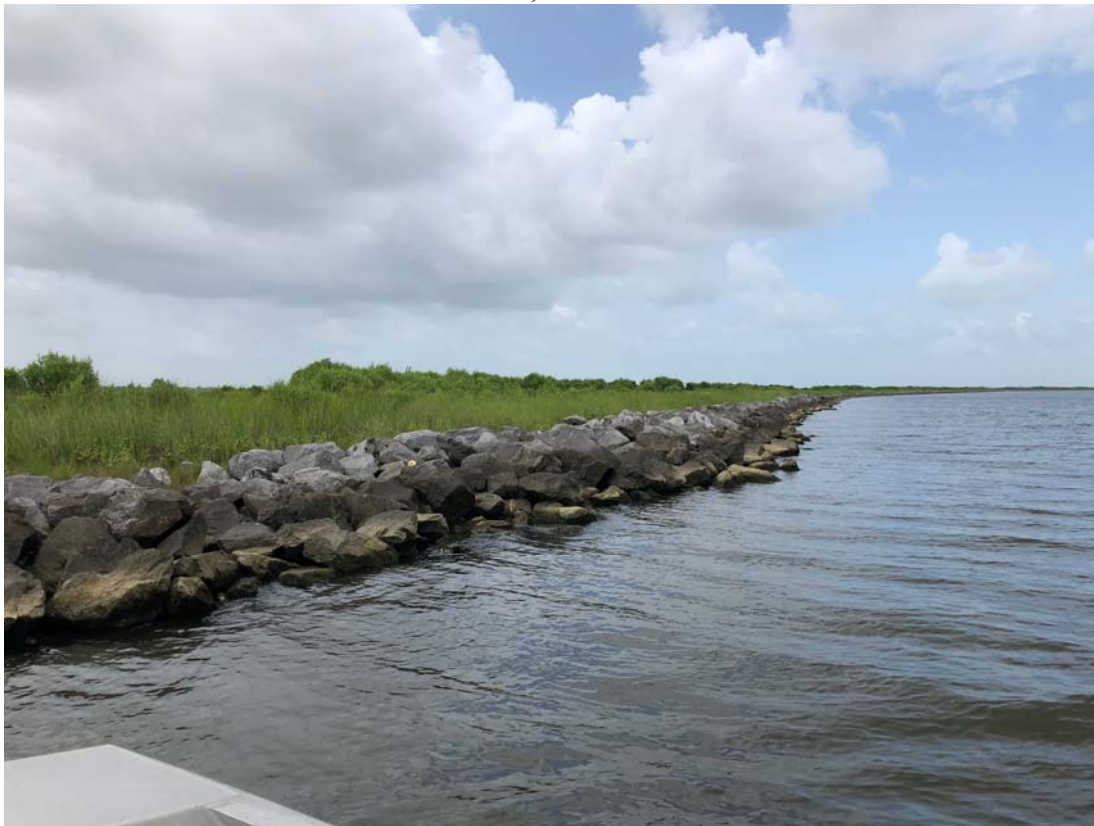
**Photo 23: Reach 4**  
29°51'41.21", -89°39'22.66"

- E. Breakwater Reach 4 (East of Bayou Yscloskey)** – The rock breakwater appears to be in good condition with the exception of one area roughly 200' long at approximately 29°51'44.85", -89°39'39.40" that has settled to about +1.75' NAVD 88.

| MAINTENANCE INSPECTION REPORT CHECK SHEET | | | | | |
|---|---|---|---|--|--|
| Reach 4<br>Rock Breakwater | Good | Some settlement | N/A | 23 | The rock breakwater appears to be in good condition with the exception of one area roughly 200' long at approximately 29°51'44.85", -89°39'39.40" that has settled to about +1.75' NAVD 88. |
